Facility Condition Assessment Summary Report

Carnell School

January 31, 2017

Facility Condition Assessment
July 2015

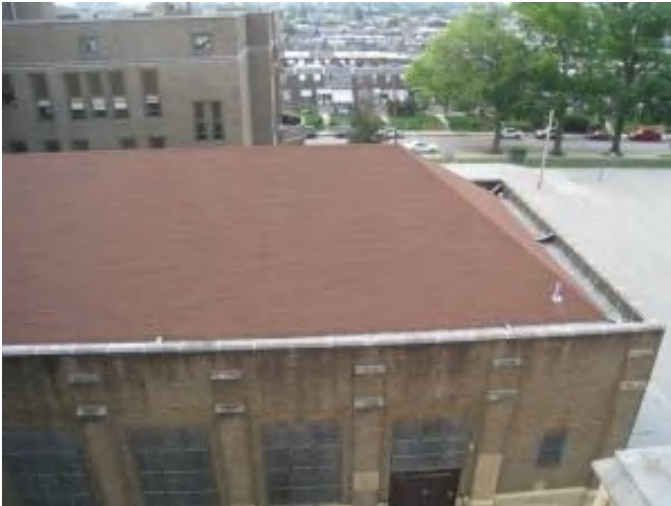
System: B3010105 - Built-Up

Location: main bldg - auditorium

Distress: Beyond Service Life

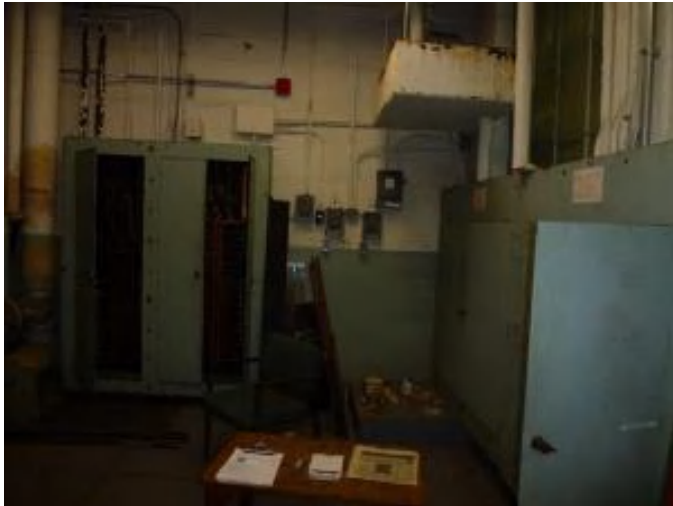
System: D5010 - Electrical Service/Distribution

Location: Boiler Room in the basement

Distress: Beyond Service Life

Notes: Install a new emergency power system including 100KW diesel generator and respective transfer switch.

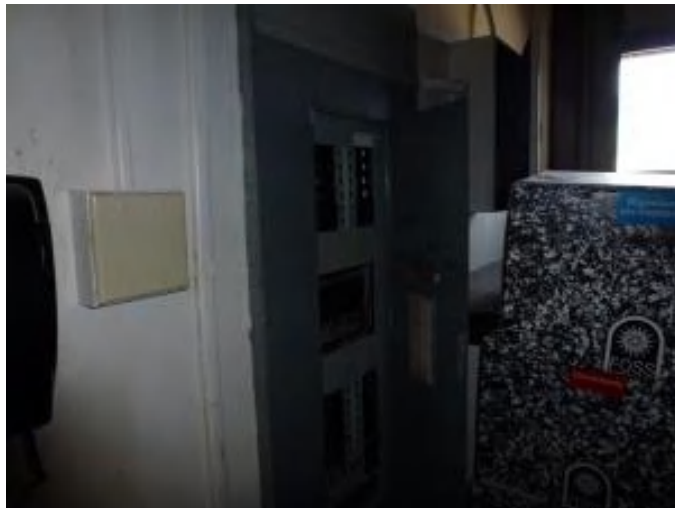
System: E1020 - Institutional Equipment

Location: Auditorium

Distress: Beyond Service Life

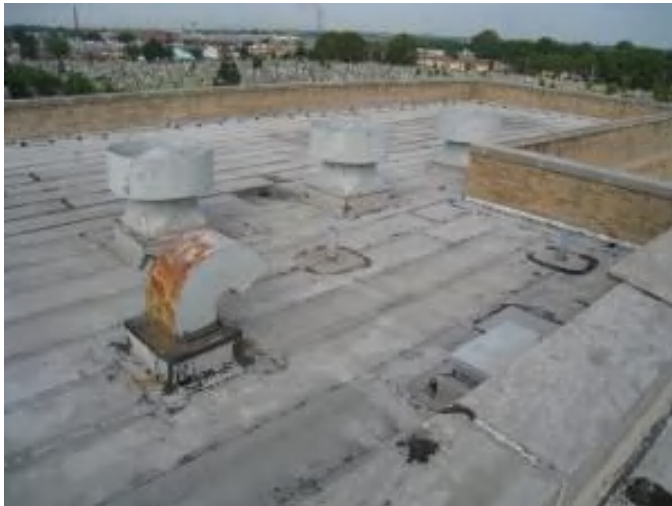
System: D2040 - Rain Water Drainage

Location: main building roof

Distress: Building / MEP Codes

Notes: Add overflow scuppers to main building roof parapets

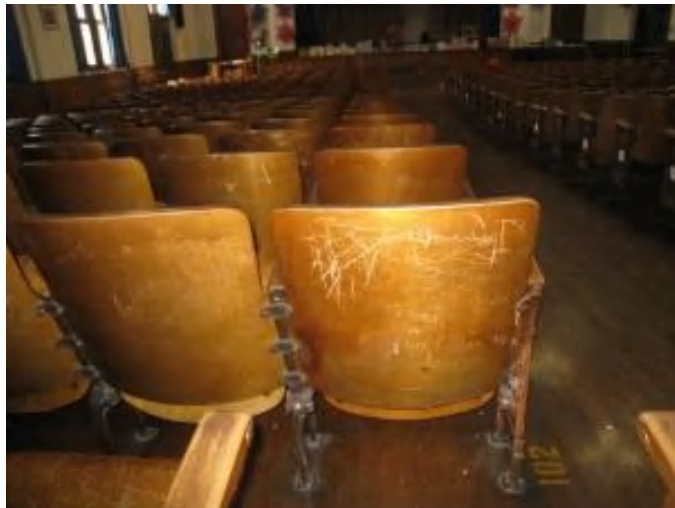
System: E2010 - Fixed Furnishings

Furnishings include the original folding wood seating in the auditorium which is still in use; however many seats need to be repaired to operate properly and many are scratched. With the unavailability of parts for repair and the worn condition of the seating, full replacement is required. Casework in classrooms and the office is damaged, worn and needs replacement.

Location: main bldg - auditorium

Distress: Beyond Service Life

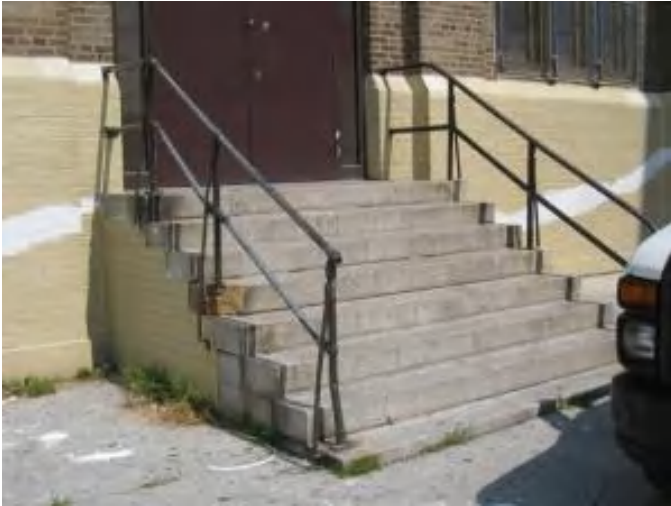
System: B2030 - Exterior Doors

Exterior doors in the main building are painted steel framed flush hollow metal units with steel frames. Some doors have small glazing vision panels. Doors are in generally poor condition, have broken or non-functioning panic hardware, rusted dented panels and frames, and are not ADA compliant. There are no handicap entrances, no accessible ramps and no elevators. All exterior steel doors and hardware systems need to be replaced. Exterior entrance doors in the LSH are painted aluminum tube frame system door units with plexiglass glazing and glass side lights. Plexiglass is scratched and needs replacing. Rear and side doors are painted hollow metal with small, glazed, vision panels or large plexiglass; front doors and accessible entrance have full glass sidelights with plexiglass in painted aluminum frame doors. All doors are in generally poor condition, with scratched and dented panels and frames. There is a labeled ADA accessible entrance on the side of the building, which needs cleaning, repainting and repairs to the aluminum frame.

Location: main bldg

Distress: Building / MEP Codes

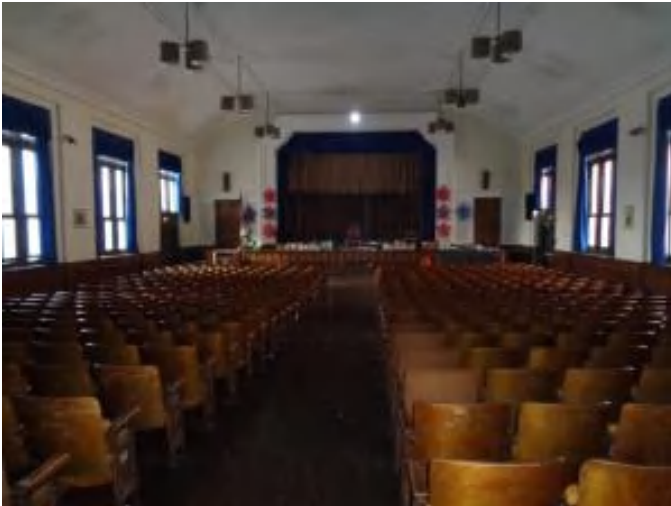
System: D3040 - Distribution Systems

Location: main building

Distress: Obsolete

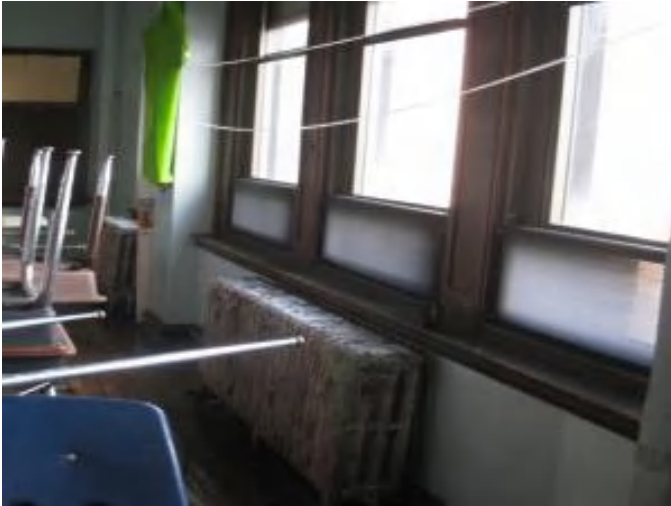
System: B2020 - Exterior Windows

Exterior windows in the main building were replaced in the 1990's with bronze anodized aluminum frame operable single hung units with single thickness clear plexiglass acrylic vision panel glazing. Windows are in poor condition with oxidized frames and severely scratched single-pane plexiglass vision panels. Operable units are difficult to operate up and down or do not stay open due to broken internal counterbalance weights, accidentally slamming closed in some cases – a potential safety hazard. Single pane plexiglas units do not meet today's energy code requirements and are large sources of heat loss. Exterior windows in the LSH are insulated glass in a painted aluminum tube framing system. The sidelight glass at the main entrance is broken. Doors have a single layer of plexiglas as glazing. Exterior windows are protected by security screen that cover all windows on all sides of the building. The screens facing the play area are dented and there is graffiti on many of the screens. Most of the graffiti has been painted over with paint that doesn't completely cover the graffiti and doesn't match the existing screen color.

Location: main bldg

Distress: Beyond Service Life

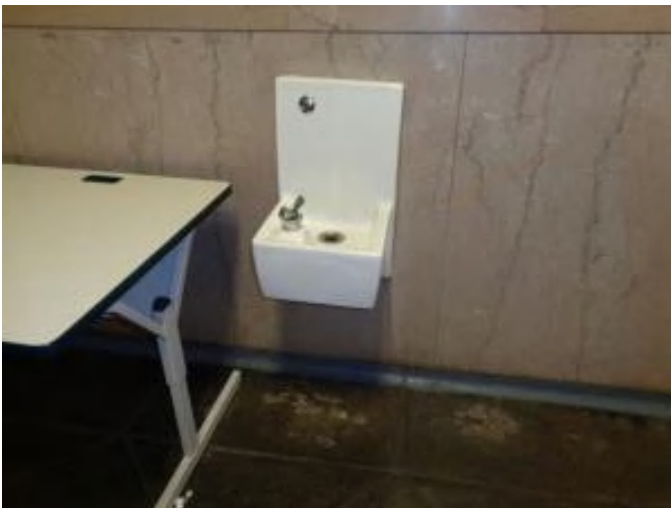
System: D2010 - Plumbing Fixtures

The plumbing fixtures throughout the main building are beyond their serviceable life and should all be replaced, with exception of the gang bathrooms and the stainless steel sink. The Little School House needs only a fire suppression system for the grease hood.

Location: main building

Distress: Obsolete

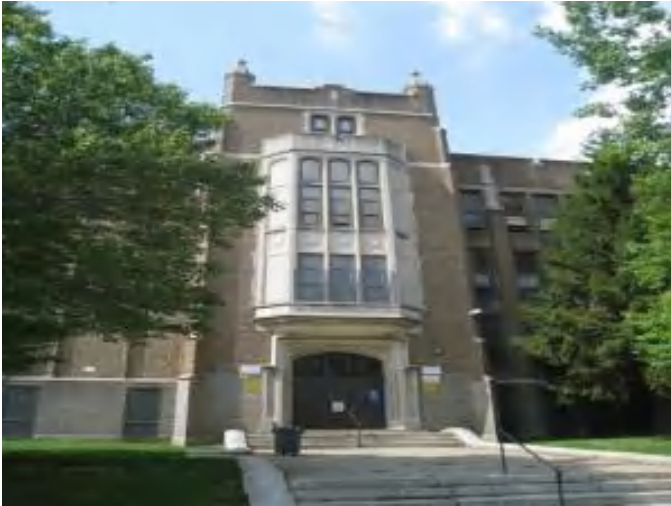
System: B2010 - Exterior Walls

Location: main bldg
Distress: Appearance
Category: 3 - Operations / Maint.
Priority: 5 - Response Time (> 5 yrs)
Correction: Sooty and dirty walls - powerwash

Notes: Clean (powerwash) exterior brickwork front + sides of main building

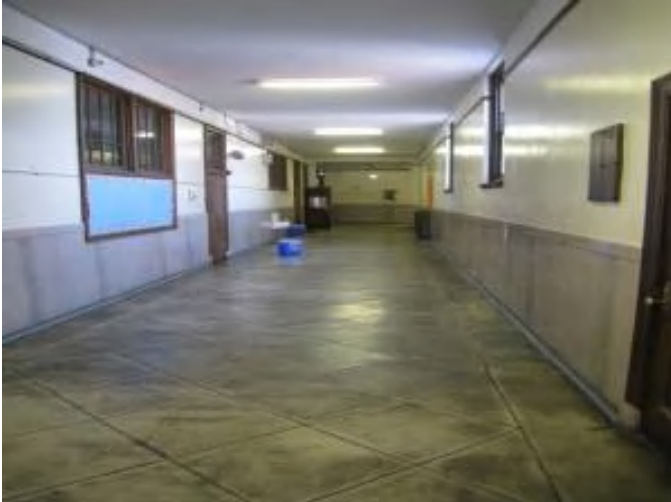
System: C1010 - Partitions

Location: main bldg
Distress: Obsolete
Category: 3 - Operations / Maint.
Priority: 5 - Response Time (> 5 yrs)
Correction: Install fire rated walls and door where required
- insert number of doors

Notes: Remove non-rated glass panels between classrooms and corridors; fill with fire rated gyp bd sys

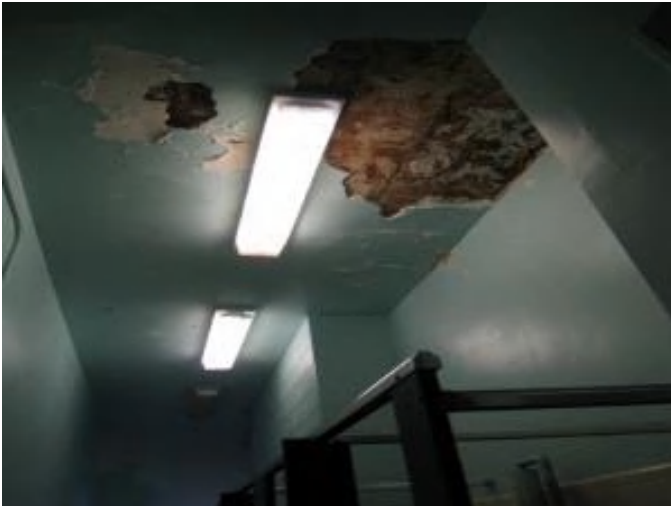
System: C3030 - Ceiling Finishes

Ceiling finishes in the original building are mostly exposed plaster throughout the original building with suspended fluorescent lighting fixtures; minor cracking is evident throughout the building. Outside the auditorium and above the stage are areas of heavily damaged plaster ceilings due to past leaks, in need of repair. Corridors in Element 2 are finished with 12"x12" concealed spline acoustical tiles with surface mounted lighting fixtures in generally aged and worn condition. Ceiling finishes in LSH corridors and the Multi-Purpose Room, and the office areas consist of 2x4 recessed acoustical tile ceilings with recessed 2x4 fluorescent lighting fixtures. Classrooms have stained wood deck single slope cathedral ceilings with suspended acoustical lighting fixtures. Mechanical areas have no ceilings.

Location: main bldg

Distress: Appearance

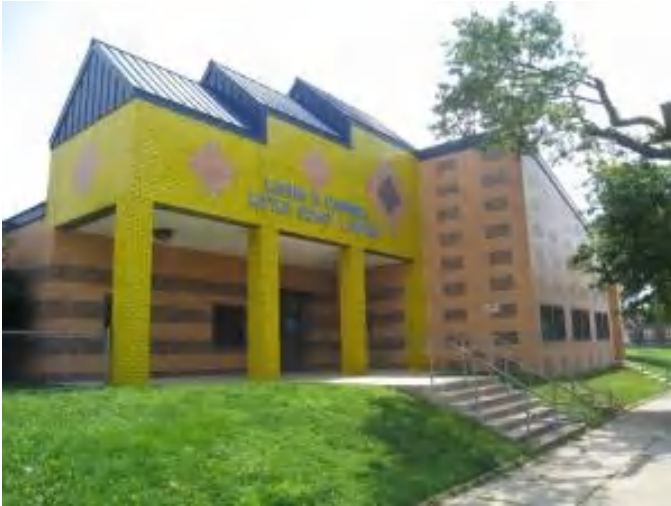
System: C1030 - Fittings

Location: LSH

Distress: Appearance

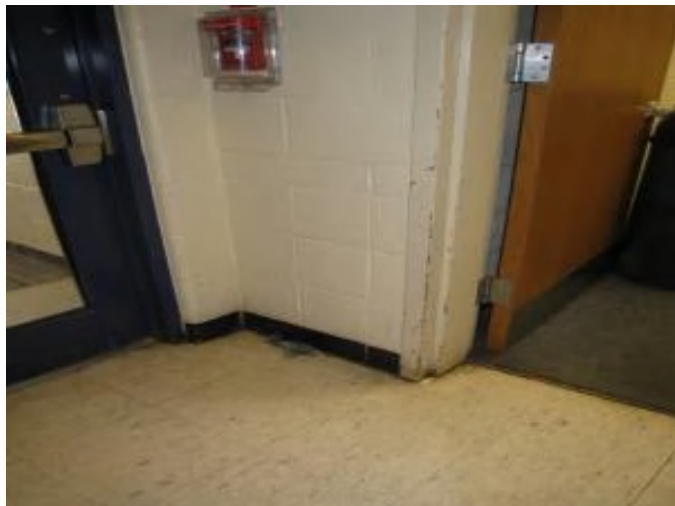
System: C1020 - Interior Doors

Location: LSH

Distress: Appearance

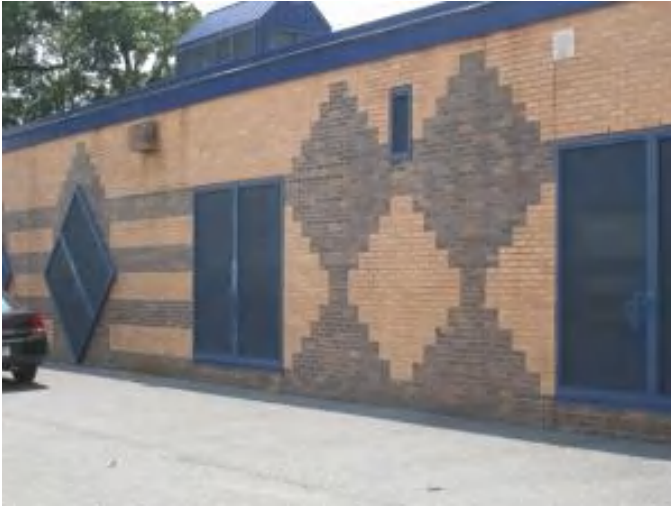
System: B2010 - Exterior Walls

Location: LSH

Distress: Appearance

Notes: Clean exterior brickwork

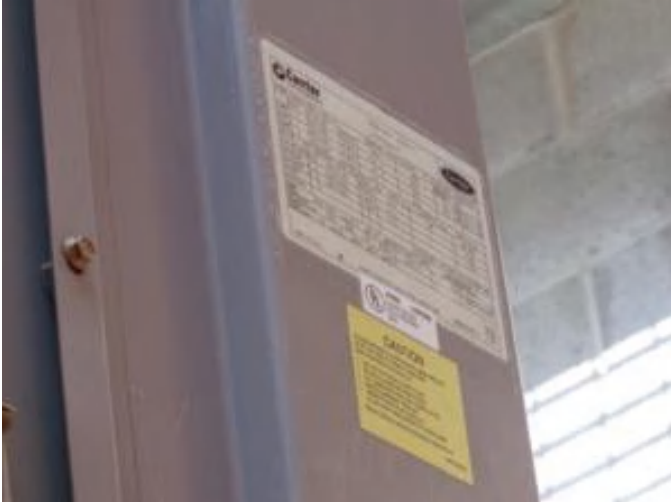
System: D3030 - Cooling Generating Systems

Location: LSH

Distress: Obsolete
