### Cooke School

**S710001;Cooke**

**Site Assessment Report**

February 1, 2017

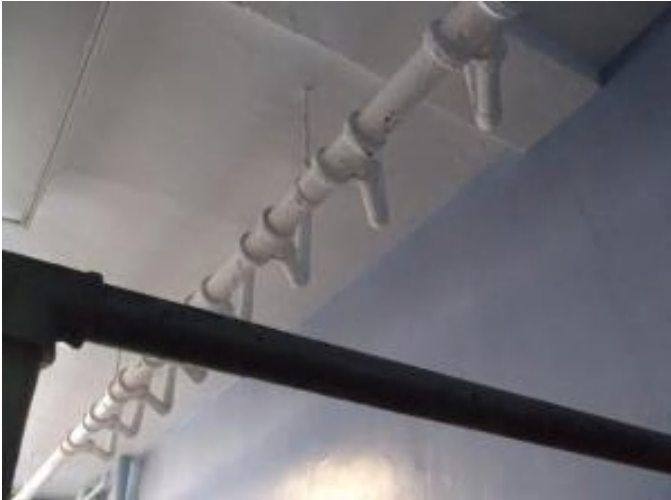
**System: D2030 - Sanitary Waste**

**Location:** Throughout the building

**Distress:** Beyond Service Life

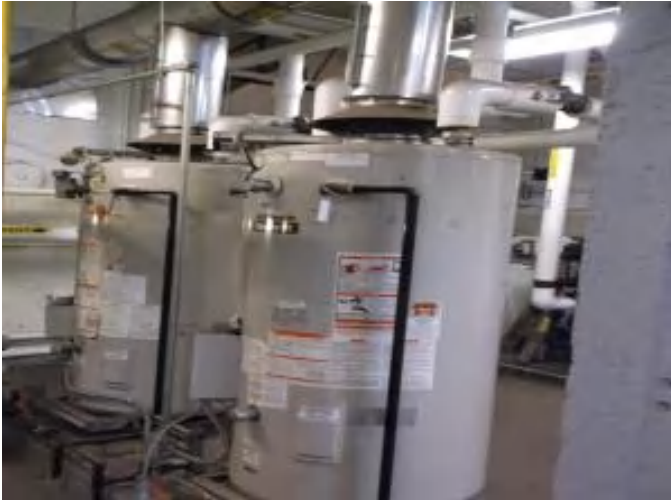
**System: D2020 - Domestic Water Distribution**

**Location:** Main boiler mechanical equipment room

**Distress:** Beyond Service Life

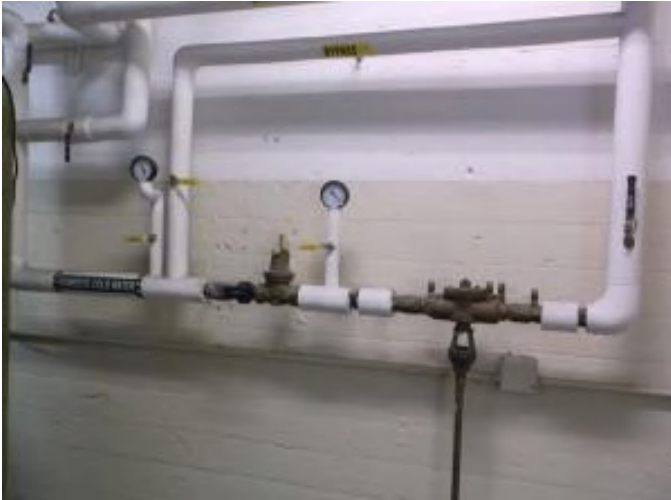
**System: D2020 - Domestic Water Distribution**

**Location:** Throughout the building

**Distress:** Beyond Service Life

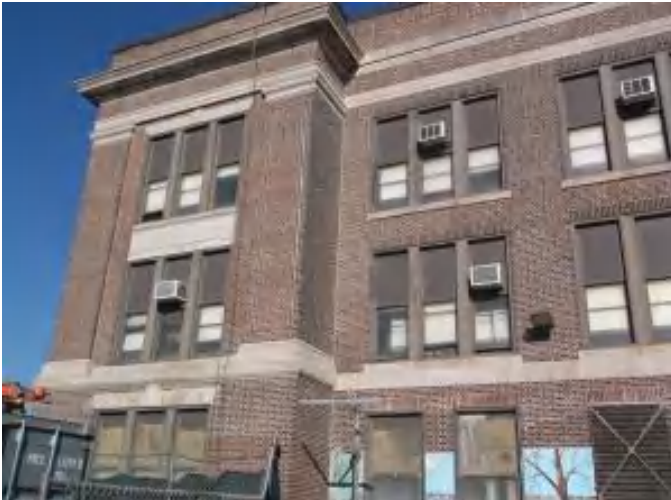
**System: D3030 - Cooling Generating Systems**

Cooling Generating Systems – There are a few area which have window air conditioning units, but predominantly the building does not have cooling systems.

**Location:** Adjacent to building

**Distress:** Beyond Service Life

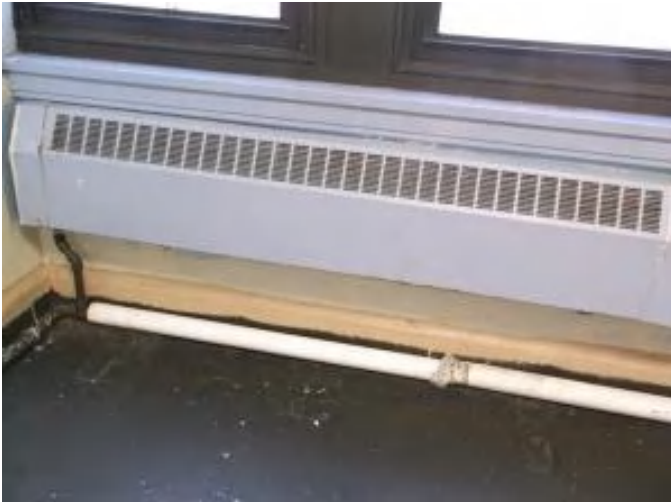
**System: D3040 - Distribution Systems**

**Location:** Throughout the building

**Distress:** Beyond Service Life
