Facility Condition Assessment Summary Report

Day School

School District of Philadelphia
S620001;Day
Final
Site Assessment Report
January 31, 2017

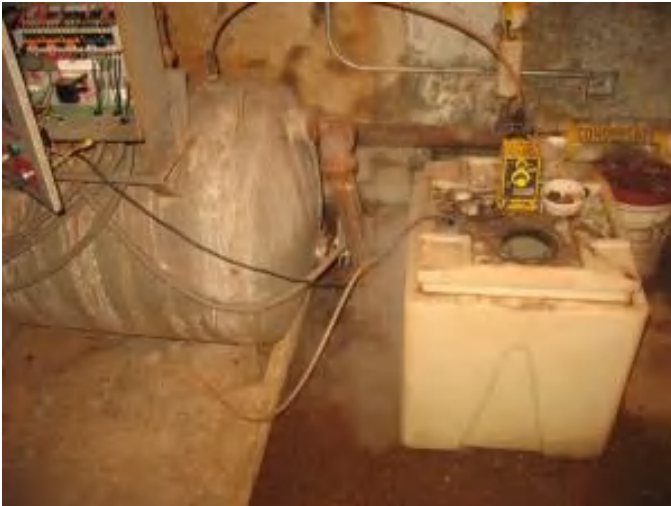
System: D3040 - Distribution Systems

Location: Throughout building

Distress: Failing

Notes: Conduct a steam trap survey to identify and replace failed traps passing live steam into the condensate piping system.

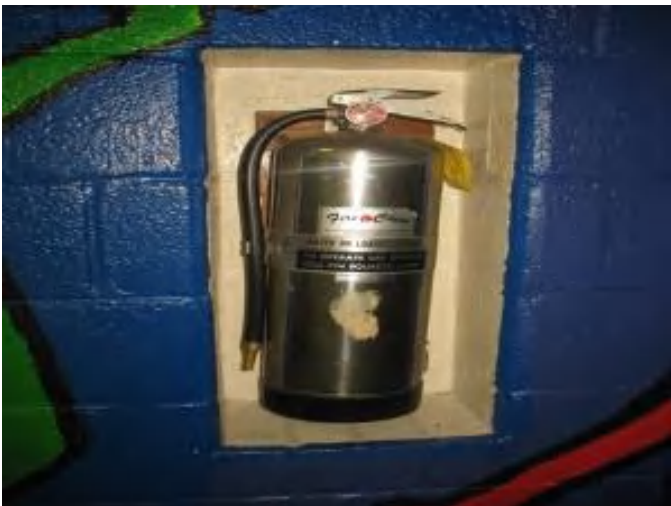
System: D4010 - Sprinklers

Location: Throughout building

Distress: Life Safety / NFPA / PFD

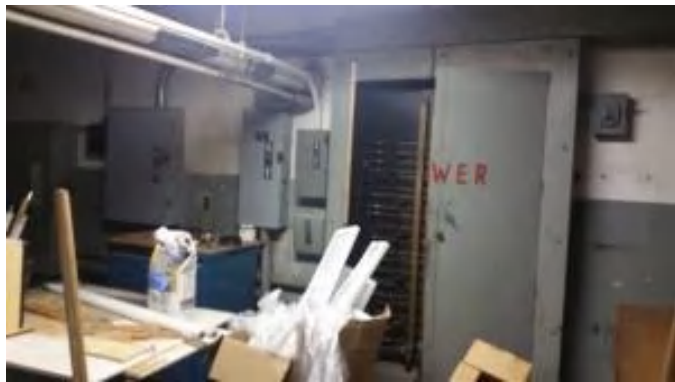
System: D5010 - Electrical Service/Distribution

Location: throughout the building

Distress: Beyond Service Life

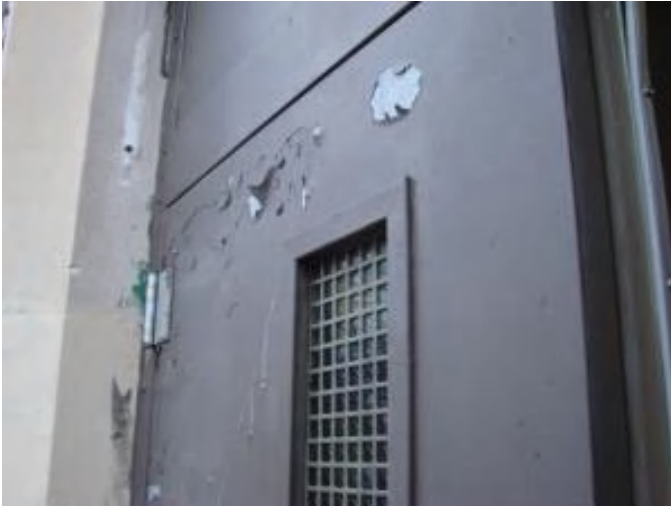
System: B2030 - Exterior Doors

Location: Throughout

Distress: Beyond Service Life

Notes: Replace exterior doors – beyond service life and damaged

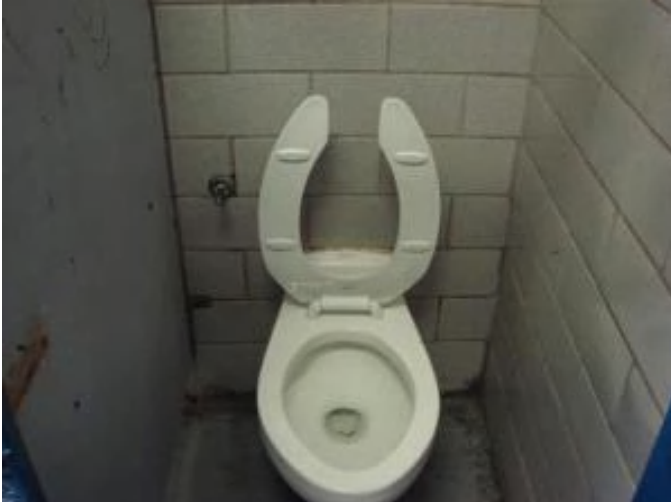
System: C1030 - Fittings

Location: Toilets

Distress: Accessibility

Notes: Replace toilet partitions for accessibility

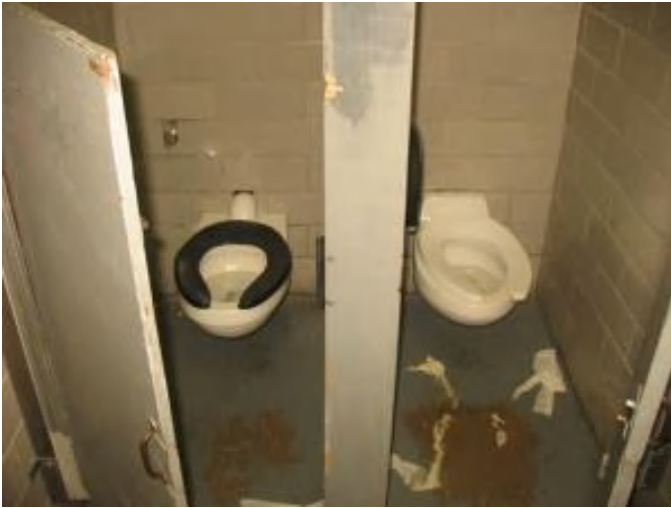
System: D2010 - Plumbing Fixtures

Location: Restrooms

Distress: Beyond Service Life

Notes: Replace twenty (20) water closets, in use beyond their service life, in the restrooms with new code compliant fixtures.

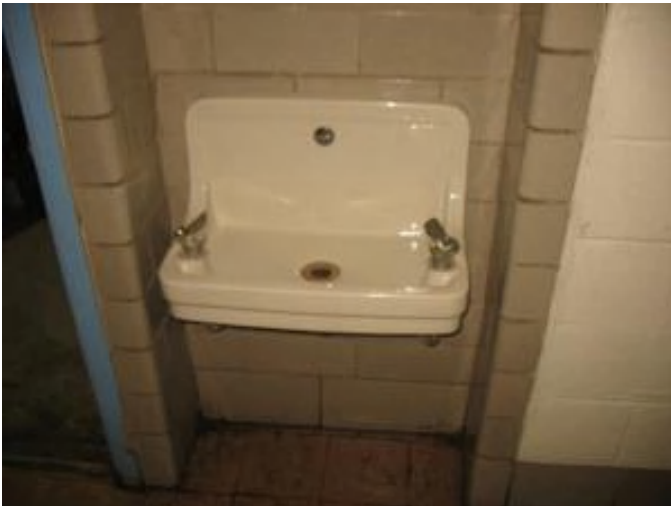
System: D2010 - Plumbing Fixtures

Location: Corridors

Distress: Beyond Service Life

Notes: Replace seven (7) porcelain wall hung drinking fountains in the corridors. These units are beyond their service life and most are NOT accessible type.

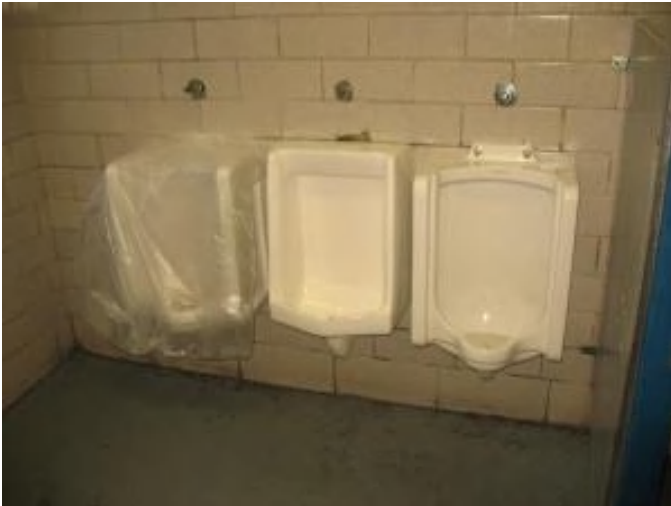
System: D2010 - Plumbing Fixtures

Location: Restrooms

Distress: Beyond Service Life

Notes: Replace twelve (12) urinals, in use beyond their service life, in the restrooms with new low flow fixtures.

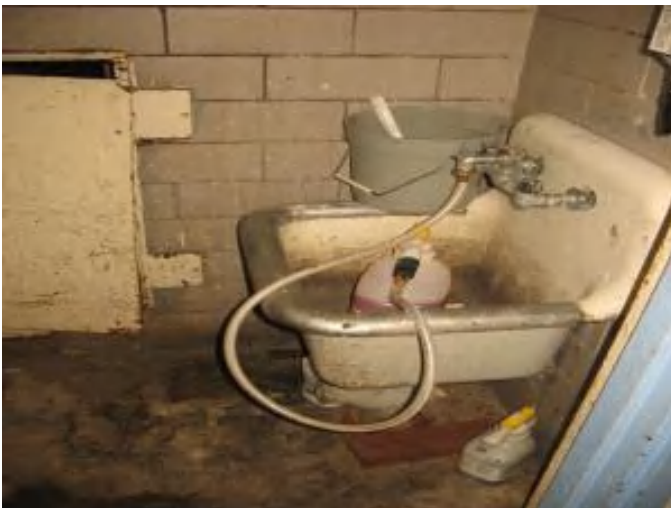
System: D2010 - Plumbing Fixtures

Location: Corridors

Distress: Beyond Service Life

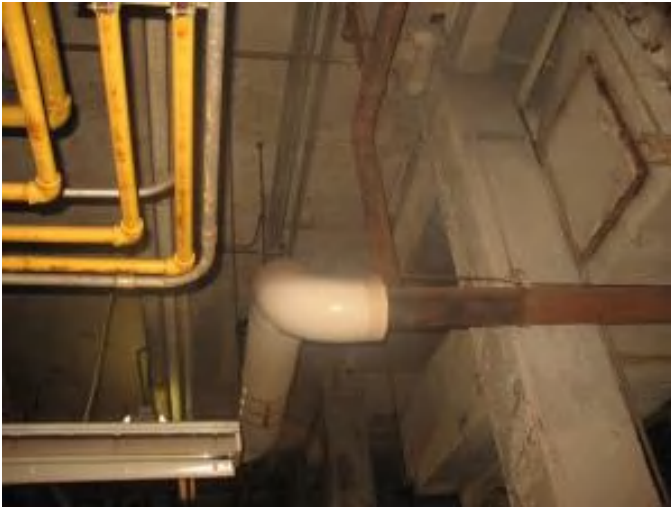
System: D3040 - Distribution Systems

Location: Throughout building

Distress: Beyond Service Life

Notes: Hire a qualified contractor to examine the steam and condensate piping, in service for nearly 65 years, and perform additional testing to locate and replace any damaged piping and to further quantify the extent of potential failures.

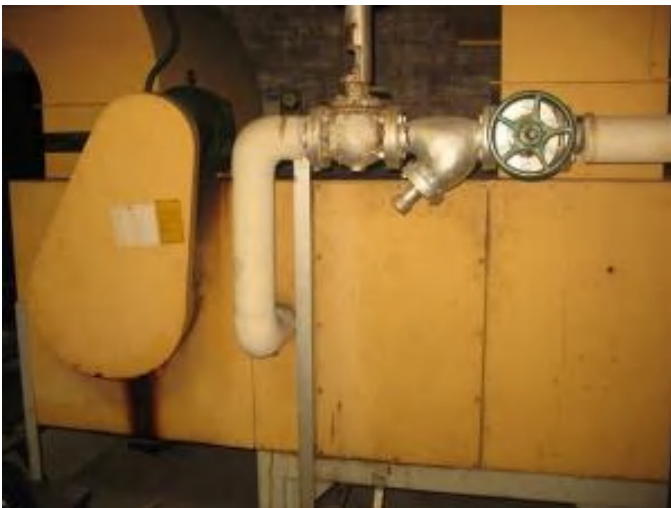
System: D3040 - Distribution Systems

Location: Gymnasium/Cafeteria

Distress: Beyond Service Life

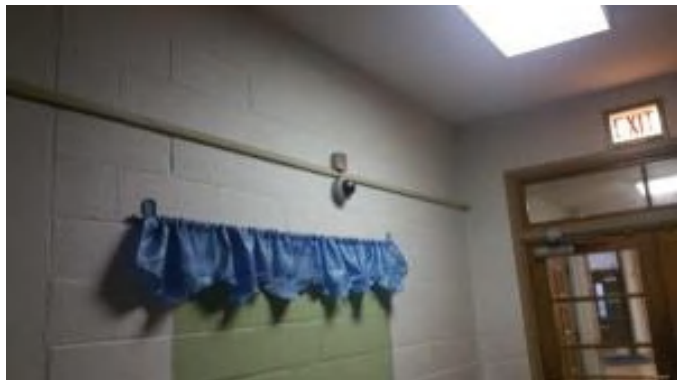
System: D5090 - Other Electrical Systems

Location: throughout the building

Distress: Beyond Service Life

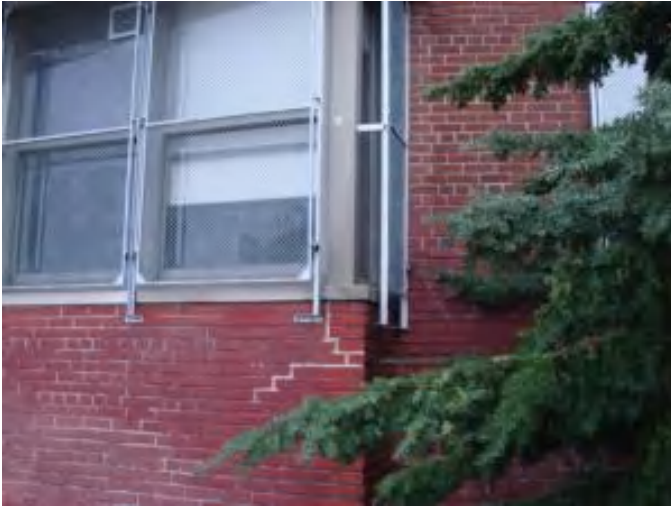
System: B2010 - Exterior Walls

Location: Exterior walls

Distress: Damaged

Notes: Repair cracks in exterior brick masonry

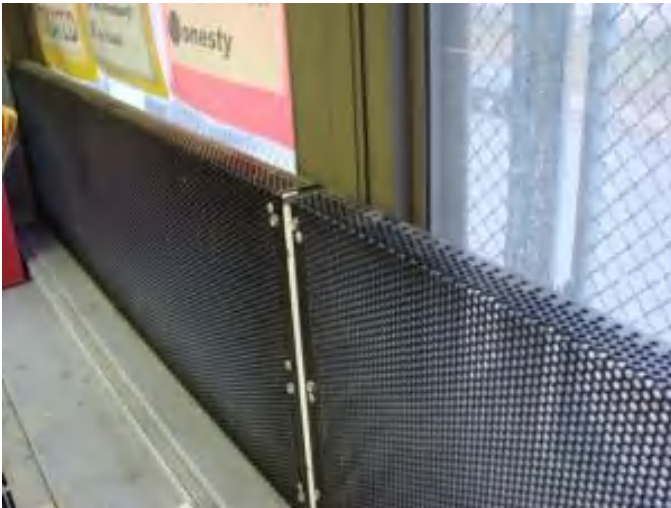
System: B2020 - Exterior Windows

Location: Ext. windows

Distress: Energy Efficiency

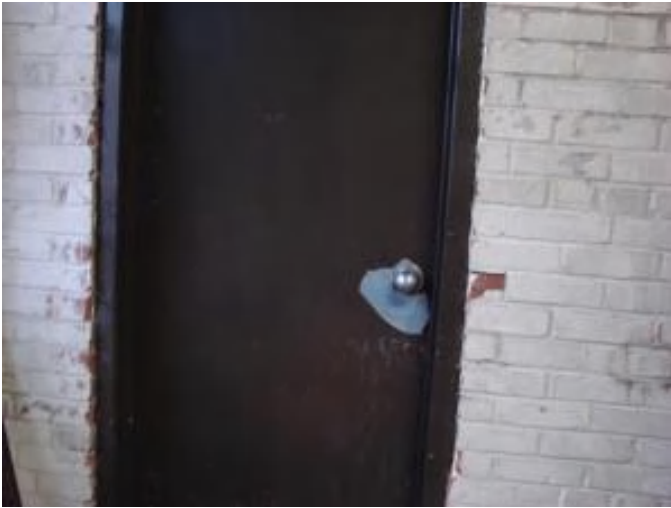
System: C3010230 - Paint & Covering

Location: Throughout

Distress: Maintenance Required

Notes: Repaint interior wall surfaces – 80% beyond service life

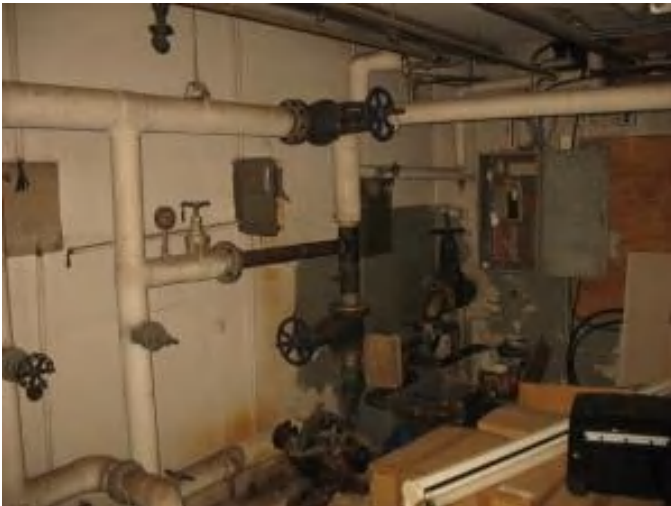
System: D2020 - Domestic Water Distribution

Location: Throughout building

Distress: Beyond Service Life

Notes: Hire a qualified contractor to perform a detailed inspection of the domestic water piping, in use for an unknown amount of time, and replace any damaged piping.

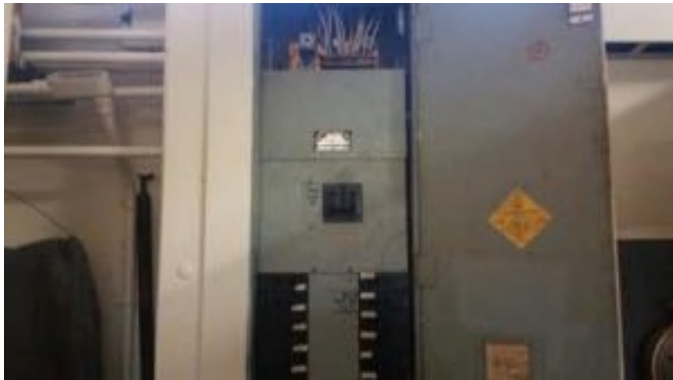
System: D5010 - Electrical Service/Distribution

Location: electrical room

Distress: Beyond Service Life

Notes: Install new Site electrical service 1000KVA, 480V, 3 Phase to feed the existing loads plus new HVAC additional loads. Install new 480V, 3 phase switchgear. Install a new MCC for the new HVAC loads. Install a new 120V/208V, 3 phase switchboard.

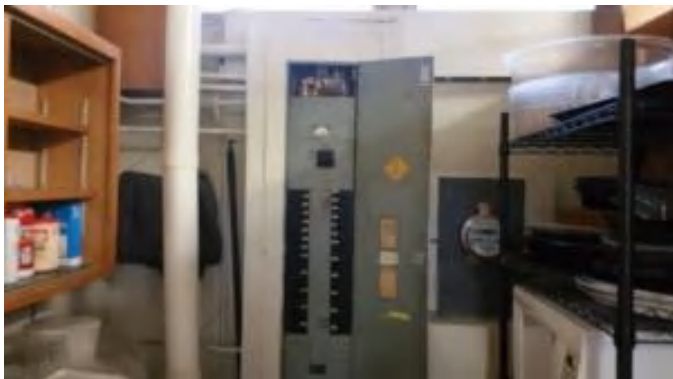
System: D5010 - Electrical Service/Distribution

Location: electrical room

Distress: Inadequate

Notes: Install new MCCs for mechanical loads and a new 120V 3 phase switchboard for all the 120V panels.

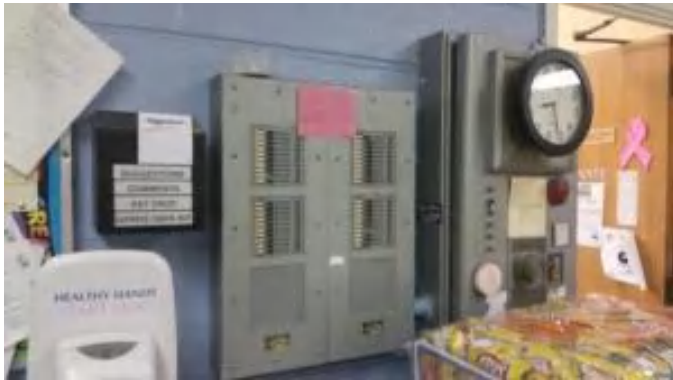
System: D5030 - Communications and Security

Location: throughout the building

Distress: Beyond Service Life

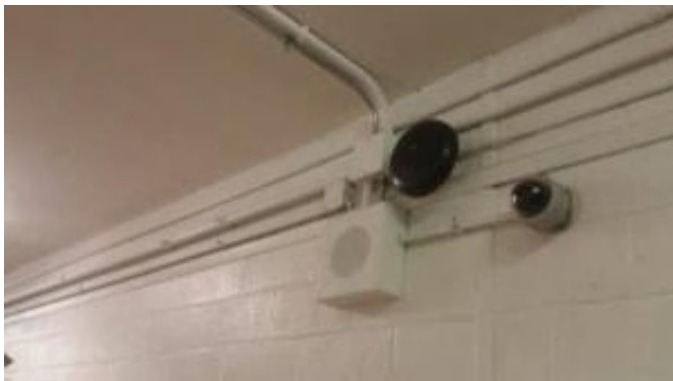
System: D5030 - Communications and Security

Location: throughout the building

Distress: Beyond Service Life

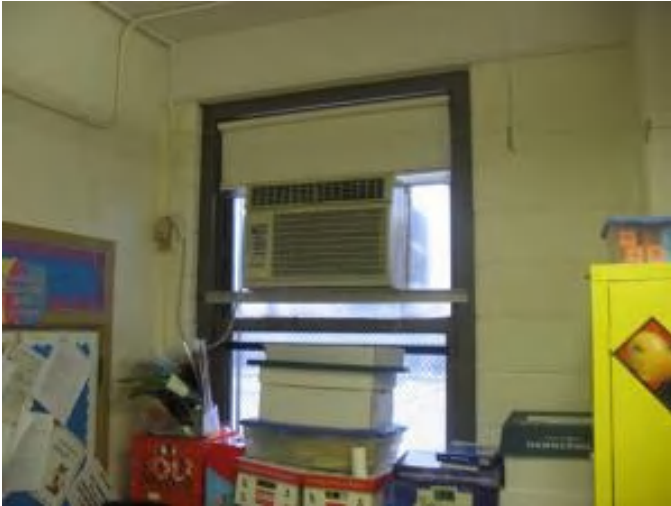
System: D3030 - Cooling Generating Systems

Location: Throughout building

Distress: Inadequate

Notes: Remove the window air conditioning units and install a 120 ton air-cooled chiller with chilled water distribution piping and pumps located in a mechanical room to supply more reliable air conditioning for the building with a much longer service life.

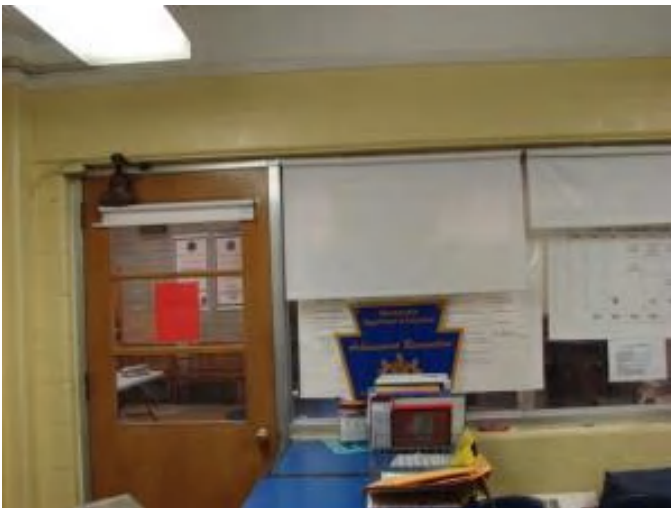
System: D3040 - Distribution Systems

Location: Administration offices

Distress: Building / MEP Codes

Notes: Provide ventilation for the administration offices by installing a fan coil air handling unit hung from the structure with outdoor air ducted to the unit from louvers in window openings.

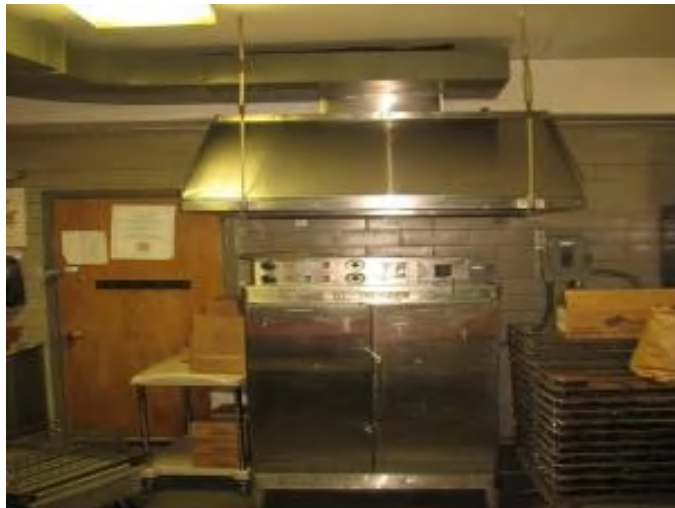
System: D3040 - Distribution Systems

Location: Kitchen

Distress: Inadequate

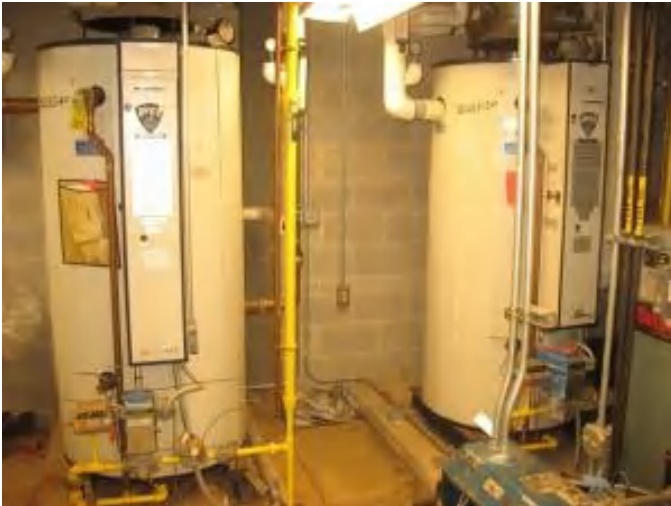
System: D2020 - Domestic Water Distribution

Location: Mechanical room

Distress: Beyond Service Life

Notes: Replace the two (2) 125 gallon vertical gas fired domestic hot water heaters which are original to the building and beyond their service life.

Correction: Replace vertical tank type gas-fired water heater (120 gal)

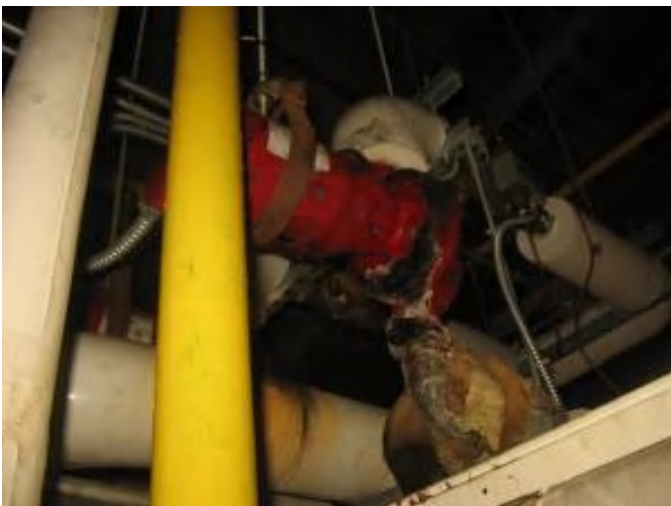
System: D3020 - Heat Generating Systems

Location: Mechanical room

Distress: Damaged

Notes: Replace one (1) ½ HP in-line hot water circulating pump which is leaking and damaged from rust.

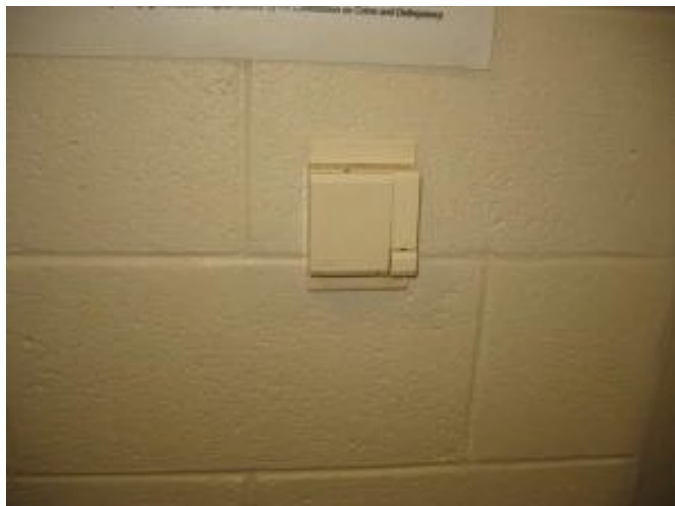
System: D3060 - Controls & Instrumentation

Location: Throughout building

Distress: Energy Efficiency

Notes: Replace the existing controls for the HVAC systems with modern DDC modules to improve reliability and energy efficiency. Provide a new building automation system (BAS) with communication interface to the preferred system in use throughout the District.

Correction: Replace pneumatic controls with DDC (75KSF)

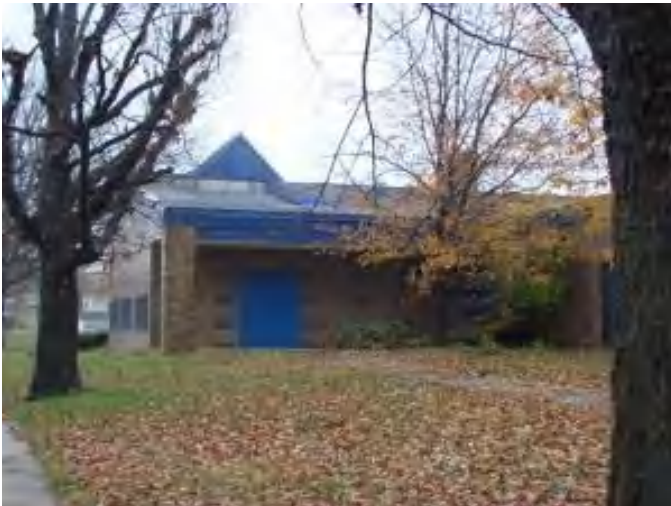
System: B3010140 - Shingle & Tile

Location: Entire building

Distress: Damaged

Notes: Repair gutter drains and seal joint

Correction: Remove and replace step flashing for shingle roofs

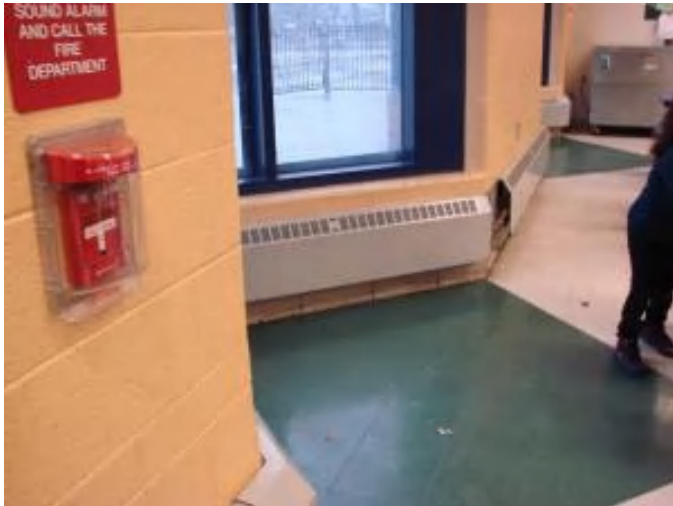
System: B2020 - Exterior Windows

Location: Throughout

Distress: Energy Efficiency

Notes: Replace Plexiglas window – hazed and not energy efficient

Correction: Remove and replace double slider windows

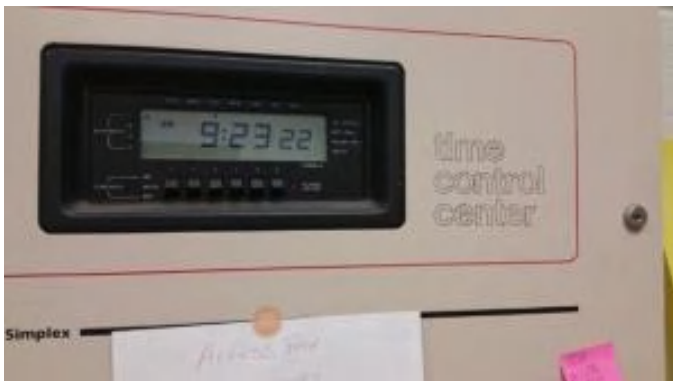
System: D5030 - Communications and Security

Location: throughout the building

Distress: Inadequate

Notes: Install a Clock System.

Correction: Add/Replace Clock System or Components

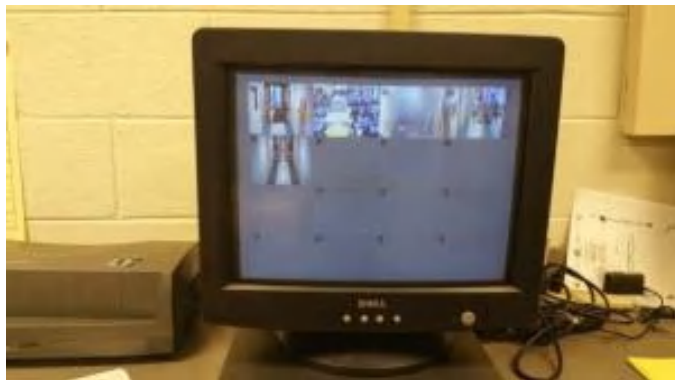
System: D5030 - Communications and Security

Location: throughout the building

Distress: Inadequate

Correction: Add/Replace Video Surveillance System

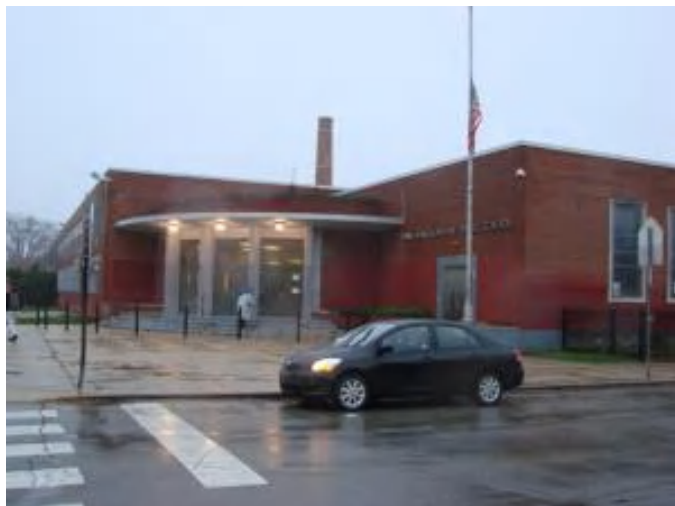
System: G2030 - Pedestrian Paving

Location: Entrance

Distress: Accessibility

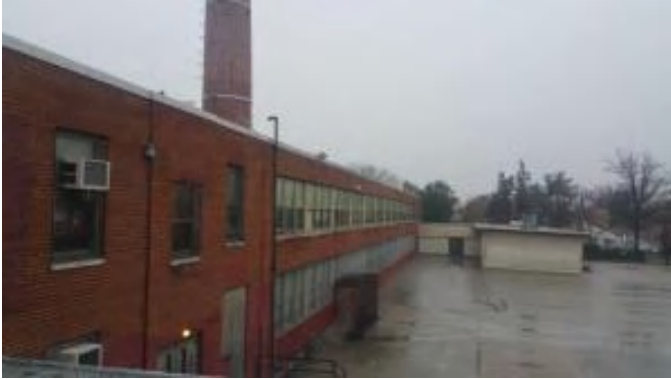
System: G4020 - Site Lighting

Location: grounds

Distress: Inadequate

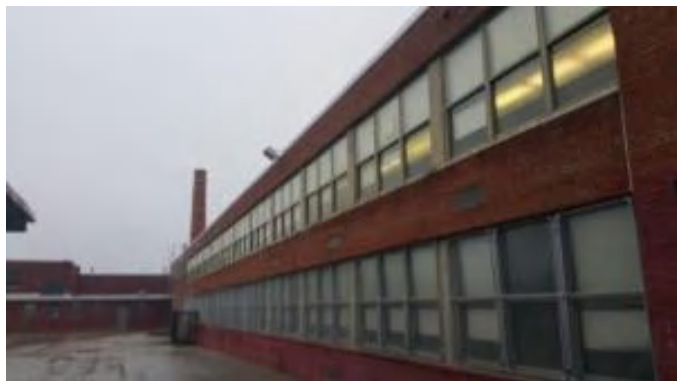
System: G4030 - Site Communications & Security

Location: grounds

Distress: Inadequate
