Decatur School

Decatur Annex School

School District of Philadelphia
S833001; Shallcross and Decatur
Final
Site Assessment Report
January 31, 2017

Facility Condition Assessment
September 2015

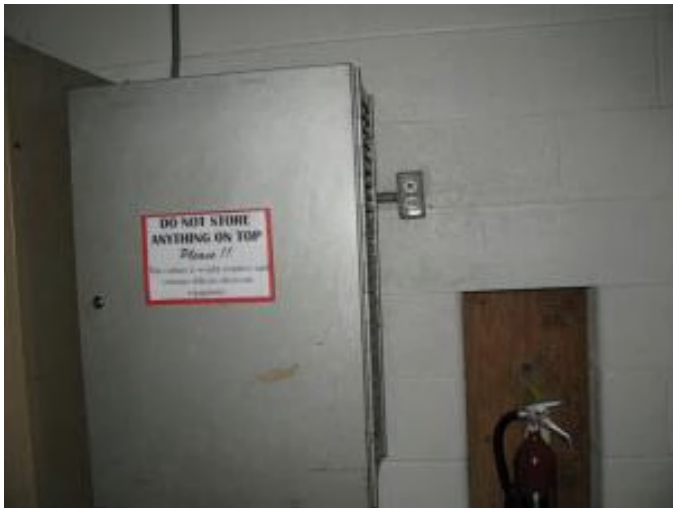
Location: Auditorium (Decatur)

System: D5030 - Communications and Security

Distress: Beyond Service Life

Notes: Provide new sound system including a freestanding 19" rack backstage with mixer per amplifiers, CD player, cassette player, AM-FM radio, graphic or parametric equalizer, and receivers for wireless microphone.

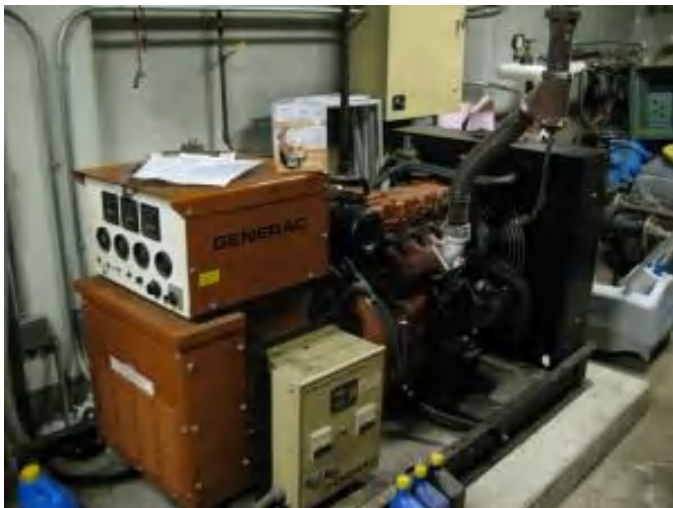
Location: Boiler Room (Decatur)

System: D5090 - Other Electrical Systems

Distress: Beyond Service Life

Notes: Replace existing back up power system with a new emergency power system including 100KW diesel generator and auto transfer switch.

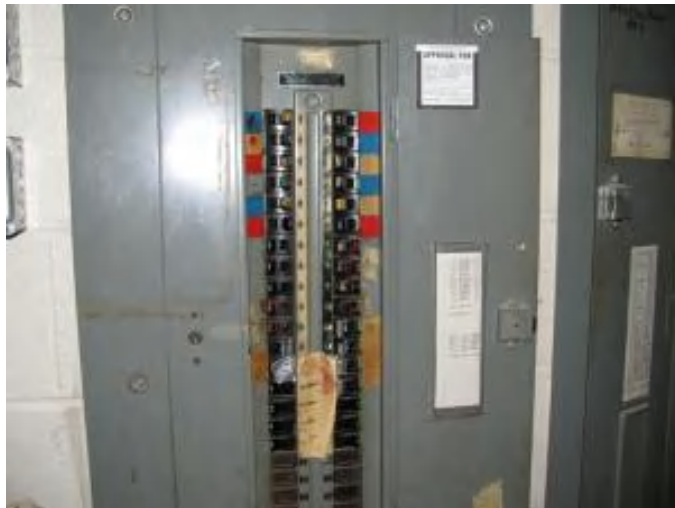
Location: Auditorium (Decatur)

System: E1020 - Institutional Equipment

Distress: Beyond Service Life

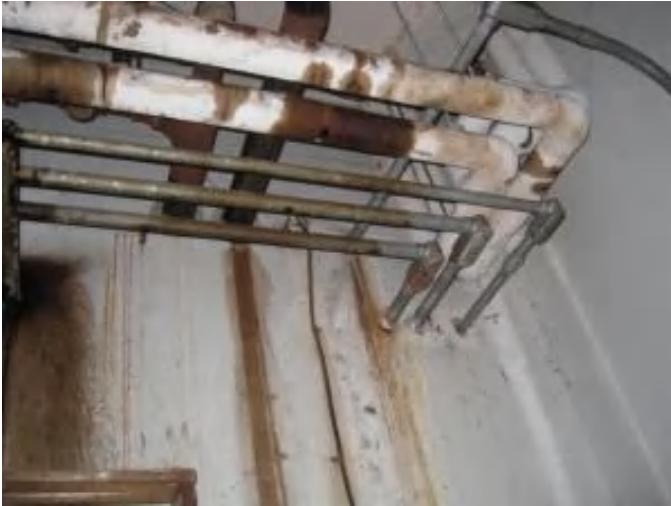
Location: Decatur Main Building - basement

System: A2020 - Basement Walls

Distress: Failing

Notes: Repair leak around fuel oil pipe where entering the basement

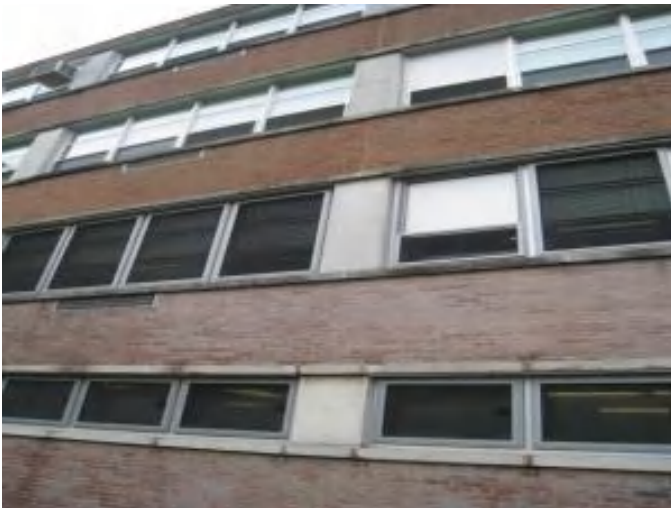
Location: Decatur Main Building - exterior walls

System: B2010 - Exterior Walls

Distress: Appearance

Notes: Powerwash exterior front and sides (20,000sf)

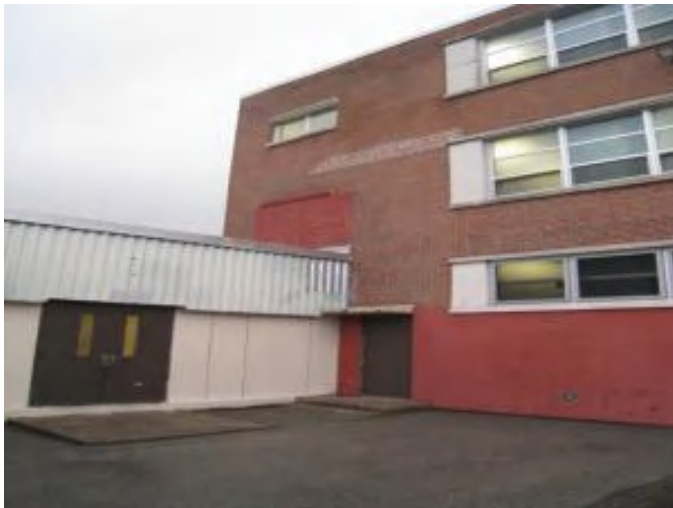
Location: Decatur Main Building + Addition exterior library connector corridor

System: B2010 - Exterior Walls

Distress: Failing

Notes: Replace metal siding above head height on Library Addition connecting corridor (500sf)

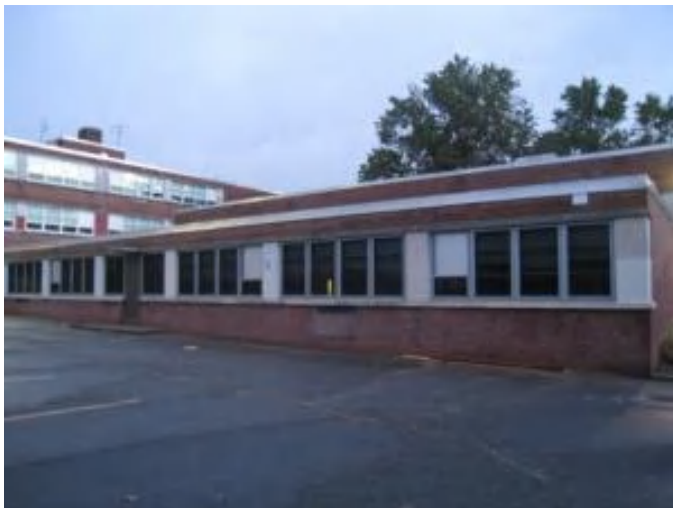
Location: Decatur Main Building - exterior walls

System: B2010 - Exterior Walls

Distress: Damaged

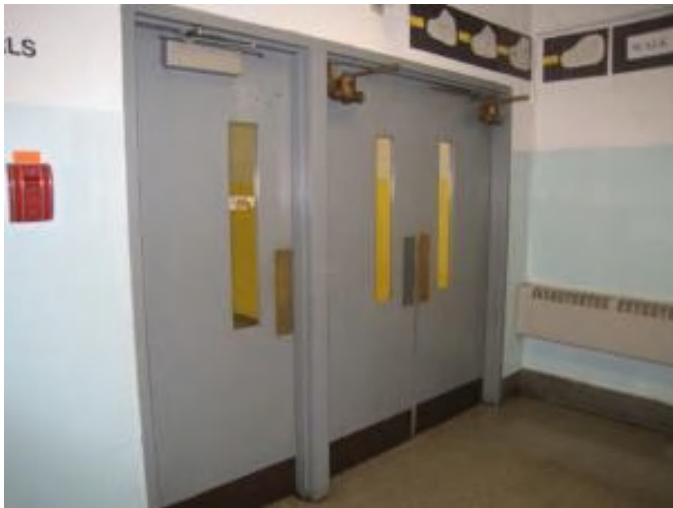
Location: Decatur Main Building - mech room + stairs

System: C1020 - Interior Doors

Distress: Damaged

Notes: Repaint steel doors in mechanical rooms and stairs (28) 3x7

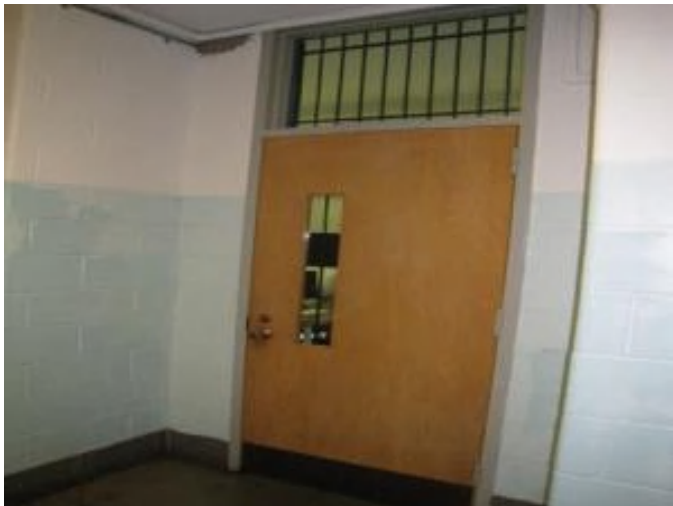
Location: Decatur Main Building

System: C1020 - Interior Doors

Distress: Appearance

Notes: Refinish wood doors into first floor classrooms, storage rooms, and other doors recently replaced (20) 3x7

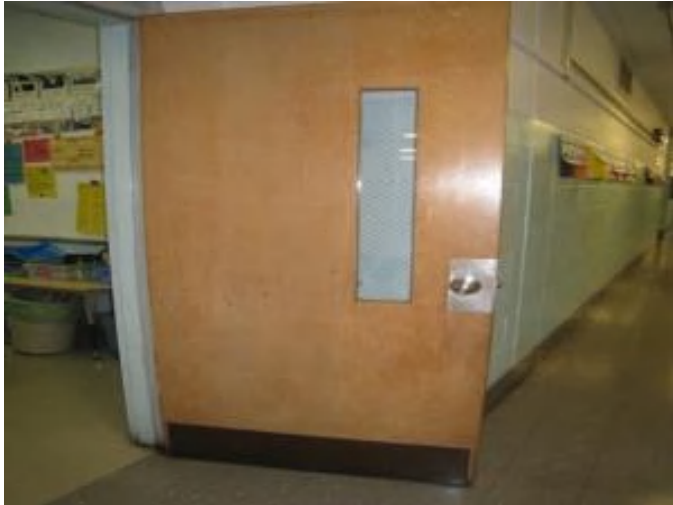
Location: Decatur Main Building - classroom + office doors

System: C1020 - Interior Doors

Distress: Security Issue

Notes: Provide security hardware for classrooms and offices, locking from the inside of the room (60)

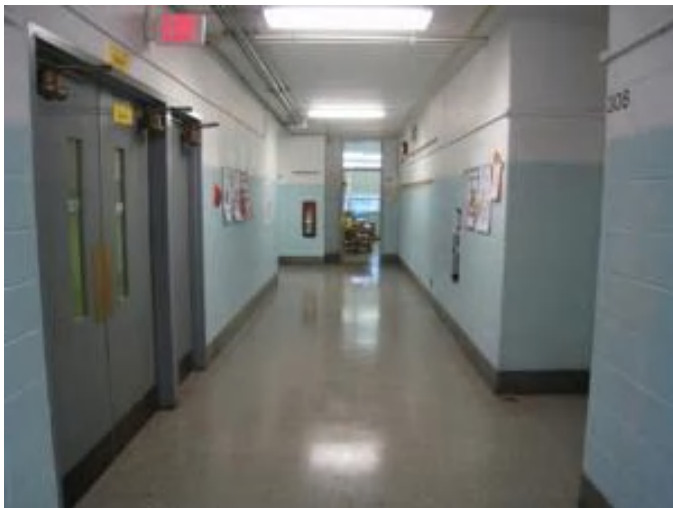
Location: Decatur Main Building - mech rm + stairs

System: C1020 - Interior Doors

Distress: Appearance

Notes: Repaint metal frames in mechanical rooms and stairs (28) 3x7

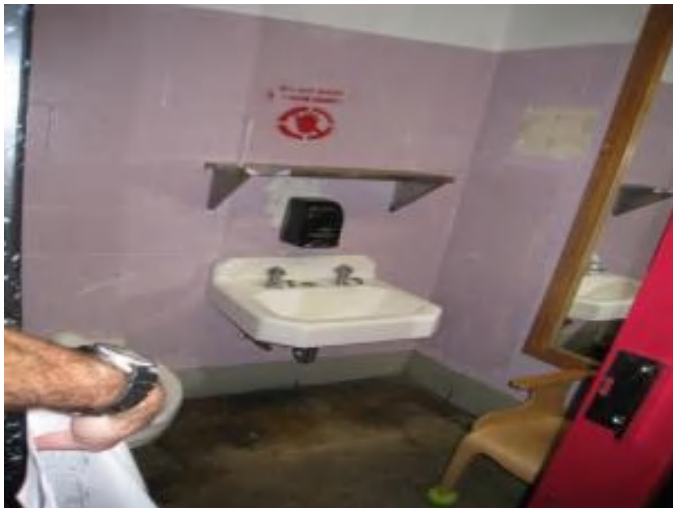
Location: Decatur Main Building - toilet rooms

System: C1030 - Fittings

Distress: Failing

Notes: Replace transite toilet room partitions with plastic partitions in Faculty toilet rooms (6 toilet compartments)

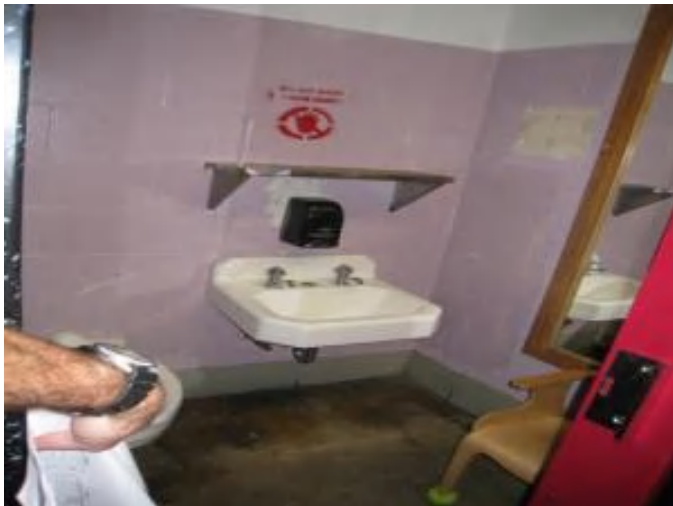
Location: Decatur Main Building - toilet rooms

System: C1030 - Fittings

Distress: Failing

Notes: Provide toilet room accessories where partitions are replaced (6)

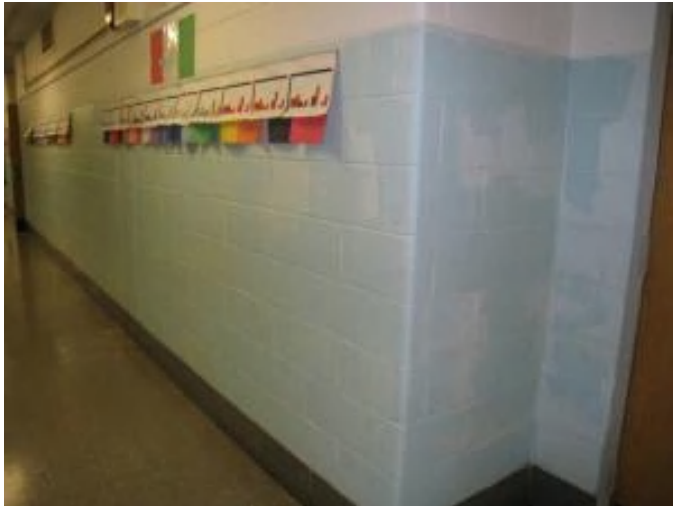
Location: Decatur Main Building - interior

System: C3010230 - Paint & Covering

Distress: Appearance

Notes: Repaint interior block walls where surface is damaged in cafeteria, kitchen, corridors, classrooms, and stairways (10,000sf)

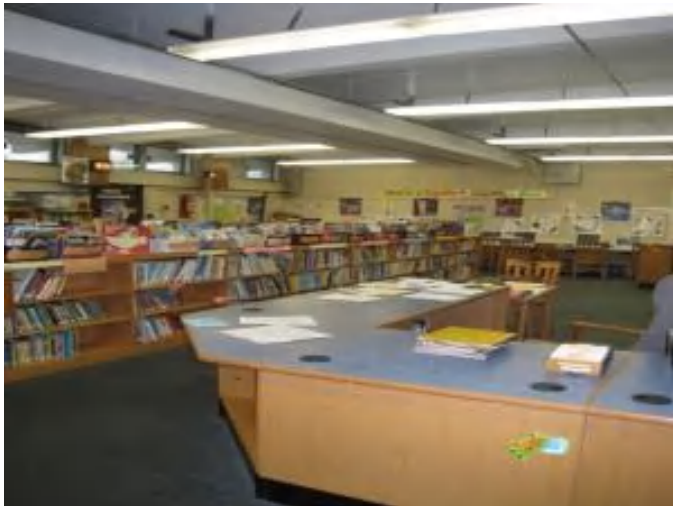
Location: Decatur Main Building - library + offices

System: C3020411 - Carpet

Distress: Damaged

Notes: Replace carpet in library and offices (2700sf)

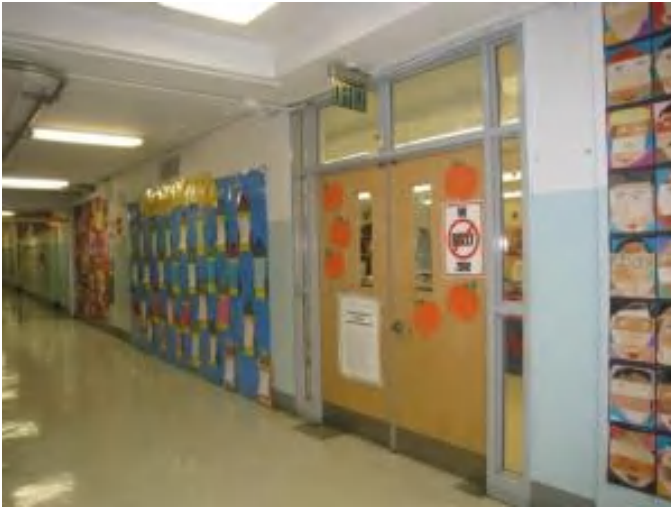
Location: Decatur Main Building - floors

System: C3020413 - Vinyl Flooring

Distress: Beyond Service Life

Notes: Remove 9"x9" VAT floors in classrooms, corridors, and auditorium with and replace with VCT (68,047sf)

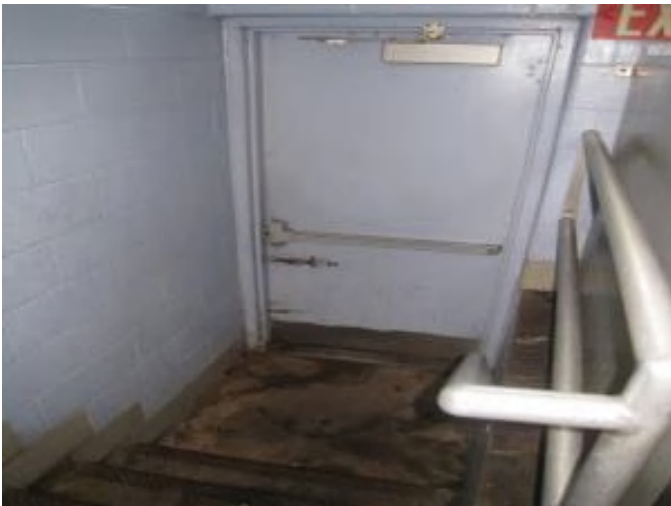
Location: Decatur Main Building - concrete slabs all floors

System: C3020415 - Concrete Floor Finishes

Distress: Appearance

Notes: Strip and reseal or paint concrete floors in stairways, toilet rooms, and parts of basement, (14,500sf)

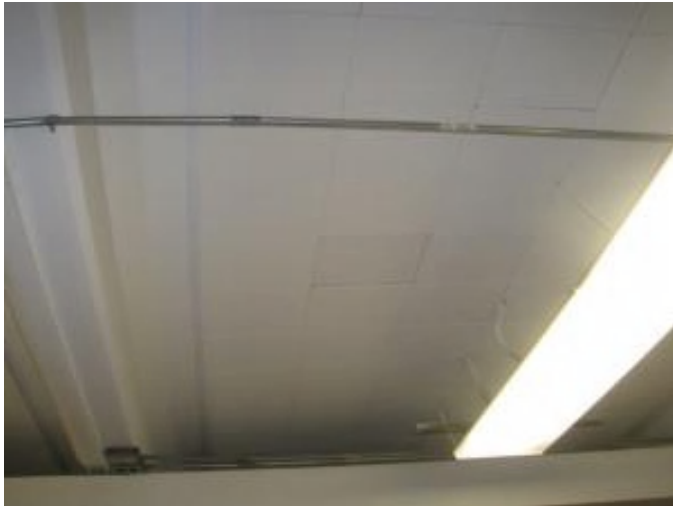
Location: Decatur Main Building - ceiling

System: C3030 - Ceiling Finishes

Distress: Damaged

Notes: Replace acoustical tile ceiling in auditorium and library (7000sf)

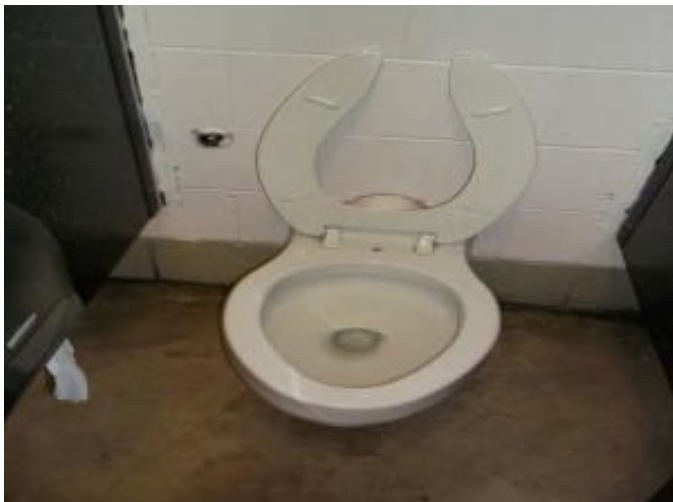
Location: Decatur Main Building - throughout the building

System: D2010 - Plumbing Fixtures

Distress: Beyond Service Life

Notes: In the Main Building replace all water closets in the building with lower flow fixtures, as the fixtures are original.

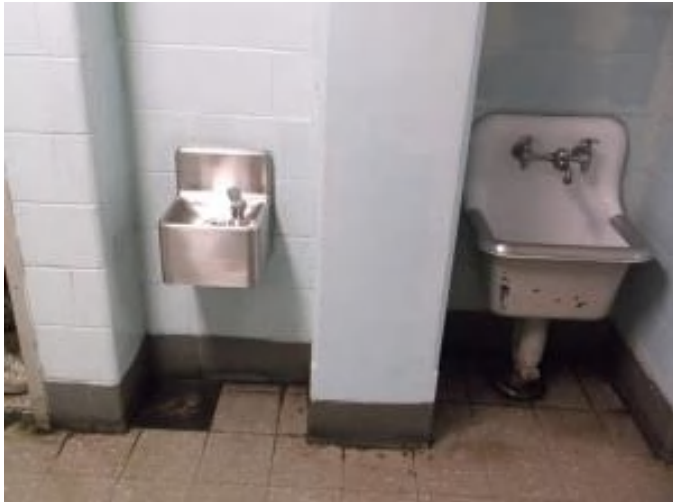
Location: Decatur Main Building - throughout the building

System: D2010 - Plumbing Fixtures

Distress: Beyond Service Life

Notes: In the Main Building replace the wall hung drinking fountains and integral refrigerated coolers in the corridors and at the restrooms. These units are well beyond their service life and most are NOT accessible type.

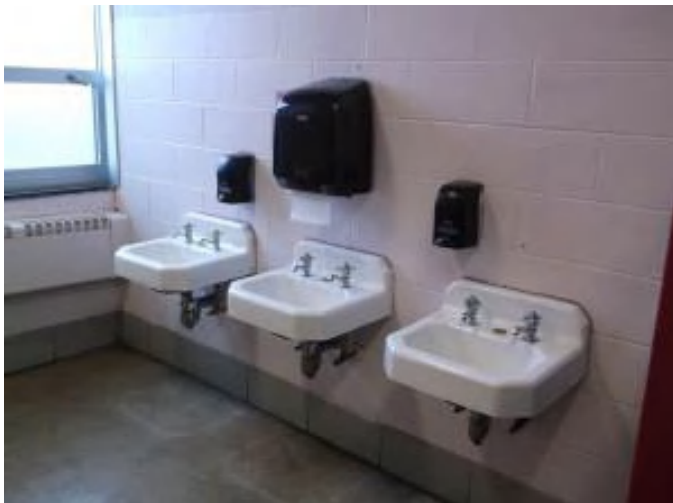
Location: Decatur Main Building - throughout the building

System: D2010 - Plumbing Fixtures

Distress: Beyond Service Life

Notes: In the Main Building replace all lavatories in the building with lower flow fixtures, as the fixtures are original.

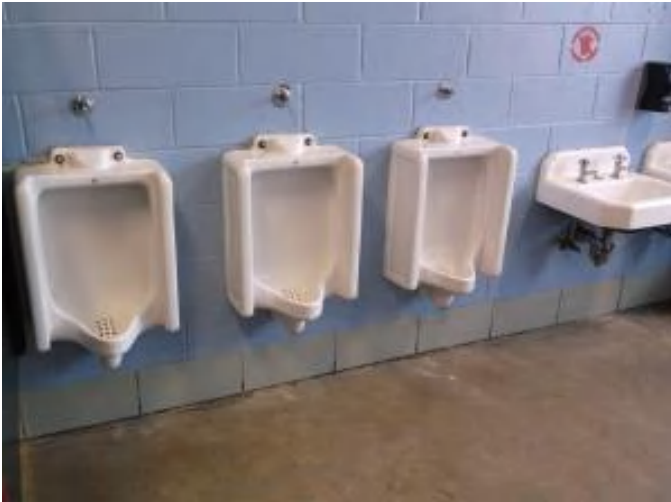
Location: Decatur Main Building - throughout the building

System: D2010 - Plumbing Fixtures

Distress: Beyond Service Life

Notes: In the Main Building replace all urinals in the building with lower flow fixtures, as the fixtures are original. In the Main Building replace all urinals in the building with lower flow fixtures, as the fixtures are original.

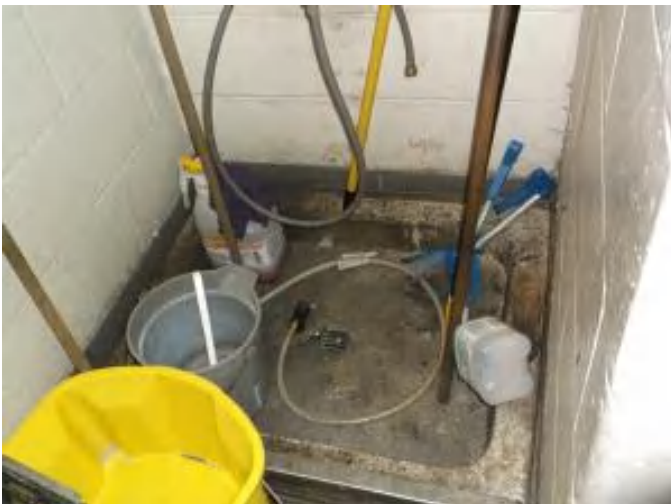
Location: Decatur Main Building - throughout the building

System: D2010 - Plumbing Fixtures

Distress: Beyond Service Life

Notes: In the Main Building replace service sinks (janitor sinks) in the building

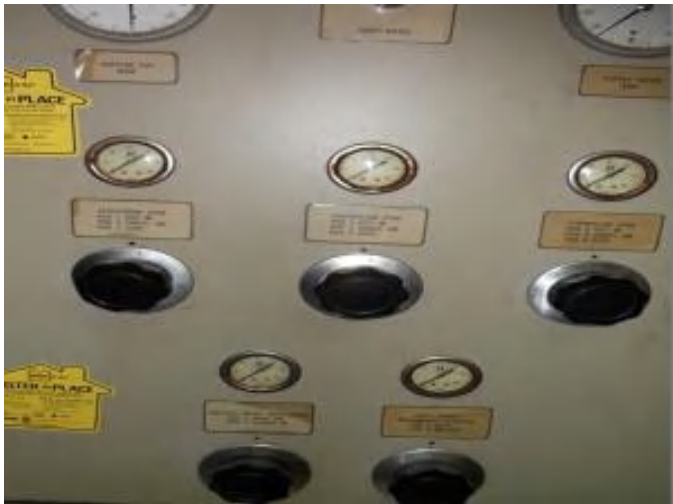
Location: Decatur Main Building - throughout the building

System: D3060 - Controls & Instrumentation

Distress: Beyond Service Life

Notes: In the Main Building replace the pneumatic controls for the HVAC systems with modern DDC modules, valves and actuators to improve reliability and energy efficiency. In the Main Building provide a new building automation system (BAS) with communication interface to the preferred system in use throughout the District.

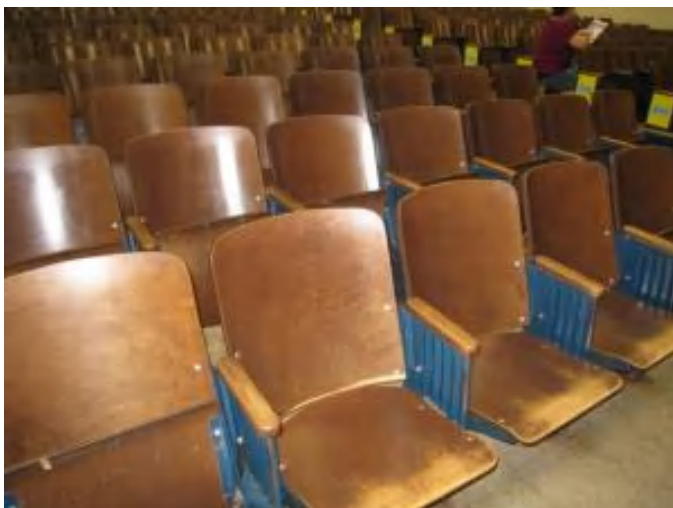
Location: Decatur Main Building - auditorium

System: E2010 - Fixed Furnishings

Distress: Appearance

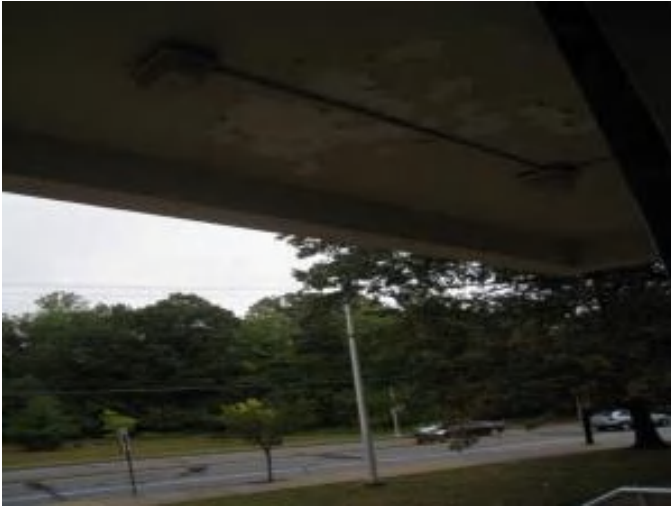
Location: Decatur Main Building - entrance overhangs

System: C3030 - Ceiling Finishes

Distress: Failing

Notes: Repaint underside of concrete overhangs at entrances (100sf)

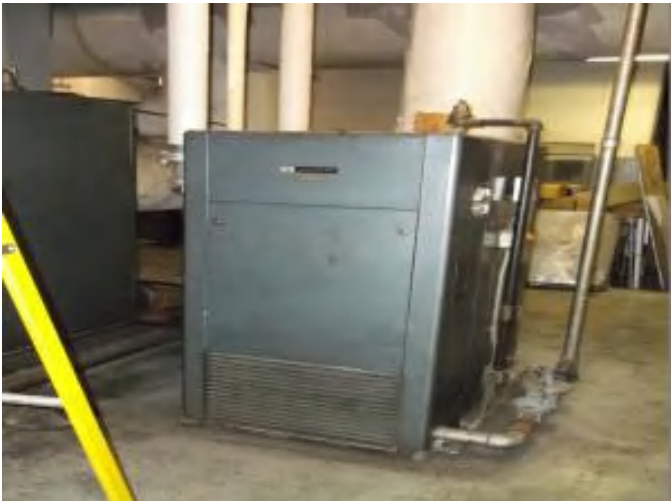
Location: Decatur Main Building - main boiler rmechanical equipment room

System: D2020 - Domestic Water Distribution

Distress: Beyond Service Life

Notes: In the Main Building replace natural gas fired boiler and storage tank with vertical tank type water heaters.

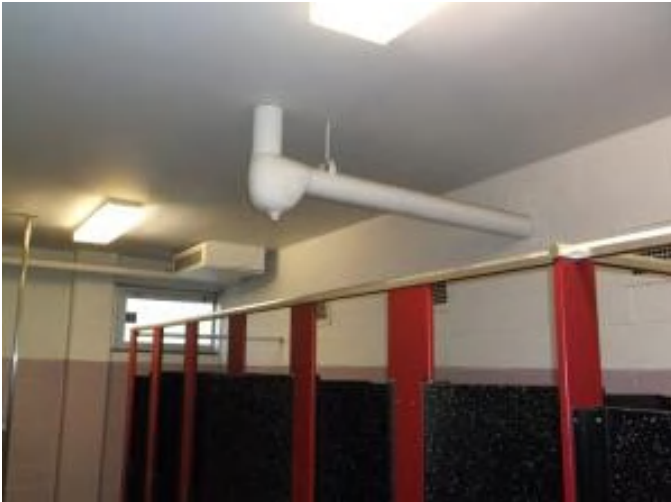
Location: Decatur Main Building - throughout the building

System: D2030 - Sanitary Waste

Distress: Beyond Service Life

Notes: In the Main Building hire a qualified contractor to perform a detailed examination of the sanitary waste piping using visual inspection and video cameras to locate and replace any damaged piping and to further quantify the extent of potential failures

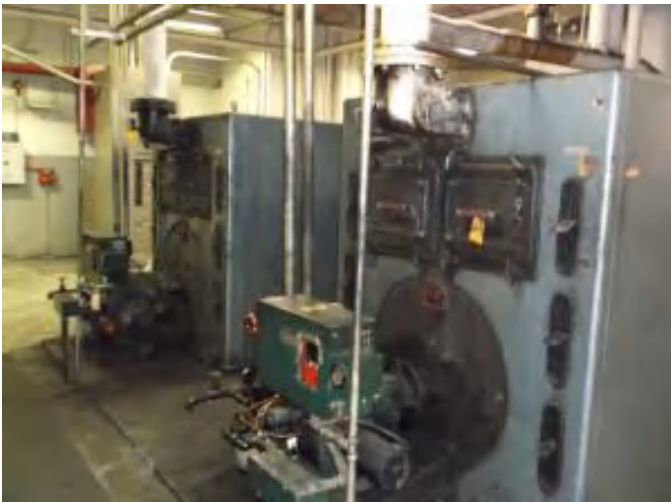
Location: Decatur Main Building - main boiler mechanical equipment room

System: D3020 - Heat Generating Systems

Distress: Beyond Service Life

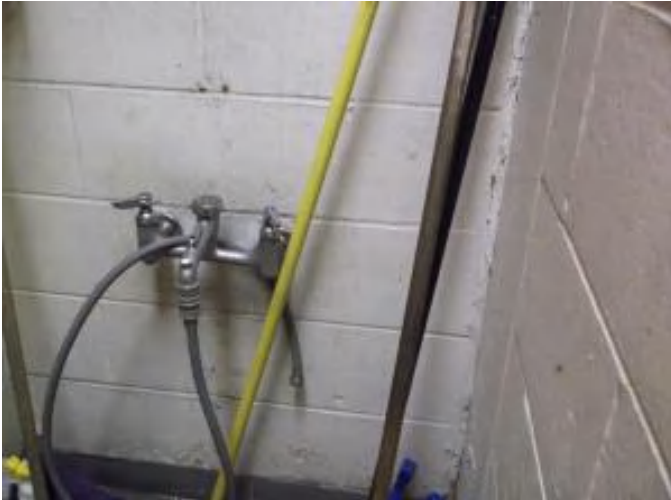
Location: Decatur Main Building - throughout the building

System: D2020 - Domestic Water Distribution

Distress: Beyond Service Life

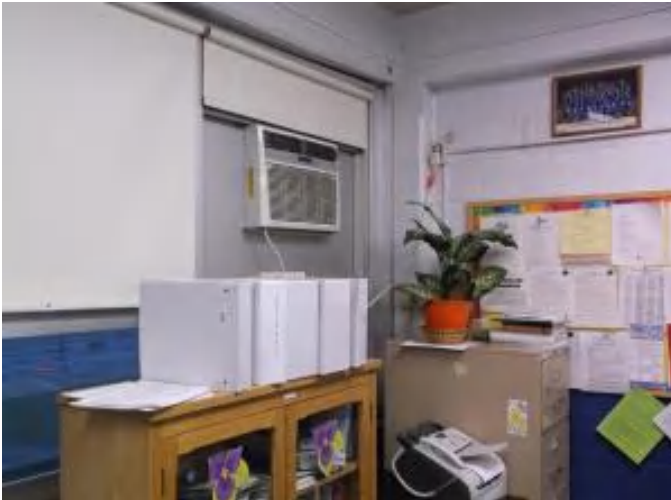
System: D3030 - Cooling Generating Systems

Location: Decatur Main Building - adjacent to the building

Distress: Inadequate

Notes: In the Main Building remove the window air conditioning units and install a 250 ton air-cooled chiller on the roof with chilled water distribution piping and pumps located in a mechanical room on the basement level to supply more reliable air conditioning for the building with a much longer service life.

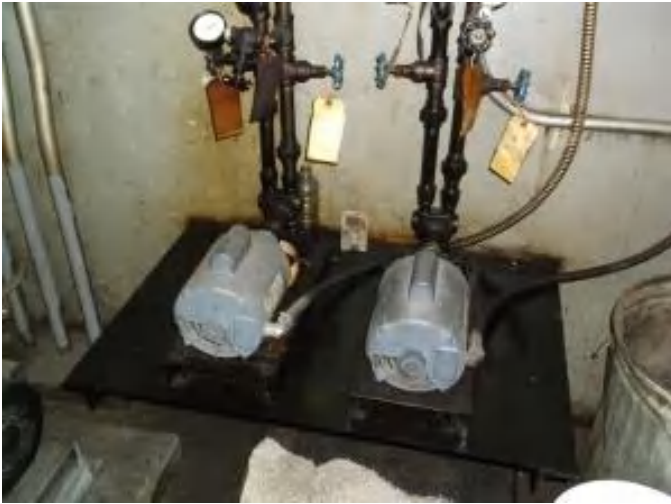
System: D3040 - Distribution Systems

Location: Decatur Main Building - throughout the building

Distress: Beyond Service Life

Correction: Replace hydronic heating piping (75KSF)

Notes: In the Main Building hire a qualified contractor to examine the heating water piping in service for 51 years and perform additional testing to locate and replace any damaged piping and to further quantify the extent of potential failures. The District should budget for replacing this piping over the next 10 years.

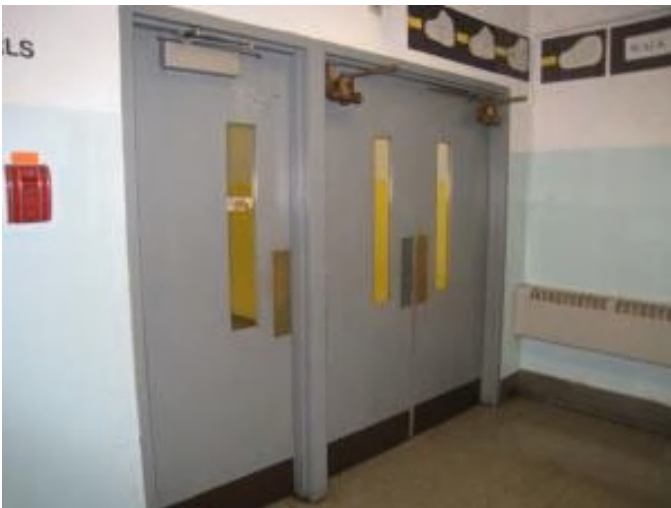
System: D3040 - Distribution Systems

Location: Decatur Main Building - throughout the building

Distress: Beyond Service Life

Notes: In the Main Building provide ventilation for the corridors at one basement and nine first floor entryways (10 locations total) by installing fan coil air handling units hung from the structure with outdoor air ducted to the unit from louvers in the window openings

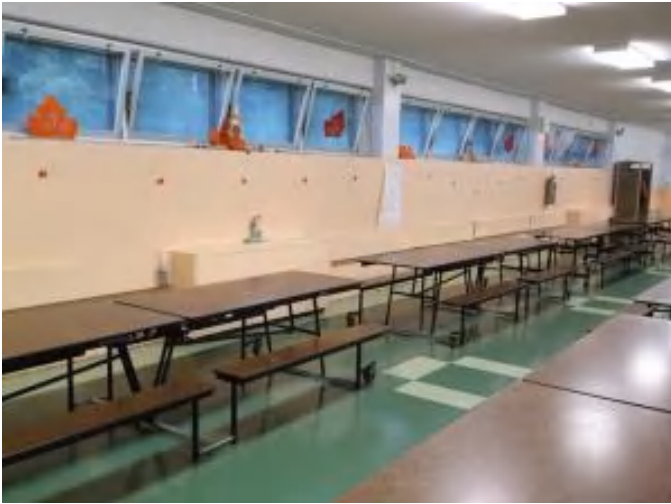
System: D3040 - Distribution Systems

Location: Decatur Main Building - roof

Distress: Beyond Service Life

Notes: In the Main Building provide ventilation, heating and cooling for the Cafeteria by removing the existing unit ventilators and installing a package rooftop constant volume air handling unit with distribution ductwork and registers.

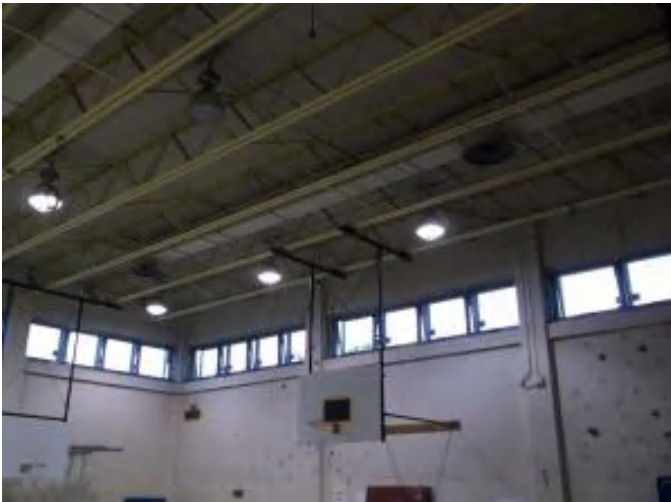
System: D3040 - Distribution Systems

Location: Decatur Main Building - roof

Distress: Beyond Service Life

Notes: In the Main Building provide ventilation, heating and cooling for the gymnasium by installing a packaged roof top unit.

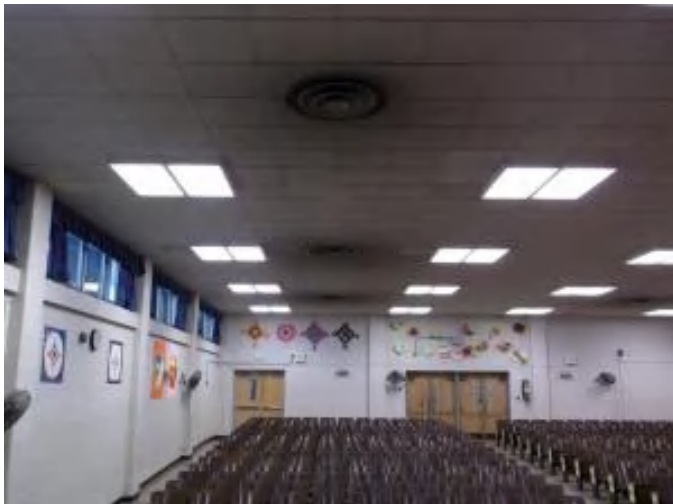
System: D3040 - Distribution Systems

Location: Decatur Main Building - roof

Distress: Beyond Service Life

Notes: In the Main Building provide ventilation, heating and cooling for the Auditorium by removing the existing unit ventilators and installing a package rooftop constant volume air handling unit with distribution ductwork and registers.

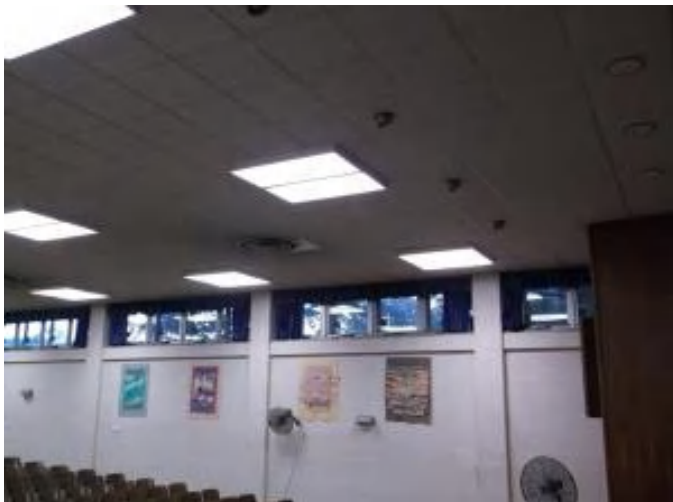
System: D4010 - Sprinklers

Location: Decatur Main Building - throughout the building

Distress: Beyond Service Life

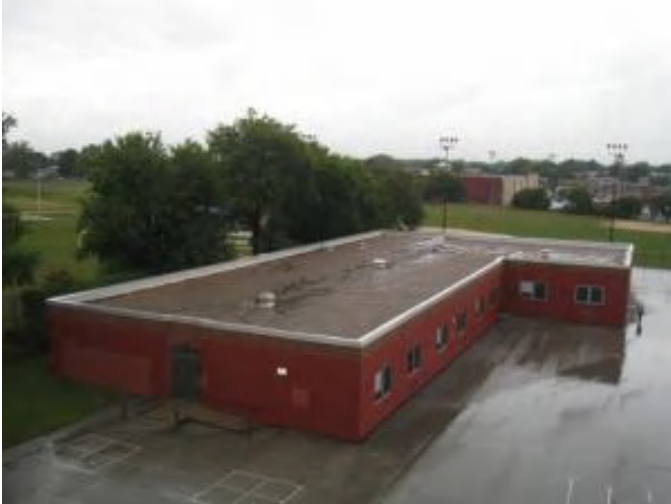
System: B3010105 - Built-Up

Location: Decatur Annex - roof

Distress: Beyond Service Life

Correction: Remove and Replace Built Up Roof

Notes: Replace roof (13,200sf)

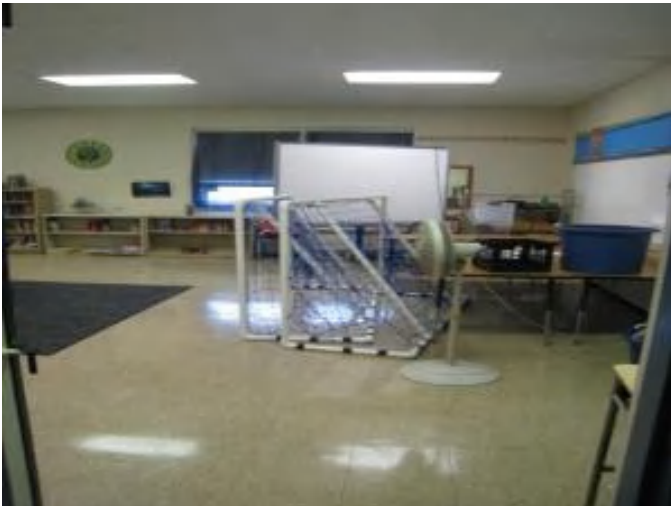
System: D3040 - Distribution Systems

Location: Decatur Annex - throughout the building

Distress: Beyond Service Life

Correction: Replace the existing unit ventilators with new units designed to provide adequate ventilation per ASHRAE Std 62 - insert the SF of bldg. in the qty.

Notes: In the Annex replace the existing unit ventilators throughout the building with new units designed to provide adequate ventilation per ASHRAE Std 62. The new units shall be equipped with hot water / chilled water coils and integral heat exchanger.

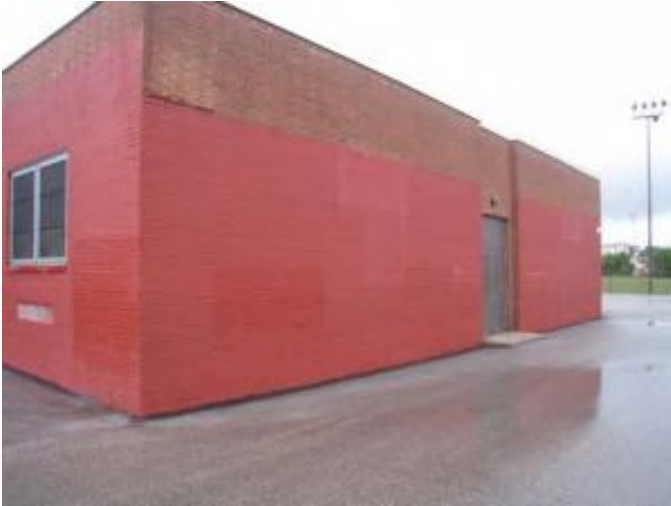
System: B2010 - Exterior Walls

Location: Decatur Annex - exterior walls

Distress: Appearance

Notes: Repaint exterior walls exposed to view of play area (3000sf)

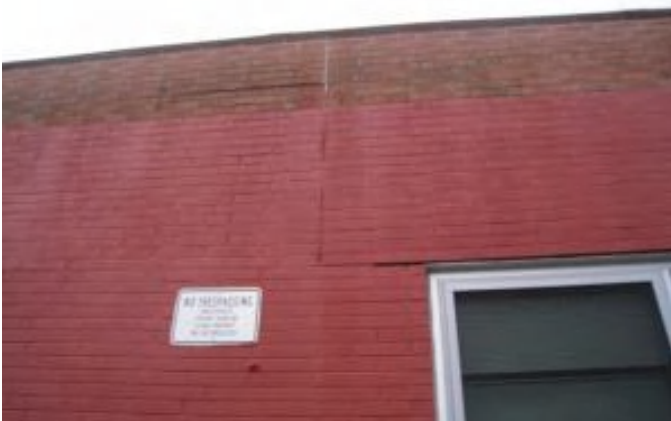
System: B2010 - Exterior Walls

Location: Decatur Annex - exterior wall

Distress: Failing

Correction: Repair cracks in masonry - replace missing mortar and repoint - SF of wall area

Notes: Repair cracked masonry (500sf)

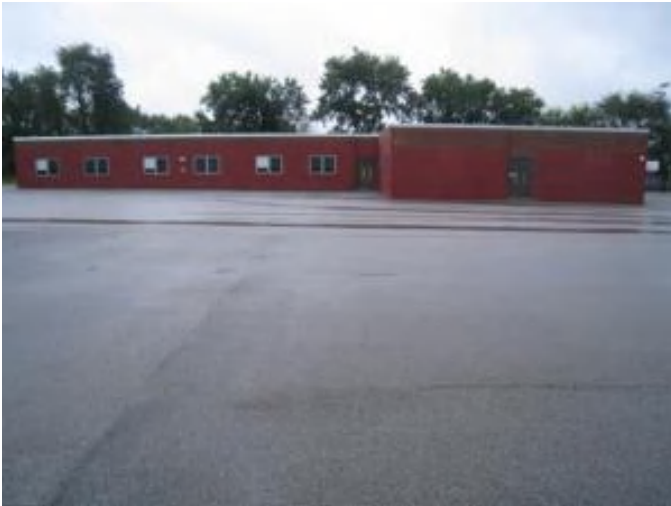
System: B2030 - Exterior Doors

Location: Decatur Annex - exterior doors

Distress: Appearance

Notes: Repaint exterior doors (5 3x7)

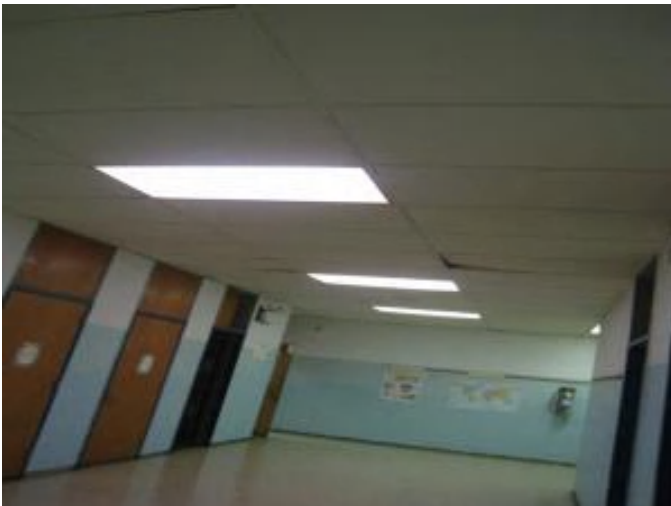
System: C1020 - Interior Doors

Location: Decatur Annex - interiors

Distress: Appearance

Notes: Refinish interior doors (16 3x7)

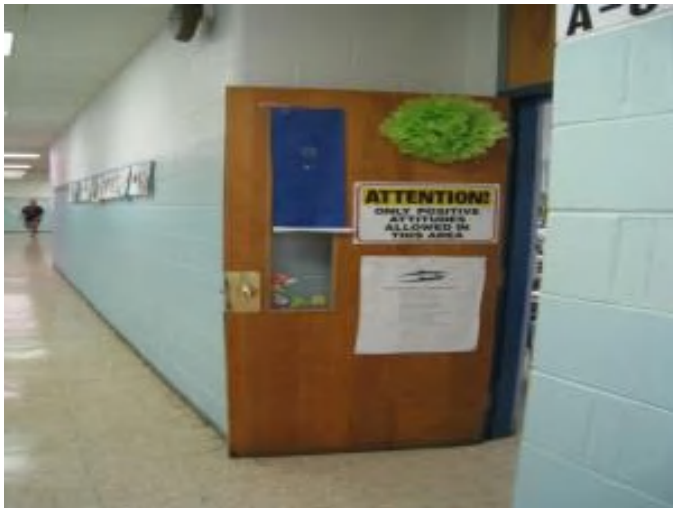
System: C1020 - Interior Doors

Location: Decatur Annex - interiors

Distress: Security Issue

Notes: Provide new lever locksets and security locks for classroom doors (10)

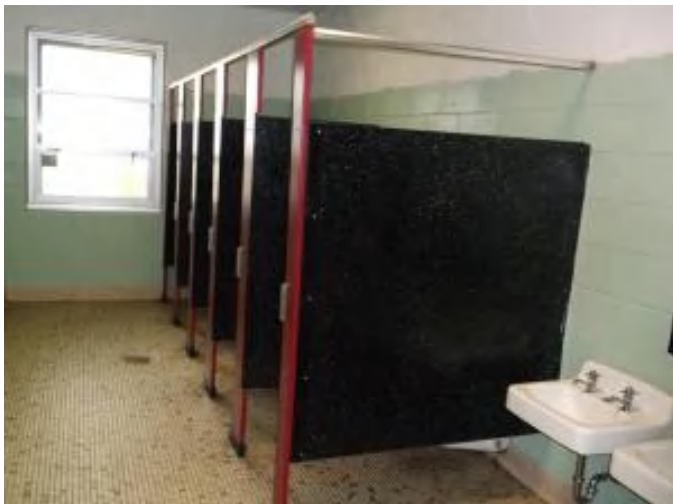
System: D2010 - Plumbing Fixtures

Location: Decatur Annex - throughout the building

Distress: Beyond Service Life

Correction: Remove and replace or replace water closet - quantify additional units

Notes: In the Annex replace all water closets in the building with lower flow fixtures, as the fixtures are original.

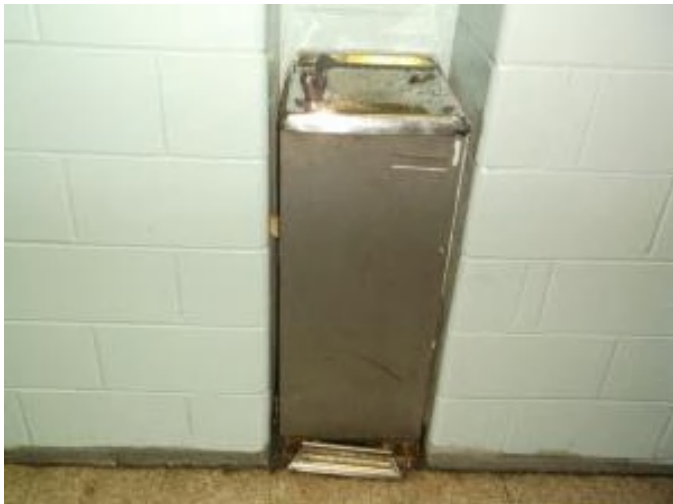
System: D2010 - Plumbing Fixtures

Location: Decatur Annex - throughout the building

Distress: Beyond Service Life

Correction: Remove and replace water fountains to meet ADA - includes high and low fountains and new recessed alcove

Notes: In the Annex replace the wall hung drinking fountains and integral refrigerated coolers in the corridors and at the restrooms. These units are well beyond their service life and most are NOT accessible type

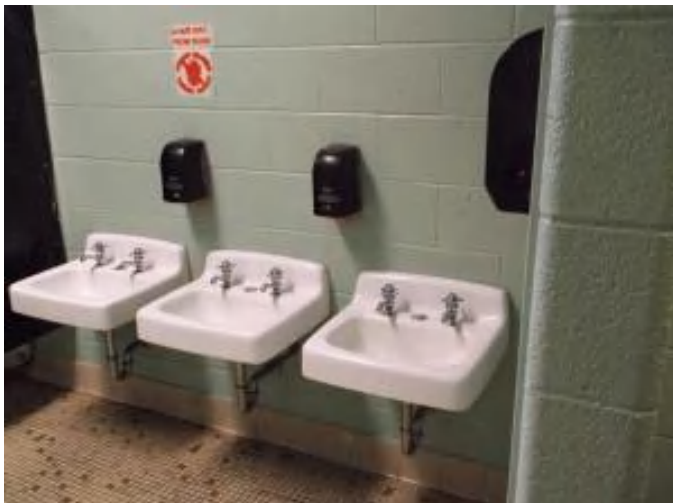
System: D2010 - Plumbing Fixtures

Location: Decatur Annex - throughout the building

Distress: Beyond Service Life

Correction: Remove and replace or replace lavatory - quantify accessible if required

Notes: In the Annex replace all lavatories in the building with lower flow fixtures, as the fixtures are original.

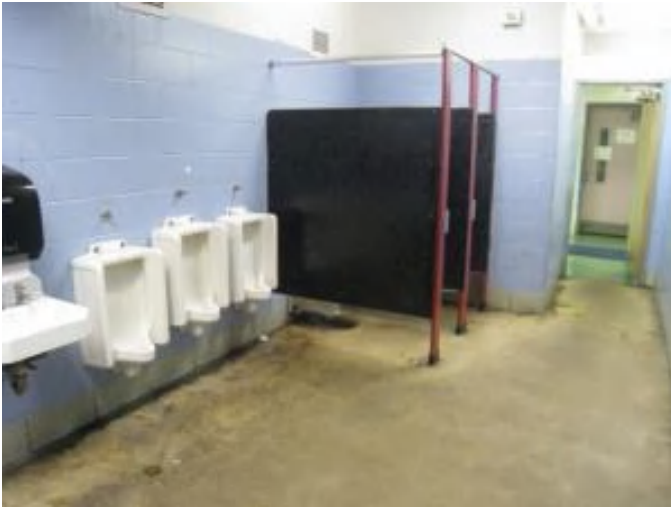
System: D2010 - Plumbing Fixtures

Location: Decatur Annex - throughout the building

Distress: Beyond Service Life

Correction: Remove and replace or replace stall or floor type urinal

Notes: In the Annex replace all urinals in the building with lower flow fixtures, as the fixtures are original. In the Main Building replace all urinals in the building with lower flow fixtures, as the fixtures are original.

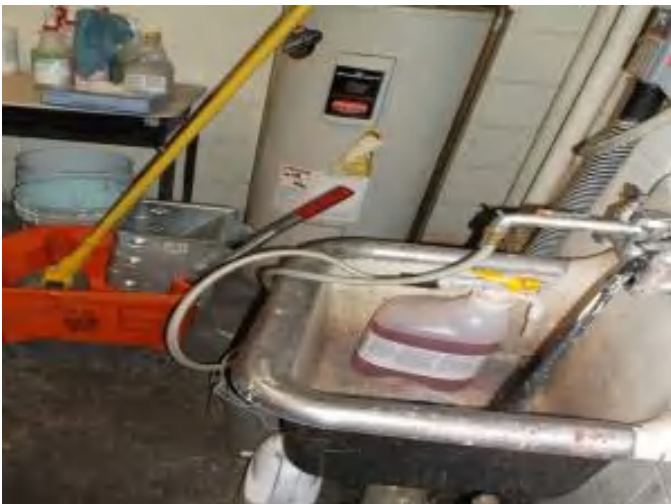
System: D2010 - Plumbing Fixtures

Location: Decatur Annex - throughout the building

Distress: Beyond Service Life

Correction: Remove and replace floor janitor or mop sink - insert the quantity

Notes: In the Annex replace service sinks (janitor sinks) in the building

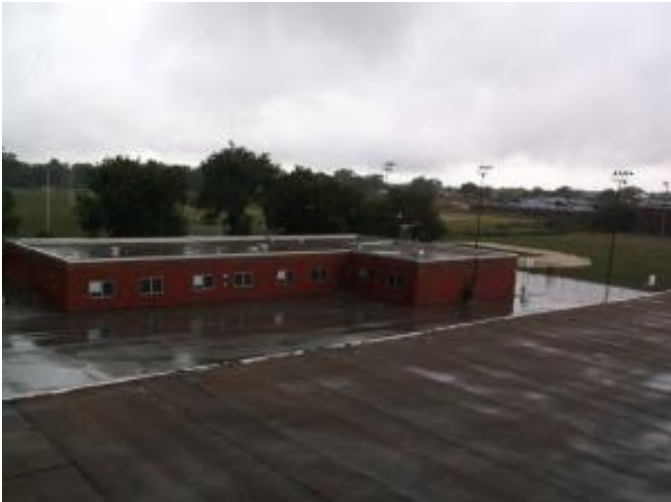
System: D3040 - Distribution Systems

Location: Decatur Annex - roof

Distress: Beyond Service Life

Correction: Replace rooftop gravity ventilator units - select the proper type and size

Notes: In the Annex replace exhaust fans.

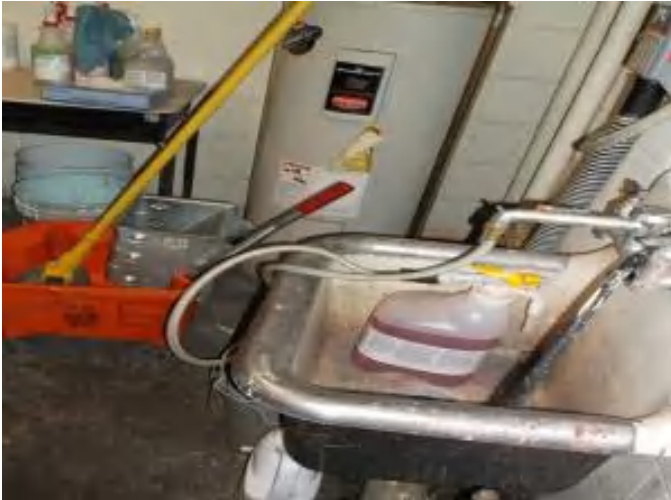
System: D2020 - Domestic Water Distribution

Location: Decatur Annex - closet

Distress: Beyond Service Life

Correction: Replace vertical tank type gas-fired water heater (120 gal)

Notes: In Annex replace vertical tank electric water heater.

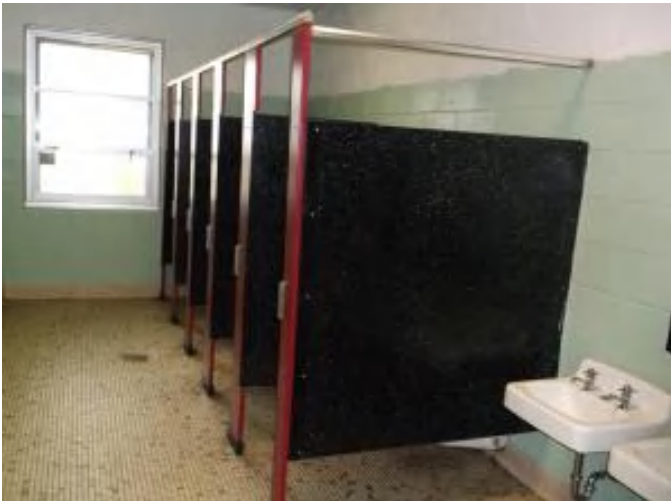
System: D2030 - Sanitary Waste

Location: Decatur Annex - throughout the building

Distress: Beyond Service Life

Correction: Inspect sanitary waste piping and replace damaged sections. (+50KSF)

Notes: In the Annex hire a qualified contractor to perform a detailed examination of the sanitary waste piping using visual inspection and video cameras to locate and replace any damaged piping and to further quantify the extent of potential failures.

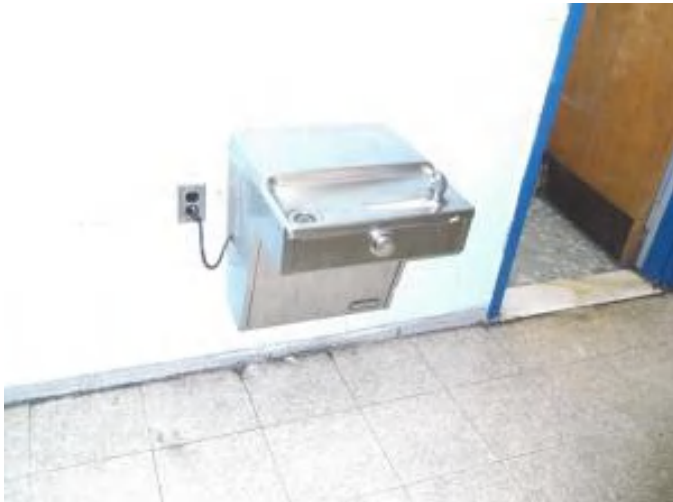
System: D2020 - Domestic Water Distribution

Location: Decatur Annex - throughout the building

Distress: Beyond Service Life

Correction: Replace domestic water piping (75 KSF)

Notes: In the Annex inspect and replace the original as needed the domestic water piping in the building

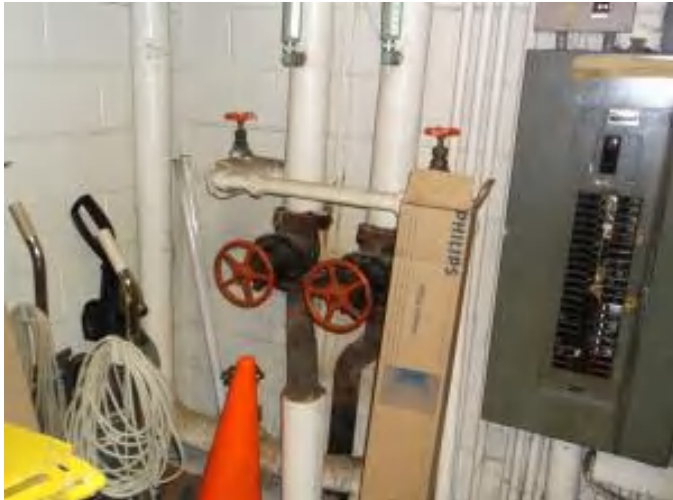
System: D3040 - Distribution Systems

Location: Decatur Annex - throughout the building

Distress: Beyond Service Life

Correction: Replace hydronic heating piping (75KSF)

Notes: In the Annex hire a qualified contractor to examine the heating water piping in service for 51 years and perform additional testing to locate and replace any damaged piping and to further quantify the extent of potential failures. The District should budget for replacing this piping over the next 10 years.

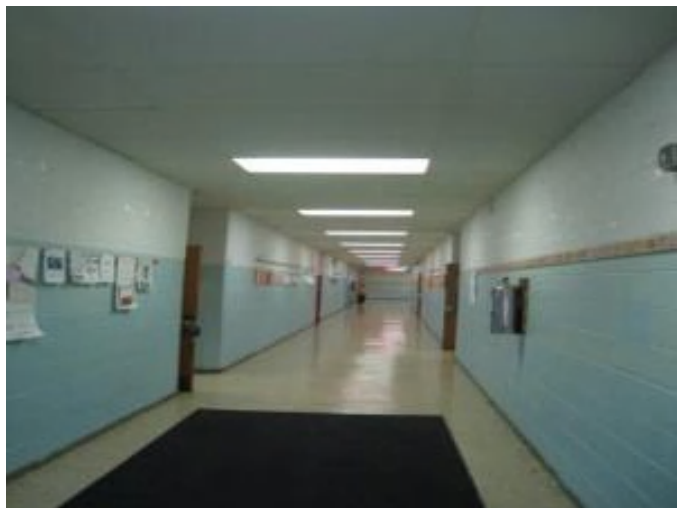
System: D4010 - Sprinklers

Location: Decatur Annex - throughout the building

Distress: Life Safety / NFPA / PFD

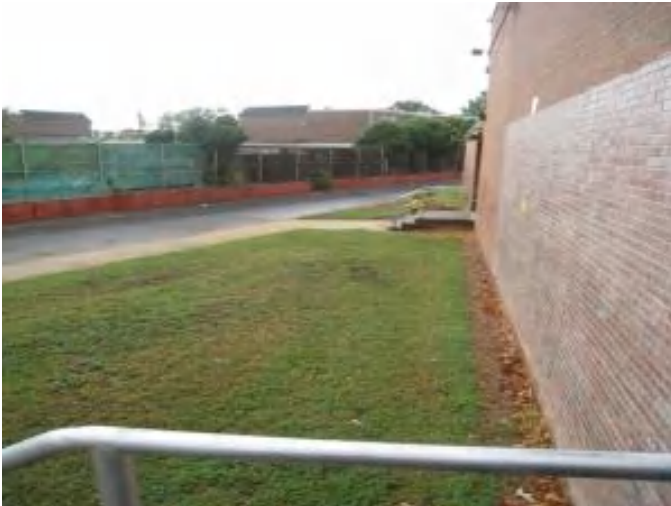
System: G2030 - Pedestrian Paving

Location: Decatur site at main building

Distress: Accessibility

Notes: Provide new ADA accessible handicap ramp into side of building (30ft)
