Decatur School

Decatur Annex School

School District of Philadelphia
S833001; Shallcross and Decatur
Final
Site Assessment Report
January 31, 2017

Facility Condition Assessment
September 2015

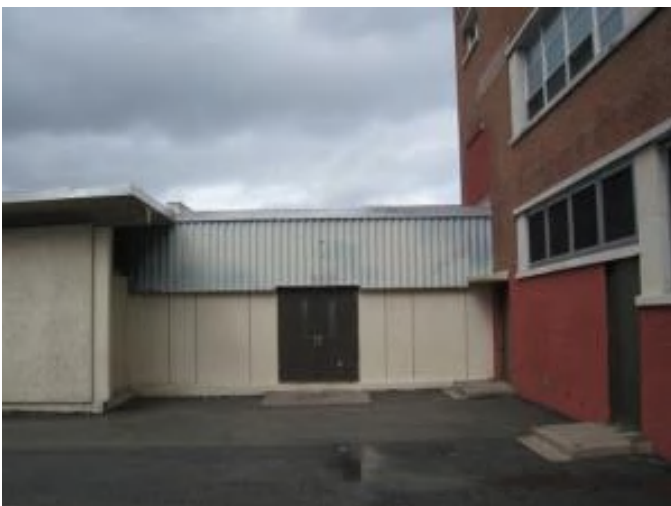
System: G2030 - Pedestrian Paving

Location: Decatur site at main building

Distress: Accessibility

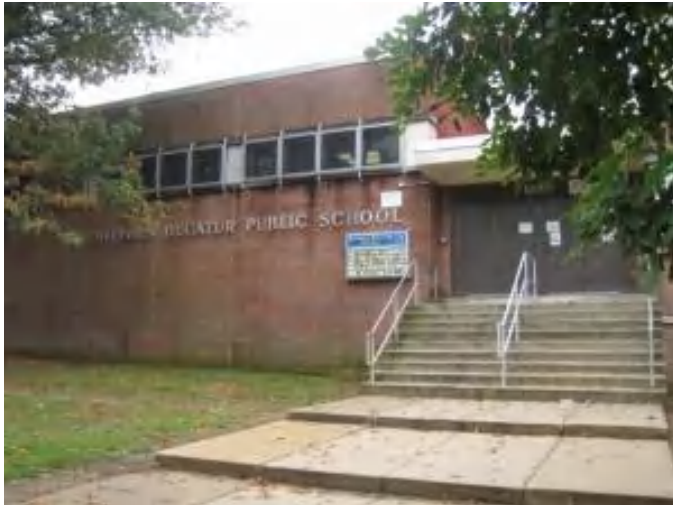
System: G2030 - Pedestrian Paving

Location: Decatur main building entrance walkway and sidewalk

Distress: Failing

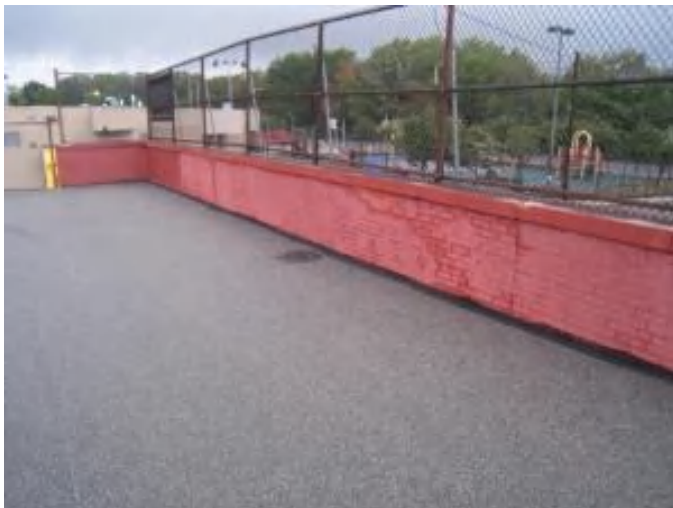
Location: Decatur site retaining wall

Distress: Failing

Notes: Repair brick retaining wall, cracking in two locations (200sf)

Correction: Repair exterior brick retaining wall - per LF of wall - up to 4' tall

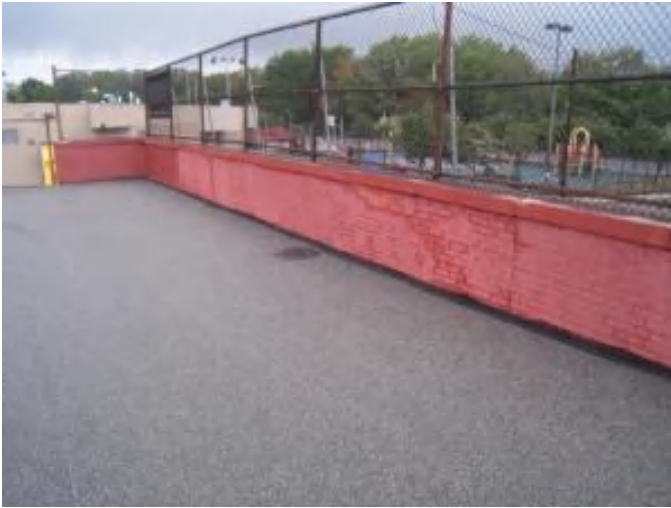
Location: Decatur site - fence on retaining wall

Distress: Failing

Notes: Provide new chain link fence on top of retaining wall (160ft)

Correction: Replace chain link fence - 6' high

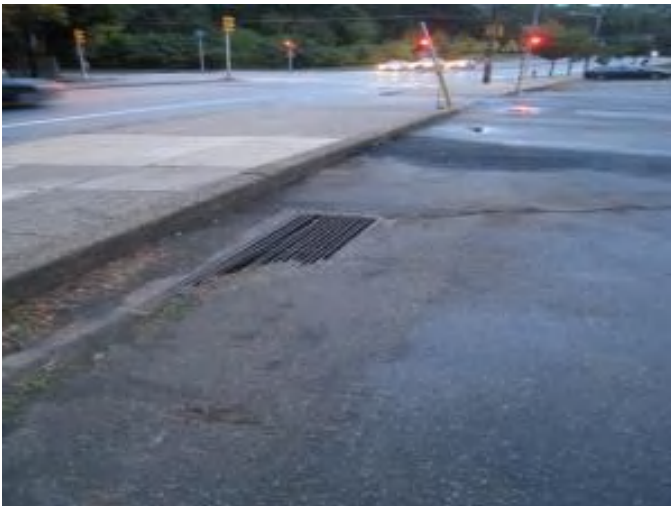
Location: Decatur front parking lot

Distress: Failing

Correction: Remove and replace failed or collapsed storm or sanitary drain line - minimum of 30 LF - per LF

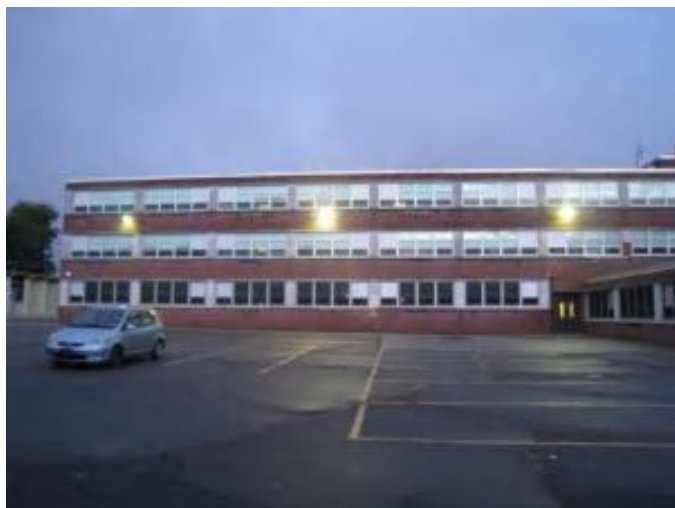
Location: Decatur parking lots

Distress: Failing

Notes: Repave cracked and damaged asphalt parking lots in front and rear with new asphalt, including restriping (40,000)
