## Facility Condition Assessment Summary Report

### Disston School

School District of Philadelphia  
**S824001;Disston**  
Final  
**Site Assessment Report**

January 31, 2017

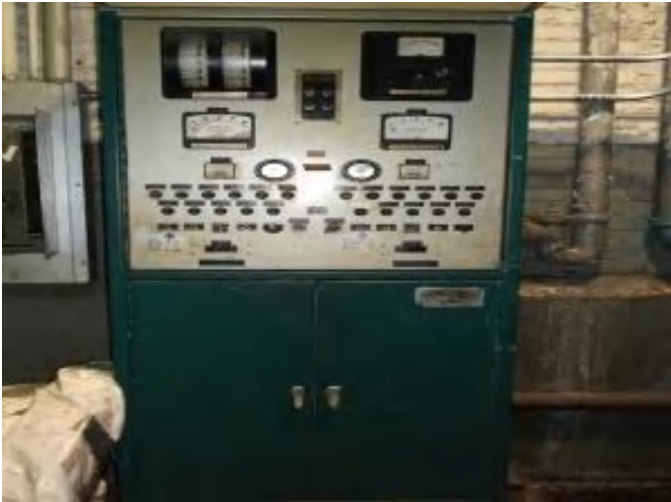
**System: D3060 - Controls & Instrumentation**

**Location:** Throughout the building

**Distress:** Beyond Service Life

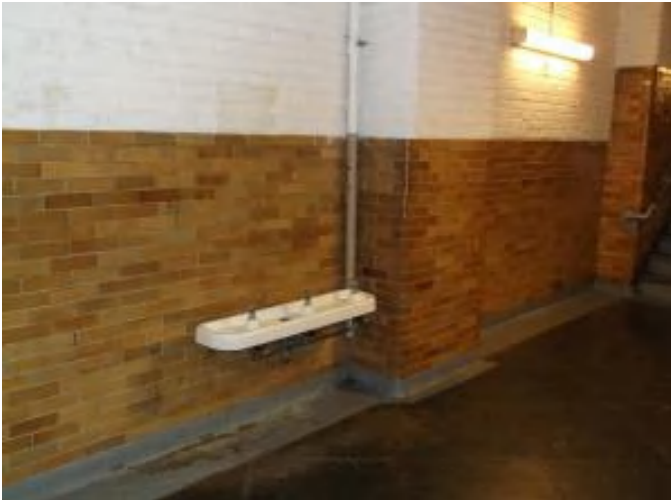
**System: D2030 - Sanitary Waste**

Sanitary Waste - The sanitary waste piping system in the original building is extra heavy cast iron with lead and oakum seals and appears to be the original piping installed in the building. It is therefore recommended to inspect this piping and repair or replace sections as needed. The sanitary system leaves the building by gravity flow.

**Location:** Throughout the building

**Distress:** Beyond Service Life

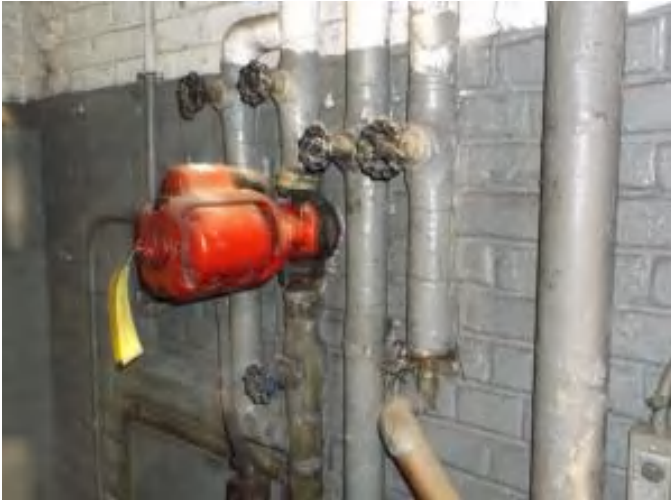
**System: D2020 - Domestic Water Distribution**

Domestic Water Distribution – It appears that the 4" domestic water service piping is mostly soldered copper. Water service enters the building in the basement, with double check backflow preventer (RPZA – reduced pressure zone assembly) and a 4" water meter on the main line upon entering the building. The water meter appears to be new. The piping is copper with soldered joints. The distribution piping appears to be original and is at the end of its service life and is recommended to be inspected and repaired as needed.

**Location:** Throughout the building

**Distress:** Beyond Service Life

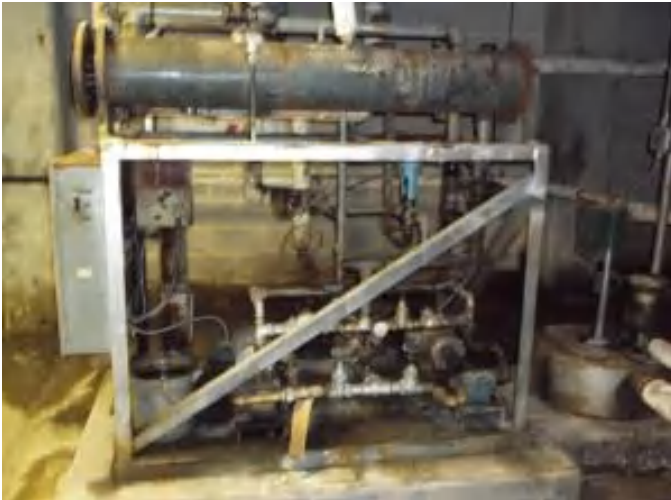
**System: D3020 - Heat Generating Systems**

**Location:** Boiler Mechanical Equipment Room

**Distress:** Beyond Service Life

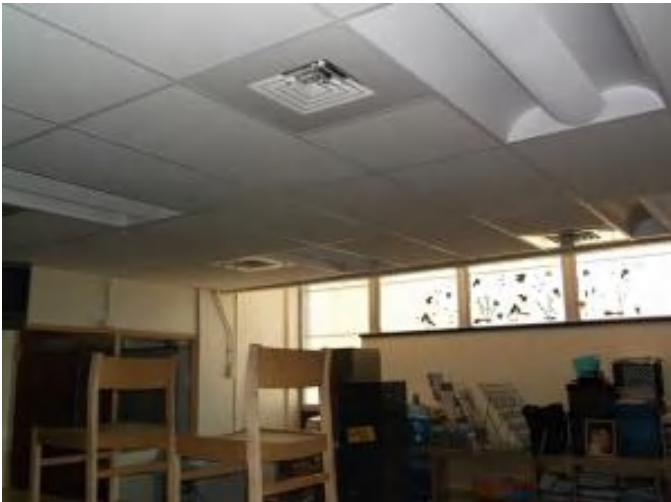
**System: D4010 - Sprinklers**

**Location:** Throughout the building

**Distress:** Life Safety / NFPA / PFD
