## Facility Condition Assessment Summary Report

### Fitzpatrick School

### Fitzpatrick (Annex) School

January 31, 2017

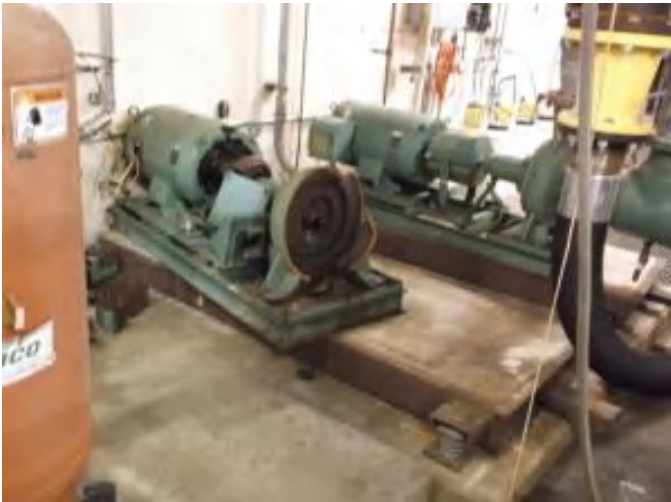
**Location:** Boiler Room

**Distress:** Damaged

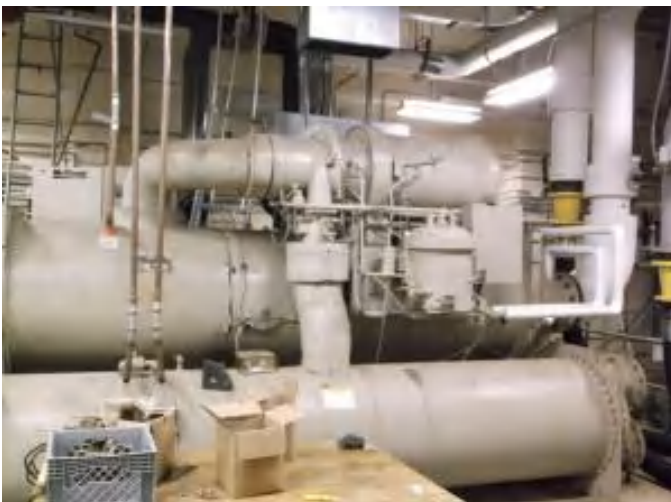
**Location:** Boiler Room

**Distress:** Damaged

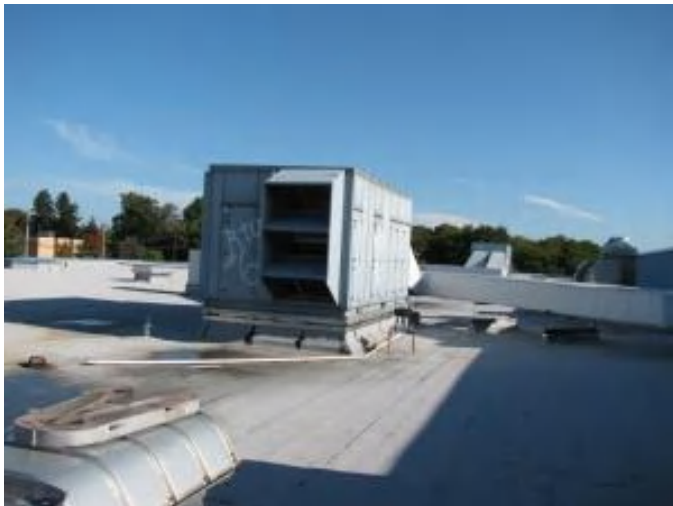
**Location:** Rush - Roof  
**Distress:** Life Safety / NFPA / PFD  
**Category:** 1 - Health & Safety  
**Priority:** 1 - Response Time (< 2 yr)  
**Correction:** Provide Lightning Protection System  
**Qty:** 1.00  
**Unit of Measure:** LS  
**Estimate:** \$27,510.31  
**Assessor Name:** Craig Anding  
**Date Created:** 10/22/2015

**Notes:** Perform lightning protection studies to ascertain that the mechanical equipment on the roof are protected against the lightning strokes.

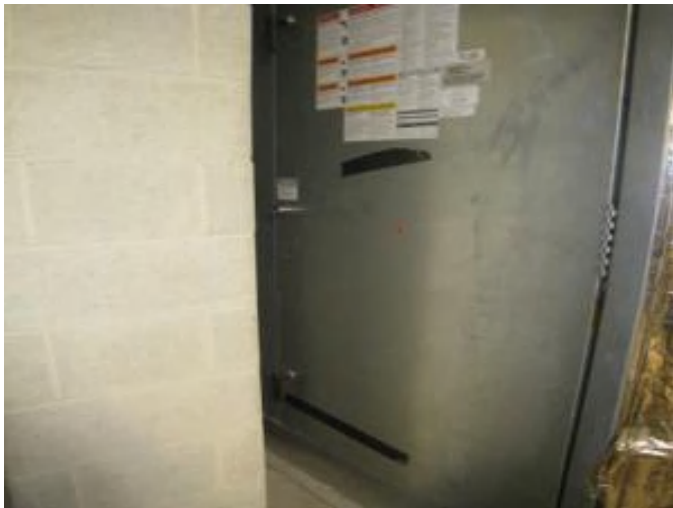
**Location:** Rush - interior doors

**Distress:** Appearance

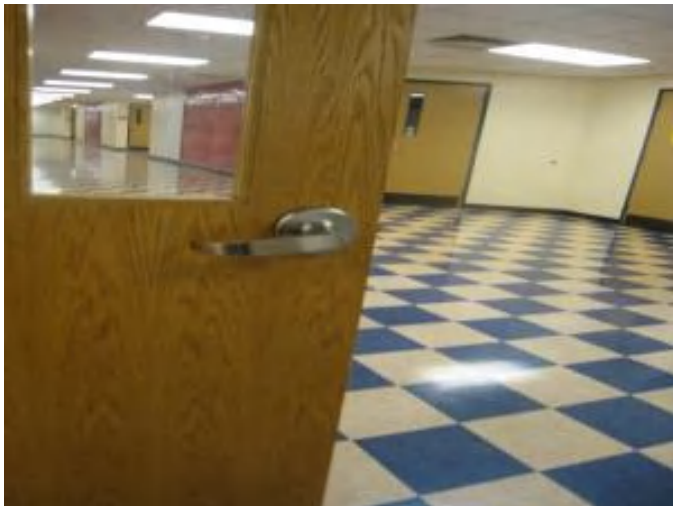
**Location:** Rush - classroom doors

**Distress:** Security Issue

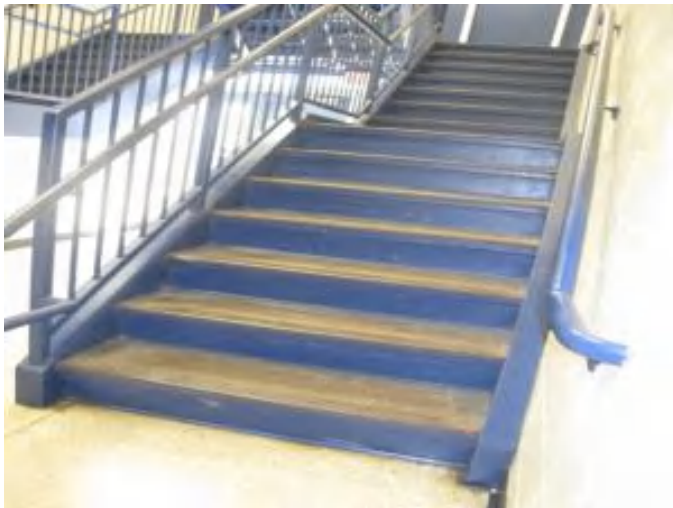
**Location:** Rush - stairways

**Distress:** Appearance

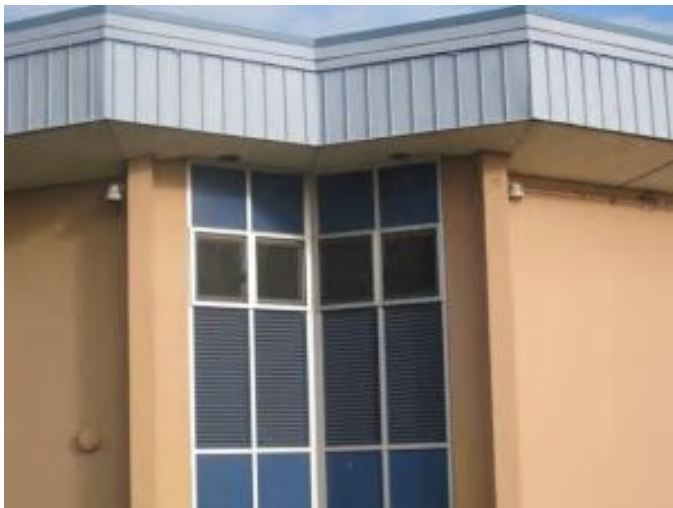
**Location:** Rush - soffit

**Distress:** Appearance

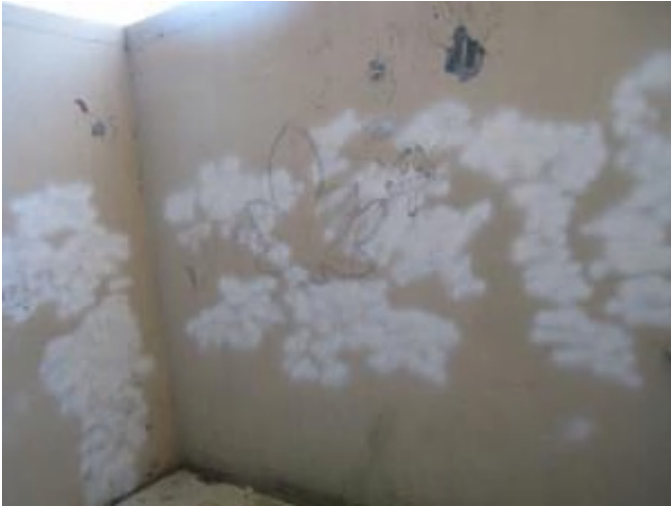
**Location:** Rush - concrete retaining walls in front of building

**Distress:** Appearance

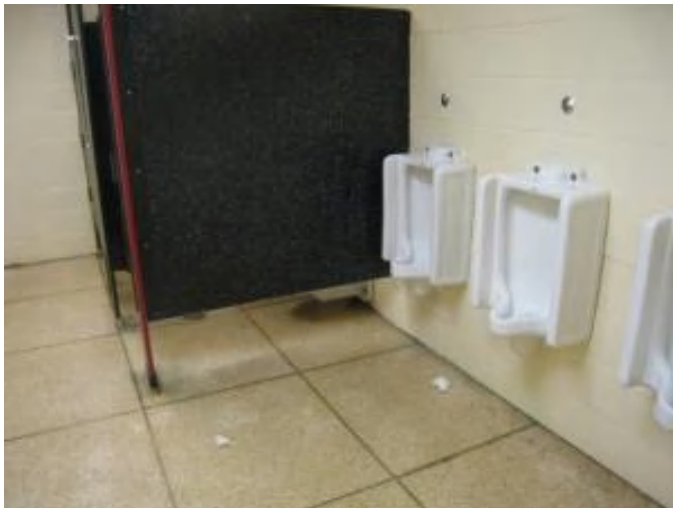
**Location:** Rush - toilet room floors

**Distress:** Appearance

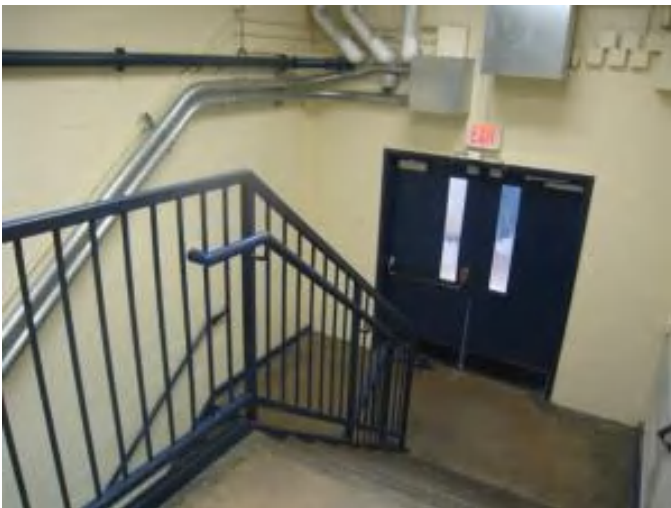
**Location:** Rush - floors

**Distress:** Appearance

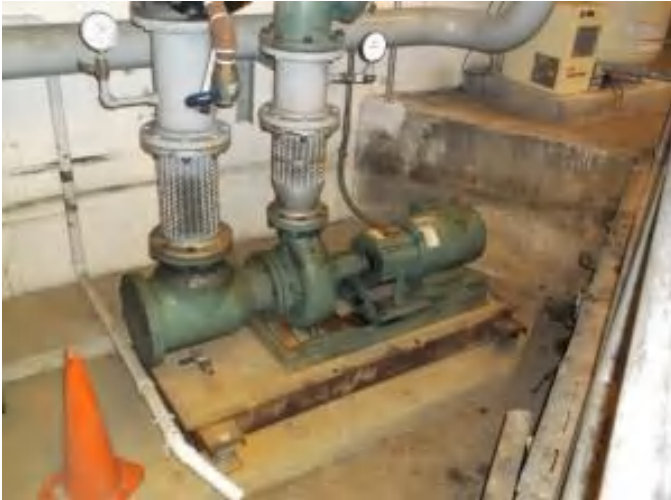
**Location:** Boiler Room

**Distress:** Beyond Service Life

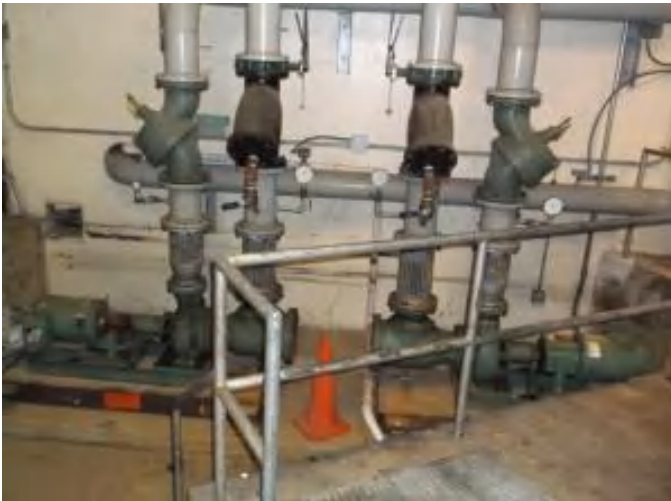
**Location:** Boiler Room

**Distress:** Damaged

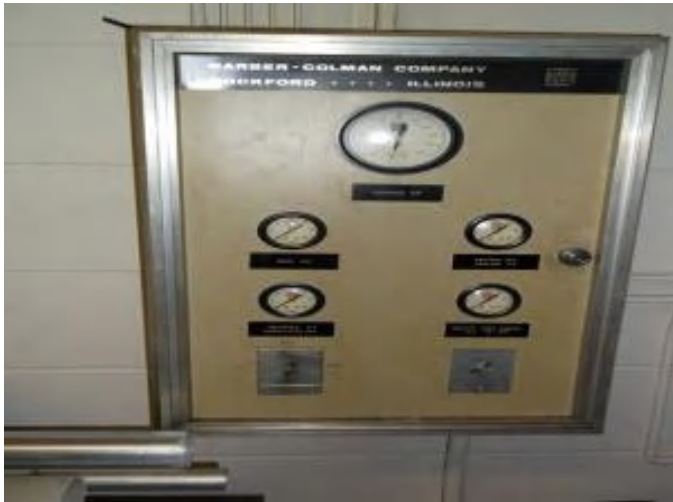
**Location:** Throughout Building

**Distress:** Beyond Service Life

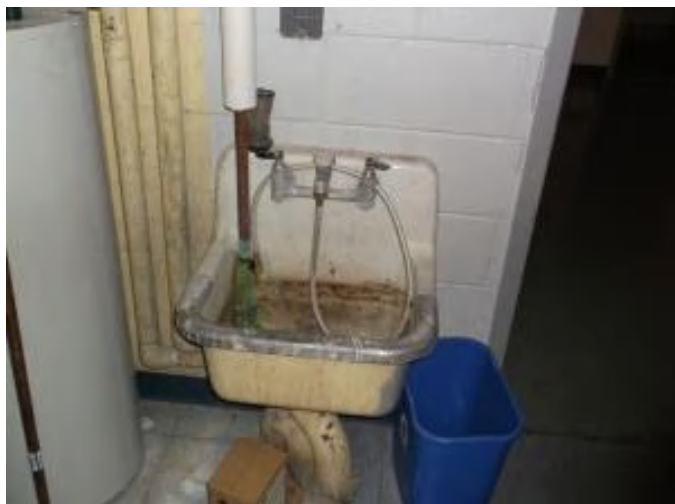
**Location:** Janitor Closet

**Distress:** Beyond Service Life

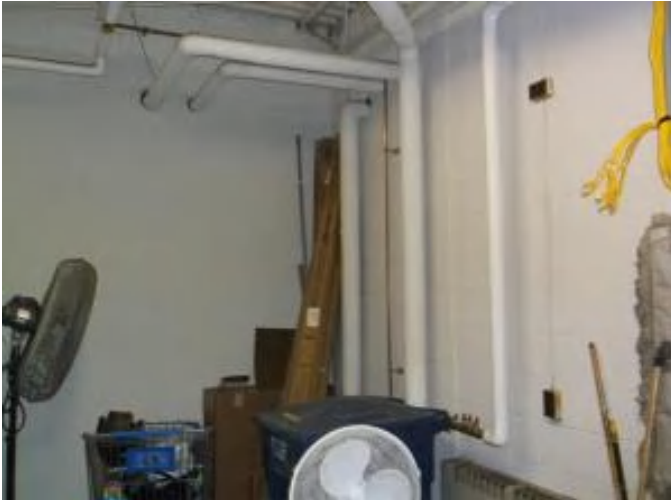
**Location:** Throughout Building

**Distress:** Beyond Service Life

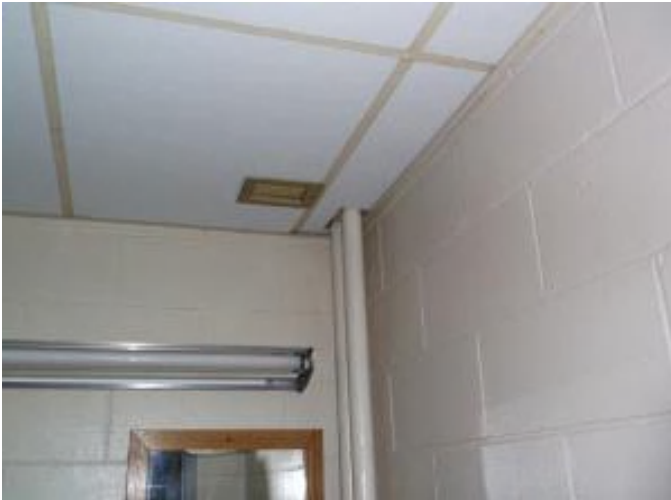
**Location:** Throughout Building

**Distress:** Life Safety / NFPA / PFD

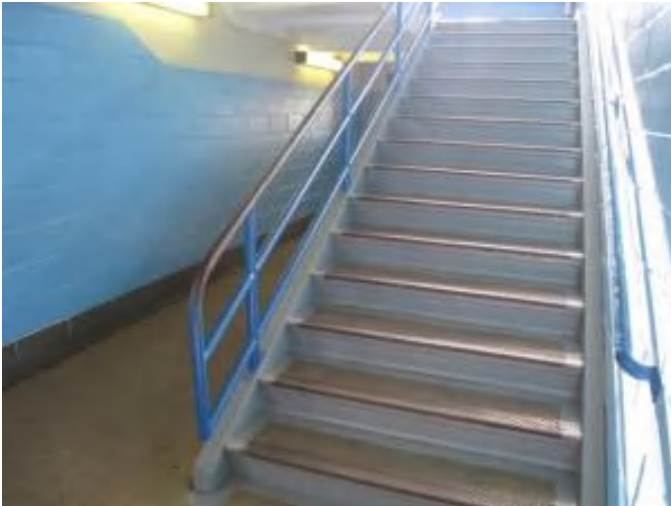
**Location:** Fitzpatrick - stairways

#### System: C2010 - Stair Construction

**Distress:** Building / MEP Codes

**Correction:** Replace inadequate or install proper stair railing  
- select appropriate material

**Notes:** Replace stairway handrails and guards with code compliant system (600lf)

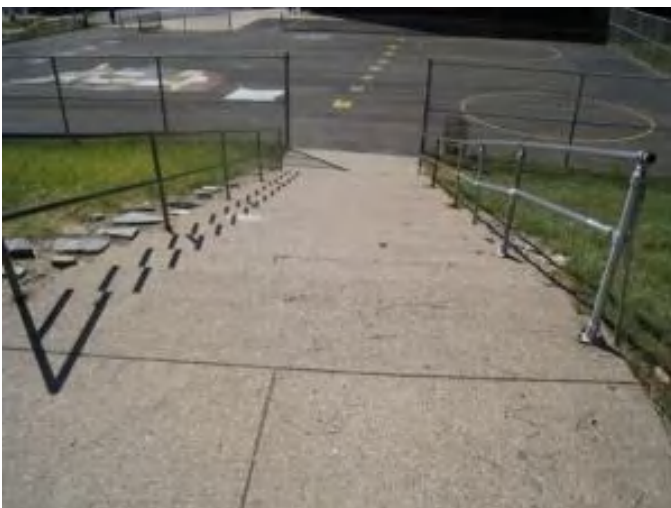
**Location:** Fitzpatrick - exterior handrails

#### System: C2010 - Stair Construction

**Distress:** Building / MEP Codes

**Correction:** Replace inadequate or install proper stair railing  
- select appropriate material

**Notes:** Replace exterior handrails along Knights Road entrance stairs, complying with 2015 building codes (32ft total length) and side stairs leading up to faculty parking lot (36ft total length)

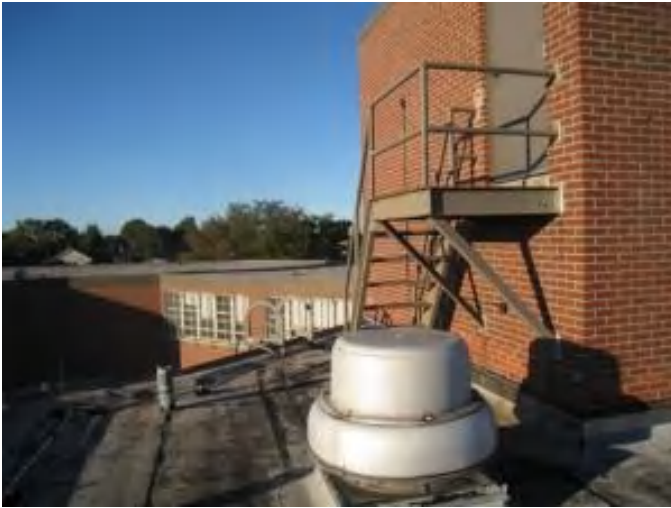
**Location:** Fitzpatrick - roof edge

**System: C2010 - Stair Construction**

**Distress:** Building / MEP Codes

**Correction:** Replace inadequate or install proper stair railing  
- select appropriate material

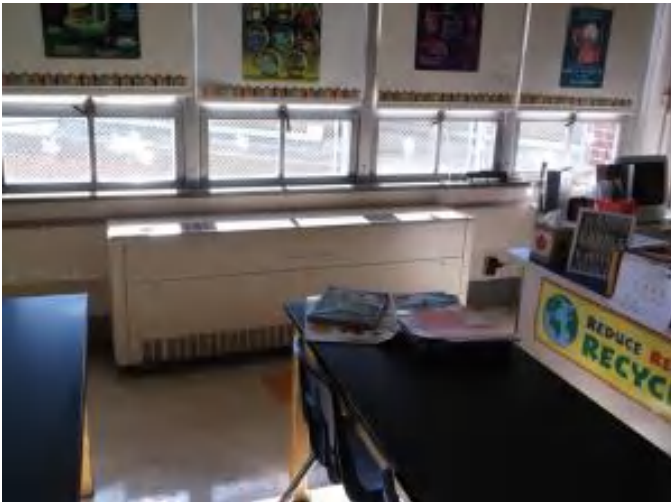
**Location:** Fitzpatrick - throughout the building

**System: D3040 - Distribution Systems**

**Distress:** Beyond Service Life

**Correction:** Replace the existing unit ventilators with new units designed to provide adequate ventilation per ASHRAE Std 62 - insert the SF of bldg. in the qty.

**Notes:** In the Main Building replace the existing unit ventilators throughout the building with new units designed to provide adequate ventilation per ASHRAE Std 62. The new units shall be equipped with hot water / chilled water coils and integral heat exchangers

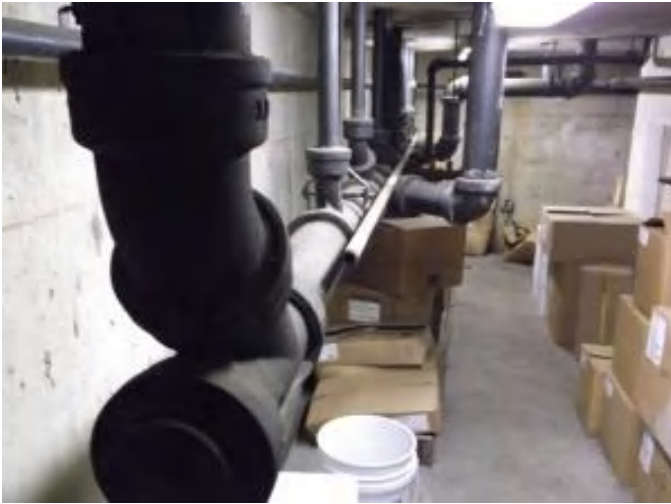
**Location:** Fitzpatrick - throughout the building

**System: D3040 - Distribution Systems**

**Distress:** Beyond Service Life

**Correction:** Conduct a steam trap survey and replace failed units.

**Notes:** In the Main Building conduct a steam trap survey to identify and replace failed traps passing live steam into the condensate piping system.

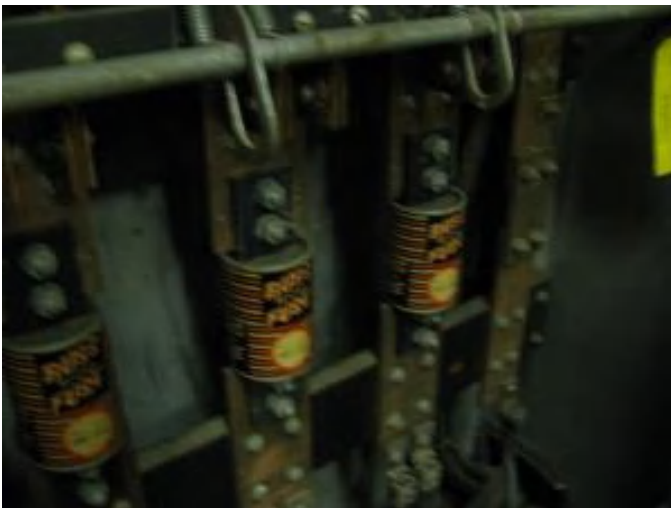
**Location:** Fitzpatrick - Boiler Room

**System: D5010 - Electrical Service/Distribution**

**Distress:** Beyond Service Life

**Correction:** Replace Switchboard

**Notes:** Upgrade the existing electrical service with a new service. Replace the existing switchboard with new 2000A, 208/120V, 3PH, 4 wire switchboards.

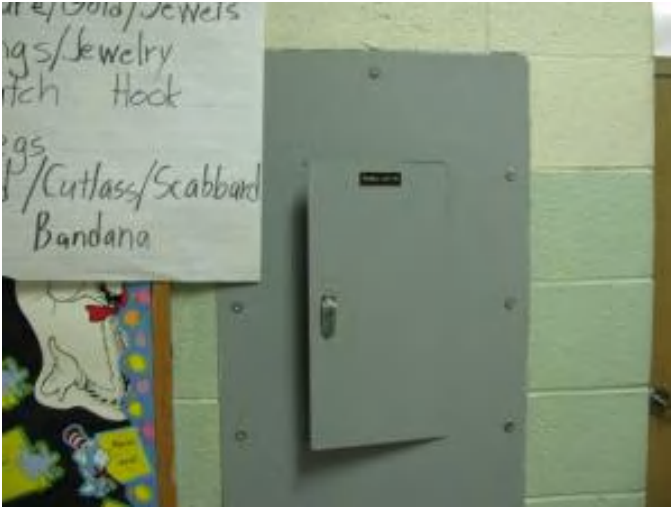
**Location:** Fitzpatrick - Entire Building

**System: D5010 - Electrical Service/Distribution**

**Distress:** Beyond Service Life

**Correction:** Replace Electrical Distribution System (U)

**Notes:** Replace the entire distribution system with new panel boards and new feeders. Provide arc flash label on all panel boards. Estimated, 15 panel boards.

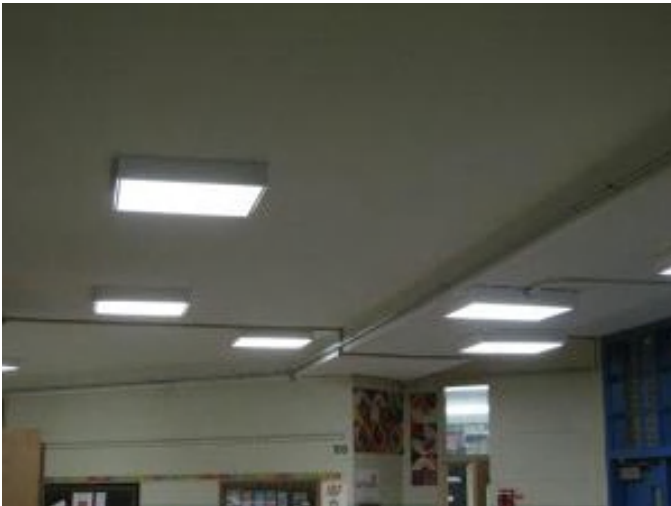
**Location:** Fitzpatrick- Entire Building

**System: D5020 - Lighting and Branch Wiring**

**Distress:** Beyond Service Life

**Correction:** Replace Lighting Fixtures (SF)

**Notes:** Replace all lighting fixtures with new fluorescent lighting fixtures with T-5 lamp. Replace Gymnasium lights with LED high bay fixtures. Estimated 16each.

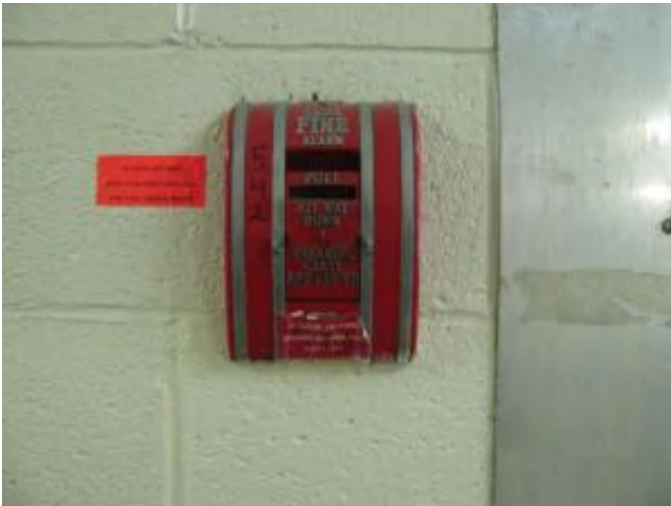
**Location:** Fitzpatrick- Entire Building

**System: D5030 - Communications and Security**

**Distress:** Beyond Service Life

**Correction:** Replace fire alarm system

**Notes:** Replace existing fire alarm system with an automatic fire alarm system including smoke detectors in corridors and other recommended areas per NEC. Install horn/strobes in class rooms, corridors, offices, toilets, library and other recommended areas per codes.

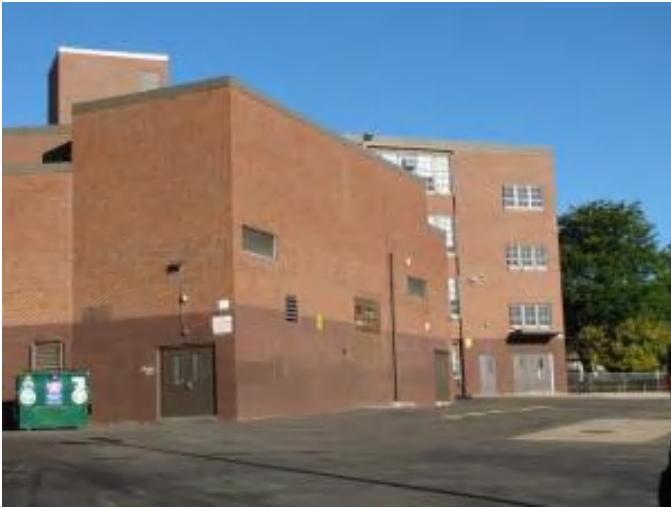
**Location:** Fitzpatrick- Entire Building

**System: D5030 - Communications and Security**

**Distress:** Security Issue

**Correction:** Add/Replace Video Surveillance System

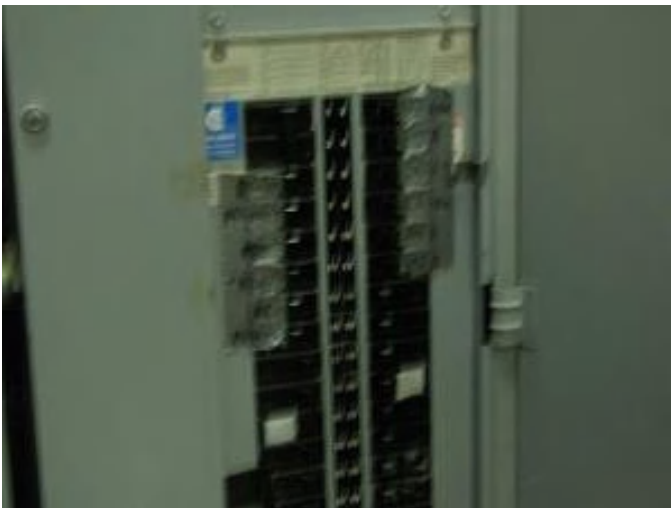
**Location:** Fitzpatrick - Entire Building

**System: E1020 - Institutional Equipment**

**Distress:** Beyond Service Life

**Correction:** Add/Replace Stage Theatrical Lighting System

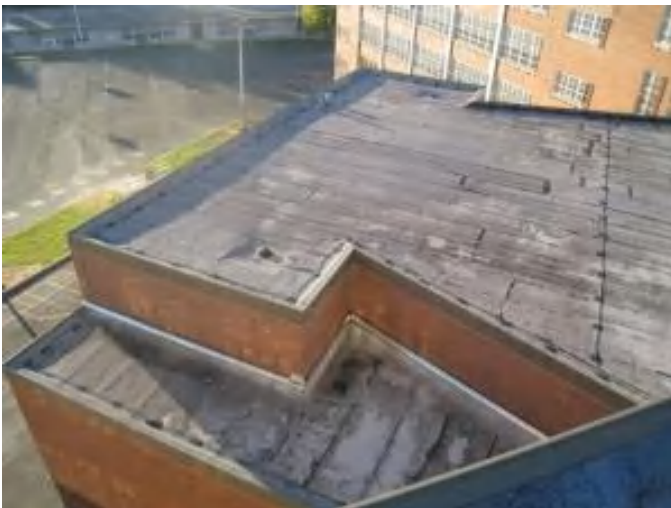
**Location:** Fitzpatrick - brick walls at roof

**System: B2010 - Exterior Walls**

**Distress:** Building Envelope Integrity

**Correction:** Remove and replace expansion joints at exterior walls

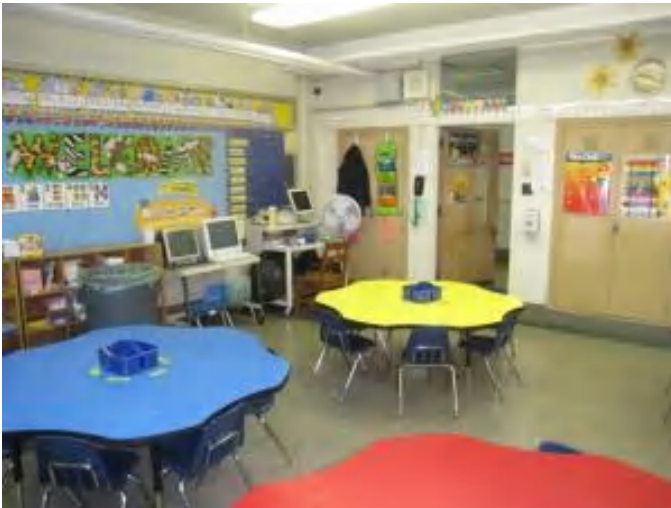
**Location:** Fitzpatrick - interior transoms above doors

**System: B2020 - Exterior Windows**

**Distress:** Building / MEP Codes

**Correction:** Remove and replace aluminum windows - pick the appropriate size and style and insert the number of units

**Notes:** Replace non-fire rated, non-safety glazed transoms above doors on 2nd and 3rd floor, mostly - with fire rated glazing (50 @ 6sf)

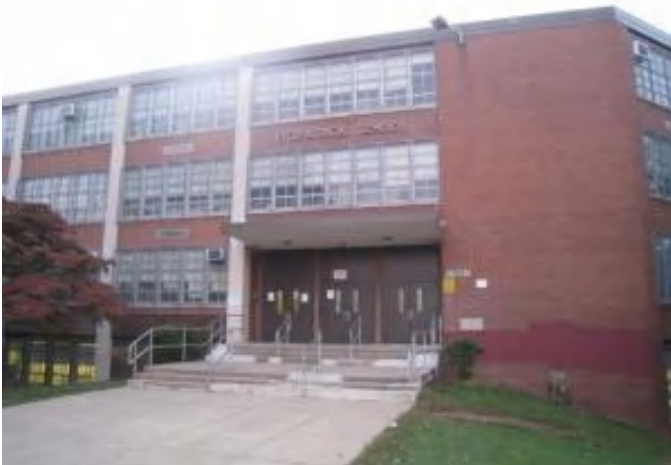
**Location:** Fitzpatrick - exterior doors

**System: B2030 - Exterior Doors**

**Distress:** Energy Efficiency

**Correction:** Replace hardware with compliant hardware, paint and weatherstrip - per leaf

**Notes:** Replace weatherstripping on exterior metal doors and repaint doors and frames (18) 3x7

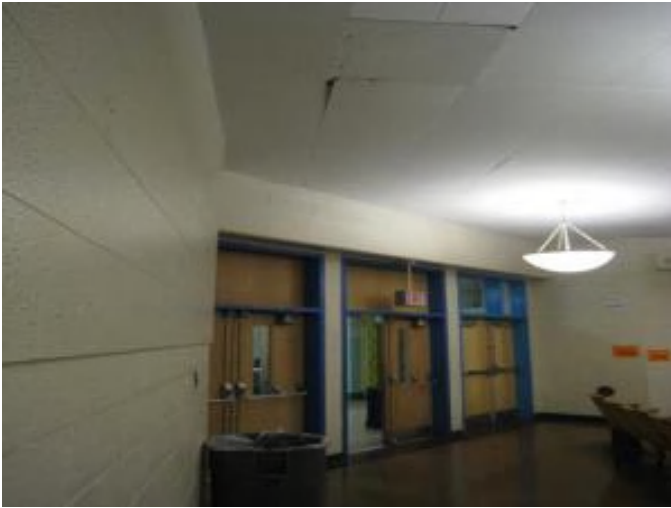
**Location:** Fitzpatrick - interior doors

**System: C1020 - Interior Doors**

**Distress:** Appearance

**Correction:** Remove and replace interior doors - wood doors with hollow metal frames - per leaf

**Notes:** Replace all original wood doors into classroom, toilet rooms, office, and auditorium in corridors where damaged; first floor doors already replaced (50) 3x7

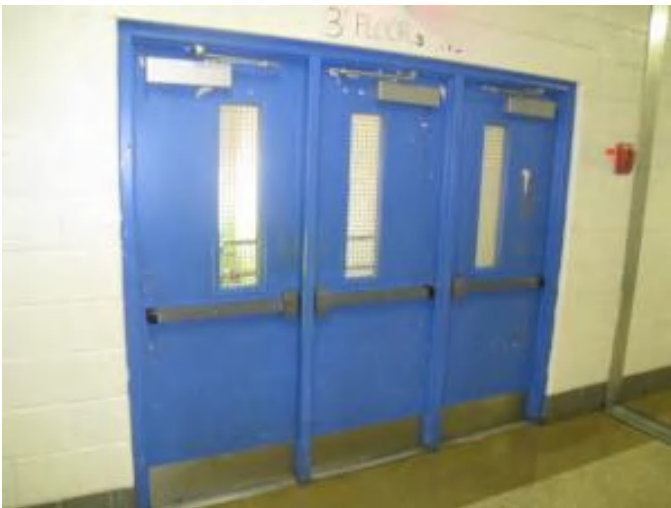
**Location:** Fitzpatrick - interior doors

**System: C1020 - Interior Doors**

**Distress:** Appearance

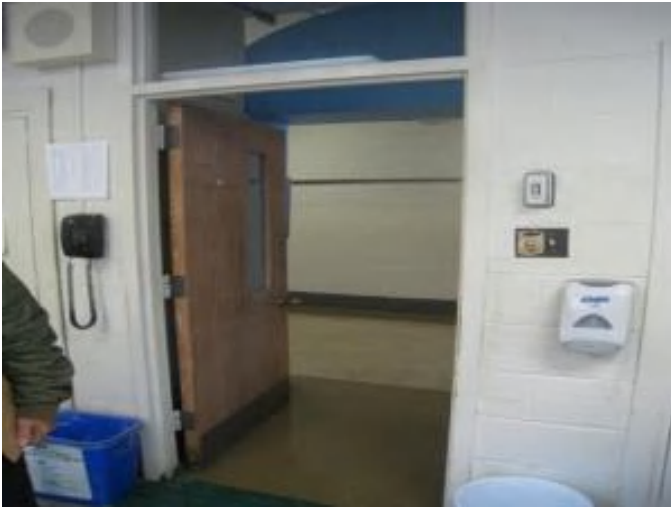
**Location:** Fitzpatrick - interior door hardware

**System: C1020 - Interior Doors**

**Distress:** Security Issue

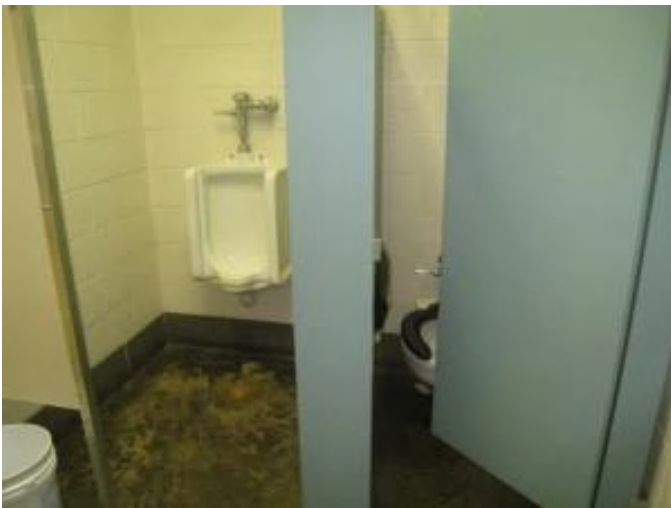
**Location:** Fitzpatrick - toilet rooms

**System: C1030 - Fittings**

**Distress:** Beyond Service Life

**Correction:** Remove and replace toilet partitions

**Notes:** Replace metal and transite toilet room partitions in faculty toilet rooms with HDPE plastic partitions (8 toilet compartments)

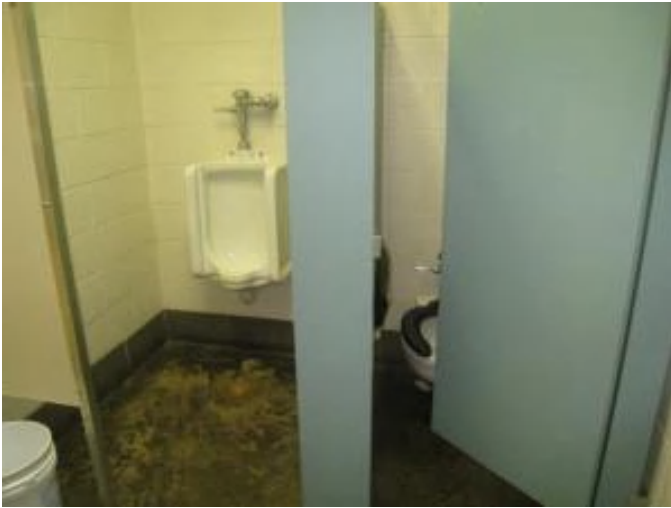
**Location:** Fitzpatrick - toilet rooms

**System: C1030 - Fittings**

**Distress:** Beyond Service Life

**Correction:** Replace toilet accessories - select accessories and quantity

**Notes:** Provide toilet room accessories where partitions are replaced (4 toilet rooms)

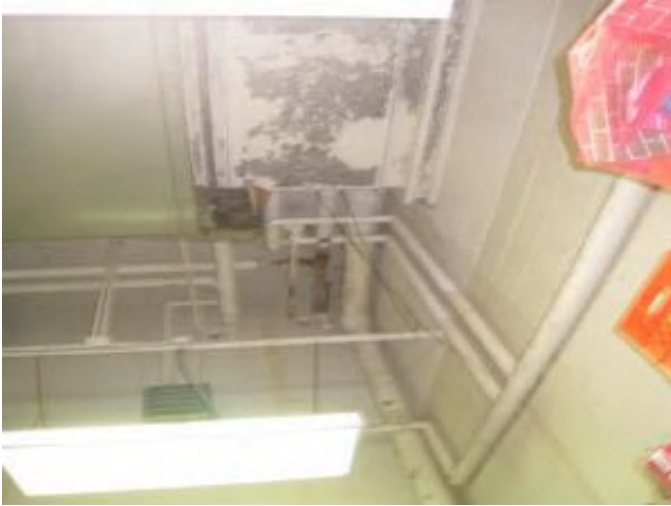
**Location:** Fitzpatrick - interior walls

**System: C3010230 - Paint & Covering**

**Distress:** Appearance

**Correction:** Repair and repaint all interior walls - SF of wall surface

**Notes:** Repair and repaint interior plaster walls and concrete ceilings where damaged in corridors, classrooms, gymnasium office (duct), and stairways (2000sf)

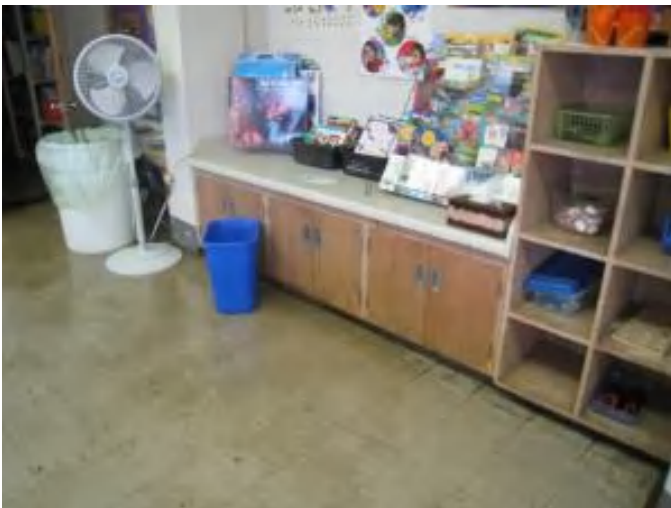
**Location:** Fitzpatrick - floors

**System: C3020413 - Vinyl Flooring**

**Distress:** Beyond Service Life

**Correction:** Remove VAT and replace with VCT - SF of area

**Notes:** Remove 9"x9" VAT floors in classrooms, offices, cafeteria, and auditorium with and replace with VCT (54,950sf)

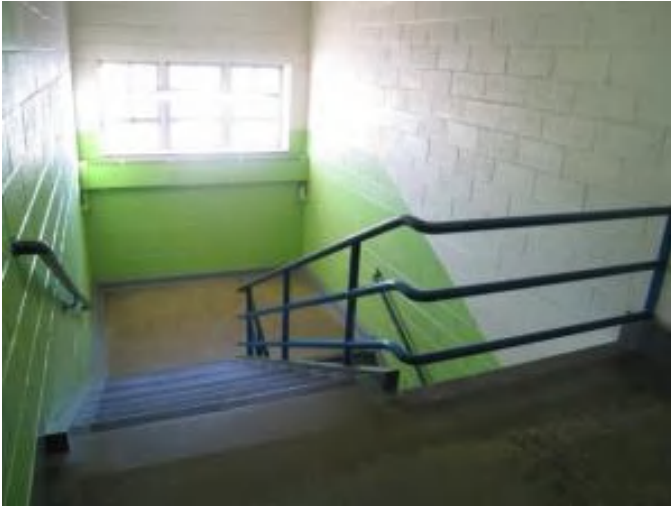
**Location:** Fitzpatrick - mechanical rooms, toilet rooms, stairs

**System: C3020415 - Concrete Floor Finishes**

**Distress:** Appearance

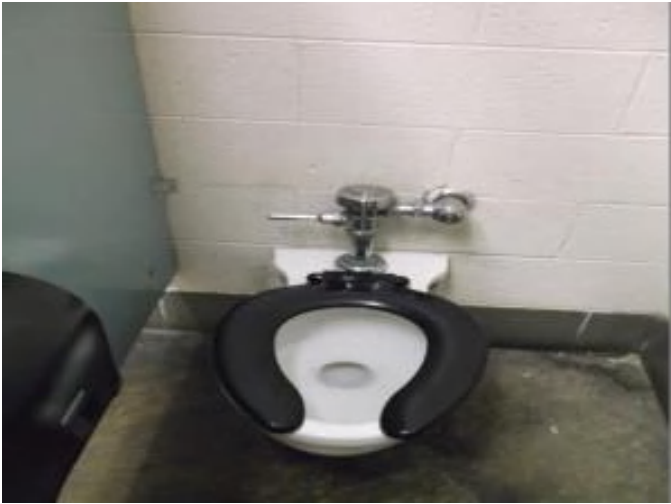
**Location:** Fitzpatrick - throughout the building

**System: D2010 - Plumbing Fixtures**

**Distress:** Beyond Service Life

**Correction:** Remove and replace or replace water closet - quantify additional units

**Notes:** In the Main Building replace all water closets in the building with lower flow fixtures, as the fixtures are original.

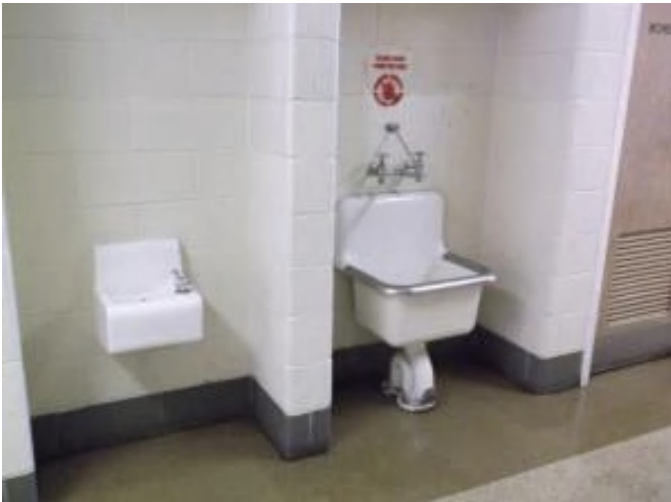
**Location:** Fitzpatrick - throughout the building

**System: D2010 - Plumbing Fixtures**

**Distress:** Beyond Service Life

**Correction:** Remove and replace water fountains to meet ADA - includes high and low fountains and new recessed alcove

**Notes:** In the Main Building Replace the wall hung drinking fountains and integral refrigerated coolers in the corridors and at the restrooms. These units are well beyond their service life and most are NOT accessible type.

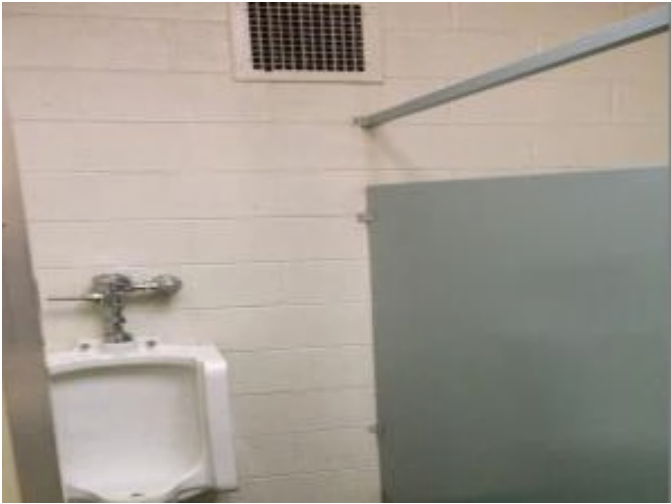
**Location:** Fitzpatrick - throughout the building

**System: D2010 - Plumbing Fixtures**

**Distress:** Beyond Service Life

**Correction:** Remove and replace or replace stall or floor type urinal

**Notes:** In the Main Building replace all urinals in the building with lower flow fixtures, as the fixtures are original.

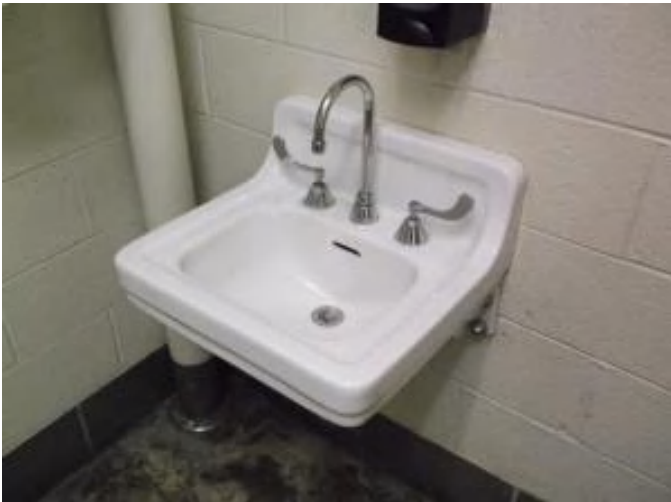
**Location:** Fitzpatrick - throughout the building

**System: D2010 - Plumbing Fixtures**

**Distress:** Beyond Service Life

**Correction:** Remove and replace or replace lavatory - quantify accessible if required

**Notes:** In the Main Building replace all lavatories in the building with lower flow fixtures, as the fixtures are original.

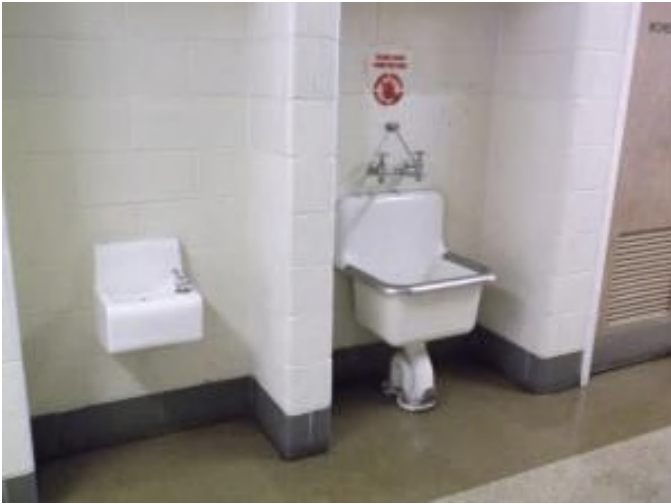
**Location:** Fitzpatrick - throughout the building

**System: D2010 - Plumbing Fixtures**

**Distress:** Beyond Service Life

**Correction:** Remove and replace floor janitor or mop sink - insert the quantity

**Notes:** In the Main Building replace service sinks (janitor sinks) in the building.

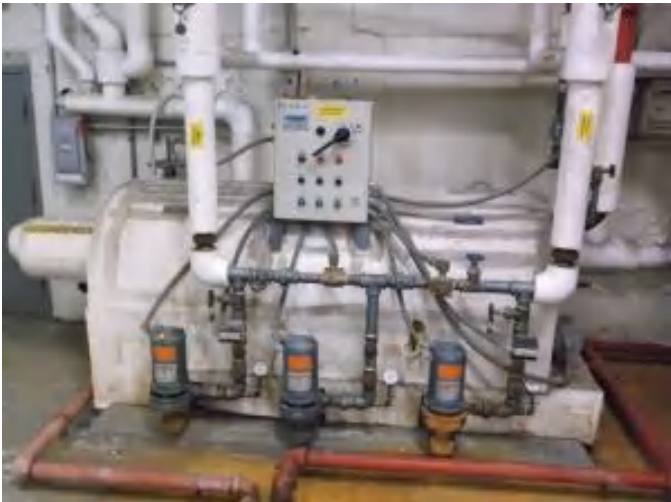
**Location:** Fitzpatrick - throughout the building

**System: D3020 - Heat Generating Systems**

**Distress:** Beyond Service Life

**Correction:** Replace boiler feed pump (duplex) and surge tank

**Notes:** Replace boiler feedwater system.

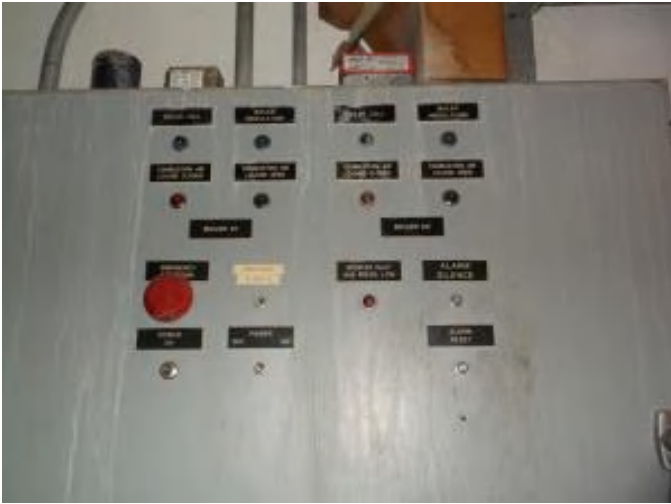
**Location:** Fitzpatrick - throughout the building

**System: D3060 - Controls & Instrumentation**

**Distress:** Beyond Service Life

**Correction:** Replace pneumatic controls with DDC (75KSF)

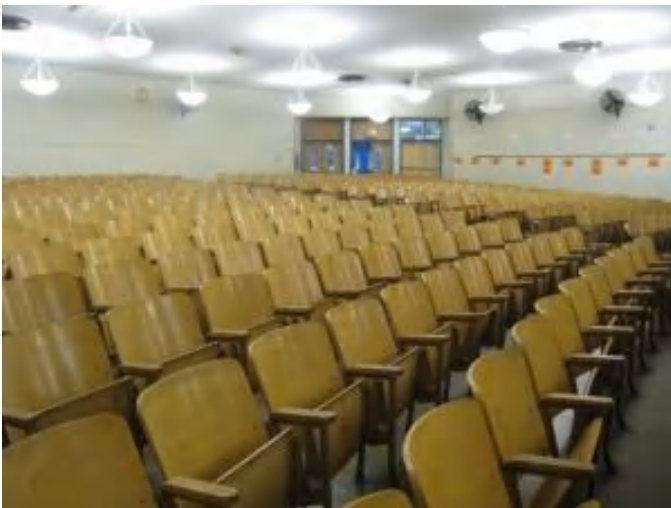
**Location:** Fitzpatrick - auditorium

**System: E2010 - Fixed Furnishings**

**Distress:** Appearance

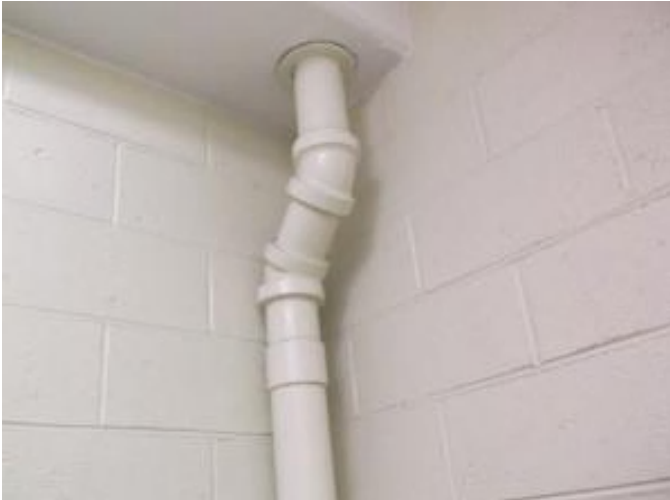
**Location:** Fitzpatrick - throughout the building

**System: D2030 - Sanitary Waste**

**Distress:** Beyond Service Life

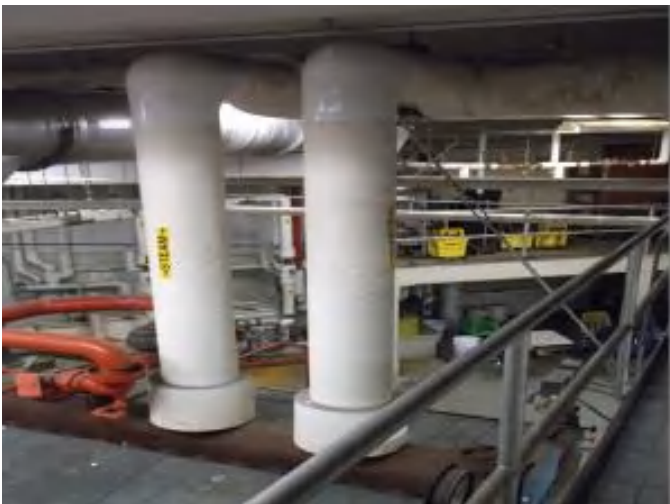
**Location:** Fitzpatrick - throughout the building

**System: D3040 - Distribution Systems**

**Distress:** Beyond Service Life

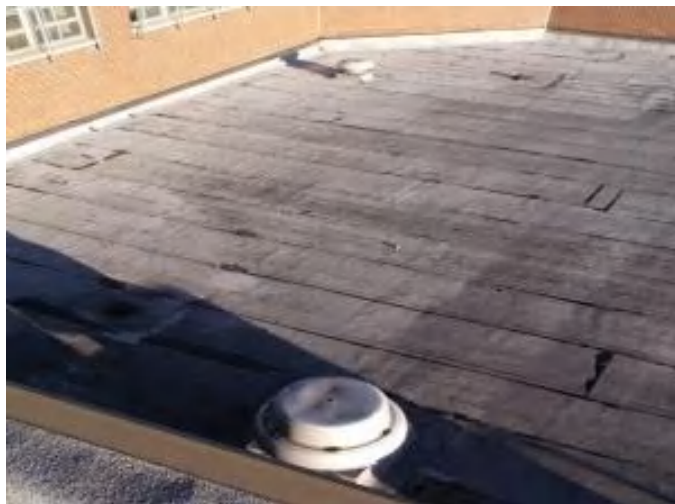
**Location:** Fitzpatrick - roof

**System: D3040 - Distribution Systems**

**Distress:** Beyond Service Life

**Correction:** Replace power roof ventilator (24" dia.)

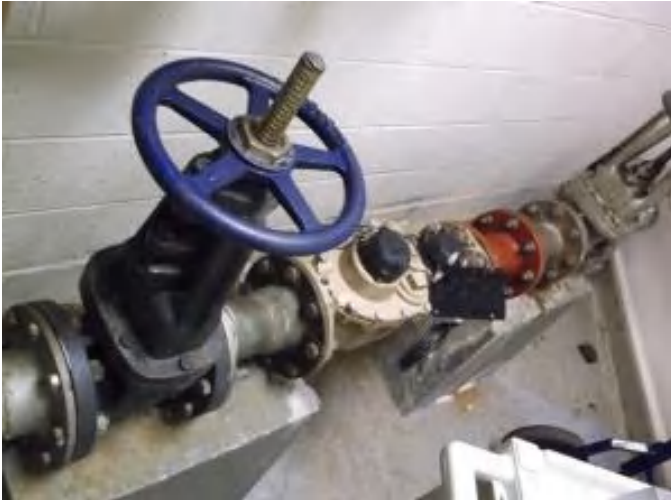
**Location:** Fitzpatrick - throughout the building

**System: D2020 - Domestic Water Distribution**

**Distress:** Beyond Service Life

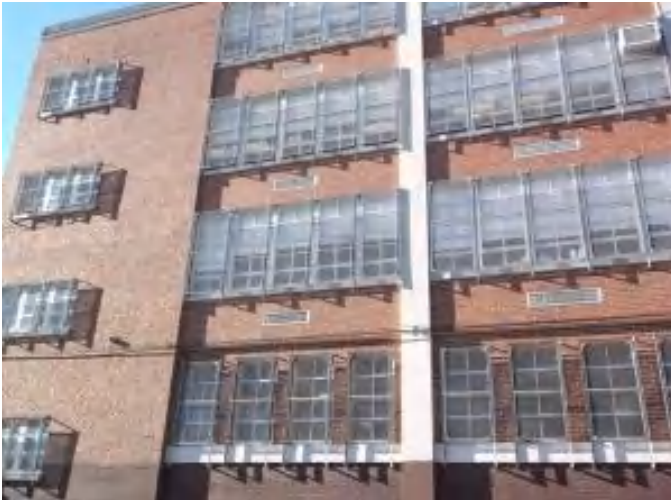
**Location:** Fitzpatrick - throughout the building

**System: D3030 - Cooling Generating Systems**

**Distress:** Inadequate

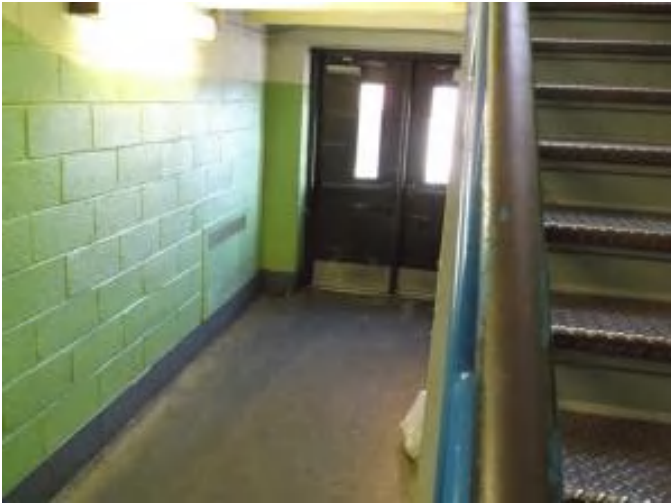
**Location:** Fitzpatrick - throughout the building

**System: D3040 - Distribution Systems**

**Distress:** Beyond Service Life

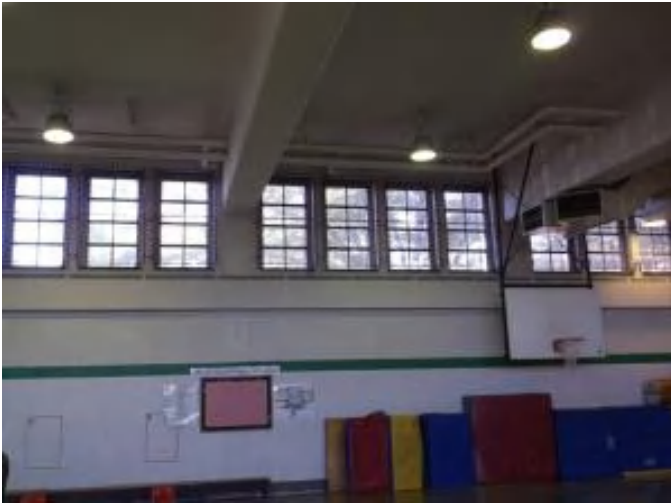
**Location:** Fitzpatrick - roof

**System: D3040 - Distribution Systems**

**Distress:** Beyond Service Life

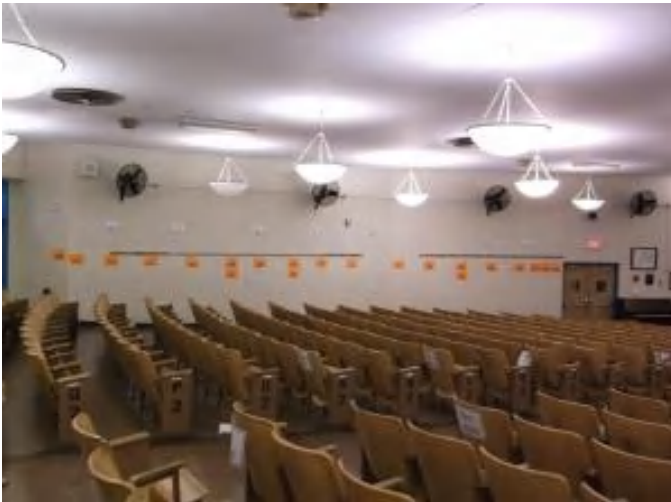
**Location:** Fitzpatrick - roof

**System: D3040 - Distribution Systems**

**Distress:** Beyond Service Life

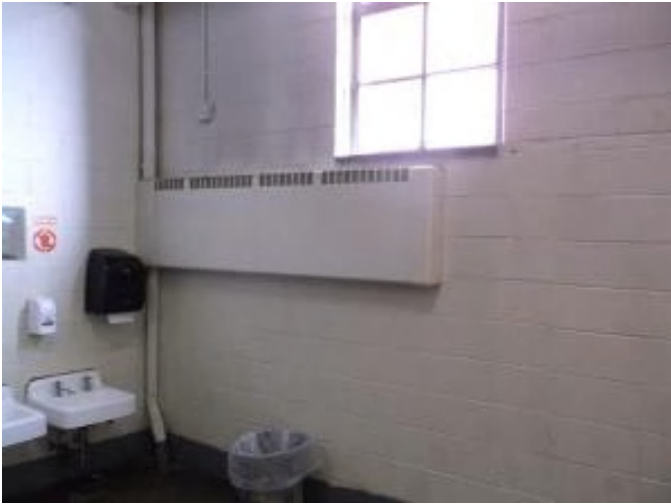
**Location:** Fitzpatrick - throughout the building

**System: D3040 - Distribution Systems**

**Distress:** Beyond Service Life

**Correction:** Replace finned tube radiation terminals (per 100 LF)

**Notes:** In the Main Building replace the steam convection units and any of the original radiant heating (manifold) terminals fashioned from welded piping still present in the building with finned tube elements to protect students from exposure to the hot surfaces.

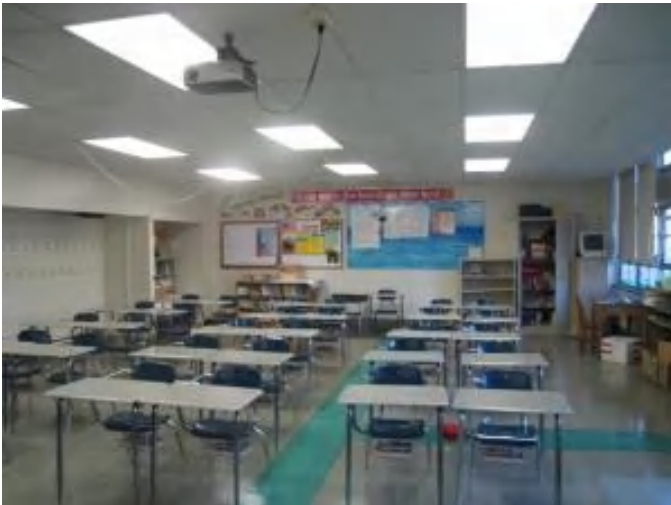
**Location:** Fitzpatrick - throughout the building

**System: D4010 - Sprinklers**

**Distress:** Life Safety / NFPA / PFD

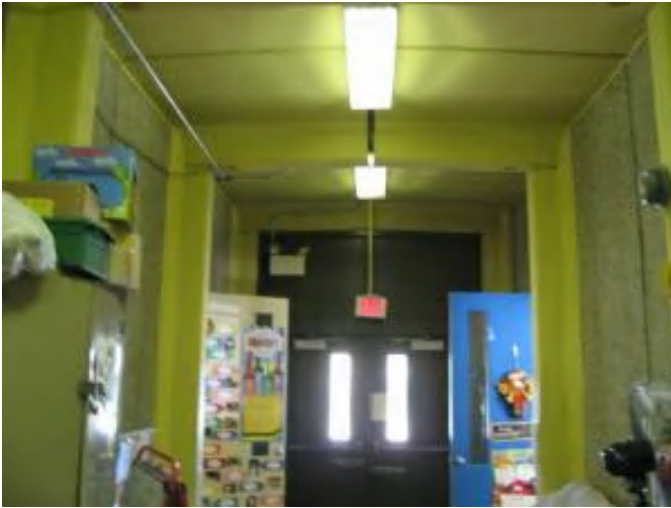
**Location:** Fitzpatrick Annex - Entire Building

**System: D5030 - Communications and Security**

**Distress:** Security Issue

**Correction:** Add/Replace Video Surveillance System

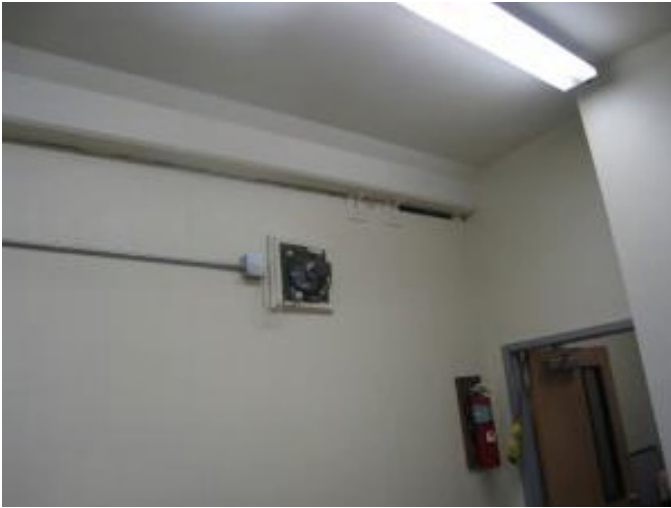
**Location:** Fitzpatrick Annex - doors

**System: C1020 - Interior Doors**

**Distress:** Building / MEP Codes

**Correction:** Replace door knobs with compliant lever type
