## Facility Condition Assessment Summary Report

### Fitzpatrick School

### Fitzpatrick (Annex) School

January 31, 2017

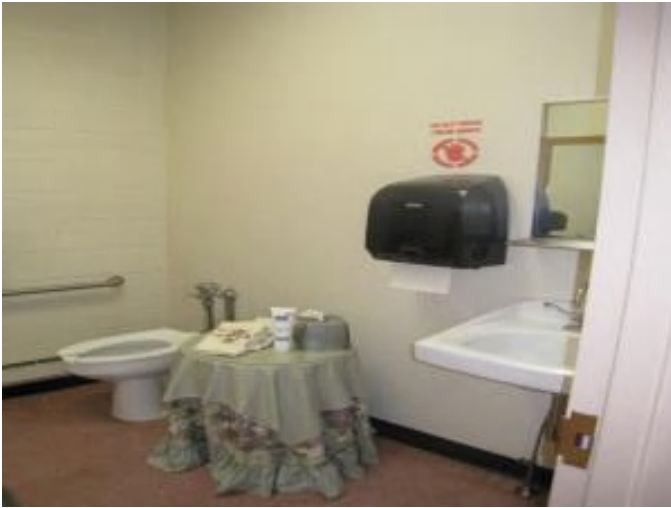
**Location:** Fitzpatrick Annex - toilet room

**System: C1030 - Fittings**

**Distress:** Building / MEP Codes

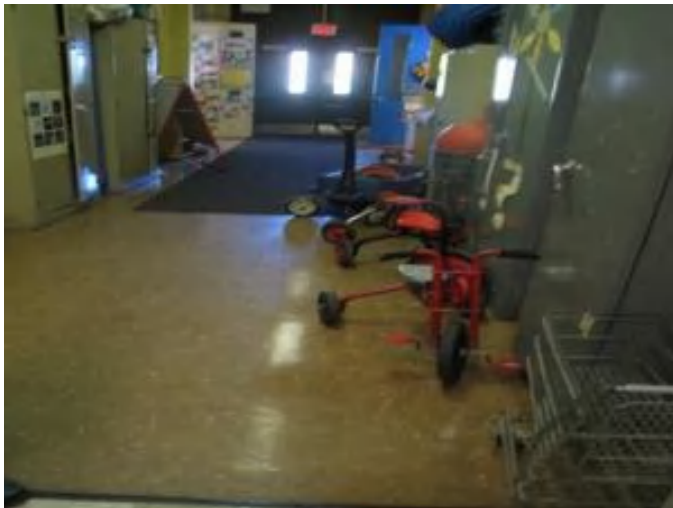
**Location:** Fitzpatrick Annex - floors

**System: C3020413 - Vinyl Flooring**

**Distress:** Beyond Service Life

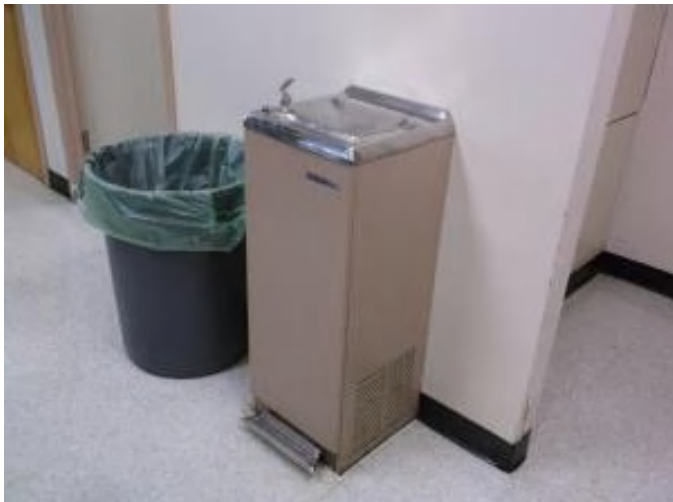
**Location:** Fitzpatrick Annex - throughout the building

**System: D2010 - Plumbing Fixtures**

**Distress:** Beyond Service Life

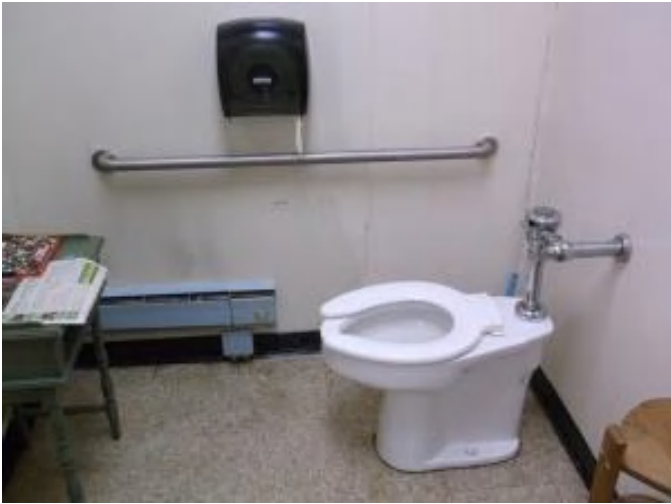
**Location:** Fitzpatrick Annex - throughout the building

**System: D2010 - Plumbing Fixtures**

**Distress:** Beyond Service Life

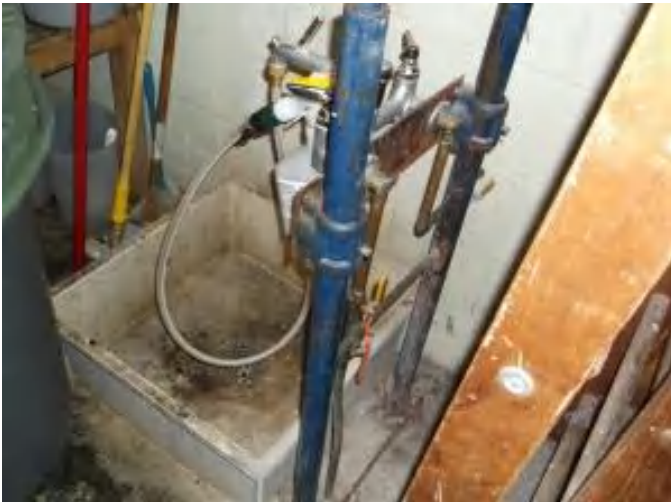
**Location:** Fitzpatrick Annex - throughout the building

**System: D2010 - Plumbing Fixtures**

**Distress:** Beyond Service Life

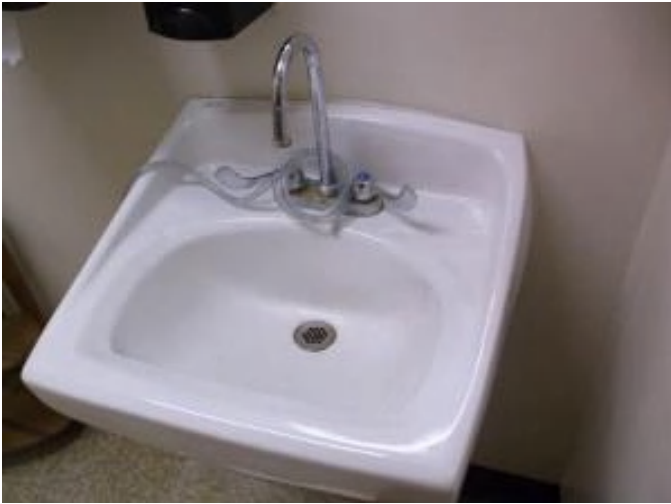
**Location:** Fitzpatrick Annex - throughout the building

**System: D2010 - Plumbing Fixtures**

**Distress:** Beyond Service Life

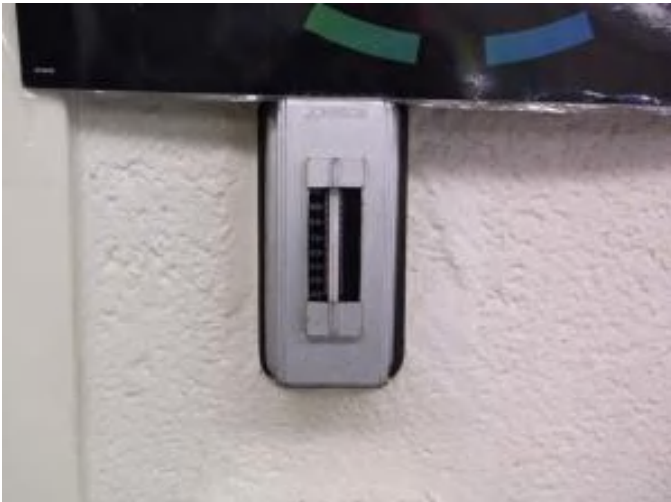
**Location:** Fitzpatrick Annex - throughout the building

**System: D3060 - Controls & Instrumentation**

**Distress:** Beyond Service Life

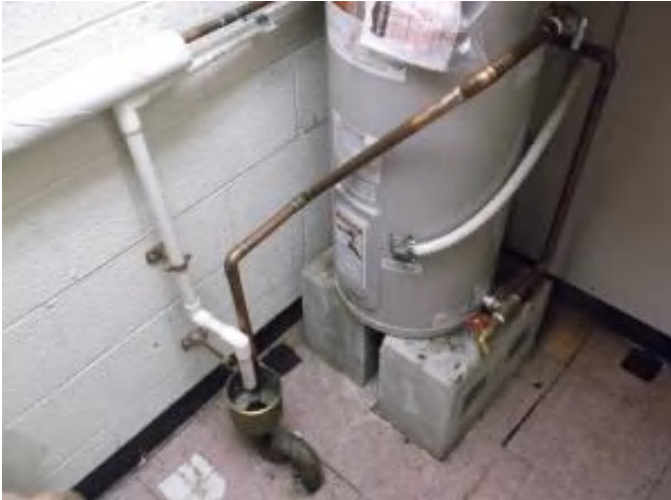
**Location:** Fitzpatrick Annex - throughout the building

**System: D2030 - Sanitary Waste**

**Distress:** Beyond Service Life

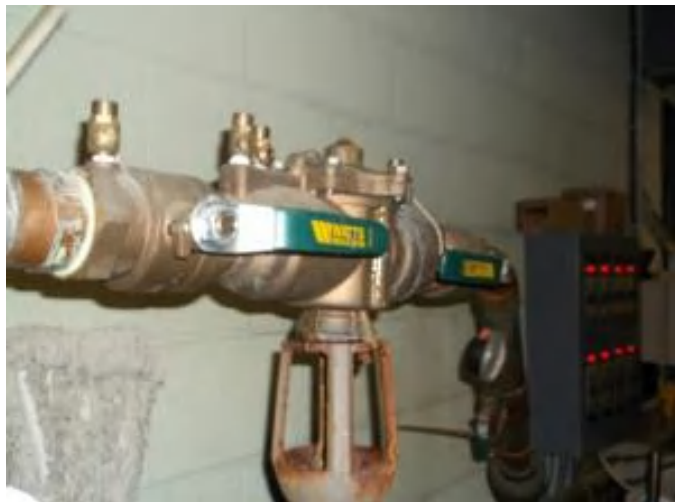
**Location:** Fitzpatrick Annex - throughout the building

**System: D2020 - Domestic Water Distribution**

**Distress:** Beyond Service Life

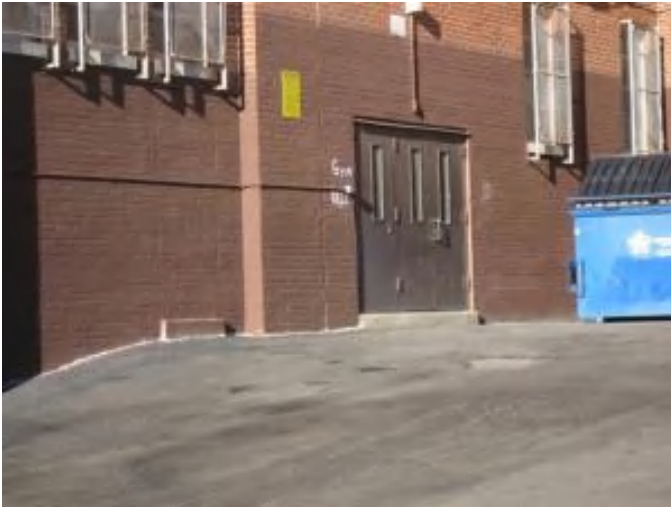
**Location:** Fitzpatrick - handicap sloped entrance

**System: G2030 - Pedestrian Paving**

**Distress:** Building / MEP Codes

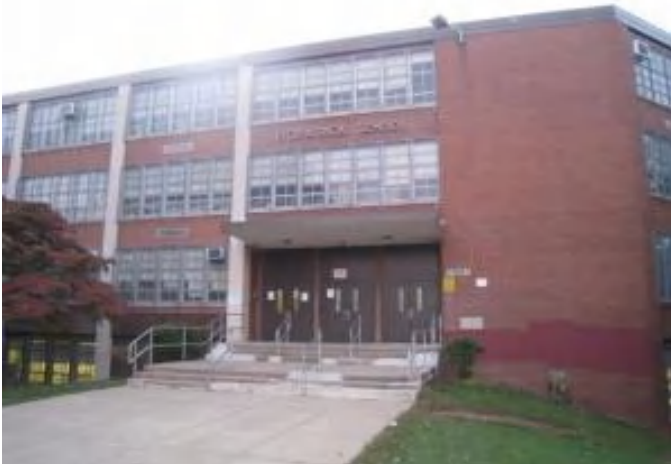
**Location:** Fitzpatrick - regrading

**System: G2040 - Site Development**

**Distress:** Inadequate
