Facility Condition Assessment Summary Report

Frank School

School District of Philadelphia

January 31, 2017

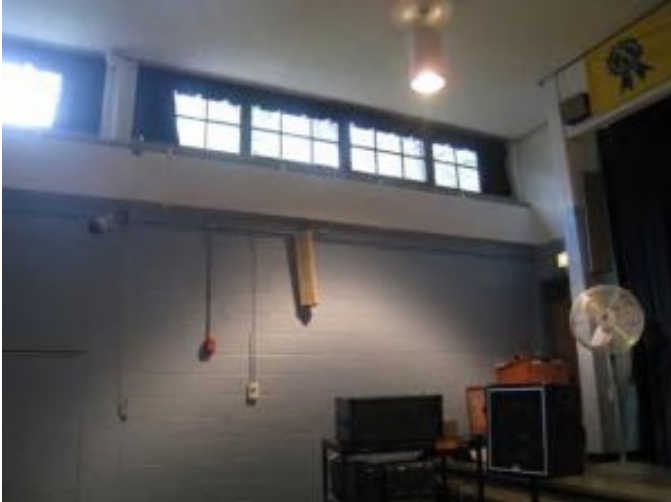
System: B2020 - Exterior Windows

Location: Main Building - exterior windows

Distress: Beyond Service Life

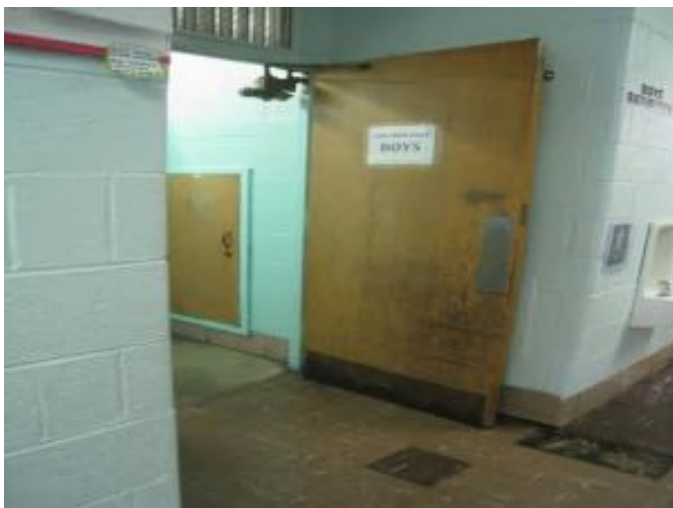
System: C1020 - Interior Doors

Location: Main Building - interior doors

Distress: Appearance

Notes: Refinish wood doors into classroom, toilet rooms, office, and auditorium in corridors (110) 3x7 doors

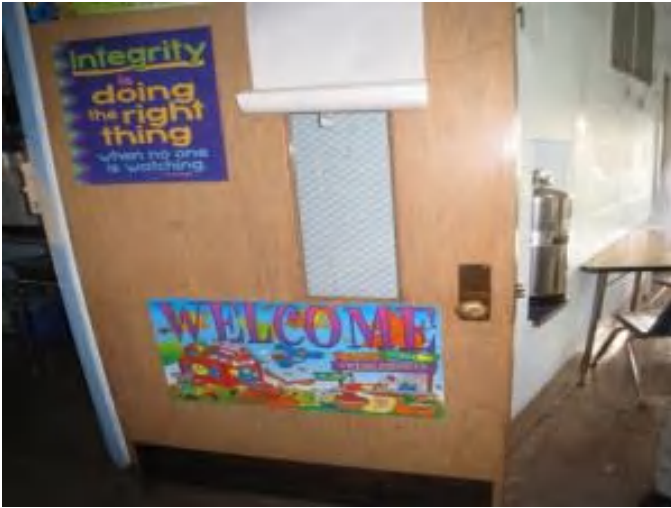
System: C1020 - Interior Doors

Location: Main Building - interior doors

Distress: Building / MEP Codes

Notes: Refinish wood doors into classroom, toilet rooms, office, and auditorium in corridors and provide new lever locksets (110) 3x7 doors

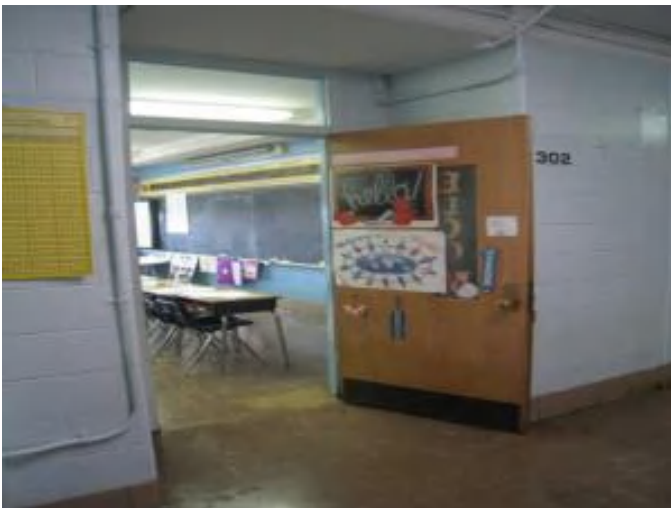
System: C1020 - Interior Doors

Location: Main Building - corridor doors - classrooms and offices

Distress: Security Issue

Notes: Provide security hardware for classrooms and offices, locking from the inside of the room (55)

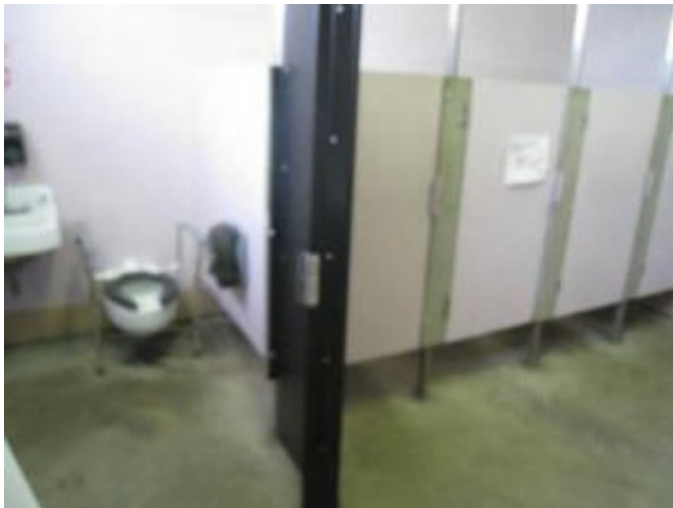
System: C1030 - Fittings

Location: Main Building - toilet rooms

Distress: Beyond Service Life

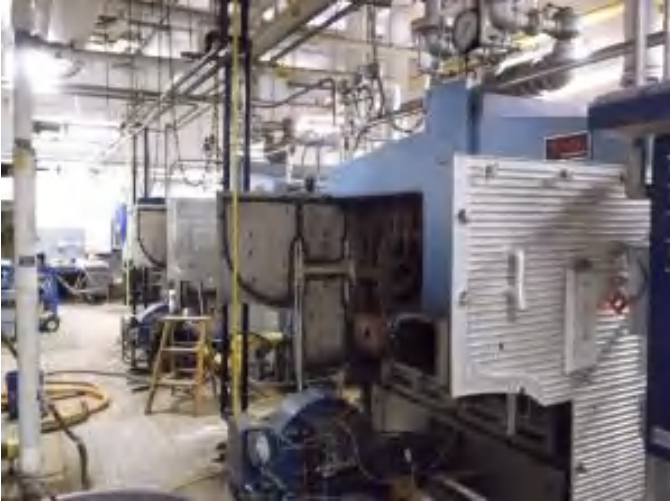
System: D3020 - Heat Generating Systems

Location: Main Building - main boiler mechanical equipment room

Distress: Beyond Service Life

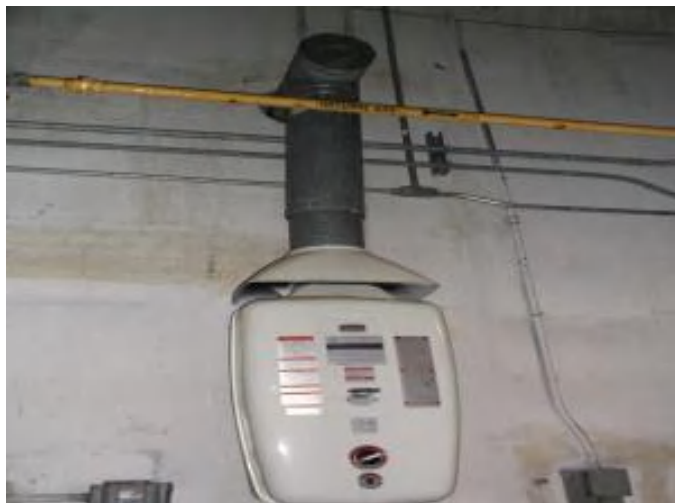
System: D2020 - Domestic Water Distribution

Location: Main Building - main mechanical boiler equipment room

Distress: Beyond Service Life

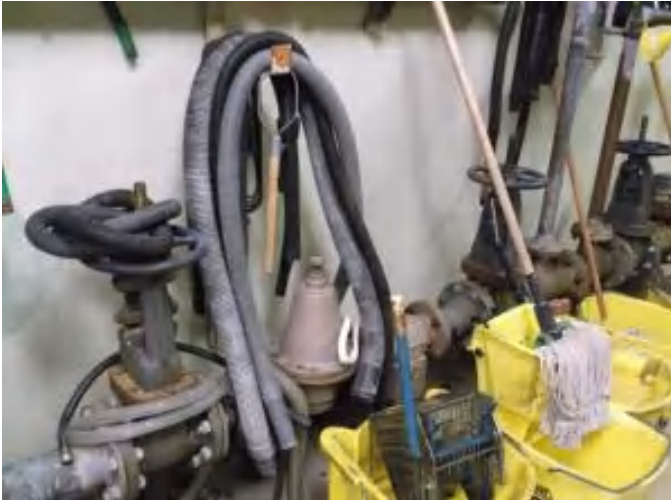
System: D2020 - Domestic Water Distribution

Location: Main Building - throughout the building

Distress: Beyond Service Life

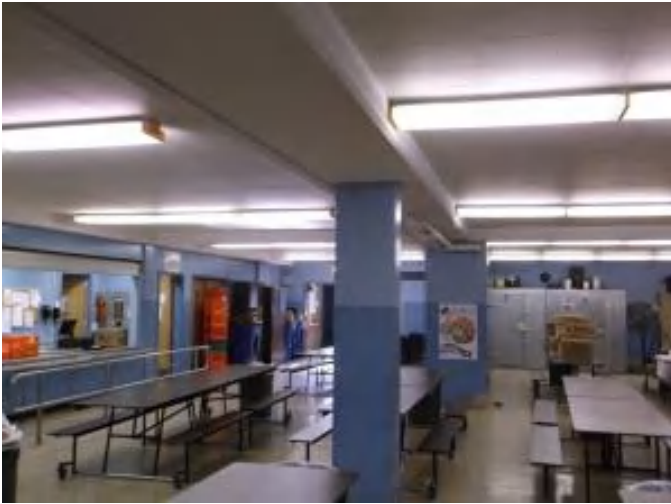
System: D3040 - Distribution Systems

Location: Main Building - roof

Distress: Beyond Service Life

Notes: In the Main Building provide ventilation, heating and cooling for the Cafeteria by removing the existing unit ventilators and installing a package rooftop constant volume air handling unit with distribution ductwork and registers.

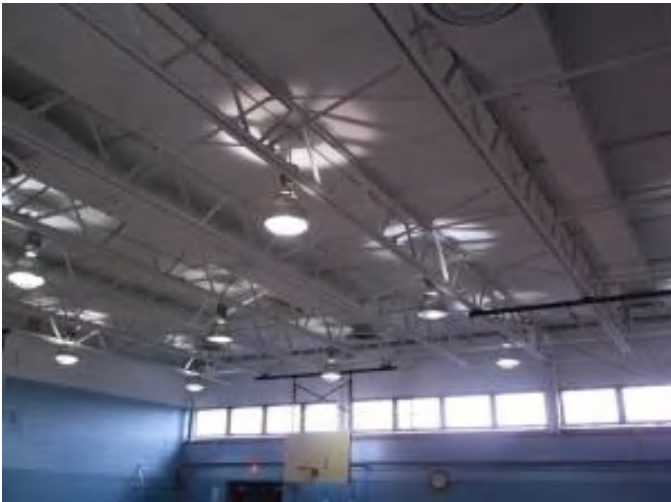
System: D3040 - Distribution Systems

Location: Main Building - roof

Distress: Beyond Service Life

Notes: In the Main Building provide ventilation, heating and cooling for the gymnasium by installing a packaged roof top unit.

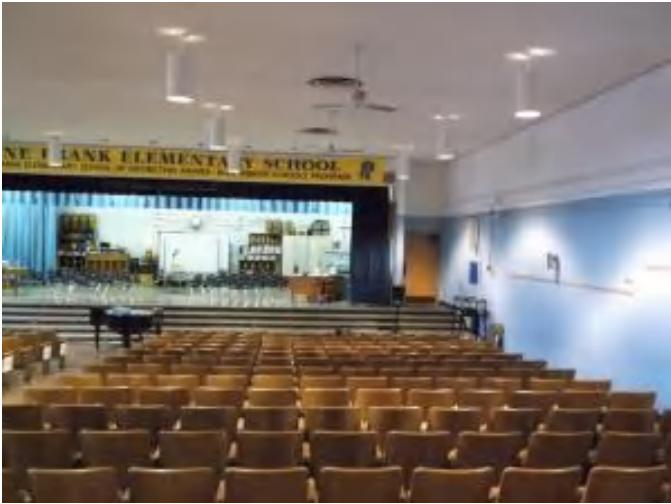
System: D3040 - Distribution Systems

Location: Main Building - roof

Distress: Beyond Service Life

Notes: In the Main Building provide ventilation, heating and cooling for the Auditorium by removing the existing unit ventilators and installing a package rooftop constant volume air handling unit with distribution ductwork and registers.

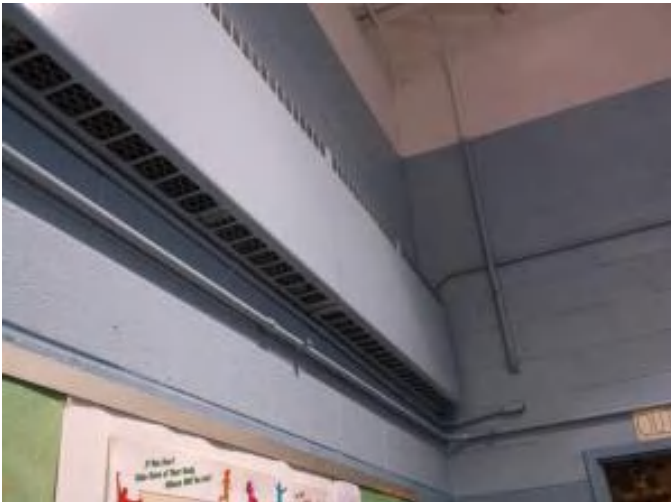
System: D3040 - Distribution Systems

Location: Main Building - throughout the building

Distress: Beyond Service Life

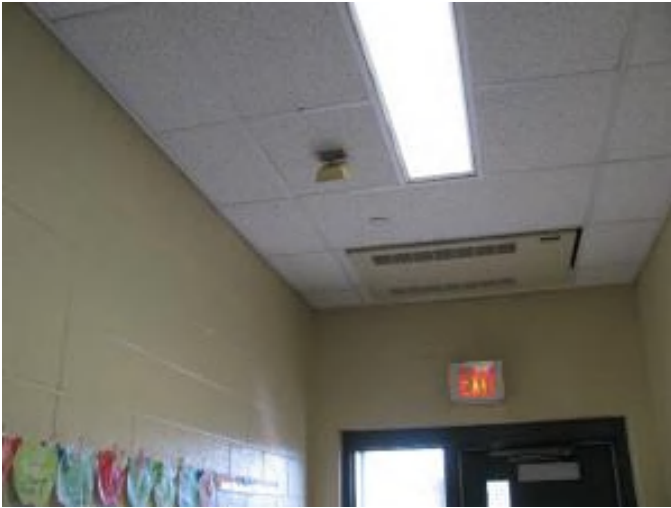
System: D5020 - Lighting and Branch Wiring

Location: LSH - Entire Building

Distress: Life Safety / NFPA / PFD

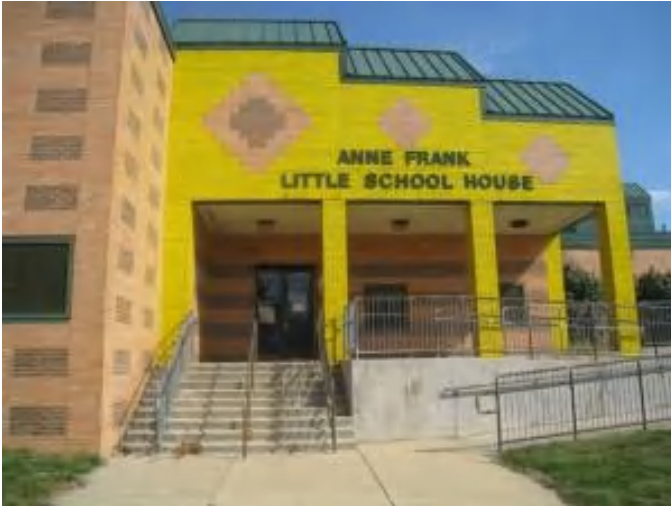
System: B2010 - Exterior Walls

Location: LSH - metal panel doghouses and roofs

Distress: Appearance

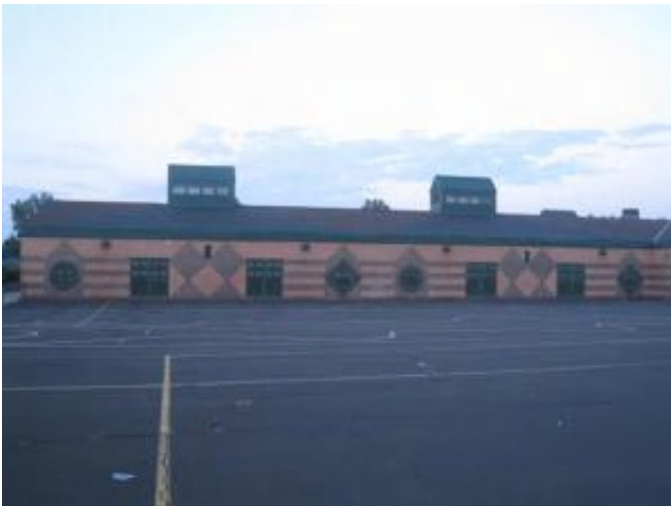
System: B3010140 - Shingle & Tile

Location: LSH - gutter

Distress: Building Envelope Integrity

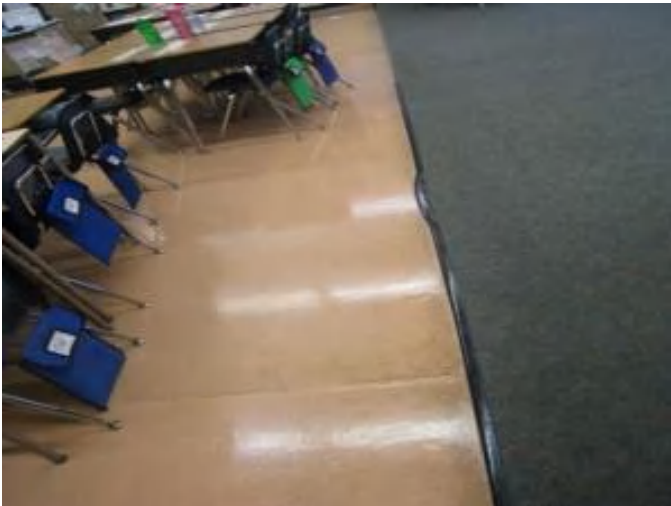
System: C3020411 - Carpet

Location: LSH - classrooms

Distress: Beyond Service Life

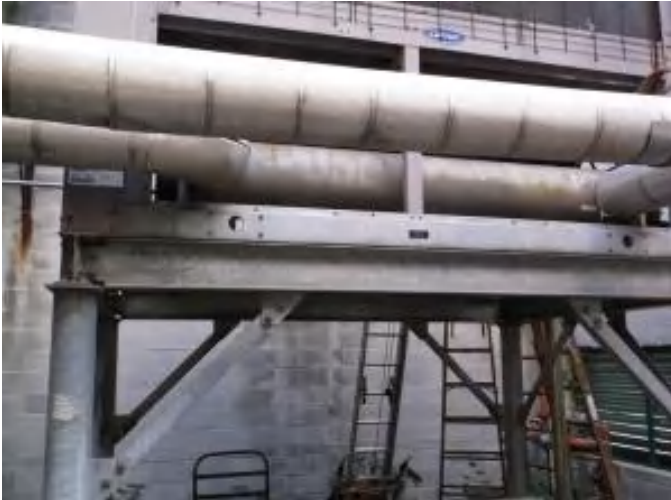
System: D3040 - Distribution Systems

Location: LSH - Main boiler mechanical equipment room

Distress: Beyond Service Life
