## Facility Condition Assessment Summary Report

### Frankford School

School District of Philadelphia  
**S701001;Frankford**  
Final  
**Site Assessment Report**  
January 31, 2017

Facility Condition Assessment  
December 2015

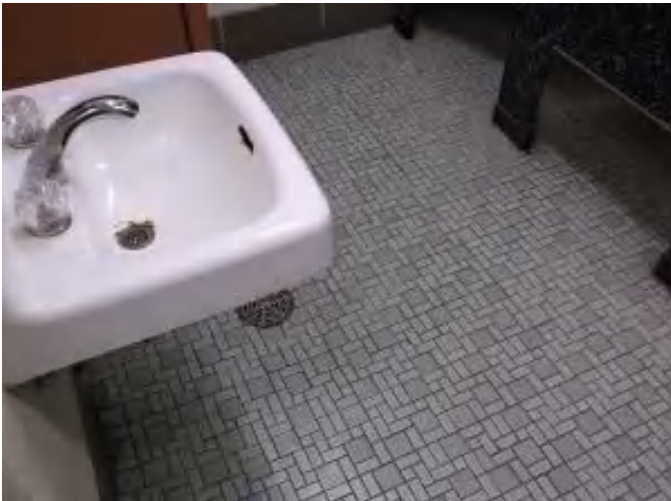
**Location:** Throughout the building

**System: D2010 - Plumbing Fixtures**

**Distress:** Beyond Service Life

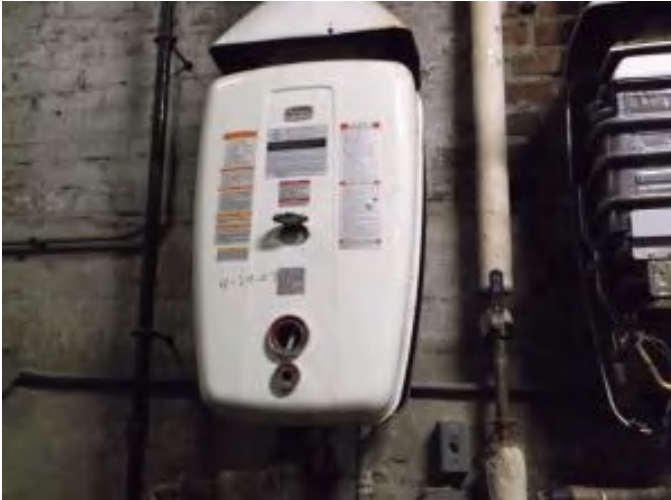
**Location:** Main boiler mechanical equipment room

**System: D2020 - Domestic Water Distribution**

**Distress:** Beyond Service Life

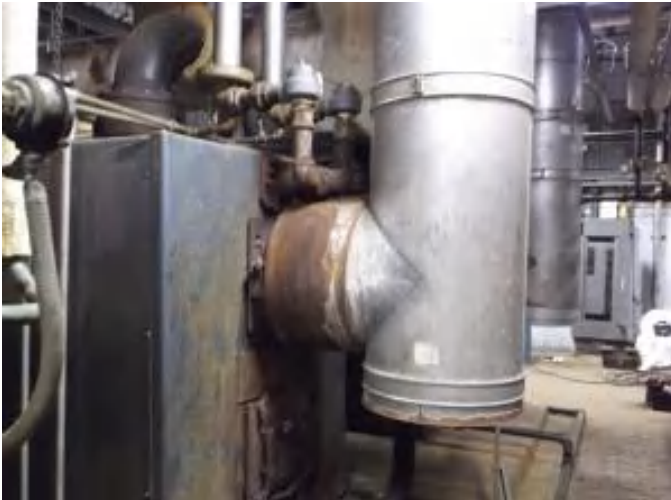
**Location:** Main boiler mechanical equipment room

**System: D3020 - Heat Generating Systems**

**Distress:** Beyond Service Life

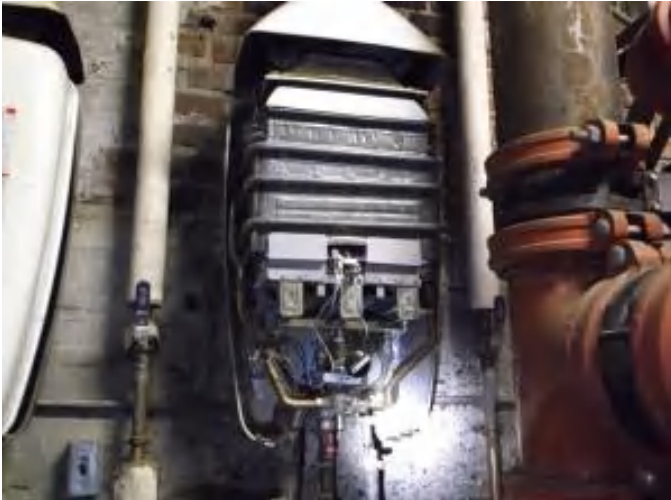
**Location:** Main boiler mechanical equipment room

**System: D2020 - Domestic Water Distribution**

**Distress:** Beyond Service Life
