Facility Condition Assessment Summary Report

Harding Middle School

School District of Philadelphia
S711001;Harding
Final
Site Assessment Report

January 31, 2017

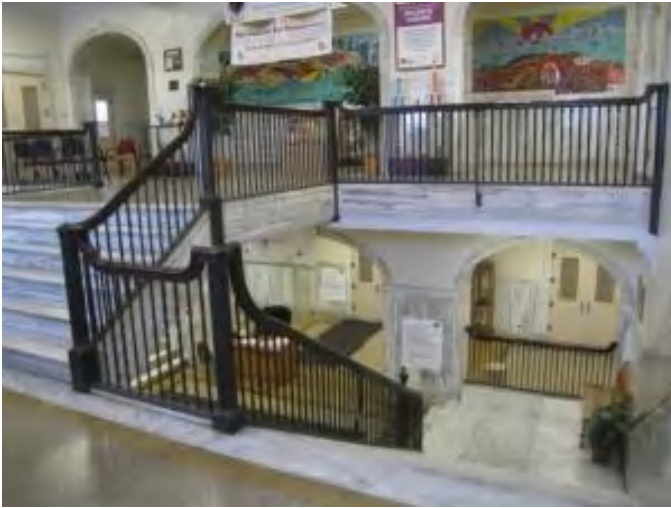
Location: stairways

System: C2010 - Stair Construction

Distress: Building / MEP Codes

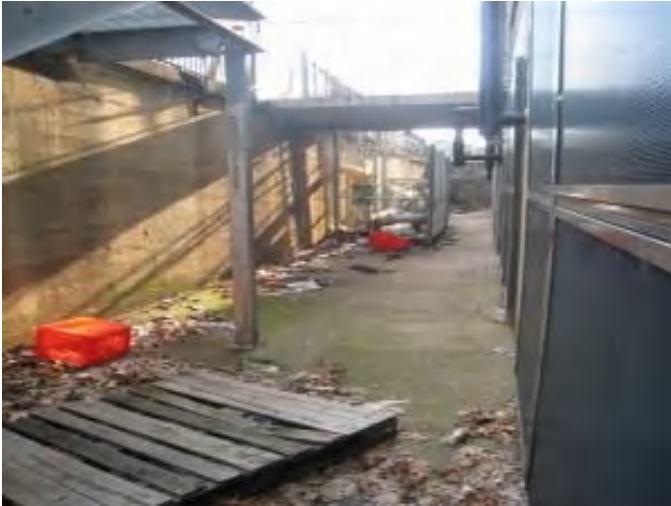
Location: rear entrance bridge

System: A2020 - Basement Walls

Distress: Failing

Notes: Remove concrete walk "bridge" over window well; repair concrete areaway retaining wall, replace beam and raised structural slab

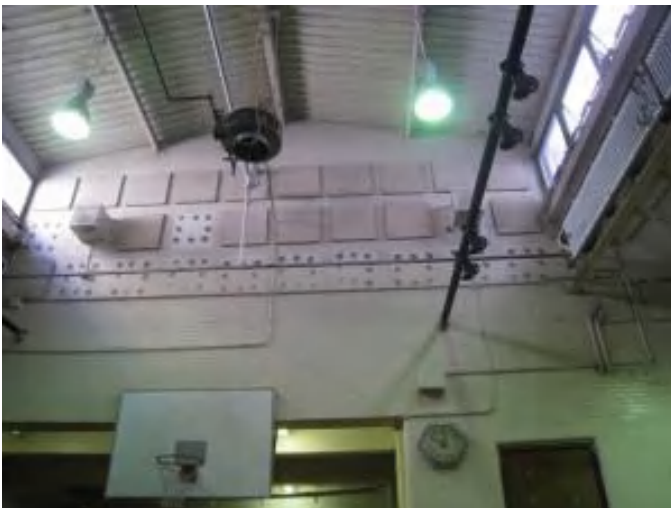
Location: gym

System: B2010 - Exterior Walls

Distress: Failing

Notes: Repair cracked painted brick wall in gym

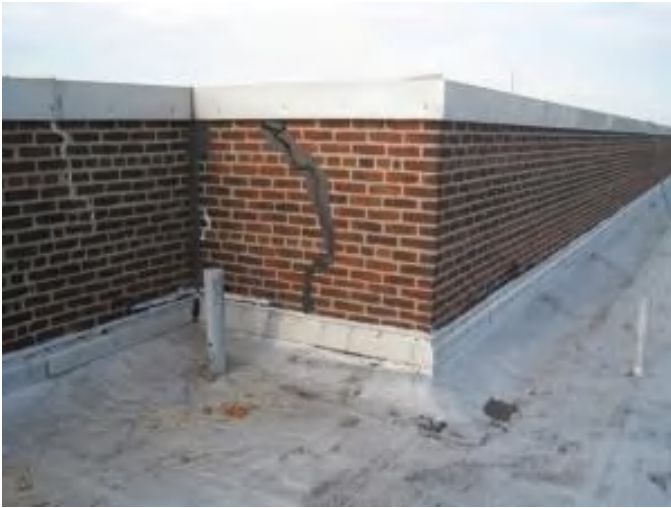
Location: exterior walls

System: B2010 - Exterior Walls

Distress: Failing

Notes: Repoint cracks in parapet above counterflashing, masonry walls above roof, cracks in brick walls on facing inside of "O", and joints above and below limestone band

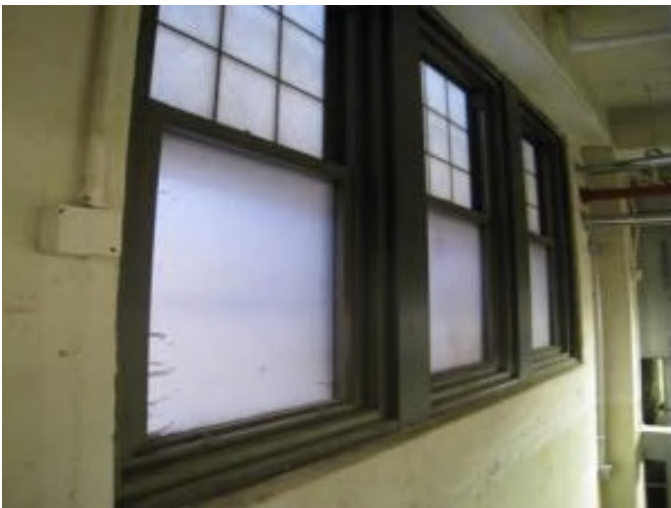
Location: exterior walls - windows

System: B2020 - Exterior Windows

Distress: Failing

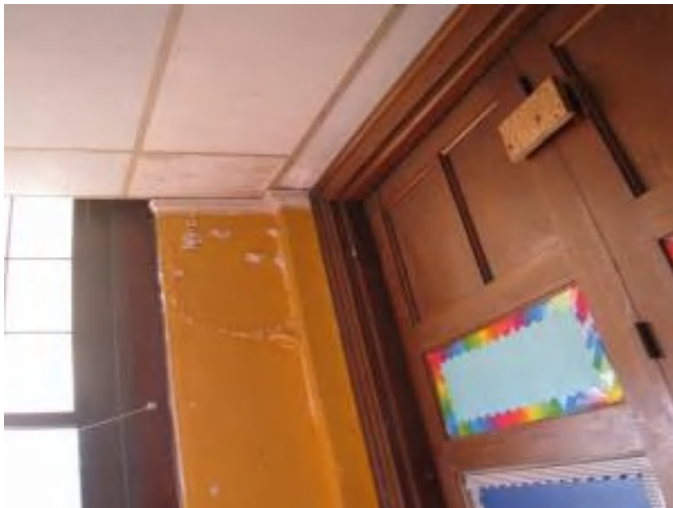
Location: classrooms

System: C1010 - Partitions

Distress: Failing

Notes: Remove folding wood partitions; replace with gypsum board and metal stud walls

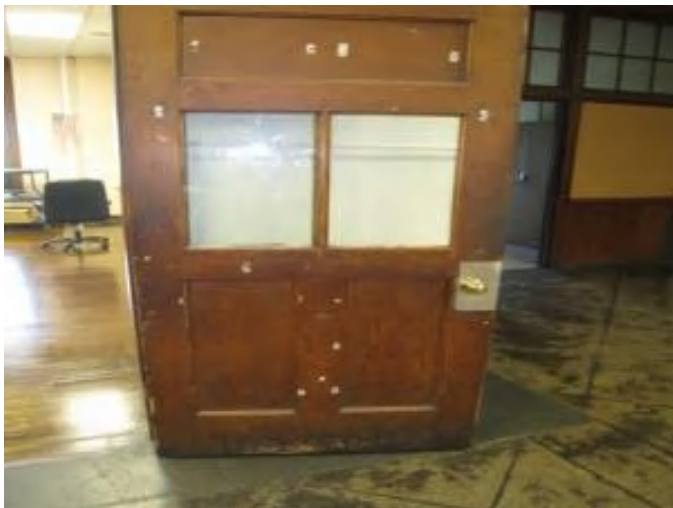
Location: classroom doors in corridors

System: C1020 - Interior Doors

Distress: Damaged

Notes: Remove and replace all original wood interior doors, frames and hardware in classrooms, closets, offices, etc

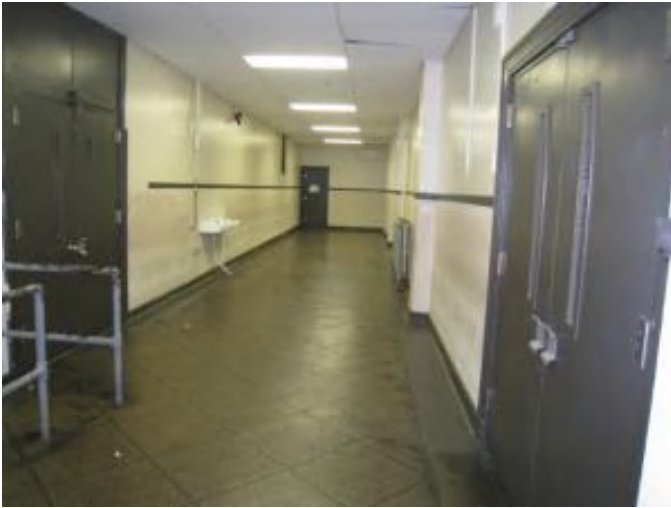
Location: basement

System: C1020 - Interior Doors

Distress: Failing

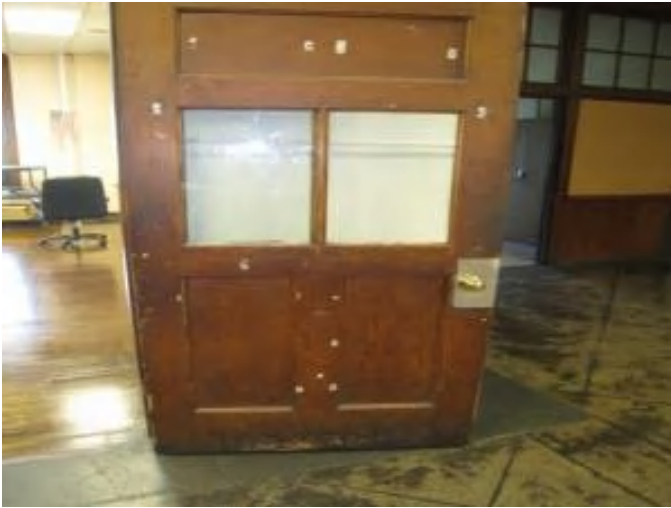
Location: classrooms, offices

System: C1020 - Interior Doors

Distress: Security Issue

Notes: provide security hardware in classroom and office doors which permits the doors to be locked from the inside

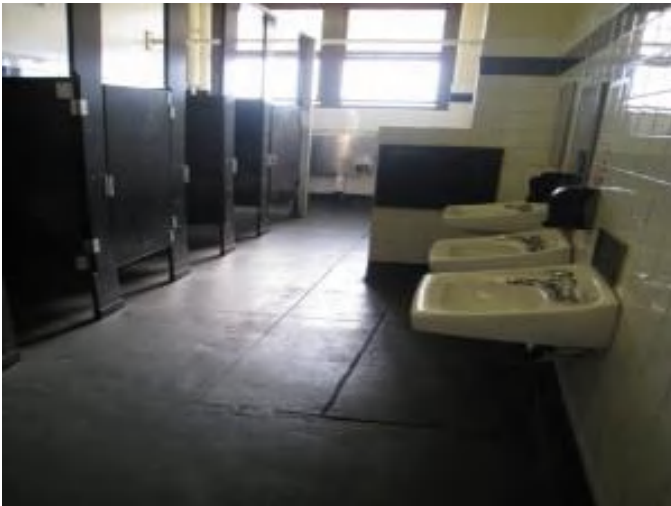
Location: toilet rooms

System: C1030 - Fittings

Distress: Damaged

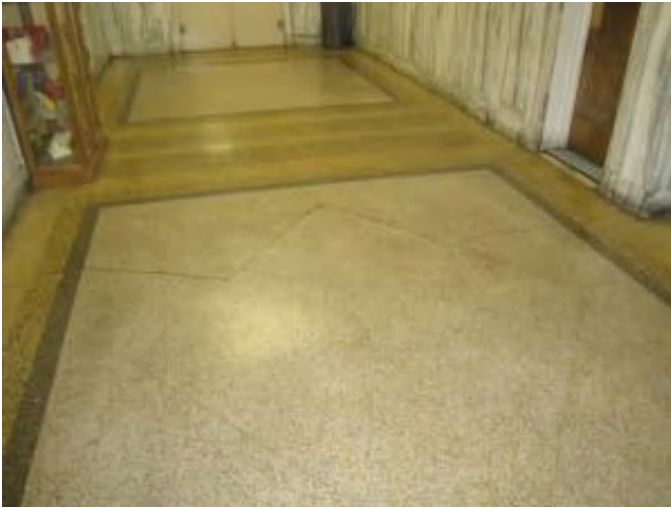
Location: lobby - terrazzo floor

System: C3020412 - Terrazzo & Tile

Distress: Damaged

Notes: Repair cracks in terrazzo

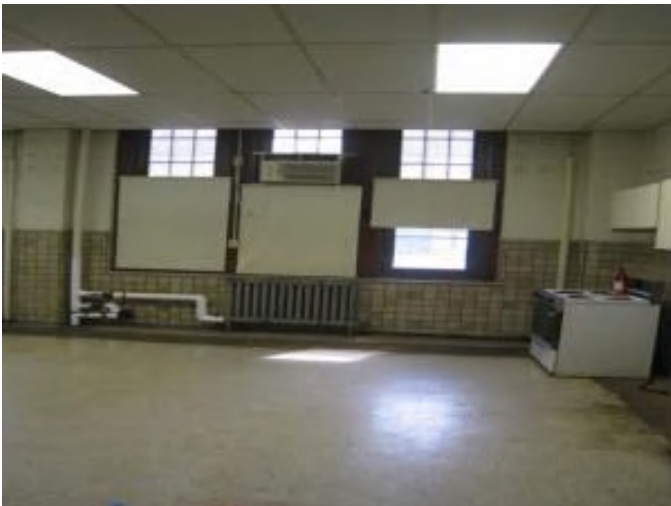
Location: interior room floors - cafeteria, classrooms

System: C3020413 - Vinyl Flooring

Distress: Failing

Notes: Replace VCT floors assume (assume 50% of total sf of VCT)

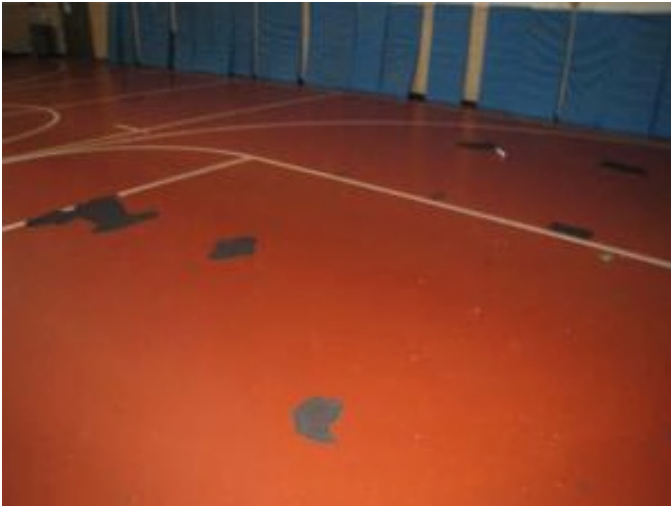
Location: gym - seamless vinyl

System: C3020413 - Vinyl Flooring

Distress: Failing

Notes: Remove and replace all seamless vinyl floors in gymnasiums

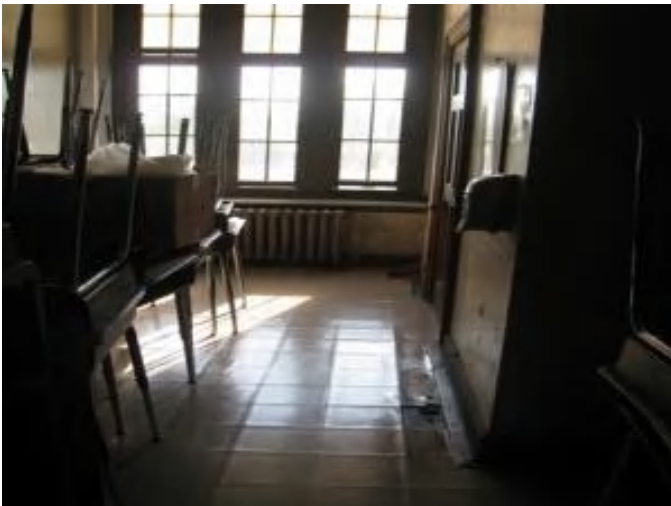
Location: all interior room floors

System: C3020413 - Vinyl Flooring

Distress: Life Safety / NFPA / PFD

Notes: Replace VAT floors using proper asbestos abatement procedures if determined asbestos is present.

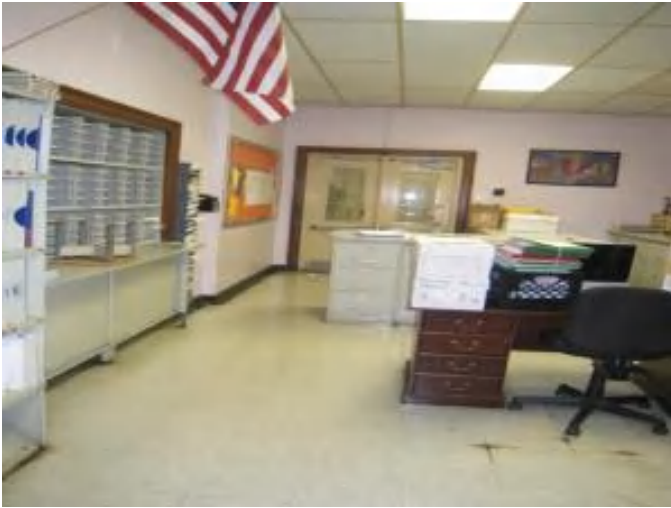
Location: interior room floors - offices, classrooms

System: C3020413 - Vinyl Flooring

Distress: Appearance

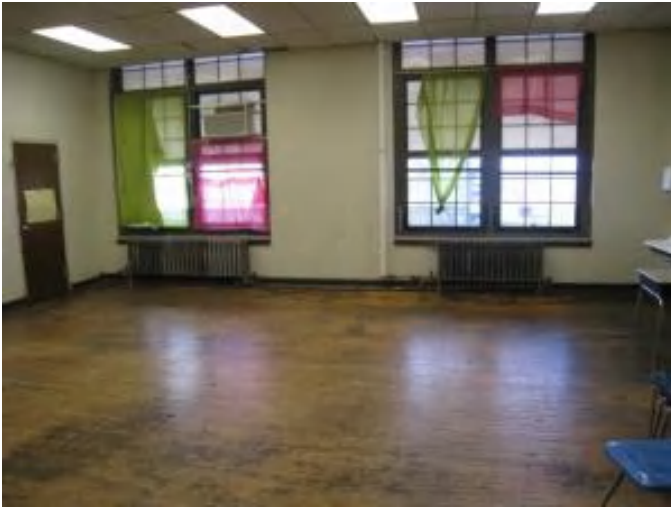
Location: classrooms, auditorium

System: C3020414 - Wood Flooring

Distress: Damaged

Notes: Strip, sand, repair and refinish all wood floors in classrooms and in auditorium

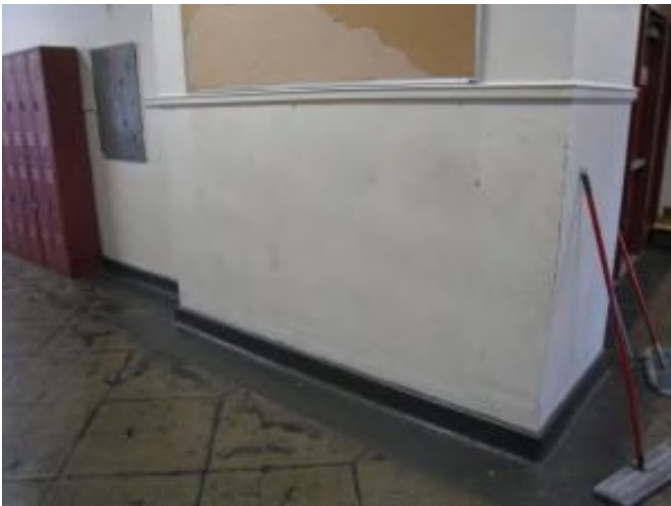
Location: basement floor

System: C3020415 - Concrete Floor Finishes

Distress: Appearance

Notes: Clean and repaint basement floor in mechanical rooms; clean and reseal concrete floors in hallways, stairways, and toilet rooms

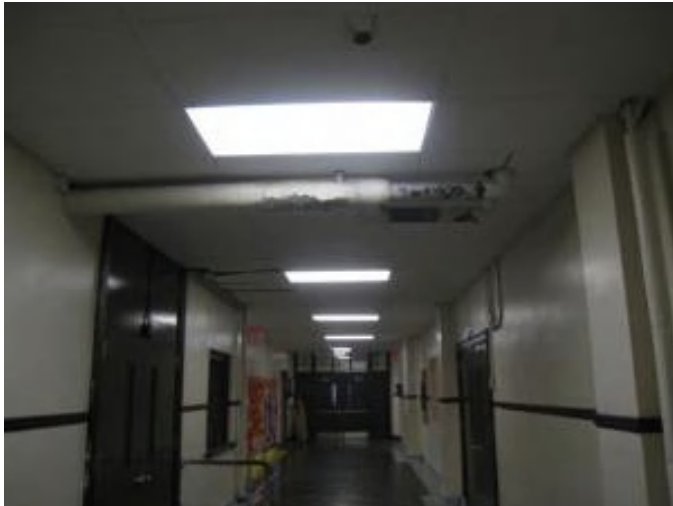
Location: ceilings - classrooms, corridors, offices

System: C3030 - Ceiling Finishes

Distress: Damaged

Notes: Replace 2x4 acoustical tile ceilings where damaged

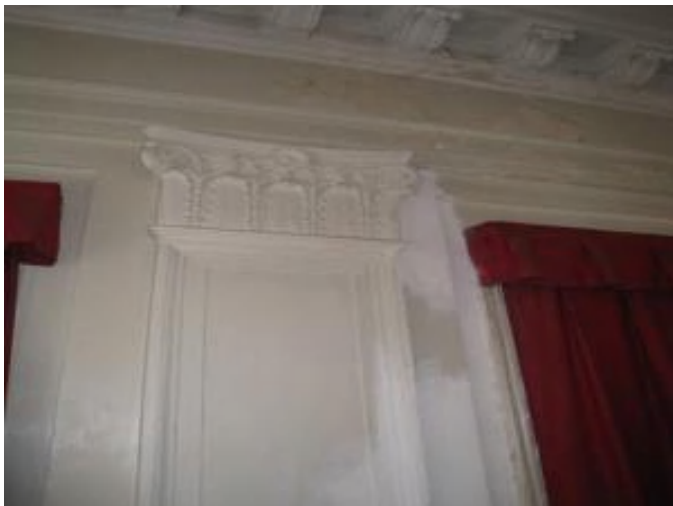
Location: auditorium

System: C3030 - Ceiling Finishes

Distress: Damaged

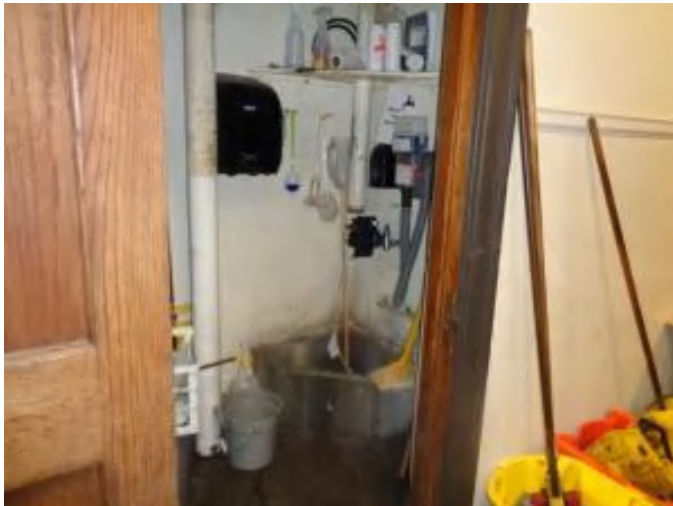
Location: Throughout the building

Service sinks are available in the hallways for use by the janitorial staff and appears to be 50 years old. These sinks are generally in converted closets and have no exhaust. Replacement is recommended for all service sinks in the building.

System: D2010 - Plumbing Fixtures

Distress: Beyond Service Life

Notes: Replace all service sinks throughout the building

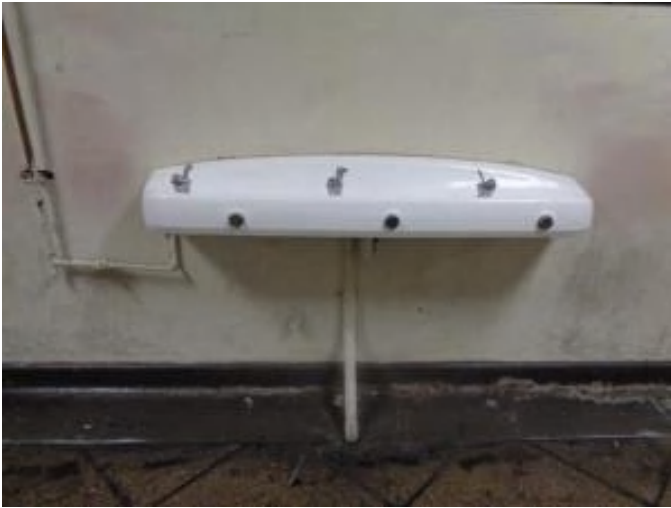
Location: Throughout the building

Drinking fountains in the corridors and at the restrooms are wall hung. Some original equipment drinking fountains remain while some appear to have been replaced 20-30 years ago. It is recommended to replace all drinking fountains throughout the building.

System: D2010 - Plumbing Fixtures

Distress: Beyond Service Life

Notes: Replace all drinking fountains throughout the building

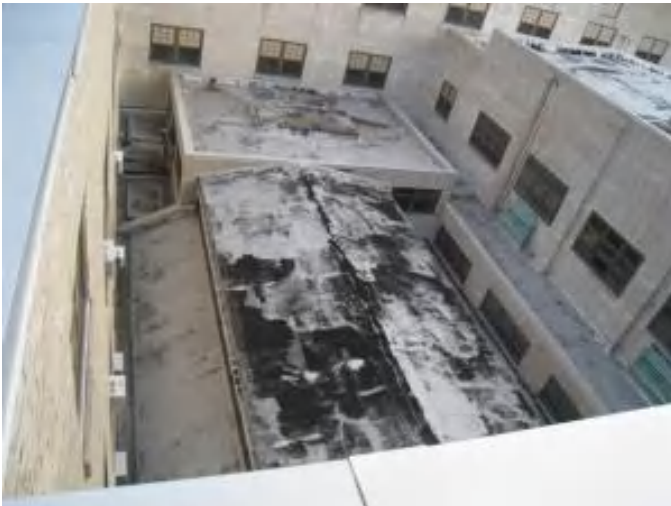
Location: low roofs

System: D2040 - Rain Water Drainage

Distress: Building / MEP Codes

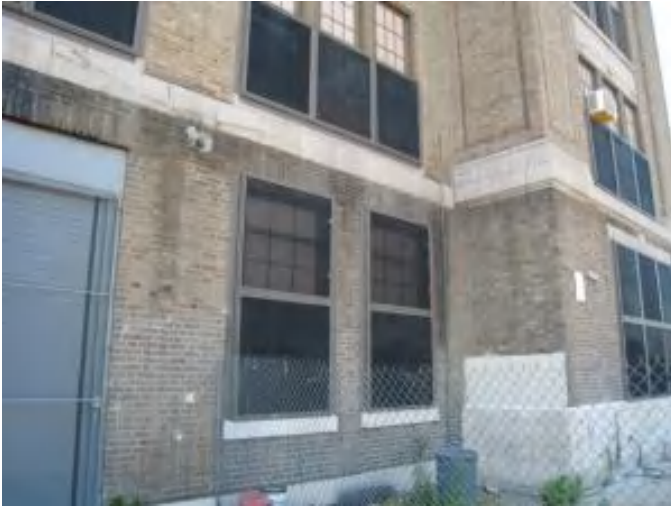
Location: exterior wall

System: B2010 - Exterior Walls

Distress: Appearance

Notes: Powerwash rear building wall and limestone band that surrounds building

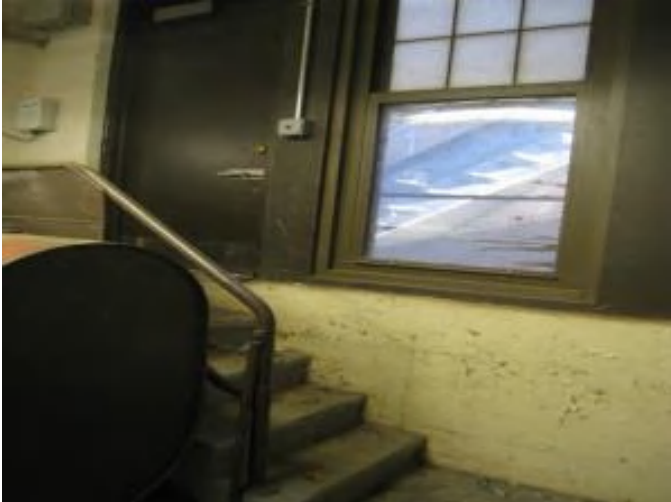
Location: basement stairs

System: C3010230 - Paint & Covering

Distress: Appearance

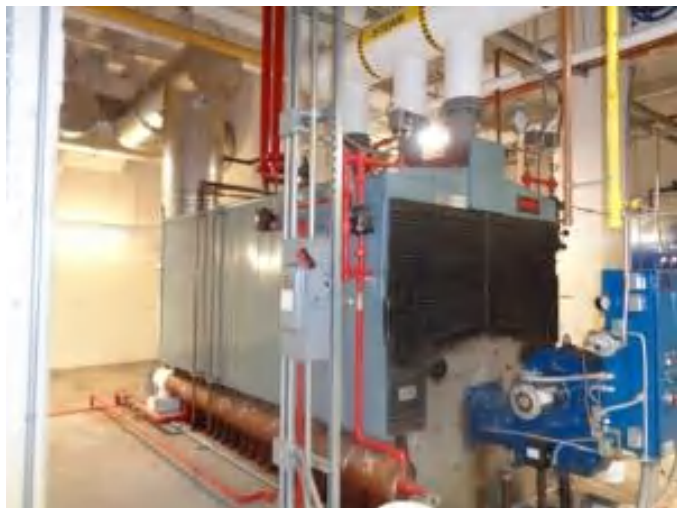
Location: Throughout the building

The steam and condensate return lines throughout the building are older, are missing insulation, and are most likely beyond their service life. According to the building engineer, most radiators in the building have hand control valves to allow users to turn up or down the heat as needed.

System: D3040 - Distribution Systems

Distress: Beyond Service Life

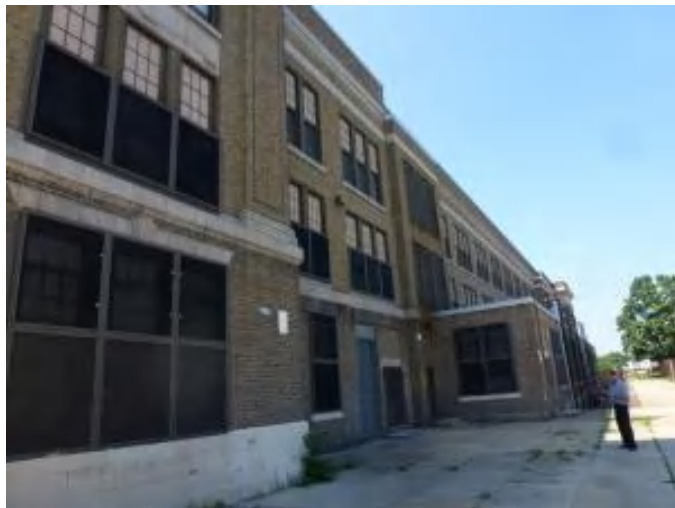
Location: Exterior walls

System: D5030 - Communications and Security

Distress: Inadequate

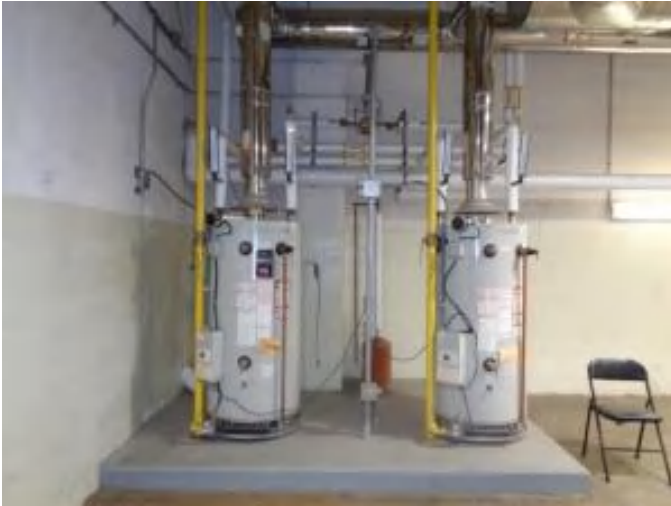
Location: Throughout the building

Domestic Water Distribution - Domestic water distribution piping is primarily soldered copper. Water service enters the building in the basement, with backflow preventers and the water meter on the main line after entering the building. The distribution piping appears to have been updated at some point in the building's life. However, there are areas where the copper pipe has begun to leak. There are no water booster pumps in this facility. A thorough inspection of the domestic water distribution system is recommended due to its age and the prevalence of leaks.

System: D2020 - Domestic Water Distribution

Distress: Beyond Service Life

Notes: Inspect domestic water distribution system throughout the building and repair/replace as necessary.

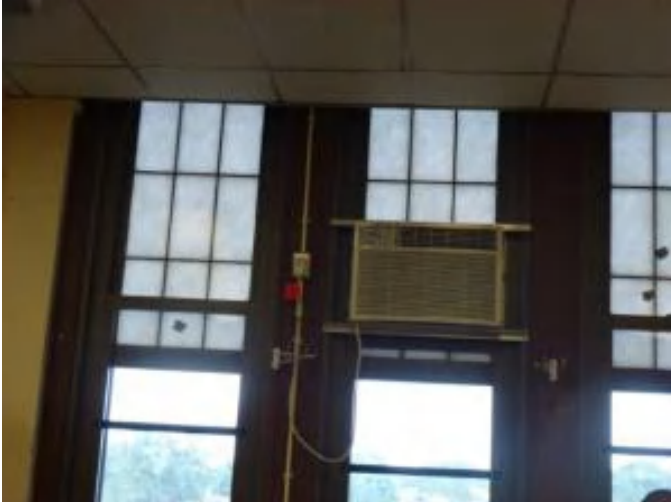
Location: Adjacent to building

System: D3030 - Cooling Generating Systems

Distress: Inadequate

Notes: Install chiller and chilled water distribution system

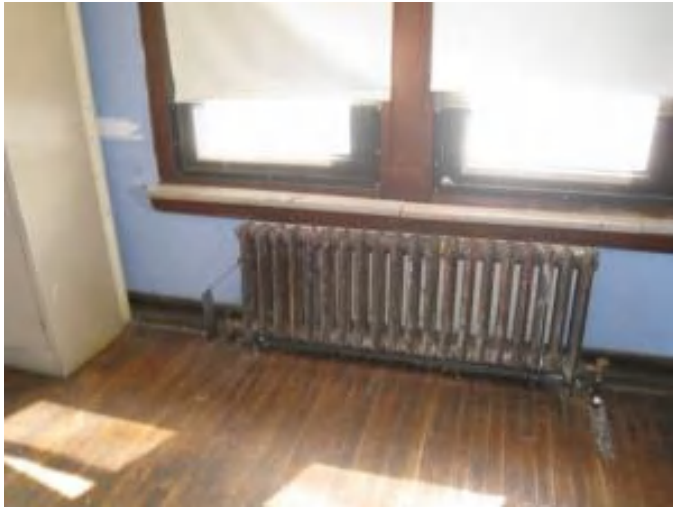
Location: Throughout the building

System: D3040 - Distribution Systems

Distress: Building / MEP Codes

Notes: Install unit ventilators in all classrooms. Replace the existing unit ventilators throughout the building with new units designed to provide adequate ventilation per ASHRAE Std. 62. The new units shall be equipped with hot water / chilled water coils and integral heat recovery wheels. Install steam converters in the existing boiler room with circulating pumps, distribution piping and controls to provide heating hot water for the new coils

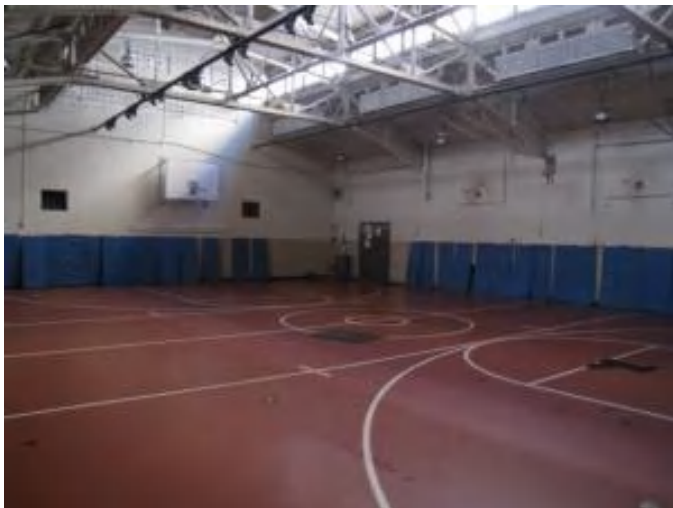
Location: Gymnasiums

System: D3040 - Distribution Systems

Distress: Building / MEP Codes

Notes: Install AHUs to condition the 2 gymnasiums. Provide ventilation, heating and cooling for the Auditorium by installing a package rooftop constant volume air handling unit with distribution ductwork and registers

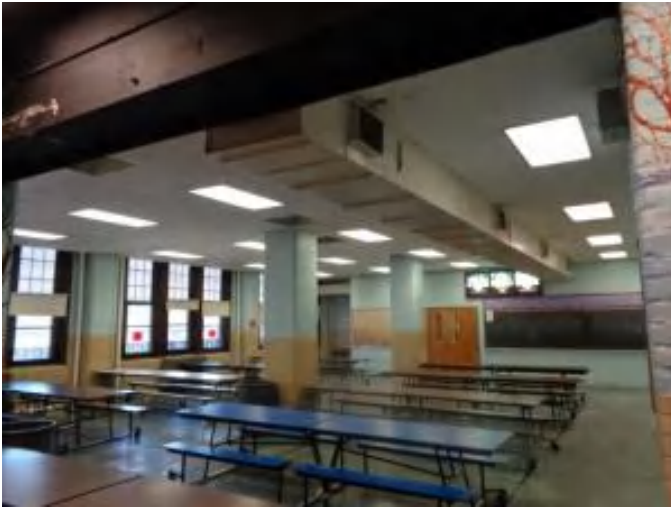
Location: Cafeteria

System: D3040 - Distribution Systems

Distress: Building / MEP Codes

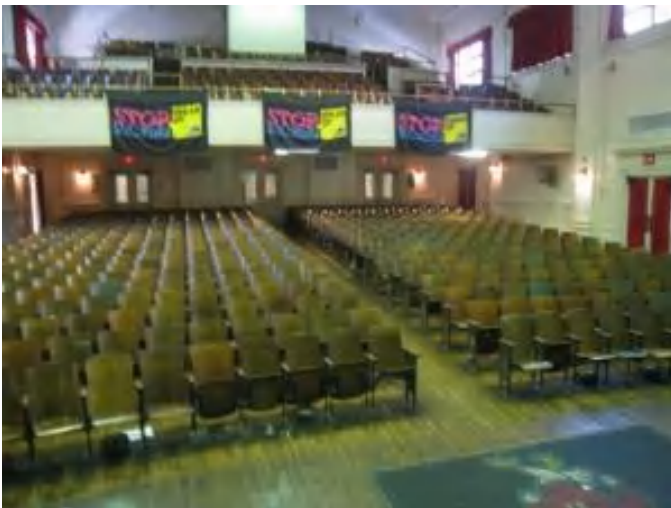
Location: Auditorium

System: D3040 - Distribution Systems

Distress: Building / MEP Codes

Notes: Install AHUs to condition the auditorium. Provide ventilation, heating and cooling for the Auditorium by installing a package rooftop constant volume air handling unit with distribution ductwork and registers

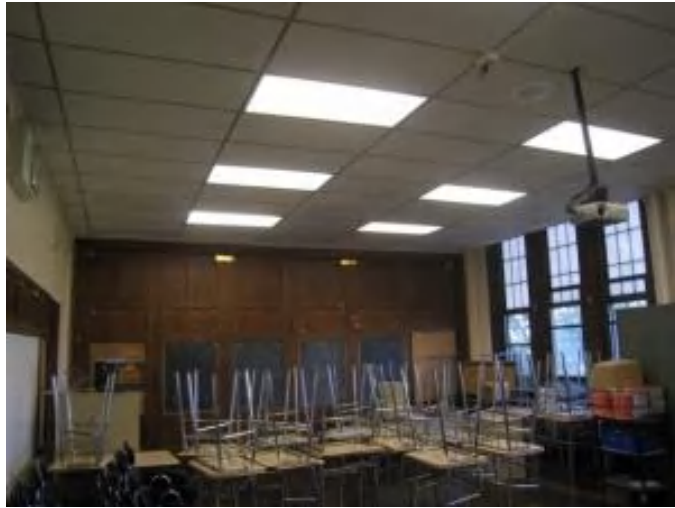
Location: Throughout the building

System: D4010 - Sprinklers

Distress: Life Safety / NFPA / PFD

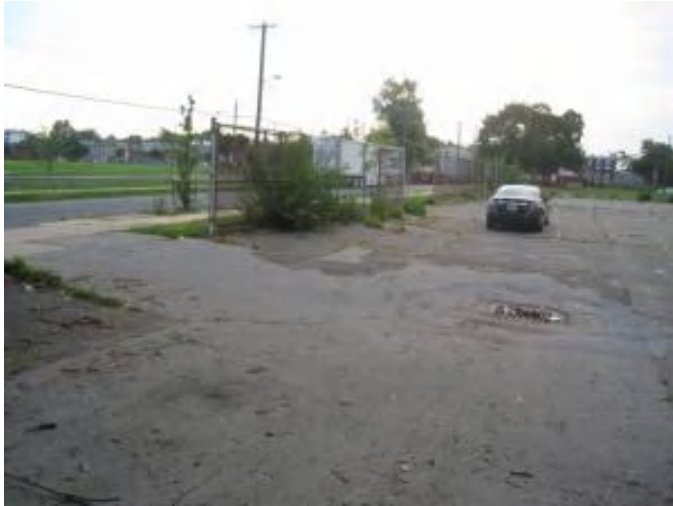
Location: parking lot

System: G2020 - Parking Lots

Distress: Damaged

Notes: Repave 100% of rear parking lot

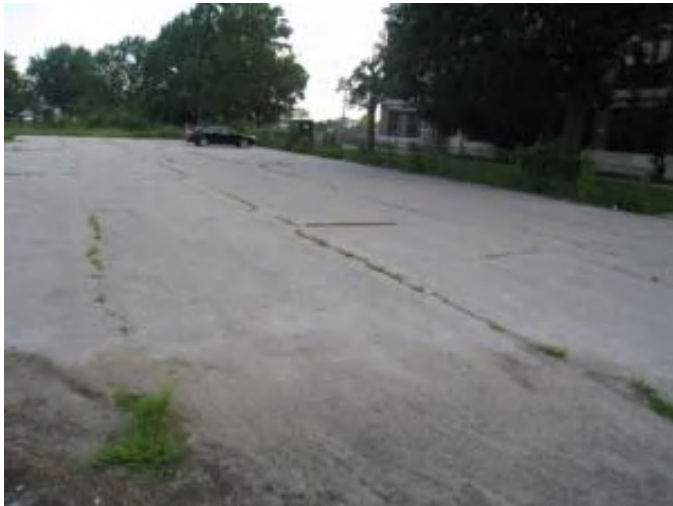
Location: parking lot

System: G2020 - Parking Lots

Distress: Failing

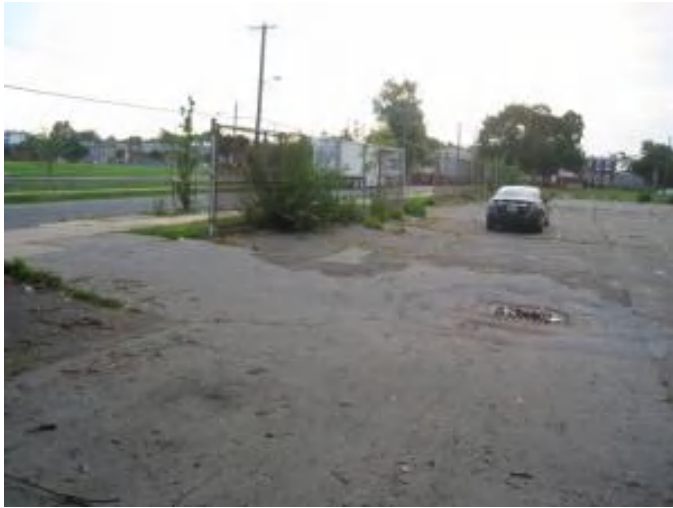
Location: site fence

System: G2040 - Site Development

Distress: Damaged
