Facility Condition Assessment Summary Report

Harrington School

Harrington Annex School

January 30, 2017

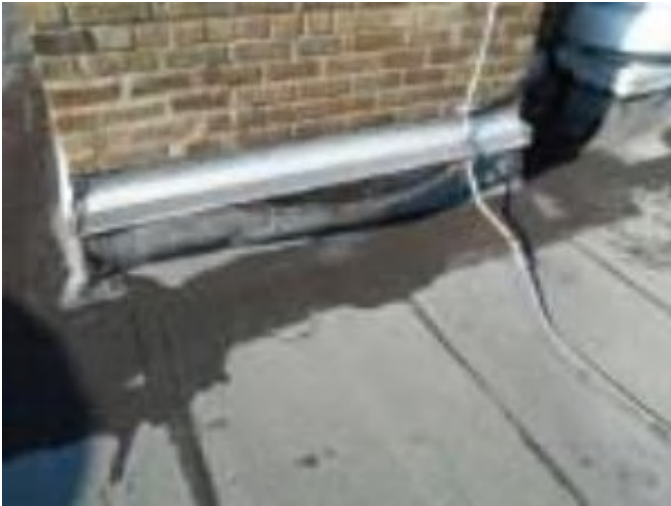
Location: Roof

The roof is covered with a membrane of modified bituminous roll roofing built-up with bonded seams installed in approximately 1995. Scuppers handle overflow from failed roof drains. The roof is in poor condition with failing seams and flashings. Several leaks were reported by the maintenance staff and evidence of roof leaks was observed through damaged interior finishes. Skylights over the light shaft above the basement stairwell are also damaged and should be replaced. To reach the high roof of the original building, the maintenance staff climbs a fixed interior metal ladder to the attic level mechanical space and then goes through an access door opening at the roof level. A permanent door should be installed to provide access to the low roof, which is currently through a window from the 2nd floor.

System: B3010105 - Built-Up

Distress: Beyond Service Life

- Repair failing mortar joints in the masonry exterior walls
- Replace failing roofing system including insulation, flashing, counter flashing, reglets and coping

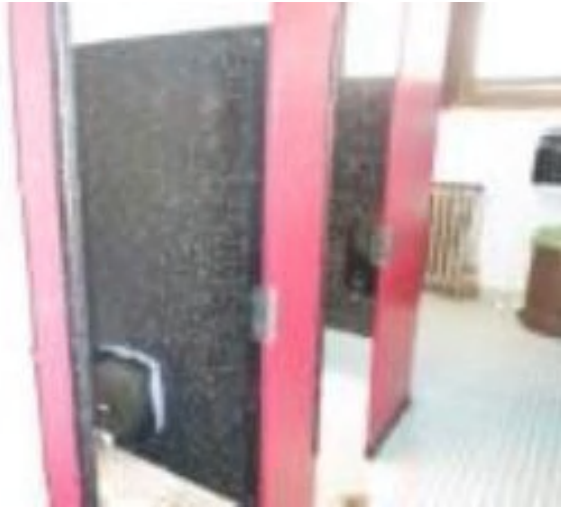
Location: First floor

System: C1010 - Partitions

Distress: Accessibility

Notes: Modify the student restrooms on the 1st Floor to provide full accessibility including new toilet partitions, toilet accessories and grab bars.

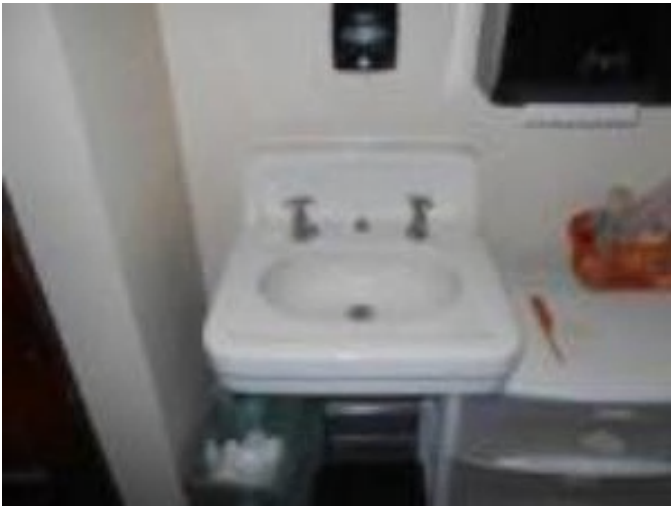
Location: First floor

System: C1010 - Partitions

Distress: Accessibility

Notes: Provide a single (unisex) accessible restroom for staff on the 1st Floor

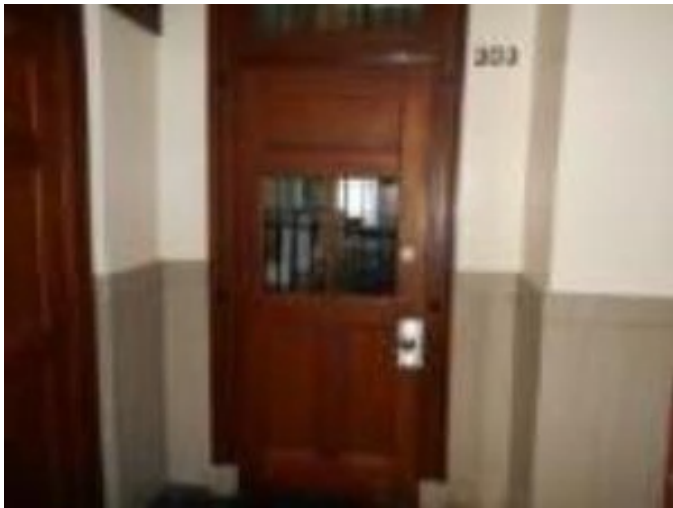
Location: Classroom doors

System: C1020 - Interior Doors

Distress: Accessibility

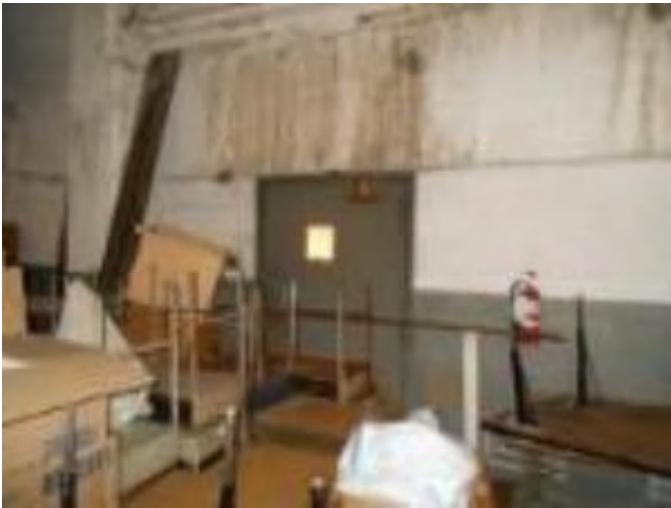
Location: Boiler and electrical rooms

System: C2010 - Stair Construction

Distress: Accessibility

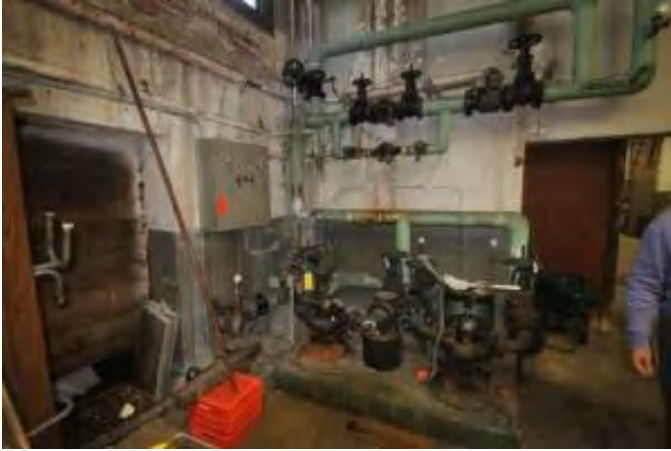
Location: Boiler room

System: D2020 - Domestic Water Distribution

Distress: Building / MEP Codes

Notes: Install 3 inch backflow preventer at water entry, including demolition of disused booster

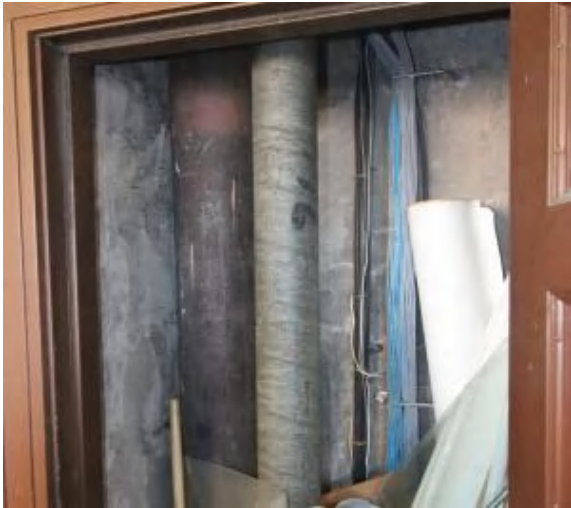
Location: Entire building

System: D2040 - Rain Water Drainage

Distress: Beyond Service Life

Notes: Inspect and repair rain water drain pipe

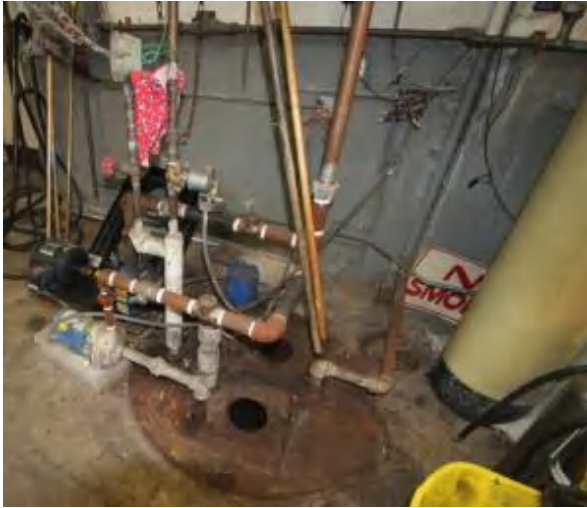
Location: Boiler room

System: D3020 - Heat Generating Systems

Distress: Beyond Service Life

Notes: Replace condensate collection tank, boiler feed water sump, and water softener including pumps

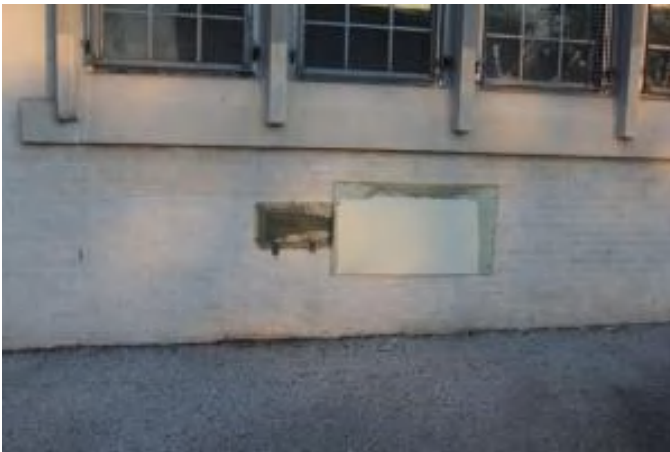
Location: Addition classrooms

System: D3040 - Distribution Systems

Distress: Beyond Service Life

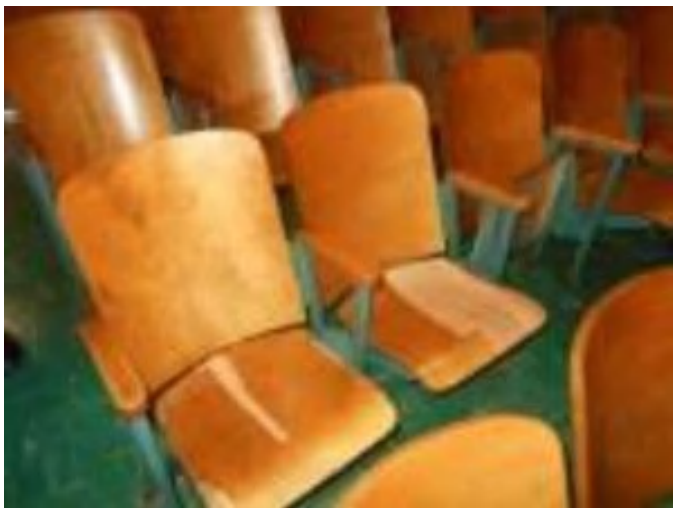
Location: Auditorium

System: E2010 - Fixed Furnishings

Distress: Beyond Service Life

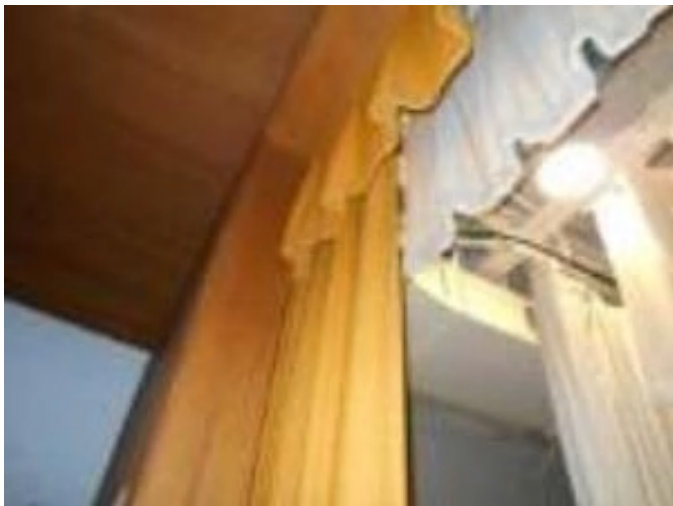
Location: Auditorium

System: E2010 - Fixed Furnishings

Distress: Appearance

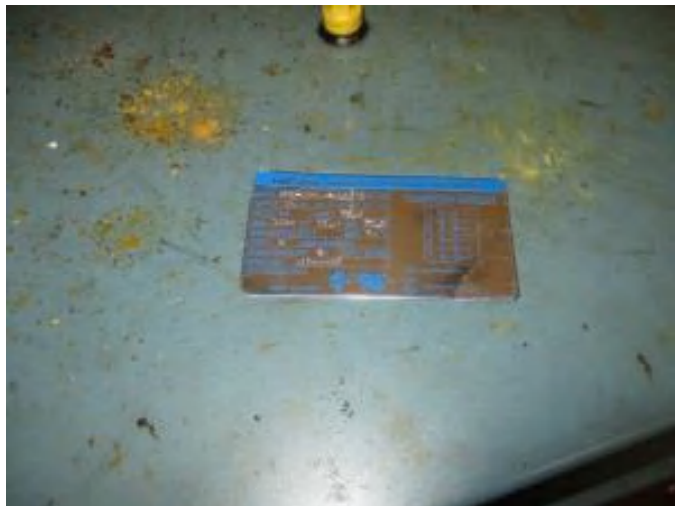
Location: Basement - Elevator Machine Room

The school is provided with one hydraulic elevator manufactured by HIGEN with 25HP motor. Elevator controller is the relay type. The elevator should be replaced as it looks as though it has already exceeded its anticipated service life.

System: D1010 - Elevators and Lifts

Distress: Beyond Service Life

Notes: Provide new hydraulic elevator motor and controller.

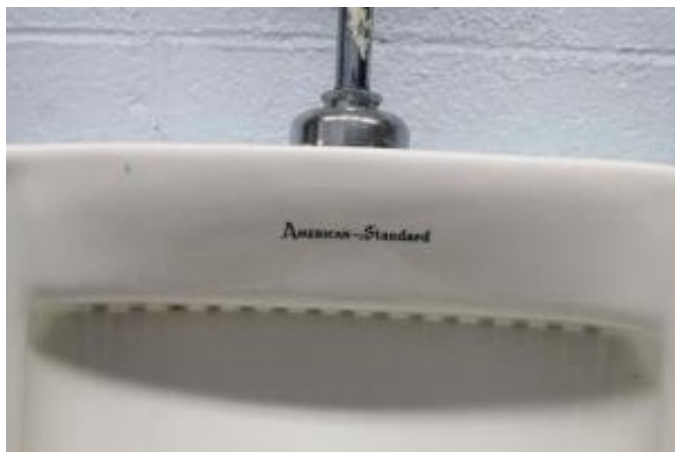
Location: Toilet rooms

System: D2010 - Plumbing Fixtures

Distress: Beyond Service Life

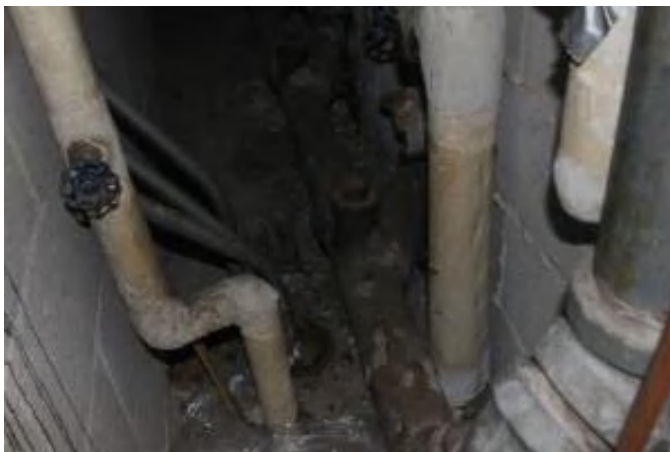
Location: Entire building

The sanitary sewer piping is threaded galvanized steel and cast iron pipe. The galvanized pipe dates the system to the 1960s, and it should be inspected in detail and repaired or replaced as needed. The building does not have a sewage ejector.

System: D2030 - Sanitary Waste

Distress: Beyond Service Life

Notes: Inspect and repair sanitary drain pipe

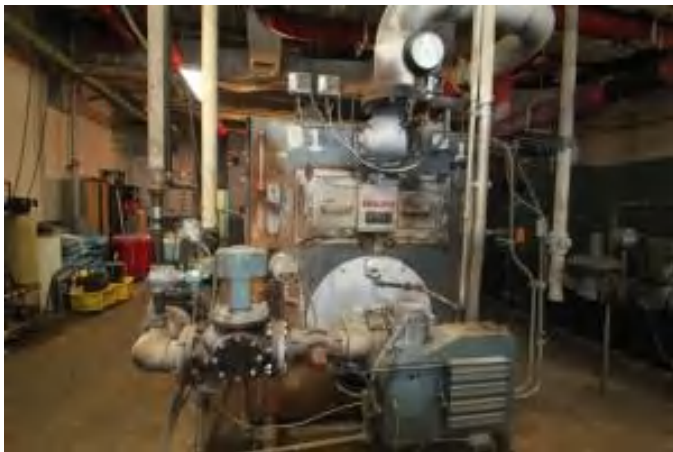
Location: Boiler room

Steam is generated by two Weil-McLain model BG-1994SF cast iron sectional boilers with 4,060 MBH (121 HP) net capacity installed in 1969. Each boiler is equipped with a Gordon Piatt model WFE12-0-50 burner operating on natural gas only. Gas service enters the building from Baltimore Ave. through a 4 inch line without a booster. The building does not have an oil storage tank. The boilers have exceeded their life expectancy by 12 years and should be scheduled for replacement due to age. The condensate collection tank is below the main level of the basement floor at the end of the condensate trough and has two transfer pumps. Two boiler feedwater pumps draw from a sump in the floor of the boiler room. There is only one feedwater supply pipe. The condensate and feedwater system should be replaced when new boilers are installed. A water softener is installed for the makeup water in boiler room near the feedwater sump. The engineer stated he softener was inoperative. No problems were reported with steam traps, and there was no evidence of moisture damage at the condensate collection tank. Steam and condensate piping is black steel with welded and threaded fittings. Visible portions of the condensate pipes are severely rusted and some sections of pipe have rusted completely in two. The engineer stated there were no problems with steam pipes. Condensate pipes should be inspected in detail and repaired or replaced as needed.

System: D3020 - Heat Generating Systems

Distress: Beyond Service Life

Notes: Replace boilers due to age

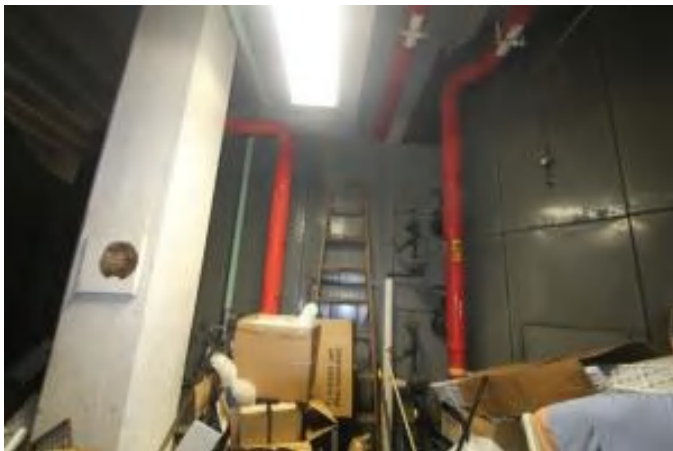
Location: Original building

Original classrooms were heated and ventilated by the basement air handler. It includes an intake section with fresh outdoor air inlet and recirculation from the attic plenum, cast iron primary and secondary steam coils, air washer, and fan. The attic is labeled as containing asbestos. The AHU is not operated currently. Capacity is estimated 55,000 CFM. It should be replaced by a 100% outside air unit including cooling coils and have connected supply ducts cleaned and insulated. Classroom exhaust air was ducted up to the attic plenum and out through gravity vents in the roof. Some exhaust ducts are still open in the attic but there is no air flow because the AHU blower is not used. The auditorium has a dedicated McQuay model LS-111V, single fan, estimated 5,500 CFM capacity, vertical air handler manufactured in 1969 (along with the outside condensing unit). Air supply is ducted to the back of the auditorium and return grills are located below the stage. The fan wheel was recently replaced according to the building engineer. The classrooms at the back of the building have unit ventilators for heating and ventilation. They have had their outside air intake grilles blocked to prevent outside air infiltration because their damper controls do not work and the heating coils are not powerful enough to warm 100% outside air during the winter. Even if controls worked properly, these units have exceeded their useful life and should be replaced. Toilet rooms originally exhausted via building pressurization into dedicated ducts leading to gravity vents on the roof. These have been supplemented by powered roof top exhaust fans. Several exhaust fans were not running at the time of inspection and should be repaired or replaced. The cafeteria kitchen has no gas burning equipment, no fume hood, and no fire suppression system.

System: D3040 - Distribution Systems

Distress: Beyond Service Life

Notes: Replace AHU for original building including duct restoration and replacement

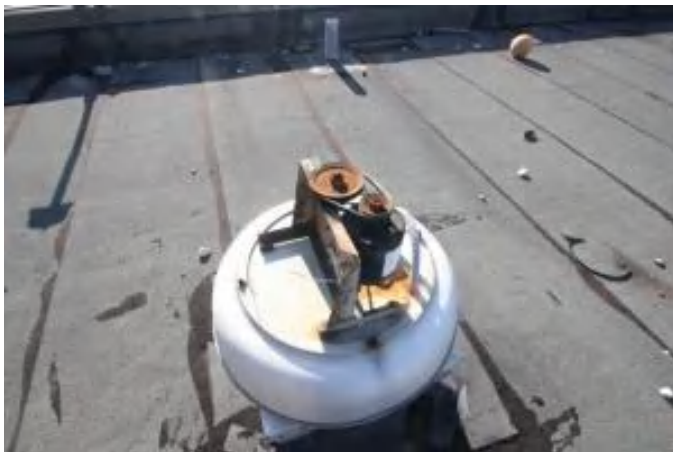
Location: Toilet rooms

System: D3040 - Distribution Systems

Distress: Failing

Notes: Replace inoperative rooftop vent fans for toilet exhaust

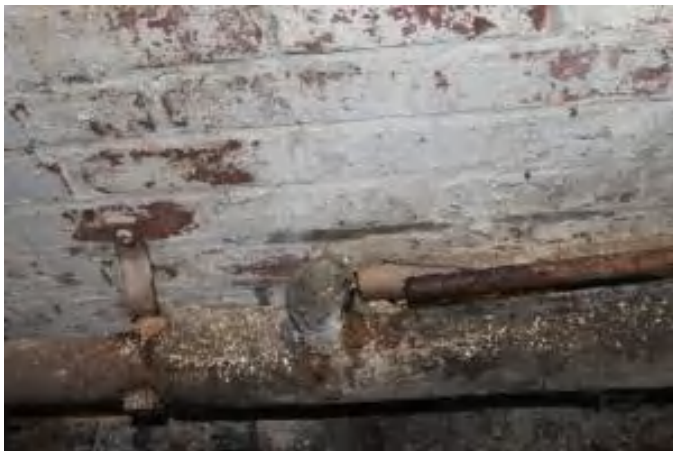
Location: Entire building

System: D3040 - Distribution Systems

Distress: Failing

Notes: Inspect and repair condensate pipe

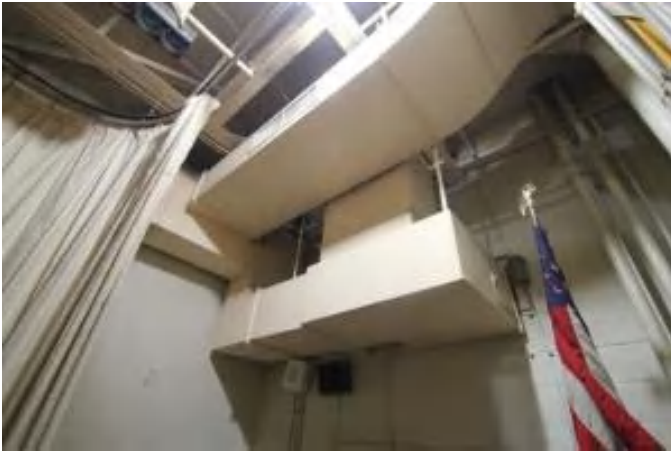
Location: Auditorium

System: D3040 - Distribution Systems

Distress: Beyond Service Life

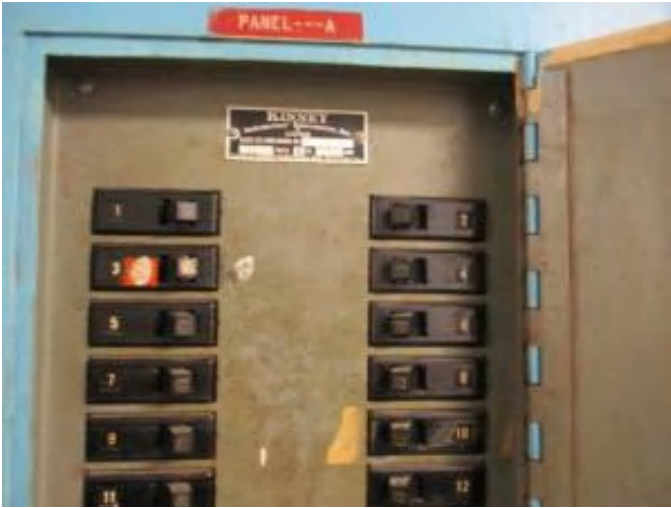
Location: Entire Building

System: D5010 - Electrical Service/Distribution

Distress: Beyond Service Life

Notes: Provide one double-duplex receptacle per classroom wall. Approximate 120 receptacles.

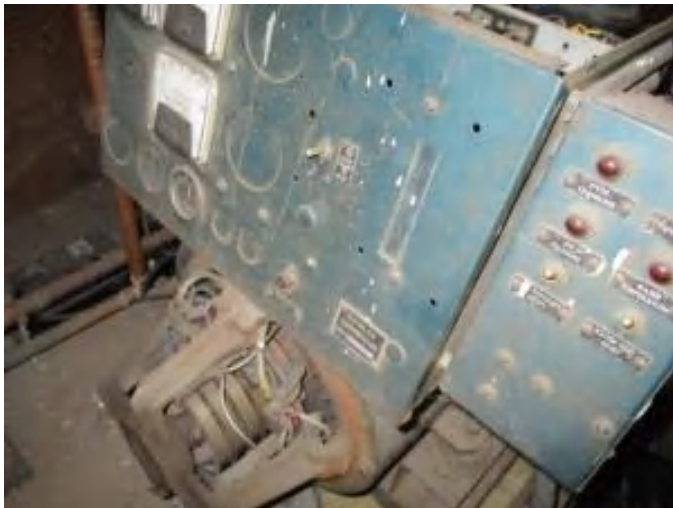
Location: Outdoor

System: D5090 - Other Electrical Systems

Distress: Life Safety / NFPA / PFD

Notes: Provide 70KW, outdoor, diesel powered generator

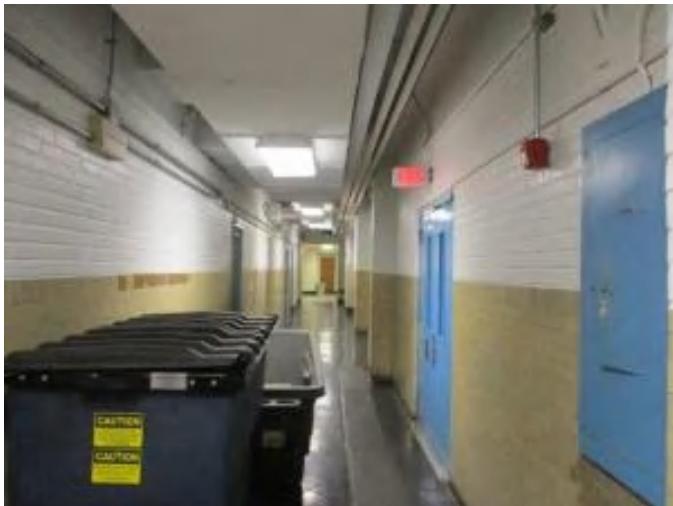
Location: Entire Building

Since the emergency system is inoperative the school does not have emergency lighting. Provide the school exit ways with wall mounted emergency lighting fixtures with battery backup. Replace existing exit signs with exit signs with battery backup.

System: D5090 - Other Electrical Systems

Distress: Life Safety / NFPA / PFD

Notes: Provide wall mounted emergency lighting fixtures with battery backup. Approximate 30

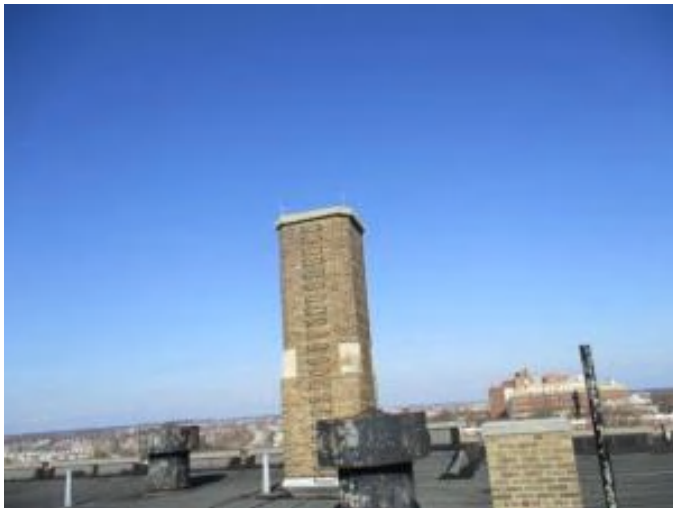
Location: Roof

System: D5090 - Other Electrical Systems

Distress: Building / MEP Codes

Notes: Prepare a study to determine if the air terminals mounted on the school chimney provide the proper protection to the school building.

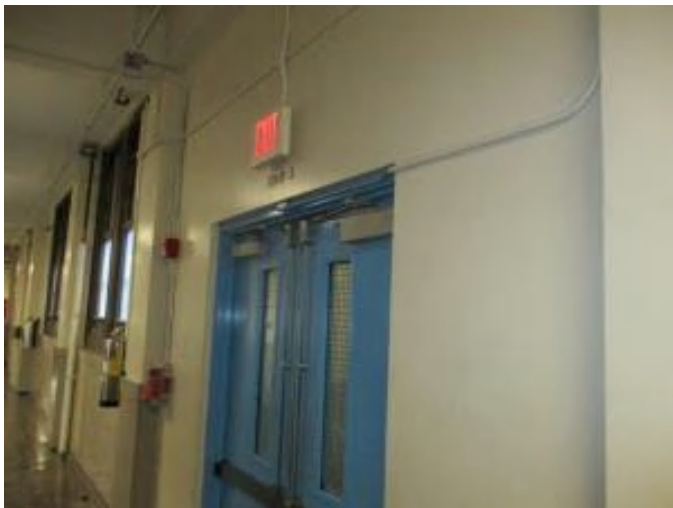
Location: Entire Building

System: D5090 - Other Electrical Systems

Distress: Life Safety / NFPA / PFD

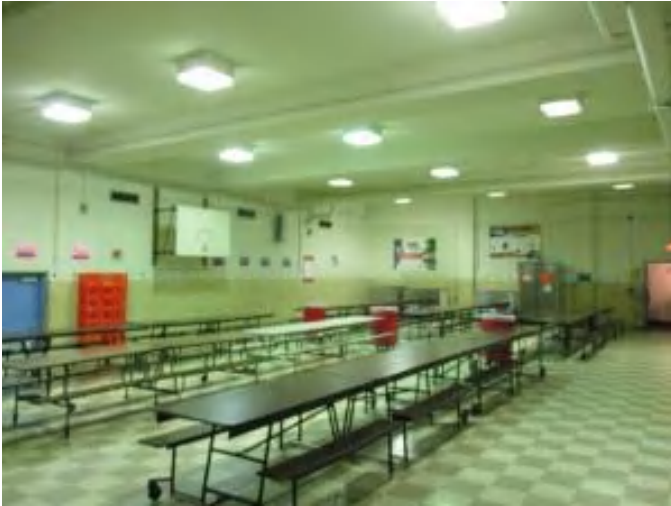
Location: Entire Building

System: D5030 - Communications and Security

Distress: Security Issue

Notes: Provide indoor surveillance CCTV cameras for total coverage of the school interior. Approximate 30 CCTV cameras.

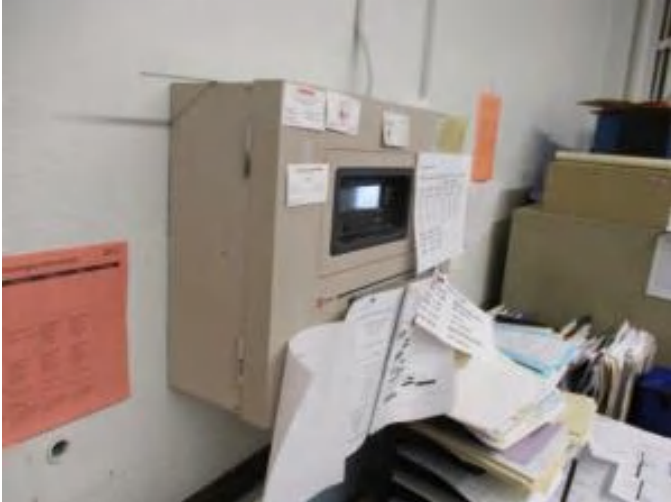
Location: Entire Building

System: D5030 - Communications and Security

Distress: Obsolete

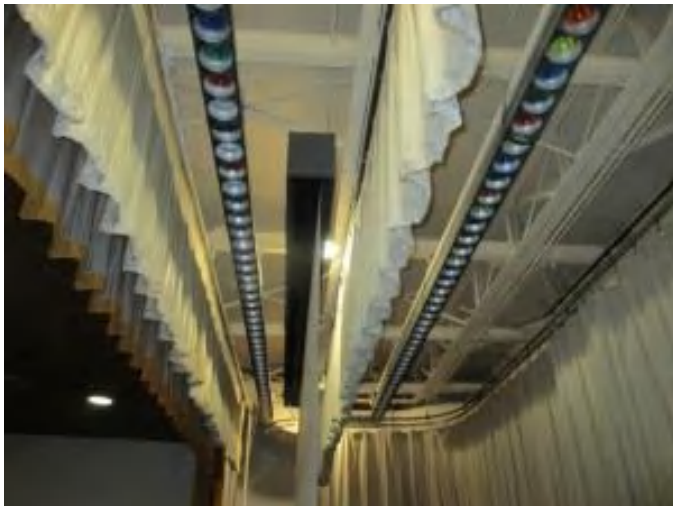
Location: Auditorium

System: E1020 - Institutional Equipment

Distress: Obsolete

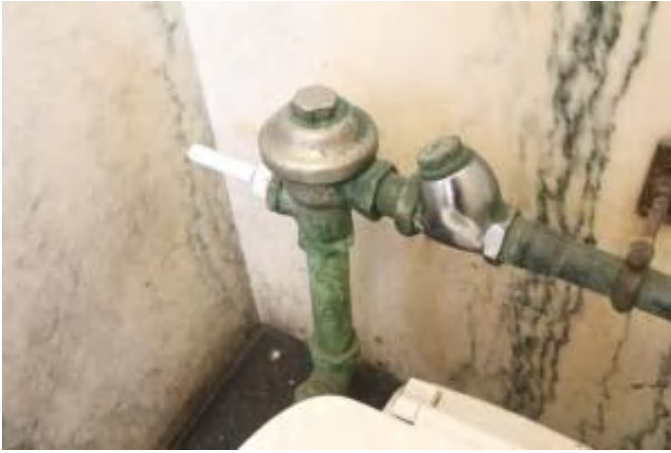
Location: Entire building

System: D2020 - Domestic Water Distribution

Distress: Beyond Service Life

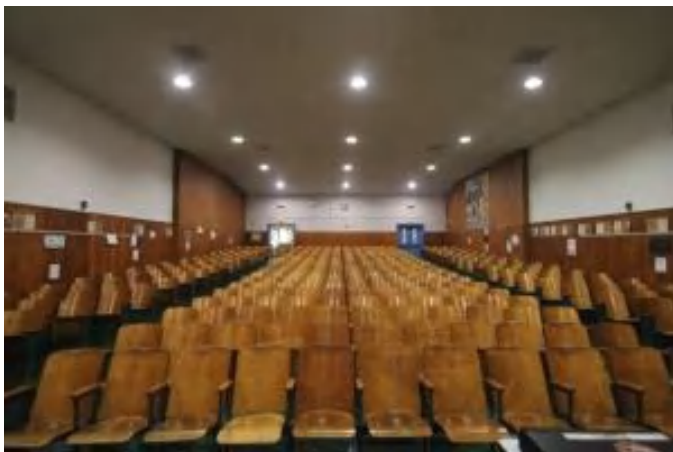
Location: Entire building

The school building has dry standpipes but does not have sprinklers. Multiple standpipes are located in fire tower stairwells and include rooftop connections. Standpipes are threaded steel pipe and likely date to circa 1970 when the addition was built. They are in fair condition and should be serviceable for at least 10 more years with routine inspections. A fire protection sprinkler system should be installed to increase occupant safety. A fire pump may be required depending on the available city water pressure.

System: D4010 - Sprinklers

Distress: Life Safety / NFPA / PFD

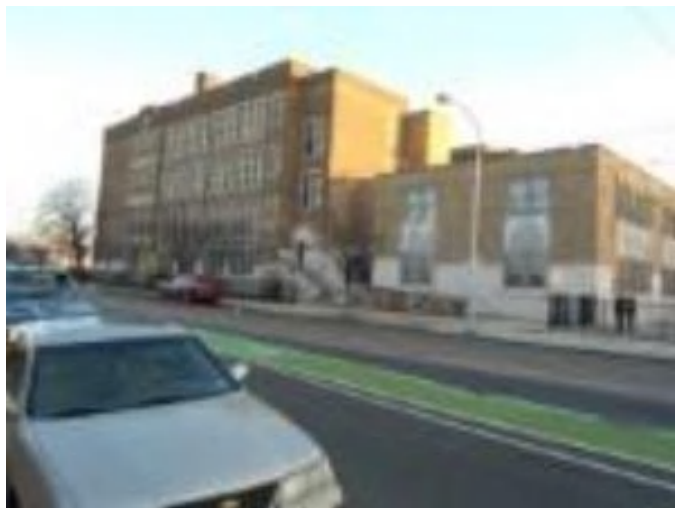
Location: North side entrance

System: G2030 - Pedestrian Paving

Distress: Accessibility

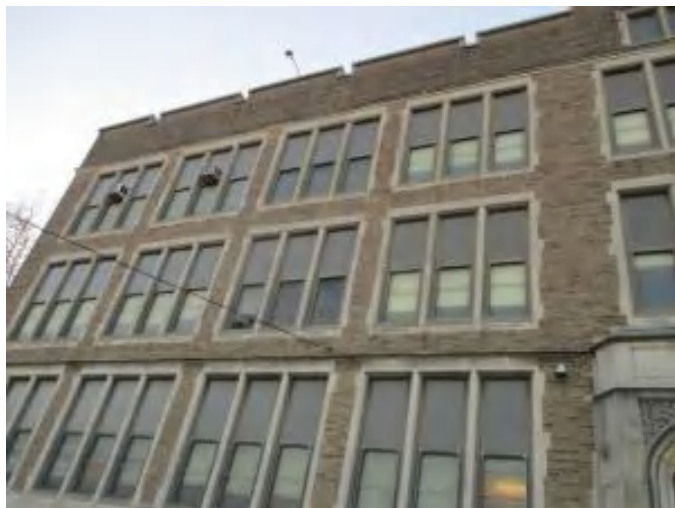
Location: Building Perimeter

System: G4030 - Site Communications & Security

Distress: Security Issue

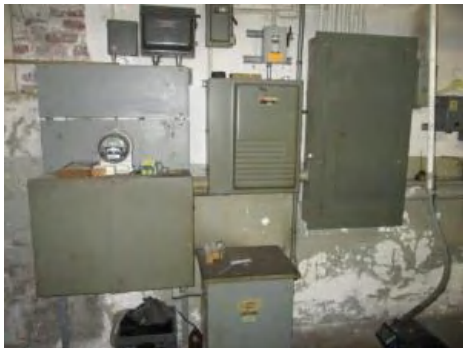
System: D5010 - Electrical Service/Distribution

Note: Phase converter 15KVA

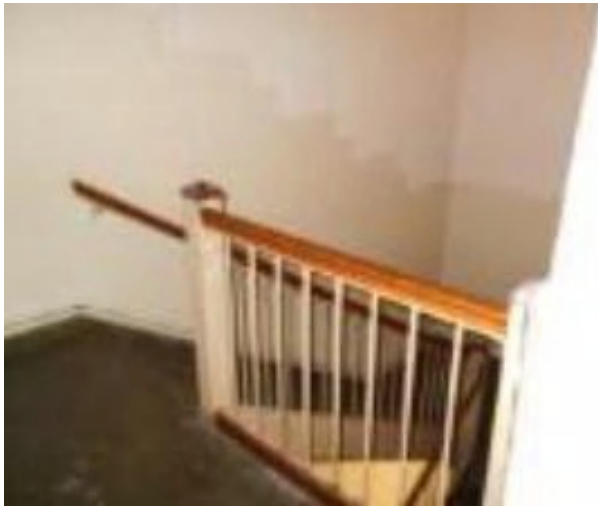
Location: Stairways

Stair construction is steel pan with cast iron non-slip treads in fair condition. Handrails are galvanized steel at the exit stair towers and painted steel at the main stair towers. Handrails do not meet modern codes for configuration with improper cross-section at rails, no extensions at landings, and improper mounting height. Barrier rails at landings and stairs are too low.

System: C2010 - Stair Construction

Distress: Building / MEP Codes

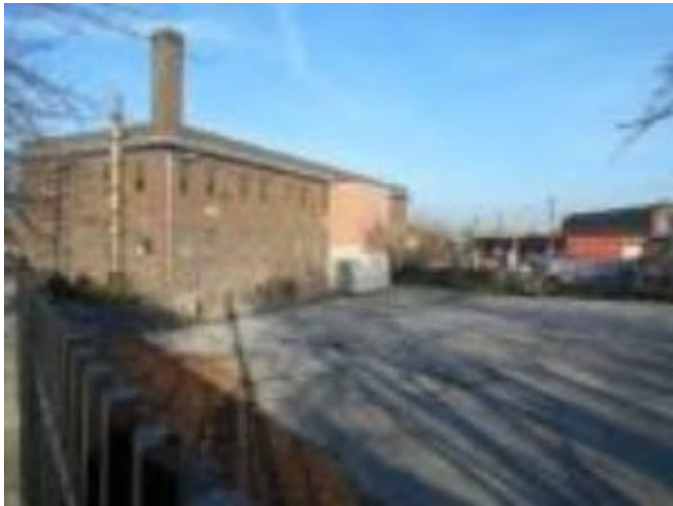
Location: Stair tower

System: B2010 - Exterior Walls

Distress: Accessibility

Notes: Provide a fixed interior metal ladder on the second floor of the stair tower with a locking access hatch at the roof level.

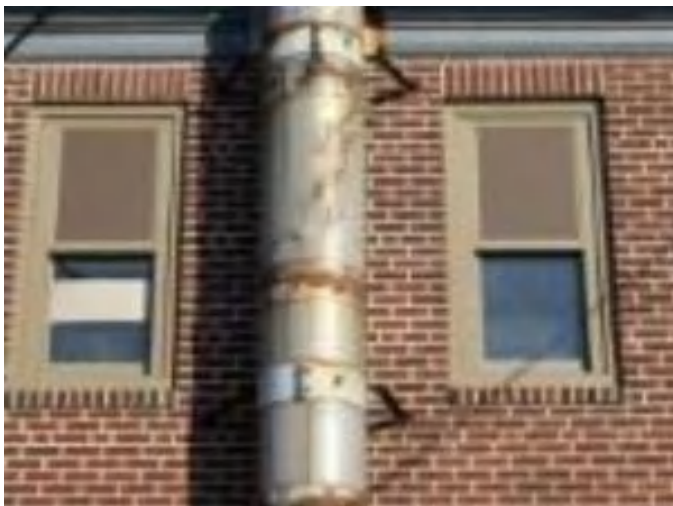
Location: Exterior windows

The original wood windows and frames installed in 1948 were replaced in the early 1980's with colored extruded aluminum single hung windows single glazed with acrylic panes with insect screens. Typically the upper pane is fitted with opaque material. All windows are generally in fair condition. Much of the glazing has hazed with age. First floor windows are fitted with security grilles. Exterior doors are typically hollow metal with glazing, in fair condition.

System: B2020 - Exterior Windows

Distress: Beyond Service Life

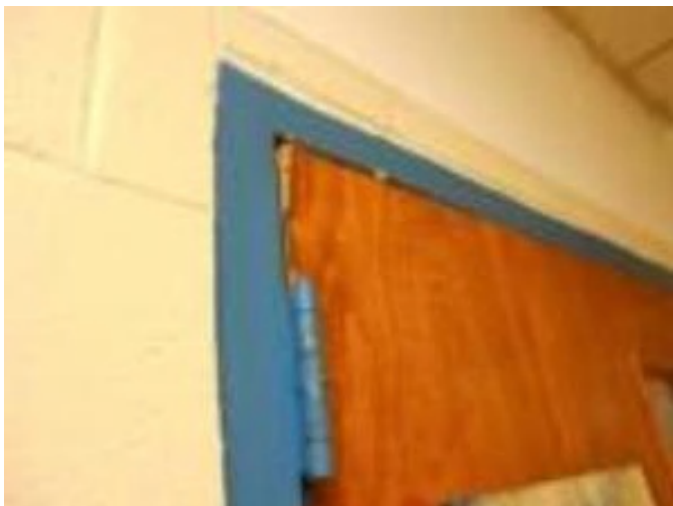
Location: Throughout the building

System: C1020 - Interior Doors

Distress: Accessibility

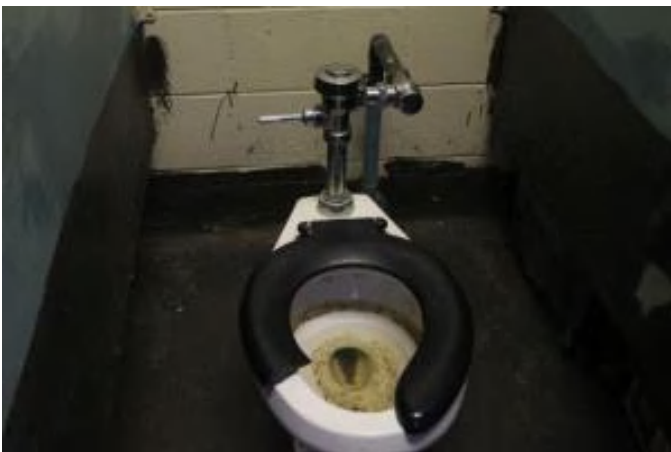
Location: Toilet rooms

Fixtures are multiple vintage and are in terrible condition. About half the lavatory faucets are inoperable, and the ground floor girls' toilet had one faucet that would not stop flowing. Cast iron ones are rusting. Faucets have separate spouts for hot and cold. Some faucets leak, and some drains back up. The lunch room lavatory was infested with fruit flies. Water closets are badly stained and one was out of order while another had a broken seat. Service sinks are wall hung, cast iron with stainless steel rim and vacuum breaker spouts. They are in just as bad condition as everything else. Fountains are wall mounted, refrigerated, past their service life, and non-accessible. All the plumbing fixtures should be replaced.

System: D2010 - Plumbing Fixtures

Distress: Appearance

Notes: Replace all lavatories due to appearance

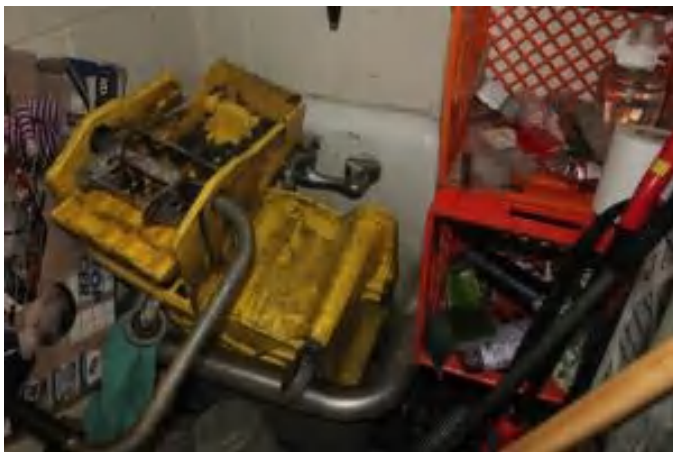
Location: Service closets

System: D2010 - Plumbing Fixtures

Distress: Appearance

Notes: Replace all service sinks due to appearance

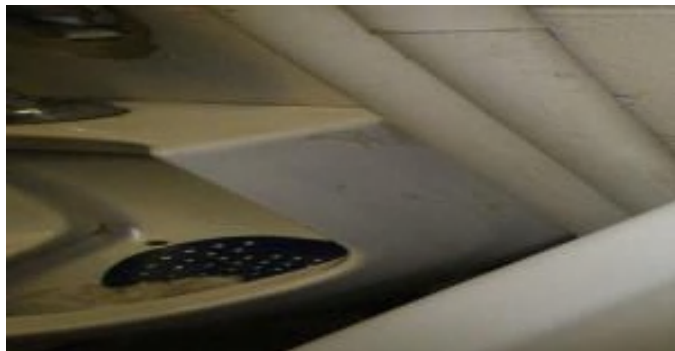
Location: Toilet rooms

System: D2010 - Plumbing Fixtures

Distress: Appearance

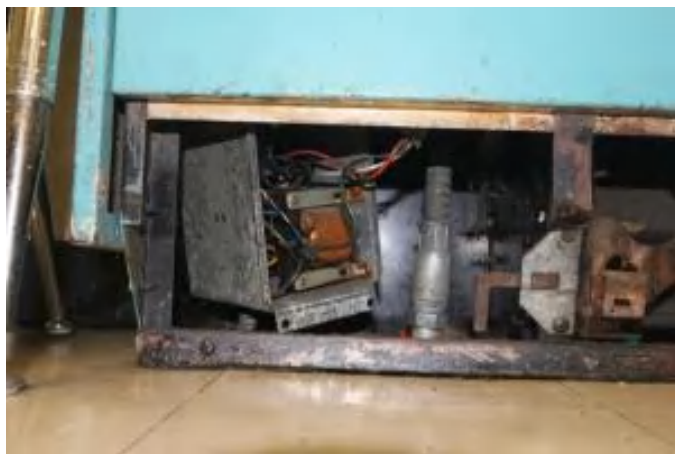
Location: Classrooms

System: D3040 - Distribution Systems

Distress: Beyond Service Life

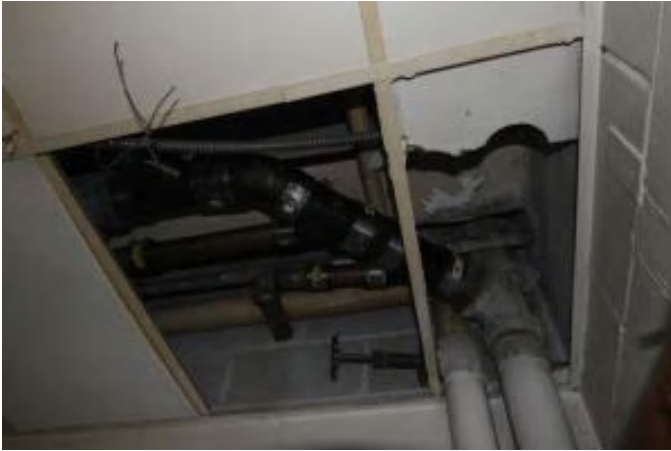
Location: Entire building

Sanitary drain piping is a combination of threaded galvanized steel and repair sections of hubless cast iron and copper with banded couplings. The steel pipes are rusting badly at their threads. The parts of the piping that have not already been repaired are likely to require repair soon based on their estimated age and visual appearance. The sanitary drain piping should be replaced entirely.

System: D2030 - Sanitary Waste

Distress: Beyond Service Life

Notes: Replace sanitary drain pipes due to age

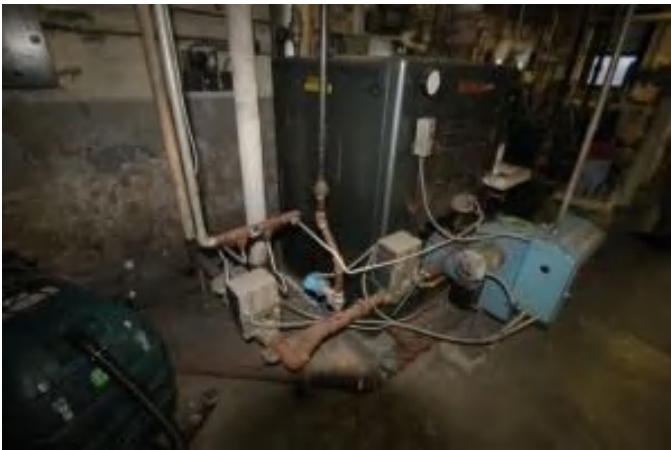
Location: Boiler room

There is one Weil Mclain model BG-684W boiler installed in 1967, 655 MBH (20 HP) capacity with Gordon Piatt burner model RC-CO-05 burning natural gas only. The boiler has exceeded its expected life span by 14 years and should be replaced. Gas service enters the building in a 2 inch line from Thomas Ave. The boiler has a draft damper on its exhaust, but it is damaged and not balanced properly. The original chimney is no longer used for the boiler, but instead a replacement metal chimney was installed along the east side of the building. This chimney is severely rusty and should be replaced when the boiler is.

System: D3020 - Heat Generating Systems

Distress: Beyond Service Life

Notes: Replace boiler due to age

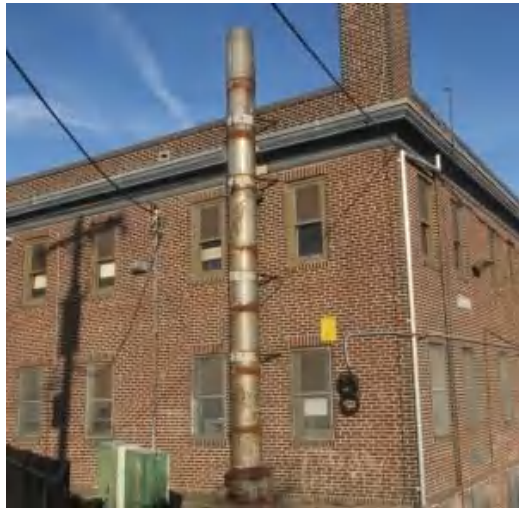
Location: Boiler room

System: D3020 - Heat Generating Systems

Distress: Failing

Notes: Replace boiler chimney and draft damper due to rust damage

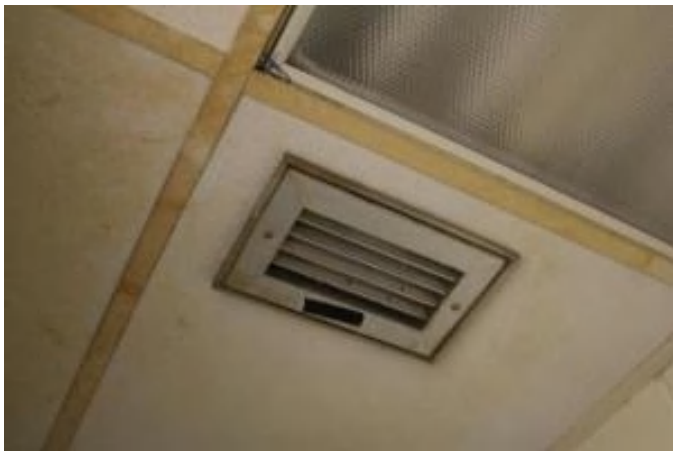
Location: Toilet rooms

System: D3040 - Distribution Systems

Distress: Failing

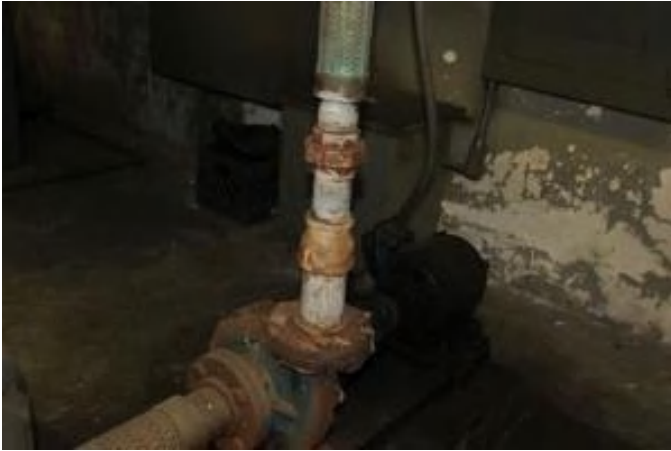
Location: Boiler room

System: D3020 - Heat Generating Systems

Distress: Beyond Service Life

Notes: Replace base mounted hydronic circulation pump

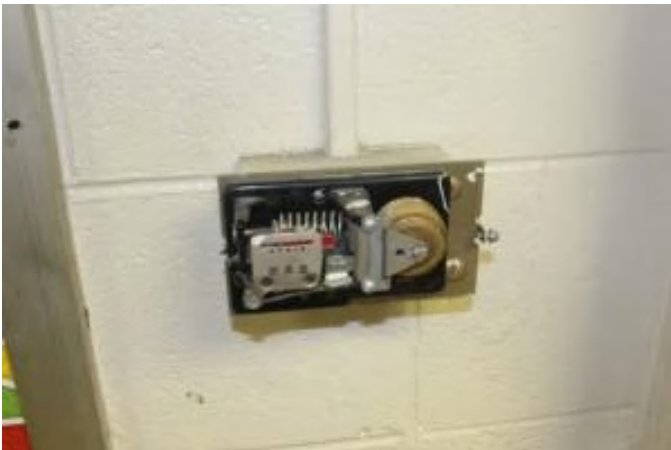
Location: Entire building

System: D3060 - Controls & Instrumentation

Distress: Obsolete

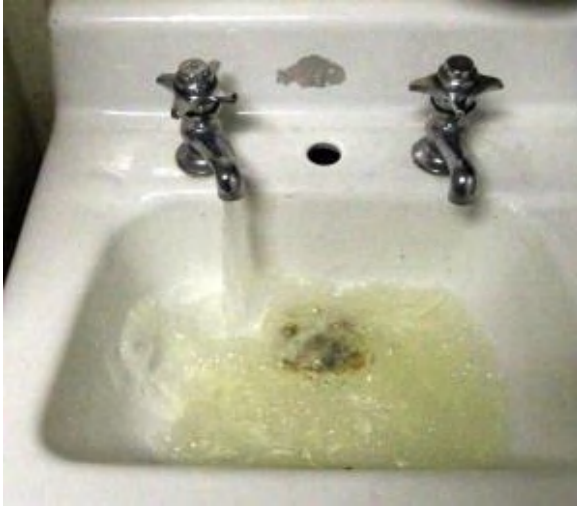
Location: Entire building

System: D2020 - Domestic Water Distribution

Distress: Appearance

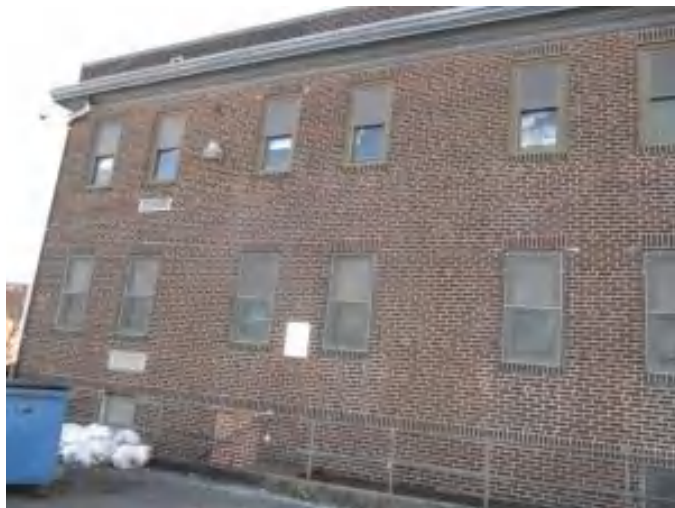
Location: Building Perimeter

System: G4030 - Site Communications & Security

Distress: Security Issue
