Facility Condition Assessment Summary Report

Holme School

School District of Philadelphia
S827001;Holme
Final
Site Assessment Report

January 31, 2017

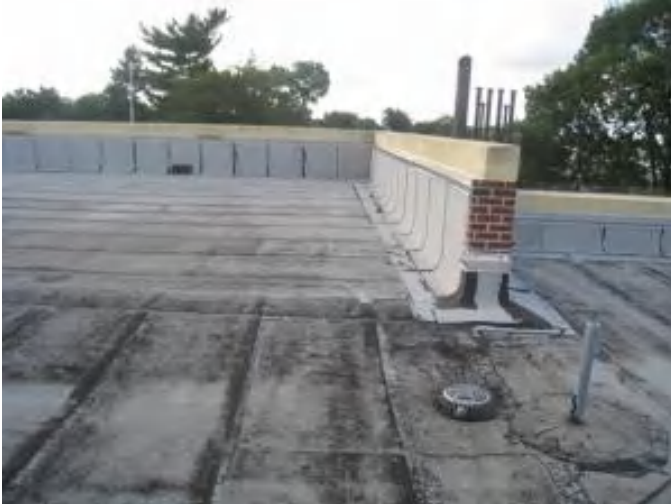
System: B3010105 - Built-Up

Roof coverings consist of a fully adhered rolled asphalt sheet system, with light gray granules embedded in the surface. Roofs are accessed by a ladder through a roof hatch. Flashing along the perimeter and rooftop equipment consists of the same type of membrane, secured to brick walls and equipment bases with aluminum counterflashing at the membrane termination. Flashing and counterflashing appear to be newer than the roof membrane and may have been replaced a number of years ago. There is a limestone parapet along the top of the brick exterior wall. It has been painted beige on the top and roof-side surfaces, presumably as a measure of moisture-proofing; limestone coping has its natural appearance facing the street. Roof membranes are worn with most ceramic granules wearing away, exposing the cracked asphalt membrane along the edges of the sheets. There are dirty areas over part of the roof indicating poor drainage and areas that have inadequate slope. There are no gutters or vertical leaders. Roof drainage is by an internal roof drain system draining by internal vertical leaders to a storm system below grade. There are overflow scuppers in the parapet at roof deck level. The roof drain over the gym that was seen to be leaking from the inside seems to be

sinking when seen from the outside. Although the membrane appears to be well-maintained and free of major visible defects, the entire roofing system is old, appears to be beyond its normal service life, and should be replaced soon.

Location: roof

Distress: Beyond Service Life

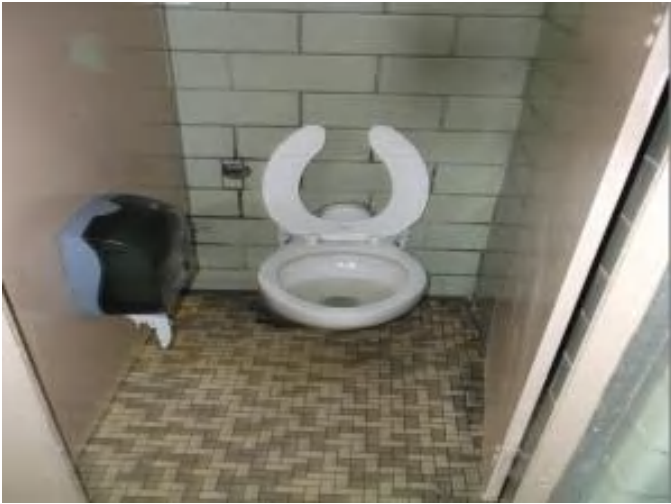
System: D2010 - Plumbing Fixtures

Plumbing Fixtures – The building is equipped with wall hung urinals (flush valve type), wall hung water closets (flush valve type), and wall hung lavatories with wheel handle faucets. Many of the original plumbing fixtures remain in service, however, these fixtures have reached the end of their service life and should be replaced. New fixtures will provide lower water consumption and provide savings on water heating costs. The bathrooms are also equipped with floor drains.

Location: Throughout the building

Distress: Beyond Service Life

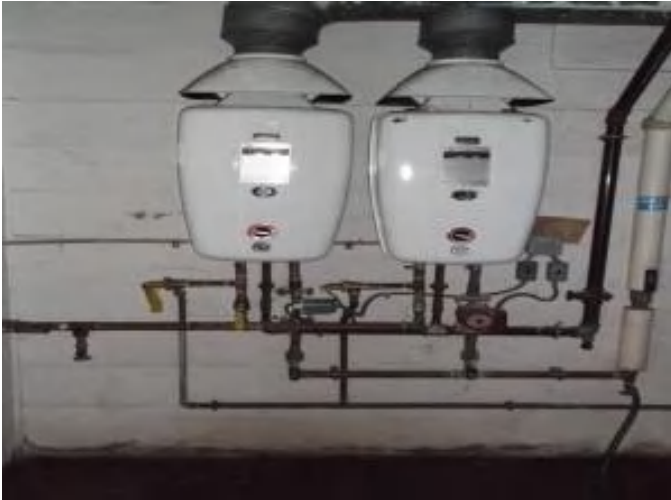
System: D2020 - Domestic Water Distribution

Location: Boiler Mechanical Equipment Room

Distress: Beyond Service Life

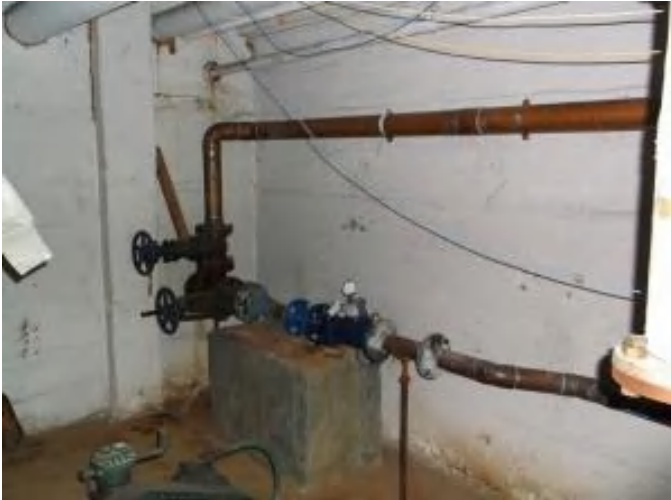
System: D2020 - Domestic Water Distribution

Domestic Water Distribution – It appears that the 4" domestic water service piping is mostly soldered copper. Water service enters the building in the basement, with double check backflow preventer (RPZA – reduced pressure zone assembly) and a 4" water meter on the main line upon entering the building. The water meter appears to be new. The piping is copper with soldered joints. The distribution piping appears to be original and is at the end of its service life and is recommended to be inspected and repaired as needed.

Location: Throughout the building

Distress: Beyond Service Life
