Facility Condition Assessment Summary Report

Kensington HS School

S501001;Kensington HS

Site Assessment Report

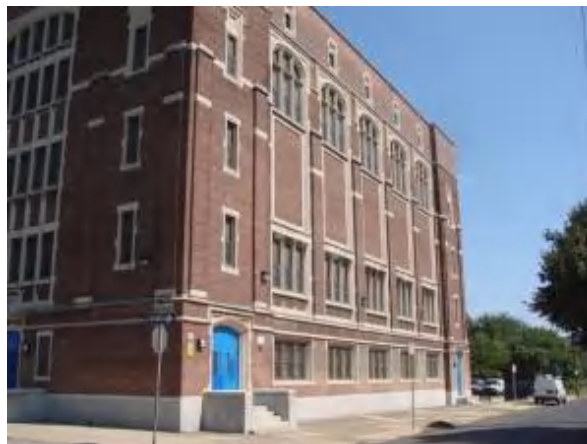
The building envelope is typically masonry with face brick with decorative stone friezes and quoining at main entrances doors. In general, masonry is in fair to poor condition with deteriorated and missing mortar from joints; the chimney shows cracks below steel banding reinforcing its top portion.

Roofing is typically built-up. All roofing and flashing is typically in poor condition with deterioration of the built-up system that allows water to pond leading to soft spots and reports of leaks.
