## Facility Condition Assessment Summary Report

### Lincoln High School

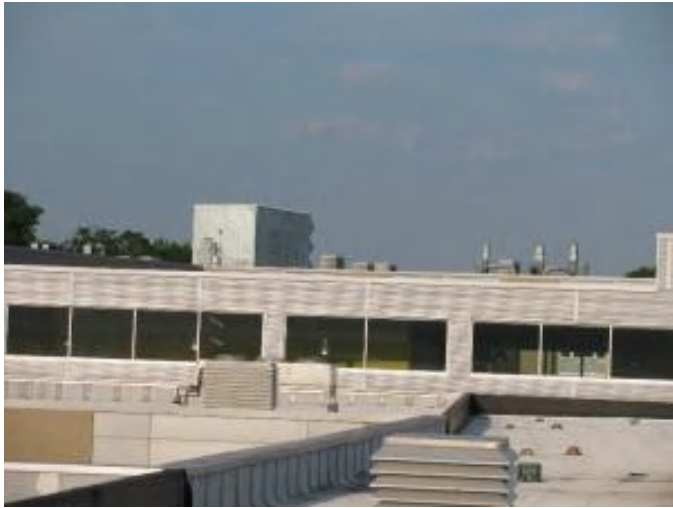
**Location:** Lincoln - Main Building - Roof

**System: D5090 - Other Electrical Systems**

**Distress:** Life Safety / NFPA / PFD

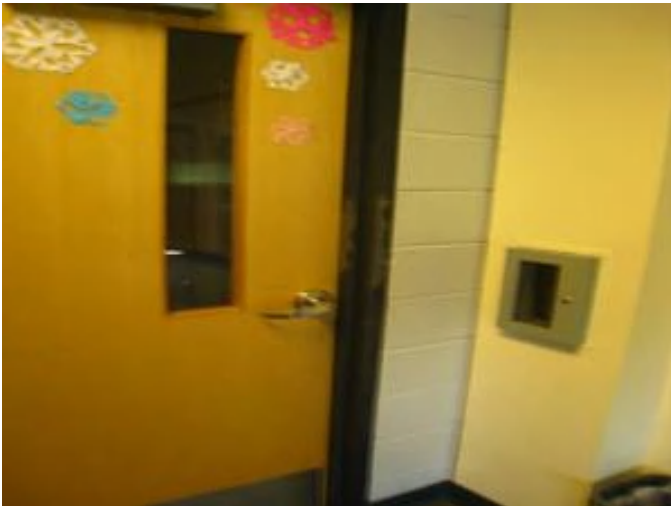
**Location:** Lincoln - Main Building - interior doors

**System: C1020 - Interior Doors**

**Distress:** Appearance

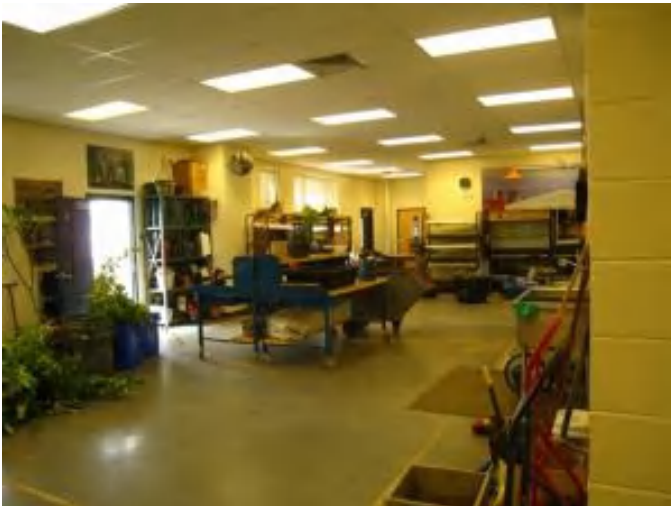
**Location:** Lincoln - Main Building - conc floors

**System: C3020415 - Concrete Floor Finishes**

**Distress:** Appearance

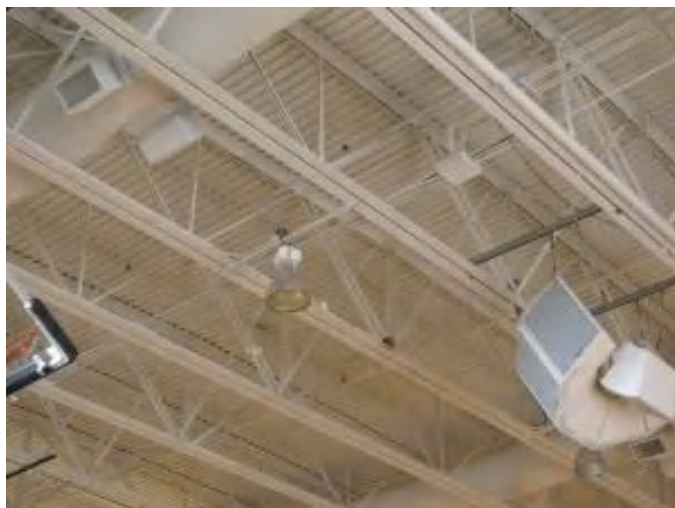
**Location:** Lincoln - Main Building - open ceiling spaces

**System: D5020 - Lighting and Branch Wiring**

**Distress:** Energy Efficiency

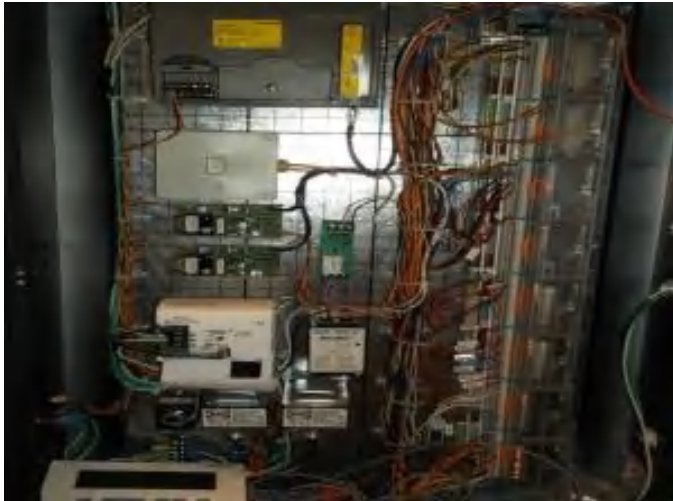
**Location:** Lincoln - Main Building - Throughout the building

**System: D3060 - Controls & Instrumentation**

**Distress:** Energy Efficiency

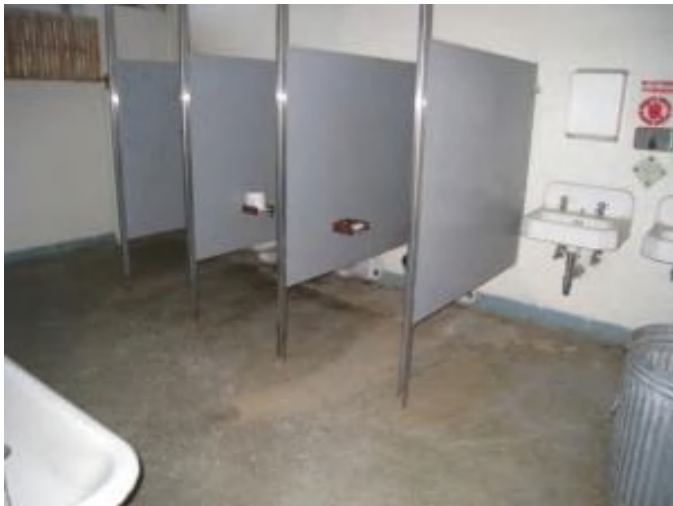
**Location:** Lincoln - Locker Facility - toilets

**System: C1030 - Fittings**

**Distress:** Beyond Service Life

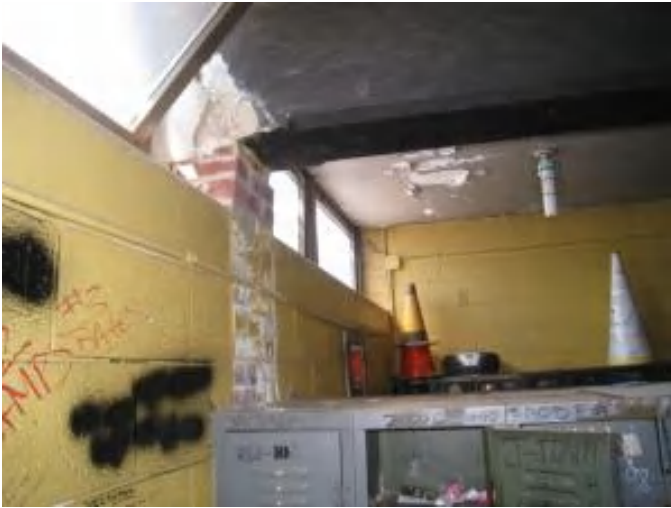
**Location:** Lincoln - Locker Facility - interiors

**System: C3010230 - Paint & Covering**

**Distress:** Appearance

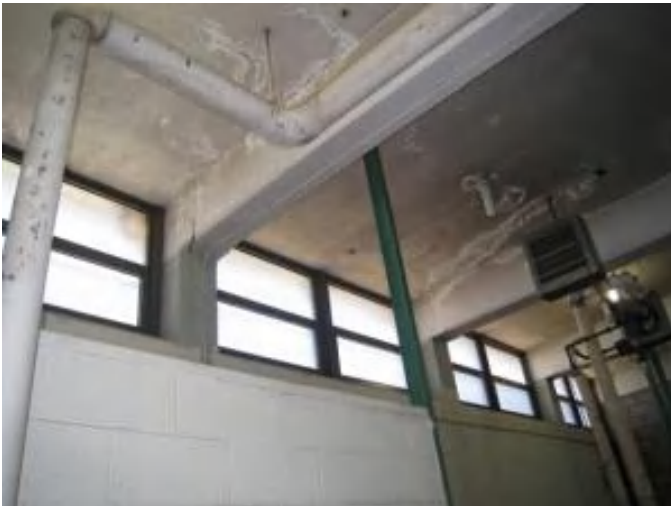
**Location:** Lincoln - Locker Facility - ceilings

**System: C3010230 - Paint & Covering**

**Distress:** Damaged

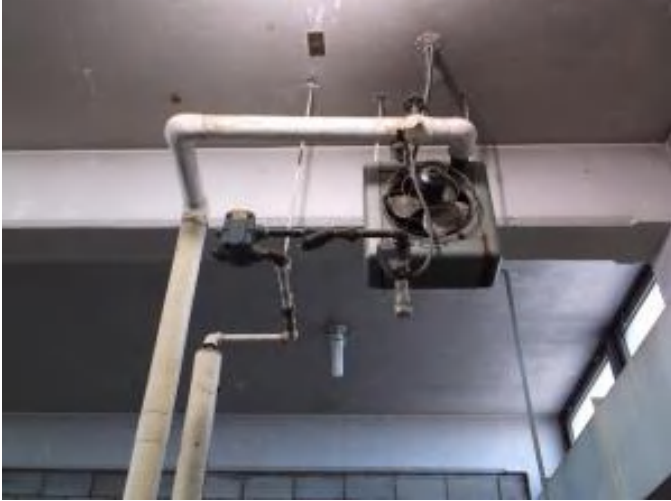
**Location:** Lincoln - Locker Facility - Throughout the building

**System: D3040 - Distribution Systems**

**Distress:** Beyond Service Life

**Correction:** Perform testing to identify and replace damaged steam and condensate piping.

**Notes:** Replace the steam condensate return system.

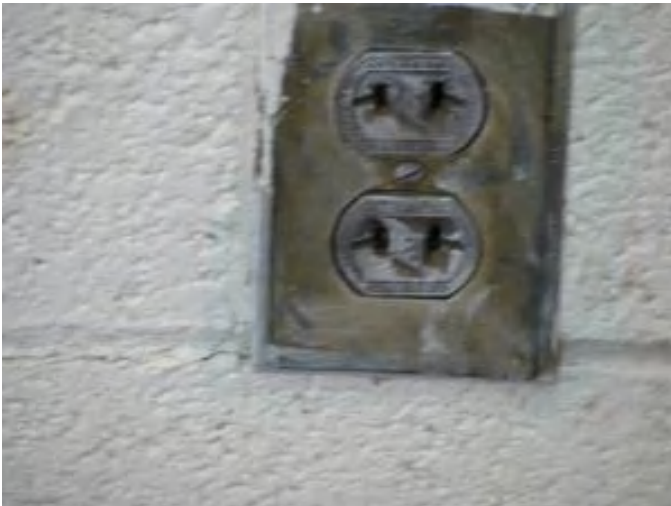
**Location:** Entire Building

**System: D5020 - Lighting and Branch Wiring**

**Distress:** Inadequate

**Correction:** Replace Wiring Devices (SF) - surface mounted conduit and boxes

**Notes:** Replace existing receptacles with duplex receptacles throughout the building. Estimated 40

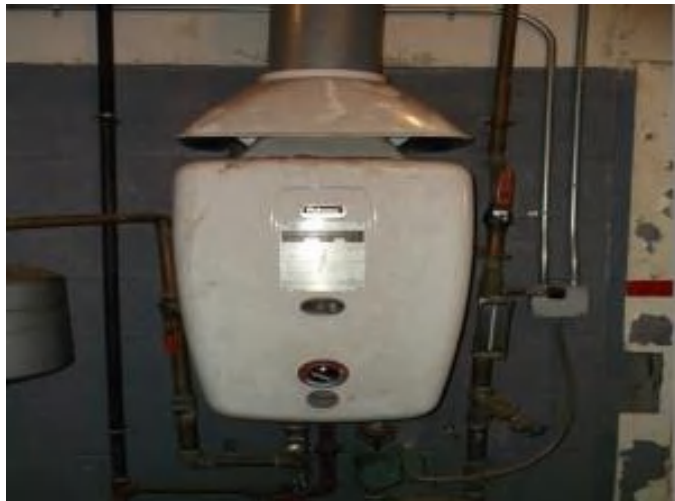
**Location:** Lincoln - Locker Facility - Main boiler mechanical equipment room

**System: D2020 - Domestic Water Distribution**

**Distress:** Beyond Service Life

**Correction:** Replace instantaneous water heater

**Notes:** Replace the gas fire instantaneous water heater.

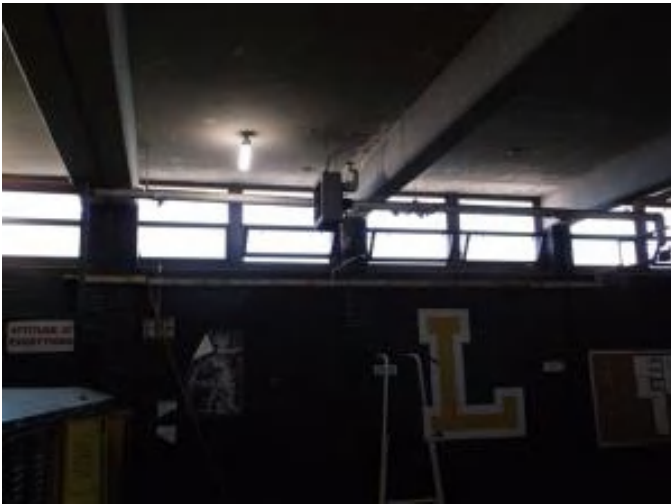
**Location:** Lincoln - Locker Facility -Throughout the building

**System: D4010 - Sprinklers**

**Distress:** Inadequate

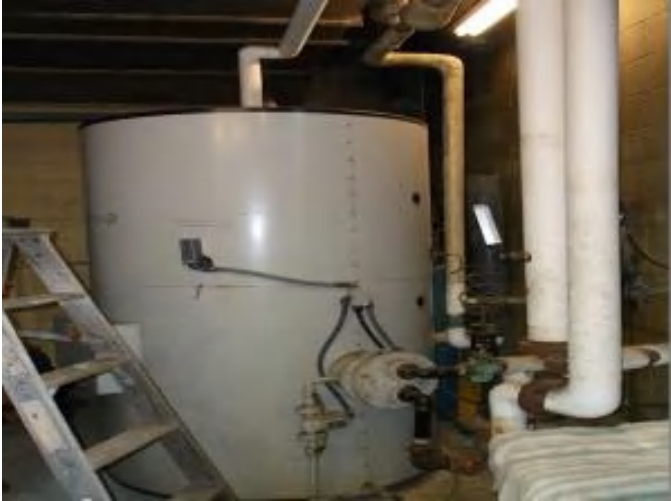
**Location:** Lincoln - Pool House - Main boiler mechanical room

**System: D2020 - Domestic Water Distribution**

**Distress:** Beyond Service Life

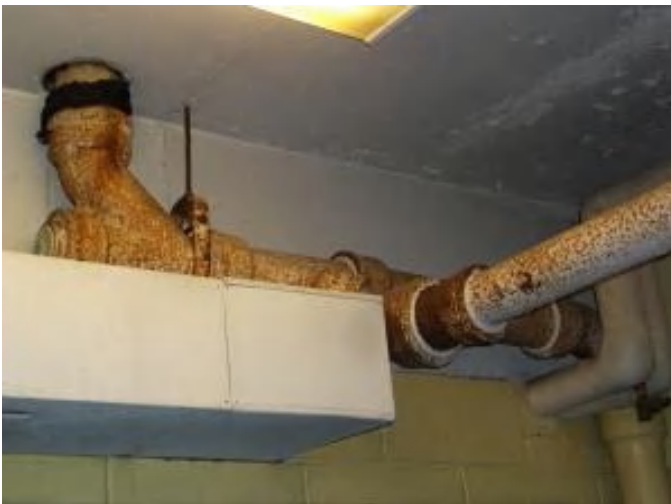
**Location:** Lincoln - Pool House - Throughout the building

**System: D2030 - Sanitary Waste**

**Distress:** Beyond Service Life

**Notes:** Hire a qualified contractor to perform a detailed examination of the sanitary waste piping using visual inspection and video cameras to locate and replace any damaged piping and to further quantify the extent of potential failures.

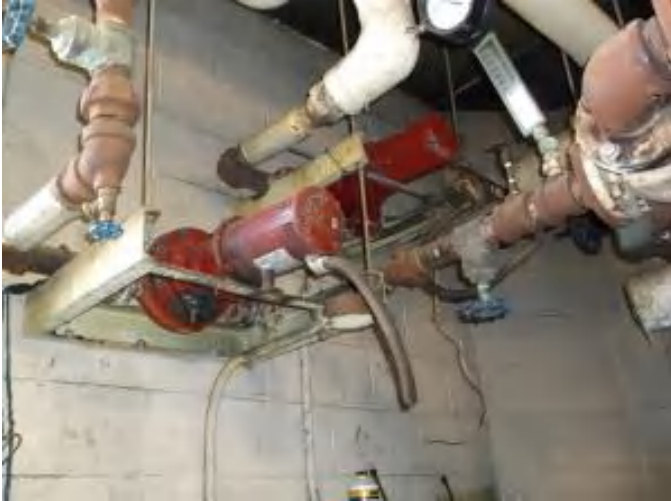
**Location:** Lincoln - Pool House - Main boiler mechanical equipment room

**System: D3020 - Heat Generating Systems**

**Distress:** Beyond Service Life

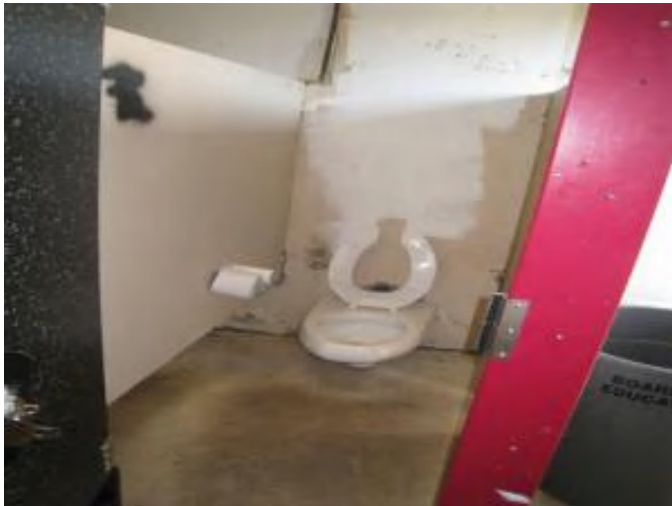
**Location:** Lincoln - Stands and Toilet Facilities

### **System: C1030 - Fittings**

**Distress:** Beyond Service Life

**Correction:** Replace toilet accessories - select accessories and quantity

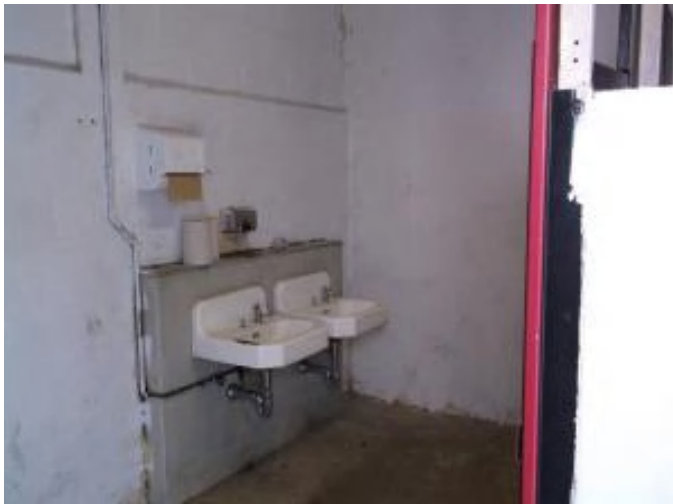
**Location:** Lincoln - Stands and Toilet Facilities- Restroom

**System: D2010 - Plumbing Fixtures**

**Distress:** Beyond Service Life

**Correction:** Remove and replace or replace lavatory - quantify accessible if required

**Notes:** Replace all lavatories in the building with lower flow fixtures, as the fixtures are original.

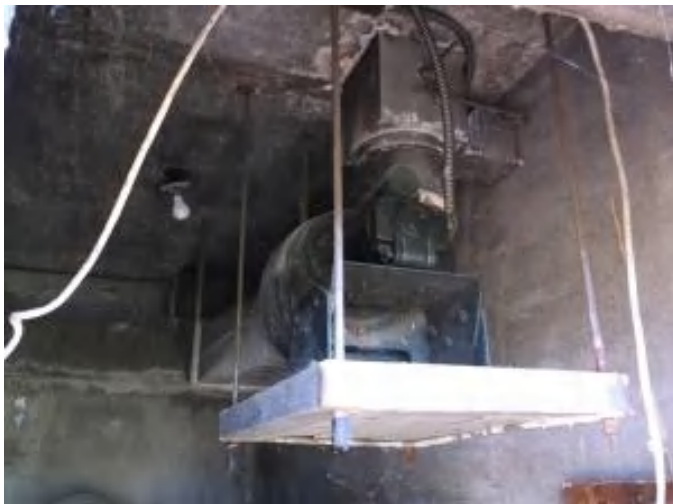
**Location:** Lincoln - Stands and Toilet Facilities- Restrooms

**System: D3040 - Distribution Systems**

**Distress:** Beyond Service Life

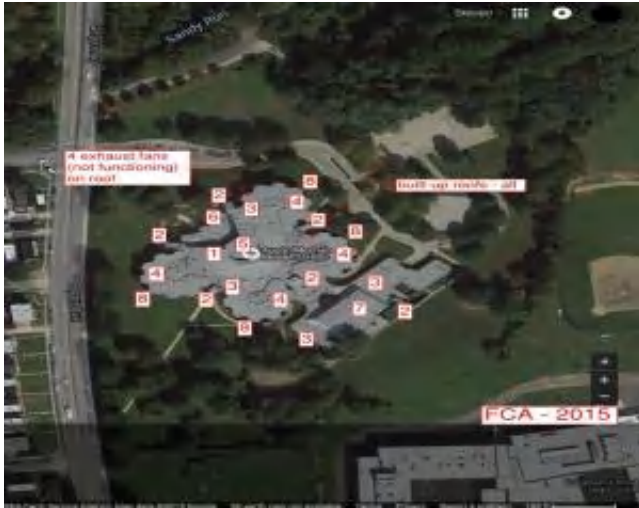
**Location:** Meehan - roof

#### System: B3010105 - Built-Up

**Distress:** Failing

**Notes:** Remove and replace existing flat roof and insulation; 8 levels (94,000sf)

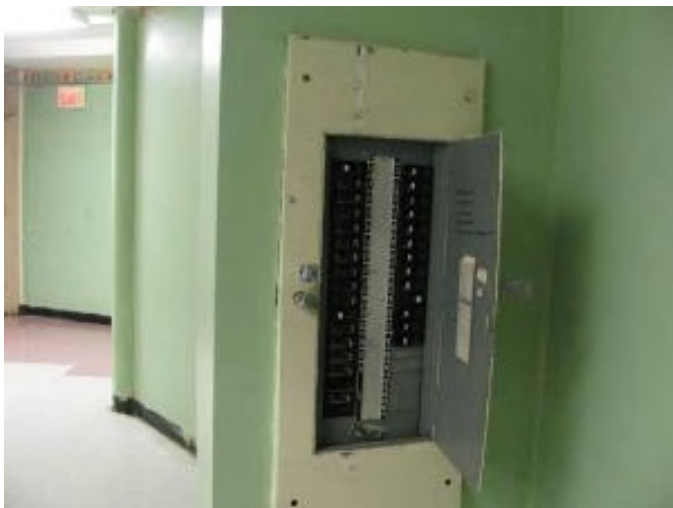
**Location:** Meehan - entire building

**System: D5010 - Electrical Service/Distribution**

**Distress:** Beyond Service Life

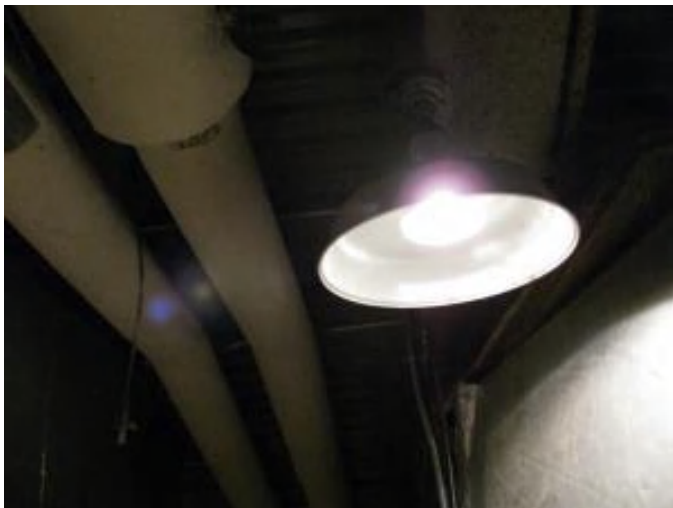
**Location:** Meehan-Entire Building

**System: D5020 - Lighting and Branch Wiring**

**Distress:** Beyond Service Life

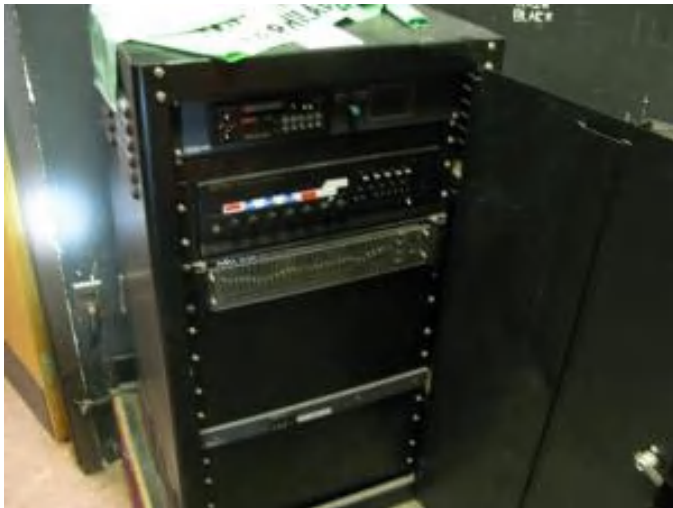
**Location:** Meehan - Backstage

**System: D5030 - Communications and Security**

**Distress:** Beyond Service Life

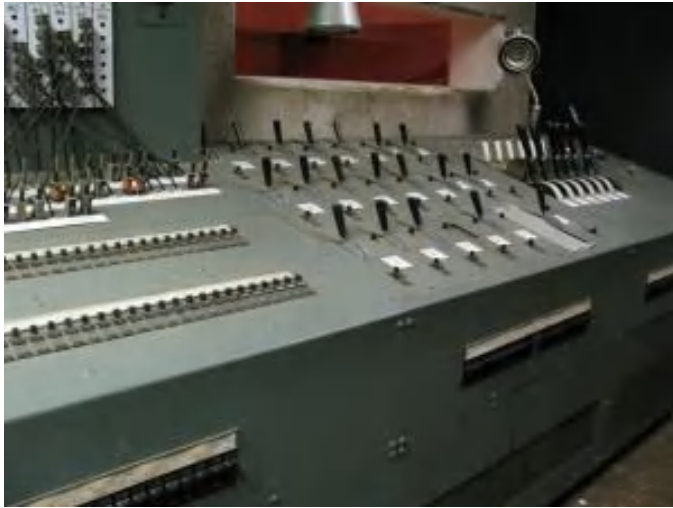
**Location:** Meehan- Auditorium

**System: E1020 - Institutional Equipment**

**Distress:** Beyond Service Life

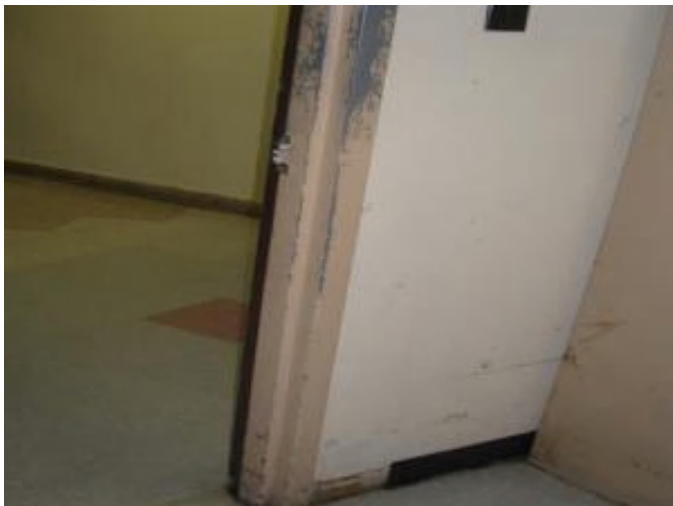
**Location:** Meehan - gyp bd walls and clgs

**System: C3010230 - Paint & Covering**

**Distress:** Damaged

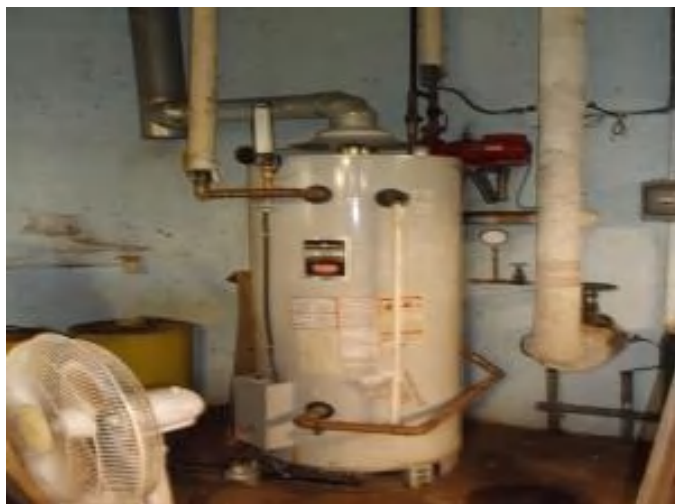
**Location:** Meehan - Boiler Mechanical Equipment Room

**System: D2020 - Domestic Water Distribution**

**Distress:** Beyond Service Life

**Correction:** Replace vertical tank type gas-fired water heater (120 gal)

**Notes:** Replace natural gas fired water heater.

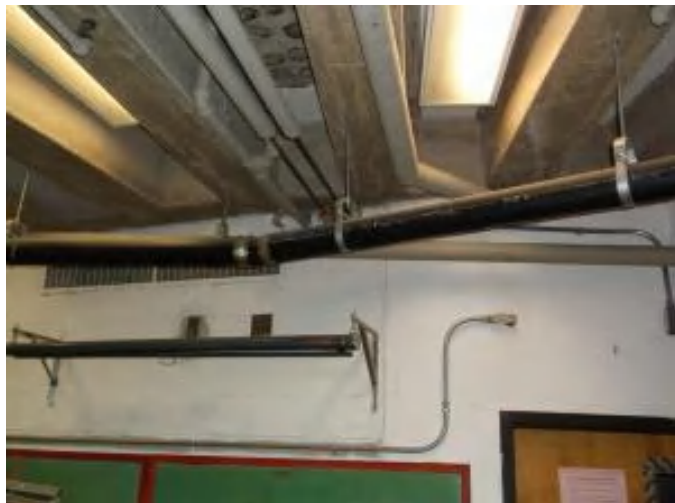
**Location:** Meehan - Throughout the building

**System: D2030 - Sanitary Waste**

**Distress:** Beyond Service Life

**Correction:** Inspect sanitary waste piping and replace damaged sections. (+200KSF)

**Notes:** Hire a qualified contractor to perform a detailed examination of the sanitary waste piping using visual inspection and video cameras to locate and replace any damaged piping and to further quantify the extent of potential failures.

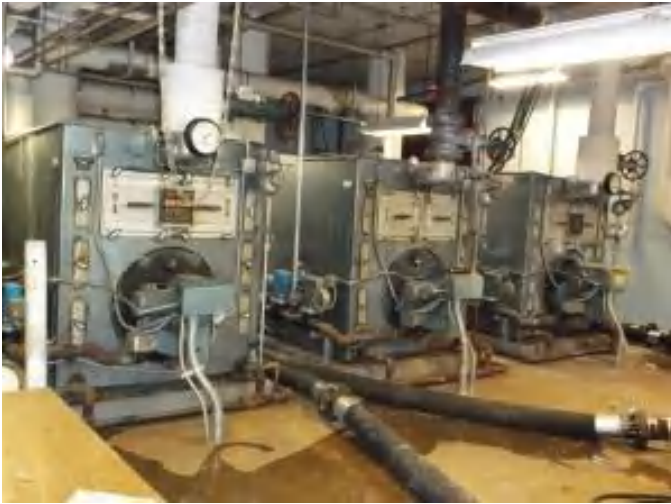
**Location:** Meehan - Boiler Mechanical Equipment Room

**System: D3020 - Heat Generating Systems**

**Distress:** Beyond Service Life

**Correction:** Replace boiler, cast iron sectional (100 HP)

**Notes:** Replace the three 3,791 MBH Weil McLain 94 series hot water boilers estimated to have been in service since the 1970s.

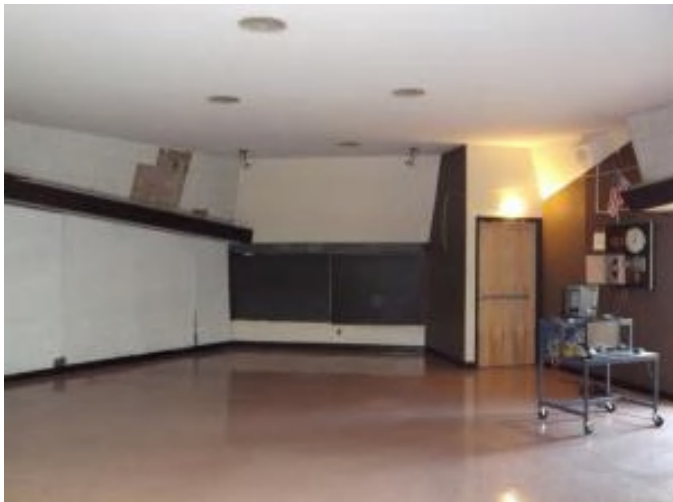
**Location:** Meehan - Throughout the building

**System: D4010 - Sprinklers**

**Distress:** Life Safety / NFPA / PFD

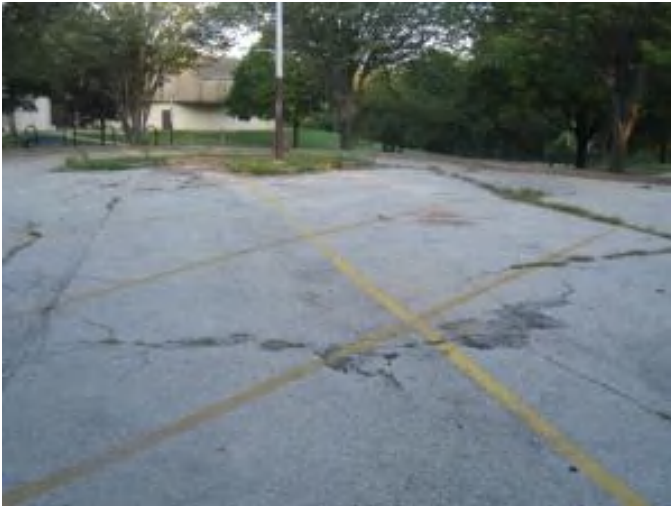
**Location:** Meehan - parking lots and roadways

#### System: G2020 - Parking Lots

**Distress:** Damaged

**Correction:** Remove and replace AC paving parking lot

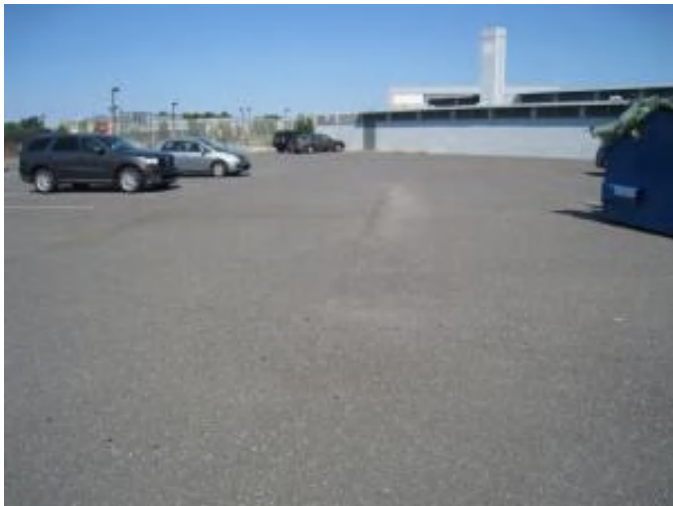
**Location:** Lincoln - Locker Facility

**System: G2020 - Parking Lots**

**Distress:** Failing

**Correction:** Fill cracks in AC paving - by the LF - average size and depth of crack

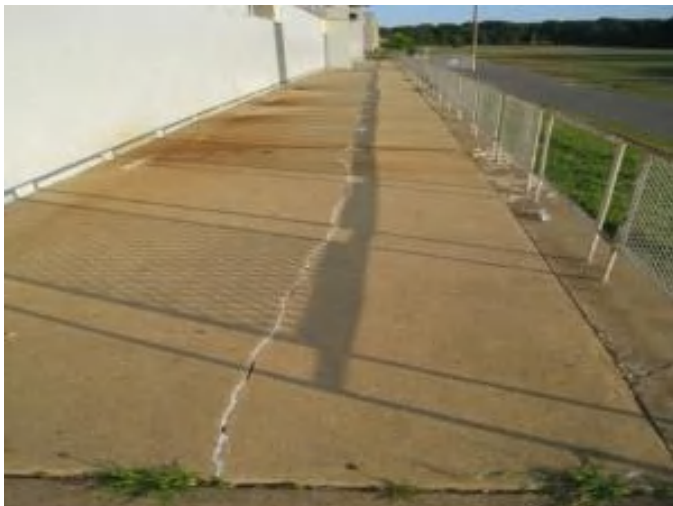
**Location:** Lincoln - Locker Facility

**System: G2030 - Pedestrian Paving**

**Distress:** Failing

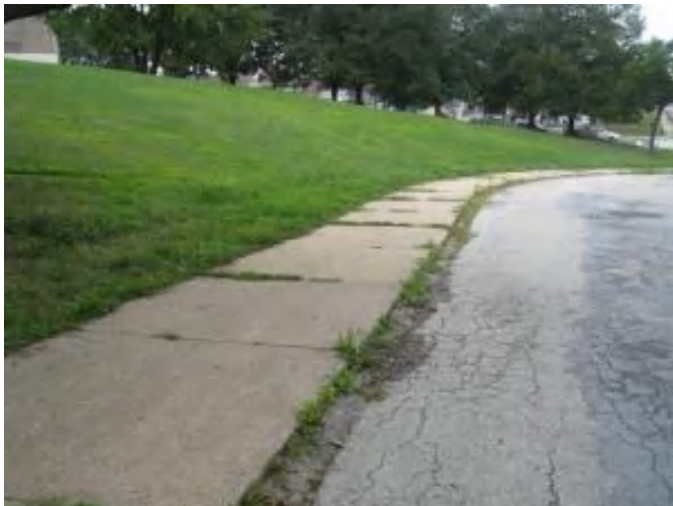
**Location:** Meehan - concrete walkways

**System: G2030 - Pedestrian Paving**

**Distress:** Damaged

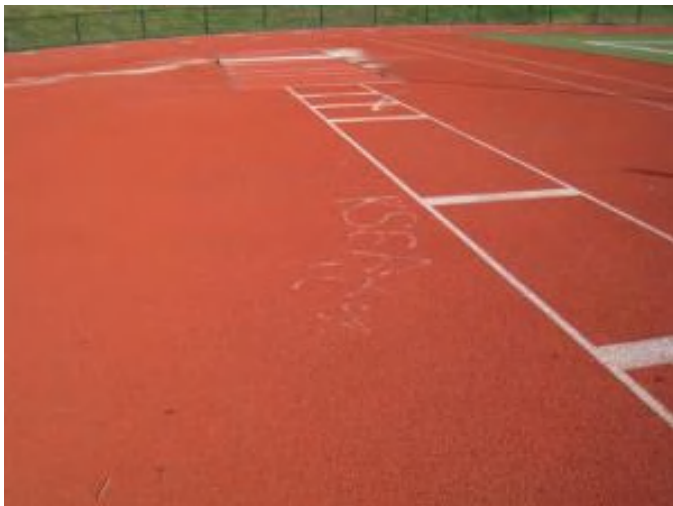
**Location:** Lincoln - track

**System: G2030 - Pedestrian Paving**

**Distress:** Damaged

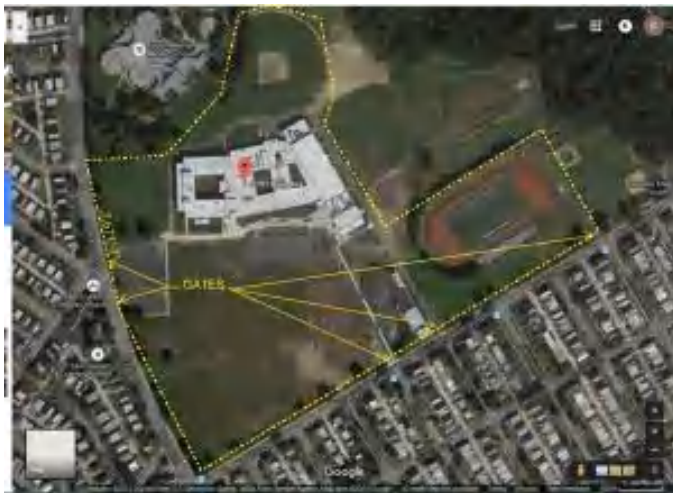
**Location:** Lincoln - Main Building - parking lots

**System: G2040 - Site Development**

**Distress:** Inadequate

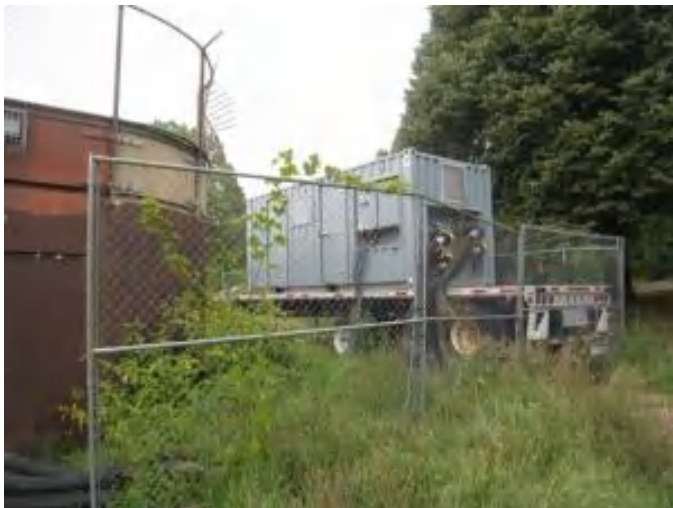
**Location:** Meehan - trim landscaping

**System: G2050 - Landscaping & Irrigation**

**Distress:** Maintenance Required
