## Facility Condition Assessment Summary Report

### Ludlow School

School District of Philadelphia  
**S534001;Ludlow**  
Final  
**Site Assessment Report**  
January 31, 2017

Gross Area (SF):	70,230
Year Built:	1927
Last Renovation:	
Replacement Value:	\$35,073,521
Repair Cost:	\$17,140,258.19
Total FCI:	48.87 %
Total RSLI:	81.90 %

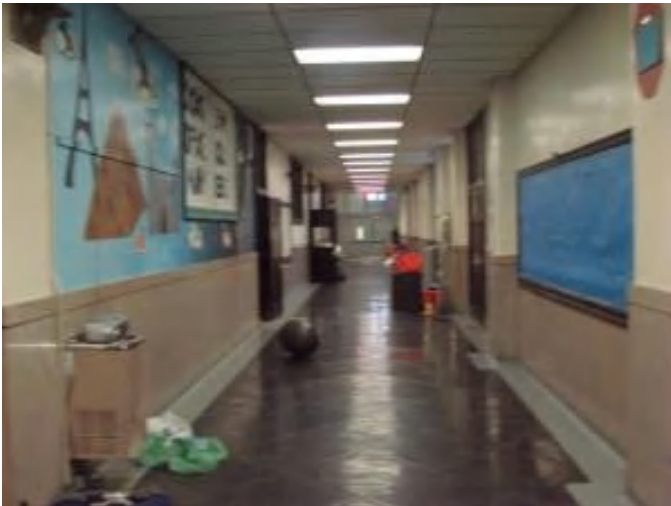
**System: D4010 - Sprinklers**

**Location:** Throughout building

**Distress:** Life Safety / NFPA / PFD

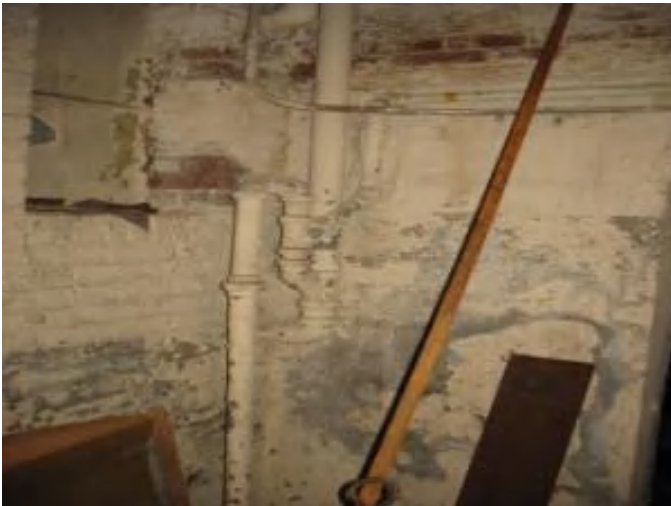
**System: D2030 - Sanitary Waste**

The maintenance staff reported mostly minor problems with the sanitary waste piping systems. However, the sewer piping has been in service for nearly 80 years and will require more frequent attention from the maintenance staff as time passes. The District should hire a qualified contractor to examine the sanitary waste piping using video cameras to locate and replace any damaged piping and to further quantify the extent of potential failures.

**Location:** Throughout building

**Distress:** Beyond Service Life

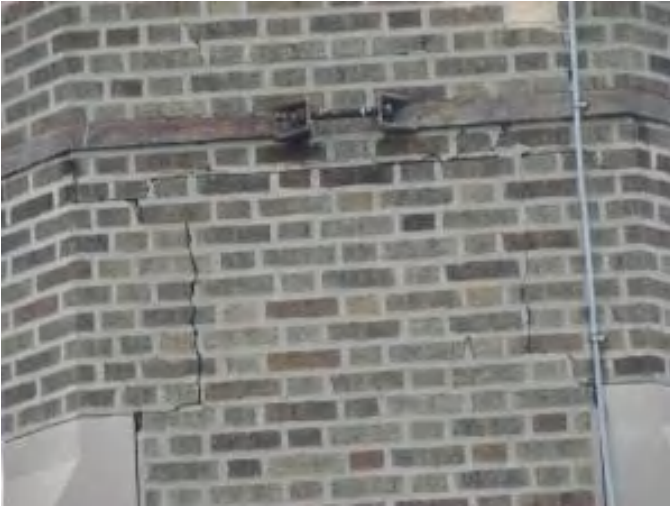
**System: B2010 - Exterior Walls**

The building envelope is typically masonry with face brick with decorative stone quoining at windows and doors perimeter. In general, masonry is in poor condition with deteriorated and missing mortar from joints; the chimney shows cracks below steel banding reinforcing its top portion.

**Location:** Exterior

**Distress:** Building Envelope Integrity

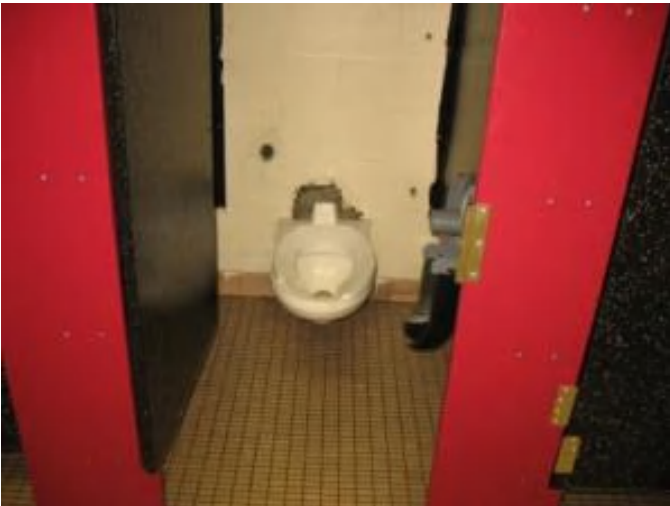
**System: D2010 - Plumbing Fixtures**

Plumbing Fixtures - The original plumbing fixtures remain in service. Fixtures in the restrooms consist of floor mounted flush valve water closets, floor mounted urinals and lavatories with flush handle faucets. The fixtures are in good condition and appear to be within their useful life. They do not require replacement. Drinking fountains in the corridors and at the restrooms are wall hung with integral refrigerated coolers. They are beyond their service life and should be replaced; most are NOT accessible type.

**Location:** Restrooms

**Distress:** Accessibility

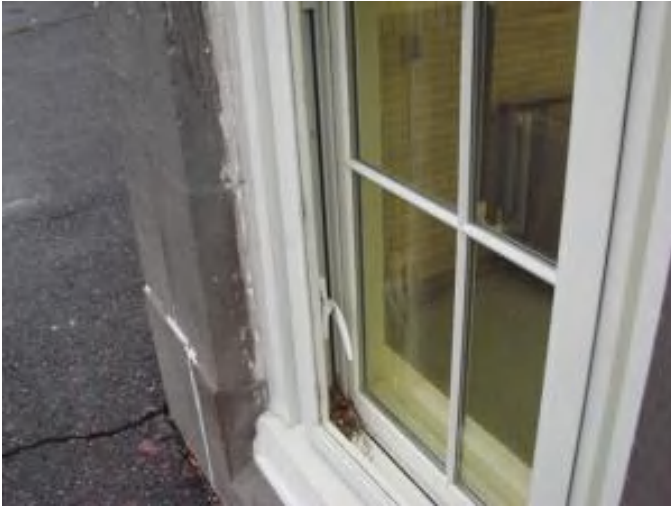
**System: B2020 - Exterior Windows**

The original windows were replaced in 2010 with extruded aluminum double hung windows, double glazed. Basement and first floor windows are fitted with integral security screens. All windows are generally in good condition; however sealant at their perimeter is deteriorated.

**Location:** Exterior

**Distress:** Building Envelope Integrity

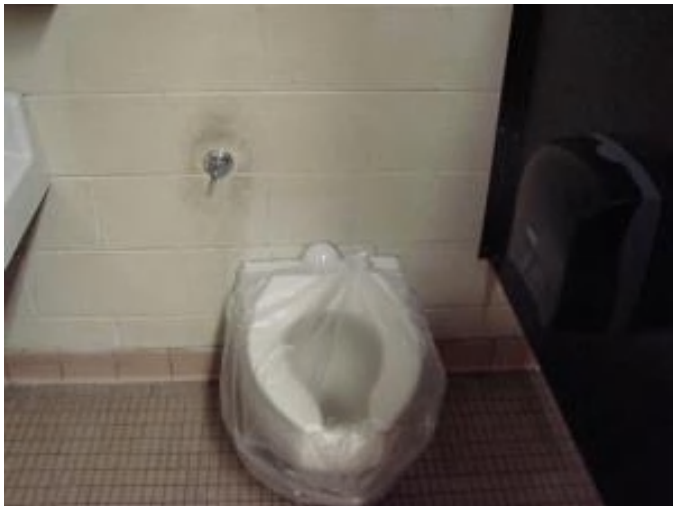
**System: C1030 - Fittings**

**Location:** Interiors/ Toilets

**Distress:** Building / MEP Codes

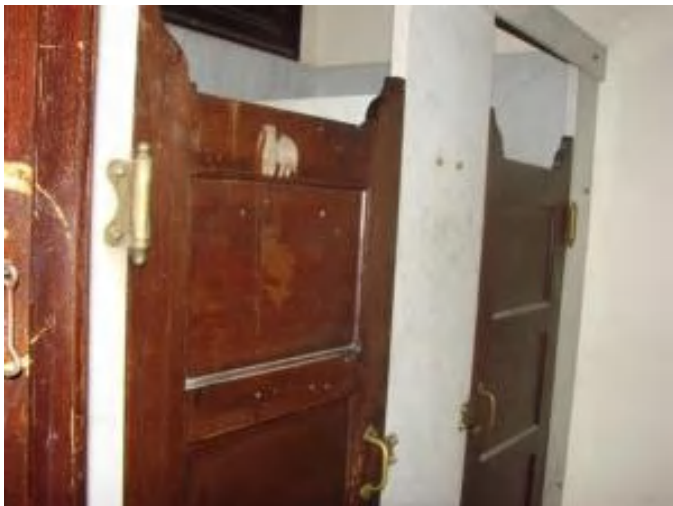
**System: C1030 - Fittings**

**Location:** Interiors/ Toilets

**Distress:** Accessibility

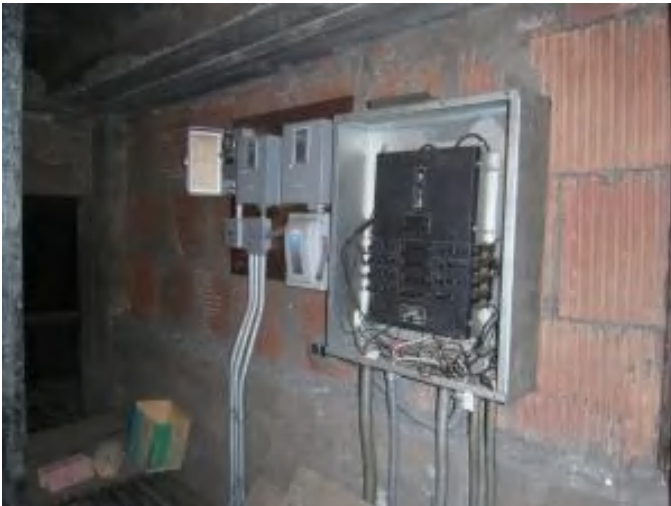
**System: D5010 - Electrical Service/Distribution**

Distribution System and Raceway System- Each floor has electrical panels to serve receptacles and lighting on that floor. A main distribution panel could not be located, and our building engineer did not know of the existence of one. These panels are past their useful life, with some containing open buses with fuses, and other panels in poor condition with rust.

**Location:** Throughout Building

**Distress:** Beyond Service Life

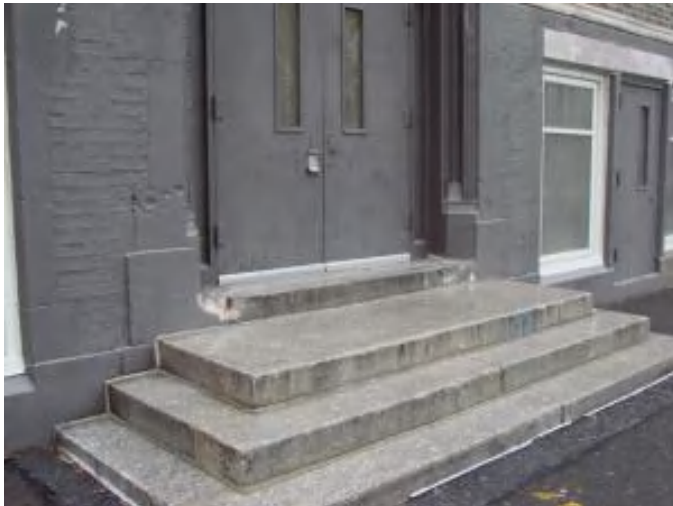
**System: B2030 - Exterior Doors**

Exterior doors are typically hollow metal in fair to good condition. Generally, the building is not accessible per ADA requirements due to first floor- grade separation with no ramps or lifts.

**Location:** Exterior

**Distress:** Maintenance Required

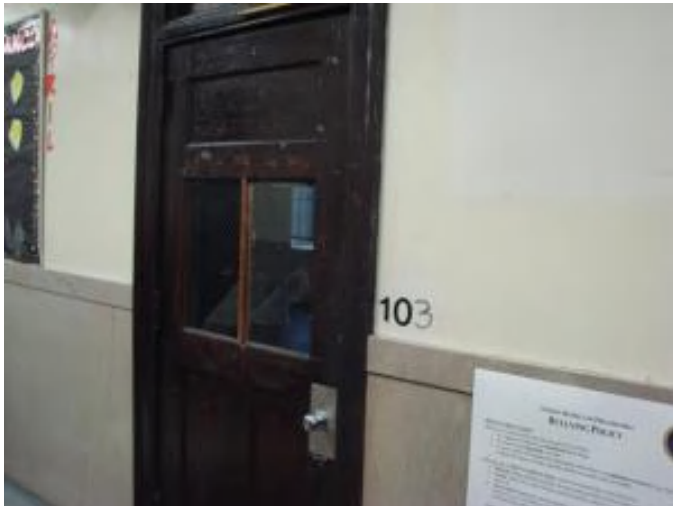
**System: C1030 - Fittings**

**Location:** Interiors

**Distress:** Beyond Service Life

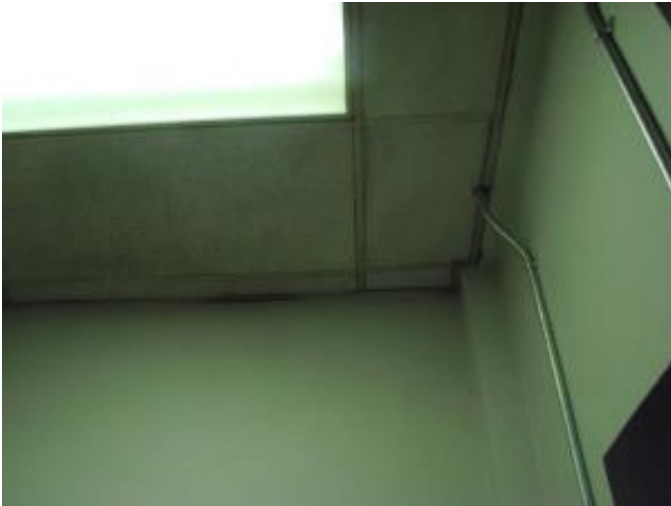
**System: C3030 - Ceiling Finishes**

**Location:** Interiors

**Distress:** Beyond Service Life

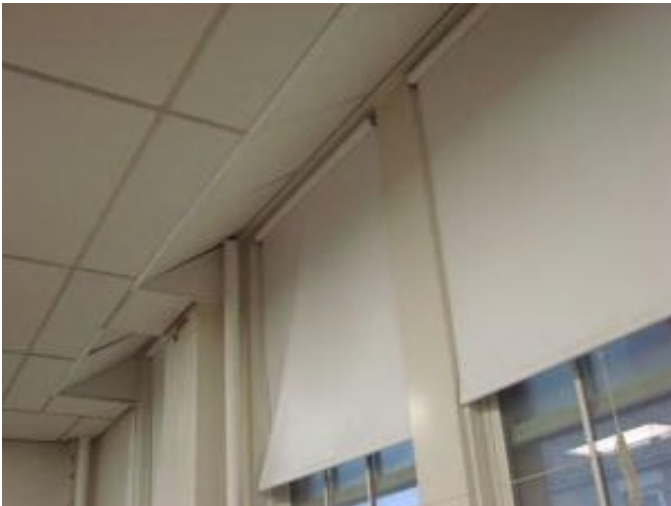
**System: C3030 - Ceiling Finishes**

**Location:** Interiors

**Distress:** Beyond Service Life

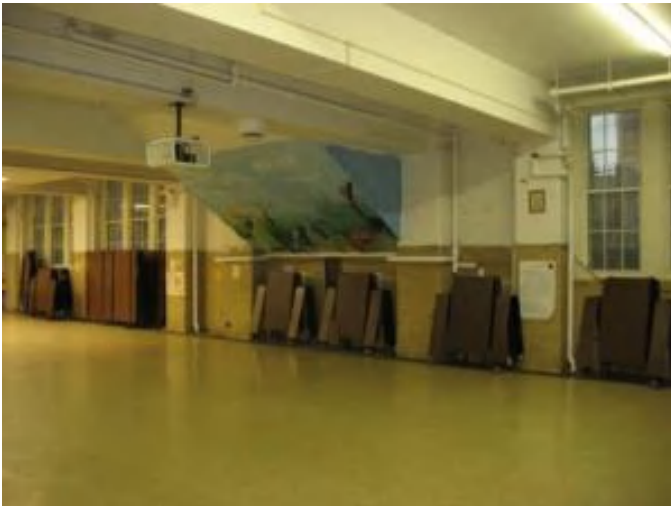
**System: D3040 - Distribution Systems**

**Location:** Cafeteria

**Distress:** Building / MEP Codes

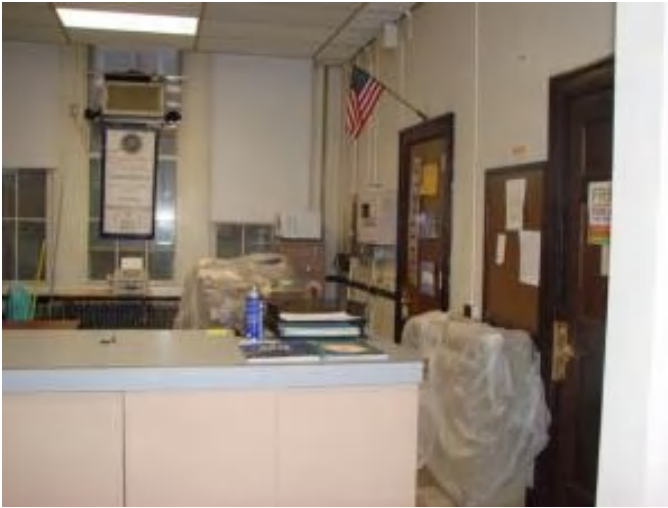
**System: D3040 - Distribution Systems**

**Location:** Administration

**Distress:** Building / MEP Codes

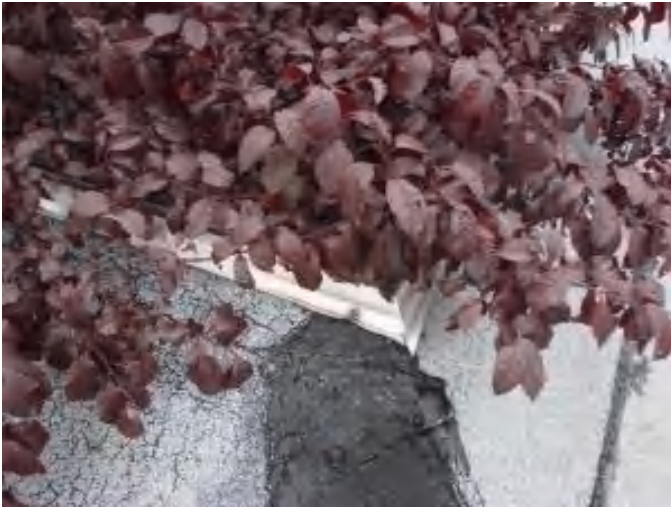
#### System: B3010105 - Built-Up

**Location:** Exterior/ Roof

**Distress:** Building Envelope Integrity

**Correction:** Remove and Replace Built Up Roof

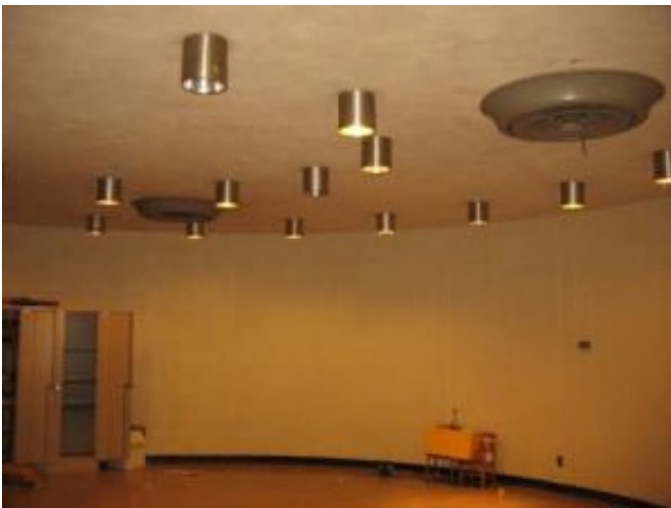
#### System: D4010 - Sprinklers

**Location:** Throughout building

**Distress:** Life Safety / NFPA / PFD

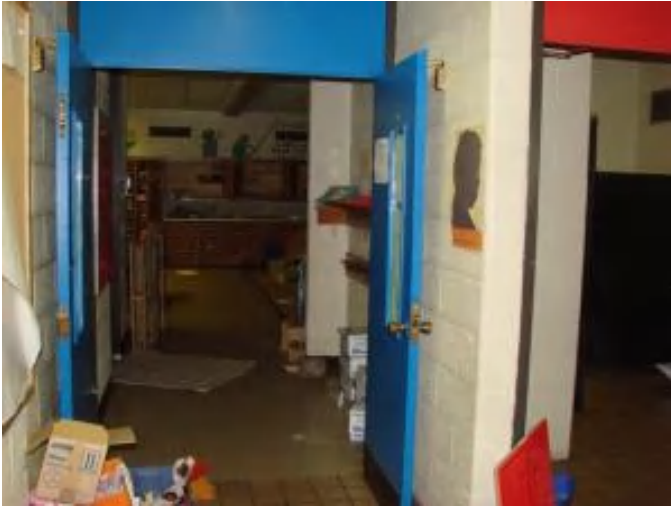
**System: C1020 - Interior Doors**

**Location:** Interiors

**Distress:** Building / MEP Codes

**Correction:** Replace door knobs with compliant lever type

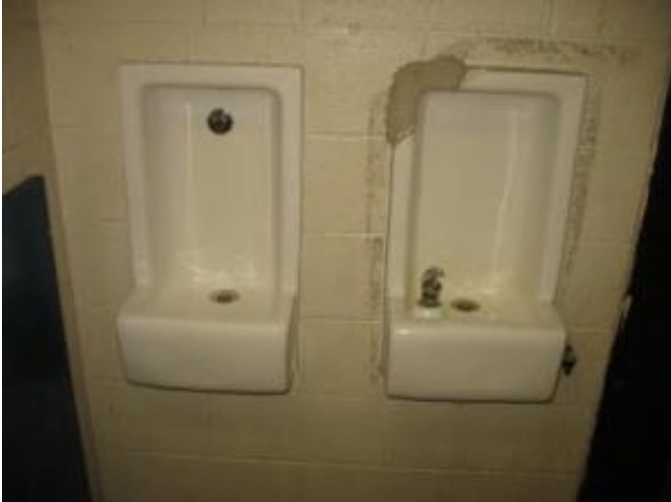
**System: D2010 - Plumbing Fixtures**

**Location:** Throughout building

**Distress:** Accessibility

**Correction:** Remove and Replace Water Fountains - without ADA new recessed alcove

**Notes:** Replace the wall hung drinking fountains and integral refrigerated coolers in the corridors and at the restrooms. These units are beyond their service life and most are NOT accessible type.

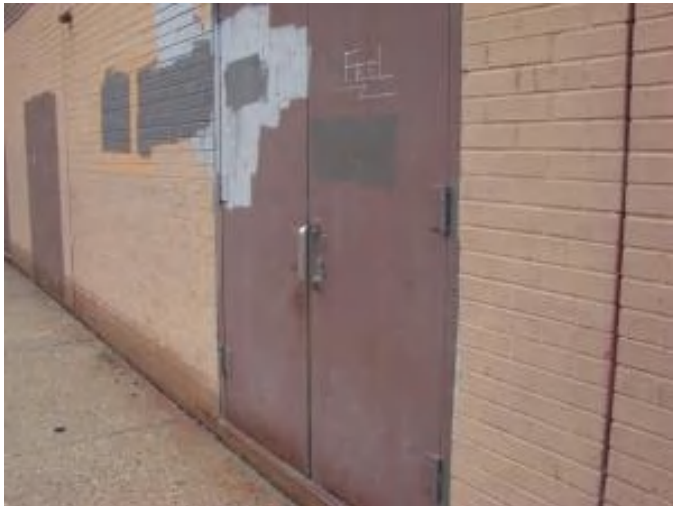
**System: B2030 - Exterior Doors**

**Location:** Exterior

**Distress:** Beyond Service Life

**Correction:** Remove and replace exterior doors - per leaf

**Notes:** Replace exterior doors; provide weatherstripping and hardware

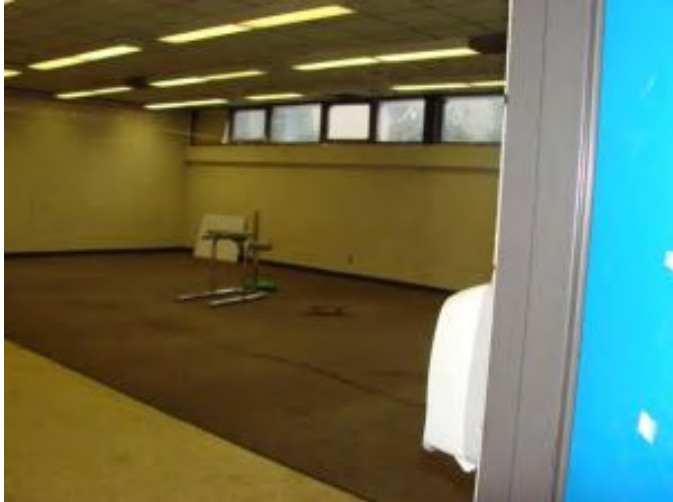
**System: C3020411 - Carpet**

**Location:** Interiors

**Distress:** Failing

**Correction:** Remove and replace carpet

**Notes:** Replace carpet flooring

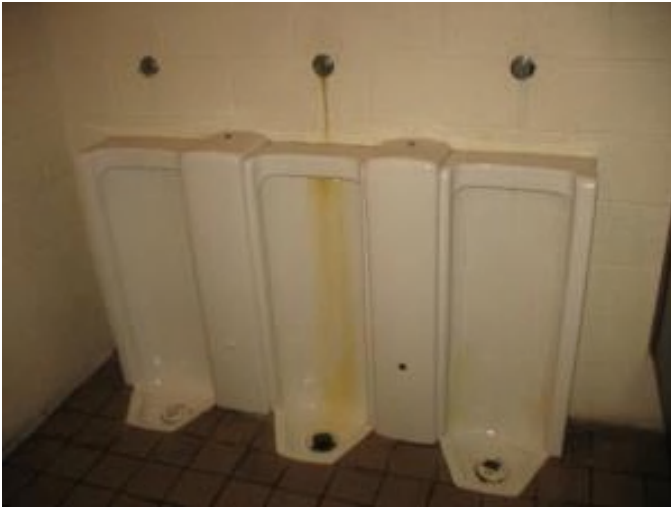
**System: D2030 - Sanitary Waste**

**Location:** Throughout bulding

**Distress:** Health Hazard / Risk

**Correction:** Inspect sanitary waste piping and replace damaged sections. (+50KSF)

**Notes:** Hire a qualified contractor to perform a detailed examination of the sanitary waste piping using visual inspection and video cameras to locate and replace any damaged piping and to further quantify the extent of potential failures.

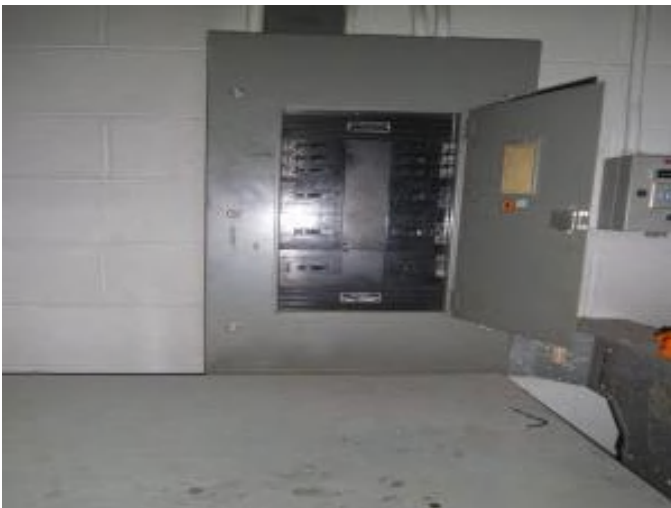
**System: D5010 - Electrical Service/Distribution**

**Location:** Throughout Building

**Distress:** Beyond Service Life

**Correction:** Replace Panelboard

**Notes:** Replace existing electrical panels.

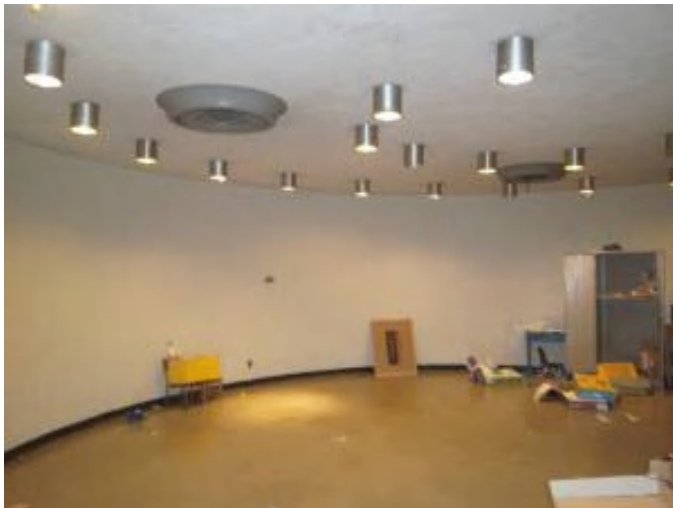
**System: D5020 - Lighting and Branch Wiring**

**Location:** Throughout Building

**Distress:** Beyond Service Life

**Correction:** Replace Lighting Fixtures (SF)

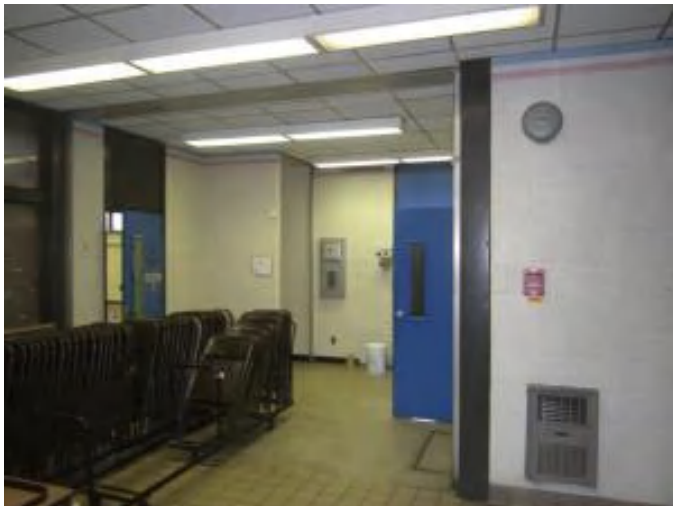
**System: D5030 - Communications and Security**

**Location:** Throughout Building

**Distress:** Beyond Service Life

**Correction:** Replace fire alarm system

**Notes:** Replace existing fire alarm system.

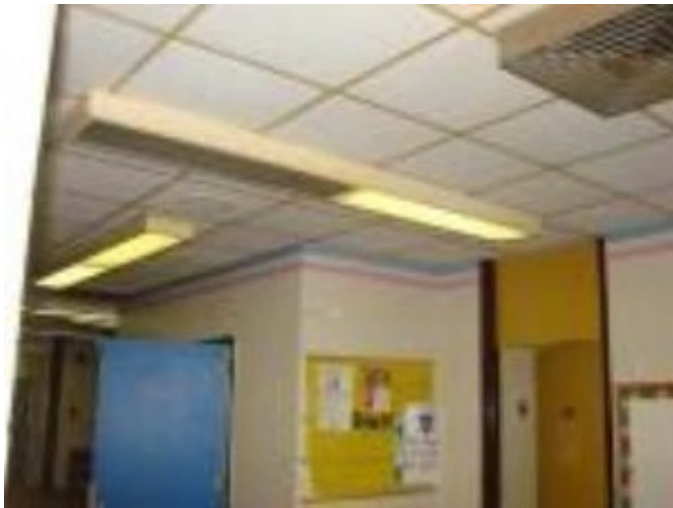
**System: D5090 - Other Electrical Systems**

**Location:** Throughout Building

**Distress:** Inadequate

**Correction:** Replace Emergency/Exit Lighting

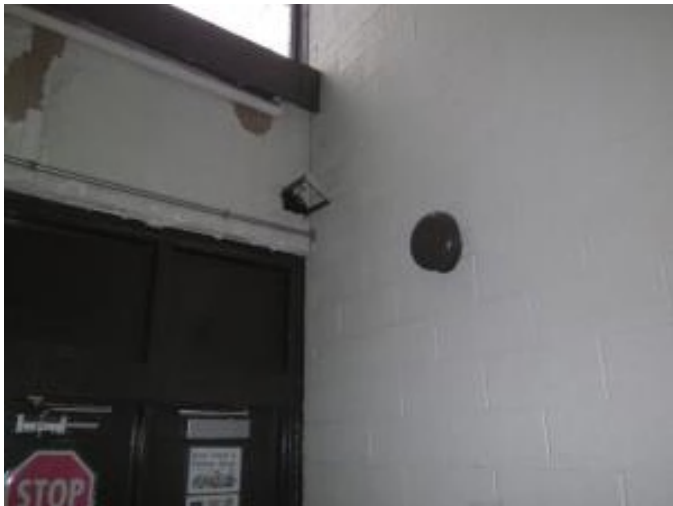
**System: D5090 - Other Electrical Systems**

**Location:** Throughout building

**Distress:** Beyond Service Life

**Correction:** Replace Emergency/Exit Lighting

**Notes:** Replace existing LED EXIT fixtures.

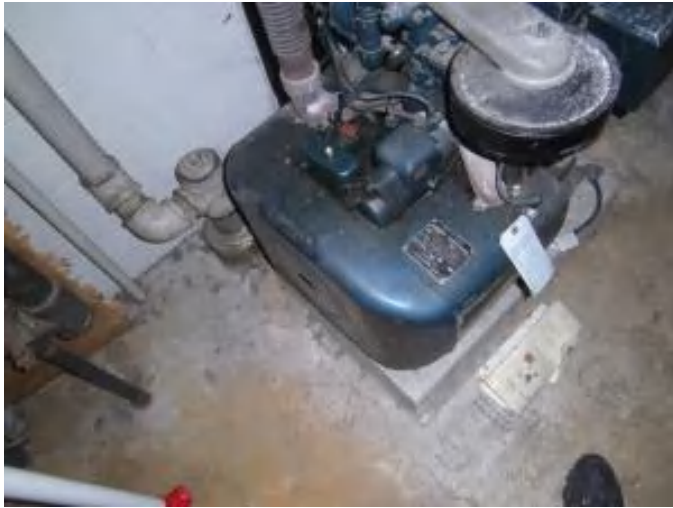
**System: D5090 - Other Electrical Systems**

**Location:** Electrical Room

**Distress:** Beyond Service Life

**Correction:** Replace standby generator system

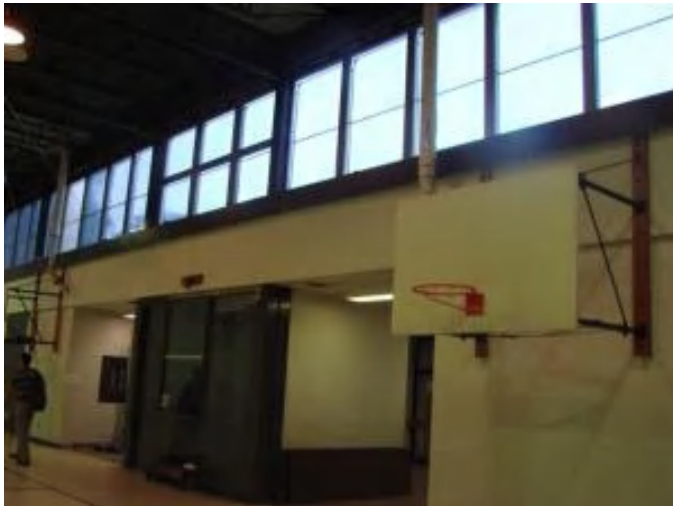
**System: B2020 - Exterior Windows**

**Location:** Exterior

**Distress:** Beyond Service Life

**Correction:** Remove and replace aluminum windows - pick the appropriate size and style and insert the number of units

**Notes:** Replace existing windows with energy efficient windows and integral security screens

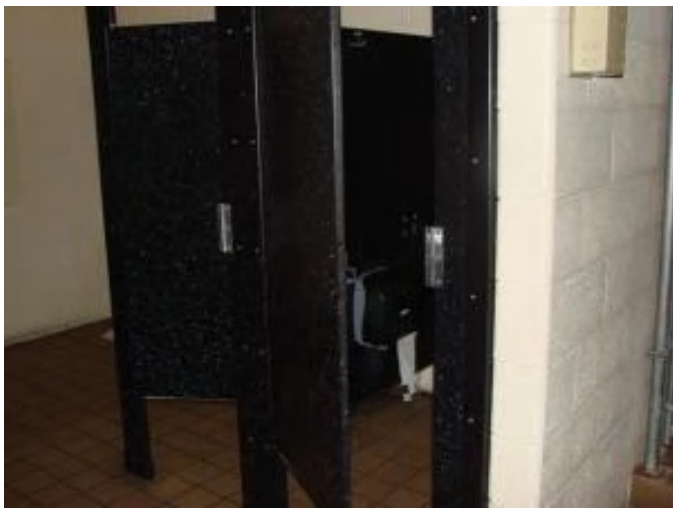
**System: C1030 - Fittings**

**Location:** Interiors

**Distress:** Accessibility

**Correction:** Remove and replace toilet partitions

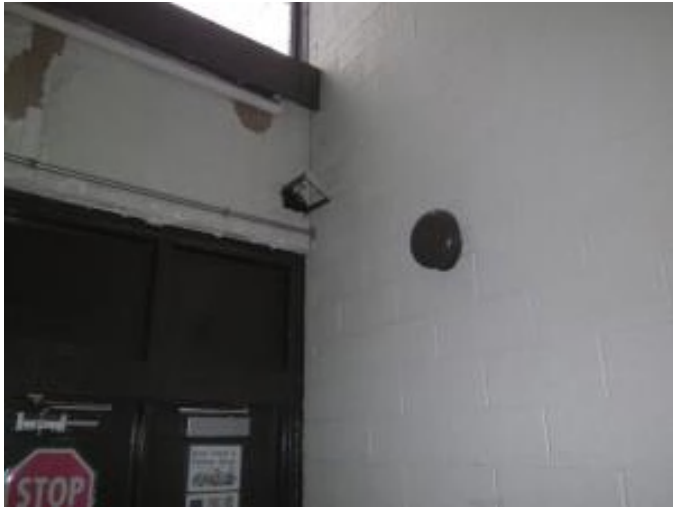
**System: D5030 - Communications and Security**

**Location:** Throughout Building

**Distress:** Security Issue

**Correction:** Add/Replace Security System

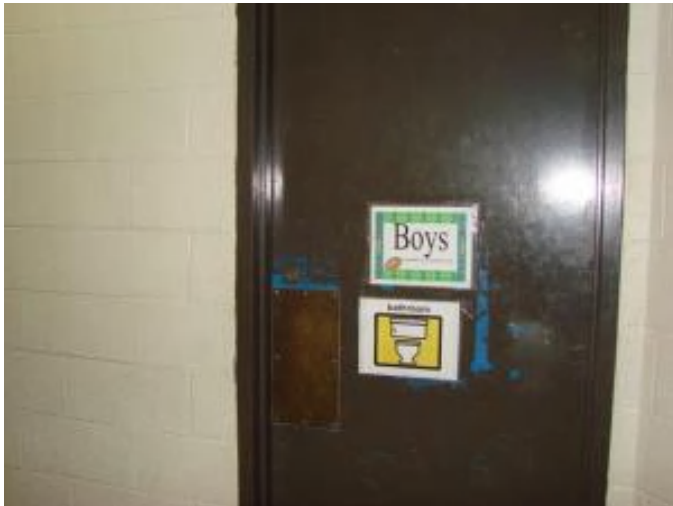
**System: C1030 - Fittings**

**Location:** Interiors

**Distress:** Inadequate

**Correction:** Replace missing or damaged signage - insert the number of rooms

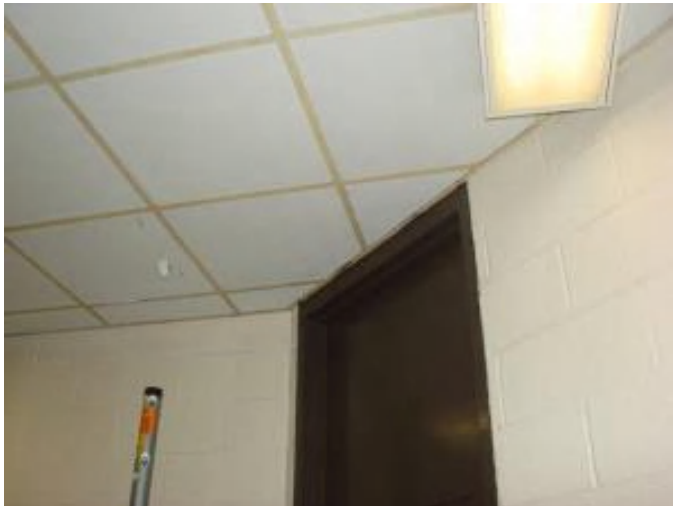
**System: C3030 - Ceiling Finishes**

**Location:** Interiors

**Distress:** Beyond Service Life

**Correction:** Remove and replace suspended acoustic ceilings - lighting not included

**Notes:** Replace aged suspended acoustical ceiling

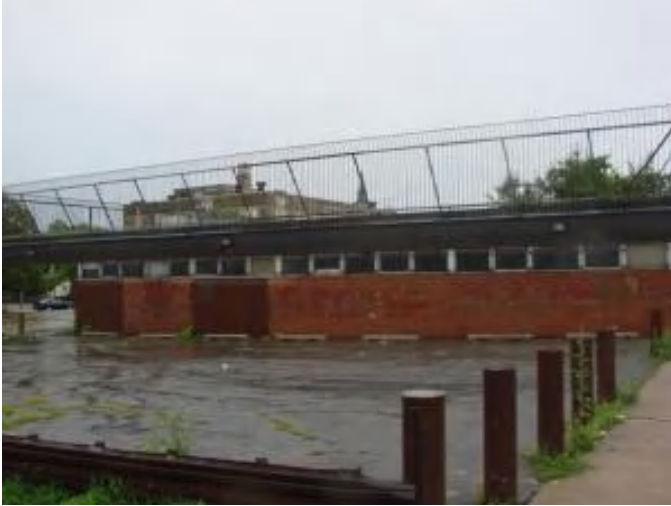
#### System: G2020 - Parking Lots

**Location:** Grounds/ Site

**Distress:** Damaged

**Correction:** Remove and replace AC paving parking lot

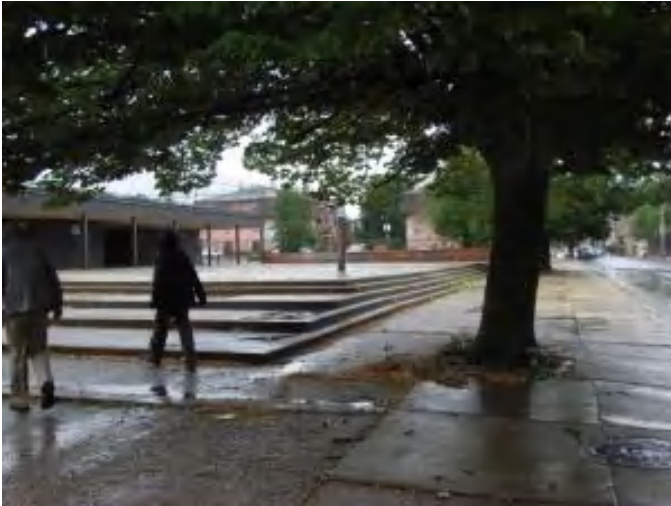
**System: G2030 - Pedestrian Paving**

**Location:** Grounds/ Site

**Distress:** Beyond Service Life

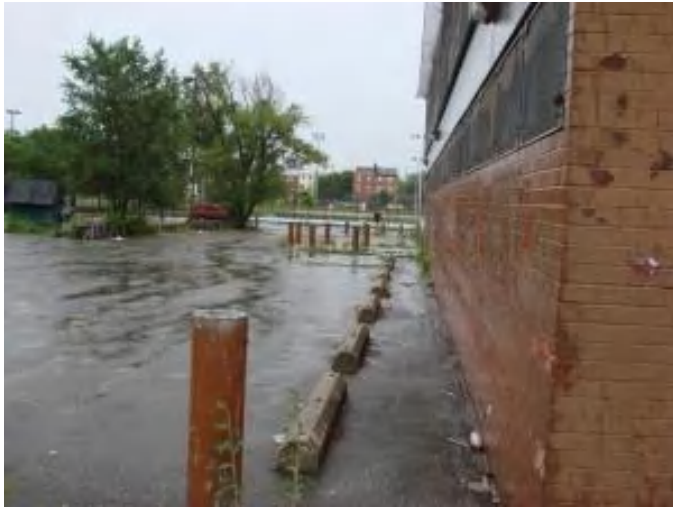
**System: G4020 - Site Lighting**

**Location:** North Side of Building

**Distress:** Beyond Service Life
