## Facility Condition Assessment Summary Report

### MLK High School

School District of Philadelphia  
**S606001; King HS and Field**  
Final  
**Site Assessment Report**  
February 1, 2017

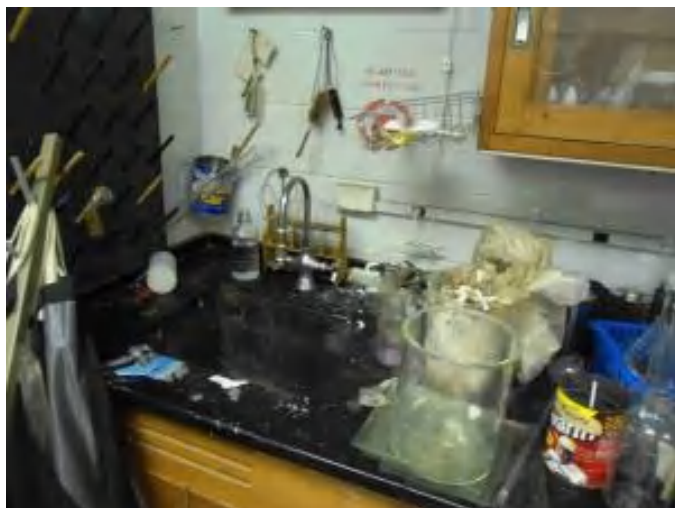
**System: C1010 - Partitions**

**Location:** Science Labs

**Distress:** Damaged

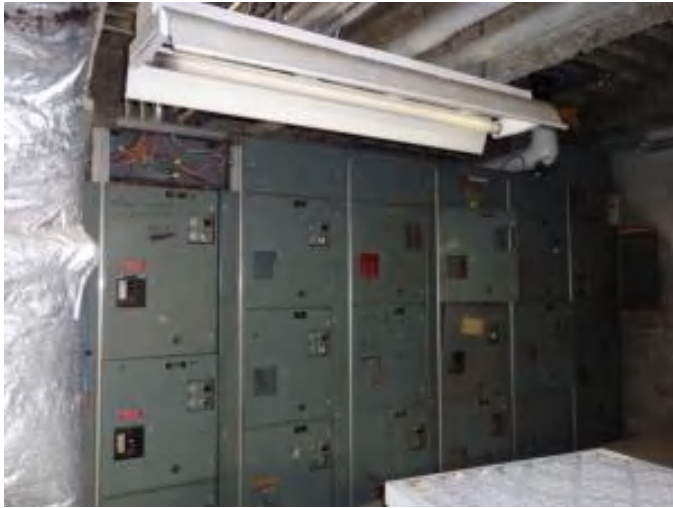
**System: D5020 - Lighting and Branch Wiring**

**Location:** Boiler, Mechanical and Electrical Rooms

**Distress:** Beyond Service Life

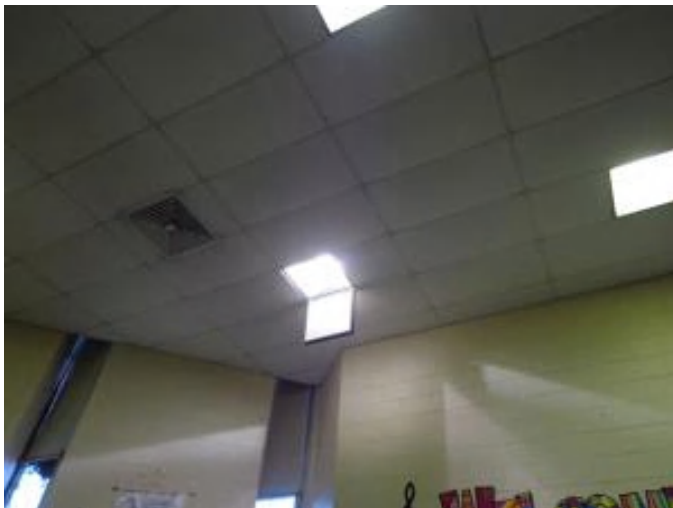
**System: D5020 - Lighting and Branch Wiring**

**Location:** Choral Hall, Music Hall, Music Instrument

**Distress:** Beyond Service Life

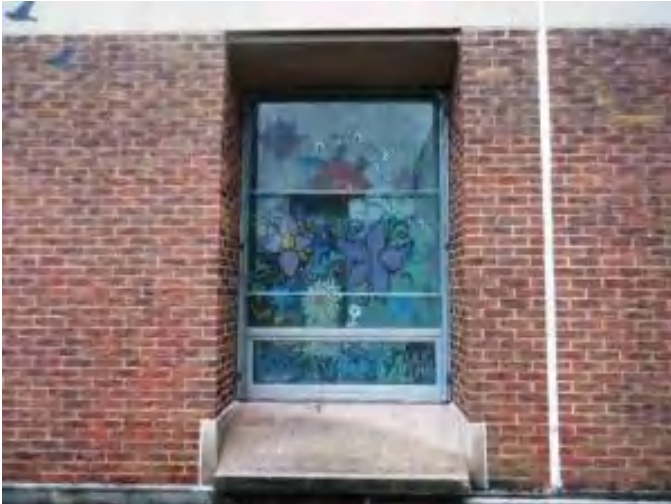
**System: B2020 - Exterior Windows**

Exterior window systems are a mix of single pane industrial grade metal, hopper and fixed aluminum framed single pane. Windows are in fair to poor condition based on the year of installation. The single pane metal-framed windows have been repaired, or have had single replacements because of damage or abuse. As indicated in the photos several of the windows are boarded up and no longer function as designed. The window systems have exceeded their useful service life. The exterior window system is recommended to be replaced with units that retain their dimensions and profiles, but that incorporate updated energy-efficient features.

**Location:** Exterior Elevation

**Distress:** Damaged

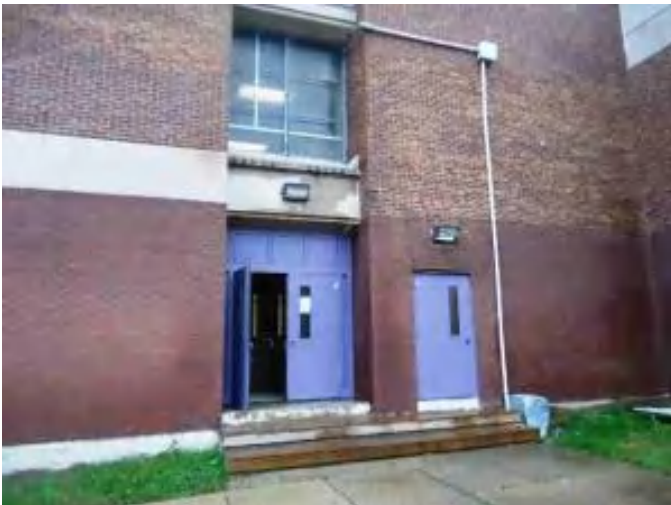
**System: B2030 - Exterior Doors**

The exterior doors are metal applications with metal frames. The exterior door system for this school is a very high traffic system. The doors are in fair condition but are aging at a faster rate than expected based on traffic and condition. The exterior door system, store front and service doors are recommended for upgrade.

**Location:** Exterior Elevation

**Distress:** Damaged

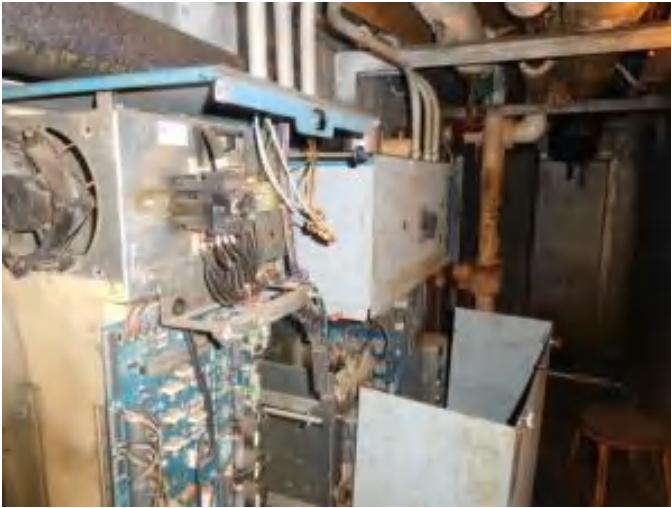
**System: D3040 - Distribution Systems**

**Location:** roof

**Distress:** Building / MEP Codes

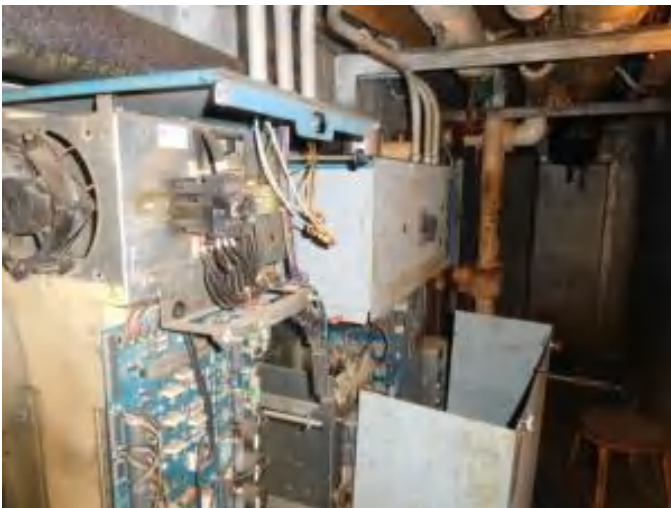
**System: D3040 - Distribution Systems**

**Location:** roof

**Distress:** Building / MEP Codes

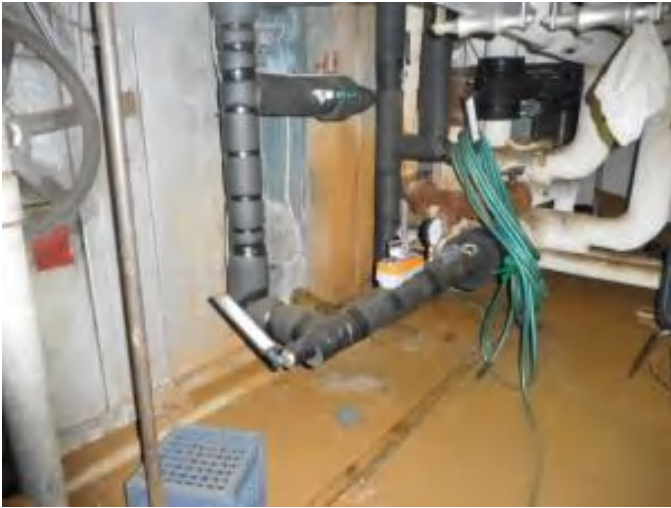
**System: D3040 - Distribution Systems**

**Location:** office area

**Distress:** Building / MEP Codes

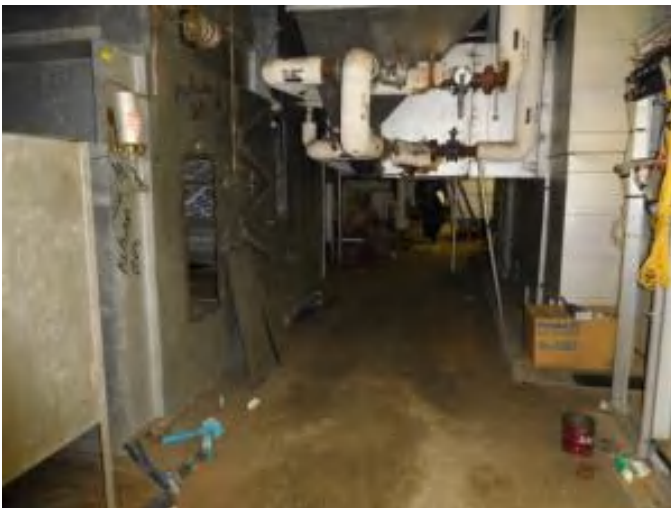
**System: D3040 - Distribution Systems**

**Location:** auditorium

**Distress:** Building / MEP Codes

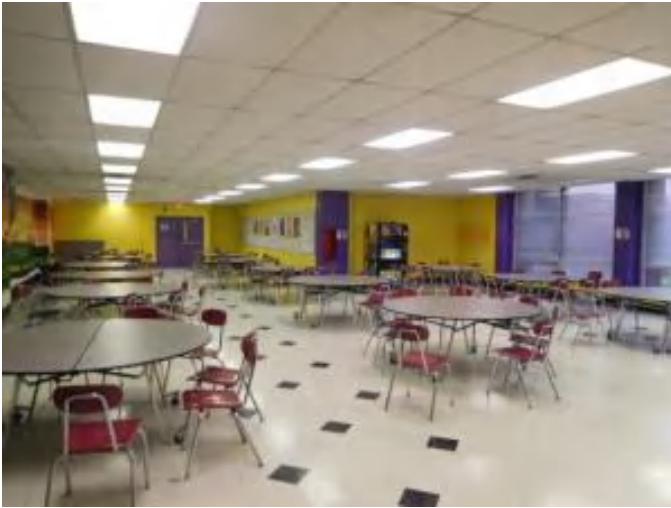
**System: D4010 - Sprinklers**

**Location:** entire building  
**Distress:** Life Safety / NFPA / PFD  
**Category:** 1 - Health & Safety  
**Priority:** 4 - Response Time (4-5 yrs)  
**Correction:** Install a fire protection sprinkler system  
**Qty:** 350,000.00  
**Unit of Measure:** S.F.  
**Estimate:** \$5,006,904.81  
**Assessor Name:** System  
**Date Created:** 01/22/2016

**Notes:** Install complete NFPA wet pipe automatic sprinkler system and standpipes in unprotected area of building. If required upgrade fire pump and jockey pump.

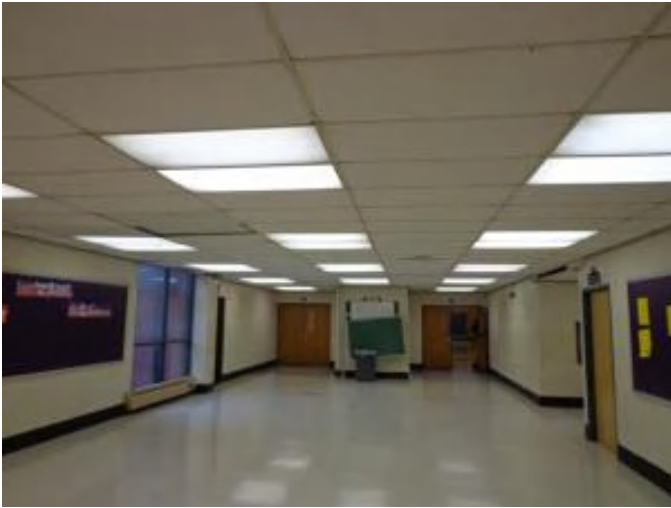
**System: D5020 - Lighting and Branch Wiring**

**Location:** Building wide

**Distress:** Beyond Service Life

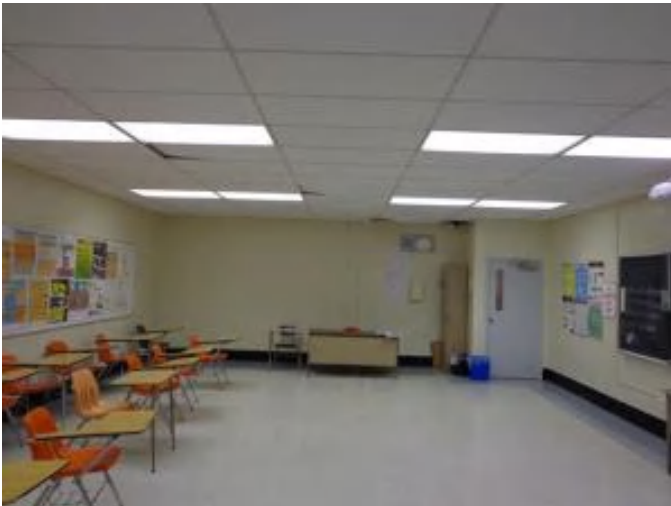
**System: D5020 - Lighting and Branch Wiring**

**Location:** Classrooms

**Distress:** Inadequate

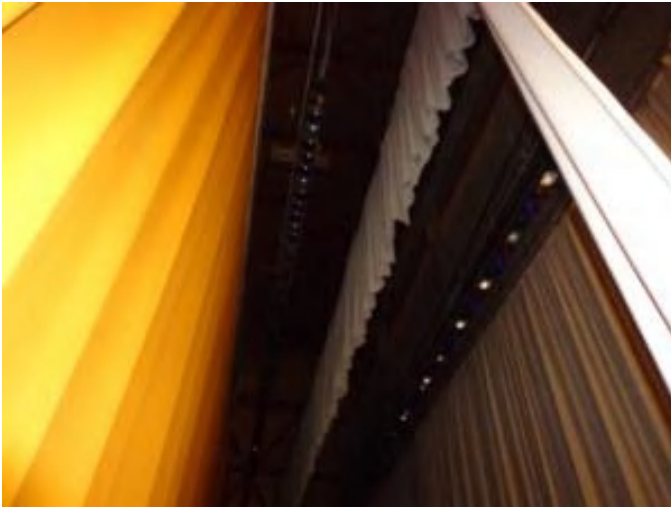
**System: D5020 - Lighting and Branch Wiring**

**Location:** Stage

**Distress:** Beyond Service Life

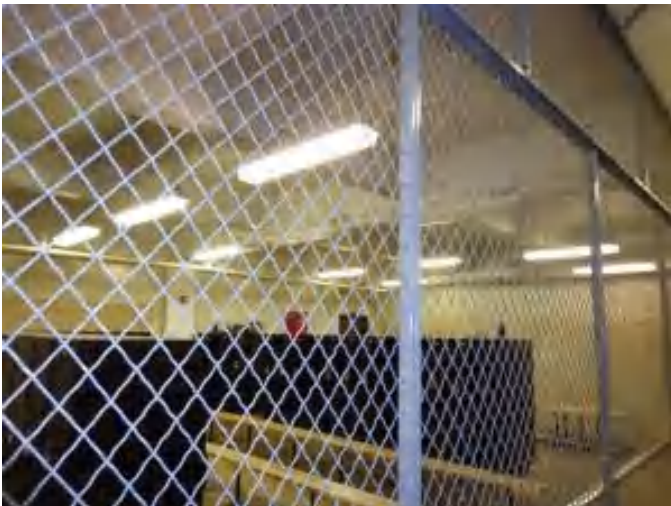
**System: D5020 - Lighting and Branch Wiring**

**Location:** Gym Locker Rooms

**Distress:** Beyond Service Life

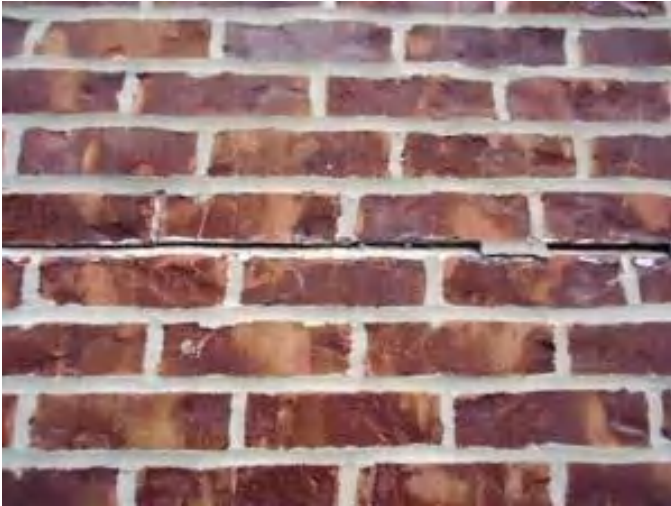
**System: B2010 - Exterior Walls**

The exterior brick surfaces are generally in fair to good condition for their age. In some locations, bricks have cracked or spalled and should be replaced. The repointing of deteriorated mortar joints is also recommended, using mortar of a similar color and consistency as the original. Following the detailed examination of the brick and repair of mortar construction joints, the entire building should be pressure washed to remove stains and embedded pollutants. If moisture is found to be penetrating the masonry facade, the application of a spray sealant to the suspected exterior masonry surface is recommended.

**Location:** Exterior Elevation

**Distress:** Damaged

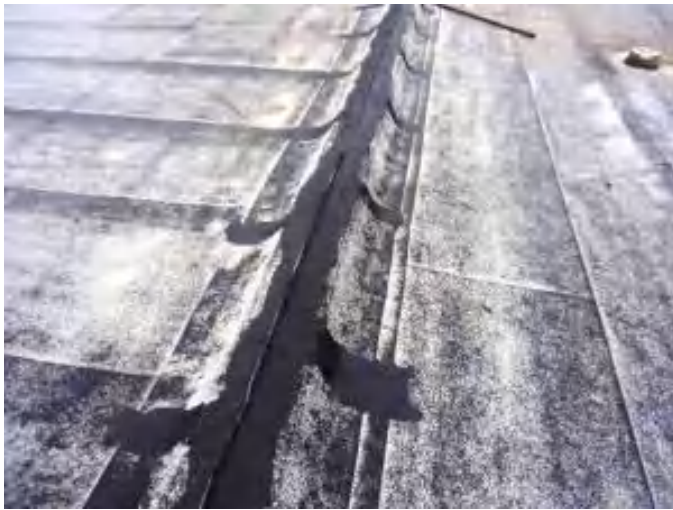
**System: B3010105 - Built-Up**

The existing built up roofing system has clear signs of ponding and there reportedly has been an increase of roofing maintenance on this single ply roofing system. Reported leaks were verified in room 206 and room 342 as well as obvious stains in ceiling tiles near the edges of the exterior walls of several classrooms. This roof is expected to required replacement within the next ten years as the repairs and maintenance outweighs the effort and requires upgrade. It is recommended that a new built-up roofing system be installed within the next ten years.

**Location:** Roof

**Distress:** Damaged

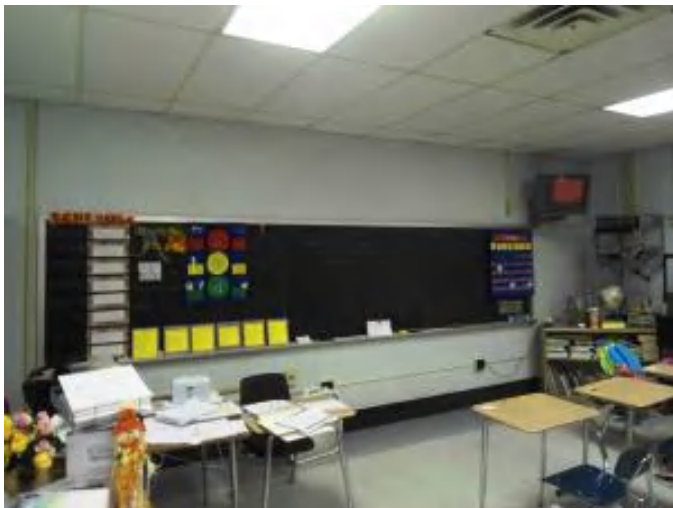
**System: C1030 - Fittings**

The classroom chalk boards are original to the buildings construction. This system is damaged and beyond its expected life, universal upgrades are warranted. Remove and upgrade chalk boards to new marker board systems.

**Location:** Classroom

**Distress:** Damaged

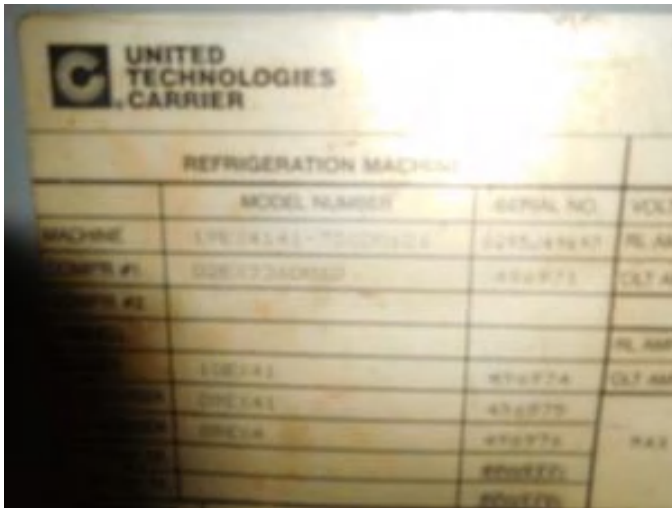
**System: D3030 - Cooling Generating Systems**

The building had a water cooled chilled water system installed in 1970 with an Evapco cooling tower on the roof and a Carrier centrifugal chiller in the mechanical room. The cooling tower is a galvanized steel three cell blow through type and has probably been replaced since the 1970 installation. This system was abandoned and a temporary rental chiller was reportedly in place during 2014 but was removed before this inspection. A project to replace the entire system is apparently out for bid but was not under construction during this inspection. There are several abandoned double suction pumps for this system including three chilled water, two condenser water and two dual temperature water. Most of these pumps have been disassembled and disconnected.

**Location:** roof, mechanical room

**Distress:** Inadequate

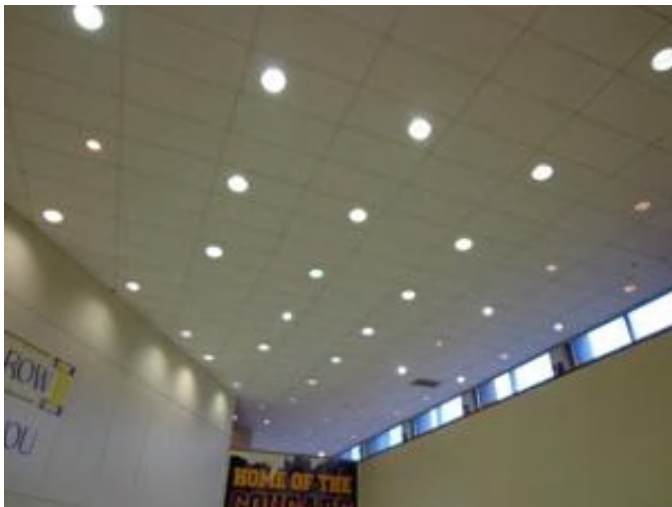
**System: D5020 - Lighting and Branch Wiring**

**Location:** Lobby

**Distress:** Appearance

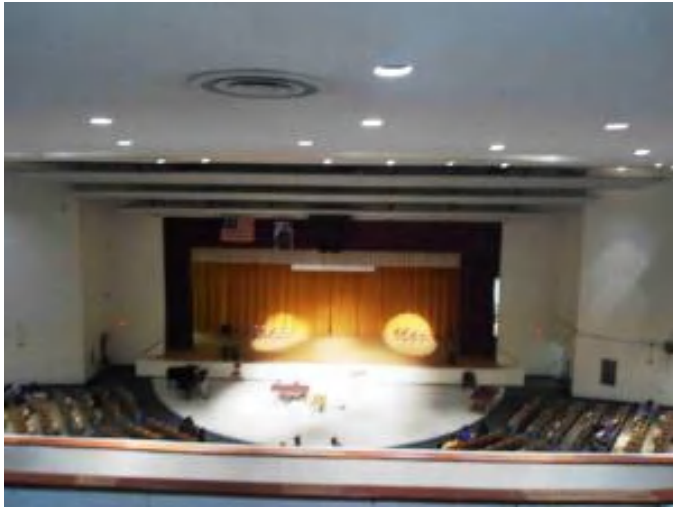
**System: E2010 - Fixed Furnishings**

Furnishings include: fixed casework and fixed auditorium seating. The fixed seating for this school is from the original construction. The systems are in fair condition considering the age and usage. This project provides a budgetary consideration for universal upgrades for the fixed seating and furnishing of this school. Ensure that ADA requirements are followed with the new seating layout.

**Location:** Auditorium

**Distress:** Damaged

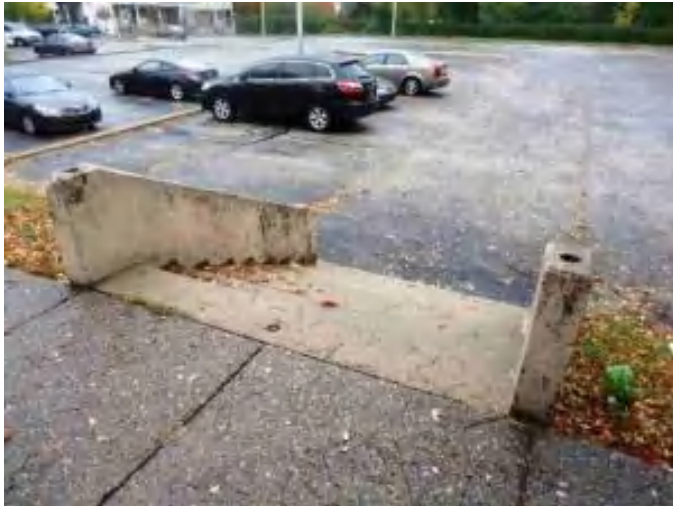
#### System: G2040 - Site Development

**Location:** Site

**Distress:** Damaged

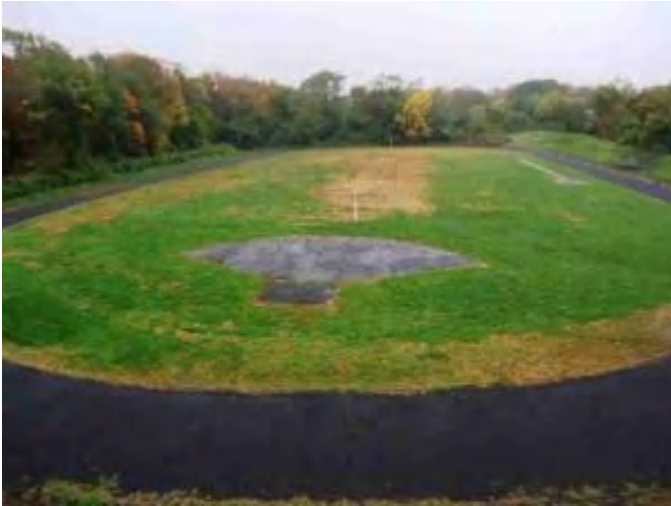
**System: G2040 - Site Development**

**Location:** Football Field

**Distress:** Damaged

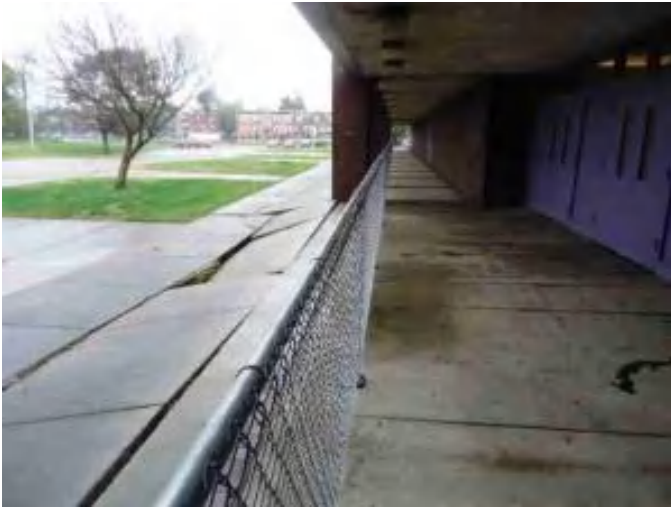
**System: G2040 - Site Development**

**Location:** Northwestern Exterior Elevation

**Distress:** Life Safety / NFPA / PFD

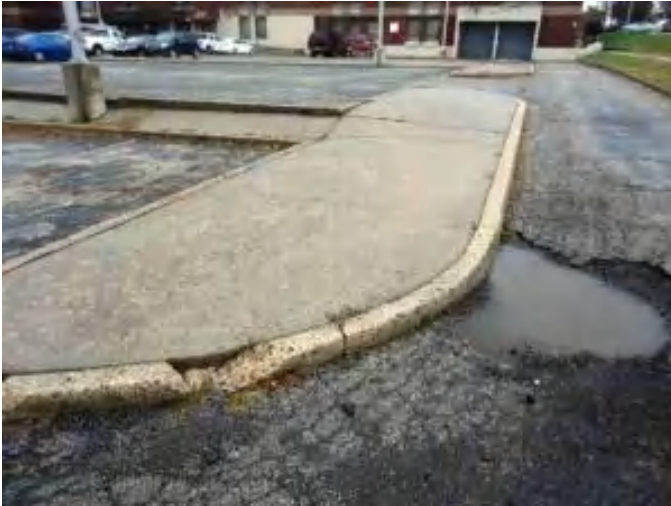
**System: G2020 - Parking Lots**

**Location:** Site

**Distress:** Damaged

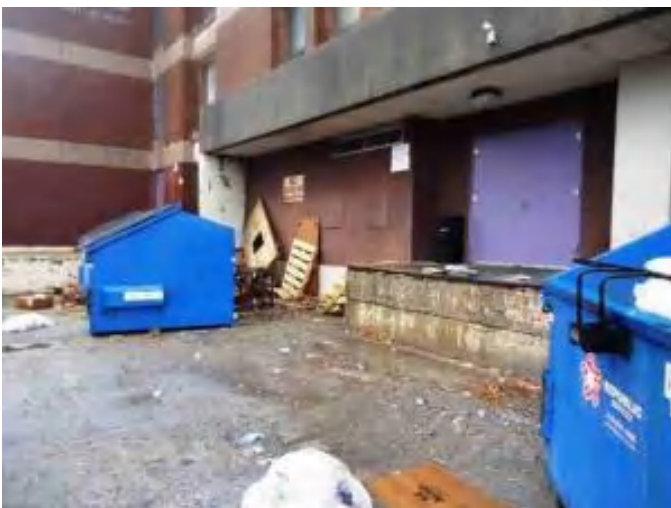
**System: G2040 - Site Development**

**Location:** Site

**Distress:** Damaged

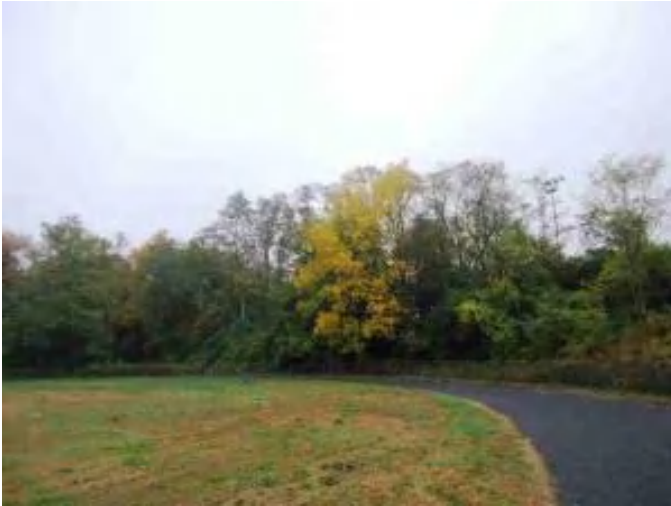
**Location:** Track

**System: G2040 - Site Development**

**Distress:** Damaged

**Notes:** The existing Track and Field is from the schools original construction. The field has several holes and the long jump, shot-put and other activity centers are in poor condition. This area presents a safety issue as well as a maintenance issue. This field is recommended to be upgraded. This deficiency is expected to be completed as part of a site effort to upgrade the Football field and the bleachers.

**Correction:** Refurbish running track - replace AC paving with asphalt latex rubber system

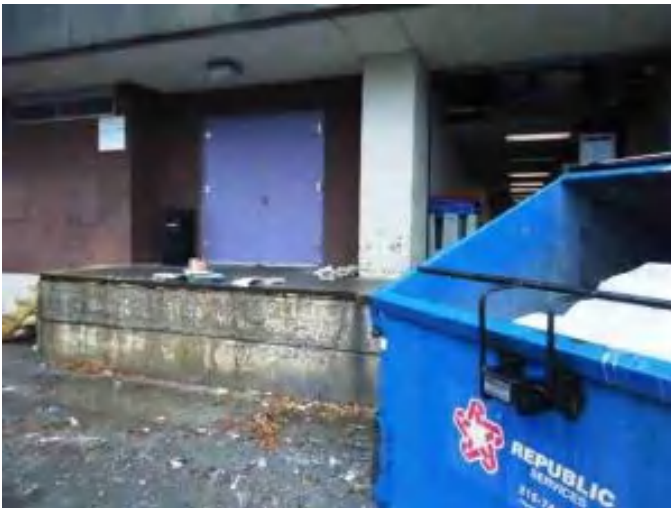
**Location:** Site

**System: G2040 - Site Development**

**Distress:** Damaged

**Notes:** The loading dock is from original construction and in poor condition. The loading dock system is recommended for upgrade to include new concrete work and railing replacement. This deficiency is expected to be completed as part of an effort to upgrade this area and should be coordinated with other loading dock projects.

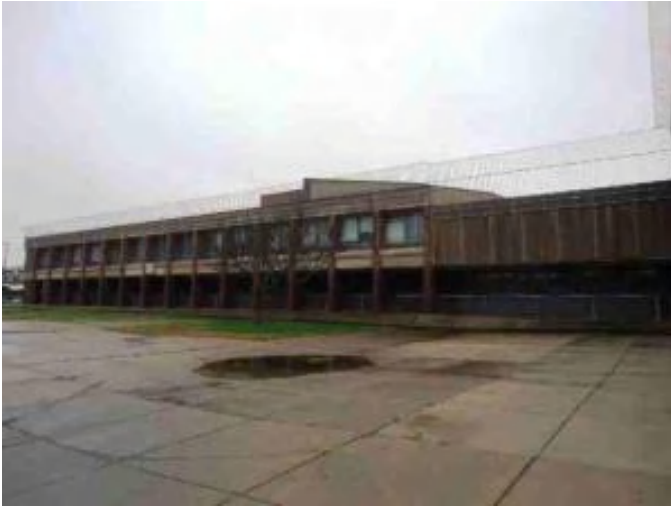
**Location:** Site

**System: G2030 - Pedestrian Paving**

**Distress:** Damaged

**Notes:** The sidewalk system is original to the buildings construction. There are a several areas of cracking concrete but no tripping hazards. The sidewalk system is expected to expire in the near future. Removal of the entire system is recommended. Universal upgrades are required and should include all aspects of current ADA legislation.

**Correction:** Remove and replace concrete sidewalk or concrete paving - 4" concrete thickness

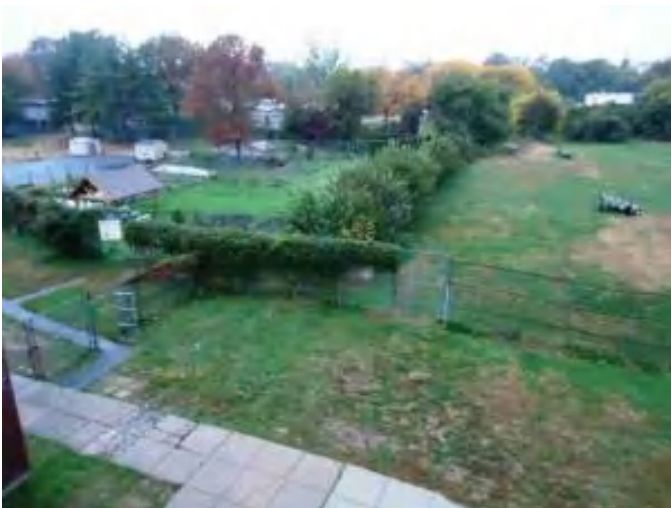
**Location:** Site

**System: G2040 - Site Development**

**Distress:** Damaged

**Notes:** This school has a perimeter fence surrounding the parking / playground area. The fence has several areas of repairs and the mounting post are damaged in several areas, overall the fence is in fair condition. This fence system is recommended to be removed and replaced with a new system within the next five to ten years.

**Correction:** Replace chain link fence - 6' high

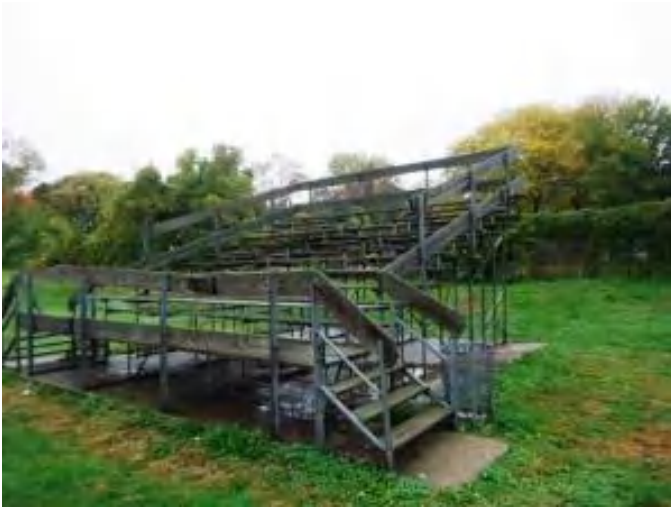
**Location:** Football Field

**System: G2040 - Site Development**

**Distress:** Damaged

**Notes:** As indicated in the photos the original bleacher system is the only system providing public seating to events at the Football and Track and Field area. This system has a metal and wooden frame with wooden seats. This system was reported to have been repaired several times in its service to the school. This system is in very poor condition and replacement is recommended. The new system is expected to have a concrete sidewalk access area and also include all aspects of the current ADA legislation.

**Correction:** Remove and replace small bleacher structures - pick the appropriate bleacher and insert the number of seats in both the qty and the estimate qty
