Facility Condition Assessment Summary Report

McDaniel School

McDaniel Annex (St Edmond) School

January 30, 2017

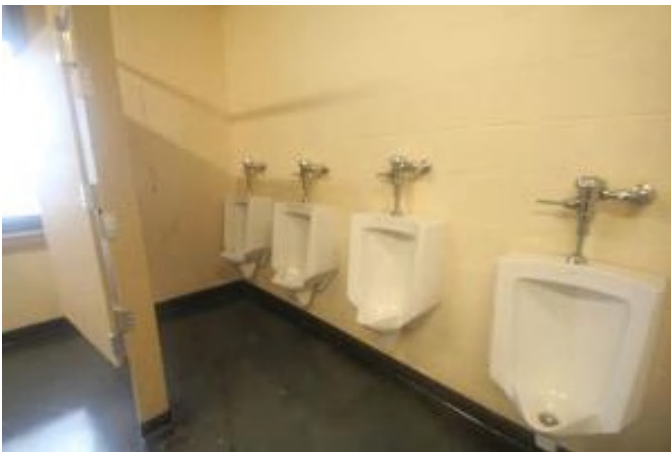
Location: Toilet Rooms

Distress: Maintenance Required

Notes: Replace 50% of flush valves due to leaks.

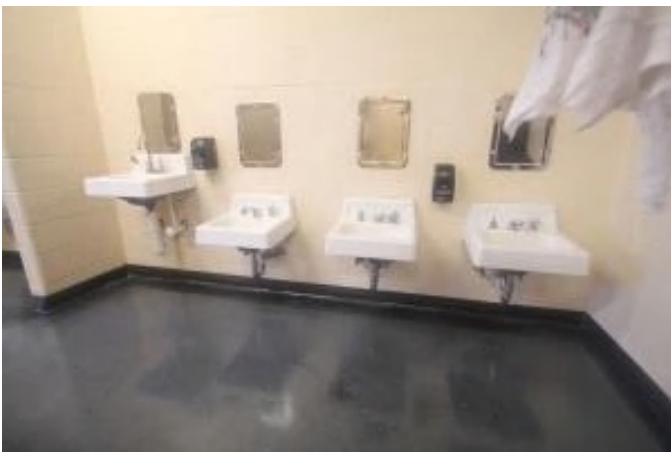
Location: Toilet rooms

Distress: Maintenance Required

Notes: Repair bathroom faucet valves.

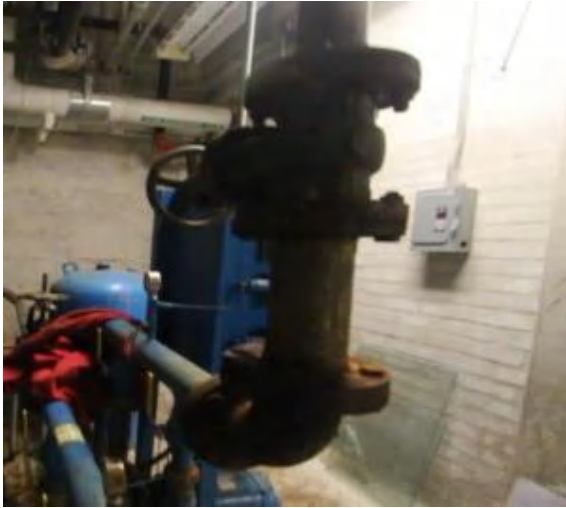
A 4" city water service enters the building along Moore Street. The 4" meter and valves are located in a small utility room on the basement level behind the boiler room. Upon entering the building, the domestic water piping first T's to two 4" gate valves. One gate valve isolates the compound water meter and the other gate valve is on the water meter bypass line. After the meter there is a third 4" gate valve, and then the water meter line and bypass line join together at a second T. These three valves are iron body gate valves with steel trim and are severely rusted

due to galvanic corrosion. The valve upstream of the water meter is so badly rusted that it was dripping water at the time of the assessment. This valve needs replacement immediately, and the others should be replaced as well before their condition deteriorates further. The single 4" domestic water line then T's to a primary 4" double backflow preventer and 2" bypass backflow preventer. Both of these have block valves and Y-strainers up stream and block valves down steam of them. The two lines then T together again and connect to a 3" copper line and 3" iron gate valve feeding the pressure booster pump system. The connection to the boiler make-up water system is located here between the back flow preventers and the domestic booster pumps. The 3" iron body gate valve upstream of the booster system is rusted so badly that it also was leaking and needs immediate replacement. The booster system includes two horizontal end suction pressure booster pumps and a pneumatic expansion tank. One pump was running at the time of inspection. Other fittings in this room, such as a flanged flexible connector down steam of the booster system, are also severely rusted and need replacement presently. A reduced pressure backflow preventer is installed on the makeup line to the boilers. The original domestic hot and cold water distribution piping was replaced in 2008 with copper piping and soldered fittings. The domestic water distribution piping should be serviceable for the next 20 years or more.

Location: Basement
Distress: Failing
Category: 3 - Operations / Maint.
Priority: 1 - Response Time (< 2 yr)
Correction: Replace valves
Qty: 4.00
Unit of Measure: Ea.
Estimate: \$11,059.60
Assessor Name: Craig Anding
Date Created: 08/10/2015

Notes: Replace severely rusted gate valve and other fittings on building water entry.

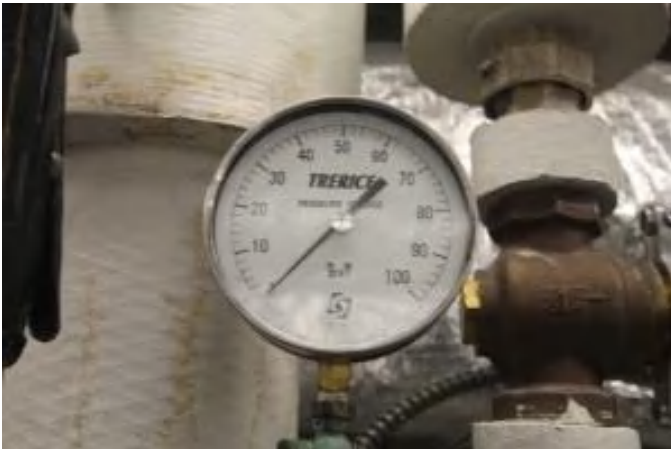
The building controls were updated in 2008 to digital and will not need replacement for 10-15 years. Multiple thermometers and pressure gauges on the mechanical systems are broken and need replacement.

Location: Boiler room, AHUs
Distress: Damaged
Category: 3 - Operations / Maint.
Priority: 1 - Response Time (< 2 yr)
Correction: Replace temperature, pressure gauges (enter estimate)
Qty: 20.00
Unit of Measure: Ea.
Estimate: \$2,820.32
Assessor Name: Craig Anding
Date Created: 08/10/2015

Notes: Replace broken temperature and pressure instrumentation.

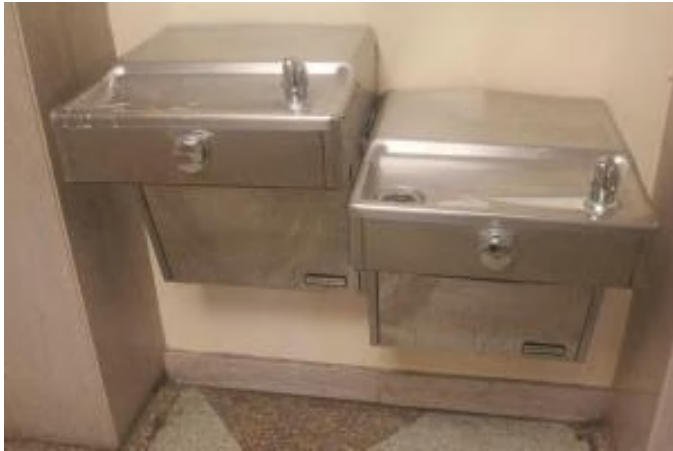
Location: Corridors

Drinking fountains are wall mounted in pairs in hallway alcoves. They are accessible wall hung with integral refrigerated coolers. They were installed in 2008 and are well within their service life but many of them do not run due to lack of maintenance. For example, one pair does not flow, has clogged drains, and is infested with fruit flies. Fountains should be repaired within one year.

Distress: Maintenance Required

Notes: Replace or repair inoperable wall hung drinking fountains with clogged drains.

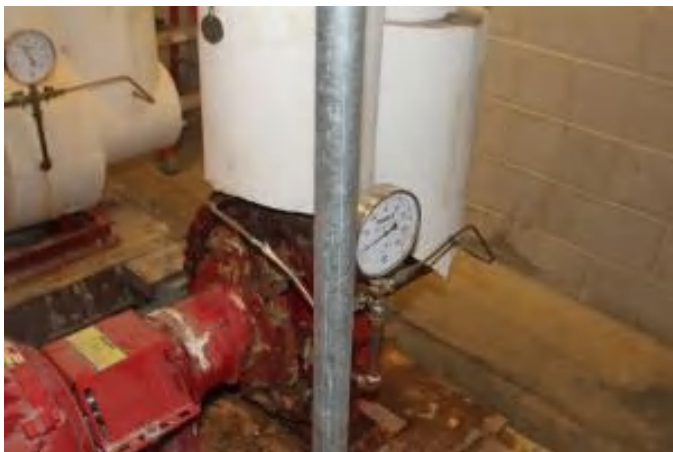
Location: Basement

Two rooftop air-cooled, screw compressor, 177 and 98 ton cooling capacity, standard efficiency, R-134a chillers supply chilled water to air handlers and unit ventilators throughout the building. There are 4 chilled water pumps. The entire chilled water system was installed in 2008. The chillers should not need replacement in 10 years. The chilled water pumps leak and need to be rebuilt. The location and cause of leaks was not determined during the inspection because the leaking pumps were not running at the time.

Distress: Maintenance Required

Notes: Rebuild three leaking chilled water circulation pumps.

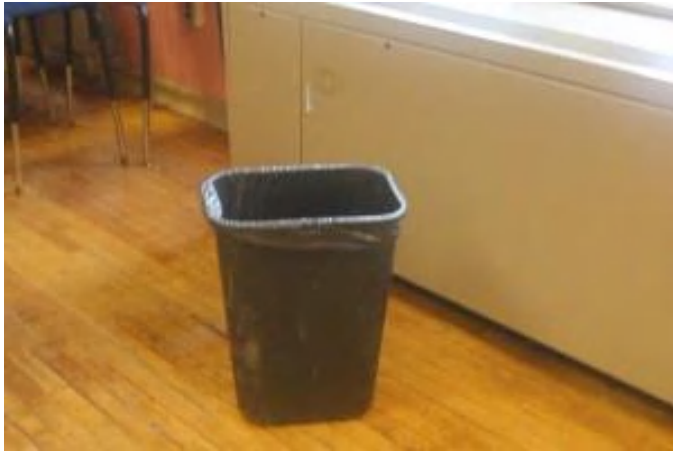
Location: Classrooms

Unit ventilators provide heating, cooling, and ventilation for the majority of the classrooms. The unit ventilators were installed in 2008 and are equipped with mixing dampers and hydronic heating and cooling coils. The outdoor air intake for these units is through original openings in the building façade. The unit ventilators are well within their anticipated service life and should not need replacement for 10-15 years. Some units have developed leaks causing damage to floors and ceilings. One unit was leaking at the time of the inspection as dripping was present in the classroom below it and the area smelled like antifreeze. Another unit had a fan rattling during the inspection. These units should all be inspected for problems and cleaned of dust and rubbish.

Distress: Failing

Notes: Replace (or repair) leaking unit ventilators.

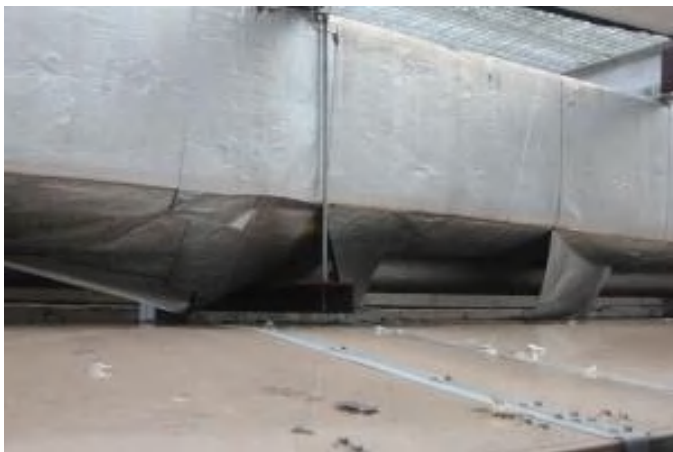
Location: Roof top, window well, fan rooms.

A rooftop air handler serves hallways on the upper floors and a second outdoor air handler in the window well alongside the lunch room serves the basement level. Insulation is falling off the ground level unit. Three air handlers inside the building serve the auditorium and other spaces. Their duct work has insulation falling off and is perforated in multiple areas. The basement fan room where they are located is infested with fruit flies. The air handlers were installed in 2008. With insulation repairs and routine preventive maintenance they should last 20 more years.

Distress: Maintenance Required

Notes: Repair insulation and perform preventive maintenance on five air handlers and associated ducts.

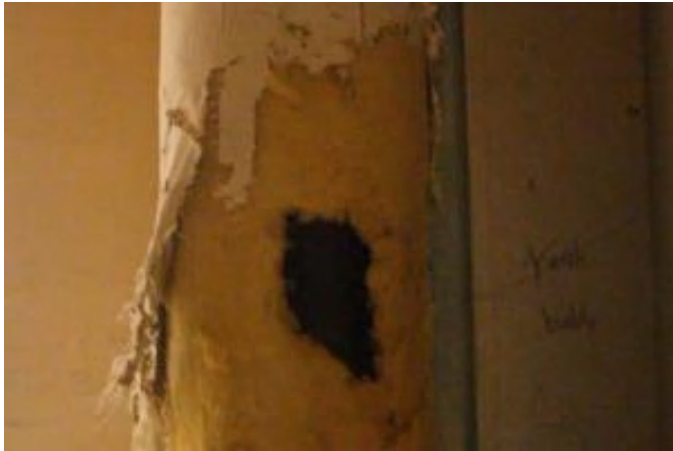
Hydronic heated and chilled water piping is threaded steel pipe installed in 2008. The pipe is in good condition and should not need replacement for 25 years, but pipe insulation is damaged in many areas exposing piping to ambient air leading to condensation. The hydronic piping insulation

Location: Entire building
Distress: Damaged
Category: 3 - Operations / Maint.
Priority: 2 - Response Time (2-3 yrs)
Correction: Replace hydronic distribution piping insulation - 100 LF of piping
Qty: 500.00
Unit of Measure: L.F.
Estimate: \$17,457.06
Assessor Name: Craig Anding
Date Created: 08/10/2015

Notes: Repair hydronic piping insulation.

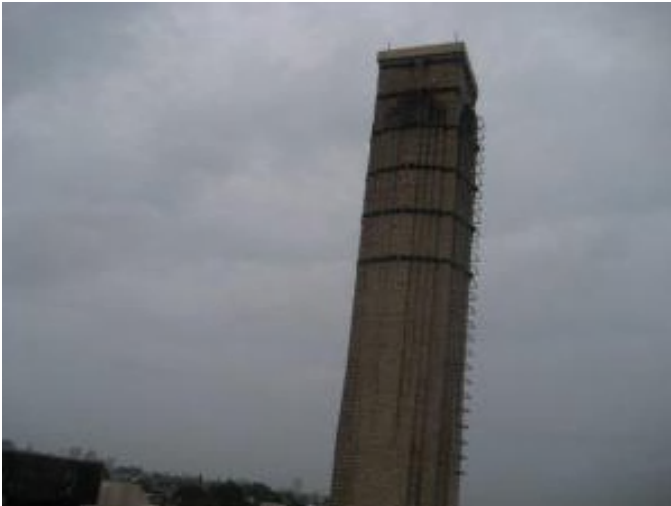
Location: Roof

Distress: Building / MEP Codes

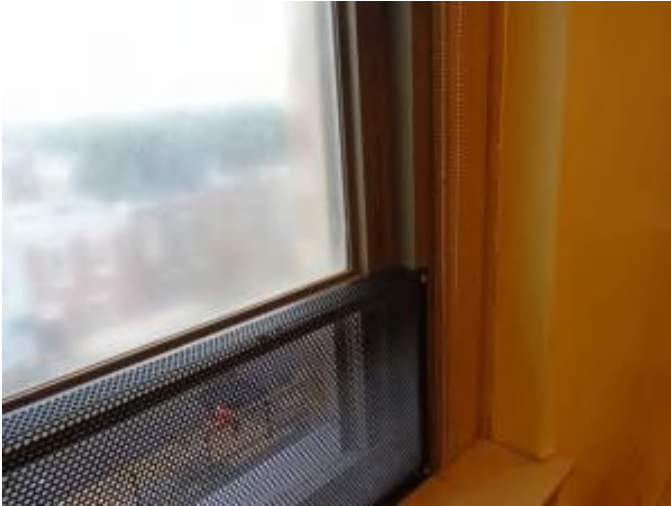
Location: Throughout

Distress: Beyond Service Life

Notes: Replace hazed Plexiglas windows

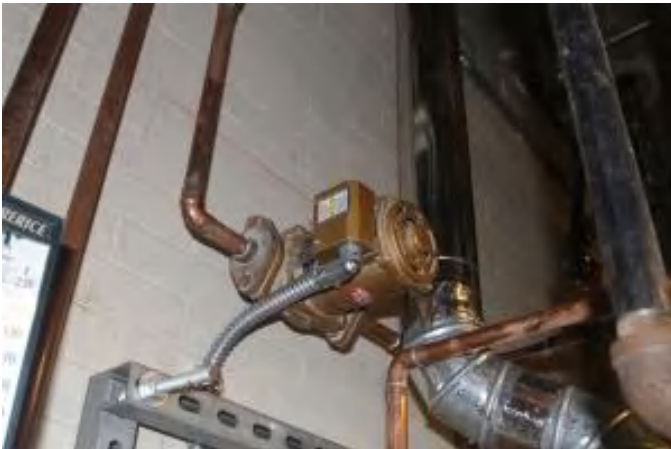
Location: Basement
Distress: Inadequate
Category: 4 - Capital Improvement
Priority: 4 - Response Time (4-5 yrs)
Correction: Provide expansion tank for water heater.
Qty: 1.00
Unit of Measure: Ea.
Estimate: \$9,560.11
Assessor Name: Craig Anding
Date Created: 09/21/2015

Notes: Add expansion tank to hot water plumbing.

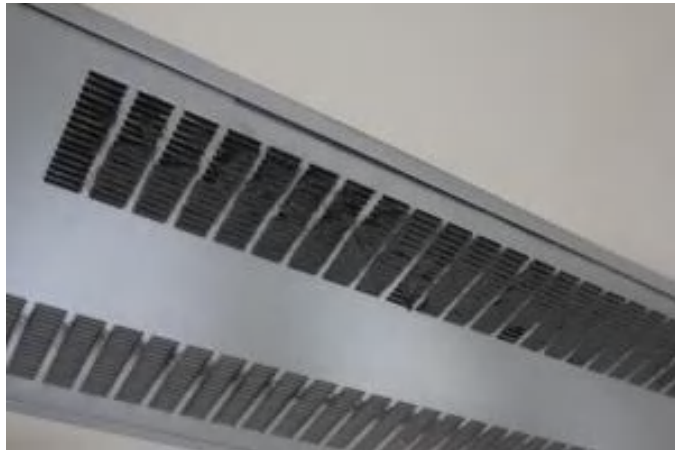
Location: Network room, entry vestibule, etc.

Four rooftop, ductless, split system, 2 ton capacity heat pumps provide heating and cooling to network closets and other small rooms in the building. The indoor unit in the basement electronic equipment room was inoperable and the room was very warm. Ceiling mounted units in the main building entrance vestibule had extremely dusty grills. All these units should be cleaned, inspected, and repaired as needed.

Distress: Maintenance Required

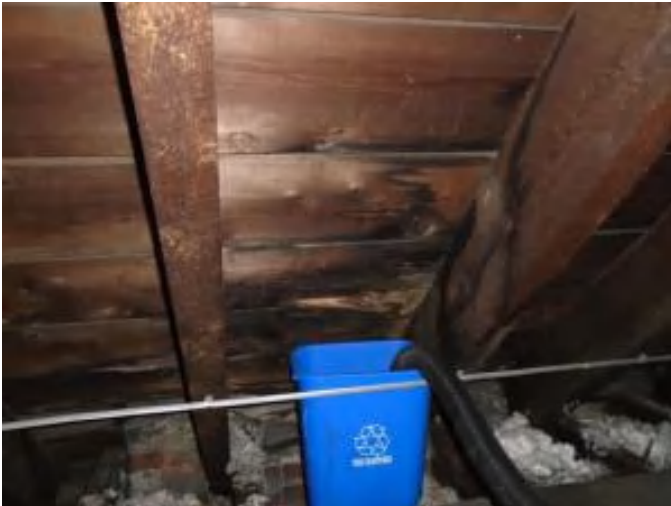
Location: Roof

System: B3010140 - Shingle & Tile

Distress: Maintenance Required

Notes: Repair and seal roofing around roof scuppers – leaking into attic

Correction: Remove and replace step flashing for shingle roofs

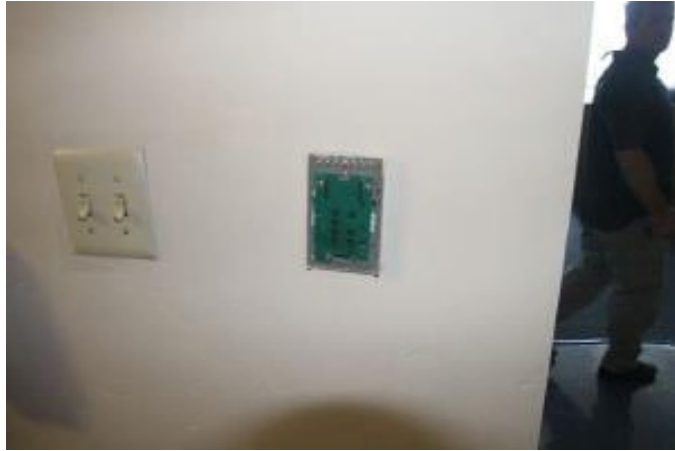
Location: Classrooms

System: D3060 - Controls & Instrumentation

Distress: Damaged

Notes: Replace broken thermostats

Correction: Replace temperature, pressure gauges (enter estimate)

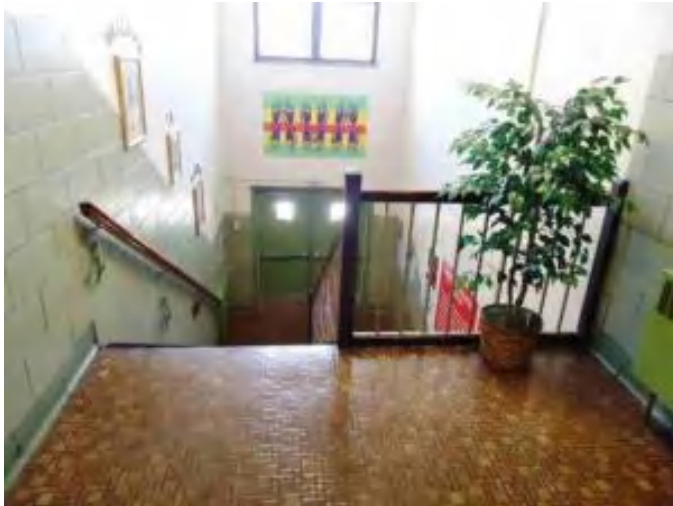
Location: Stairs

System: C1010 - Partitions

Distress: Life Safety / NFPA / PFD

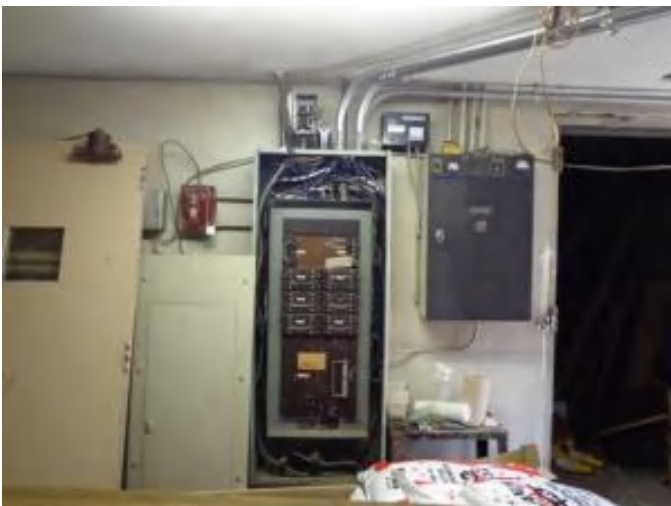
Location: Main Electrical Room, Boiler Room, Gym platform

System: D5010 - Electrical Service/Distribution

Distress: Beyond Service Life

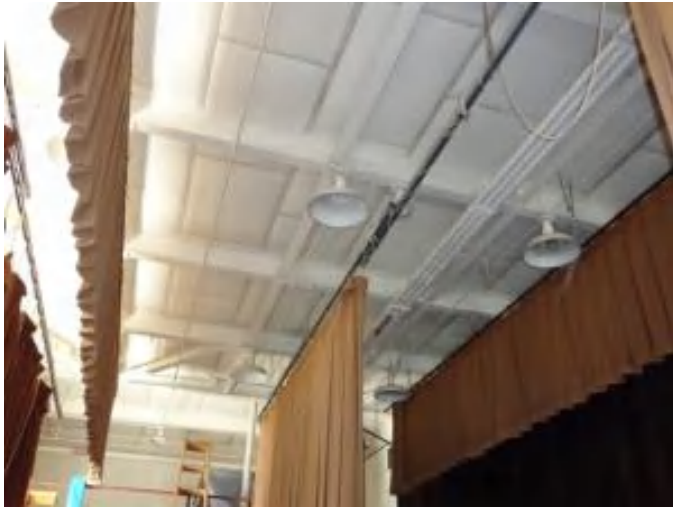
Location: Gym platform, Boiler Room

System: D5020 - Lighting and Branch Wiring

Distress: Energy Efficiency

Notes: Replace incandescent lighting fixtures on the gymnasium platform and in the Boiler Room with 4 foot industrial fluorescent fixtures.

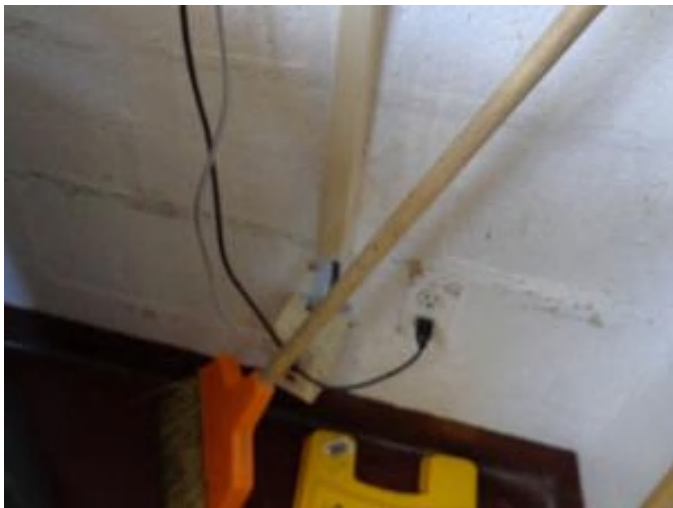
Location: Gym kitchen

System: D5020 - Lighting and Branch Wiring

Distress: Life Safety / NFPA / PFD

Notes: Replace fire alarm system with an addressable type system.

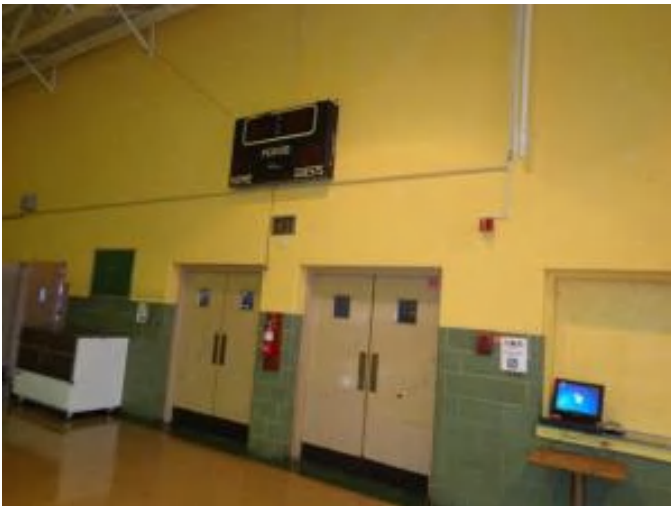
System: D5090 - Other Electrical Systems

Location: Building wide
Distress: Life Safety / NFPA / PFD
Category: 1 - Health & Safety
Priority: 3 - Response Time (3-4 yrs)
Correction: Add Emergency/Exit Lighting
Qty: 33.00
Unit of Measure: Ea.
Estimate: \$37,849.74
Assessor Name: System
Date Created: 10/19/2015

Notes: Replace all exit signs with battery type emergency exit signs and provide emergency lighting units (ELUs) in corridors, stairwells, restrooms, gymnasium, platform, kitchen, and other rooms as needed for safe egress. Estimate includes (13) exit signs and (20) ELUs.

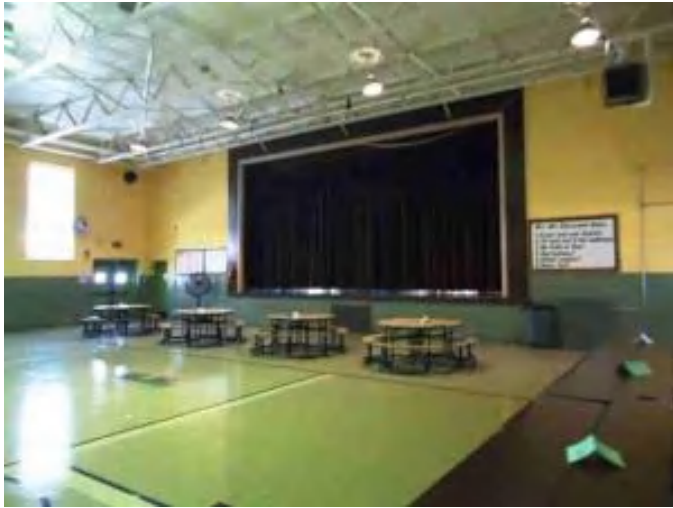
Location: Stage

System: E2010 - Fixed Furnishings

Distress: Life Safety / NFPA / PFD

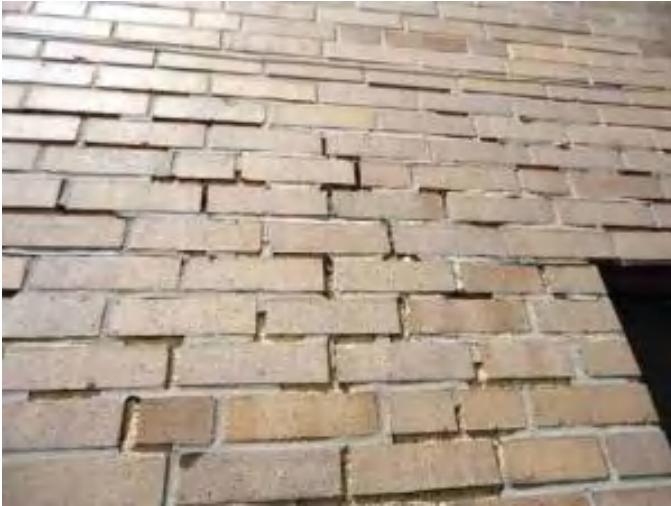
Location: Exterior Elevation

System: B2010 - Exterior Walls

Distress: Damaged

Notes: The exterior brick surfaces are generally in fair to good condition for their age. In some locations, bricks have cracked or spalled and should be replaced. The repointing of deteriorated mortar joints is also recommended, using mortar of a similar color and consistency as the original. Following the detailed examination of the brick and repair of mortar construction joints, the entire building should be pressure washed to remove stains and embedded pollutants. If moisture is found to be penetrating the masonry facade, the application of a spray sealant to the suspected exterior masonry surface is recommended.

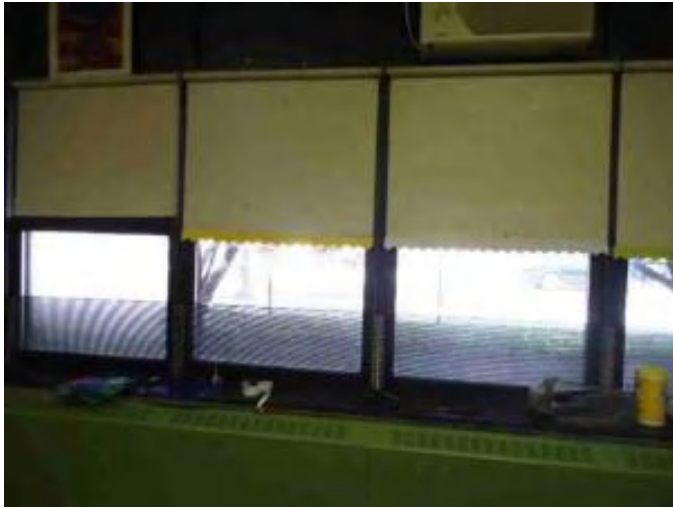
Location: Exterior Elevation

System: B2020 - Exterior Windows

Distress: Damaged

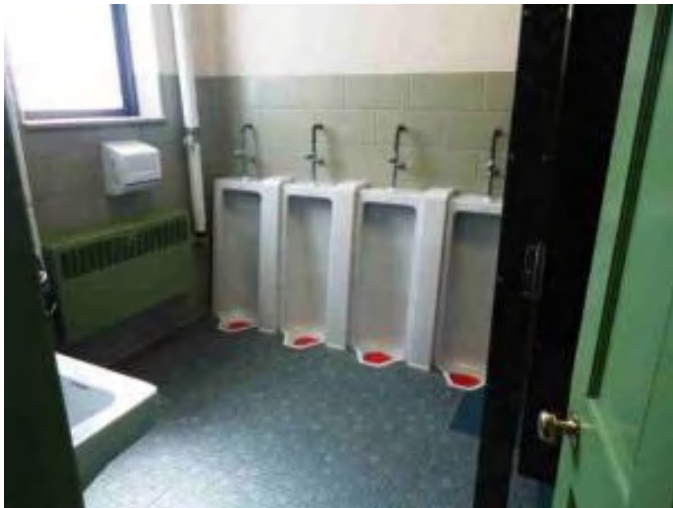
Location: Restrooms

System: C1010 - Partitions

Distress: Damaged

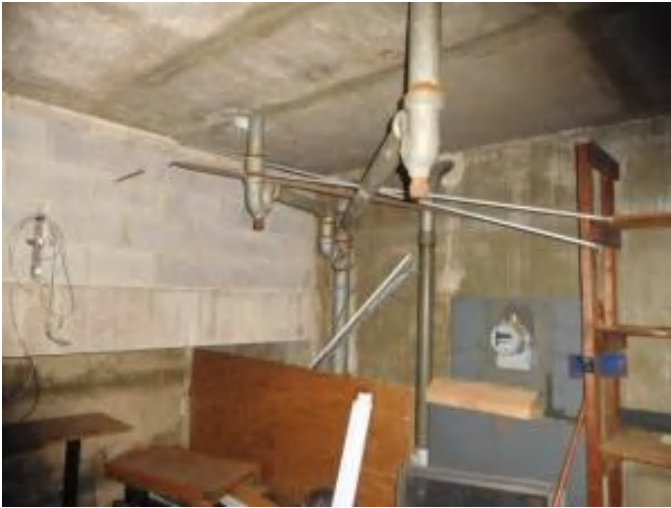
Location: entire building

System: D2030 - Sanitary Waste

Distress: Beyond Service Life

Correction: Inspect sanitary waste piping and replace damaged sections. (+50KSF)

Notes: Inspect old cast iron sanitary piping including camera observation and replace damaged sections.

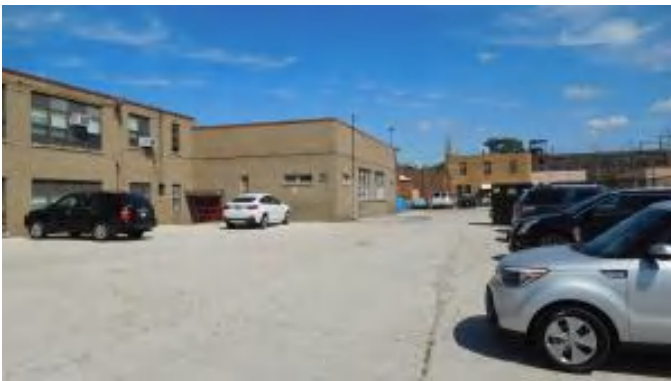
Location: entire building

System: D3040 - Distribution Systems

Distress: Building / MEP Codes

Notes: Provide a four pipe fan coil system with roof mounted outside air system ducted to each fan coil unit. Provide a fan coil unit for each classroom and separate area. Include new pumps for hot water, piping, control valves and controls, to replace existing heating system.

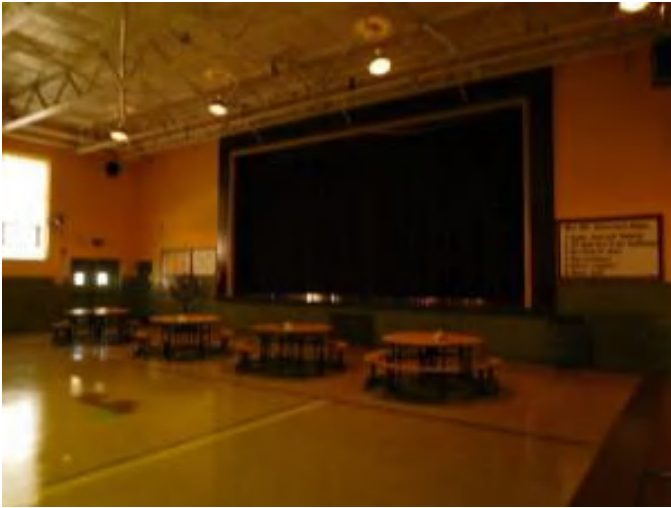
Location: cafeteria

System: D3040 - Distribution Systems

Distress: Building / MEP Codes

Notes: Provide a new central station air handling unit for the cafeteria with hot and chilled water coils, filters, outside and return air dampers, hydronic valves and controls, blower and motor. Connect to hot and chilled water systems.

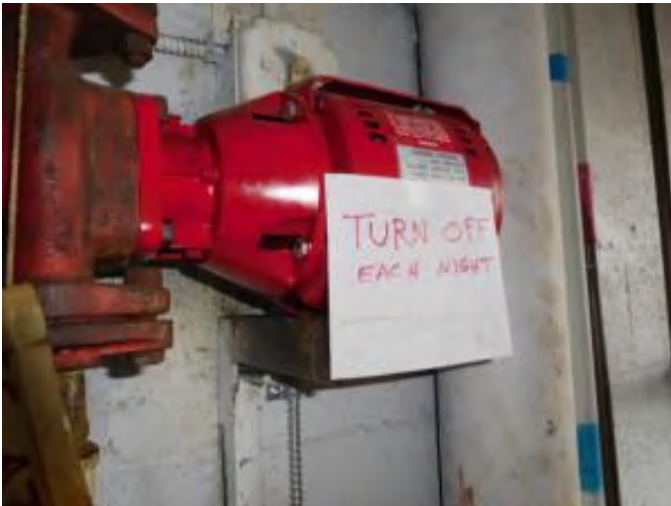
Location: entire building

System: D3060 - Controls & Instrumentation

Distress: Inadequate

Correction: Replace pneumatic controls with DDC (75KSF)

Notes: Install new direct digital control system and building automation system with remote computer control capability and graphics package.

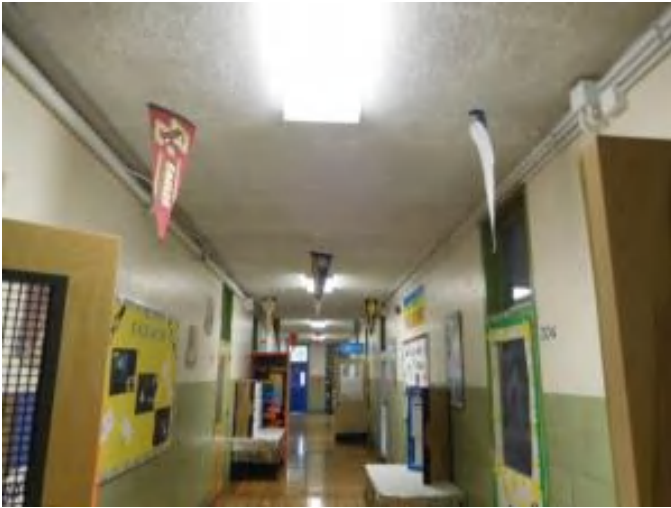
Location: entire building

System: D4010 - Sprinklers

Distress: Life Safety / NFPA / PFD

Notes: Install complete NFPA wet pipe automatic sprinkler system and standpipes. If required provide fire pump and jockey pump with controller.

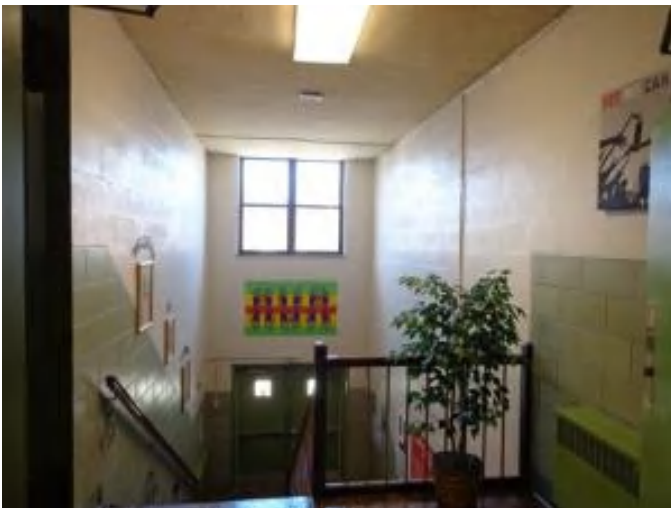
Location: Building wide

System: D5030 - Communications and Security

Distress: Inadequate

Correction: Add/Replace Video Surveillance System

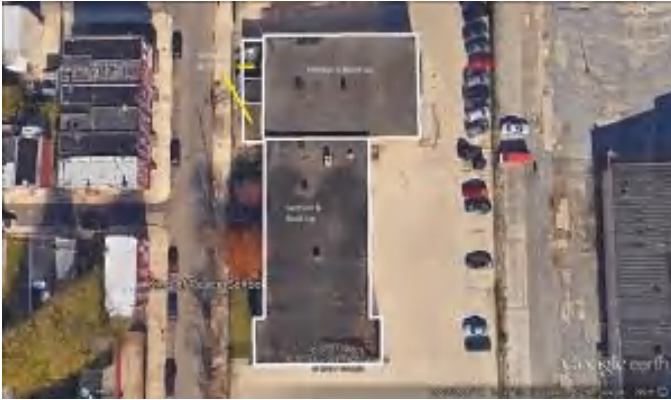
System: B3010105 - Built-Up

Location: Roof
Distress: Damaged
Category: 3 - Operations / Maint.
Priority: 5 - Response Time (> 5 yrs)
Correction: Remove and Replace Built Up Roof
Qty: 10,000.00
Unit of Measure: S.F.
Estimate: \$338,820.11
Assessor Name: System
Date Created: 11/20/2015

Notes: During the time of the inspection roof access was not available. According to reports the roofing system is over twenty years of age and was recently repaired over the Cafeteria/Auditorium. The roofing system is not expected to outlast the ten-year scope of this analysis. Future budget modeling should include provisions for the replacement of all failing roofing systems.

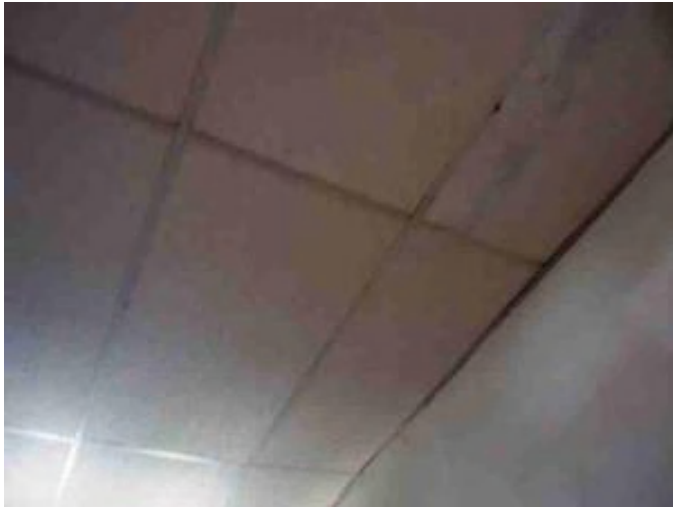
Location: Building Wide

System: C3030 - Ceiling Finishes

Distress: Damaged

Notes: The ceiling finish is a mix of 12 x 12 ceiling grid, painted and 2 x 4 Acoustical tile finish. Ceilings have been repaired in several areas and is in good condition considering the age of the application and the current condition of the school. The ceiling finish is expected to require upgrades to support the recommended efforts in this report prior to re-opening. This deficiency provides a budgetary consideration for removal and replacement of the current ceiling finish to a new acoustical tile finish. Considering the recommended mechanical and electrical upgrades this effort should be completed as part of an overall renewal program for the school. No work should be considered until after the recommended exterior efforts are complete.

Correction: Remove and replace suspended acoustic ceilings - lighting not included

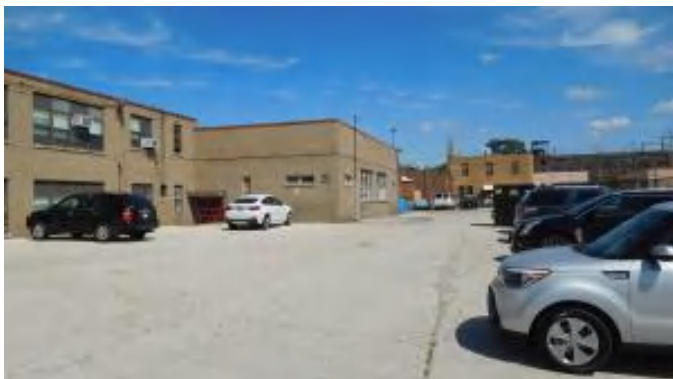
System: D3030 - Cooling Generating Systems

Location: roof, mechanical room
Distress: Inadequate
Category: 4 - Capital Improvement
Priority: 5 - Response Time (> 5 yrs)
Correction: Install chilled water system with distribution piping and pumps. (+25KSF)
Qty: 21,224.00
Unit of Measure: S.F.
Estimate: \$619,942.24
Assessor Name: System
Date Created: 11/10/2015

Notes: Remove the window air conditioning units and install a fifty five ton air-cooled chiller on the roof with chilled water distribution piping, two pumps, chemical treatment and controls located in a mechanical room on the basement level.

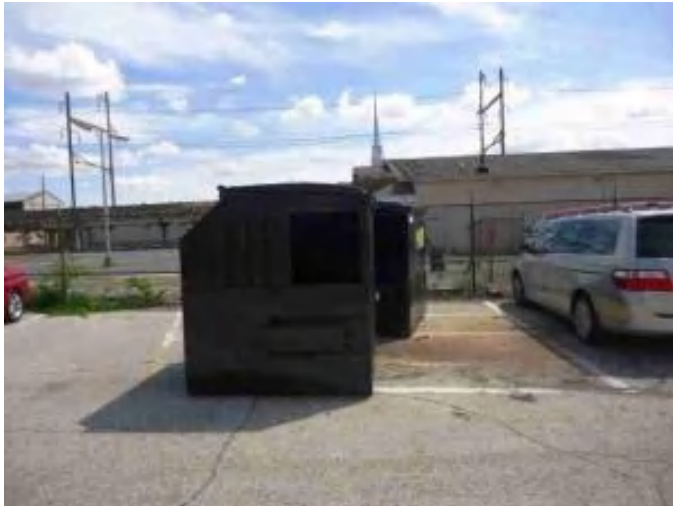
Location: Site

System: G2040 - Site Development

Distress: Health Hazard / Risk

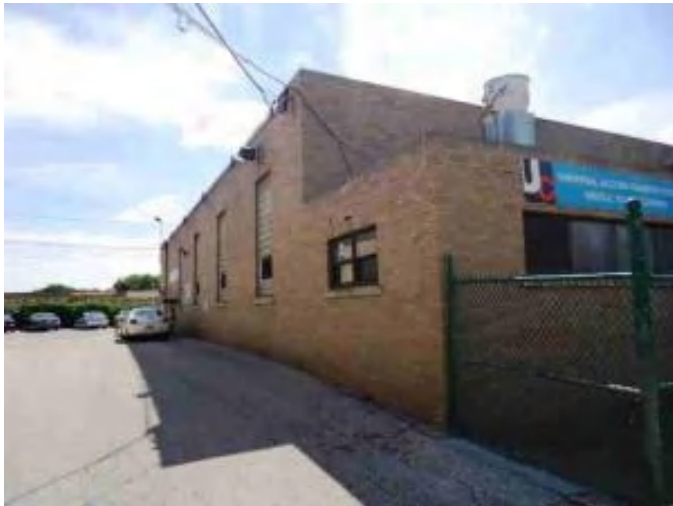
Location: Parking Lot

System: G2020 - Parking Lots

Distress: Damaged

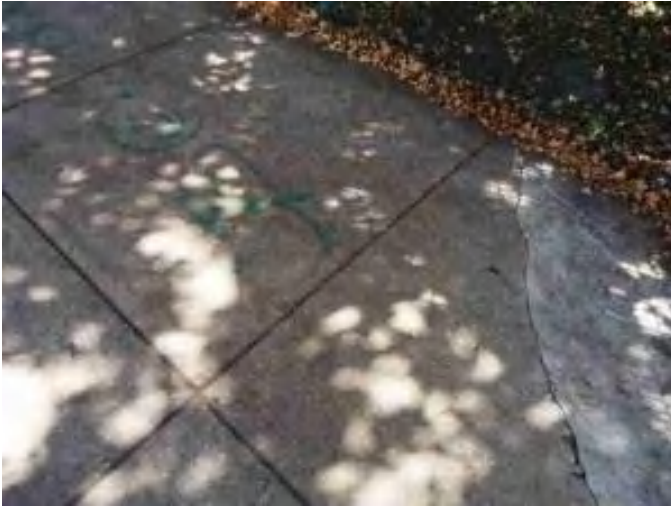
Location: Site

System: G2030 - Pedestrian Paving

Distress: Damaged

Notes: The sidewalk system is original to the buildings construction. There are a several areas of cracking concrete but no tripping hazards. The sidewalk system is expected to expire in the near future. Removal of the entire system is recommended. Universal upgrades are required and should include all aspects of current ADA legislation.

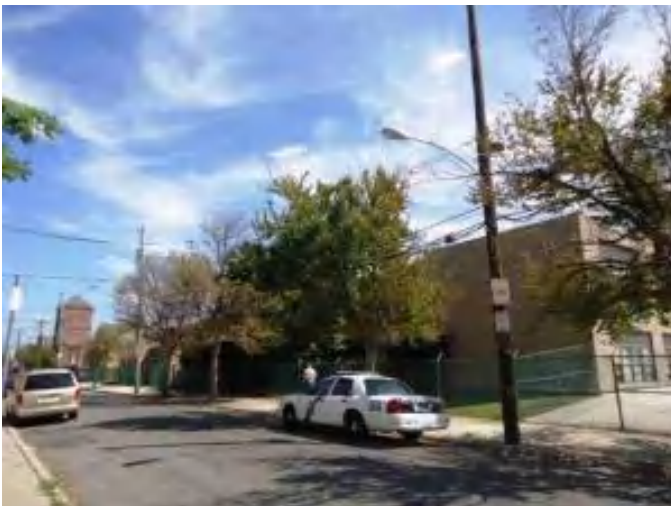
Location: Site

System: G2040 - Site Development

Distress: Damaged
