Facility Condition Assessment Summary Report

Meehan Middle School

S801001;Lincoln, Meehan, and Field

Site Assessment Report

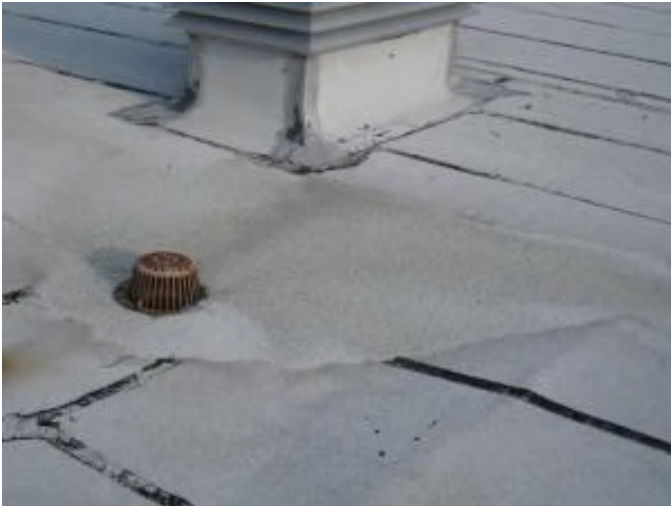
Location: Lincoln - Main Building - roof

System: B3010105 - Built-Up

Distress: Failing

Notes: Replace built-up roof over entire building; include fall protection devices @ mech. equip. (215,000sf)

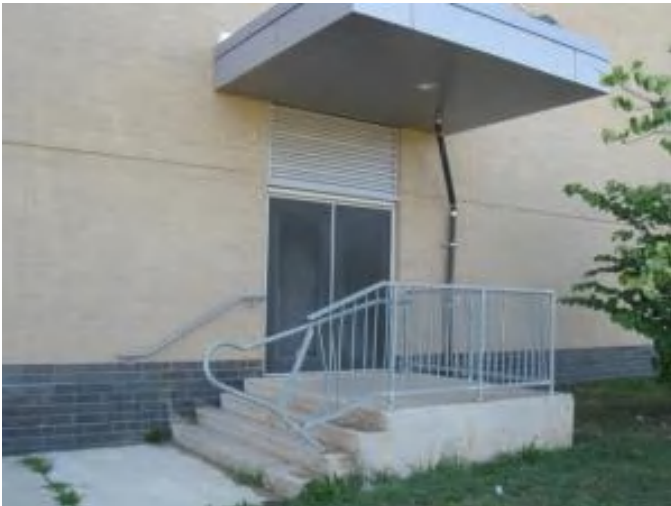
Location: Lincoln - Main Building - rear stair

System: C2010 - Stair Construction

Distress: Damaged

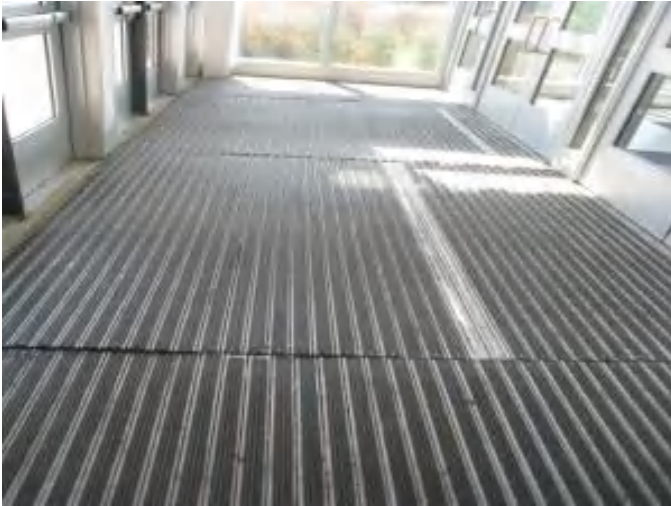
Location: Lincoln - Main Building - entrance vestibule

System: B1010 - Floor Construction

Distress: Damaged

Notes: Replace traffic mat at main personnel entrances (250sf)

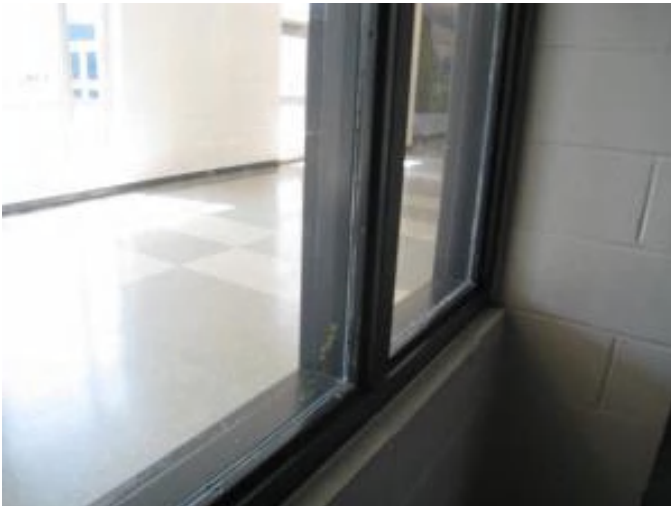
Location: Lincoln - Main Building - cafe vision panels

System: B2020 - Exterior Windows

Distress: Health Hazard / Risk

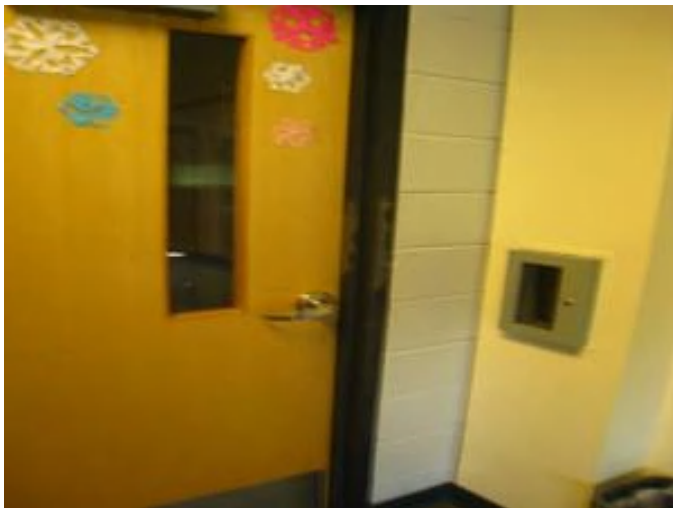
Location: Lincoln - Main Building - interior doors

System: C1020 - Interior Doors

Distress: Appearance

Notes: Repaint hollow metal door frames (40) 3'x7'

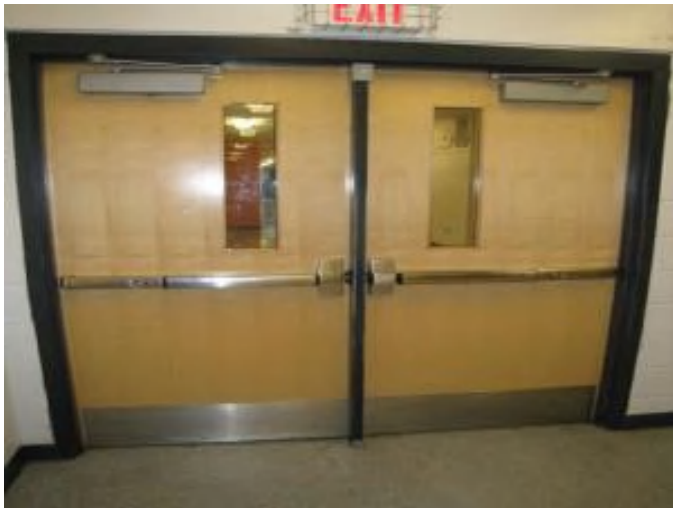
Location: Lincoln - Main Building - interior doors

System: C1020 - Interior Doors

Distress: Appearance

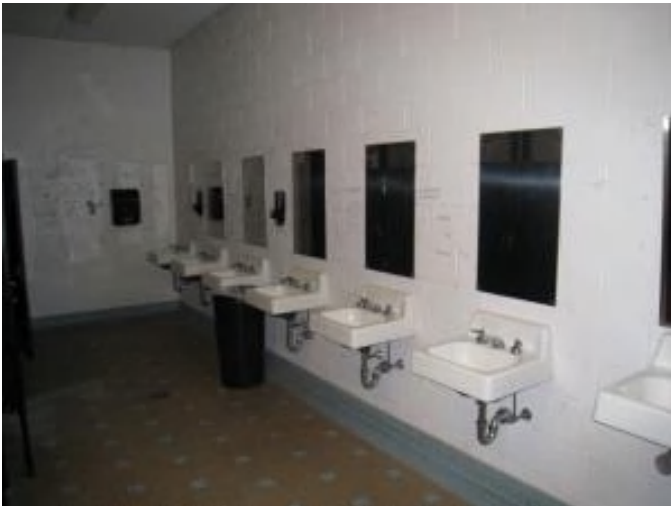
Location: Lincoln - Main Building - toilet rooms

System: C3010230 - Paint & Covering

Distress: Damaged

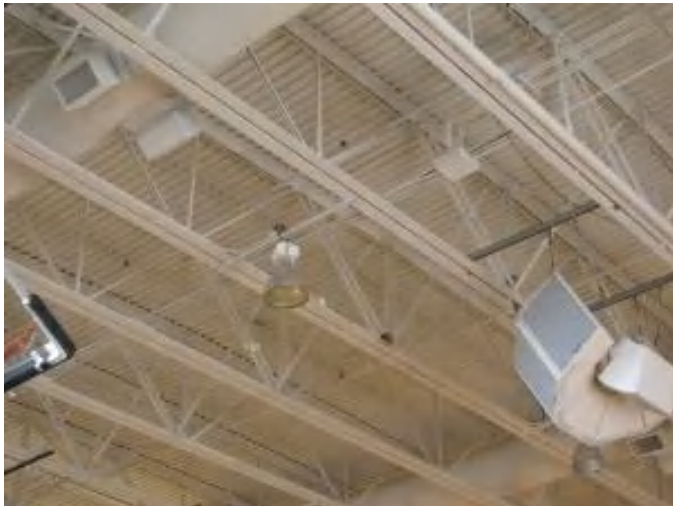
Location: Lincoln - Main Building - open ceiling spaces

System: D5020 - Lighting and Branch Wiring

Distress: Energy Efficiency

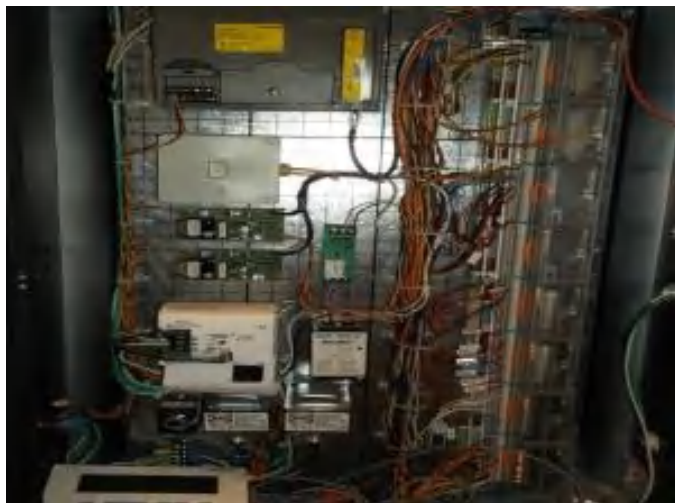
Location: Lincoln - Main Building - Throughout the building

System: D3060 - Controls & Instrumentation

Distress: Energy Efficiency

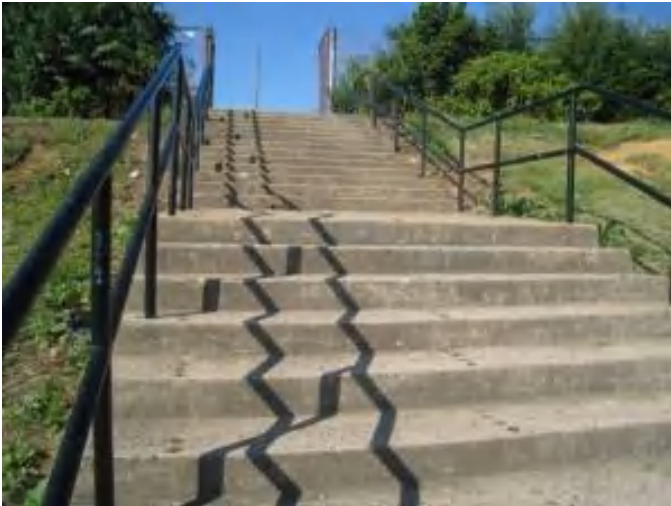
Location: Lincoln - Locker Facility - exterior stairs

System: C2010 - Stair Construction

Distress: Failing

Notes: Repair exterior concrete stairs (40 risers x 5ft wide and railings) + (25 risers x 5ft) + (24 risers x 3ft)

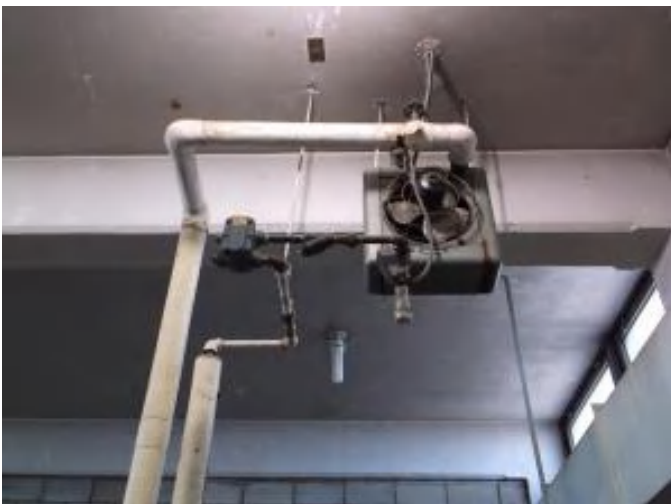
Location: Lincoln - Locker Facility - Throughout the building

System: D3040 - Distribution Systems

Distress: Beyond Service Life

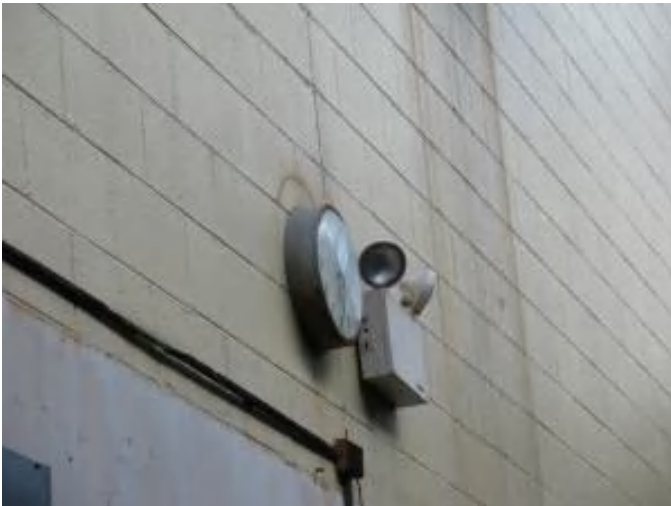
Location: Entire Building

System: D5030 - Communications and Security

Distress: Inadequate

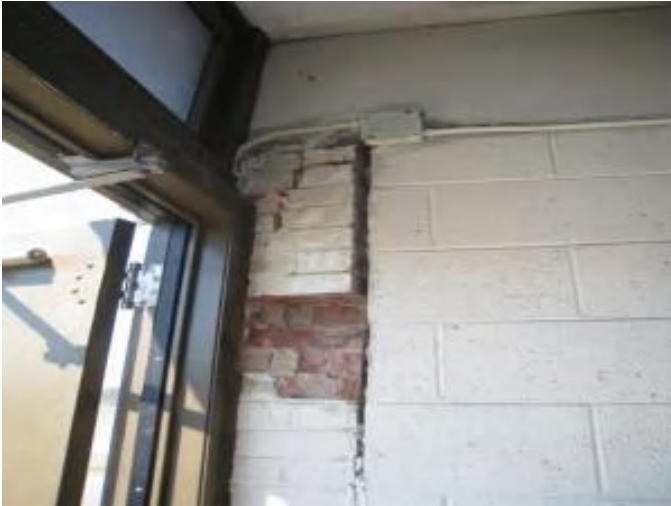
Location: Lincoln - Locker Facility - concrete beams

System: B1010 - Floor Construction

Distress: Damaged

Notes: Three concrete beams and masonry supports are failing – reconstruct reinforced beams and supports (300sf)

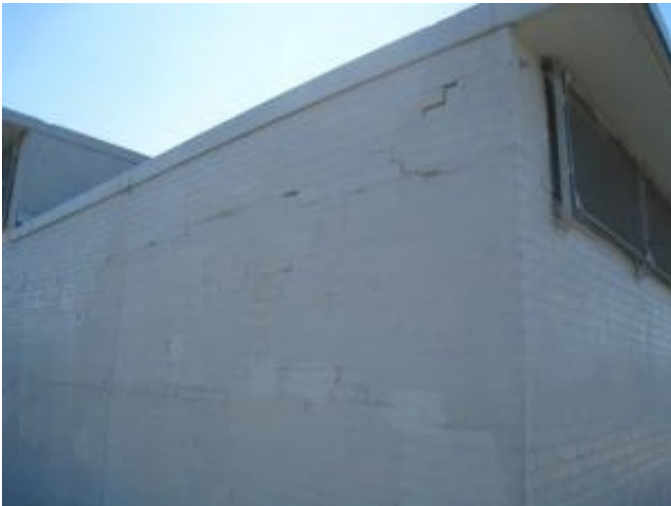
Location: Lincoln - Locker Facility - outside wall

System: B2010 - Exterior Walls

Distress: Failing

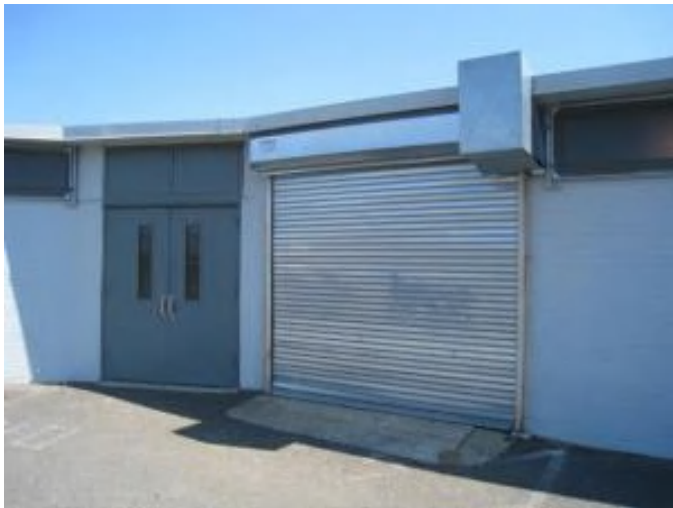
Location: Lincoln - Locker Facility - rollup door

System: B2030 - Exterior Doors

Distress: Appearance

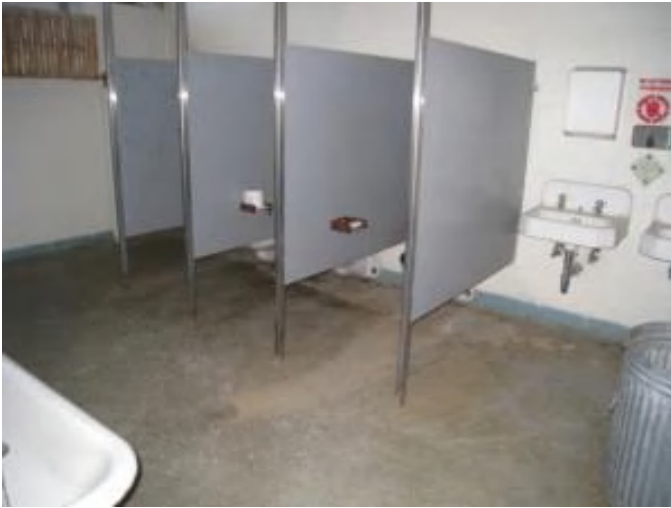
Location: Lincoln - Locker Facility - toilets

System: C1030 - Fittings

Distress: Beyond Service Life

Notes: Replace toilet room accessories (12 toilet paper, 8 soap, 4 paper towel, 4 waste cans)

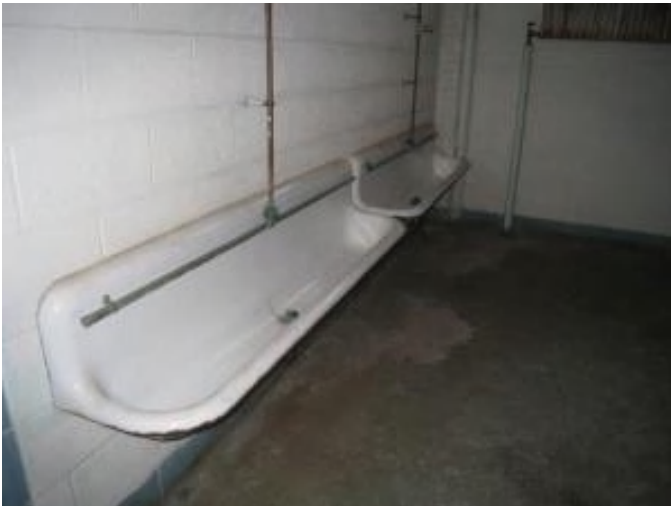
Location: Lincoln - Locker Facility - toilets

System: C1030 - Fittings

Distress: Failing

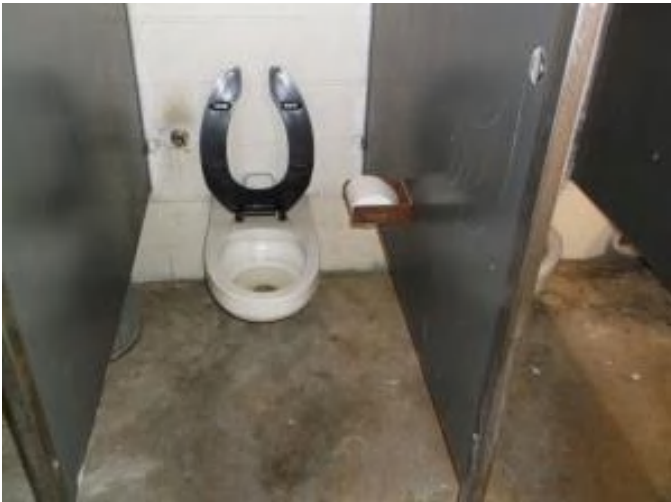
Location: Lincoln - Locker Facility - Throughout the building

System: D2010 - Plumbing Fixtures

Distress: Beyond Service Life

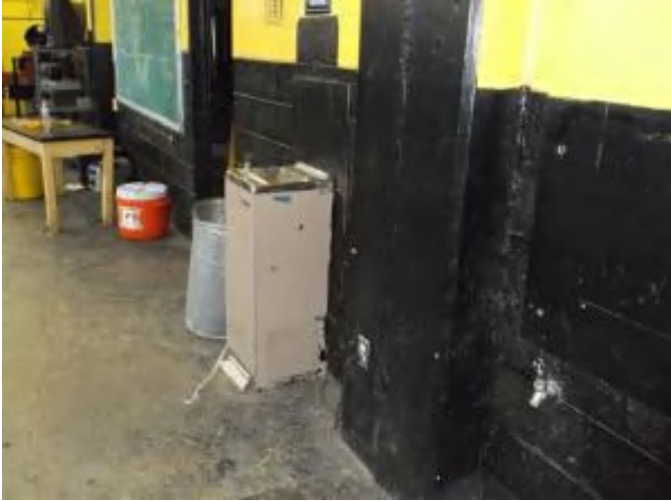
Location: Lincoln - Locker Facility - Throughout the building

System: D2010 - Plumbing Fixtures

Distress: Beyond Service Life

Notes: Replace the integral refrigerated vertical water coolers and the drinking fountains. These units are well beyond their service life and most are NOT accessible type.

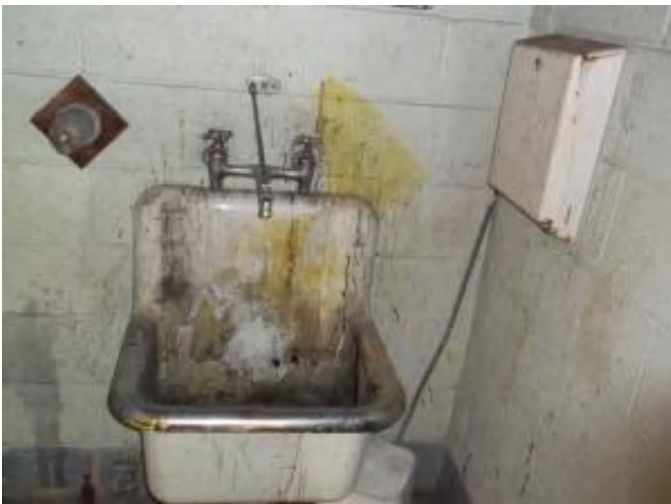
Location: Lincoln - Locker Facility - Throughout the building

System: D2010 - Plumbing Fixtures

Distress: Beyond Service Life

Notes: Replace service sinks (janitor sinks) in the building.

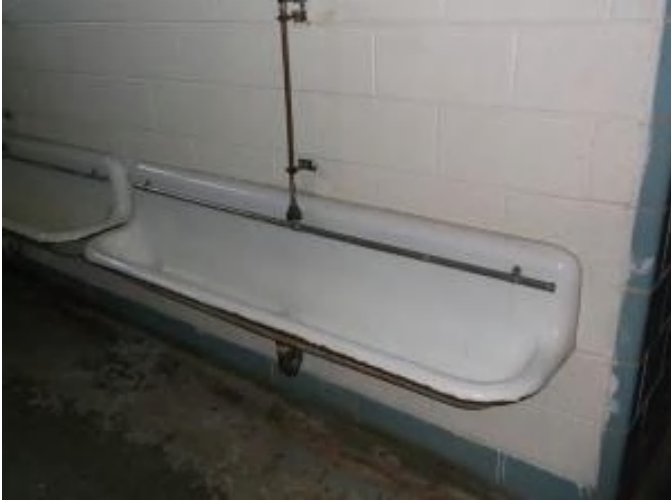
Location: Lincoln - Locker Facility - Throughout the building

System: D2010 - Plumbing Fixtures

Distress: Beyond Service Life

Notes: Replace all urinals in the building with lower flow fixtures, as the fixtures are original.

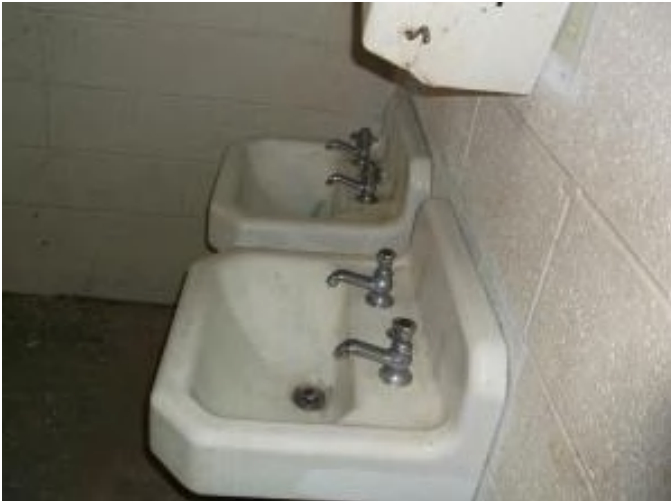
Location: Lincoln - Locker Facility - Throughout the building

System: D2010 - Plumbing Fixtures

Distress: Beyond Service Life

Notes: Replace all lavatories in the building with lower flow fixtures, as the fixtures are original.

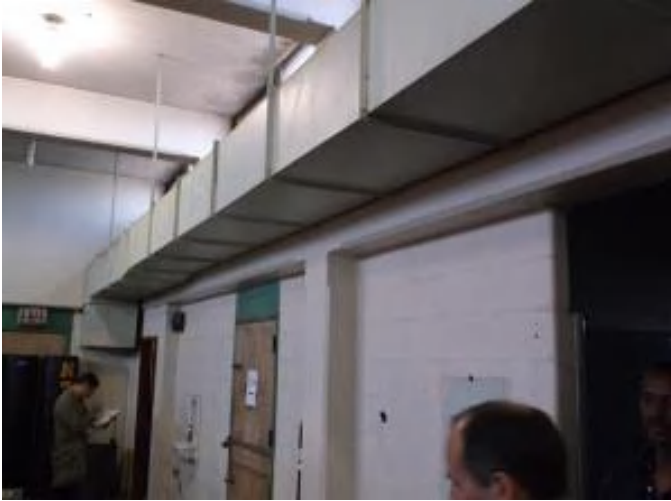
Location: Lincoln - Locker Facility -Throughout the building

System: D3040 - Distribution Systems

Distress: Beyond Service Life

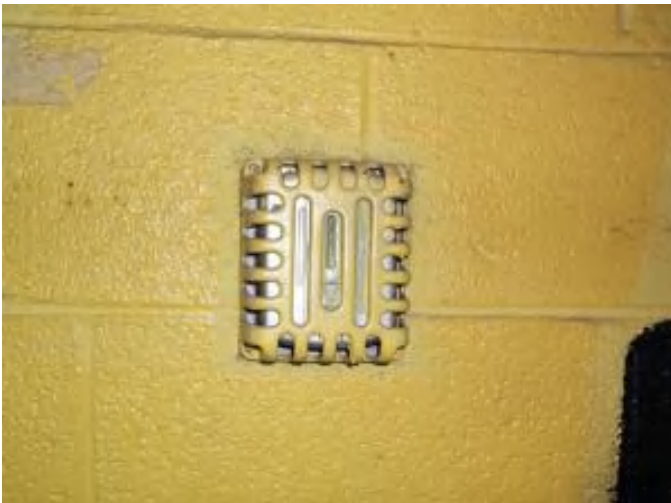
Location: Lincoln - Locker Facility - Throughout the building

System: D3060 - Controls & Instrumentation

Distress: Beyond Service Life

Correction: Replace pneumatic controls with DDC (75KSF)

Notes: Replace the pneumatic controls for the HVAC systems with modern DDC modules or electric, valves and actuators to improve reliability and energy efficiency.

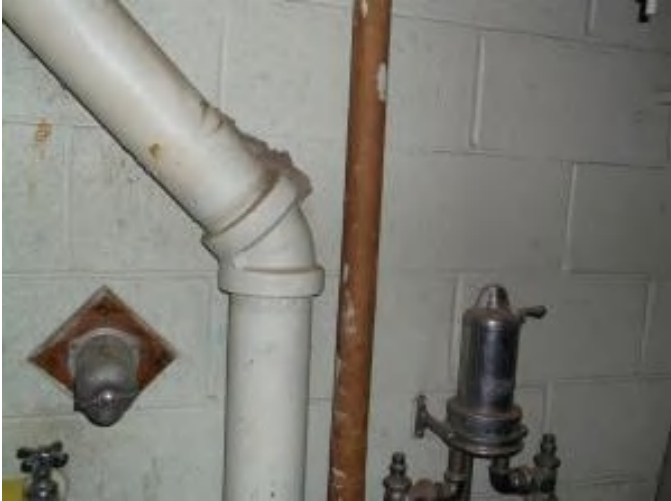
Location: Lincoln - Locker Facility - Throughout the building

System: D2030 - Sanitary Waste

Distress: Beyond Service Life

Correction: Inspect sanitary waste piping and replace damaged sections. (+50KSF)

Notes: Hire a qualified contractor to perform a detailed examination of the sanitary waste piping using visual inspection and video cameras to locate and replace any damaged piping and to further quantify the extent of potential failures.

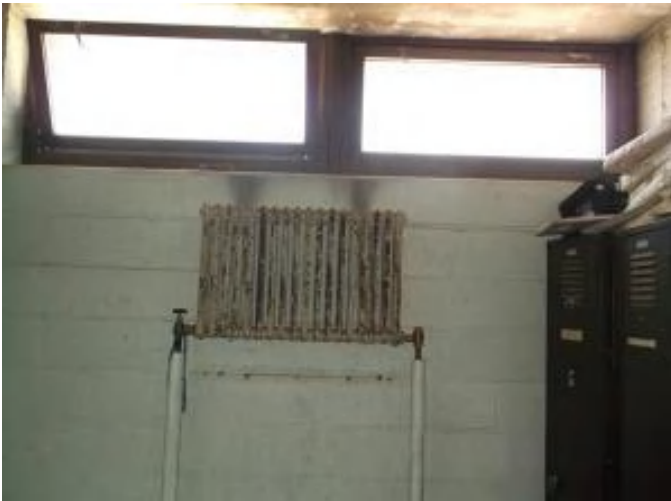
Location: Lincoln - Locker Facility - Throughout the building

System: D3040 - Distribution Systems

Distress: Beyond Service Life

Correction: Perform testing to identify and replace damaged steam and condensate piping.

Notes: Hire a qualified contractor to examine the steam and condensate piping in service for 85 years and perform additional testing to locate and replace any damaged piping and to further quantify the extent of potential failures. The District should budget for replacing this piping over the next 10 years

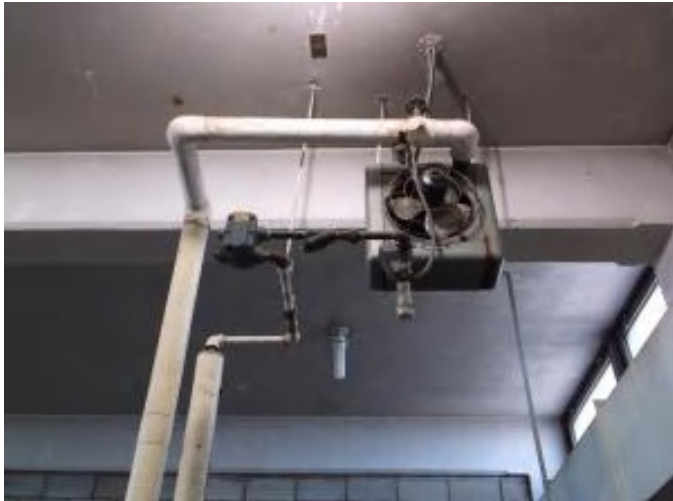
Location: Lincoln - Locker Facility - Throughout the building

System: D3040 - Distribution Systems

Distress: Beyond Service Life

Correction: Perform testing to identify and replace damaged steam and condensate piping.

Notes: Replace the steam condensate return system.

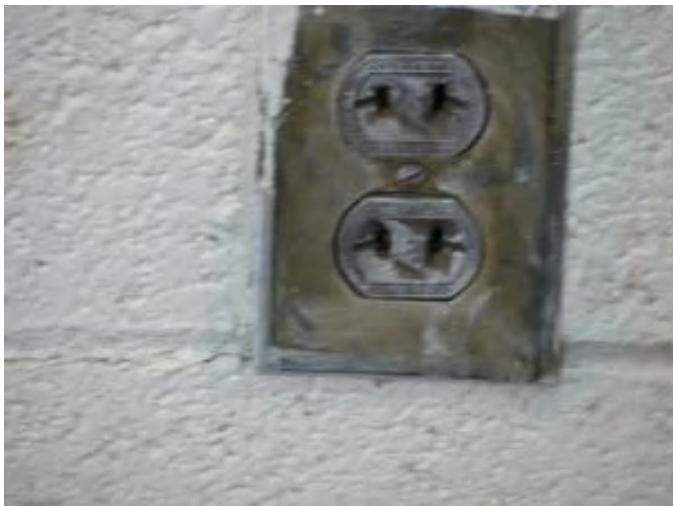
Location: Entire Building

System: D5020 - Lighting and Branch Wiring

Distress: Inadequate

Correction: Replace Wiring Devices (SF) - surface mounted conduit and boxes

Notes: Replace existing receptacles with duplex receptacles throughout the building. Estimated 40

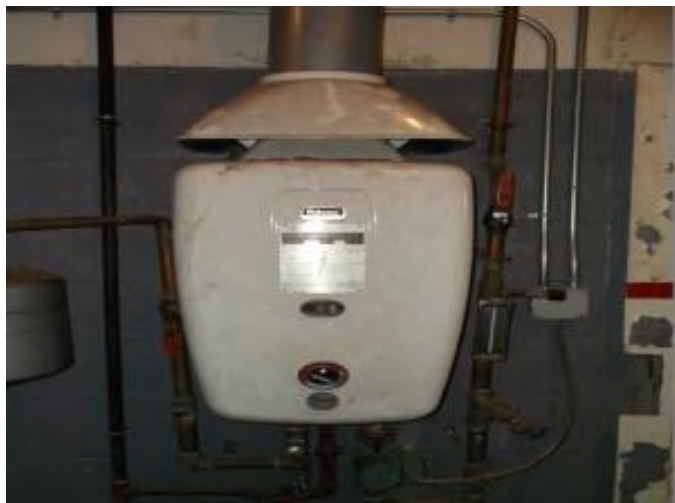
Location: Lincoln - Locker Facility - Main boiler mechanical equipment room

System: D2020 - Domestic Water Distribution

Distress: Beyond Service Life

Correction: Replace instantaneous water heater

Notes: Replace the gas fire instantaneous water heater.

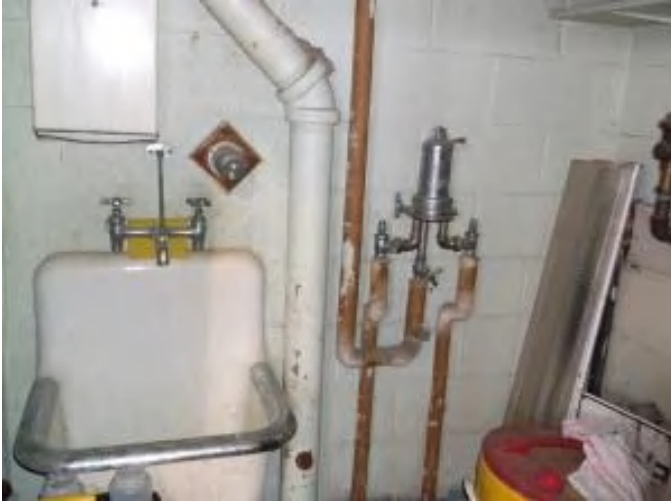
Location: Lincoln - Locker Facility - Throughout the building

System: D2020 - Domestic Water Distribution

Distress: Beyond Service Life

Correction: Replace domestic water piping (75 KSF)

Notes: Inspect and replace the original as needed the domestic water piping in the building

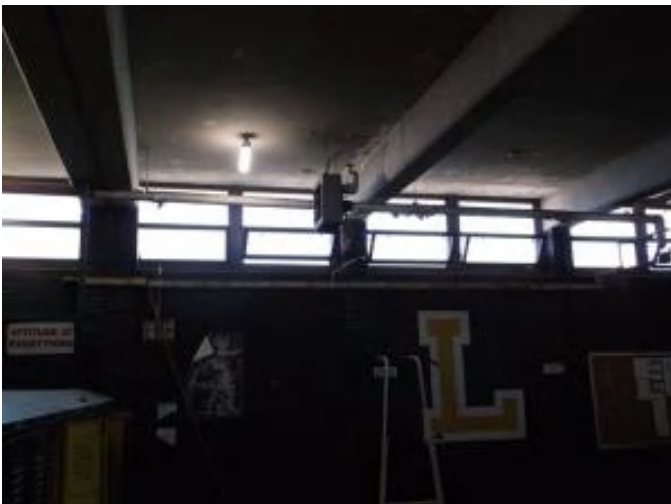
Location: Lincoln - Locker Facility -Throughout the building

System: D4010 - Sprinklers

Distress: Inadequate

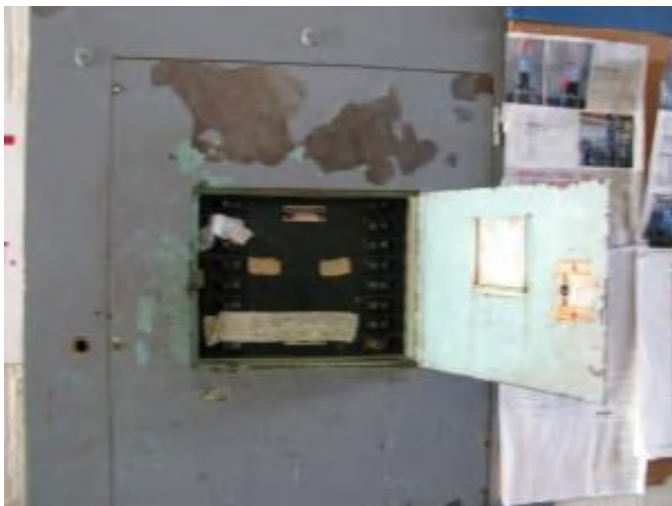
Location: Entire Building

System: D5010 - Electrical Service/Distribution

Distress: Beyond Service Life

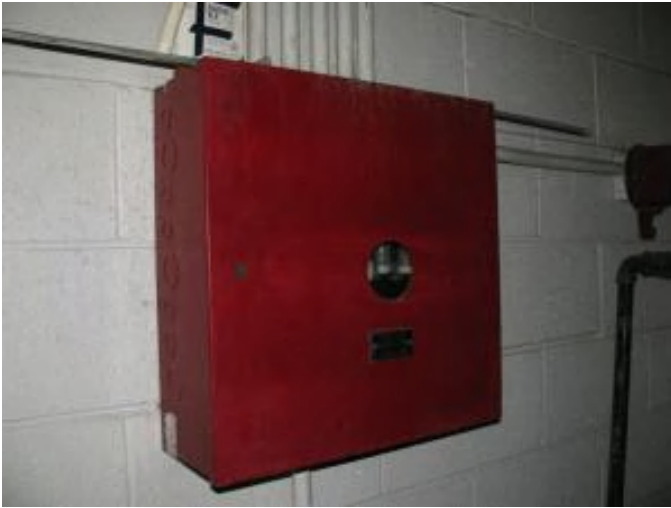
Location: Entire Building

System: D5030 - Communications and Security

Distress: Beyond Service Life

Notes: Replace existing fire alarm system with an automatic fire alarm system including smoke detectors in corridors and other recommended areas per NEC. Install horn/strobes in class rooms, corridors, offices, toilets, library and other recommended areas per codes.

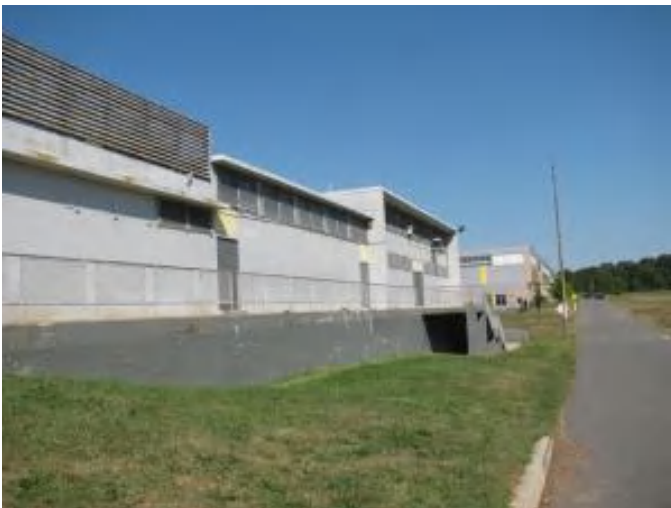
Location: Exterior Building

System: D5030 - Communications and Security

Distress: Security Issue

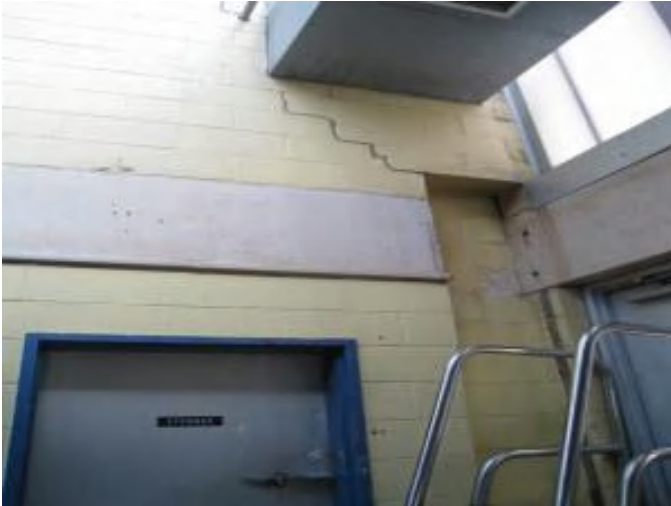
Location: Lincoln - Pool House - roof beam

Since there is no basement, the foundations could not be seen. With little cracking of walls except for an upper section under a concrete beam, the foundations are probably in good condition. A full and detailed survey of all cracked and failing areas needs to be implemented to determine the extent of failure and viability of repairing this structure.

System: B1010 - Floor Construction

Distress: Damaged

Notes: One concrete beam and masonry support is failing – reconstruct reinforced beam and support (100sf)

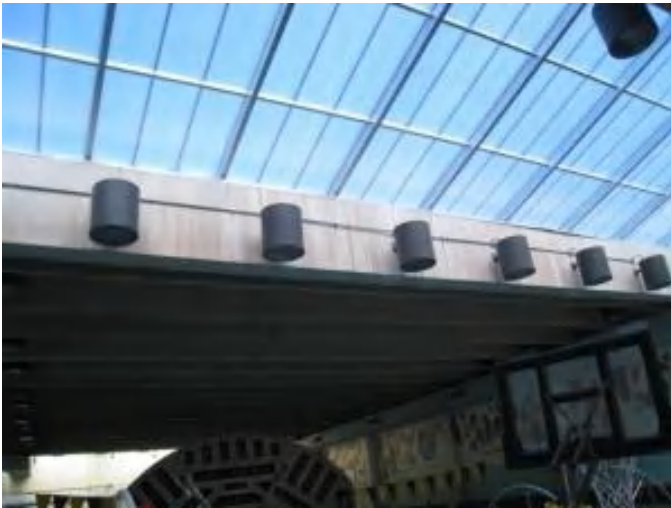
Location: Lincoln - Pool House - exterior windows

Windows are constructed of a fixed/operable hopper-type, clear anodized aluminum frame system with single pane plexiglass vision panels. This system is worn with the plexiglass so scratched that it is no longer transparent. Efflorescence is and staining is visible under some windows from excessive room humidity, leaks around frames, or possibly from being left open when raining. Regardless, all windows are failing and should be replaced.

System: B2020 - Exterior Windows

Distress: Beyond Service Life

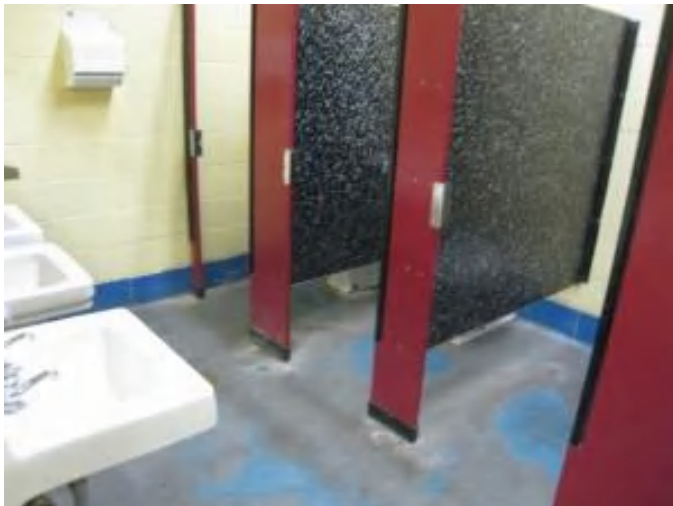
Location: Lincoln - Pool House - toilets

Toilet partitions are in poor and failing condition, missing doors, partition dividers, and toilet room accessories. All new partitions and toilet room accessories are required.

System: C1030 - Fittings

Distress: Beyond Service Life

Notes: Replace toilet partitions (12 toilet, 4 urinal)

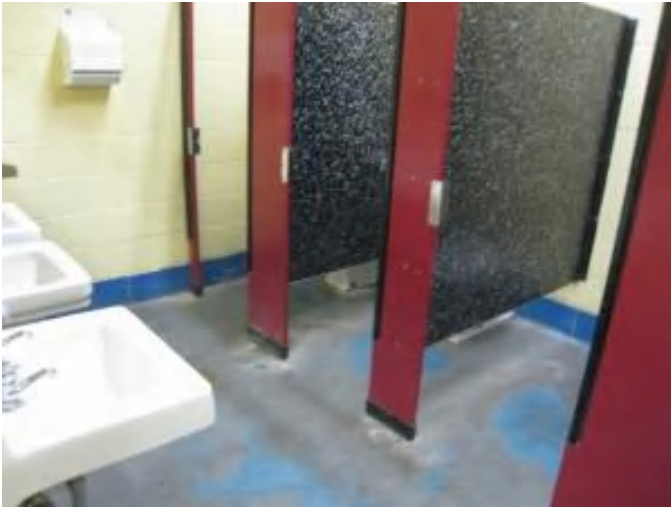
Location: Lincoln - Pool House - toilets

System: C1030 - Fittings

Distress: Beyond Service Life

Notes: Replace toilet room accessories (12 toilet paper, 8 soap, 4 paper towel, 4 waste cans)

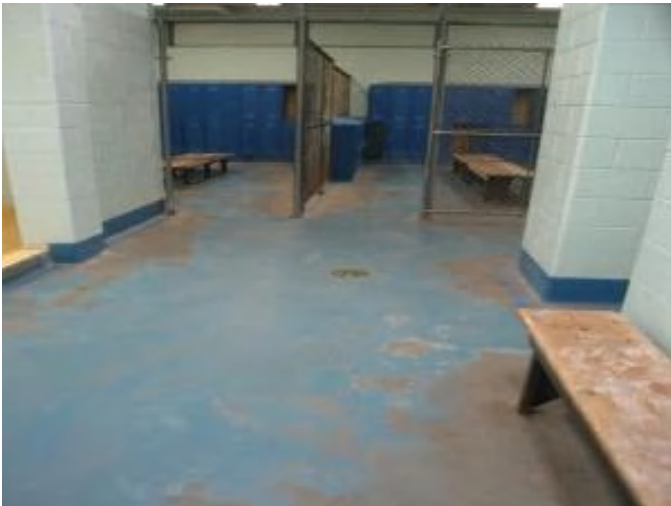
Location: Lincoln - Pool House - interiors

Due to the high moisture and condensation from the pool, toilet rooms, and lack of good ventilation and space conditioning, walls are in poor condition. The south wall has efflorescence under and around the windows from past roof leaks or window leaks. Wall should be repaired and repainted after installation of new windows.

System: C3010230 - Paint & Covering

Distress: Appearance

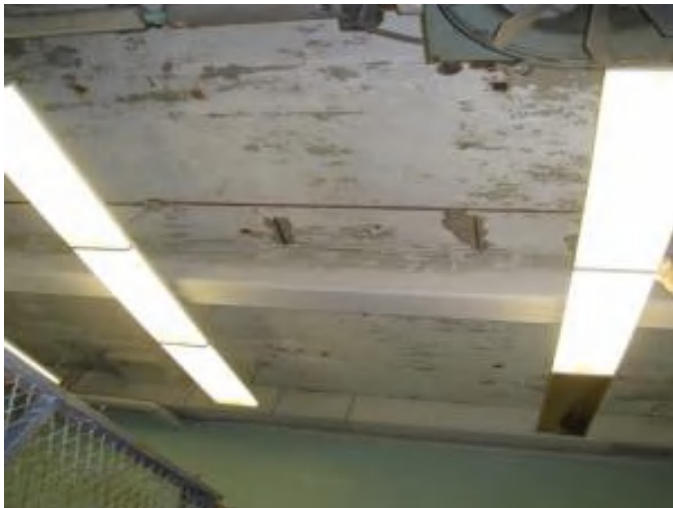
Location: Lincoln - Pool House - ceilings

Ceilings are exposed concrete T's which are in good condition. Some of the joints between T's have water marks from previous roof leaks; these marks are cosmetic and should be cleaned to improve the appearance, then all concrete T's and roof decks should be painted white which would brighten the spaces.

System: C3010230 - Paint & Covering

Distress: Appearance

Notes: Repaint all ceilings (10,000sf)

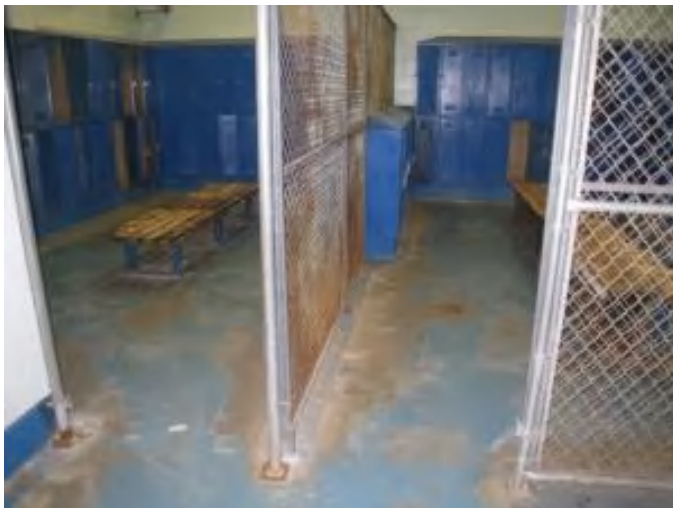
Location: Lincoln - Pool House - floors

Floors are exposed concrete that is stained, dirty, and in need of refinishing. Non-slip coatings must be used throughout the building due to the constantly wet environment.

System: C3020415 - Concrete Floor Finishes

Distress: Appearance

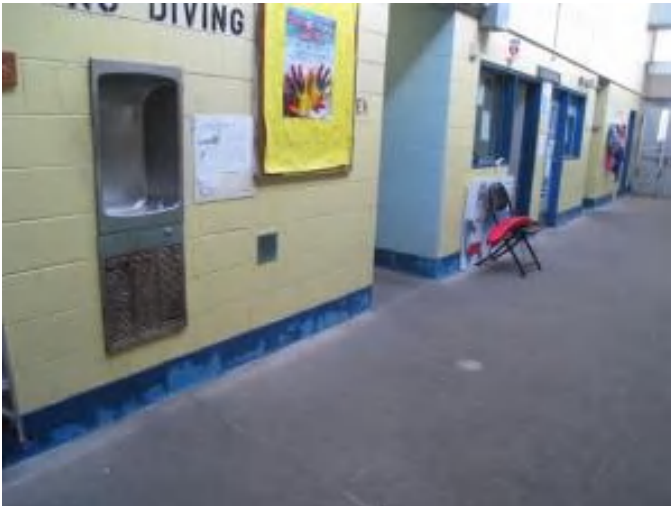
Location: Lincoln - Pool House - Throughout the building

System: D2010 - Plumbing Fixtures

Distress: Beyond Service Life

Notes: Replace service sinks (janitor sinks) in the building.

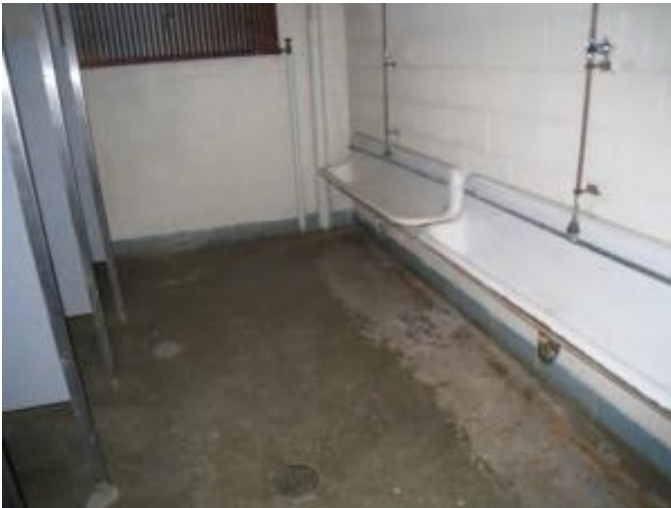
Location: Lincoln - Pool House - Throughout the building

System: D2010 - Plumbing Fixtures

Distress: Beyond Service Life

Notes: Replace all lavatories in the building with lower flow fixtures, as the fixtures are original.

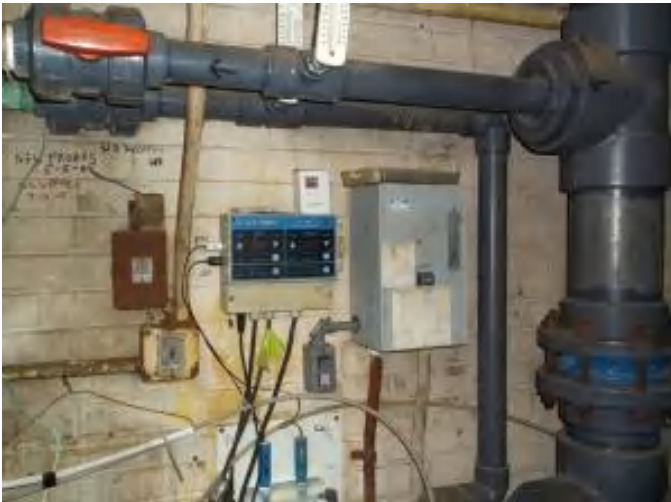
Location: Lincoln - Pool House - Throughout the building

System: D3060 - Controls & Instrumentation

Distress: Beyond Service Life

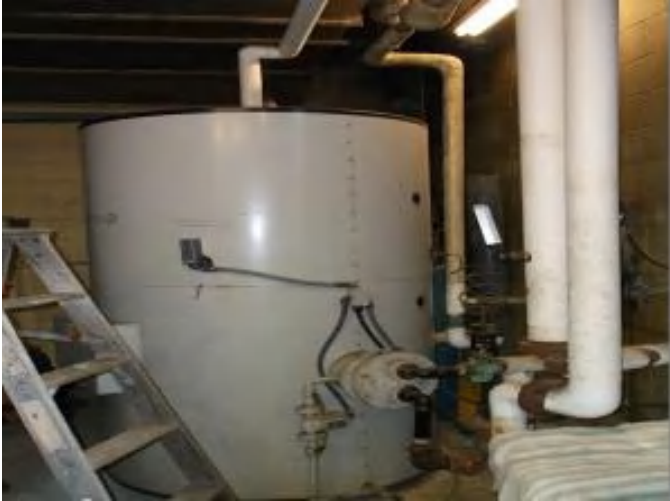
Location: Lincoln - Pool House - Main boiler mechanical room

Domestic water is generated by the two heating water boilers which transfers heat through a tube and bundle heat exchanger which then store the hot water in a vertically insulated storage tank for use. There is circulating heating pump for the heat exchanger as well as the domestic hot water system. The vertical Lonchinvar, 650 gallon, glass lined, domestic hot water storage tank is a model GVG060JR, located in the boiler mechanical equipment room. It appears that the circulating pumps have been replaced recently, however the majority of the system appears to be original, has reached the end of its service life and should be replaced. The hot water system is equipped with a common recirculation pump to serve the water.

System: D2020 - Domestic Water Distribution

Distress: Beyond Service Life

Notes: Replace domestic hot water system.

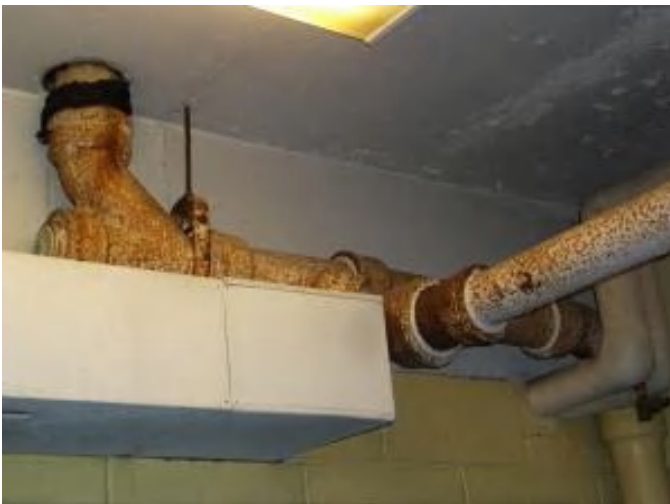
Location: Lincoln - Pool House - Throughout the building

Sanitary Waste - The sanitary waste piping system in the original building is extra heavy cast iron with lead and oakum seals and appears to be the original piping installed in the building. It is therefore recommended to inspect this piping and repair or replace sections as needed. The sanitary system leaves the building by gravity flow.

System: D2030 - Sanitary Waste

Distress: Beyond Service Life

Notes: Hire a qualified contractor to perform a detailed examination of the sanitary waste piping using visual inspection and video cameras to locate and replace any damaged piping and to further quantify the extent of potential failures.

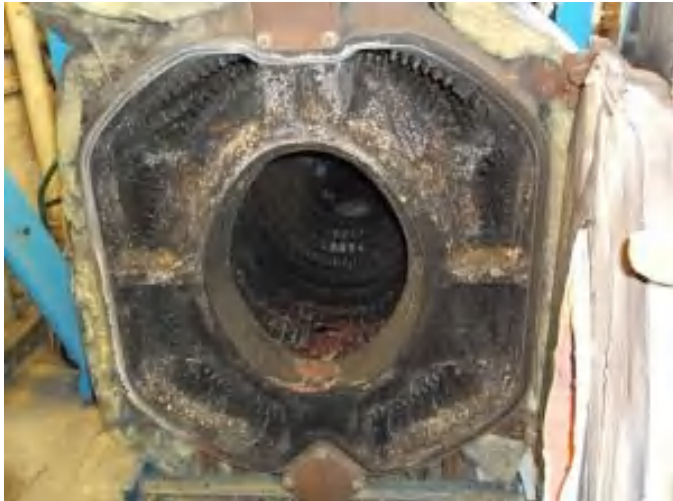
Location: Lincoln - Pool House - Main boiler mechanical equipment room

Heat Generating Systems – The two heating water boilers serve the heating needs for the building and produce heating for the domestic water system as well. Heating water is generated by two heating water boilers with number 2 fuel oil burners manufactured by Industrial Combustion. Burner oil pumps are driven by independent motors. The boilers show significant signs of wear and corrosion and should be replaced. There is no draft control on either of the boiler flues. Combustion air louvers serve the boiler room to provide combustion air for the boiler operation through a roof air intake. Burner oil pumps are driven by independent motors. The oil supply to the burner is equipped with dual solenoid valves and strainer/disposable media filter.

System: D3020 - Heat Generating Systems

Distress: Beyond Service Life

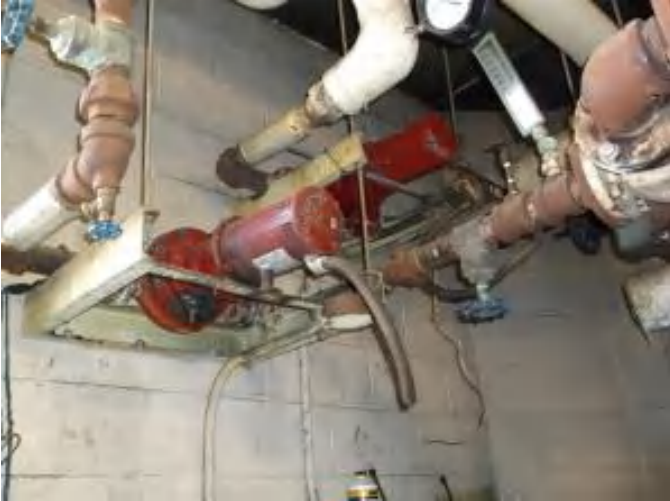
Location: Lincoln - Pool House - Main boiler mechanical equipment room

System: D3020 - Heat Generating Systems

Distress: Beyond Service Life

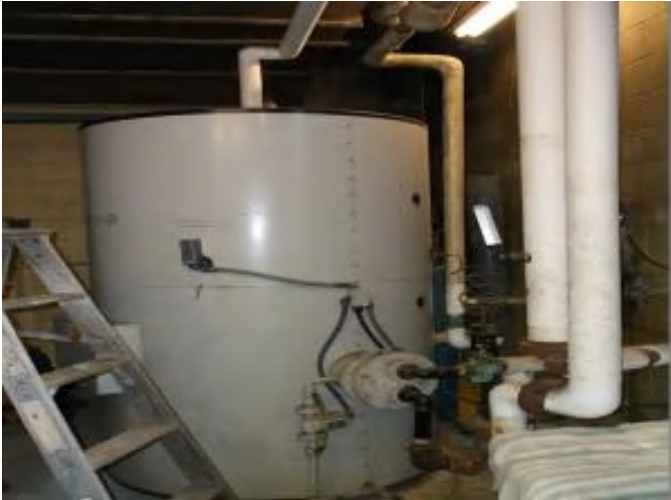
Location: Lincoln - Pool House - Throughout the building

System: D2020 - Domestic Water Distribution

Distress: Beyond Service Life

Notes: Inspect and replace the original as needed the domestic water piping in the building

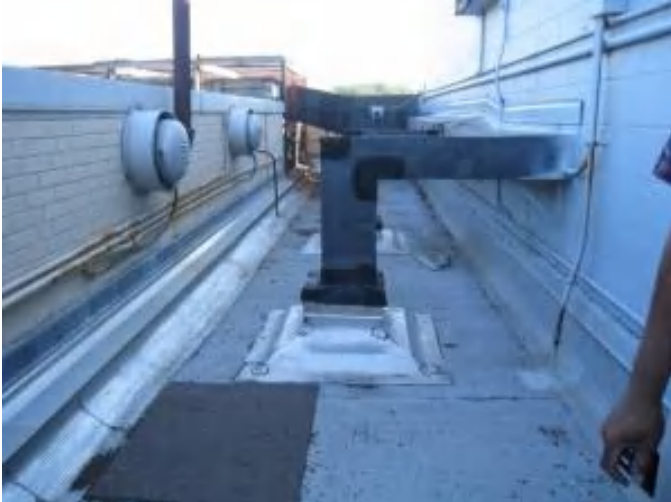
Location: Lincoln - Pool House - Roof

The pool and the locker areas are served by a ducted supply and duct low returns which are connected to two roof mounted heating hot water and ventilation units. Additional heat in the lockers is provide by horizontal suspended fan coil units with heating coils or unit heaters. Supply air is distributed through sidewall duct registers into the pool area. Outside air for ventilation is provided to these area via the outside air intakes on the roof mounted heating and ventilation units. It is recommended to replace these systems with a similar air handling unit and duct distribution but to utilize state of the art dehumidification systems, specifically used for natatoriums. For which the supply ductwork being in a chlorine and moisture laden environment the supply duct work is in good condition.

System: D3040 - Distribution Systems

Distress: Beyond Service Life

Notes: Replace the existing rooftop units, ductwork, fan coil units and unit heaters. The new units shall be designed to provide adequate ventilation per ASHRAE Std 62. The new units shall be equipped with hot water, DX coils selected for a pool environment.

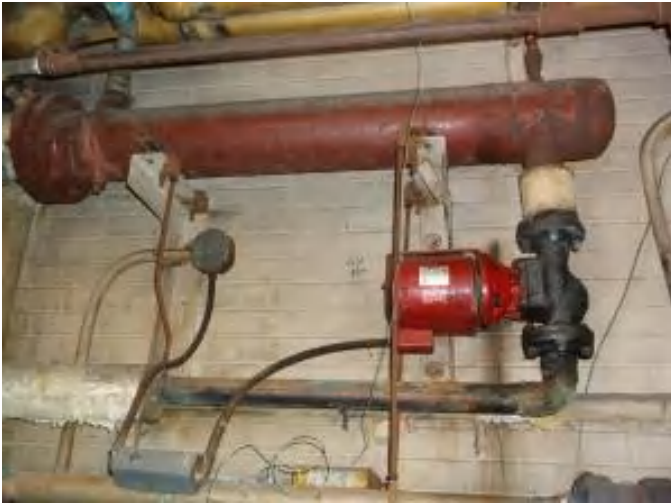
Location: Lincoln - Pool House - Throughout the building

Distribution Systems – The building heating water distribution piping is black steel with welded fittings and is original piping, is beyond its service life and should be replaced. The District should hire a qualified contractor to examine the distribution piping and perform additional testing to locate and replace any damaged piping requiring immediate replacement and to further quantify the extent of potential failures. The District should budget for replacing this piping over the next 5 years.

System: D3040 - Distribution Systems

Distress: Beyond Service Life

Notes: Hire a qualified contractor to examine the heating hot water piping in service for 60 years and perform additional testing to locate and replace any damaged piping and to further quantify the extent of potential failures. The District should budget for replacing this piping over the next 10 years.

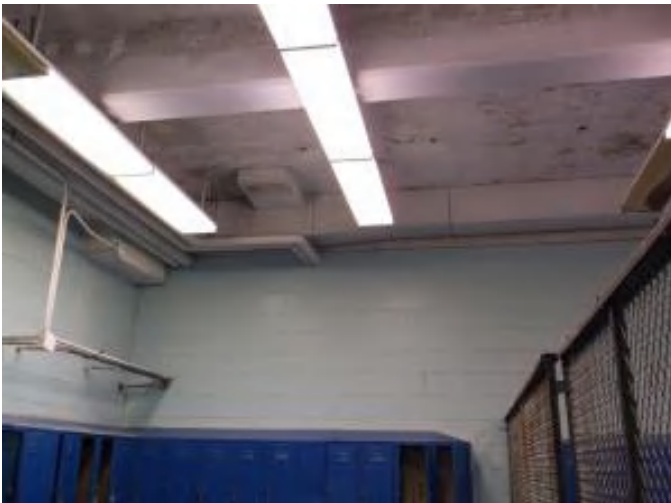
Location: Lincoln - Pool House - Throughout the building

System: D4010 - Sprinklers

Distress: Inadequate

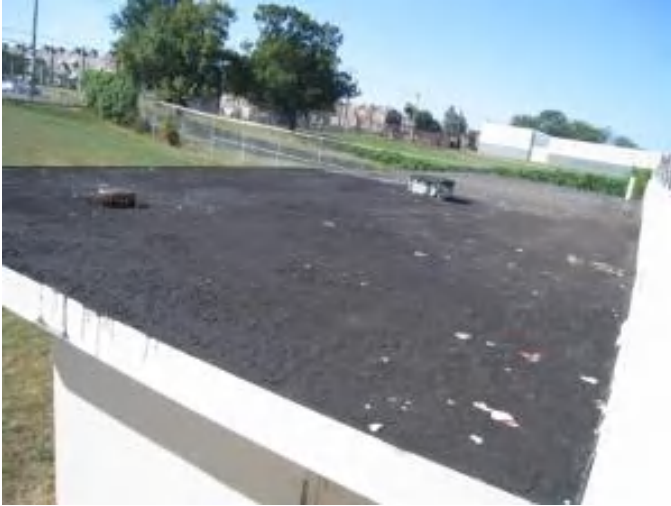
Location: Lincoln - Stands and Toilet Facilities

System: B3010105 - Built-Up

Distress: Beyond Service Life

Correction: Remove and Replace Built Up Roof

Notes: Remove existing roofs and provide new roofs (1700sf)

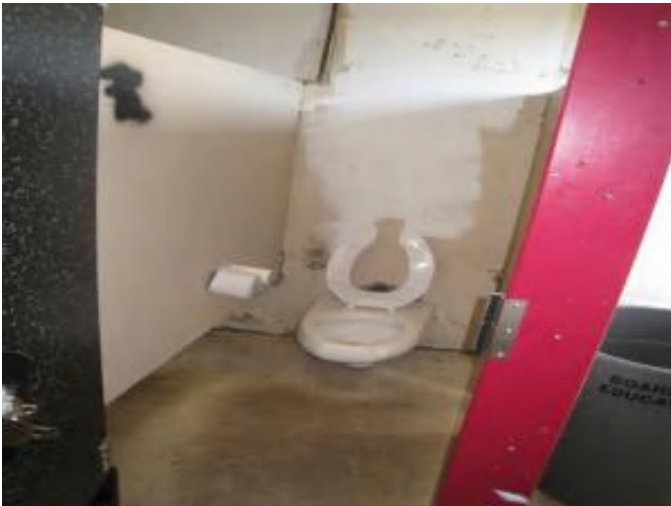
Location: Lincoln - Stands and Toilet Facilities

System: C1030 - Fittings

Distress: Beyond Service Life

Correction: Remove and replace toilet partitions

Notes: Provide new toilet partitions and accessories – all toilet facilities (estimated 16 toilets and lavatories)
