Facility Condition Assessment Summary Report

Meehan Middle School

S801001;Lincoln, Meehan, and Field

Site Assessment Report

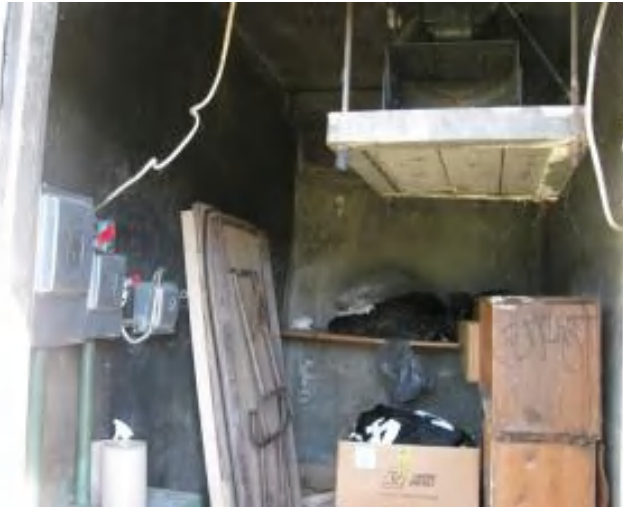
Location: Lincoln - Football field

System: D5010 - Electrical Service/Distribution

Distress: Beyond Service Life

Notes: Upgrade the existing electrical service with a new service. Provide 400A, 120/208V distribution switchboard.

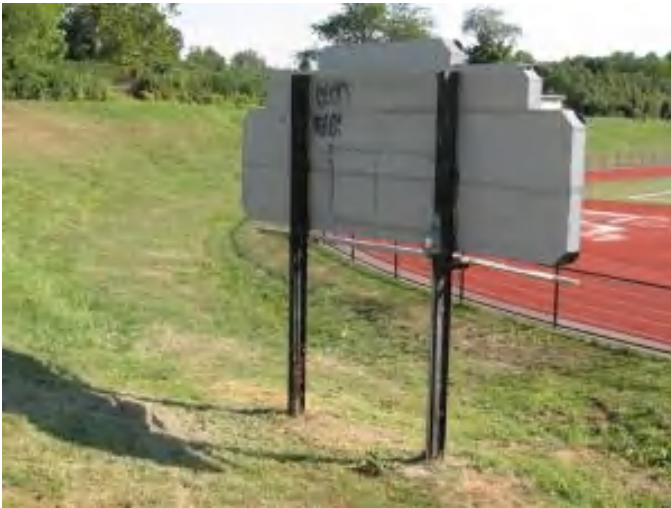
Location: LIncoln - Football field

System: D5020 - Lighting and Branch Wiring

Distress: Security Issue

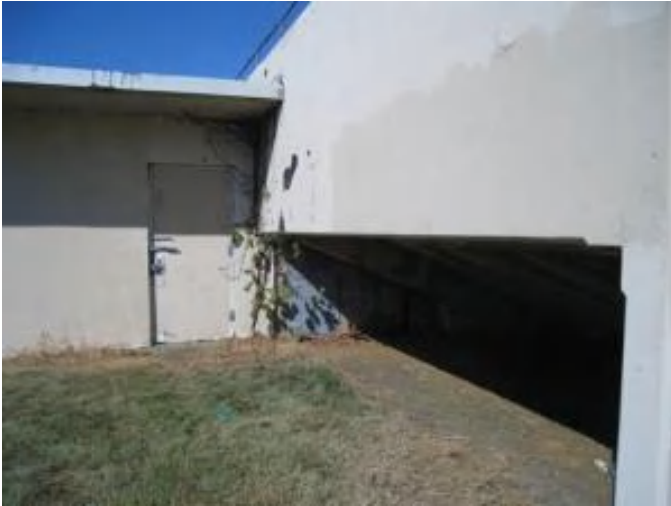
Location: Lincoln - Stands and Toilet Facilities

System: B1010 - Floor Construction

Distress: Damaged

Correction: Repair rebar and epoxy grout exposed rebar on the underside of floors and floor beams

Notes: Inspect concrete stands and document the areas where reinforcing rods are exposed and concrete is spalling. Repair spalled concrete steps, sides and top beams where cracks have formed. Estimated half of concrete structure needs repairs (8000sf)

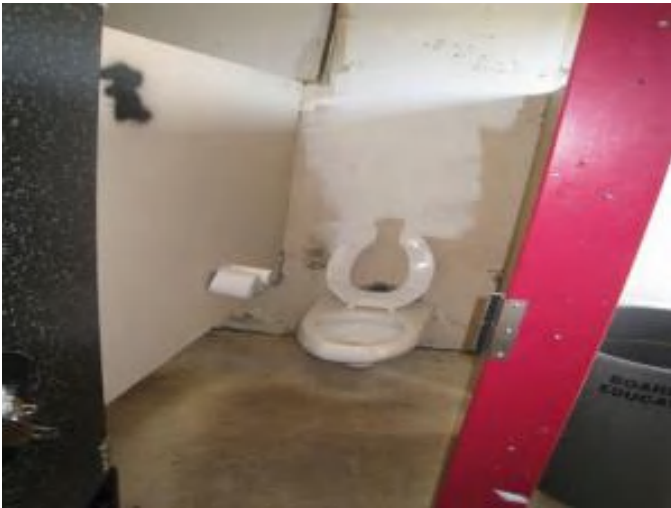
Location: Lincoln - Stands and Toilet Facilities

System: C1030 - Fittings

Distress: Beyond Service Life

Correction: Replace toilet accessories - select accessories and quantity

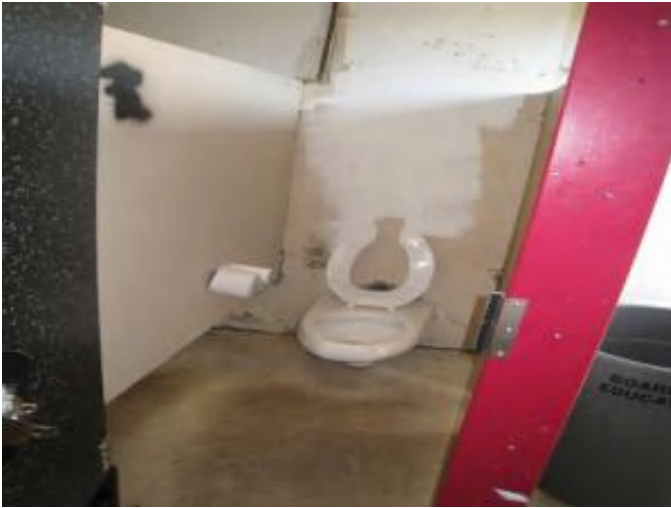
Location: Lincoln - Stands and Toilet Facilities- Restroom

System: D2010 - Plumbing Fixtures

Distress: Beyond Service Life

Correction: Remove and replace or replace water closet - quantify additional units

Notes: Replace all water closets in the building with lower flow fixtures, as the fixtures are original.

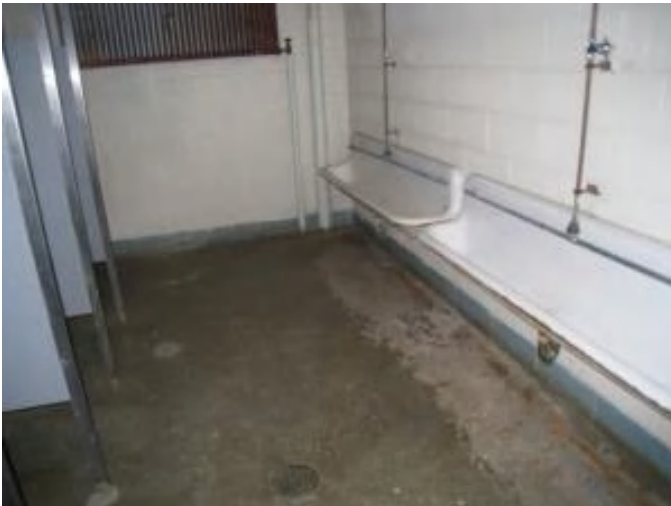
Location: Lincoln - Stands and Toilet Facilities- Restrooms

System: D2010 - Plumbing Fixtures

Distress: Beyond Service Life

Correction: Remove and replace or replace wall hung urinals

Notes: Replace all urinals in the building with lower flow fixtures, as the fixtures are original.

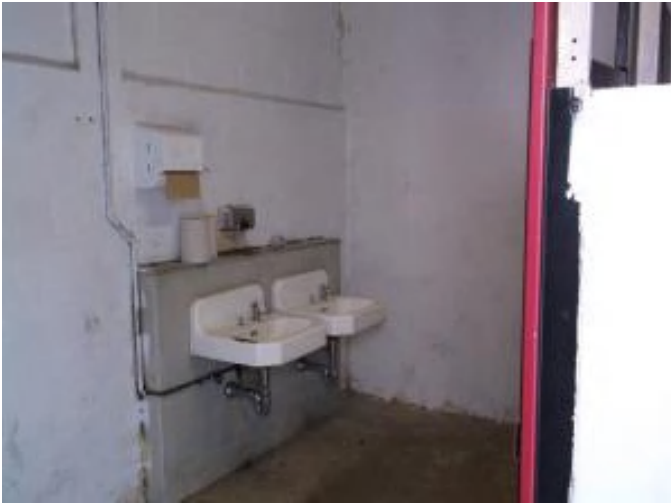
Location: Lincoln - Stands and Toilet Facilities- Restroom

System: D2010 - Plumbing Fixtures

Distress: Beyond Service Life

Correction: Remove and replace or replace lavatory - quantify accessible if required

Notes: Replace all lavatories in the building with lower flow fixtures, as the fixtures are original.

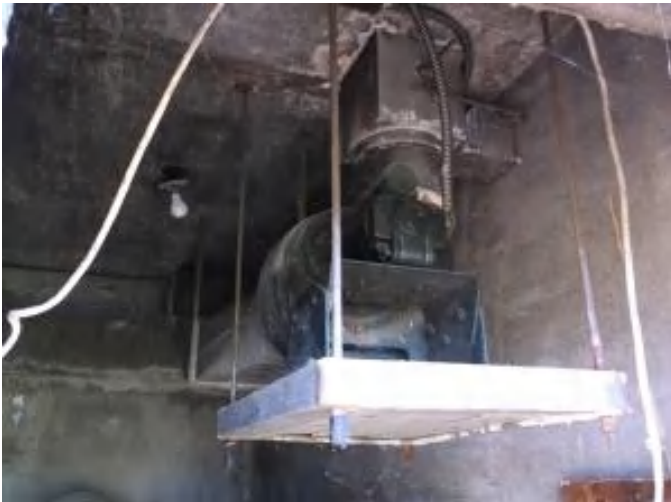
Location: Lincoln - Stands and Toilet Facilities- Restrooms

System: D3040 - Distribution Systems

Distress: Beyond Service Life

Notes: Install exhaust fans.

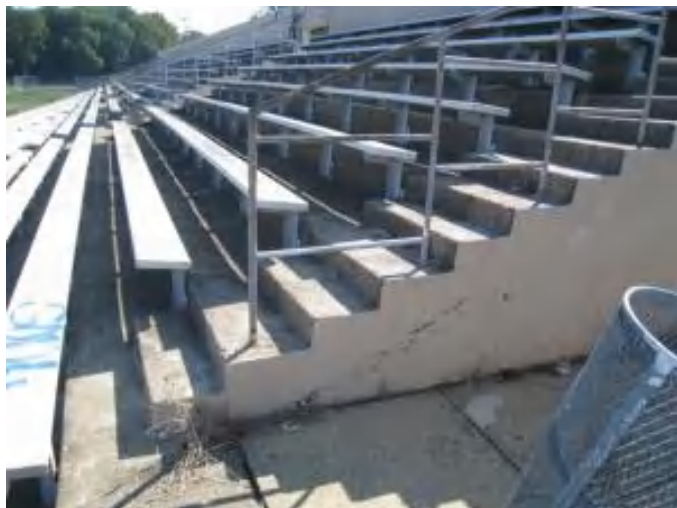
Location: Lincoln - Stands and Toilet Facilities

System: E2010 - Fixed Furnishings

Distress: Appearance

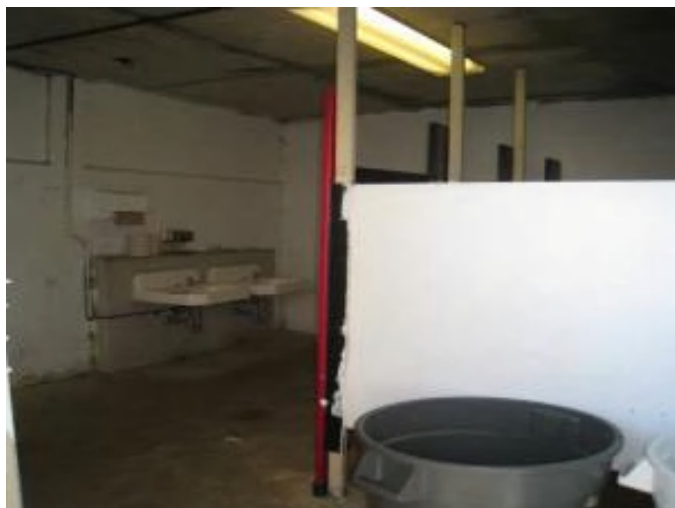
Location: Lincoln - Stands and Toilet Facilities

System: C3030 - Ceiling Finishes

Distress: Appearance

Notes: Repair and repaint toilet room ceilings (1700sf)

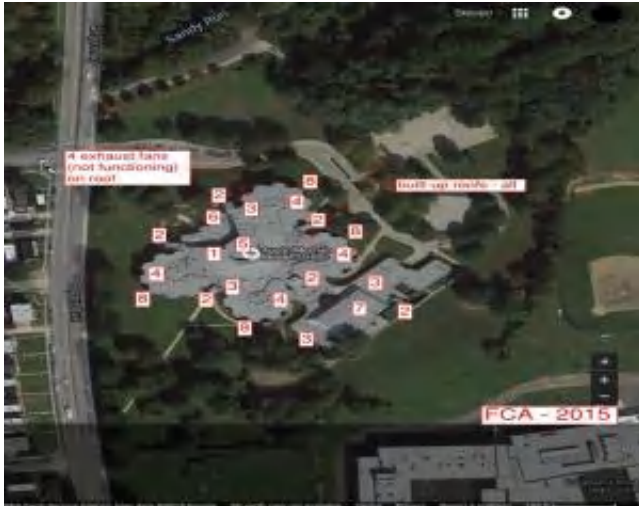
Location: Meehan - roof

Roof coverings is a fully adhered rolled asphalt sheet system with impregnated light gray granules in the surface. The system is thought to be approximately 20 years old; much of the granular coating has worn away exposing the black asphalt membrane to the sun, wind, and natural elements. There are some soft areas indicating moisture in the insulation underneath. The roof membrane is in poor condition dried cracked asphalt seen along membrane joints and flashing. Some areas are stained with dirty marks and mildew indicating poor or no drainage; water can only evaporate from these areas. The back side of some stair towers have been re-roofed with a fully adhered rubber membrane which covers over an area that had built-up asphalt and a clerestory window into the stairway. The overall condition of the roofing membrane and flashing is "weathered" and is past its normal service life of 20 years and needs to be completely replaced. Roof openings include toilet room vents, ventilation ductwork, and roof drains. Flashing of the penetrations appears to be failing and past its normal service life, although no leaks were reported at this time.

System: B3010105 - Built-Up

Distress: Failing

Notes: Remove and replace existing flat roof and insulation; 8 levels (94,000sf)

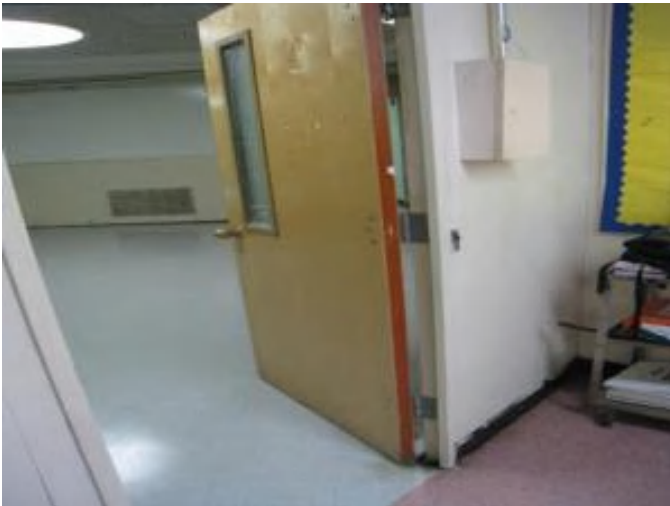
Location: Meehan - upper floor corridor walls

System: C1010 - Partitions

Distress: Building / MEP Codes

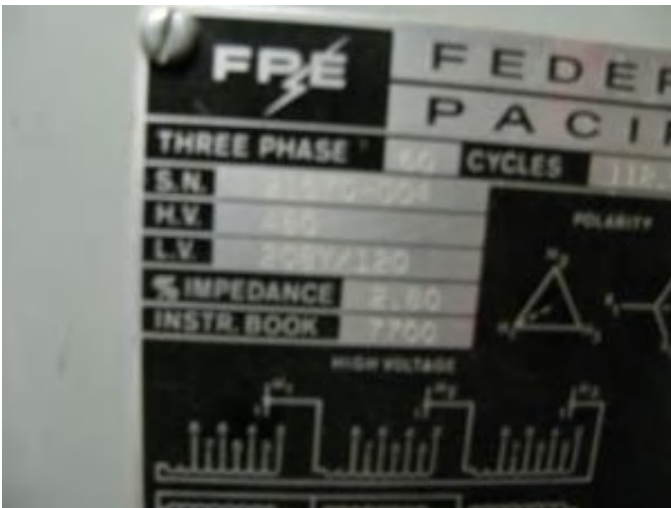
Location: Meehan- Electrical Room Basement

System: D5010 - Electrical Service/Distribution

Distress: Beyond Service Life

Notes: Upgrade the existing electrical service with a new service. Replace the existing substation with a new 3000A, 480/277V, 3PH, 4 wire substation.

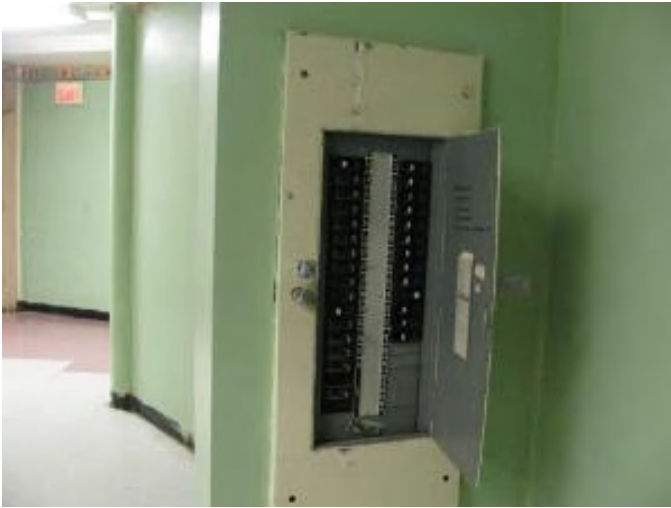
Location: Meehan - entire building

System: D5010 - Electrical Service/Distribution

Distress: Beyond Service Life

Notes: Replace the entire distribution system with new panels and new wiring/conduits. Provide arc flash label on the electrical equipment. Estimated 20 panel boards.

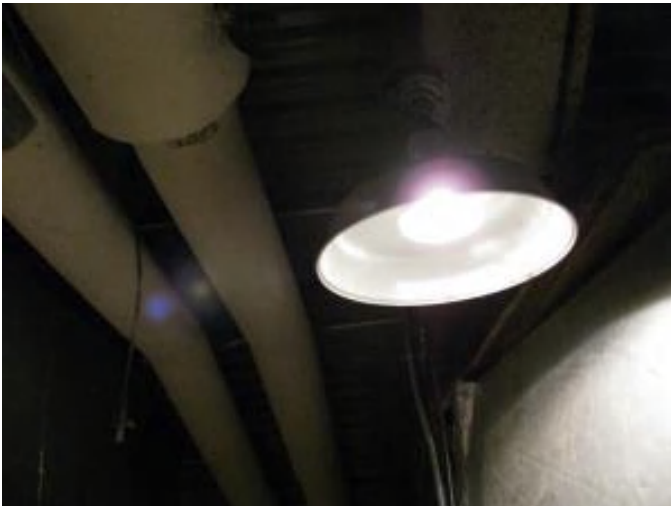
Location: Meehan-Entire Building

System: D5020 - Lighting and Branch Wiring

Distress: Beyond Service Life

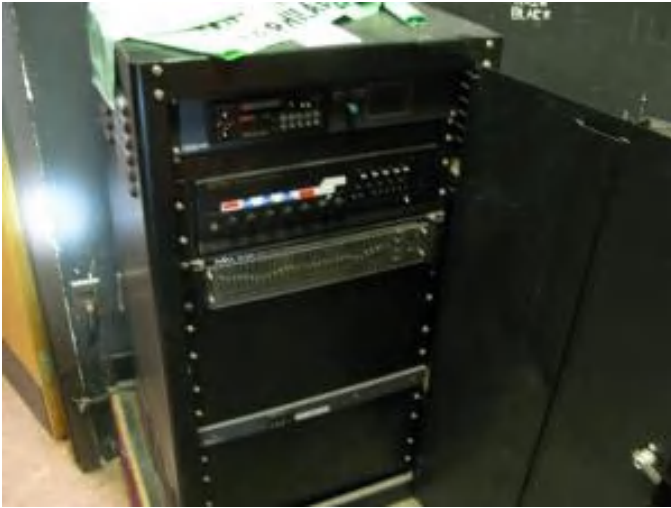
Location: Meehan - Backstage

System: D5030 - Communications and Security

Distress: Beyond Service Life

Notes: Replace sound system including a freestanding 19" rack backstage area with a mixer, amplifiers, CD player, cassette player, AM-FM radio, graphic or parametric equalizer, and receivers in auditorium and dining area.

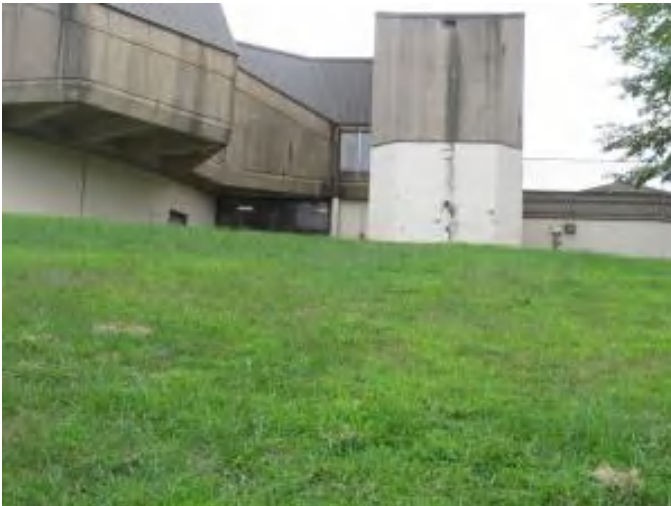
Location: Meehan- Exterior Building

System: D5030 - Communications and Security

Distress: Inadequate

Notes: Provide outdoor speakers for cover the school yard. Estimated 10each.

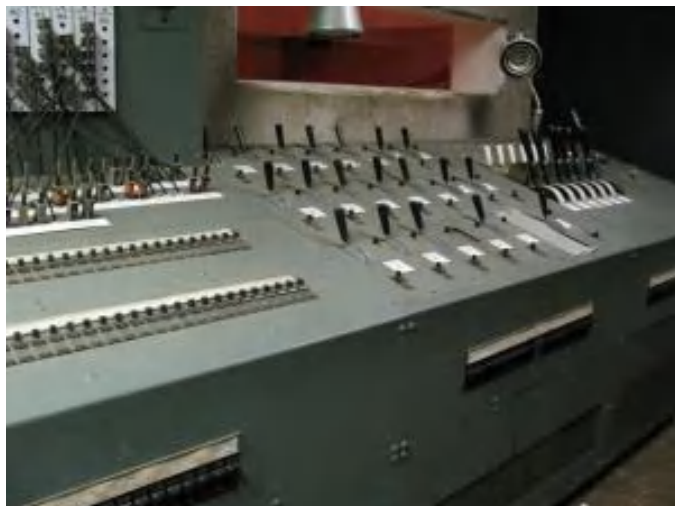
Location: Meehan- Auditorium

System: E1020 - Institutional Equipment

Distress: Beyond Service Life

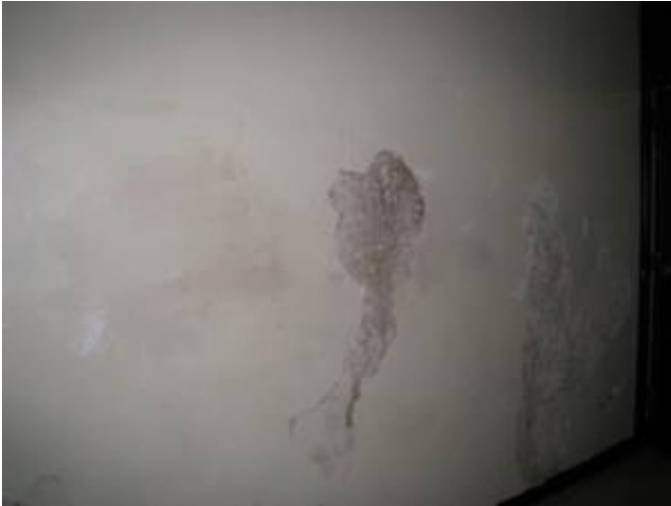
Location: Meehan - exterior wall around windows

System: A2020 - Basement Walls

Distress: Damaged

Notes: Repair water damage, cracks, and damages in concrete walls in corridors and classroom walls (1,500sf)

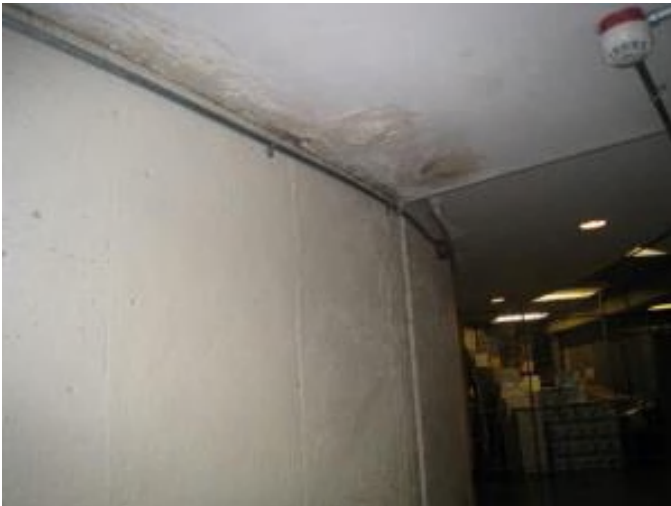
Location: Meehan - basement/foundation

Foundations are constructed of concrete. Most of the foundation and basement walls are in good condition but there are some areas of concern. The wall that faces the central circular courtyard has cracks and leaks. There are cracks in the basement at the wall and column near the entrance stairway support at the basement wall; concrete is spalling in this area. There is also a wet area in the basement near the entrance stair support. There are cracks in the circular wall near the ramp into the building, also near the main entrance. There is also spalling of some basement walls, due to moisture build-up on the other side of the wall. A possible cause for water entering the foundation wall and basement could be the poor grading outside the building. The grade and concrete walkways adjacent to the building are dead level and have not positive drainage away from the building. This would allow water to collect and drain down the foundation wall, eroding the wall below grade and eventually entering the basement through cracks. To make matters more difficult, there are several depressed window well areas, always a concern when it comes to drainage and maintenance of a dry basement. Drainage of the window well spaces could not be tested or completely inspected due to overgrown vegetation in some areas. All grading around the building needs to be studied and adjusted to allow for natural drainage away from the building foundation wall. Footings at the bottom of the foundations were not seen and their construction type or condition could not be ascertained.

System: A2020 - Basement Walls

Distress: Failing

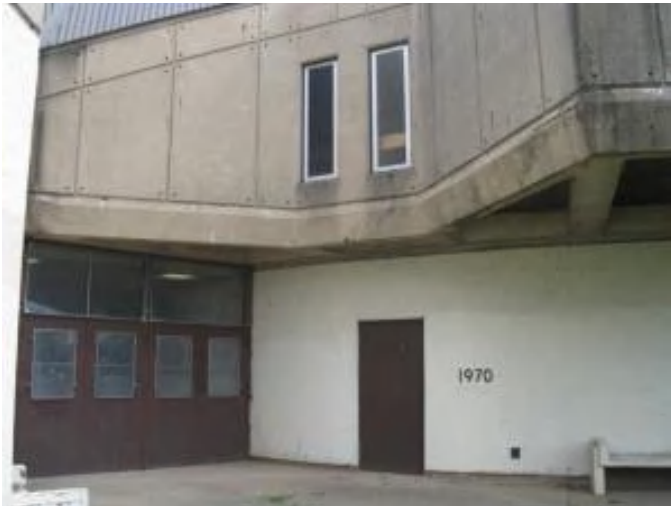
Location: Meehan - concrete walls

Exterior walls and are constructed of cast-in-place concrete and steeply sloped corrugated metal siding. The flat areas of the walls are exposed concrete and in good condition over most building wall surfaces. As is typical for the "brutalism" style, concrete tie recesses at regular locations, bold reveals simulating joints, and some variation in aggregate is visible over all wall surfaces. Walls are cantilevered approximately 8 ft. beyond the Lower Floor walls by use of large, exposed concrete beams. There are a number of areas of concern relating to the condition and structural integrity of the exterior concrete walls and bold cantilevered supports of the Upper Floor:

Sizeable cracks in the intersections of beams and walls and along the bottoms of some of the beams supporting cantilevered walls

Spalled areas of concrete walls and spalled cantilever support beams where exposed rusted steel reinforcement is visible

Horizontal cracking and spalling of concrete walls above the base of the cantilevered walls

Linear cracking of perimeter concrete beams supporting Upper Floor walls

System: B2010 - Exterior Walls

Distress: Failing

A thorough inspection of all walls and cantilever beams is required to determine where all cracking is located and if there is a common cause for groups of cracks, such as subsurface settlement. After repairs have been made, the exterior of the building should be powerwashed.

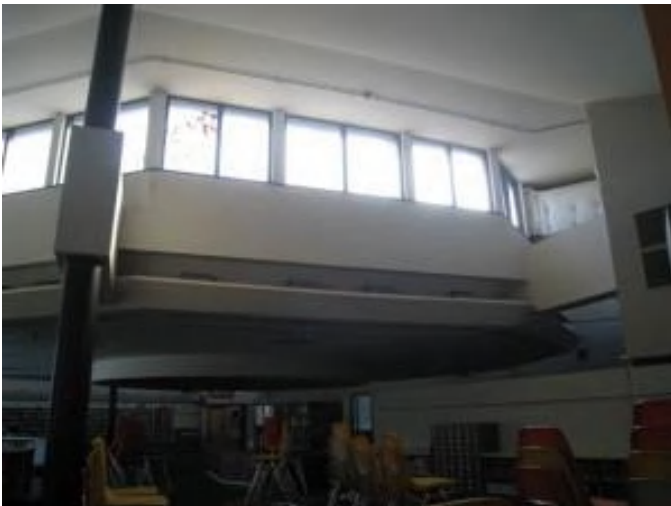
Location: Meehan - windows

Exterior windows appear to be the original anodized aluminum frame units with side-hinged operable single thickness clear plexiglass acrylic glazing. Windows are narrow and do not let in much natural light. They are positioned at the fronts of most classrooms and cause distractions to students who can easily look out windows instead of looking at teacher and are also a source of glare. They are now in poor condition with oxidized frames and severely scratched single-pane plexiglass vision panels. Most windows do not have screens and if opened would provide an easy way for students to fall out; thus, wood boards have been attached to the inside of the windows to make it more difficult for students to accidentally fall out of windows whether opened or closed. Lower floor windows are small, do not let in much natural light and look like basement windows when viewed from the inside spaces; they all have security screens and many have graffiti. The Library has clerestory windows which have been covered with graffiti. There is also a band of windows at floor level which have a view across the lower roof. These windows have numerous leaks which have damaged gypsum board walls, dampened the carpet, and caused a musty smell to persist near the windows. Units do not seal tightly and have corroded and stained frames. Single pane plexiglass units do not meet today's energy code requirements and are large sources of heat loss – they should be replaced with new insulated glazing units.

System: B2020 - Exterior Windows

Distress: Failing

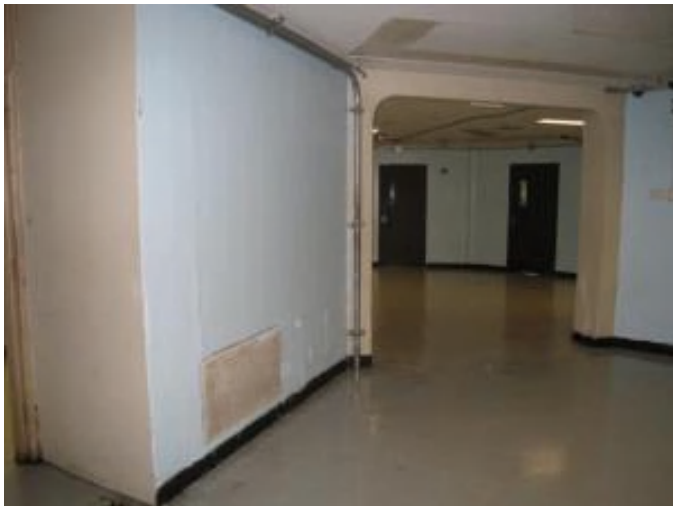
Location: Meehan - interior doors

System: C1020 - Interior Doors

Distress: Failing

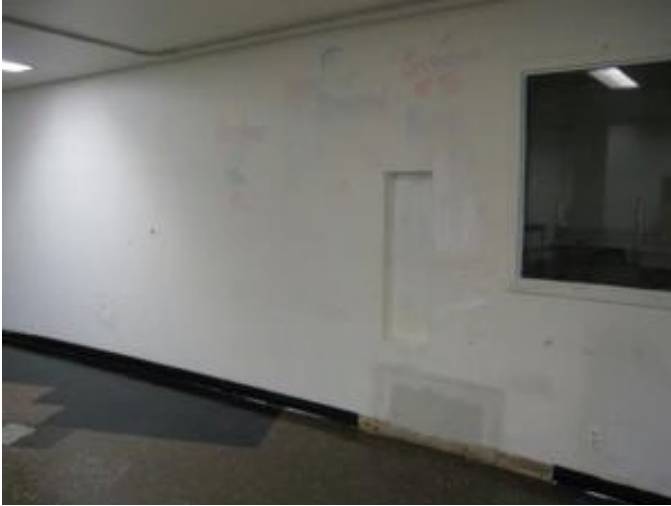
Location: Meehan - interior walls

System: C3010230 - Paint & Covering

Distress: Damaged

Notes: Repaint all remaining interior walls Upper and Ground Floor; half of walls on Lower Level (50,000sf)

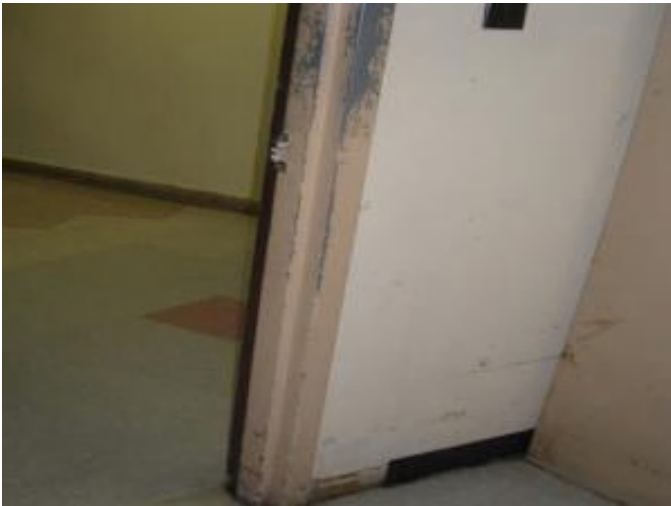
Location: Meehan - gyp bd walls and clgs

System: C3010230 - Paint & Covering

Distress: Damaged

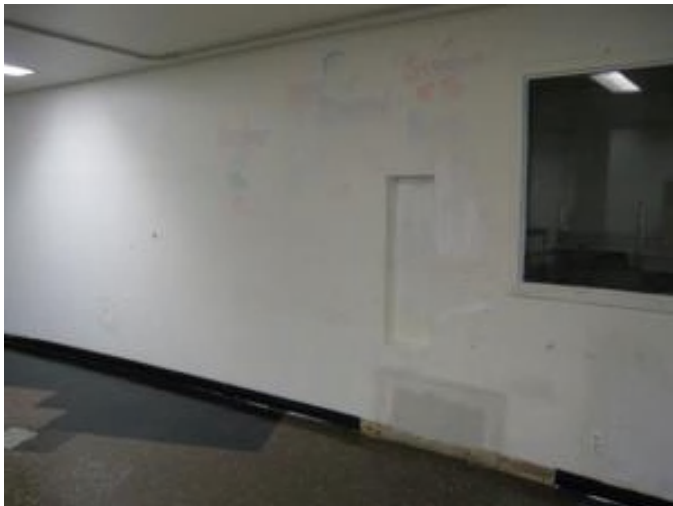
Location: Meehan - classrooms, corridors, offices

Floor finish in most of the school is 12" x 12" VCT (vinyl composition tile) glued to the concrete slab. Many Upper and Lower floor spaces have tiles have been patched and replaced with mismatching tiles – all are in poor condition; other floors have tiles that are aging and cupping on the edges also in poor condition. Some Lower Floor rooms have newer tiles in good condition. The auditorium has worn and dirty carpet circulation pathways and exposed concrete under the seating; the stage is finished with wood, in need of refinishing. There are stepped music rooms surrounding the auditorium that are either carpet which needs to be replaced or VCT which seems to be in good condition. The gymnasium has wood floors which should be refinished. Gym locker rooms are VCT which is newer and in good condition. The cafeteria area and the kitchen prep (located down the ramp in the mechanical area behind the cafeteria) is finished with VCT. Stair walking surfaces are exposed concrete which is dirty and needs to be stripped, cleaned and resealed. Most toilet rooms have ceramic mosaic floors which are dirty and in need of cleaning except for those in the special needs instructional area which are new.

System: C3020413 - Vinyl Flooring

Distress: Failing

Notes: Remove and replace damaged, old 12"x12" VCT floors in approximately half of classrooms, corridors, and offices with VCT (40,000sf)

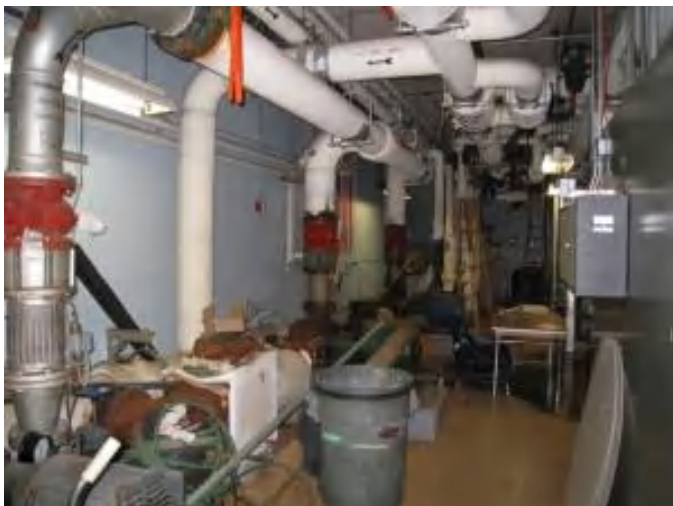
Location: Meehan - mechanical rooms, stairs

System: C3020415 - Concrete Floor Finishes

Distress: Appearance

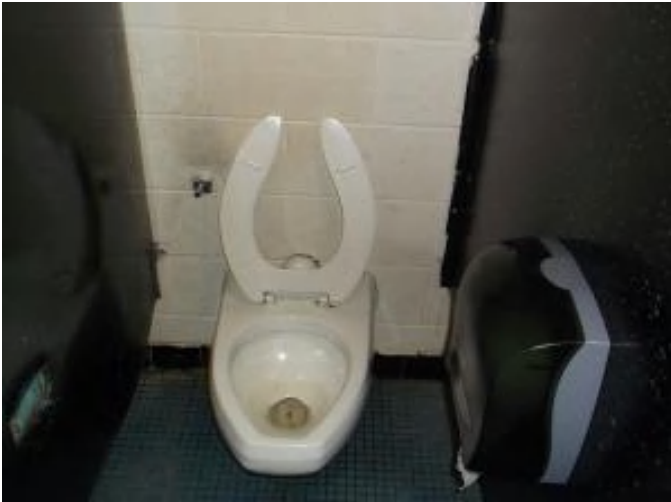
Location: Meehan - Throughout the school

System: D2010 - Plumbing Fixtures

Distress: Beyond Service Life

Notes: Replace all water closets in the building with lower flow fixtures, as the fixtures are original.

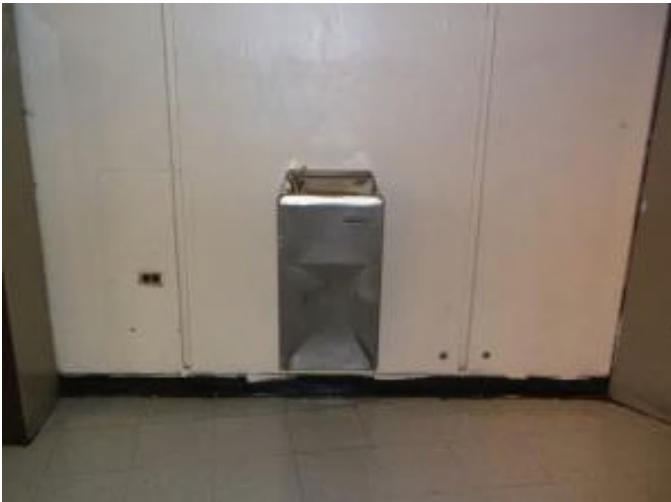
Location: Meehan - Throughout the school

Electric self-contained refrigerated wall hung drinking fountains are generally located near restroom groups in the corridors. The exception to this condition is the gymnasium and locker areas which have a combination recessed wall type electric water coolers and original drinking fountain fixtures. Most are not ADA compliant. It appears that the some of the drinking fountains have been replaced, however these fixtures have taken heavy abuse, so the replacement of all drinking fountains is recommended. .

System: D2010 - Plumbing Fixtures

Distress: Beyond Service Life

Notes: Replace the wall hung drinking fountains and integral refrigerated coolers in the corridors and at the restrooms. These units are well beyond their service life and most are NOT accessible type.

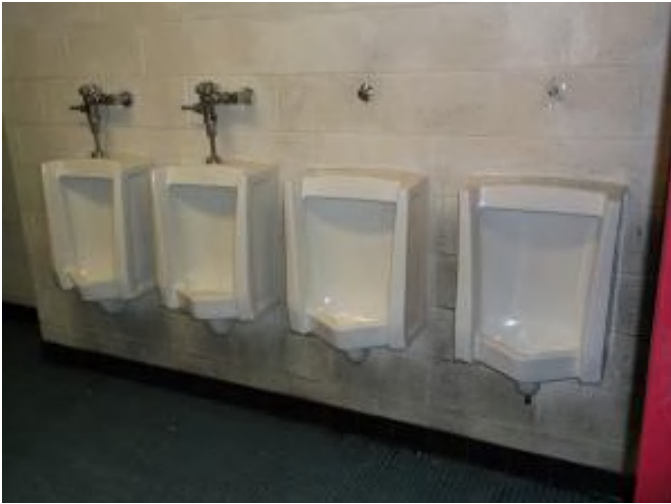
Location: Meehan - Throughout the school

System: D2010 - Plumbing Fixtures

Distress: Beyond Service Life

Notes: Replace all urinals in the building with lower flow fixtures, as the fixtures are original.

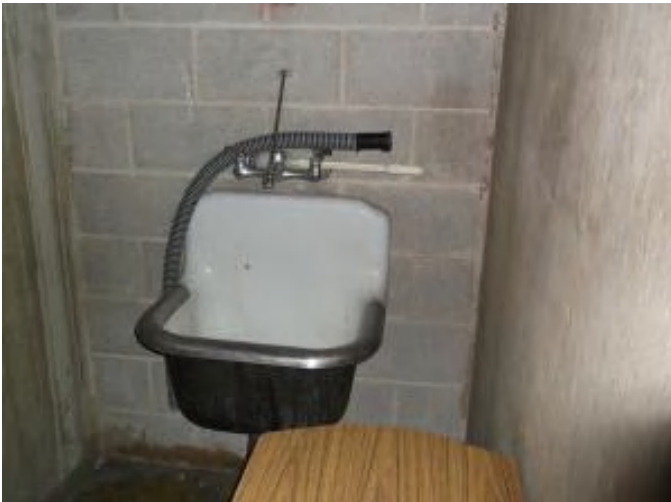
Location: Meehan - Throughout the school

Wall hung service sinks are original and are available throughout the building for use by the janitorial staff. Service sinks are typically located in the vicinity of the bathroom groups. The sinks appear have exceeded their service life and should be replaced. The Cafeteria's food prep/kitchen is equipped with one, three compartment stainless steel sink with wheel handle operated faucets and its sanitary connection is served by a floor mounted grease trap. The kitchen is also equipped with a hand sink. The triple wash sink (with wheel handles) and hand sink (with lever handles) show signs of normal usage. The grease interceptor shows no signs of rust or corrosion and is accessible for maintenance. Chemicals are injected manually into the sanitizing basin.

System: D2010 - Plumbing Fixtures

Distress: Beyond Service Life

Notes: Replace service sinks (janitor sinks) in the building

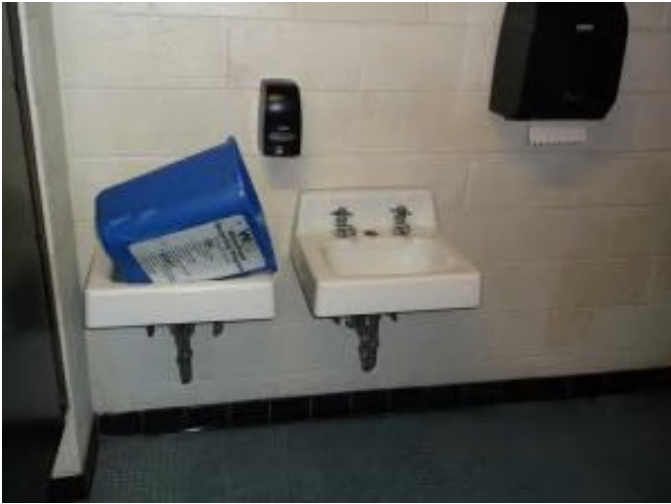
Location: Meehan - Throughout the school

System: D2010 - Plumbing Fixtures

Distress: Beyond Service Life

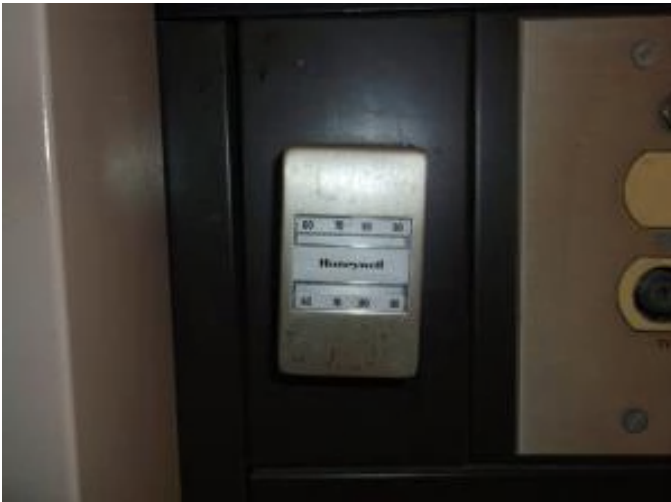
Location: Meehan - Throughout the building

System: D3060 - Controls & Instrumentation

Distress: Beyond Service Life

Correction: Replace pneumatic controls with DDC (250KSF)

Notes: Replace the pneumatic controls for the HVAC systems with modern DDC modules, valves and actuators to improve reliability and energy efficiency. Provide a new building automation system (BAS) with communication interface to the preferred system in use throughout the District.

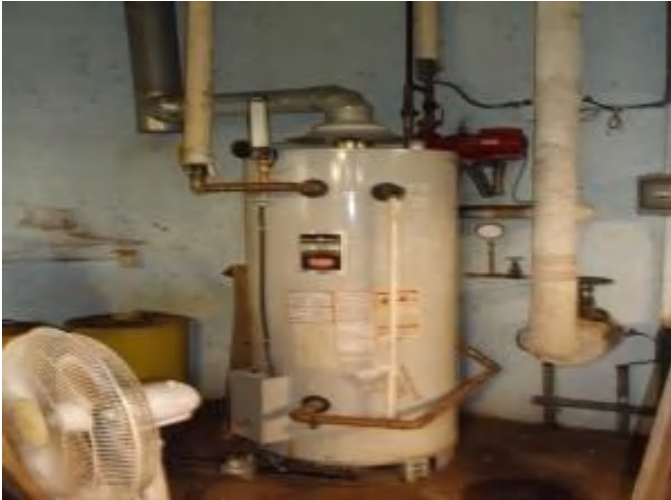
Location: Meehan - Boiler Mechanical Equipment Room

System: D2020 - Domestic Water Distribution

Distress: Beyond Service Life

Correction: Replace vertical tank type gas-fired water heater (120 gal)

Notes: Replace natural gas fired water heater.

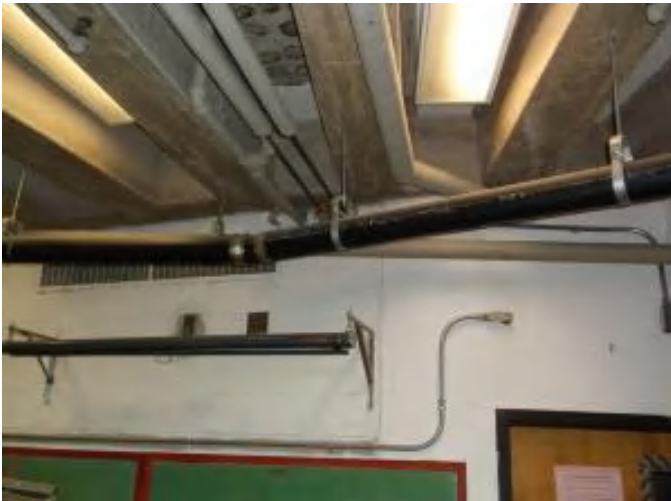
Location: Meehan - Throughout the building

System: D2030 - Sanitary Waste

Distress: Beyond Service Life

Correction: Inspect sanitary waste piping and replace damaged sections. (+200KSF)

Notes: Hire a qualified contractor to perform a detailed examination of the sanitary waste piping using visual inspection and video cameras to locate and replace any damaged piping and to further quantify the extent of potential failures.

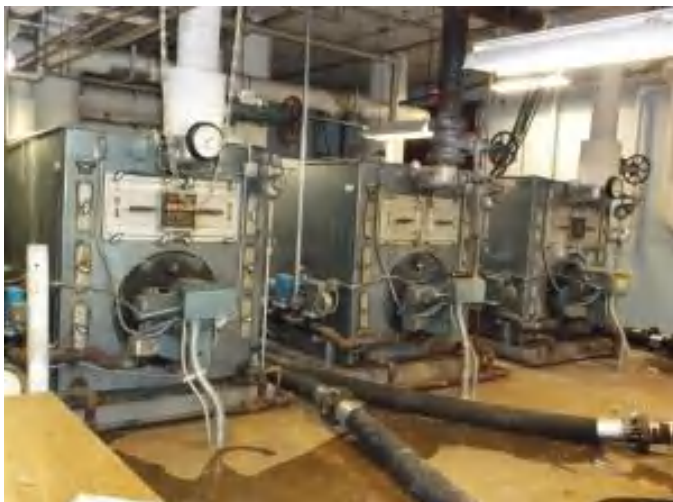
Location: Meehan - Boiler Mechanical Equipment Room

System: D3020 - Heat Generating Systems

Distress: Beyond Service Life

Correction: Replace boiler, cast iron sectional (100 HP)

Notes: Replace the three 3,791 MBH Weil McLain 94 series hot water boilers estimated to have been in service since the 1970s.

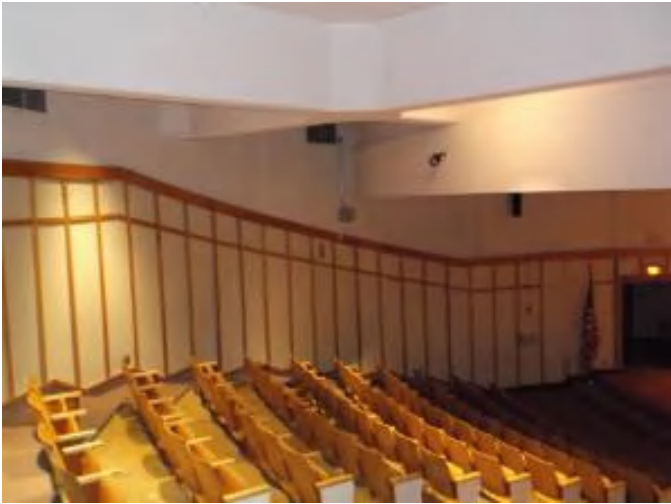
Location: Meehan - Auditorium

System: D3040 - Distribution Systems

Distress: Beyond Service Life

Correction: Replace HVAC unit for Auditorium (200 seat).

Notes: Provide ventilation, heating and cooling for the Auditorium by removing the existing air handler and installing a new modular constant volume air handling unit with heating and cooling.

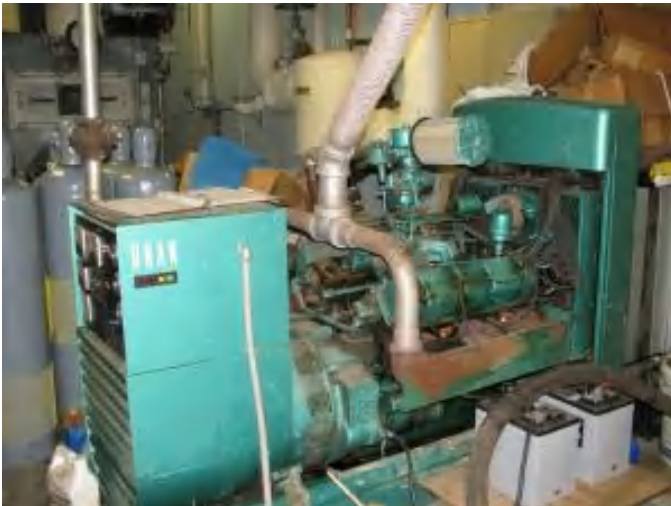
Location: Meehan- Boiler Room

System: D5090 - Other Electrical Systems

Distress: Beyond Service Life

Correction: Replace standby generator system

Notes: Replace existing generator with new 100KW generator

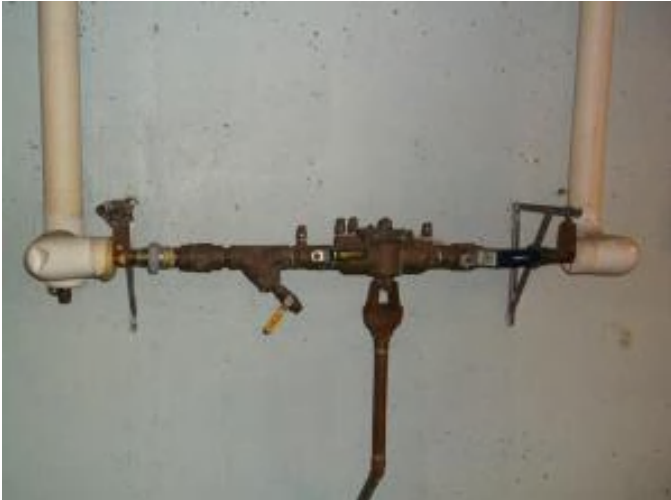
Location: Meehan - Throughout the building

System: D2020 - Domestic Water Distribution

Distress: Beyond Service Life

Correction: Replace domestic water piping (250 KSF)

Notes: Inspect and replace the original as needed the domestic water piping in the building

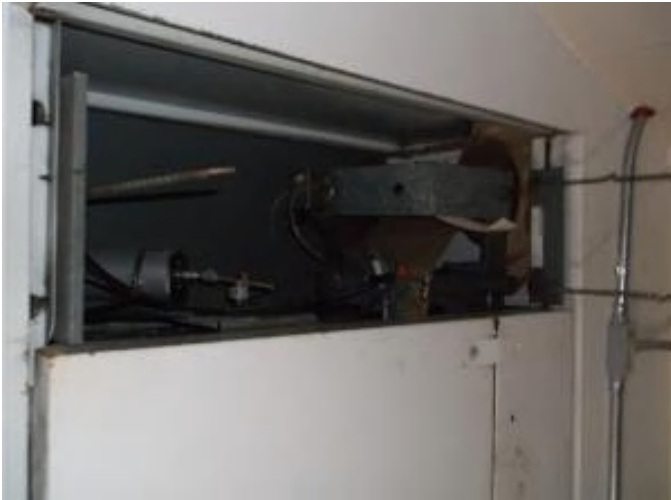
Location: Meehan - Throughout the building

System: D3040 - Distribution Systems

Distress: Beyond Service Life

Notes: Replace the existing unit ventilators throughout the building with new units designed to provide adequate ventilation per ASHRAE Std 62. The new units shall be equipped with hot water / chilled water coils and integral heat recovery wheels. Install steam converters in the existing boiler room with circulating pumps, distribution piping and controls to provide heating hot water for the new coils.

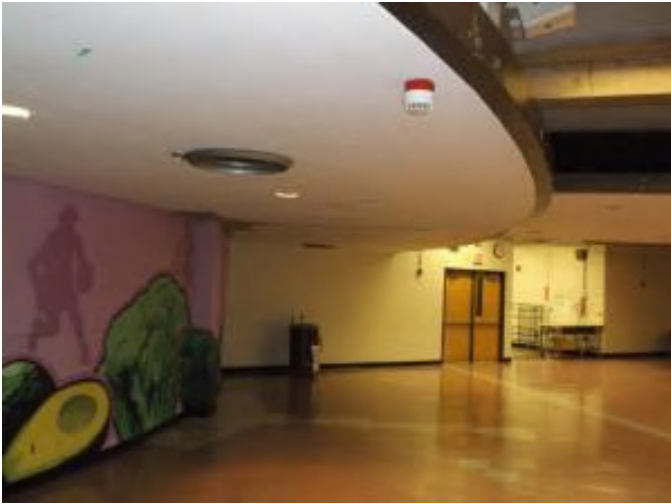
Location: Meehan - Cafeteria

System: D3040 - Distribution Systems

Distress: Beyond Service Life

Notes: Provide ventilation, heating and cooling for the Cafeteria by removing the existing air handler and installing a new modular constant volume air handling unit with heating, cooling, distribution ductwork and registers.

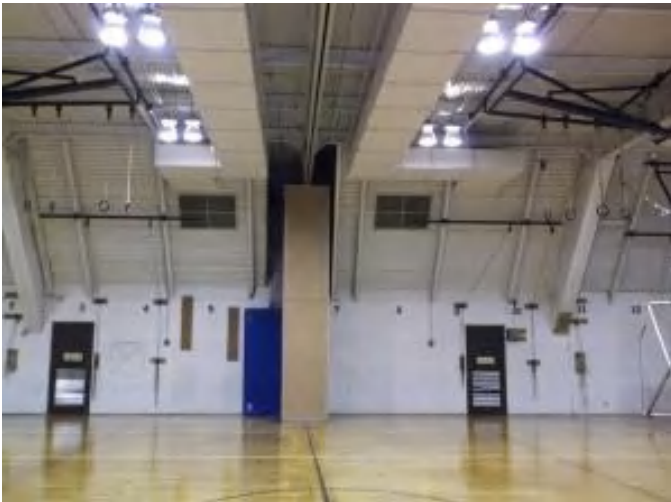
Location: Meehan - Gym

System: D3040 - Distribution Systems

Distress: Beyond Service Life

Notes: Provide ventilation, heating and cooling for the gymnasium by replacing the existing air handling unit.

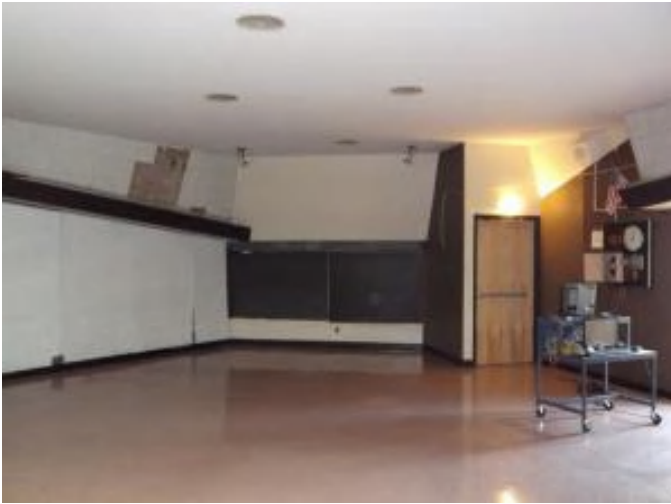
Location: Meehan - Throughout the building

System: D4010 - Sprinklers

Distress: Life Safety / NFPA / PFD

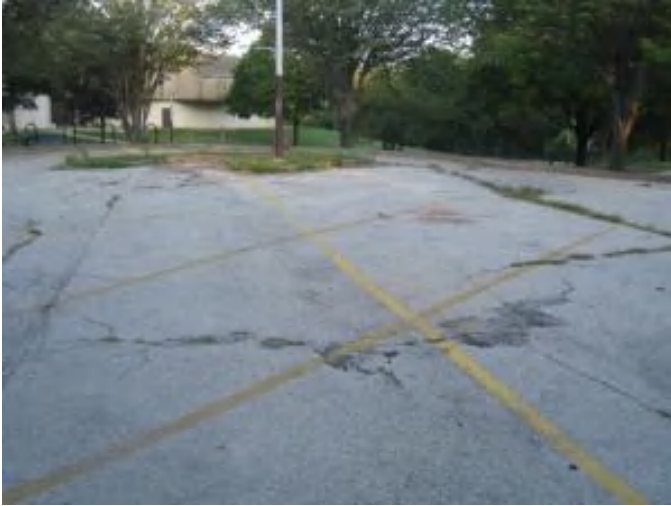
Location: Meehan - parking lots and roadways

System: G2020 - Parking Lots

Distress: Damaged

Correction: Remove and replace AC paving parking lot

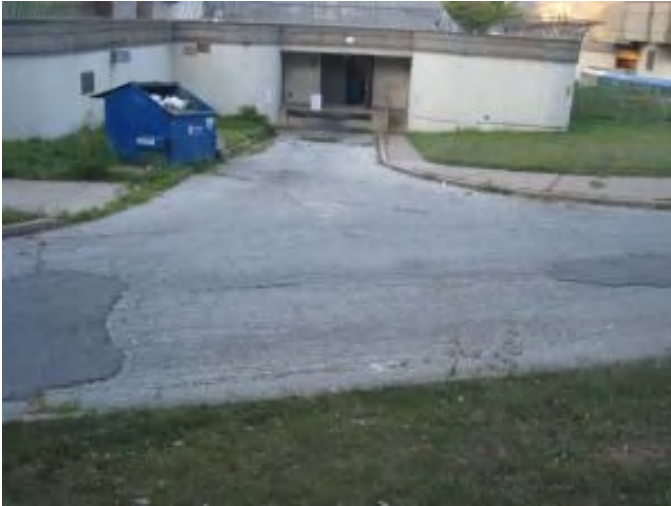
Location: Meehan - parking lots and roadways

System: G2020 - Parking Lots

Distress: Damaged

Correction: Remove and replace curbing

Notes: Replace concrete curbing (3000ft)

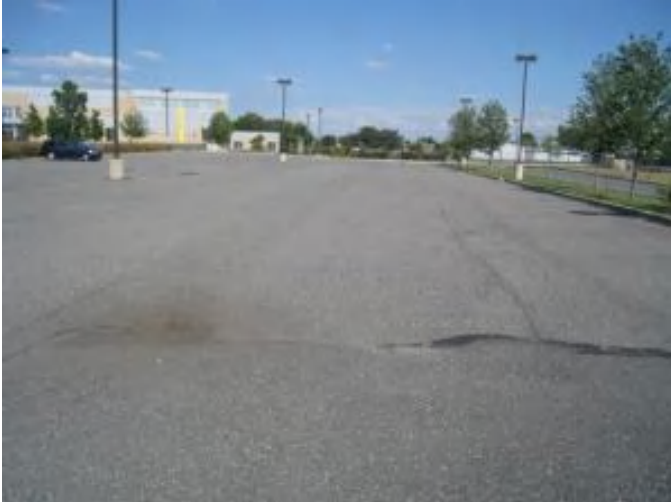
Location: Lincoln - Main Building - paving

System: G2020 - Parking Lots

Distress: Damaged

Correction: Fill cracks in AC paving - by the LF - average size and depth of crack

Notes: Fill cracks in asphalt parking lot (1000ft)

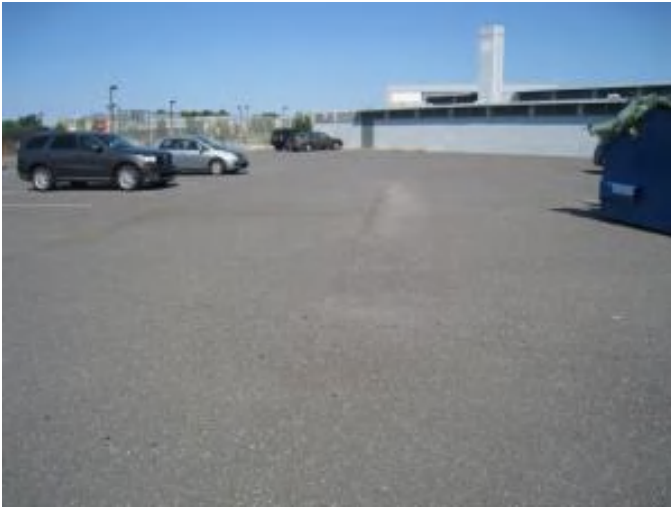
Location: Lincoln - Locker Facility

System: G2020 - Parking Lots

Distress: Failing

Correction: Fill cracks in AC paving - by the LF - average size and depth of crack

Notes: Fill cracks in asphalt parking lot (200ft)

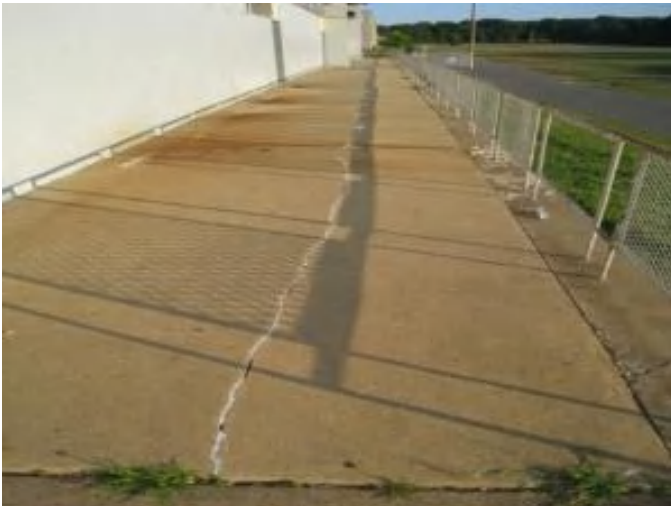
Location: Lincoln - Locker Facility

System: G2030 - Pedestrian Paving

Distress: Failing

Correction: Remove and replace concrete sidewalk or concrete paving - 4" concrete thickness

Notes: Replace concrete walkways (2000sf)

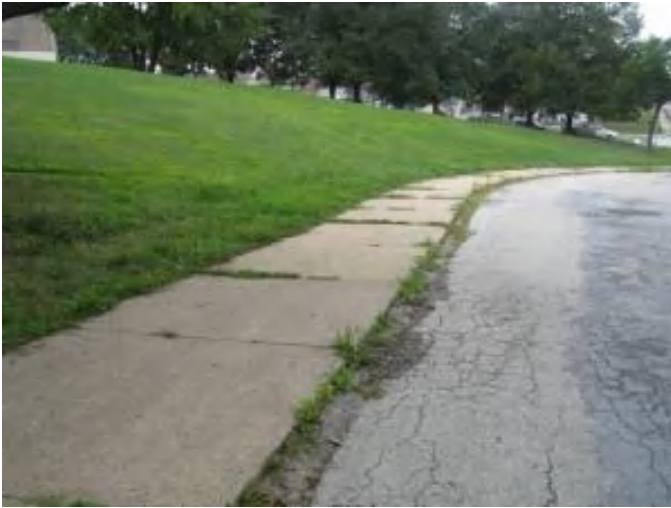
Location: Meehan - concrete walkways

System: G2030 - Pedestrian Paving

Distress: Damaged

Correction: Remove and replace concrete sidewalk or concrete paving - 4" concrete thickness

Notes: Repair concrete walkways (1000sf)

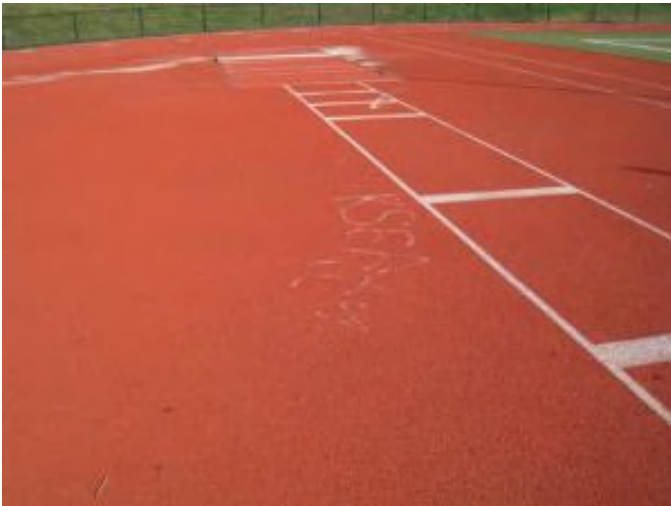
Location: Lincoln - track

System: G2030 - Pedestrian Paving

Distress: Damaged

Correction: Remove and replace resilient playground surface

Notes: Clean and repair sections of track surrounding football field (200sf)

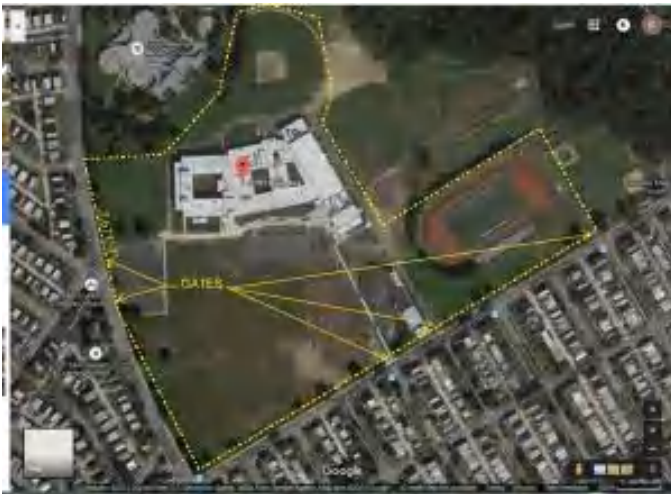
Location: Lincoln - entire site

System: G2040 - Site Development

Distress: Beyond Service Life

Correction: Replace chain link fence - 6' high

Notes: Replace/provide site fence around entire property(7600ft) total
