Facility Condition Assessment Summary Report

Meehan Middle School

S801001;Lincoln, Meehan, and Field

Site Assessment Report

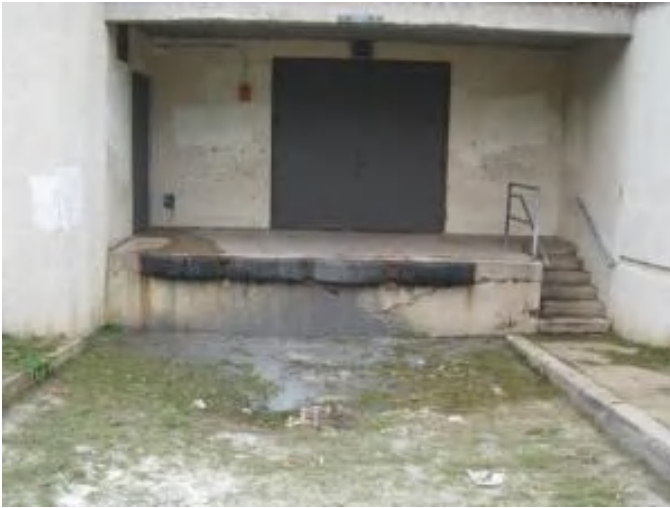
Location: Meehan - loading dock

System: G2040 - Site Development

Distress: Failing

Correction: Repair concrete retaining wall in poor condition including rebar doweling - insert the SF of wall area

Notes: Reconstruct loading dock (30sf vert, 100sf slab, 6 R)

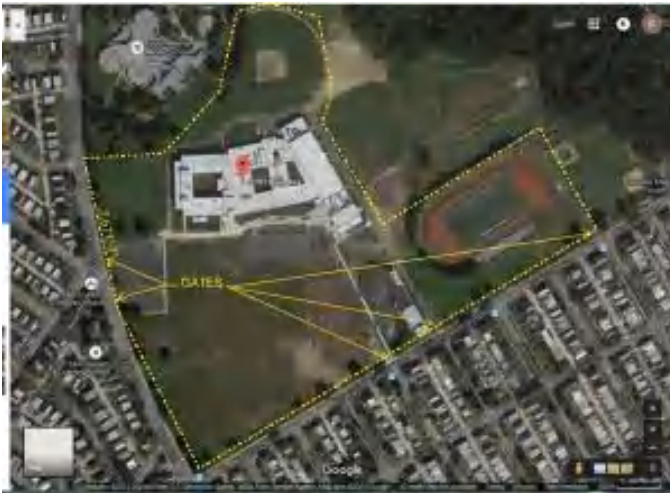
Location: Lincoln - Main Building - parking lots

System: G2040 - Site Development

Distress: Inadequate

Correction: Remove and replace chain link gate - 6' high

Notes: Provide gates for parking lot entrance facing Sackett Street (2) 20ft gates

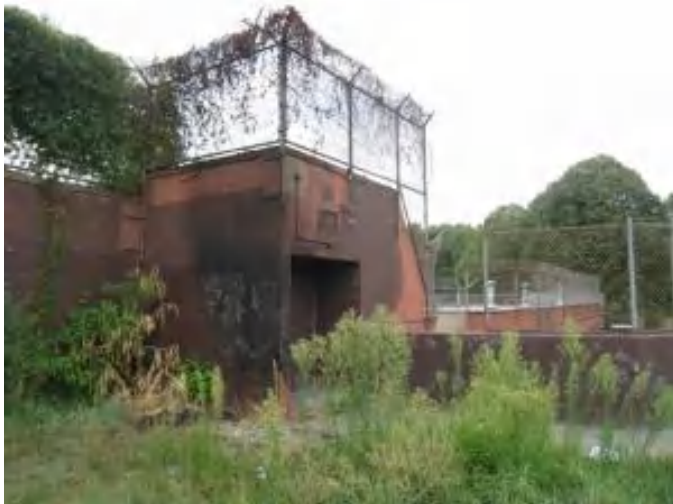
Location: Meehan - grading around building

System: G2050 - Landscaping & Irrigation

Distress: Maintenance Required

Correction: Replace landscape beds - including irrigation - small areas

Notes: Regrade exterior to provide slope away from building (8000sf)

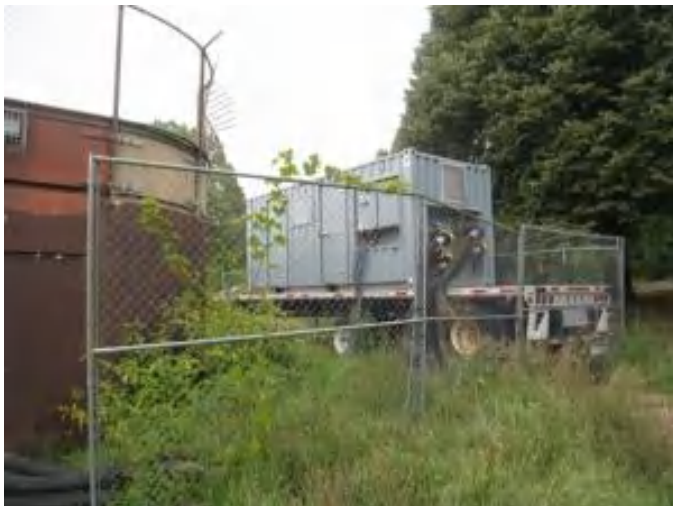
Location: Meehan - trim landscaping

System: G2050 - Landscaping & Irrigation

Distress: Maintenance Required

Correction: Replace landscape beds - including irrigation - small areas

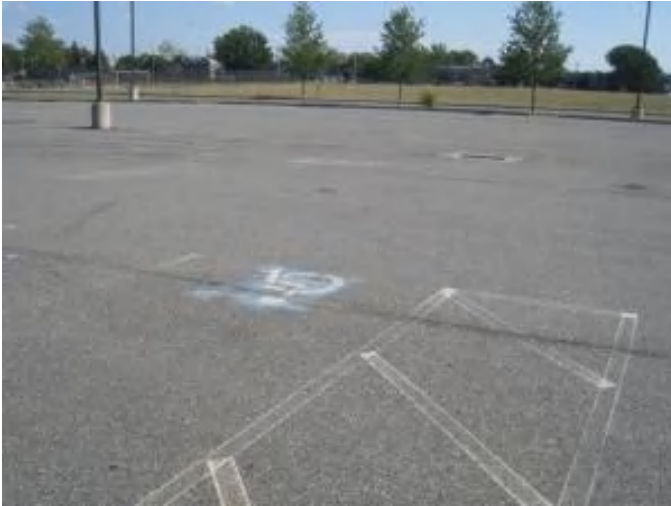
Location: Lincoln - Main Building - parking lots

System: G2020 - Parking Lots

Distress: Failing

Notes: Restripe parking lots (280 spaces + 9 HC)

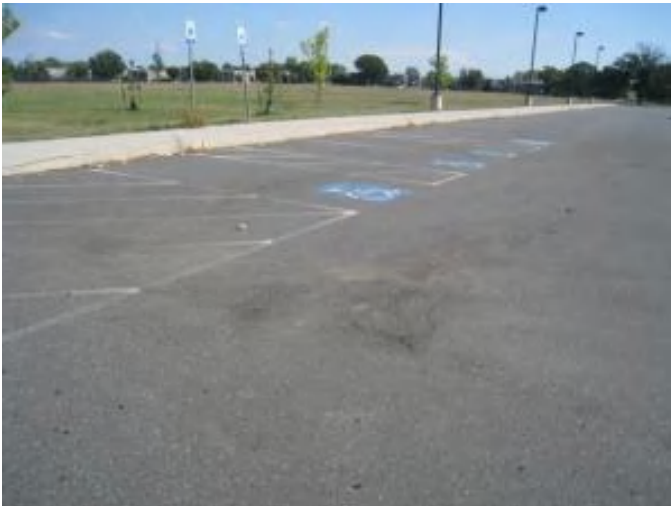
Location: Lincoln - Main Building - paving

System: G2020 - Parking Lots

Distress: Damaged
