Facility Condition Assessment Summary Report

Meredith School

School District of Philadelphia
S238001;Meredith
Final
Site Assessment Report
January 31, 2017

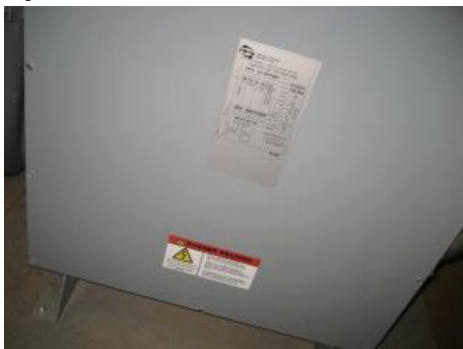
System: D5010 - Electrical Service/Distribution

A pole mounted transformer and overhead secondary conductors on Fitzwater Street serves this school. The electrical room is located in the basement approximate on the SW corner of the building. The electrical room houses the utility main disconnect switch, utility metering PECO Y6G004200001 and 600A 120/240V distribution section. Electrical service was upgraded in year 2000. The existing service has no extra capacity for expansion or new Heating, Ventilation, Air Conditioning (HVAC) system. The electrical service entrance needs to be upgraded, using the present utility pole. The new service will be 480V/277V, 3 phase power, approximate 800 Amperes and will be located in the vicinity of the existing electrical service. The new electrical service would feed a 480V Motor Control Center (MCC) and HVAC (Heating, Ventilation and Air Conditioning) equipment, and a 480V 3 phase to 120V/208V 3 phase 250 KVA step-down transformer to feed receptacles, lighting and other smaller loads.

In each floor, there are original 120/240V panel-boards for lighting and receptacles and new ones for window type air conditioning units. The original panel-boards and associated wiring have exceeded the end of their useful life and the new panel-boards are not sized to absorb additional HVAC loads. They need to be replaced. There are (1) 75KVA and (1) 50KVA phase converters from 240V to 120/208V which normally feeds newest mechanical equipment. Panel-board's doors at corridors are not locked and represent a potential hazard for students. As a safety issue all panel-boards at corridor or in areas where students are present must be provided with lockable devices.

Note: (1)75KVA and (1) 50KVA phase converters from 240V to 120/208V
