Facility Condition Assessment Summary Report

Morton School

Morton Annex (Our Lady of Loreto) School

January 30, 2017

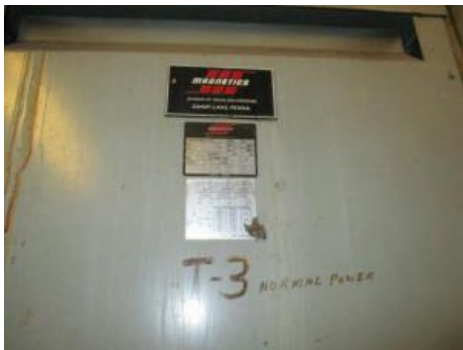
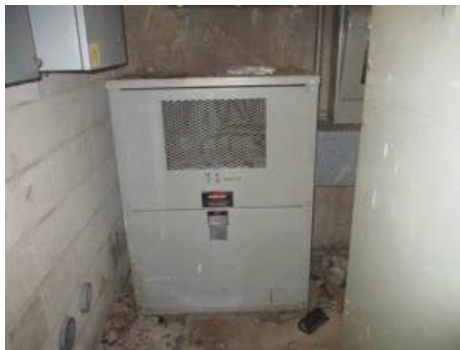
System: D5010 - Electrical Service/Distribution

A 500KVA, 13.2KV- 277/480V Unit Substation, located in the school basement serves this facility. The unit substation is manufactured by Kinney Electrical MFG Co. and is original installation and has already exceeded its 40 years of useful service life and has no extra capacity for expansion or new Heating, Ventilation, Air Conditioning (HVAC) system. An estimated 1000KVA, 13.2KV-480/277V Unit substation is required. The new unit substation will feed a 480V Motor Control Center (MCC) and HVAC (Heating, Ventilation and Air Conditioning) equipment, and a 480V 3 phase to 120V/208V 3 phase 225 KVA step-down transformer to feed receptacles, lighting and other smaller loads.

Note: Dry type transformers 112.5KVA, 75KVA and 30KVA. Manufactured by Magnetics

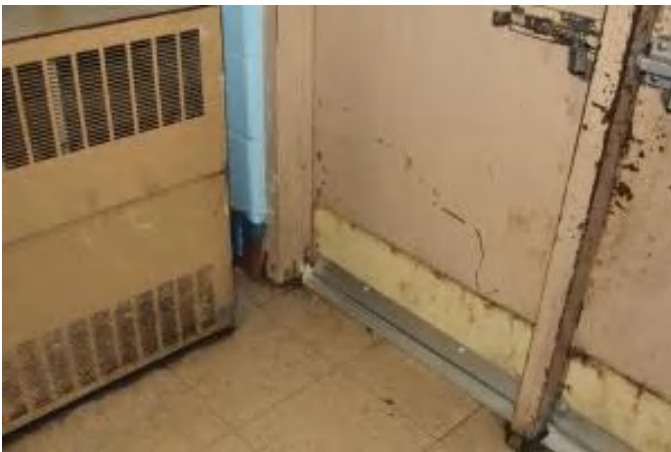
System: B2030 - Exterior Doors

Location: Throughout

Distress: Beyond Service Life

Notes: Replace exterior doors – rusted and beyond service life

Correction: Remove and replace exterior doors - per leaf

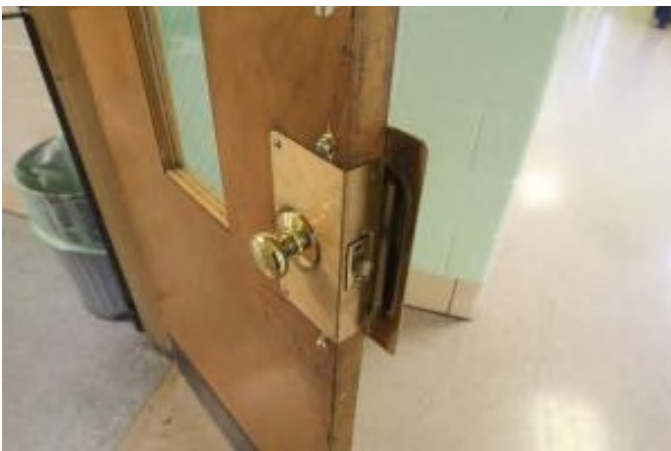
System: C1020 - Interior Doors

Location: Throughout

Distress: Accessibility

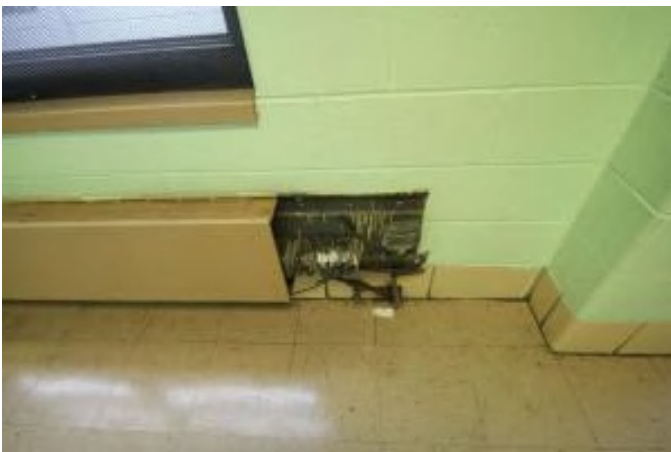
System: D3040 - Distribution Systems

There are 3 air handlers in the basement air handling room which serve the auditorium, cafeteria, and offices. These are original equipment from 1972 and were running at the time of the inspection. They have 5 HP fan motors and 1/3 HP hydronic booster pumps. Gymnasium ventilation equipment is located in the upper part of the gymnasium accessible from the second floor play court. Air handlers have exceeded their useful life and should be replaced. Hydronic pipe is steel with flanged fittings for larger sizes and threads for smaller. The building engineer said there were 7 hydronic pipe failures in the last year alone. Chilled water pipes in the boiler room and air handling room are heavily rusted due to condensation. The entire hydronic pipe network should be replaced due to reported failures and poor visible condition. Classrooms have original unit ventilators. Some units have had leaky drain pans or failed coils and leaked through the floor onto the ceiling and floor below. Condensate from unit vents leaks into an inaccessible crawl space above the main entry of the school and water drips from the overhang. Unit vents should be replaced due to age and reports and signs of failures.

Hallway radiators are finned tube units. Their covers are damaged and missing pieces, and fins are badly bent where exposed. Radiators should be replaced due to this damage. There is a mini-split air conditioner for the computer network equipment room. It is in operable condition, but the building is air conditioned already, and it probably is not needed.

Location: Classrooms
Distress: Failing
Category: 3 - Operations / Maint.
Priority: 2 - Response Time (2-3 yrs)
Correction: Replace classroom unit ventilator (htg/clg coils, 5 tons, 2,000 CFM)
Qty: 35.00
Unit of Measure: Ea.
Estimate: \$1,797,752.93
Assessor Name: James Sullivan
Date Created: 01/04/2016

Notes: Replace failing classroom unit vents and damaged hallway radiators

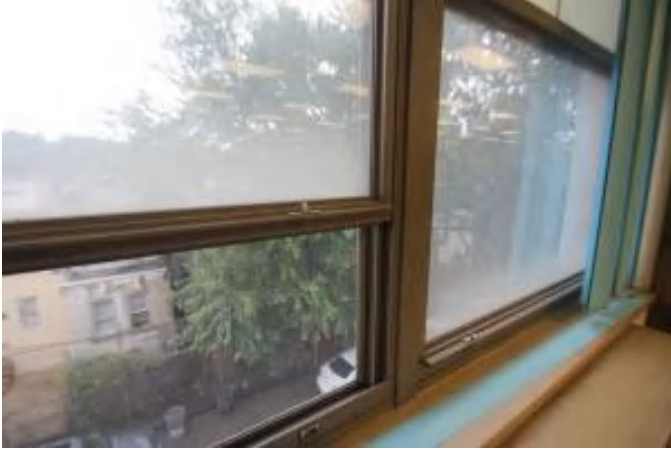
System: B2020 - Exterior Windows

Location: Throughout

Distress: Energy Efficiency

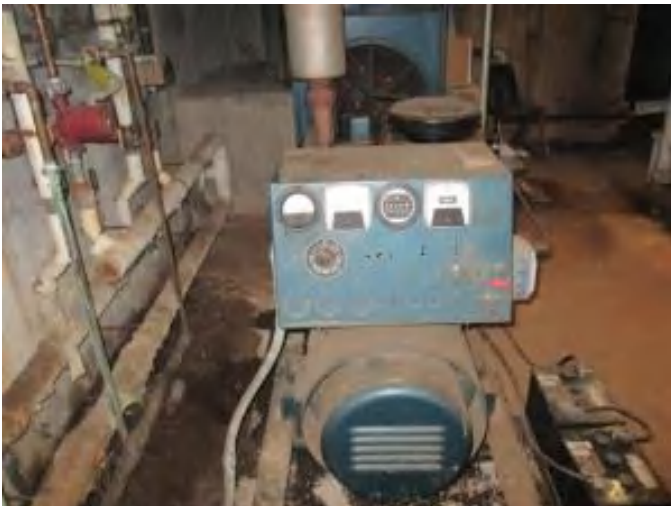
System: D5090 - Other Electrical Systems

Location: Outdoor
Distress: Beyond Service Life
Category: 3 - Operations / Maint.
Priority: 3 - Response Time (3-4 yrs)
Correction: Add Standby Generator System
Qty: 1.00
Unit of Measure: Ea.
Estimate: \$206,189.26
Assessor Name: James Sullivan
Date Created: 12/18/2015

Notes: Provide an outdoor 100KW diesel powered generator.

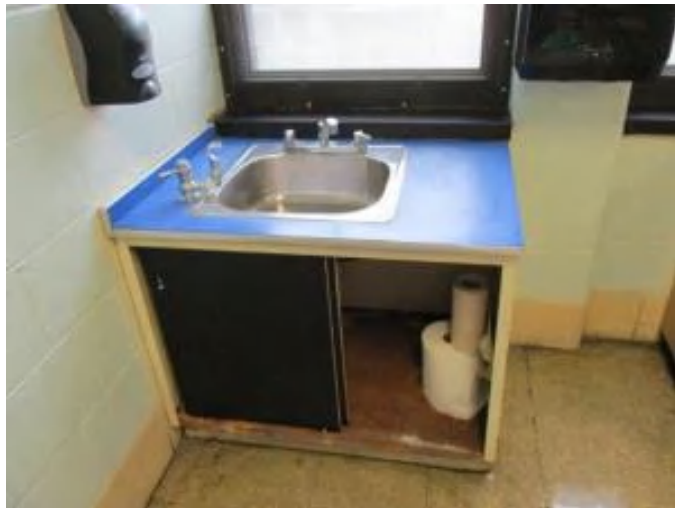
System: E2010 - Fixed Furnishings

Fixed furnishings include: fixed casework in classrooms, lounges, and IMC in fair to poor condition with some beyond service life and failing; and window shades and blinds in good condition.

Location: Classrooms

Distress: Beyond Service Life

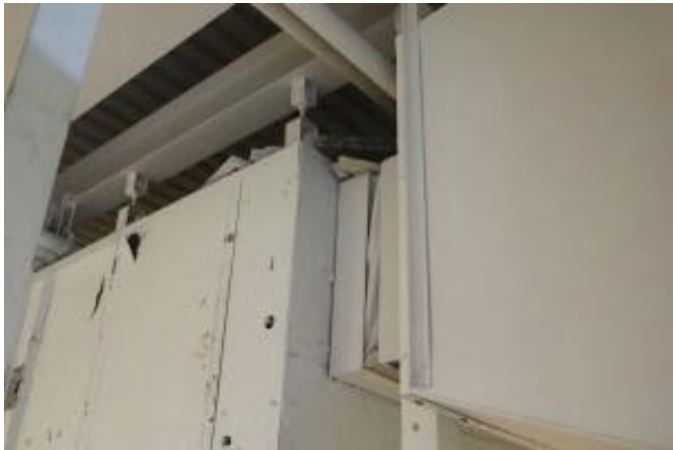
System: D3040 - Distribution Systems

Location: Second floor mechanical room

Distress: Beyond Service Life

Notes: Replace auditorium HVAC due to age

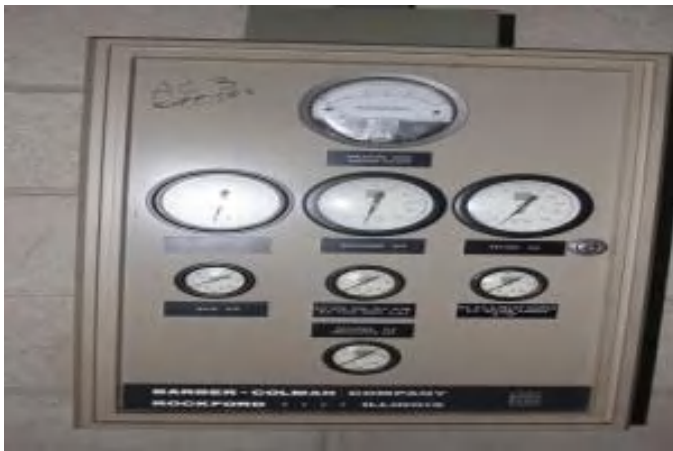
System: D3040 - Distribution Systems

Location: Air handler room

Distress: Beyond Service Life

Notes: Replace office HVAC due to age

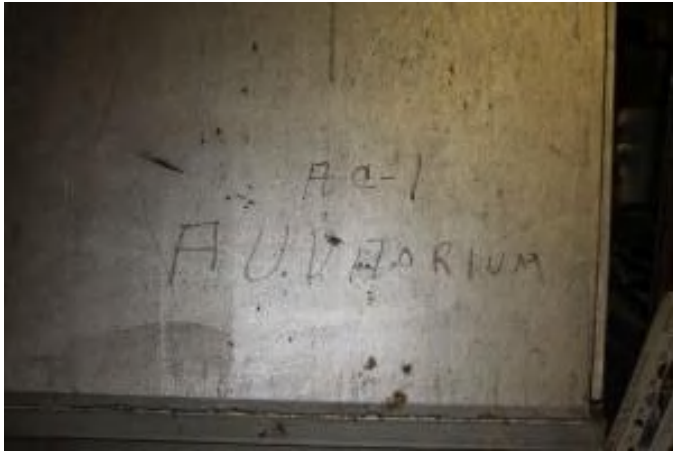
System: D3040 - Distribution Systems

Location: Air handler room

Distress: Beyond Service Life

Notes: Replace auditorium HVAC due to age

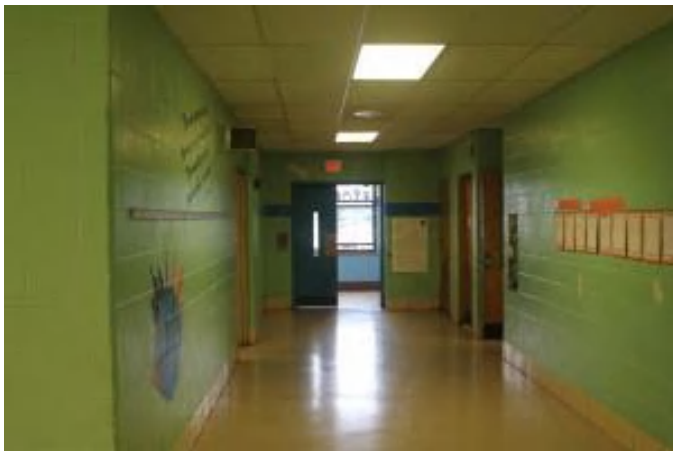
System: D4010 - Sprinklers

Location: Entire building

Distress: Life Safety / NFPA / PFD

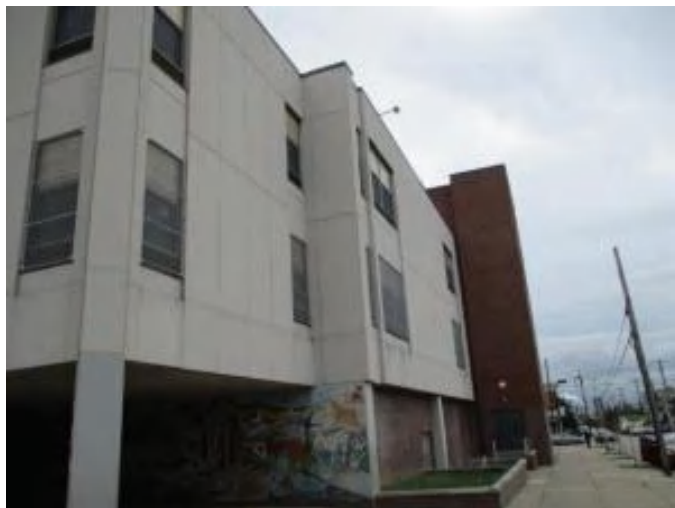
System: G4030 - Site Communications & Security

Location: Building Perimeter

Distress: Security Issue

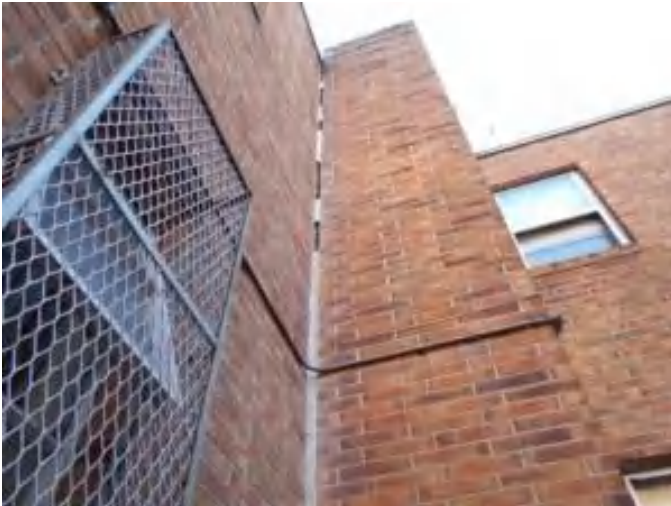
System: B2010 - Exterior Walls

Location: Exterior walls

Distress: Building Envelope Integrity

Notes: Recaulk exterior joints that are cracked and failing.

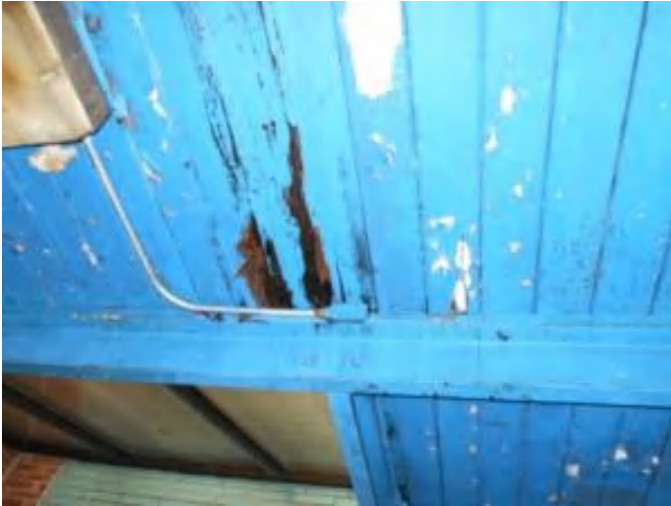
System: B1020 - Roof Construction

Location: Front entry

Distress: Failing

Correction: Repair spalled concrete roof from the top - pick the correct repair and insert the SF of floor area

Notes: Replace rotted roof decking at front entry.

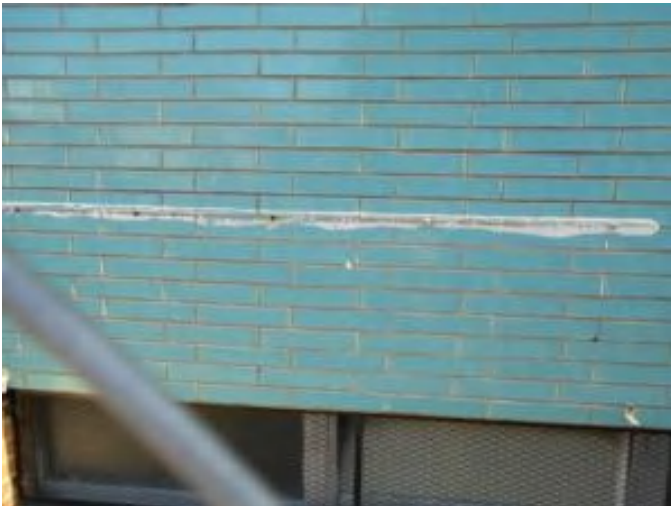
System: B2010 - Exterior Walls

Location: Exterior brick walls including glazed tile

Distress: Building Envelope Integrity

Correction: Repair cracks in masonry - replace missing mortar and repoint - SF of wall area

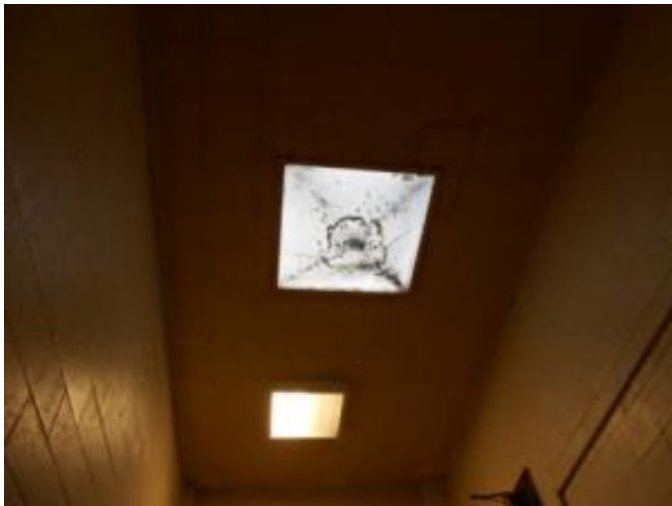
System: B3020 - Roof Openings

Location: Roof

Distress: Building Envelope Integrity

Correction: Replace skylights - pick the closest size and type

Notes: Replace skylights in poor condition.

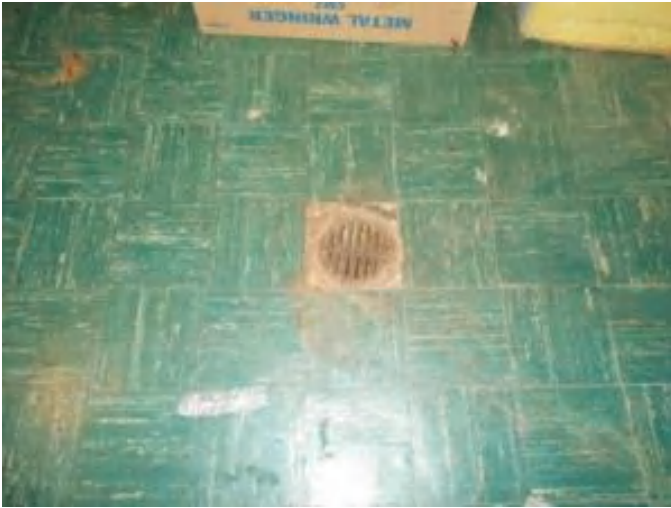
System: C3020413 - Vinyl Flooring

Location: Multi-purpose room and storage

Distress: Health Hazard / Risk

Correction: Remove VAT and replace with VCT - SF of area

Notes: Remove 9" VAT and replace with 12" VCT.

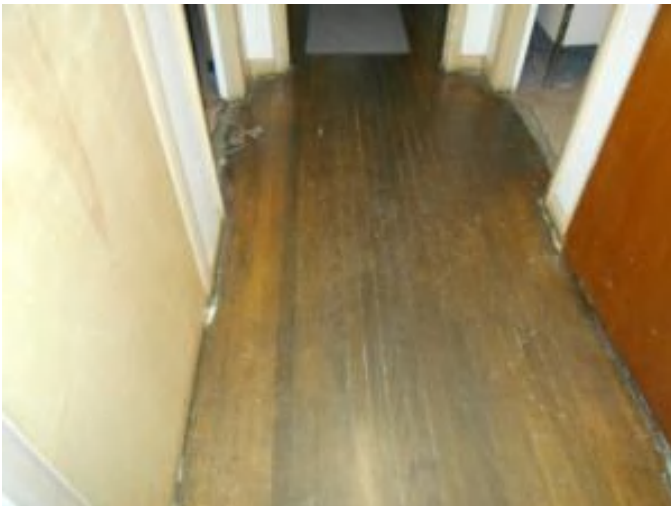
System: C3020414 - Wood Flooring

Location: Office wing

Distress: Maintenance Required

Notes: Refinish worn wood floors.

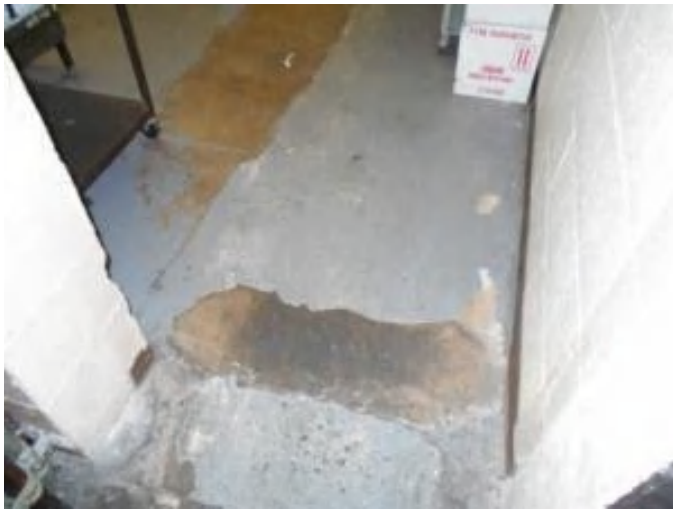
System: C3020415 - Concrete Floor Finishes

Location: School kitchen

Distress: Failing

Notes: Recoat concrete floor in kitchen for cleanliness.

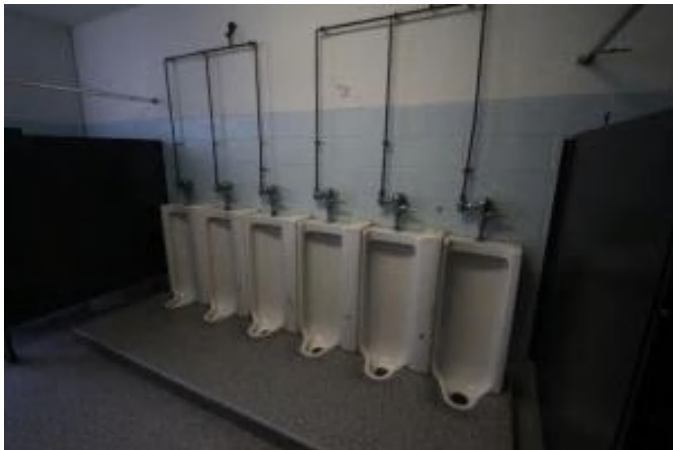
System: D2010 - Plumbing Fixtures

Location: School toilet rooms

Distress: Beyond Service Life

Correction: Remove and replace or replace stall or floor type urinal

Notes: Replace floor level urinals

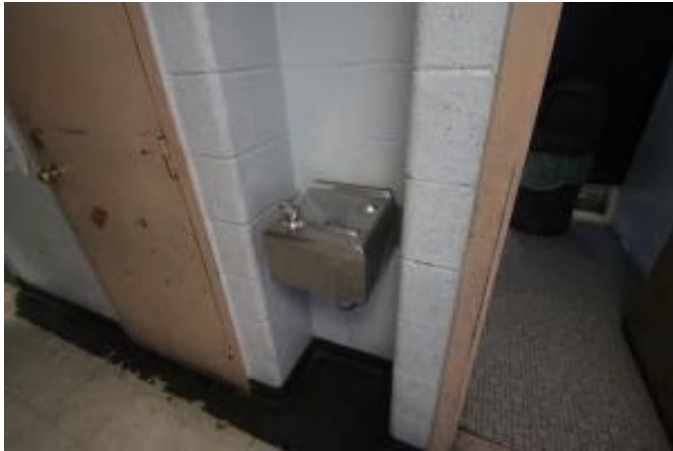
System: D2010 - Plumbing Fixtures

Location: Corridors
Distress: Accessibility
Category: 2 - Code Compliance
Priority: 2 - Response Time (2-3 yrs)
Correction: Remove and Replace Water Fountains - without ADA new recessed alcove
Qty: 3.00
Unit of Measure: Ea.
Estimate: \$22,737.57
Assessor Name: System
Date Created: 02/18/2016

Notes: Replace non-accessible fountains

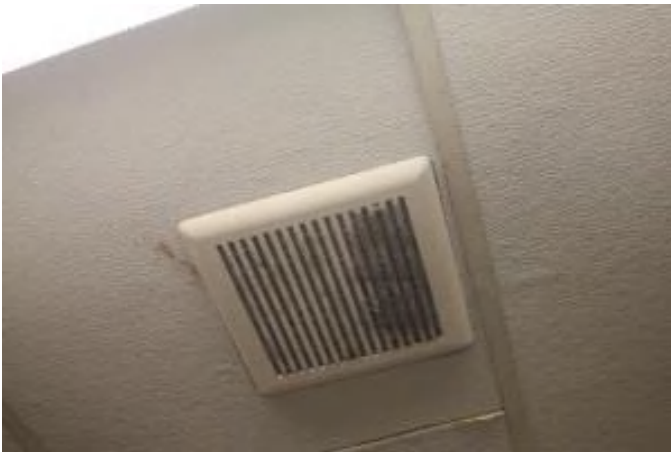
System: D3040 - Distribution Systems

Location: Toilet rooms
Distress: Beyond Service Life
Category: 3 - Operations / Maint.
Priority: 2 - Response Time (2-3 yrs)
Correction: Provide inline centrifugal fan and wall outlet louver for restroom exhaust (8 plbg fixtures)
Qty: 3.00
Unit of Measure: Ea.
Estimate: \$80,913.96
Assessor Name: System
Date Created: 02/19/2016

Notes: Replace toilet room exhaust fans

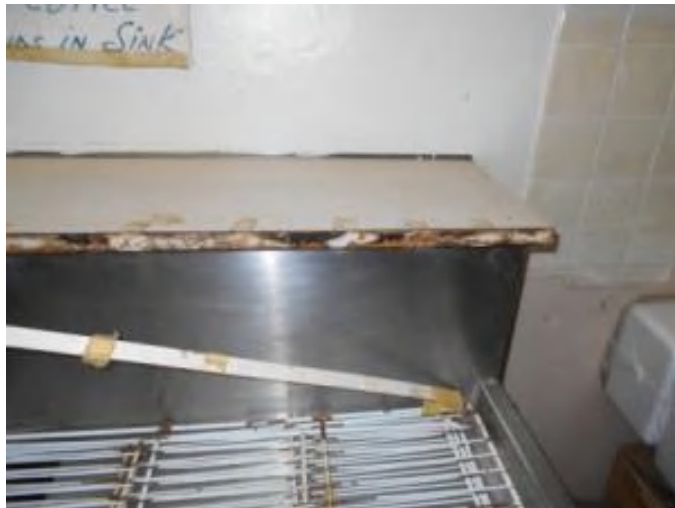
System: E1090 - Other Equipment

Location: School kitchen

Distress: Beyond Service Life

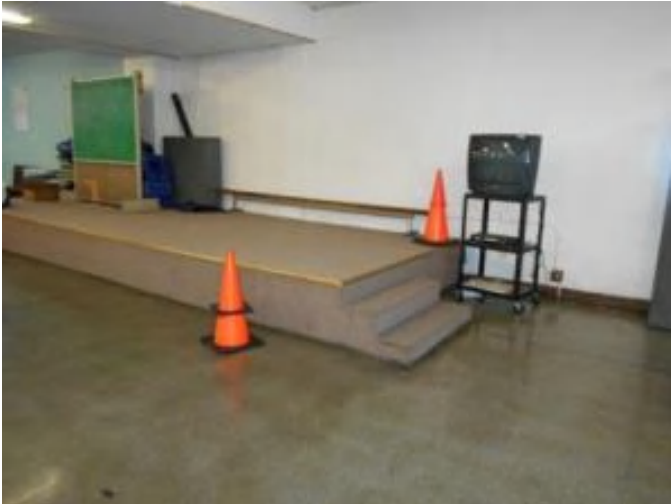
System: B1010 - Floor Construction

Location: Multipurpose room

Distress: Accessibility

Notes: Install a ramp to the platform in the multi-purpose room

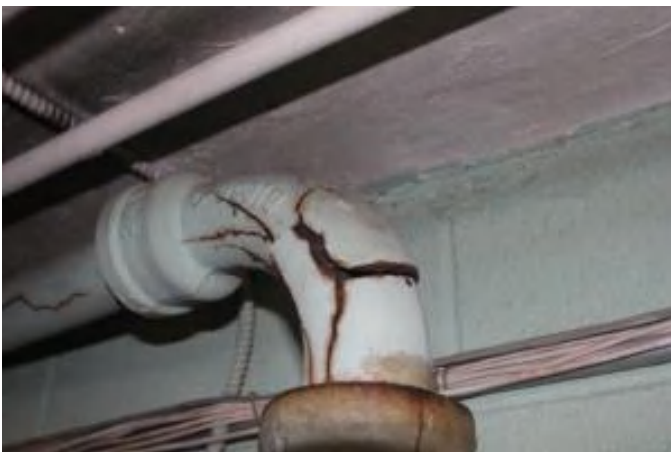
System: D2030 - Sanitary Waste

Location: Entire building

Distress: Failing

Notes: Replace sanitary drain pipes due to damage

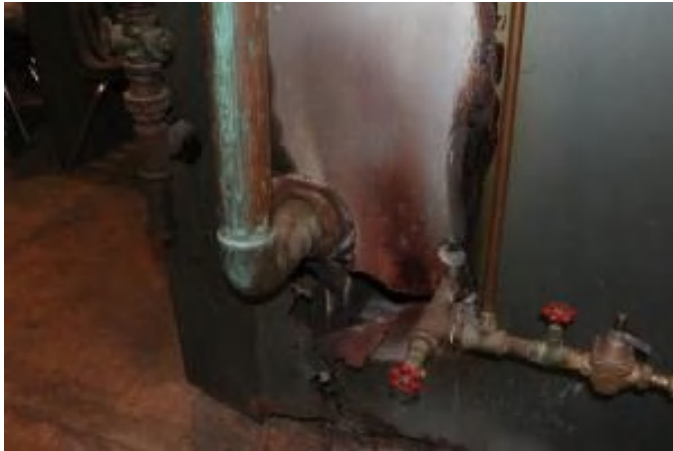
System: D3020 - Heat Generating Systems

Location: Boiler room

Distress: Damaged

Correction: Replace boiler, cast iron sectional (50 HP)

Notes: Replace boiler due to age and damage

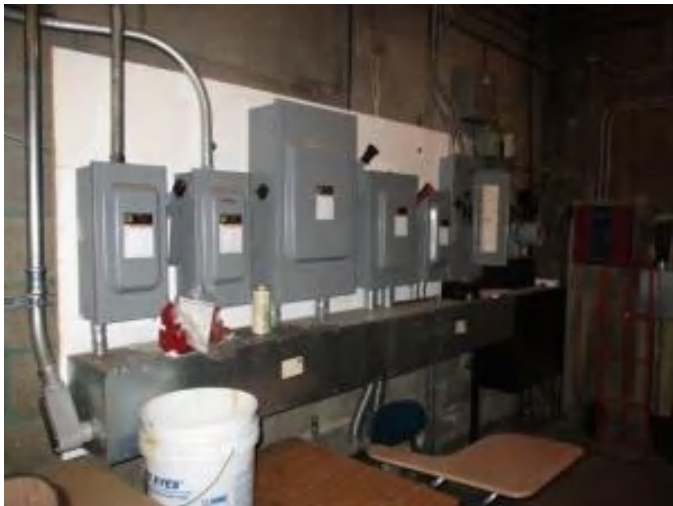
System: D5010 - Electrical Service/Distribution

Location: Basement

Distress: Inadequate

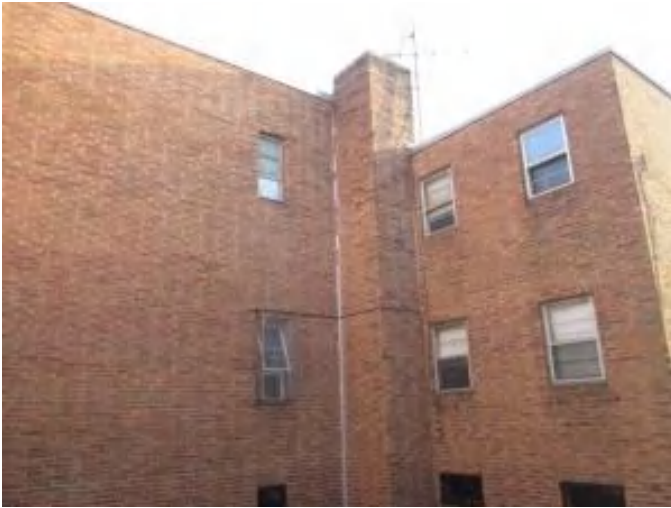
System: D5090 - Other Electrical Systems

Location: Roof

Distress: Building / MEP Codes

Notes: Prepare a study to determine if this facility requires lightning protection system

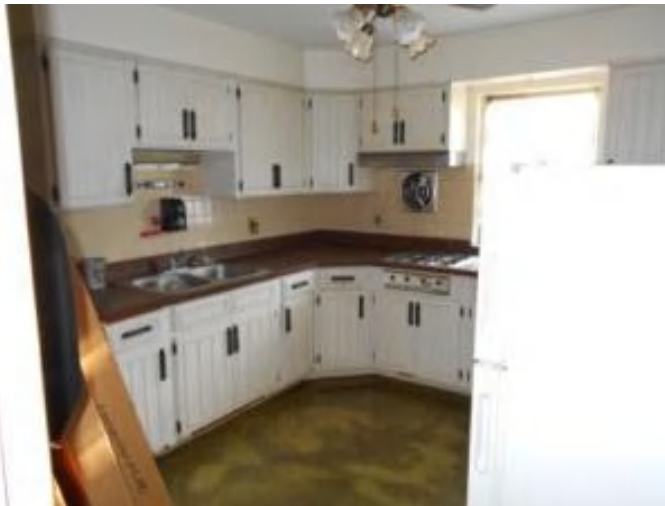
System: E2010 - Fixed Furnishings

Location: Office kitchen

Distress: Obsolete

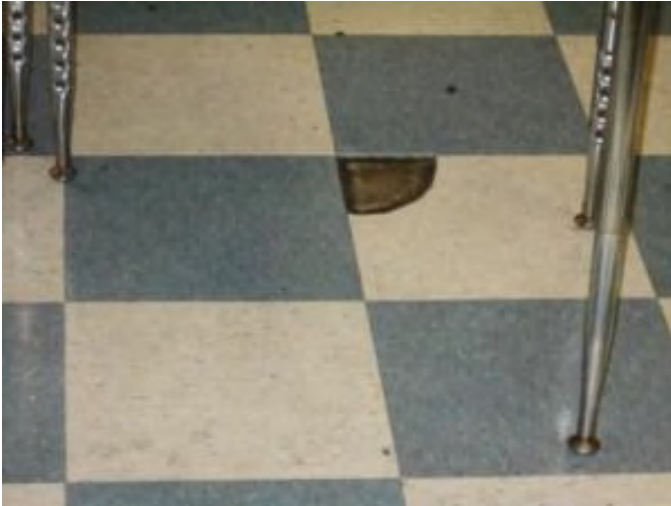
System: C3020413 - Vinyl Flooring

Location: Classrooms, corridors

Distress: Beyond Service Life

Notes: Replace 12" VCT flooring that is beginning to fail. Remove sheet vinyl flooring in office kitchen and replace with VCT.

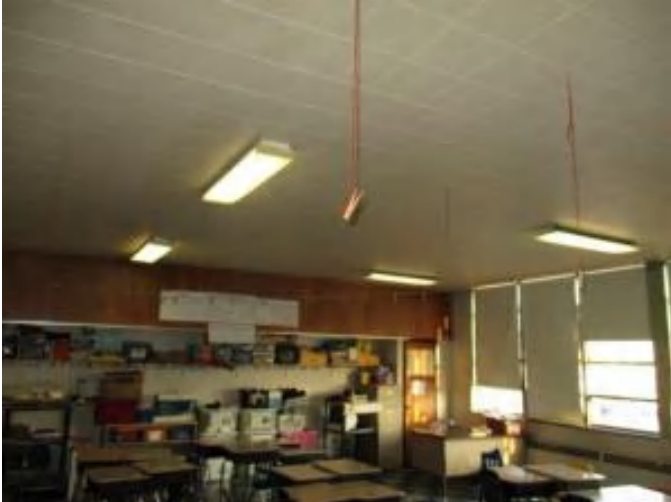
System: D5020 - Lighting and Branch Wiring

Location: Entire Building

Distress: Obsolete

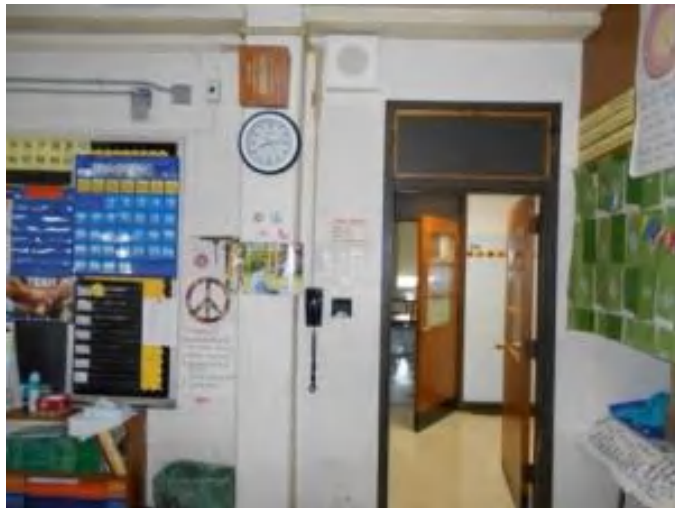
System: D5030 - Communications and Security

Location: Entire Building

Distress: Obsolete

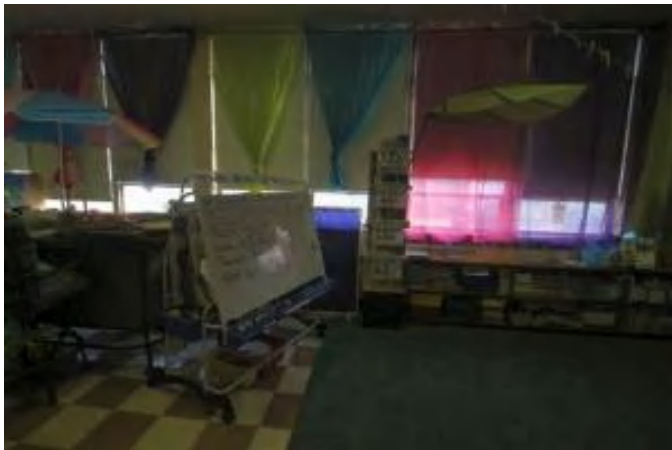
System: D3040 - Distribution Systems

Location: Classrooms

Distress: Inadequate

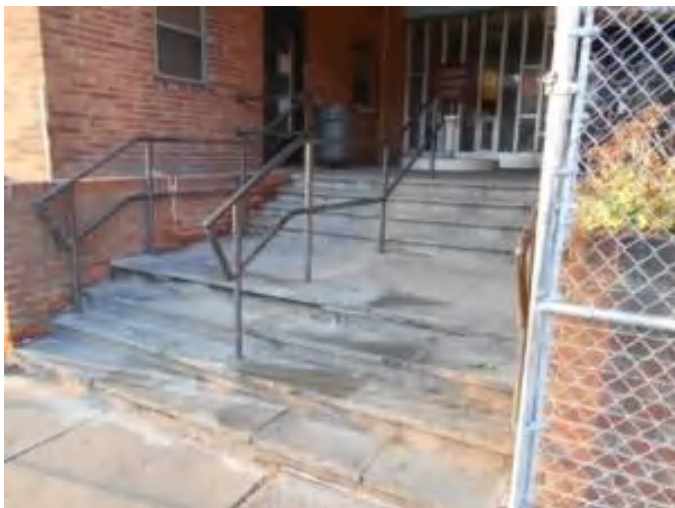
System: G2030 - Pedestrian Paving

Location: Front entry

Distress: Accessibility

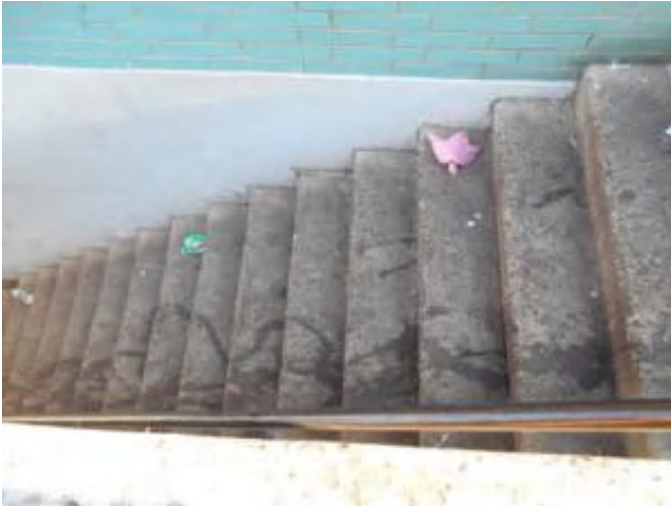
System: G2030 - Pedestrian Paving

Location: Entrances and exits

Distress: Damaged

Notes: Repair exterior stairs at all entrances/exits.

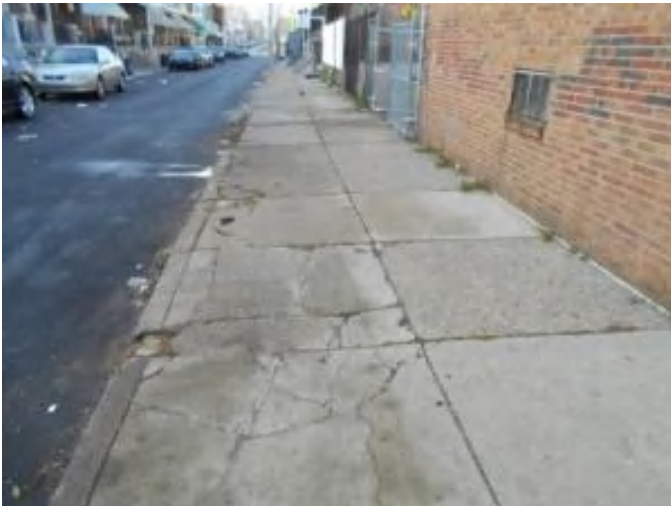
System: G2030 - Pedestrian Paving

Location: Sidewalks

Distress: Accessibility

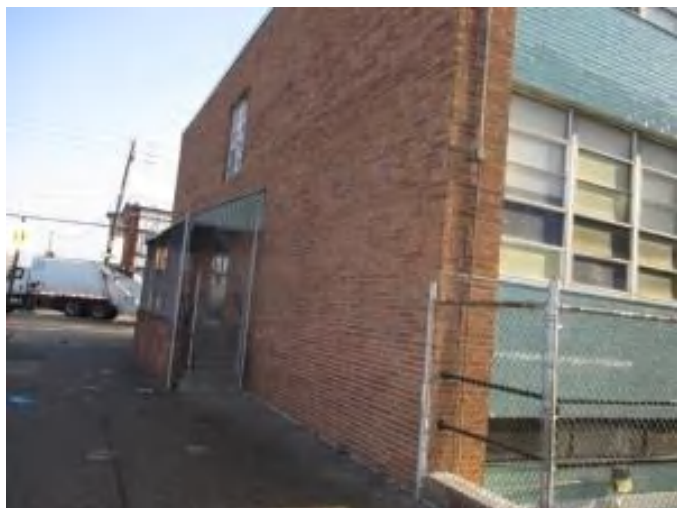
System: G4030 - Site Communications & Security

Location: Building Perimeter

Distress: Security Issue

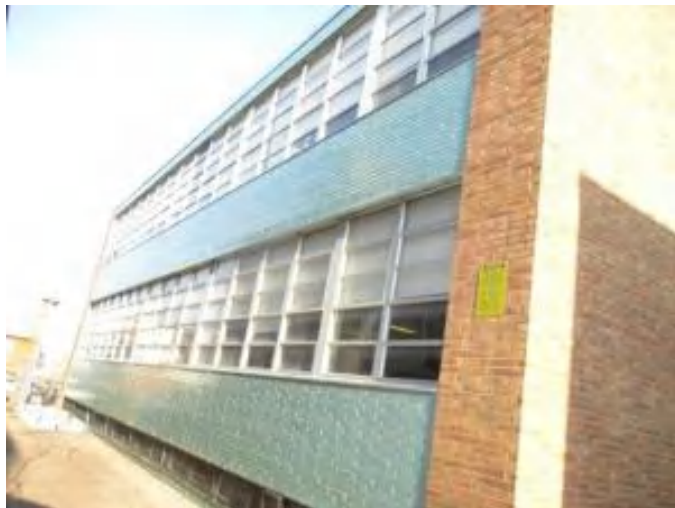
System: G4020 - Site Lighting

Location: West Exterior Wall

Distress: Security Issue
