Northeast High School

School District of Philadelphia

S802001; Northeast HS and Field

Site Assessment Report

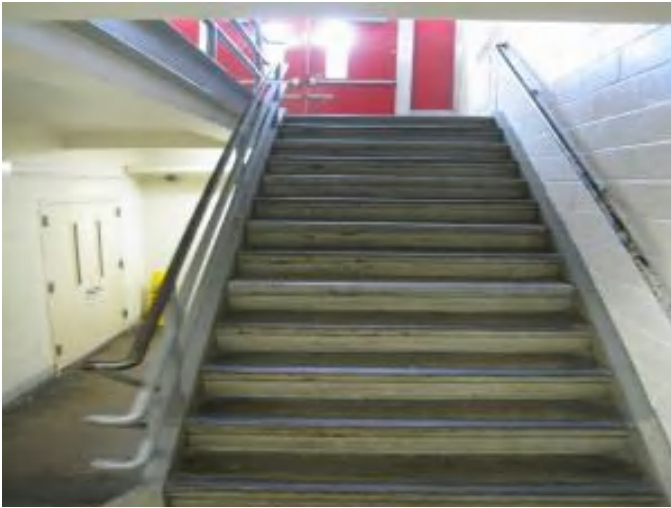
Location: stairways

System: C2010 - Stair Construction

Distress: Building / MEP Codes

Notes: Replace handrails on exterior stairs (3 sets of 20ft total length rails = 60ft grand total length)

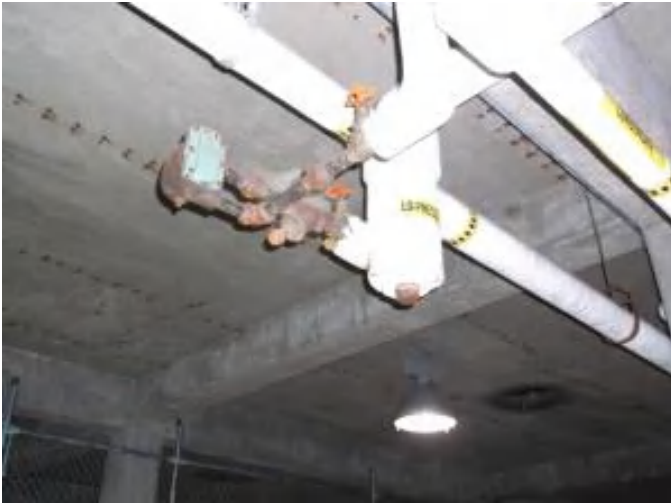
Location: Throughout the building

System: D3040 - Distribution Systems

Distress: Beyond Service Life

Notes: Conduct a steam trap survey to identify and replace failed traps passing live steam into the condensate piping system.

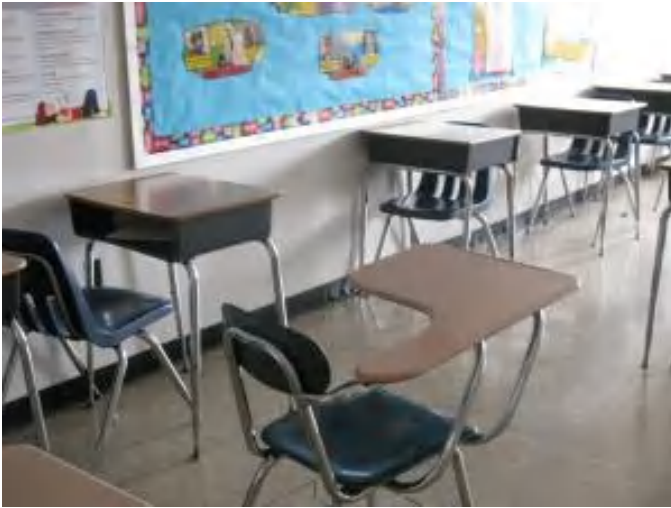
Location: Entire Building

System: D5020 - Lighting and Branch Wiring

Distress: Inadequate

Notes: Install minimum two receptacles in each wall of class rooms and sufficient number of receptacles in other areas per NEC. We recommend adding a two-compartment surface mounted raceway, for data power, for the computer lab room.

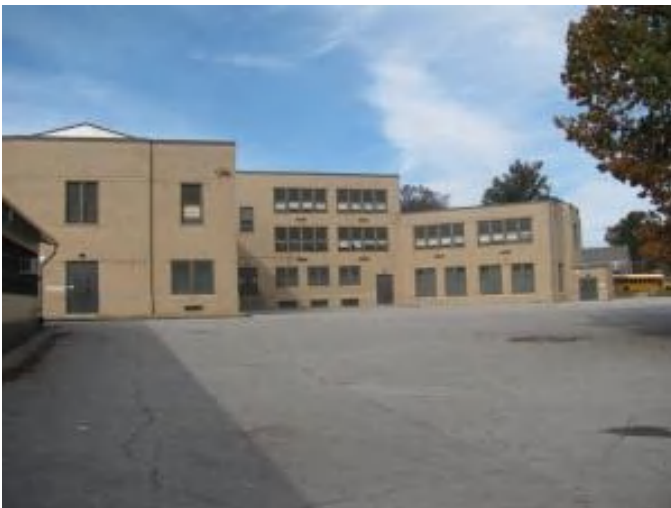
Location: Exterior Building

System: D5020 - Lighting and Branch Wiring

Distress: Damaged

Notes: Repair/replace exterior lighting fixtures. Estimated 9 lighting fixtures.

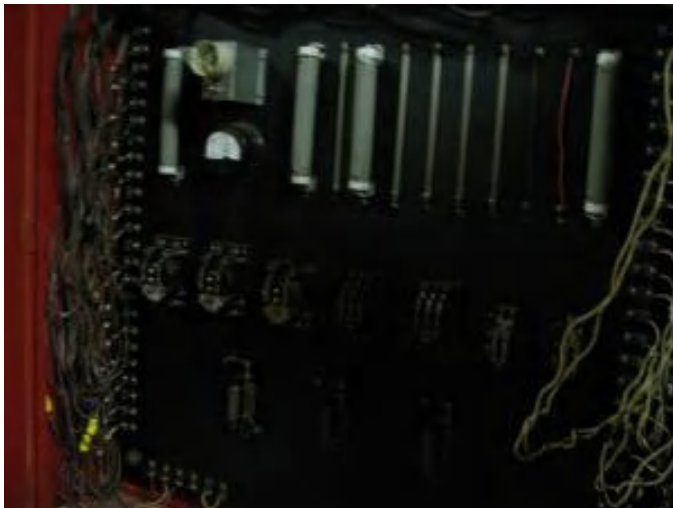
Location: Entire Building

System: D5030 - Communications and Security

Distress: Beyond Service Life

Notes: Replace existing fire alarm system with an automatic fire alarm system including smoke detectors in corridors and other recommended areas per NEC. Install horn/strobes in class rooms, corridors, offices, toilets, library and other recommended areas per codes.

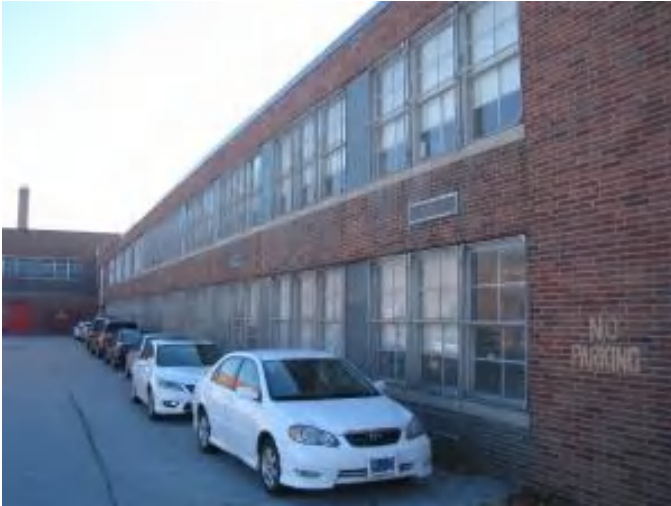
Location: exterior walls

System: B2010 - Exterior Walls

Distress: Appearance

Notes: Powerwash brick building walls, exterior and North and South courtyards (100,000sf)

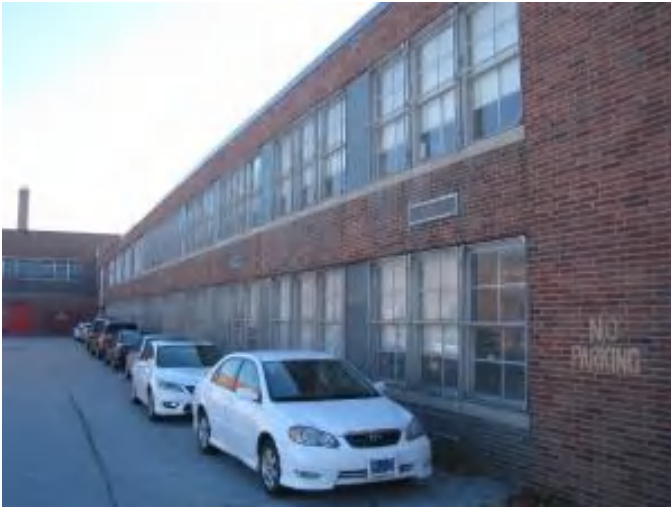
Location: exterior windows

System: B2020 - Exterior Windows

Distress: Beyond Service Life

Notes: Replace windows (402 - 4'x8'; 6 - 8'x20'h; 45 - 4'x10')

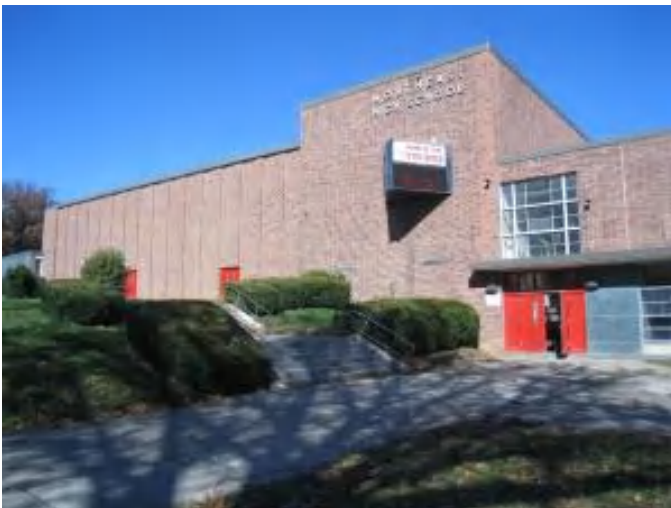
Location: exterior doors

System: B2030 - Exterior Doors

Distress: Damaged

Notes: Repaint exterior doors and frames; also provide new exit hardware. (60 3x7)

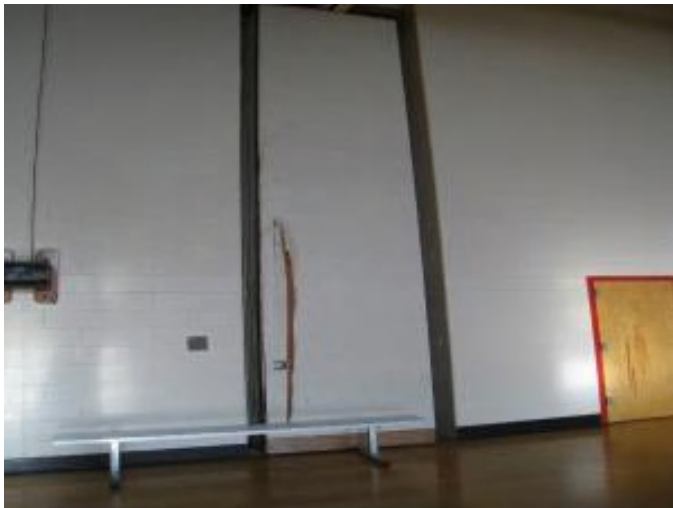
Location: gymnasiums - boy's and girl's

System: C1010 - Partitions

Distress: Damaged

Notes: Replace 2 folding room dividing partitions (2000sf + 1600sf) in each gymnasium with new partitions (3600sf)

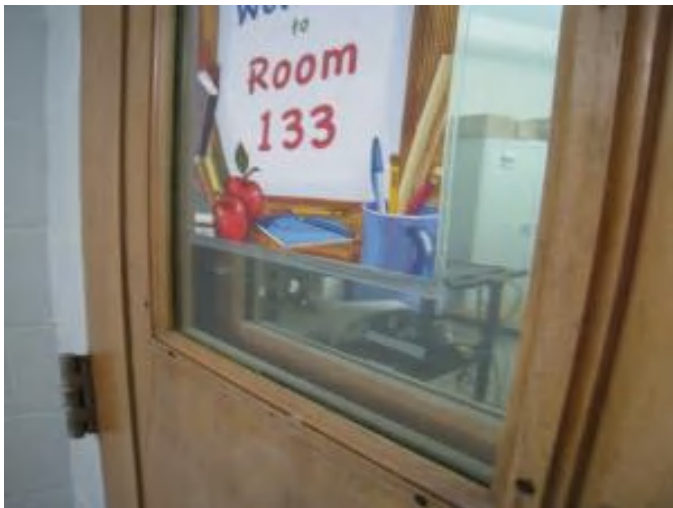
Location: corridor doors

System: C1020 - Interior Doors

Distress: Building / MEP Codes

Notes: Replace all original wood interior doors in hallways, including soundproof music room doors, with code compliant fire rated doors with fire rated vision panels (250each)

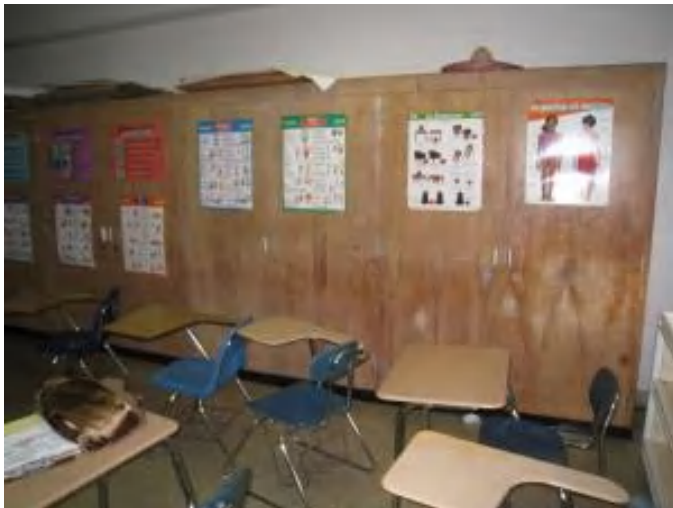
Location: inside classroom doors (closets, offices)

System: C1020 - Interior Doors

Distress: Damaged

Notes: Replace all original wood interior doors and hardware inside classrooms, closets, offices, etc. (80 each)

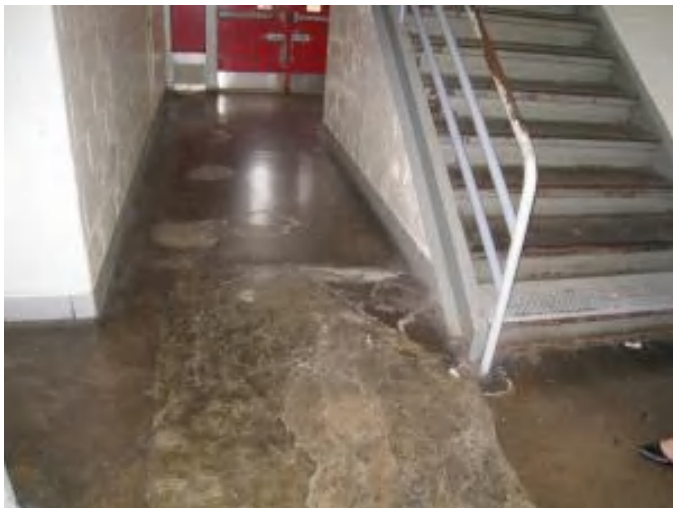
Location: interior doors

System: C1020 - Interior Doors

Distress: Damaged

Notes: Remove and replace all steel doors, frames, and hardware; fire rated doors with panic hardware for stairs and corridors (50) 3x7 doors

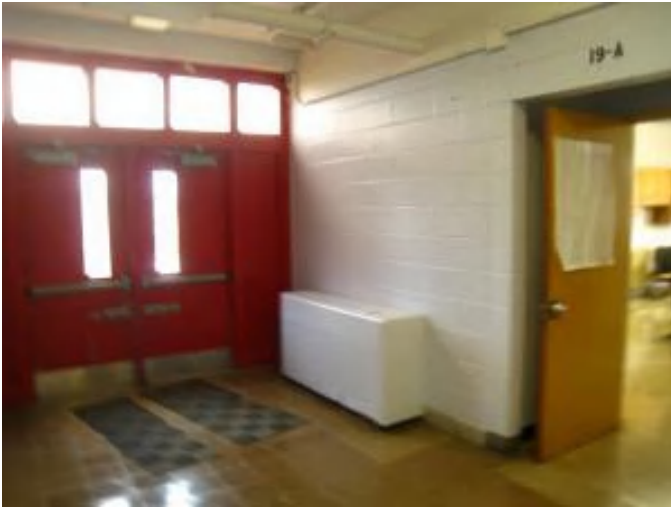
Location: corridor doors to classrooms and offices

System: C1020 - Interior Doors

Distress: Security Issue

Notes: Provide security hardware for classrooms and offices, locking from inside classroom. (200)

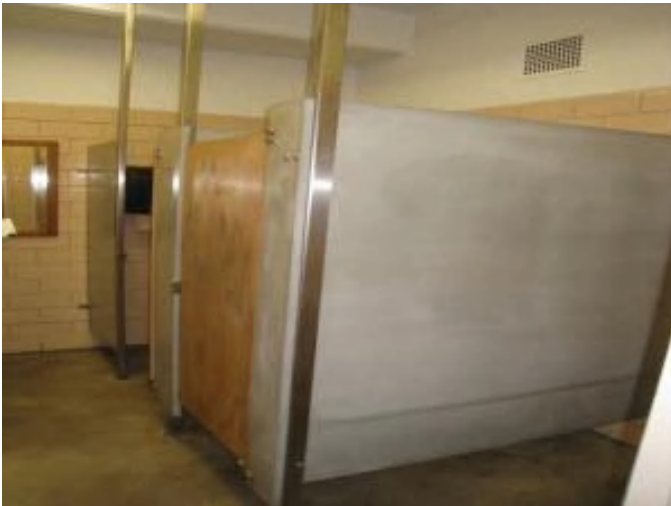
Location: toilet rooms

System: C1030 - Fittings

Distress: Beyond Service Life

Notes: Replace transite toilet room partitions with HDPE plastic partitions (assume 10)

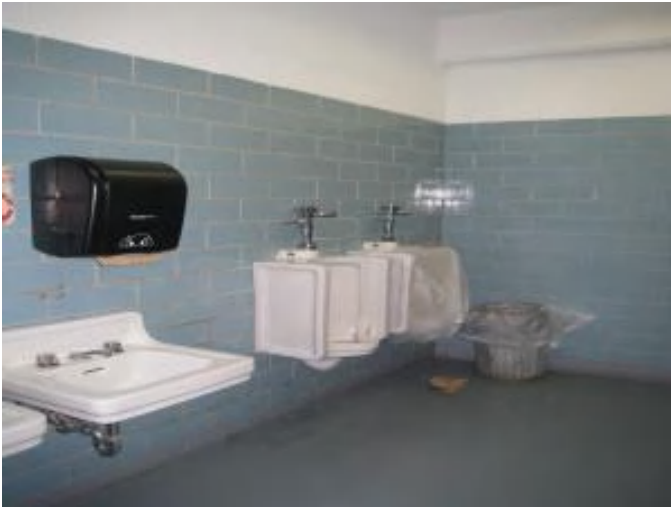
Location: toilet rooms

System: C1030 - Fittings

Distress: Damaged

Notes: Provide toilet room accessories where broken or missing (6 sets)

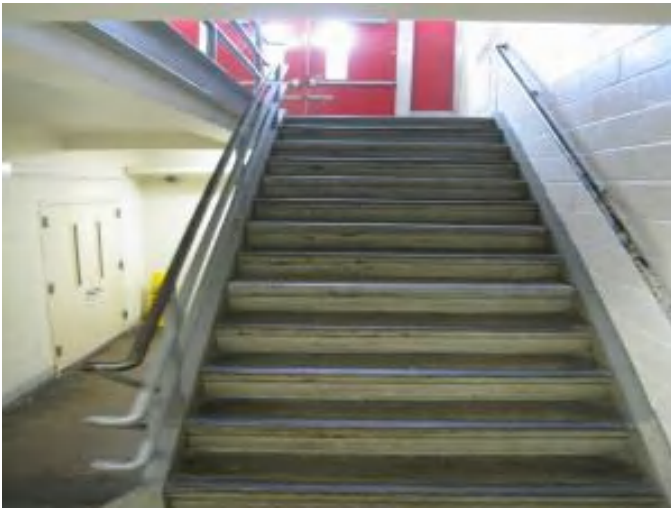
Location: stairways

System: C2010 - Stair Construction

Distress: Failing

Notes: Replace rusted flights of stairways in Stair A and D (4 flights)

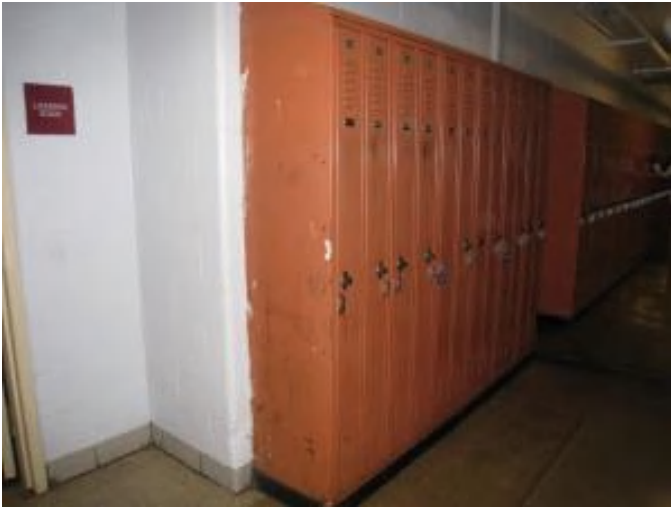
Location: hallways - lockers

System: C3010230 - Paint & Covering

Distress: Damaged

Notes: Repaint lockers located in hallways (assume lockers in 25% of corridor walls, both sides) (3000ft (lockers)x5ft h = 15,000sf)

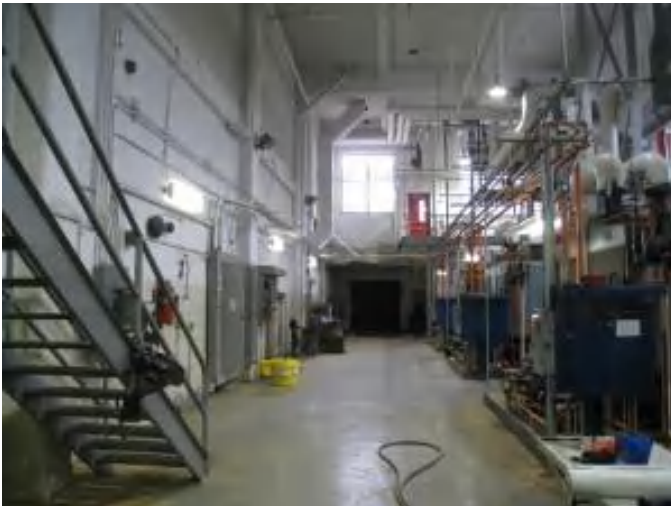
Location: boiler room

System: C3010230 - Paint & Covering

Distress: Appearance

Notes: Repaint peeling walls in boiler room (3,000sf)

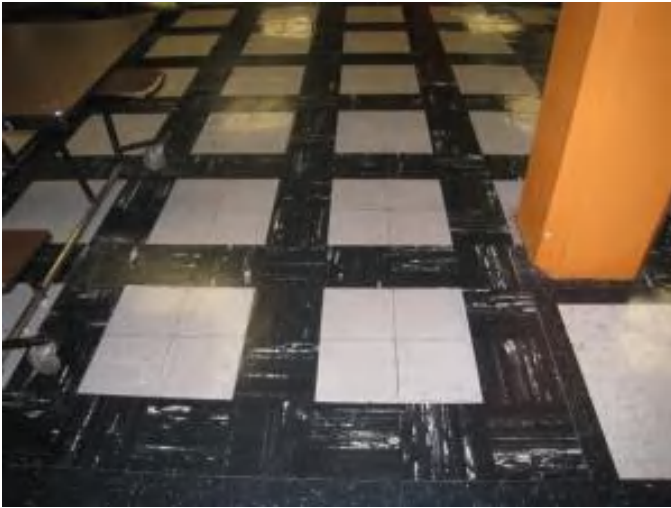
Location: cracked, damaged walls; cafeteria columns

System: C3010230 - Paint & Covering

Distress: Damaged

Notes: Repair and repaint cracked and damaged walls throughout the building and cafeteria (1500sf)

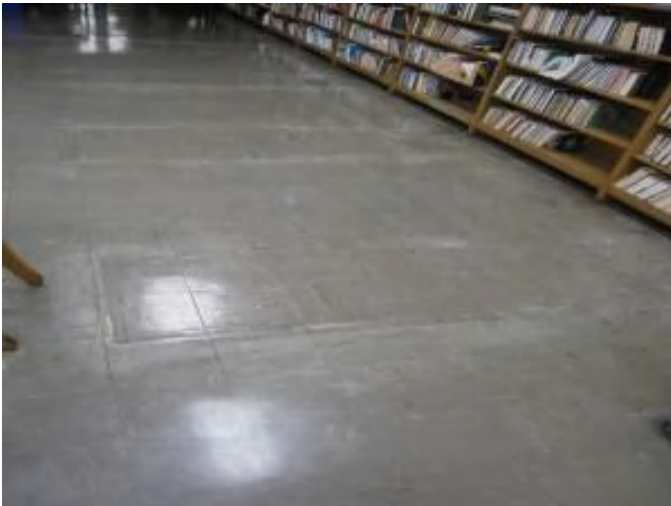
Location: VAT floors throughout the building

System: C3020413 - Vinyl Flooring

Distress: Health Hazard / Risk

Notes: Replace VAT floors using proper asbestos abatement procedures if determined asbestos is present. (261,796sf)

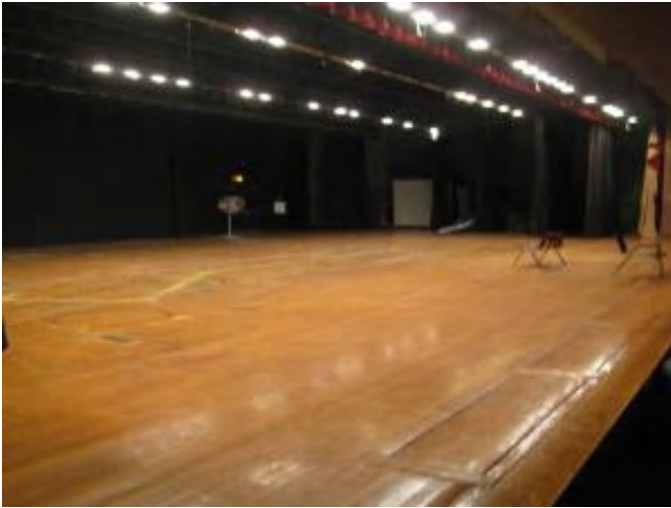
Location: stage

System: C3020414 - Wood Flooring

Distress: Appearance

Notes: Strip, sand, repair and refinish all wood stage in auditorium (3000sf)

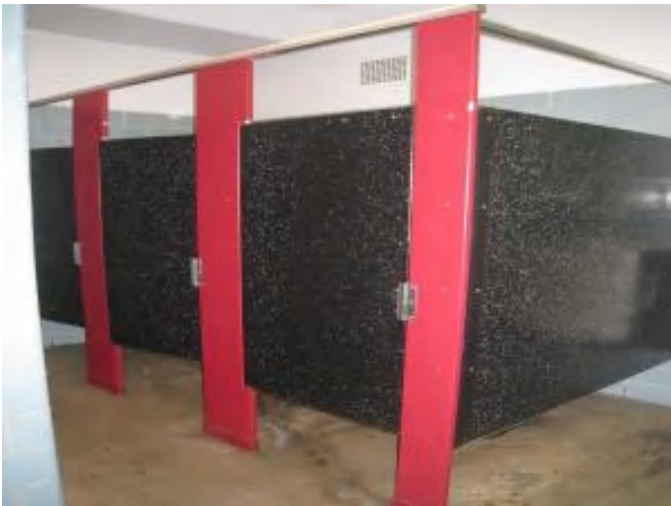
Location: basement, stairways, toilet rooms

System: C3020415 - Concrete Floor Finishes

Distress: Appearance

Notes: Clean and reseal basement floor in mechanical rooms; clean and reseal concrete floors stairways, and toilet rooms (20,000sf)

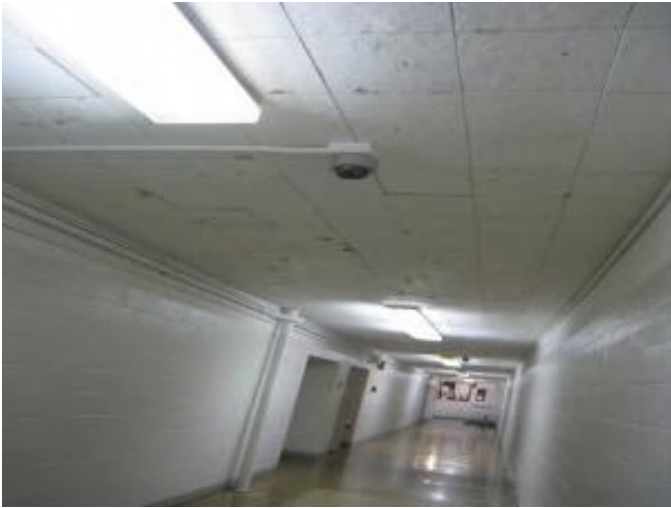
Location: corridor ceiling tiles

System: C3030 - Ceiling Finishes

Distress: Damaged

Notes: Replace 12"x12" glued-on ceiling tiles in corridors, auditorium, and cafeteria (80,000sf)

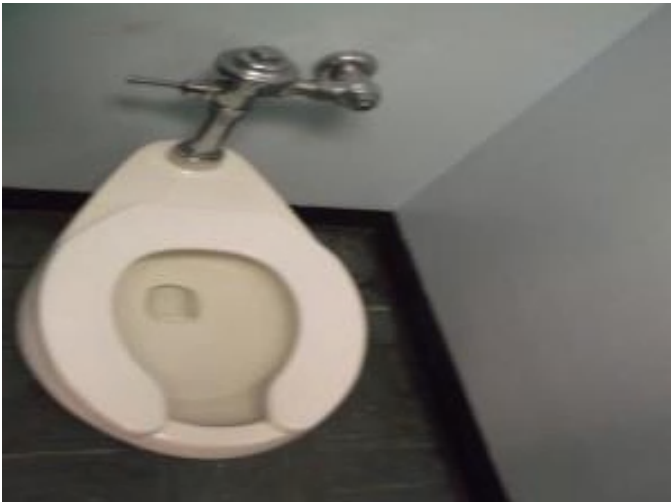
Location: Throughout the school

System: D2010 - Plumbing Fixtures

Distress: Beyond Service Life

Notes: Replace all water closets in the building with lower flow fixtures, as the fixtures are original.

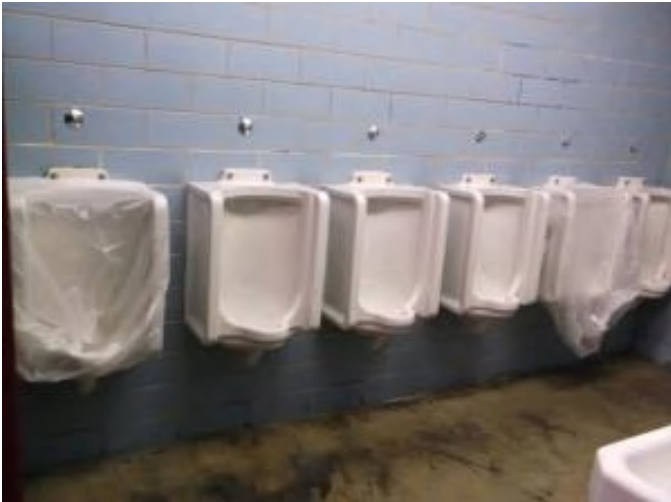
Location: Throughout the school

System: D2010 - Plumbing Fixtures

Distress: Beyond Service Life

Notes: Replace all urinals in the building with lower flow fixtures, as the fixtures are original.

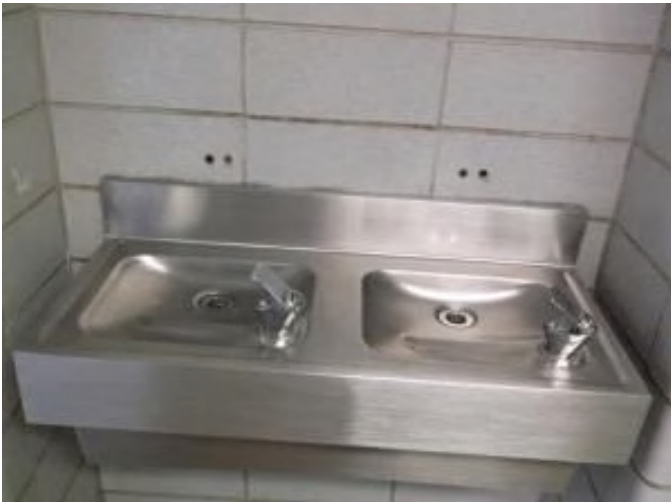
Location: Throughout the school

System: D2010 - Plumbing Fixtures

Distress: Beyond Service Life

Notes: Replace the integral refrigerated vertical water coolers and the drinking fountains. These units are well beyond their service life and most are NOT accessible type.

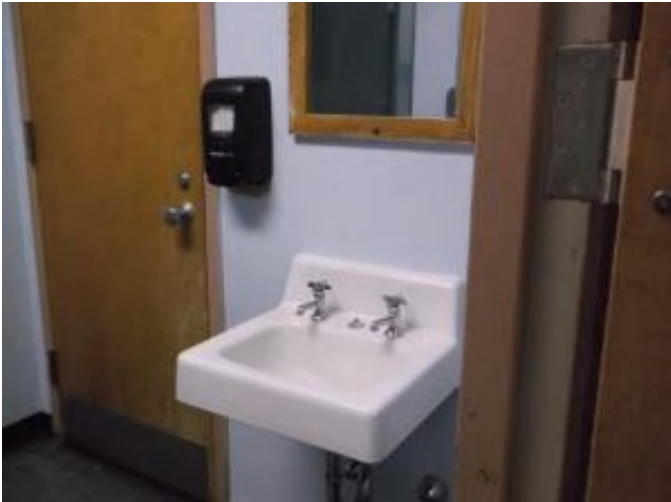
Location: Throughout the school

System: D2010 - Plumbing Fixtures

Distress: Beyond Service Life

Notes: Replace all lavatories in the building with lower flow fixtures, as the fixtures are original.

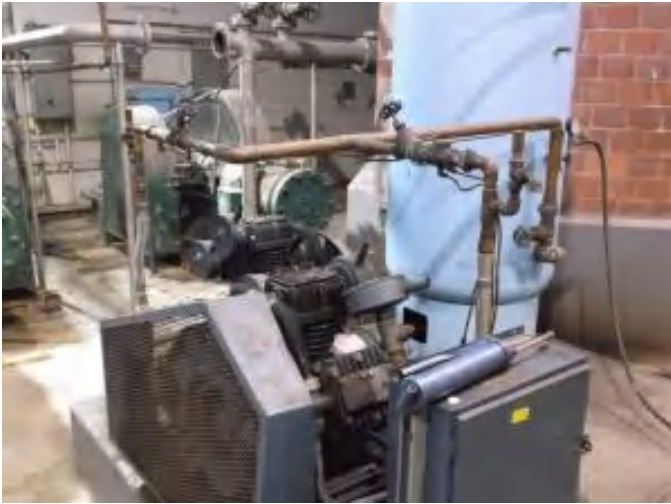
System: D3060 - Controls & Instrumentation

Location: Throughout the building

Distress: Beyond Service Life

Correction: Replace pneumatic controls with DDC (350KSF)

Notes: Replace the pneumatic controls for the HVAC systems with modern DDC modules or electric, valves and actuators to improve reliability and energy efficiency.

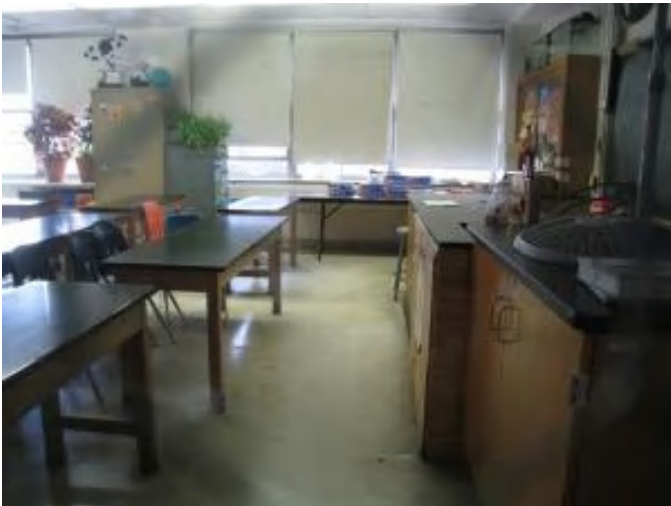
System: F1020 - Institutional Equipment

Location: science labs

Distress: Damaged

Correction: Remove and replace lab base cabinets and countertops - per LF - add sinks in plumbing fixtures if required

Notes: Replace science lab furniture (160ft)

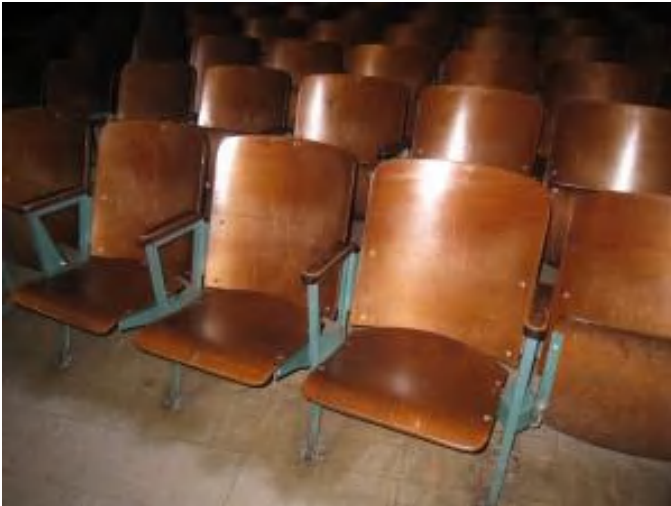
System: E2010 - Fixed Furnishings

Location: auditorium

Distress: Damaged

Correction: Replace auditorium seating - add tablet arms if required. Veneer seating is an option.

Notes: Repair and refinish damaged folding wood auditorium chairs; 33% of total = 500

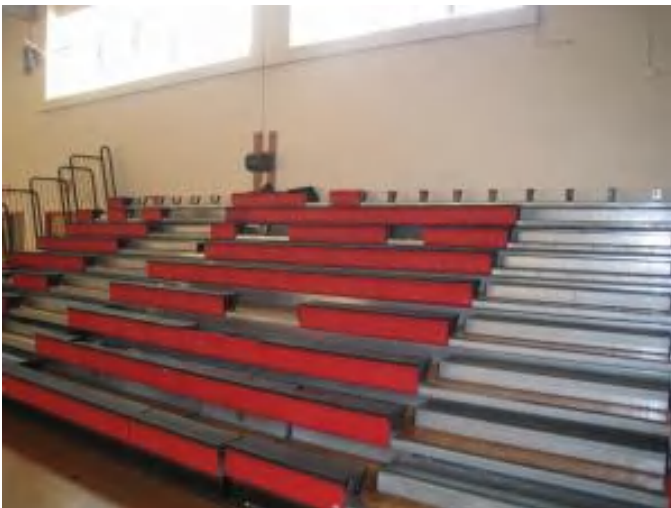
System: E2010 - Fixed Furnishings

Location: gymnasiums - boy's and girl's

Distress: Damaged

Correction: Replace broken or non-functional bleachers - select number of tiers and power if applicable

Notes: Repair damaged bleachers in gymnasiums

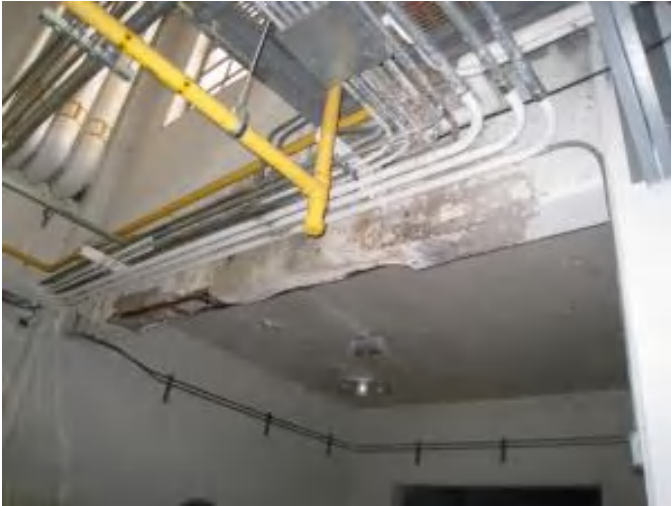
System: B1010 - Floor Construction

Location: boiler room

Distress: Failing

Notes: Repair concrete beam supporting exterior wall above, in boiler room (20ft)

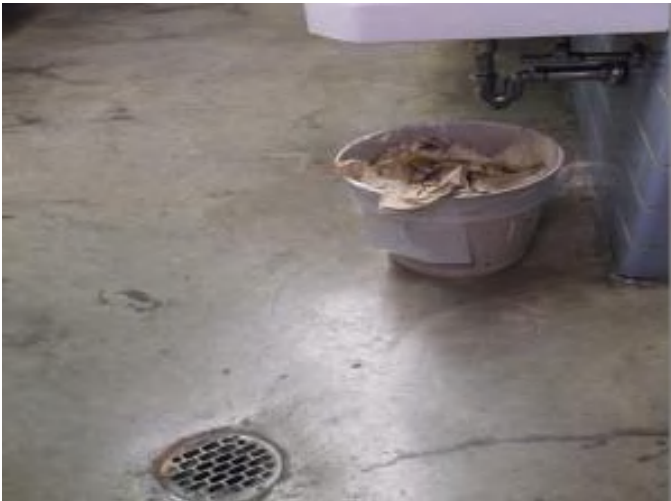
System: D2030 - Sanitary Waste

Location: Throughout the building

Distress: Beyond Service Life

Correction: Inspect sanitary waste piping and replace damaged sections. (+300KSF)

Notes: Hire a qualified contractor to perform a detailed examination of the sanitary waste piping using visual inspection and video cameras to locate and replace any damaged piping and to further quantify the extent of potential failures.

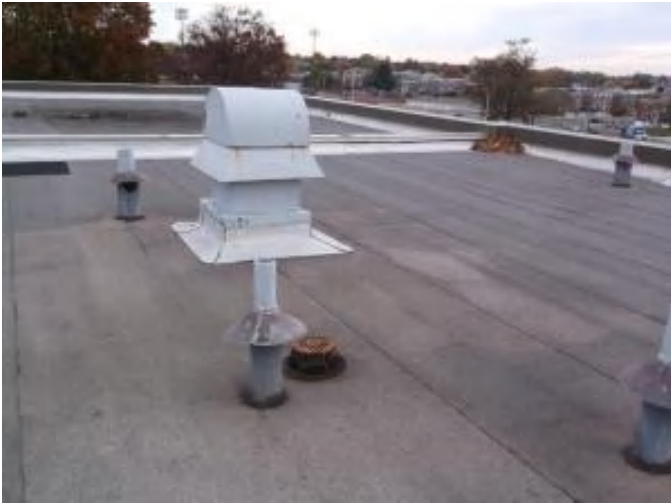
System: D3040 - Distribution Systems

Location: Roof

Distress: Beyond Service Life

Correction: Replace power roof ventilator (24" dia.)

Notes: Replace exhaust fans and ductwork.

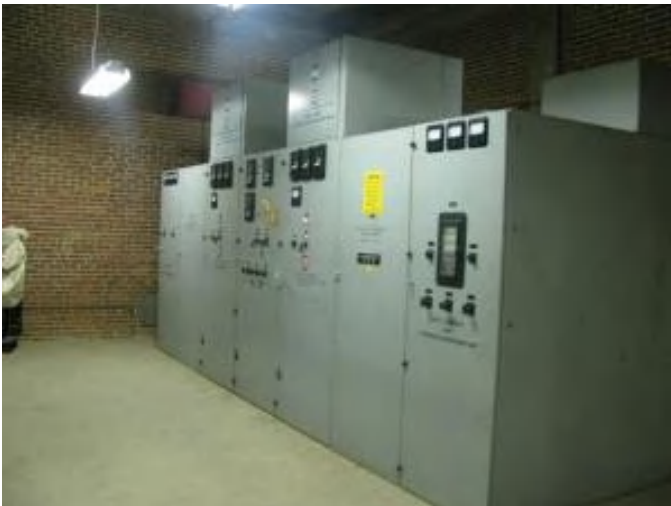
System: D5010 - Electrical Service/Distribution

Location: B802001;Northeast

Distress: Beyond Service Life

Correction: Replace Substation

Notes: Upgrade the existing electrical service with a new service. Replace the existing switchgear with new 1200A, 13200v double bus switchgear consist of two 1200A incoming breaker switches, six 600A, 13200V outgoing interrupting swathes, one tie breaker and metering sections. Provide three Substations each consist of two 600A interrupter switches, two 1000KVA, 13200V to 120/208V step down transformers and one 3000A double ended low voltage switchboards.

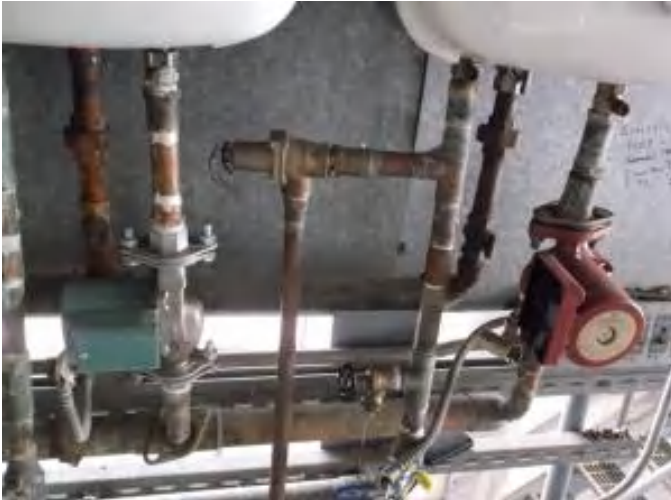
System: D2020 - Domestic Water Distribution

Location: Throughout the building

Distress: Beyond Service Life

Correction: Replace domestic water piping (350 KSF)

Notes: Inspect and replace the original as needed the domestic water piping in the building.

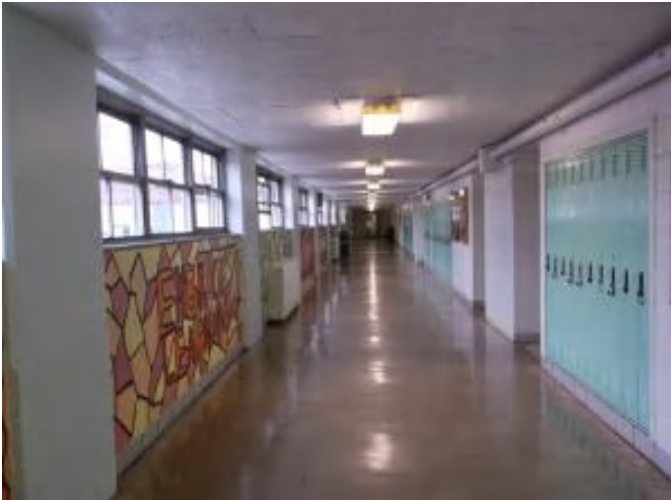
System: D4010 - Sprinklers

Location: Throughout the building

Distress: Beyond Service Life

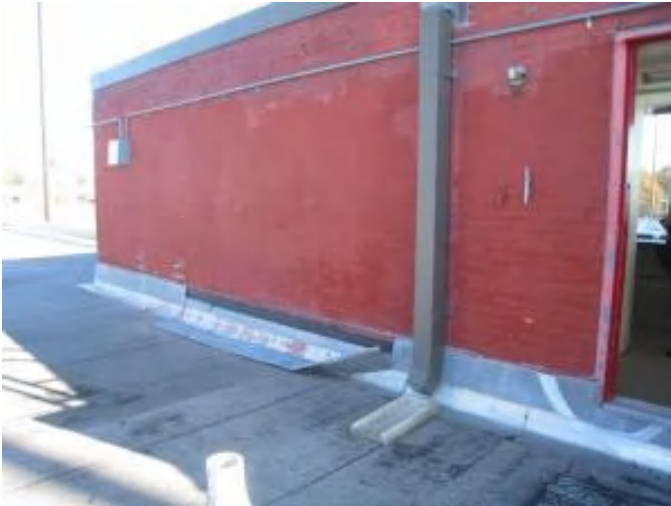
System: B3010105 - Built-Up

Location: brick structures at roof

Distress: Damaged

Notes: Repair counterflashing along brick on roof (20ft)

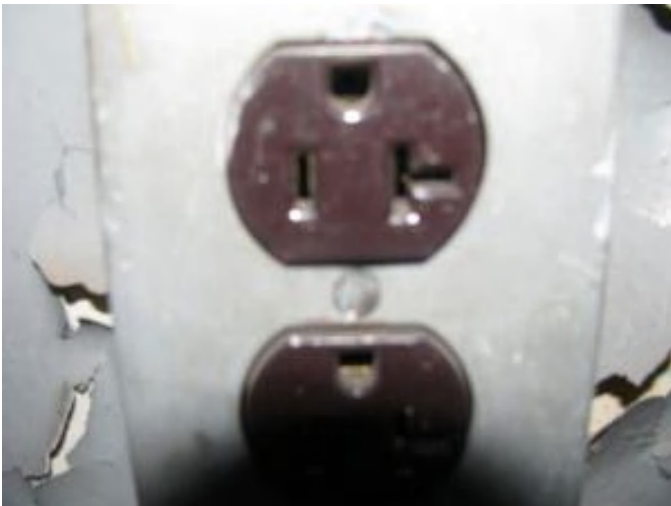
System: D5020 - Lighting and Branch Wiring

Location: Entire Building
Distress: Inadequate
Category: 3 - Operations / Maint.
Priority: 1 - Response Time (< 2 yr)
Correction: Replace Wiring Devices (SF) - surface mounted conduit and boxes
Qty: 0.00
Unit of Measure: S.F.
Estimate: \$51,510.90
Assessor Name: Craig Anding
Date Created: 12/28/2015

Notes: Replace all receptacles with new 120V, 20A duplex receptacles.

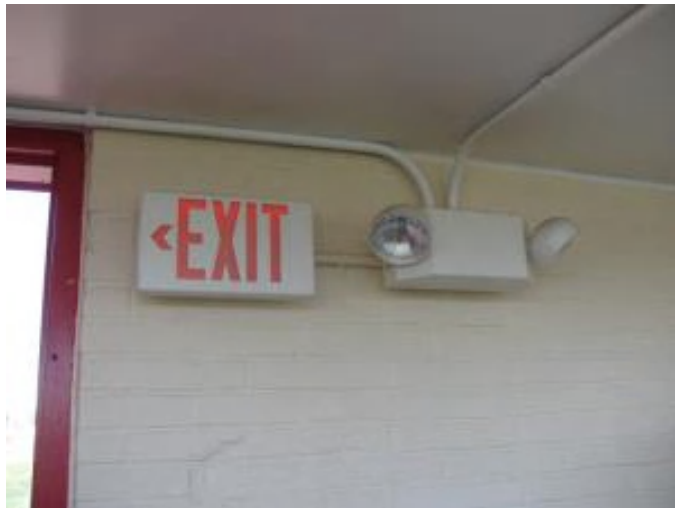
System: D5020 - Lighting and Branch Wiring

Location: Entire Building

Distress: Life Safety / NFPA / PFD

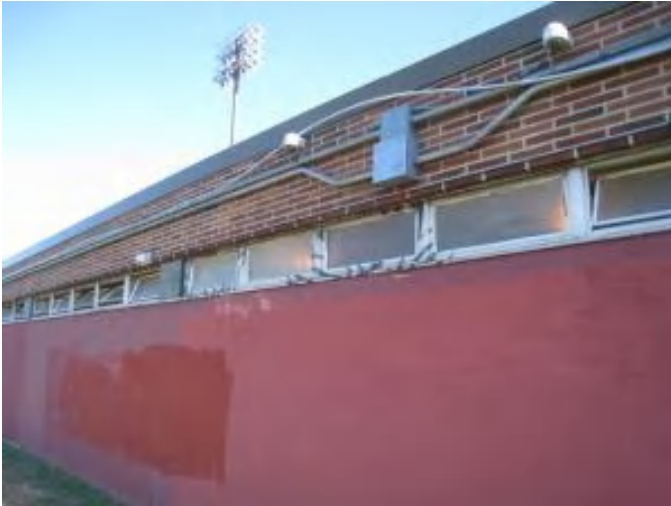
System: B2010 - Exterior Walls

Location: exterior brick - painted

Distress: Appearance

Notes: Repaint brick below windows and at roof (2500sf)

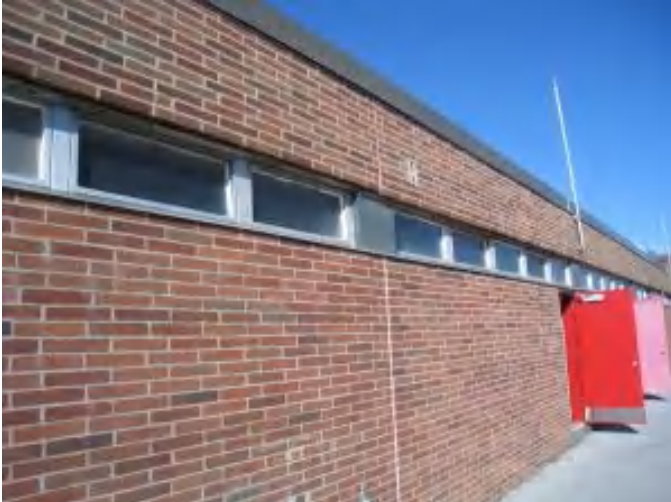
System: B2010 - Exterior Walls

Location: exterior windows

Distress: Failing

Notes: Repaint lintels (1300ft)

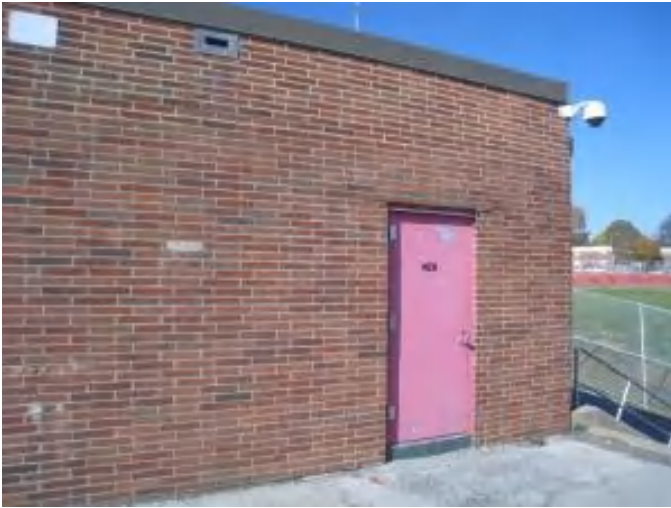
System: B2010 - Exterior Walls

Exterior walls of the Home and Visitor Fieldhouses are constructed brick. The two story corner (southeast corner) of the Home Fieldhouse has some stepped cracking. There is also some cracking along some of the lintels and near the northeast corner, but generally the brickwork is in fair condition. Some brickwork on the outside of the announcement booth above the roof level and below first floor windows needs to be repainted as it is worn and chipped. Vertical expansion joints at column lines are in poor condition with caulking and backer rods having fallen out of the joints exposing the interior to the outside elements. Caulking is failing around granite panels between bands of windows; panels need to be recaulked. The Visitor Fieldhouse has some brick cracking on the southeast corner; some cracking on the northeast corner has been recently repaired. Lintels on the east side of the Visitor Fieldhouse appeared to be in good condition.

Location: exterior walls

Distress: Failing

Notes: Repair cracked exterior northeast and southeast building corners (300sf)

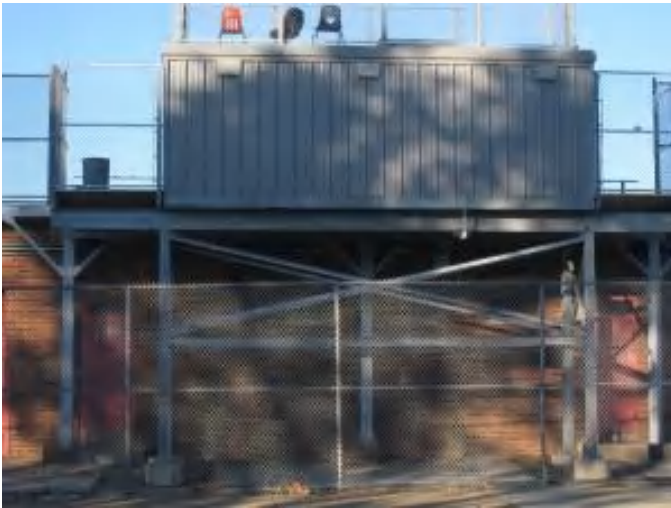
System: B2020 - Exterior Windows

Windows in the Home Fieldhouse are constructed of a fixed/operable hopper-type, clear anodized aluminum frame system with single pane glass panels. Where windows had been broken, there were replaced with plexiglass vision panels, now becoming cloudy and scratched. Staining from degrading aluminum framing and security screens is washing down brick walls and is visible under some windows. Windows are in poor condition and should be replaced. The Visitor Fieldhouse has no windows.

Location: exterior windows

Distress: Beyond Service Life

Notes: Home side: Replace exterior windows - (280) 18"x42" aluminum frame and glass hopper-style windows; + (9) 3'6"x6' single hung windows
Visitor side: (4) 18"x42"

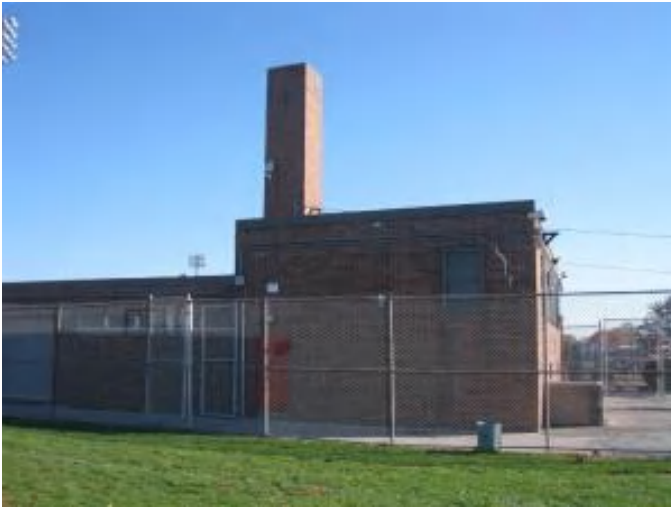
System: B2030 - Exterior Doors

Location: exterior roll up doors

Distress: Appearance

Notes: Visitor Side: Repaint galvanized rollup doors, lintels, and steel jamb guards(10) 12'x12' (ea = to 4 3x7 doors)
Home Side: Repaint galvanized rollup doors, lintels, and steel jamb guards(2) 12'x12' (ea = to 4 3x7 doors)

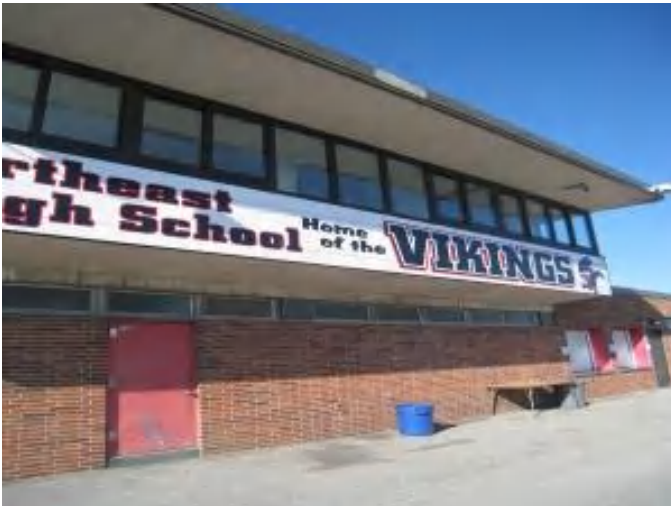
System: B2030 - Exterior Doors

Exterior doors for personnel use on the Home Fieldhouse are 3x7 hollow metal doors and frames that are damaged, have faded paint and many are rusted. All doors, frames, and hardware need to be replaced with rugged FRP doors that the District has started using for replacement doors. The Home Fieldhouse has two galvanized steel roll-up doors for access into two storage rooms, which seem to be tightly closed and in good condition. The Visitor Fieldhouse has 10 painted steel rollup doors and a few personnel doors, all in need of repainting.

Location: exterior doors

Distress: Damaged

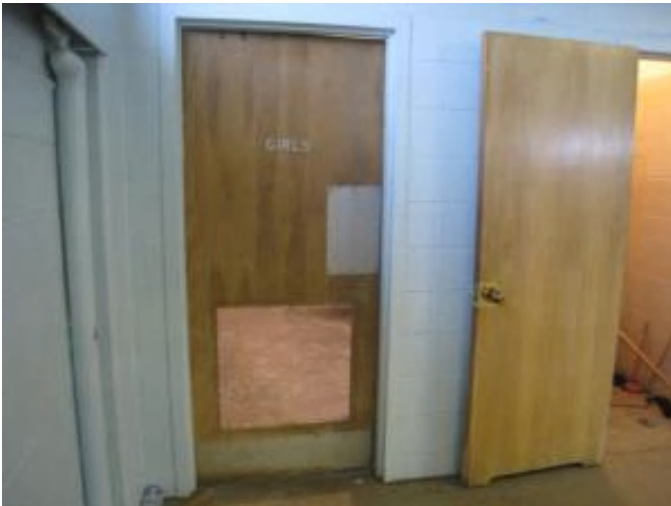
System: C1020 - Interior Doors

Interior doors are hollow metal with steel frames. All frames are steel and are damaged, rusted and beyond repair. All doors and frames require replacement.

Location: interior doors
Distress: Damaged
Category: 3 - Operations / Maint.
Priority: 2 - Response Time (2-3 yrs)
Correction: Remove and replace interior doors - wood doors with hollow metal frames - per leaf
Qty: 15.00
Unit of Measure: Ea.
Estimate: \$71,558.81
Assessor Name: Craig Anding
Date Created: 01/26/2016

Notes: Home side only: New interior doors and hardware (15 3x7)

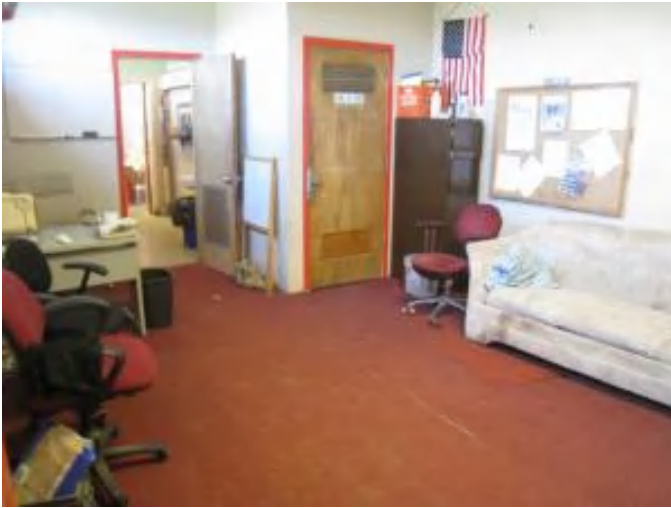
System: C3010230 - Paint & Covering

Location: interior walls

Distress: Appearance

Notes: Home Side only: Repaint all interior walls (8,000sf)

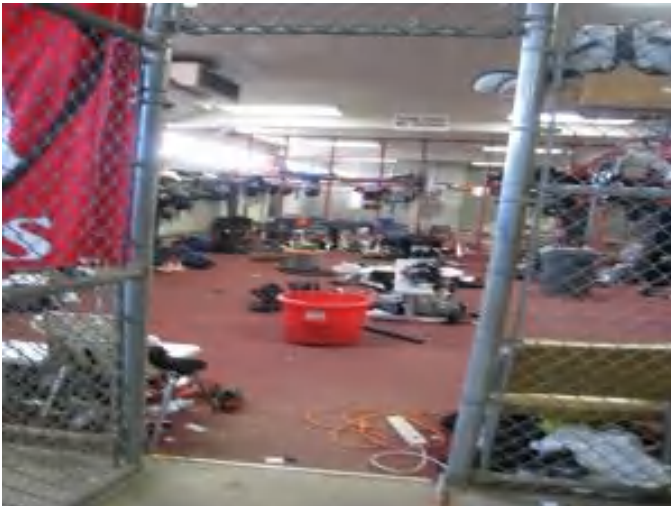
System: C3020411 - Carpet

Location: interior carpet

Distress: Damaged

Notes: Replace carpet in coach's office area and workout room (1000sf)

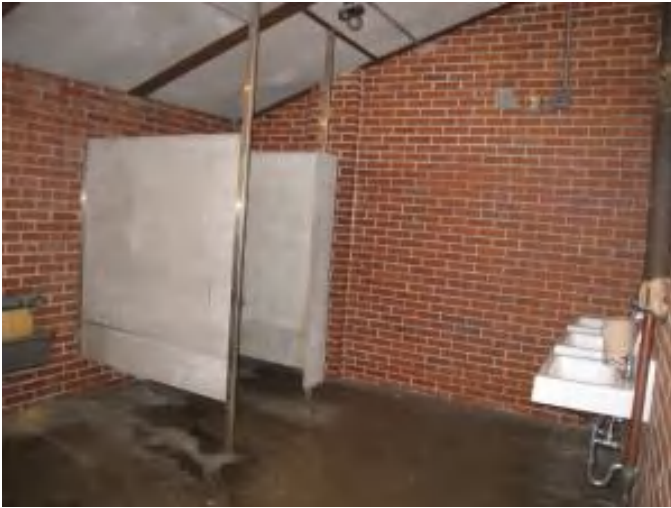
System: C3020415 - Concrete Floor Finishes

Floor finishes throughout most of both buildings are exposed concrete surfaces that are stained, dirty, and in need of refinishing with new sealer or paint. In the Home Fieldhouse, the boy's workout area and the coach's office area are finished with carpet which needs to be removed and replaced with an athletic rubber/vinyl floor. The announcement booth has a concrete floor in need of new paint. Assuming the showers are to be used, the concrete floors in these wet areas should receive a non-slip coating. The floors in the apartment were not inspected. The floors in the Visitor Fieldhouse are all exposed concrete in need of re-sealing.

Location: concrete slabs

Distress: Appearance

Notes: Home Side: Refinish all interior concrete floor slabs (16,452sf)
Visitor Side: Refinish concrete slabs (4,000sf)

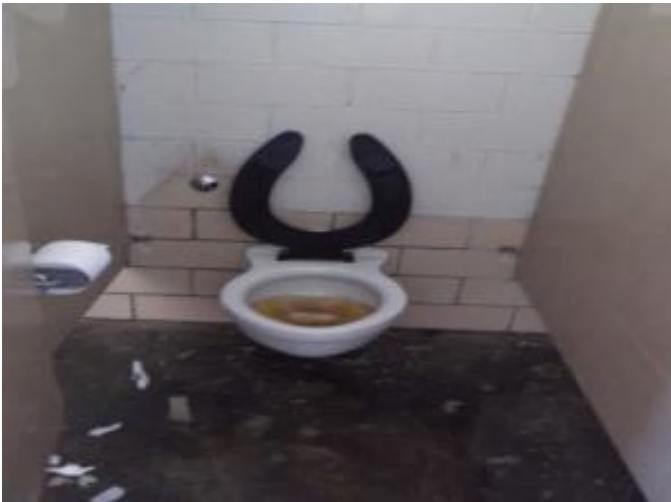
System: D2010 - Plumbing Fixtures

Location: Throughout the building

Distress: Building / MEP Codes

Notes: Replace all water closets in the building with lower flow fixtures, as the fixtures are original.

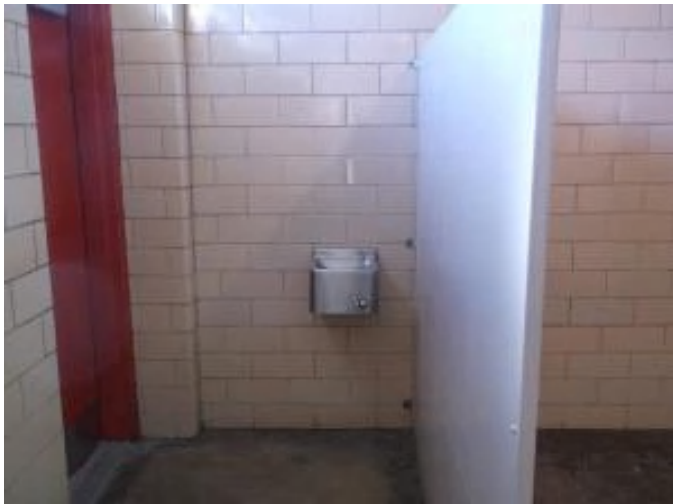
System: D2010 - Plumbing Fixtures

Within the building there are drinking fountains which are original fixtures and should be replaced. The replacement of all drinking fountains is recommended as the equipment is approximately 60 years old and beyond its service life.

Location: Throughout the building

Distress: Building / MEP Codes

Notes: Replace the integral refrigerated vertical water coolers and the drinking fountains. These units are well beyond their service life and most are NOT accessible type.

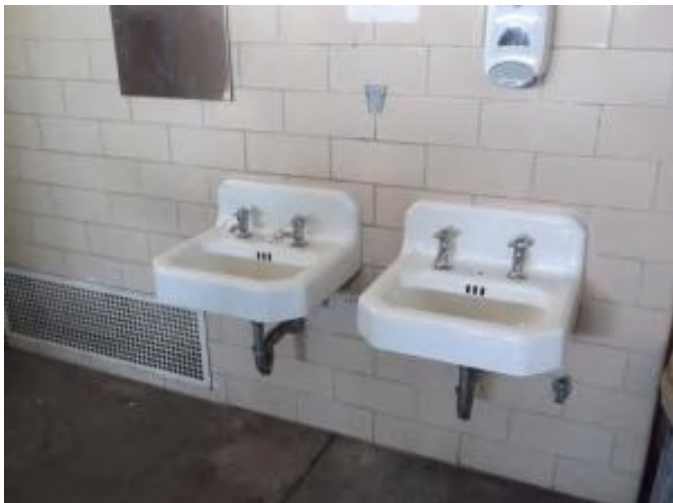
System: D2010 - Plumbing Fixtures

Location: Throughout the building

Distress: Building / MEP Codes

Notes: Replace all lavatories in the building with lower flow fixtures, as the fixtures are original.

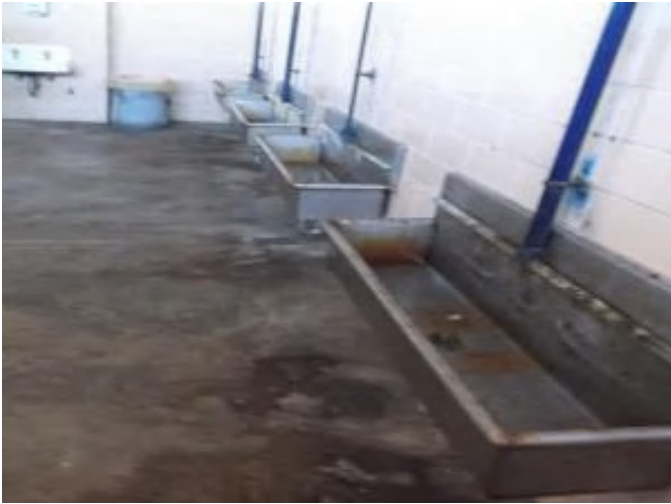
System: D2010 - Plumbing Fixtures

Location: Throughout the building

Distress: Building / MEP Codes

Notes: Replace all urinals in the building with lower flow fixtures, as the fixtures are original.

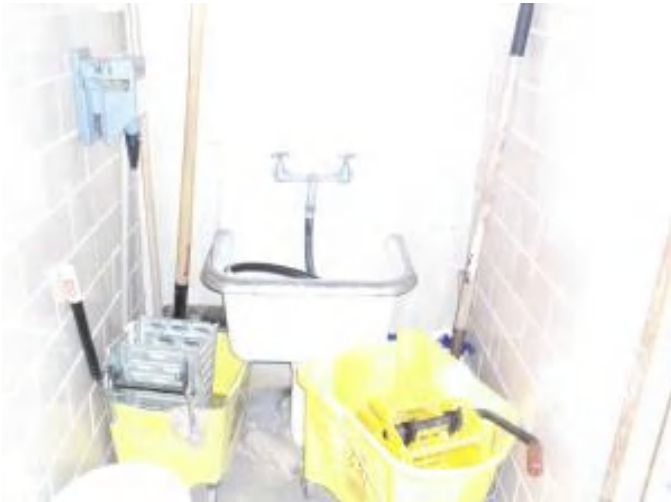
System: D2010 - Plumbing Fixtures

For the Home Stands, wall hung service sinks are original and are available within the building for use by the janitorial staff. The sinks appear have exceeded their service life, and should be replaced. The concessions stand is equipped with a hand sink. There are no service sinks for the Away Stands.

Location: Throughout the building

Distress: Building / MEP Codes

Notes: Replace service sinks (janitor sinks) in the building.
