Northeast High School

School District of Philadelphia

S802001; Northeast HS and Field

Site Assessment Report

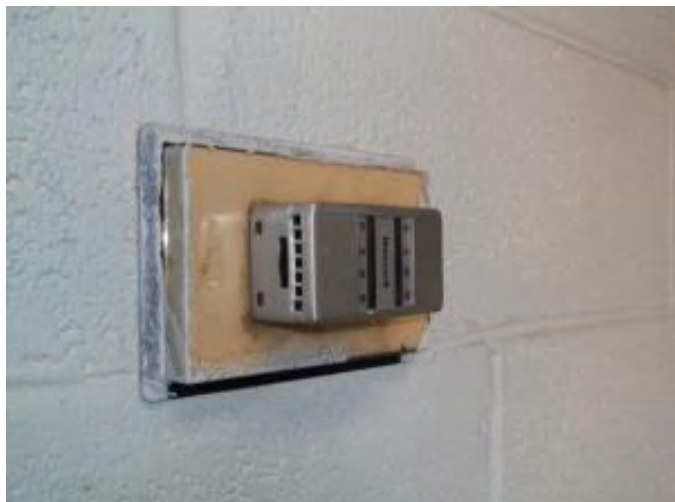
System: D3060 - Controls & Instrumentation

Location: Throughout the building

Distress: Building / MEP Codes

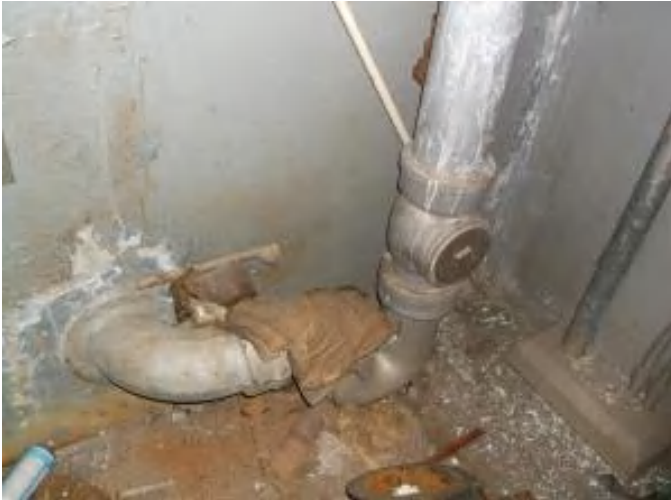
System: D2030 - Sanitary Waste

Sanitary Waste - Sanitary Waste - The sanitary waste piping system in the Home Stands and Away Stands is extra heavy cast iron with lead and oakum seals and appears to be the original piping installed in the building. It is therefore recommended to inspect this piping and repair or replace sections as needed. The sanitary system leaves the building by gravity flow.

Location: Throughout the building

Distress: Building / MEP Codes

Notes: Hire a qualified contractor to perform a detailed examination of the sanitary waste piping using visual inspection and video cameras to locate and replace any damaged piping and to further quantify the extent of potential failures.

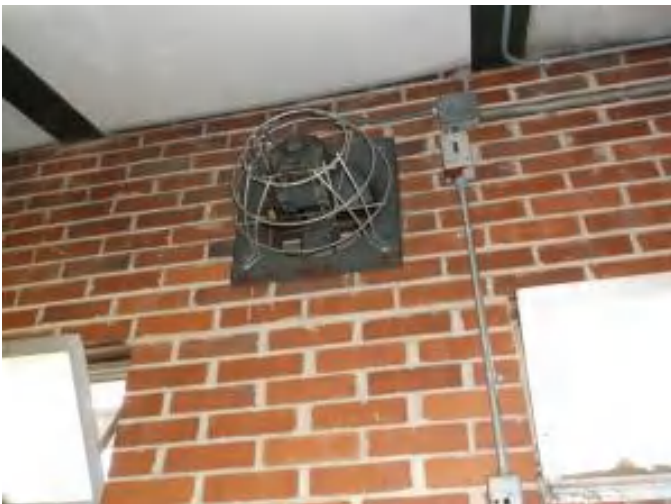
System: D3040 - Distribution Systems

Terminal & Package Units - There are roof top and through the wall exhaust fans which serve the restrooms and team room area. The ductwork and associated fans are beyond their service life and should be replaced. The concession stand area is heated by an electric vertically suspended unit heater and is provided with exhaust. Showers are served by exhaust fans. The exhaust fans and ductwork in general should be replaced with the exception of the concessions area. The security room with the camera equipment is not cooled but should have cooling provided due to the heat which is generated by the equipment.

Location: Throughout the building

Distress: Building / MEP Codes

Notes: Replace exhaust fans and ductwork

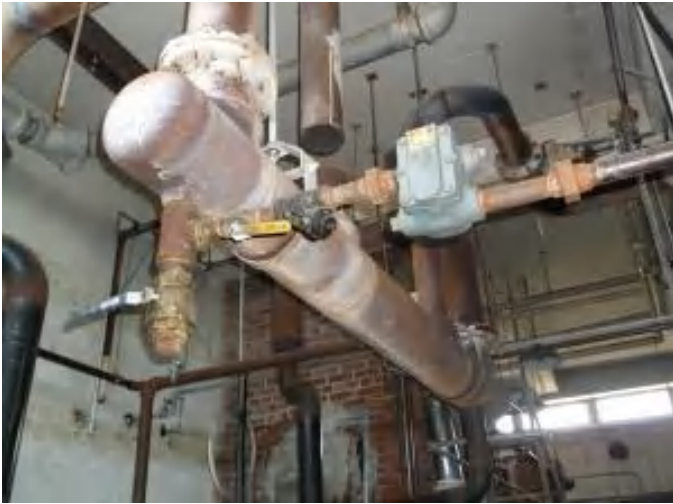
System: D3040 - Distribution Systems

Distribution Systems – For the Home Stands, the building steam distribution piping is black steel with welded fittings. There is no heating for the Away Stands. The piping has been in use beyond its service life and will require more frequent attention from the maintenance staff to address pipe/valve failures as time passes. The steam piping is not insulated. The District should hire a qualified contractor to examine the distribution piping and perform additional testing to locate and replace any damaged piping and to further quantify the extent of potential failures. The District should budget for replacing this piping over the next 5 years.

Location: Throughout the building
Distress: Building / MEP Codes
Category: 3 - Operations / Maint.
Priority: 3 - Response Time (3-4 yrs)
Correction: Perform testing to identify and replace damaged steam and condensate piping.
Qty: 24,000.00
Unit of Measure: S.F.
Estimate: \$227,048.93
Assessor Name: Craig Anding
Date Created: 02/17/2016

Notes: Hire a qualified contractor to examine the steam and condensate piping in service for 54 years and perform additional testing to locate and replace any damaged piping and to further quantify the extent of potential failures. The District should budget for replacing this piping over the next 10 years

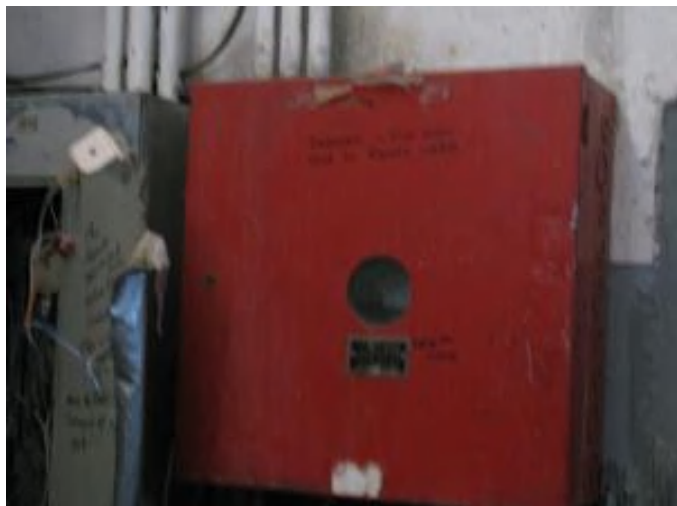
System: D5030 - Communications and Security

Location: Entier Building

Distress: Beyond Service Life

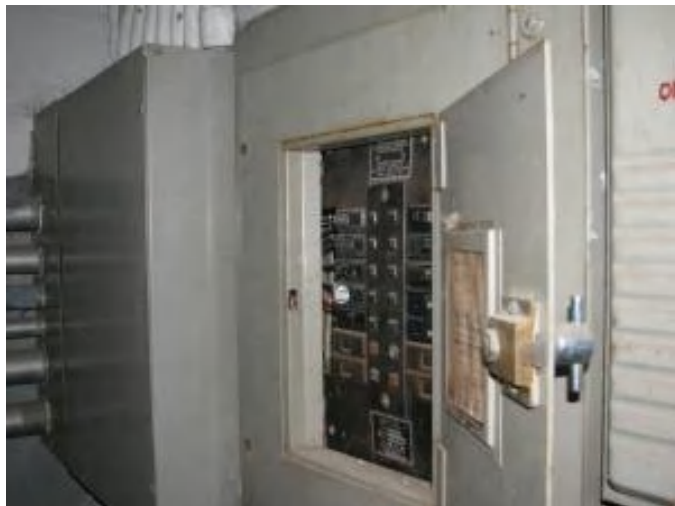
System: D5010 - Electrical Service/Distribution

Location: Electrical Room

Distress: Beyond Service Life

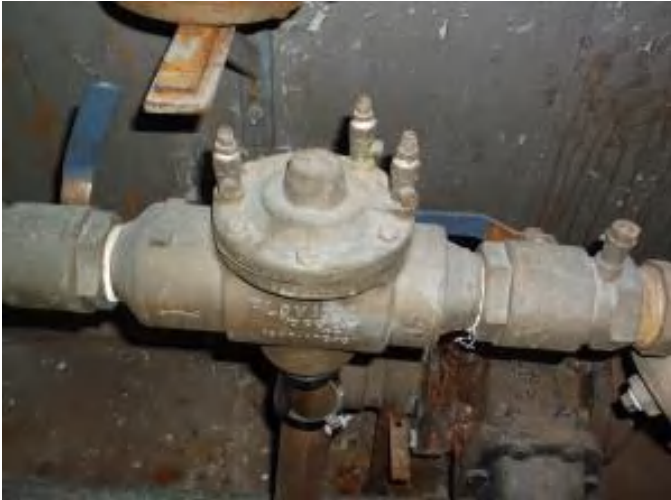
Location: Throughout the building

System: D2020 - Domestic Water Distribution

Distress: Building / MEP Codes

Correction: Replace domestic water piping (75 KSF)

Notes: Inspect and replace the original as needed the domestic water piping in the building.

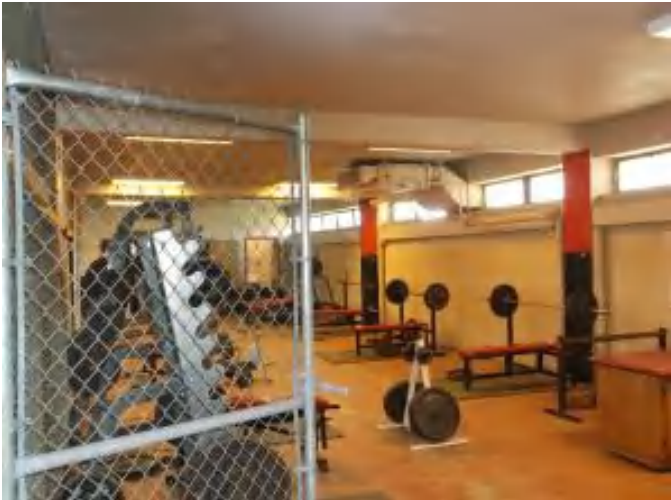
Location: Throughout the building

System: D4010 - Sprinklers

Distress: Building / MEP Codes

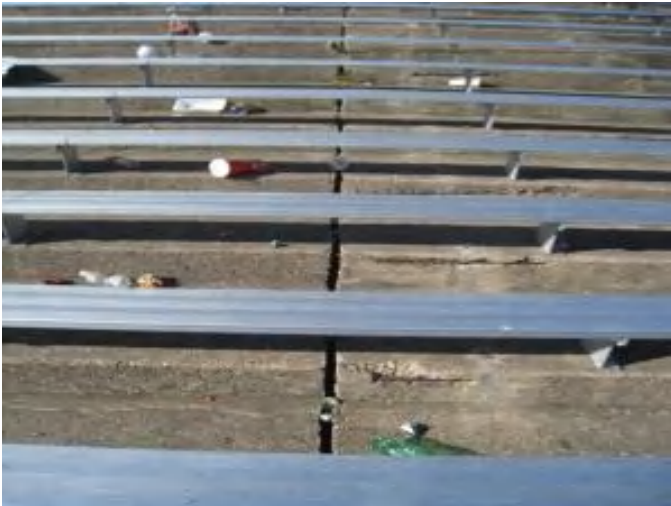
Location: home side stand support (conc slab)

Floor slabs under the aluminum seating on the Home side are in poor condition with many areas of spalling concrete and exposed, rusted reinforcing bars. Concrete nosings and risers over 25% of the surface area need to be repaired with new concrete cover. A protective, high performance paint finish should be applied over the repaired concrete for added durability. The Visitor side floors are constructed of steel plate supported by painted steel beams and columns, forming the structural system of the stands. The painted surface is wearing and rusting where paint is worn. The entire base and structure of the Visitor side needs to be properly cleaned/prepared and repainted.

System: B1010 - Floor Construction

Distress: Damaged

- Repair exposed, spalled concrete under bleacher seating (2000 sf); re-coat all concrete with high performance coating including vertical risers under bleachers (24,000 sf).

Notes: Home side only: Repair exposed, spalled concrete under bleacher seating (2000sf); recoat all concrete with high performance coating including vertical risers under bleachers (24,000sf)

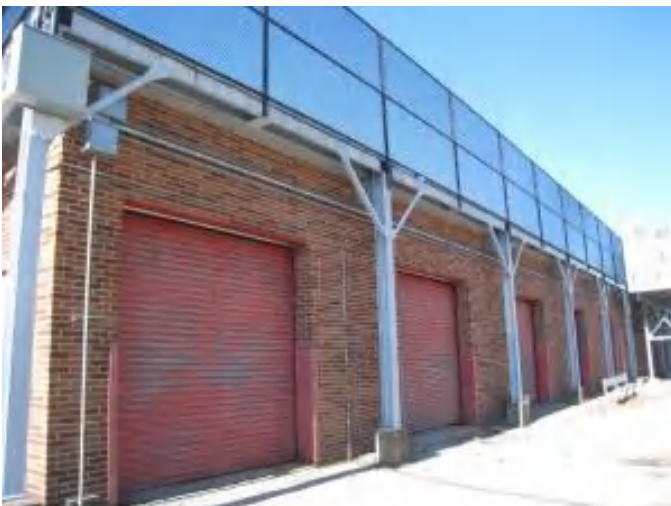
Location: bleacher support (steel)

Floor finish under the Home Stands is exposed concrete, which is worn, spalling and in need of refurbishment. After patching and repairing the surface, a high performance floor coating should be applied to protect the surface from the natural elements. The floor finish of the Visitor Stands is painted steel which is rusting and in need of a new high performance floor coating.

System: C3020415 - Concrete Floor Finishes

Distress: Failing

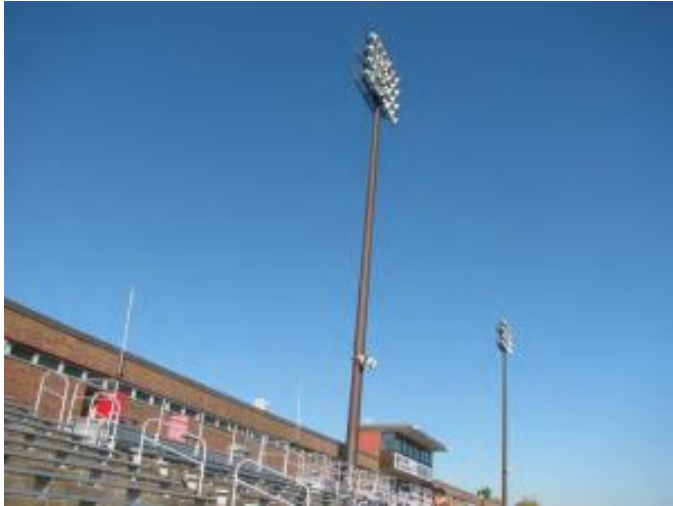
Location: Field stand

The football field sound system appears to be old; the speakers are not matched with the existing PA system. Replacement of the existing sound system with a new modern sound system is recommended.

System: D5030 - Communications and Security

Distress: Beyond Service Life

- Provide site lighting in football field.
- Provide lightning protection studies to ascertain adequacy of existing lighting protection systems.
- Replace the existing sound system with a new sound system including One 1000W power amplifier with digital processing/speaker protection, one mixer with inputs for three microphones and four additional sources (iPod, CD, MP#, etc.), one Desk Top Announcer's Microphone, one A/C Power Distributor, Portable equipment Rack, UV Resistant Speaker Cable and accessory Cables for iPod, MP3, CD Player, etc. Replace existing speakers with four sets of Weather Resistant, Full Range Loudspeakers with multi position mounting Brackets.
- Replace field lighting control panel with new panel.

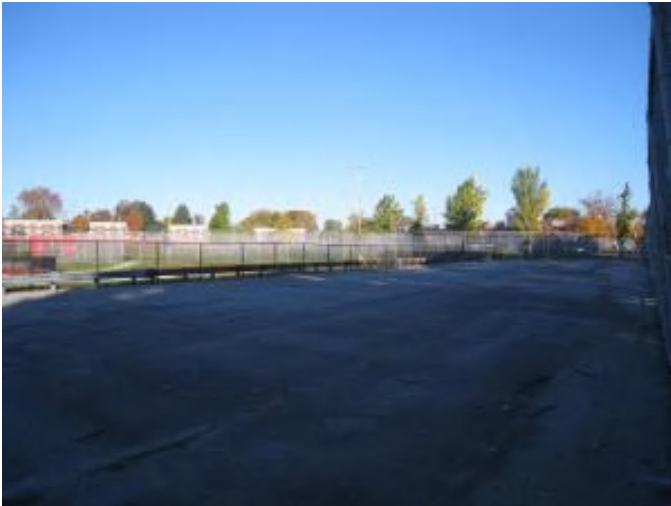
Location: Fieldhouse area, parking

Parking at the north and south ends of the football field are in fair condition. Each lot has some linear cracking that should be repaired with crackfiller to minimize further degradation.

System: G2020 - Parking Lots

Distress: Failing

Notes: Crackfill asphalt parking lots (2,500ft)

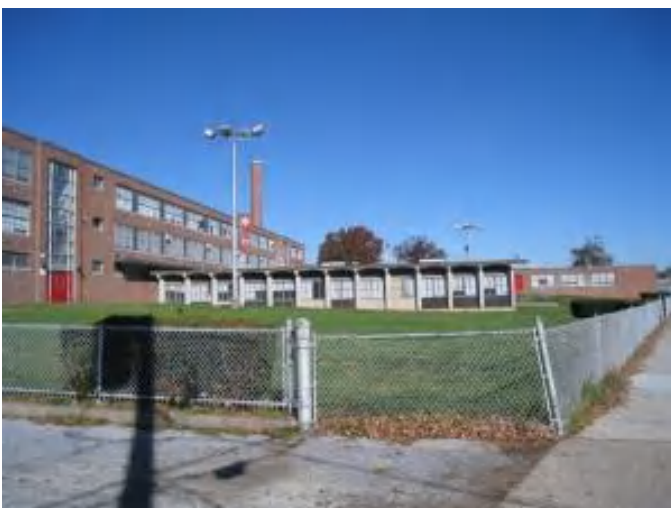
Location: mechanical area - vehicle parking and unloading

System: G2030 - Pedestrian Paving

Distress: Damaged

Notes: Repave damaged sections of concrete walkway along Cottman and Glendale Avenues (1,000sf)

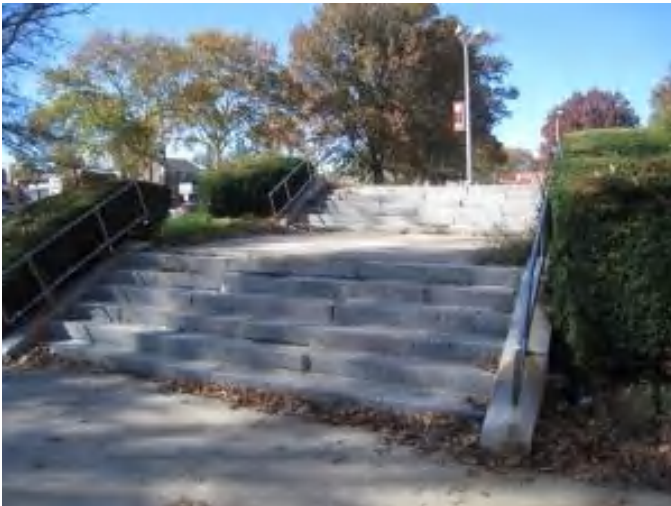
System: G2030 - Pedestrian Paving

Location: exterior stairs
Distress: Failing
Category: 3 - Operations / Maint.
Priority: 2 - Response Time (2-3 yrs)
Correction: Regrout joints between stone treads and risers - LF of grout
Qty: 540.00
Unit of Measure: L.F.
Estimate: \$8,782.74
Assessor Name: Steven Litman
Date Created: 01/25/2016

Notes: Regrout joints between limestone block tread/risers at misc. exterior stairs (18 treads, 30ft long)

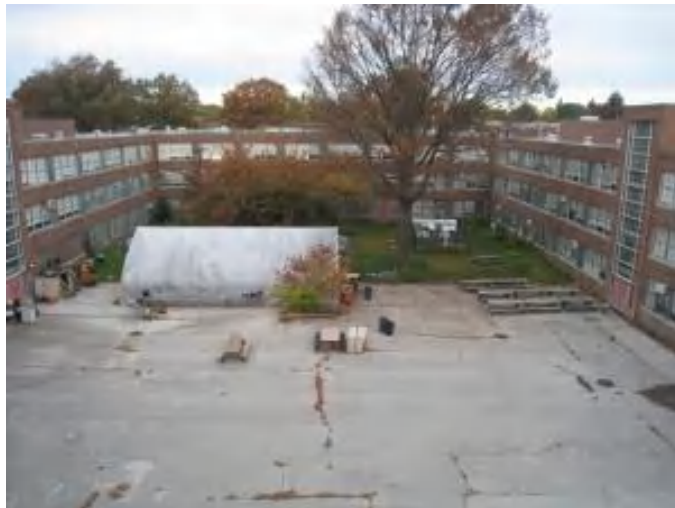
Location: south courtyard

System: G2050 - Landscaping & Irrigation

Distress: Damaged

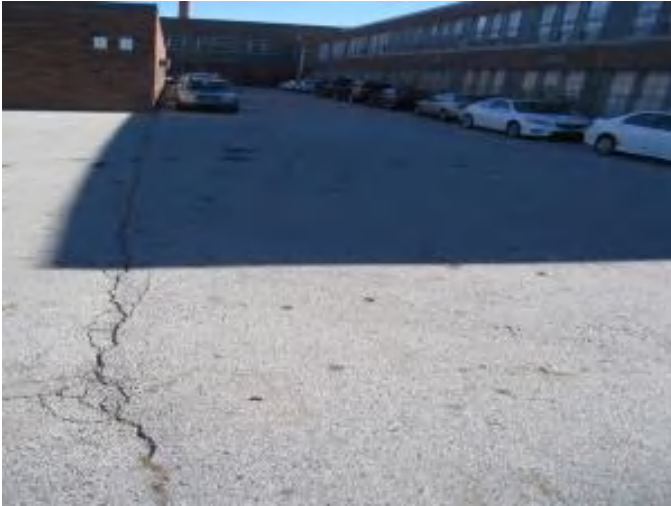
Location: parking lots

System: G2020 - Parking Lots

Distress: Damaged

Notes: Repave parking lots on Glendale and all of Faculty Parking lot on Algon Avenue (75,000sf)

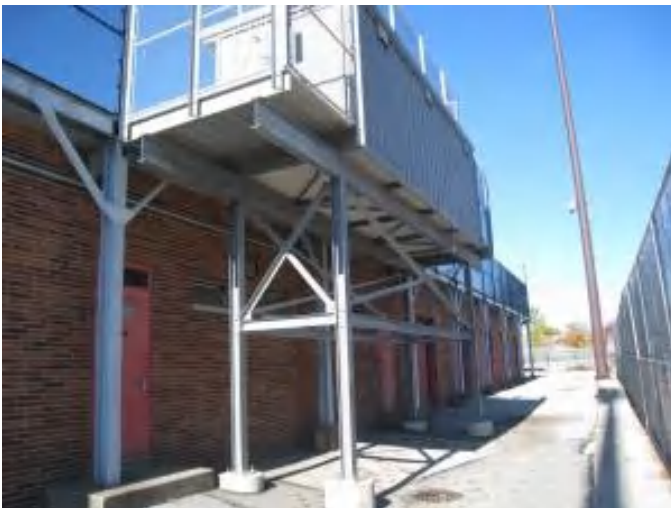
Location: Fieldhouses - pedestrian access both building, both sides

System: G2020 - Parking Lots

Distress: Failing

Notes: Repave asphalt walkways used for pedestrian access around the fieldhouses on field sides and back sides of Home and Visitor Fieldhouses (23,000sf)

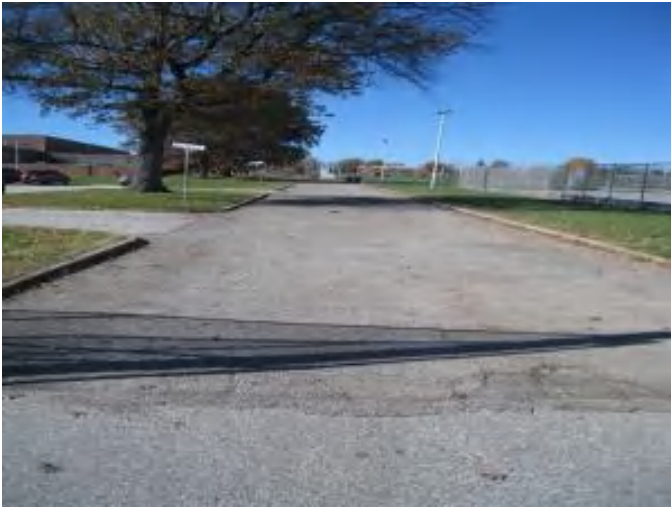
Location: mech area roadway

System: G2020 - Parking Lots

Distress: Damaged

Notes: Repave part of parking lot and all of asphalt roadway from Glendale Ave to Mechanical areas and repave driveway to kitchen loading dock from Glendale Ave (17,000sf)

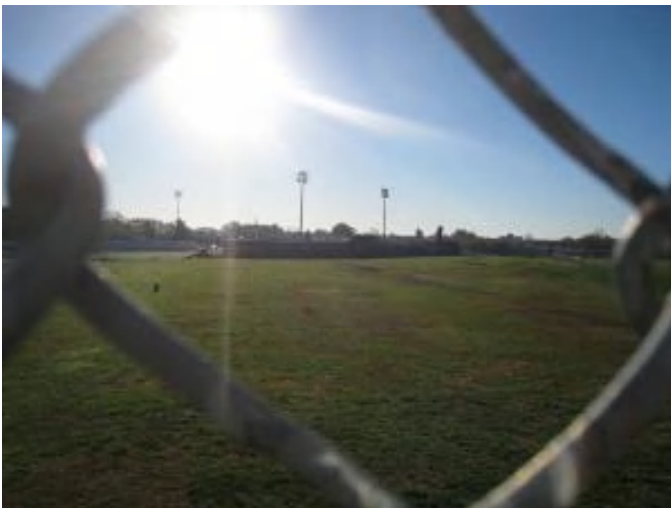
Location: Football Field

The football field is constructed of AstroTurf, and is thought to be approximately 9 years old. It is in good condition however there are some brownish areas scattered throughout the field. It appears that the field needs to be "re-dressed" to maintained a uniform surface condition. The track surrounding the football field is a textured rubberized material, also installed around 9 years ago. There are large workout and practice areas at the ends of the field area, contiguous with the running track. No deficiencies were observed.

System: G2050 - Landscaping & Irrigation

Distress: Maintenance Required
