Facility Condition Assessment Summary Report

Olney High School

School District of Philadelphia
S705001;Olney HS
Final
Site Assessment Report
February 1, 2017

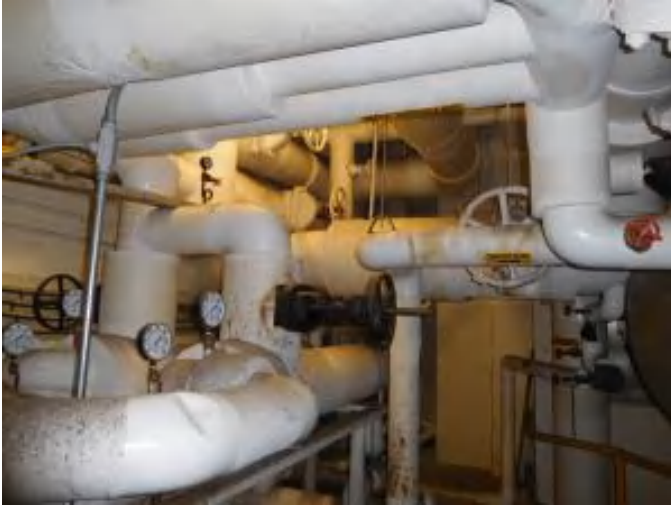
Location: mechanical room

System: D2020 - Domestic Water Distribution

Distress: Damaged

Notes: Repair/replace (4) four inch rising stem gate valves at hot water heat exchanger on mechanical room mezzanine.

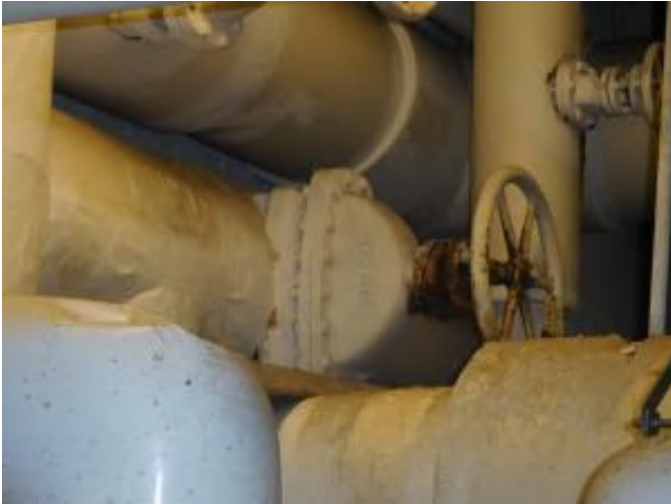
Location: mechanical room

System: D2020 - Domestic Water Distribution

Distress: Damaged

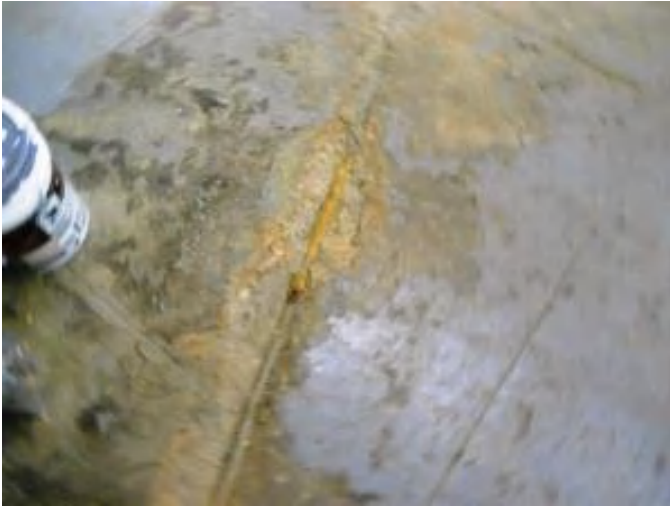
Location: Basement

System: A1010 - Standard Foundations

Distress: Damaged

Notes: There is evidence of water infiltration through the basement foundations wall. Excavation and waterproofing system upgrades are recommended. Improve the slope of the grade away from the foundation prior to restoring the landscaping system.

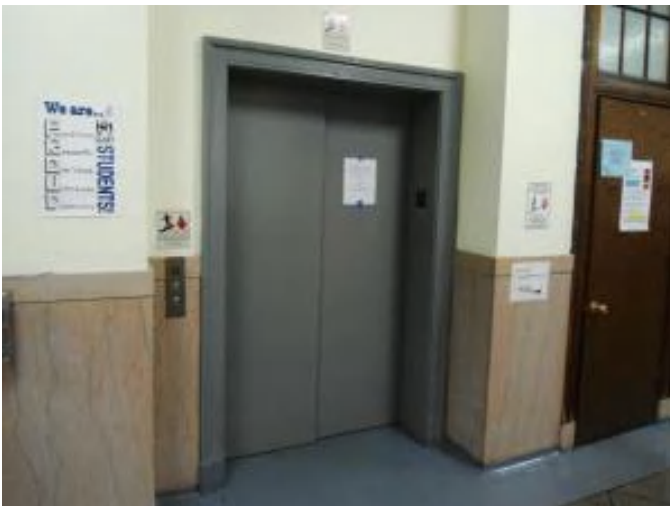
Location: Elevator

The present floor plan arrangement has the elevator lobbies opening up into the existing hall corridors. IBC 2000 states that elevators opening into a fire resistant corridor shall be provided with an elevator lobby at each floor containing such a corridor. The lobby should completely separate the elevators from the corridor with rated partitions. Elevator lobbies need to have at least one means of egress and contain smoke detectors. This deficiency recommends the construction of fire resistant barrier with automatically closing fire doors to be installed between the elevator lobbies and the corridors to provide the required separation and protection.

System: C1010 - Partitions

Distress: Life Safety / NFPA / PFD

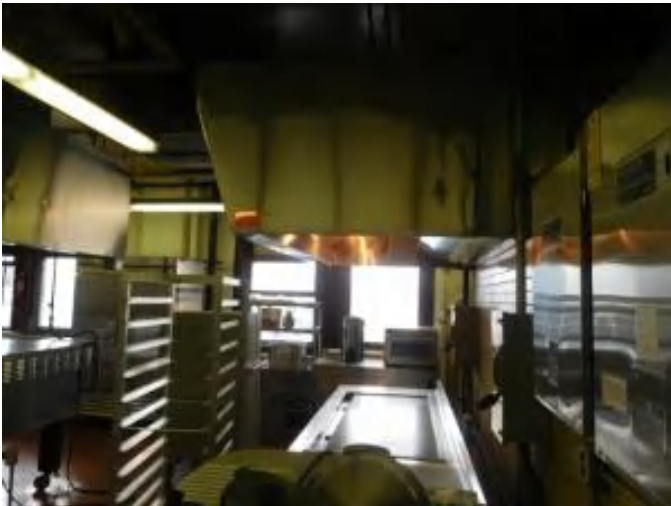
Location: Kitchen

The kitchen is illuminated with 8 foot, 4 lamp lensed wraparound fixtures with T12 lamps and need to be replaced.

System: D5020 - Lighting and Branch Wiring

Distress: Life Safety / NFPA / PFD

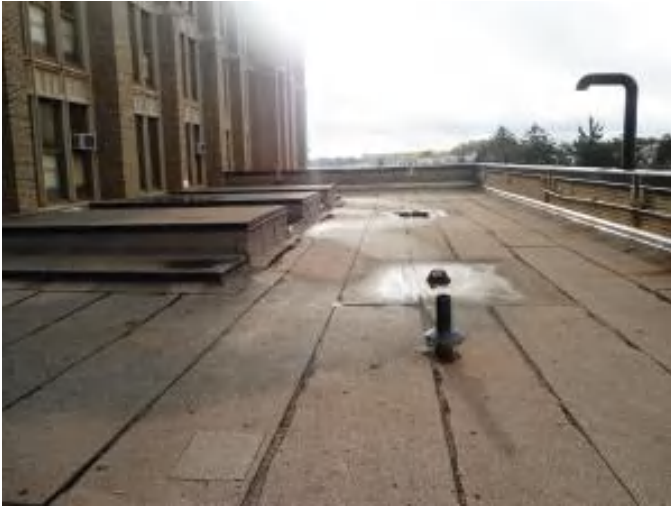
Location: Roof

There are a number of roof sections and different roof elevations ranging from the main roof to the mechanical roof. Parapet heights, coping materials, and the height of the flashing also varies in different sections. The main roof is a built up application that was installed in the early 1990'S. The other built up roofs have not conclusive installation dates and have been seal coated several times to extend the life cycle of the application. Considering the age and condition of the roofing systems, universal upgrades are recommended. Remove and replace all roof sections.

System: B3010105 - Built-Up

Distress: Damaged

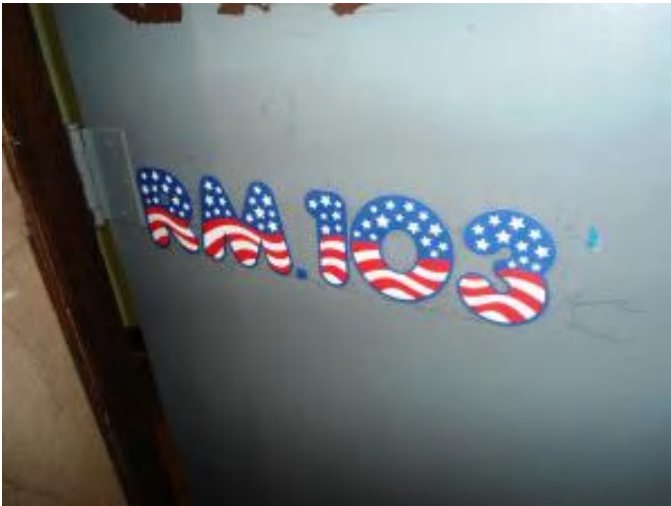
Location: Building Wide

System: C1030 - Fittings

Distress: Damaged

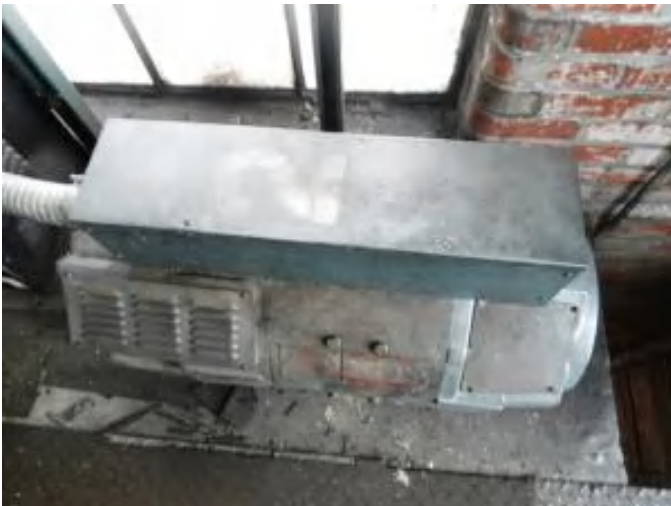
Location: Elevator Machine Rooms

System: D1010 - Elevators and Lifts

Distress: Beyond Service Life

Notes: Provide upgrade and modernization of elevator cabs, controls and machine rooms for both passenger elevators.

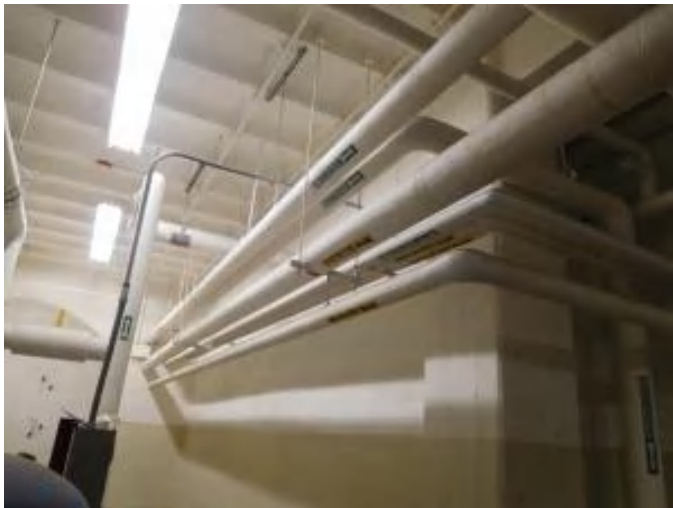
Location: entire building

System: D2020 - Domestic Water Distribution

Distress: Beyond Service Life

Notes: Replace domestic hot and cold water piping including valves, fittings, hangars and insulation.

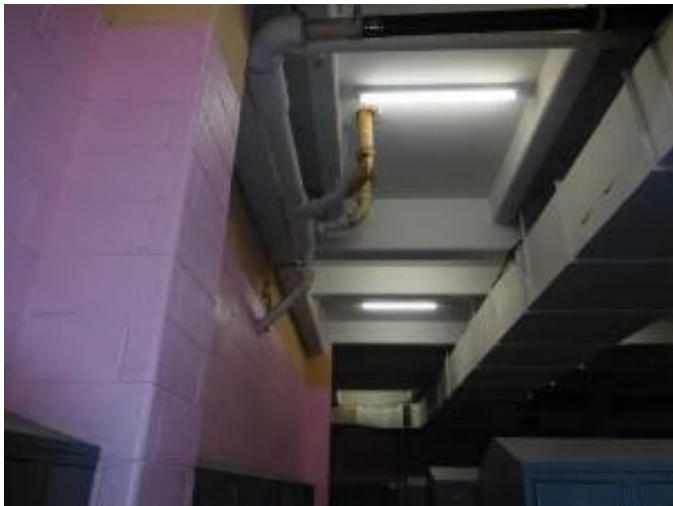
Location: entire building

System: D2030 - Sanitary Waste

Distress: Beyond Service Life

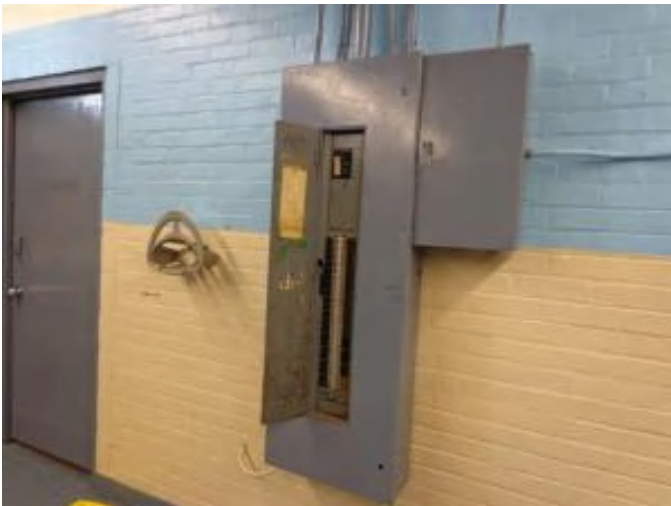
Location: Building wide

System: D5010 - Electrical Service/Distribution

Distress: Beyond Service Life

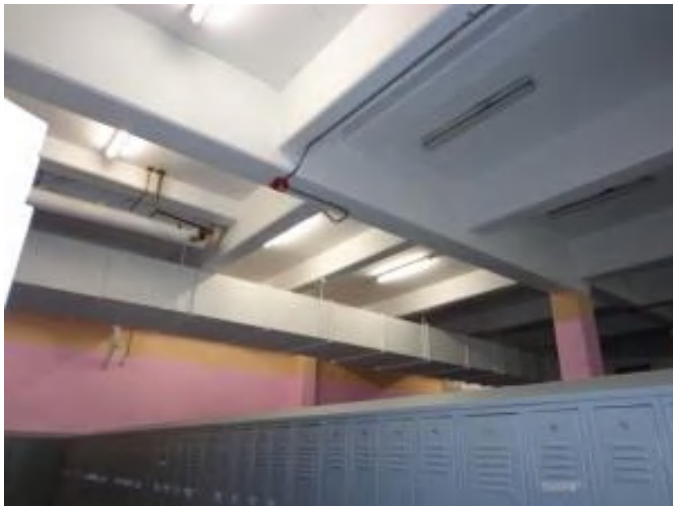
Location: Various rooms

System: D5020 - Lighting and Branch Wiring

Distress: Beyond Service Life

Notes: Provide an allowance for replacement of lighting system in staff areas, offices, cafeteria, serving, kitchen, locker rooms, toilet rooms, and other similar spaces (approximately 95,000 SF).

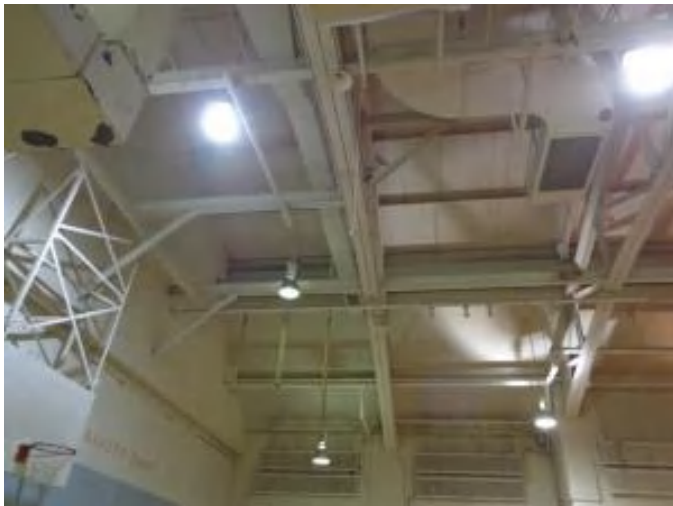
Location: Gymnasiums - Main building

System: D5020 - Lighting and Branch Wiring

Distress: Beyond Service Life

Notes: Replace a total of (28) metal halide lighting fixtures in the two smaller gymnasiums in the main building.

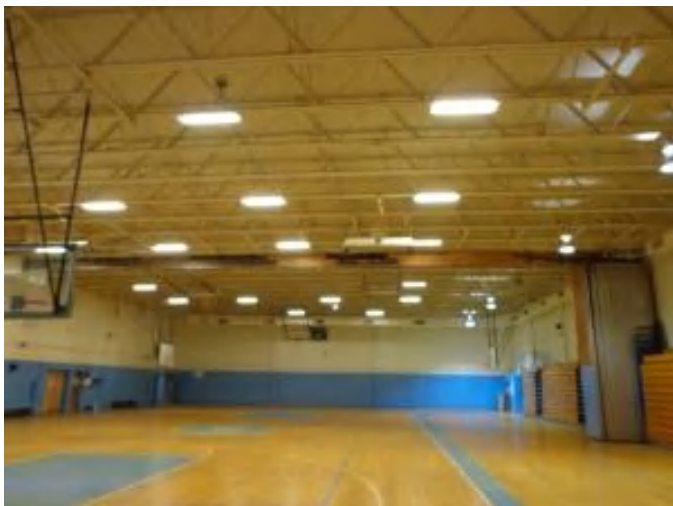
Location: Southwest Gymnasium

System: D5020 - Lighting and Branch Wiring

Distress: Maintenance Required

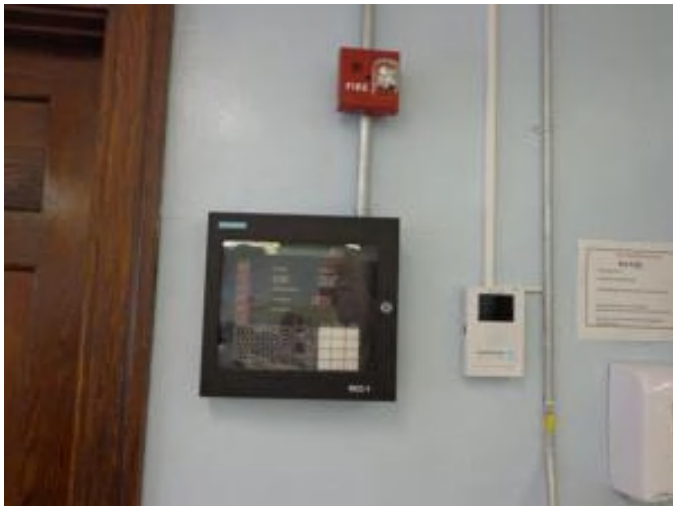
Location: Building wide

System: D5030 - Communications and Security

Distress: Life Safety / NFPA / PFD

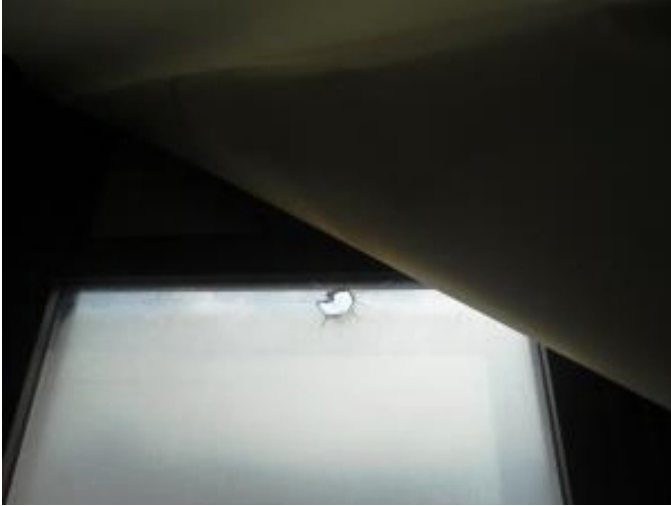
Location: Exterior Elevation

The exterior windows are a mix of the original industrial metal framed single pane applications for the modified shop classrooms and industrial rooms and aluminum framed applications in the classrooms and administrative areas. Some of the windows are operable while others no longer function. The exterior windows have exceeded the expected life cycle for this type of application. It is recommended that the exterior window system be replaced with units that retain their dimensions and profiles, but that incorporate updated energy-efficient features. Note: Several windows show evidence of fire arms activity in the local neighborhood. As indicated in the photos the integrity of the windows is driving the replacements for these specific conditions.

System: B2020 - Exterior Windows

Distress: Damaged

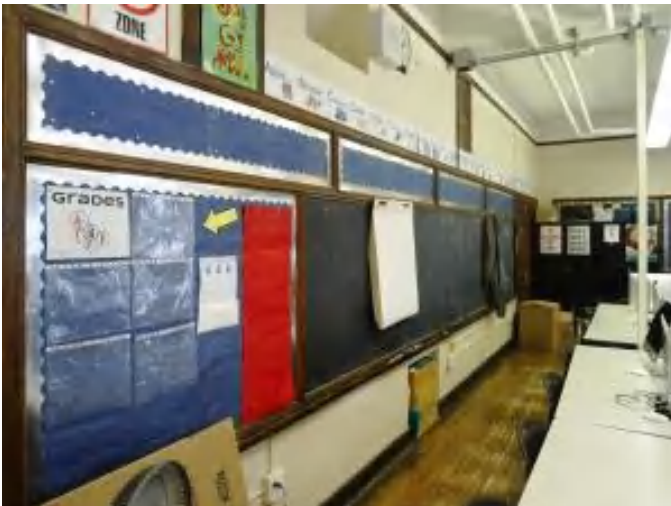
Location: Classrooms

System: C1030 - Fittings

Distress: Damaged

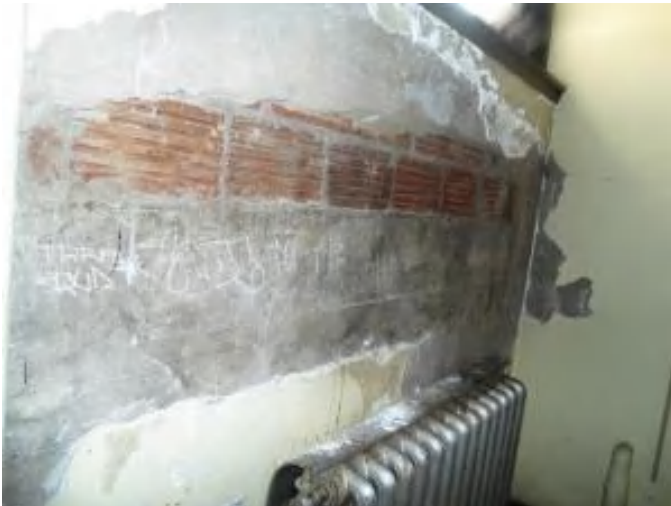
Location: Building Wide

System: C3010230 - Paint & Covering

Distress: Damaged

Notes: While using similar materials, the interior finishes vary significantly between the older and newer sections of the school. Portions of the southern vocational wing were updated in 2000. The main Gym, some classrooms, and office space, most of its corridor floors are concrete or vinyl tile, with painted masonry block walls or marble walls in the older sections and sealed unpainted concrete masonry unit (CMU) in the newer sections. The majority of the finishes are in fair condition. However, there are several minor areas of wall damage that ranges from serious to minor. Although the school is on a cyclical program of renewal and each painted surface is renewed at years end this system is at the point in which repairs are necessary. Remove damaged wall finishes and repair areas then apply primer and paint finish.

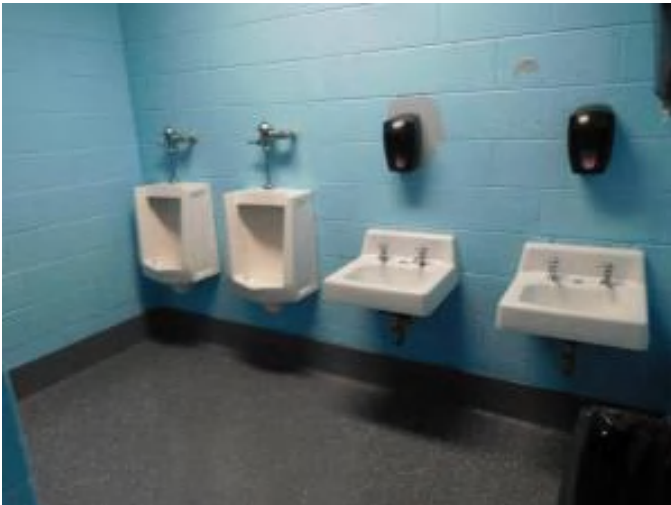
Location: toilet rooms original building

System: D3040 - Distribution Systems

Distress: Building / MEP Codes

Notes: Provide mechanical toilet exhaust system for the original building.

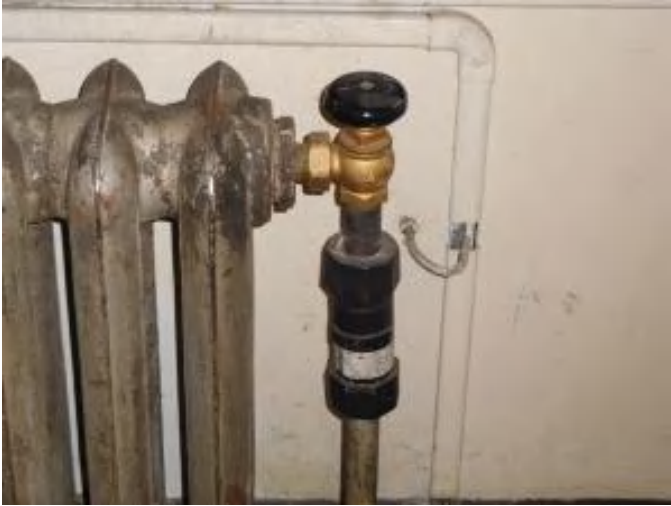
Location: entire building

System: D3060 - Controls & Instrumentation

Distress: Inadequate

Notes: Install new direct digital control system and building automation system with software, remote computer control capability and graphics package.

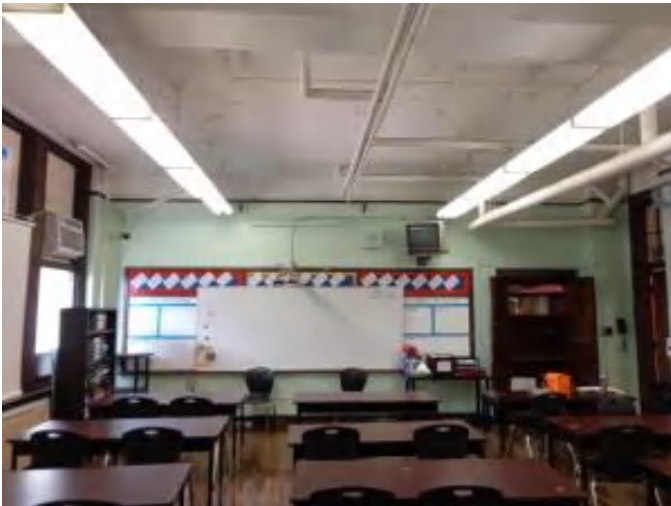
Location: Classrooms

System: D5020 - Lighting and Branch Wiring

Distress: Inadequate

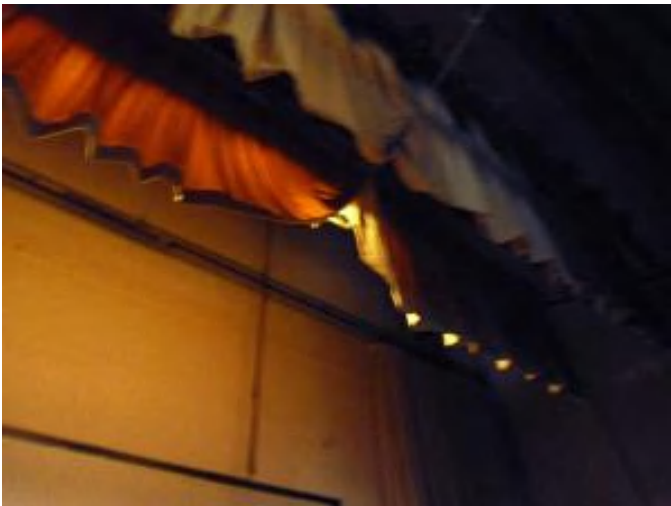
Location: Stage

The school stage has a stage curtain assembly that appears to be from the original construction. Modern applications are typically fire -proof applications with adjustable tracks and electric support for operation. The curtains are torn in a few section and the track is not functioning properly, overall the system is in poor condition. It is recommended that the curtain and track system be upgraded to a new system. Special care should be considered in regards to modern fire proofing for the new installation.

System: E2010 - Fixed Furnishings

Distress: Life Safety / NFPA / PFD

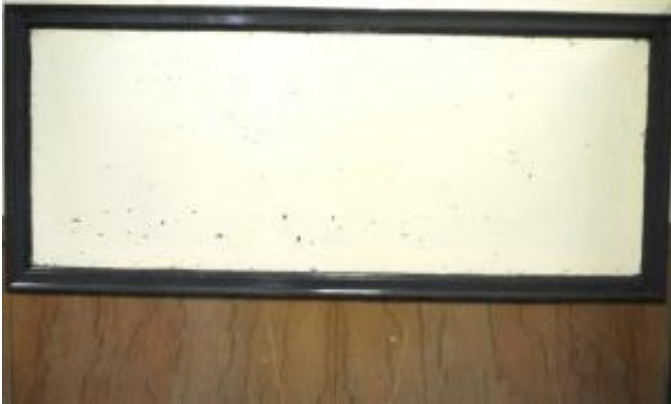
Location: Hallways Classrooms

There are several tack boards in the hallways for student displays. The systems are damaged and beyond the expected service life for this application. Remove and replace tack boards is recommended.

System: C1030 - Fittings

Distress: Damaged

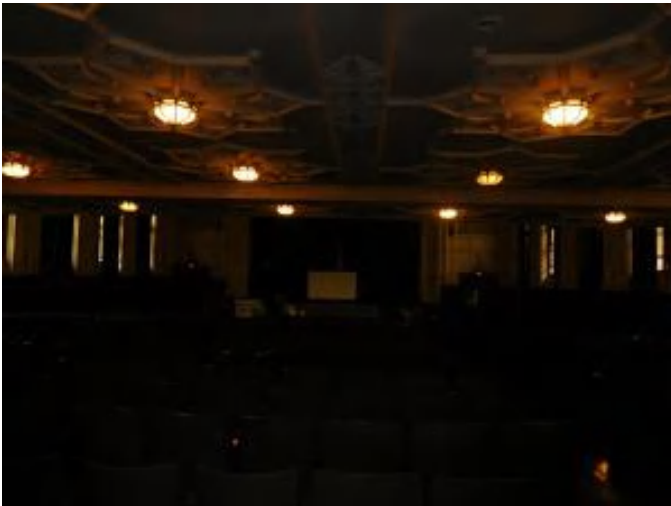
Location: auditorium

System: D3040 - Distribution Systems

Distress: Building / MEP Codes

Notes: Provide a new central station air handling unit for the auditorium with hot and chilled water coils, filters, outside and return air dampers, hydronic valves and controls, blower and motor. Connect to hot and chilled water systems.

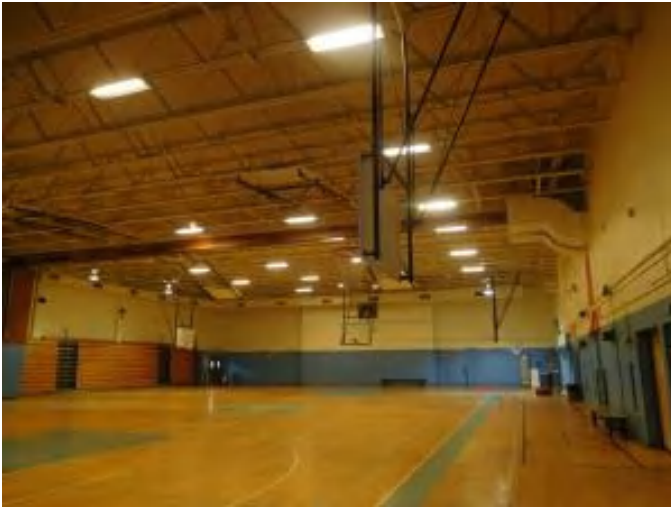
Location: gymnasiums

System: D3040 - Distribution Systems

Distress: Building / MEP Codes

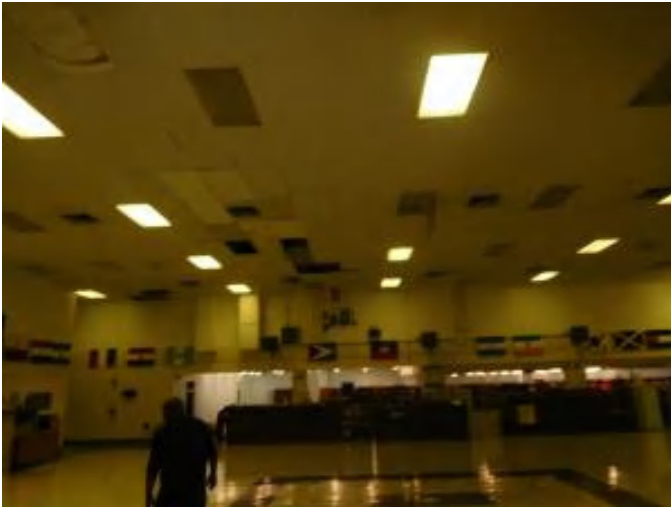
Location: entire building

System: D4010 - Sprinklers

Distress: Life Safety / NFPA / PFD

Notes: Install complete NFPA wet pipe automatic sprinkler system and standpipes. If required provide fire pump and jockey pump with controller.

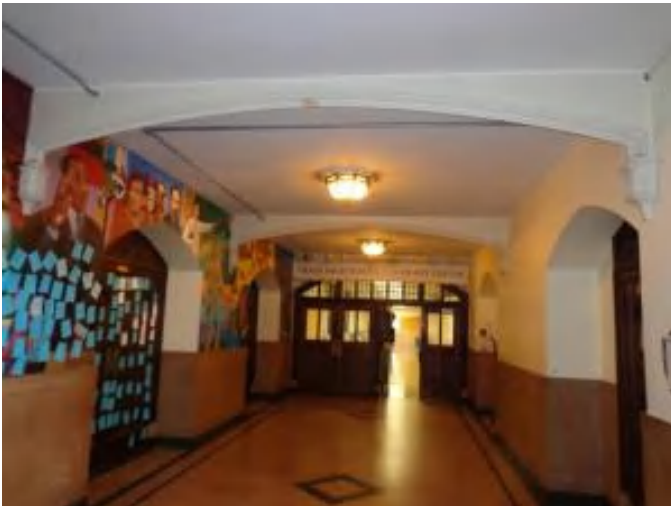
Location: Main Entrance, Corridors, Auditorium

System: D5020 - Lighting and Branch Wiring

Distress: Energy Efficiency

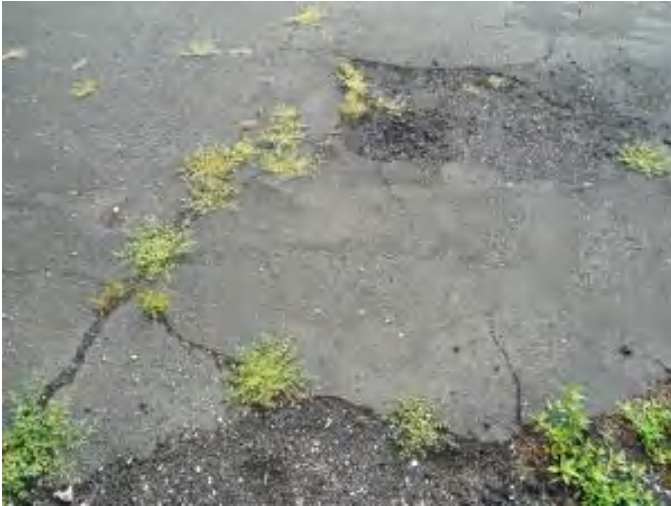
Location: Parking Lot

System: G2020 - Parking Lots

Distress: Damaged

Notes: The parking area has ADA parking with approved curb cuts for access to the sidewalks that lead to the service entrance facing the southern exterior. There is also covered parking under the constructed gym and additional parking near the old vocational school. However, the parking lots are in poor condition, the harsh environmental conditions associated with snow removal have taken its toll on the asphalt surface. Also, there is no marked path of ingress to the main entrance. This project provides a budgetary consideration for a parking lot renewal program that includes all aspects of the current ADA legislation. Universal upgrades are recommended.

Correction: Remove and replace AC paving parking lot

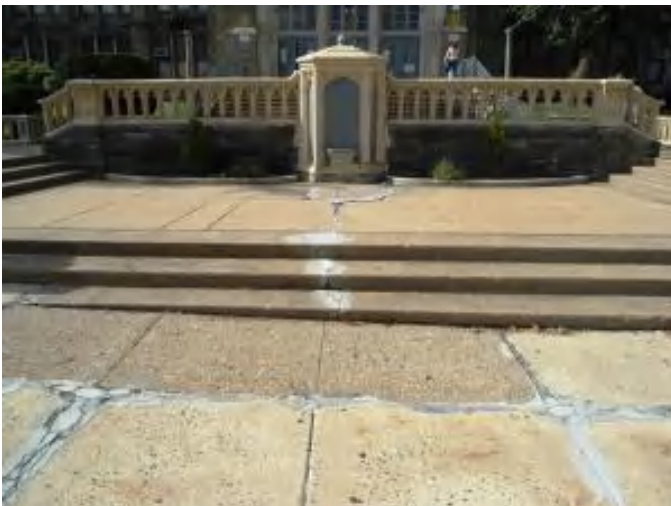
Location: Site

System: G2030 - Pedestrian Paving

Distress: Damaged

Notes: The sidewalk system is original to the buildings construction. There are a several areas of cracking concrete but no tripping hazards. The sidewalk system is expected to expire in the near future. Removal of the entire system is recommended. Universal upgrades are required and should include all aspects of current ADA legislation.

Correction: Remove and replace concrete sidewalk or concrete paving - 4" concrete thickness

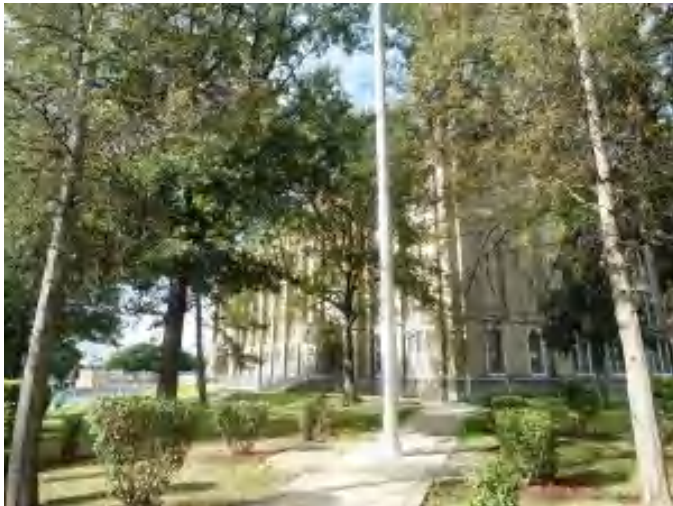
Location: Site

System: G2050 - Landscaping & Irrigation

Distress: Inadequate

Notes: The landscaping is in good condition and well maintained but with no irrigation system. The landscaping is generally located near the parking / play area of the site with limited turf sections around the general exterior of the school. This deficiency provides a budgetary consideration for the installation of an irrigation system for this site.

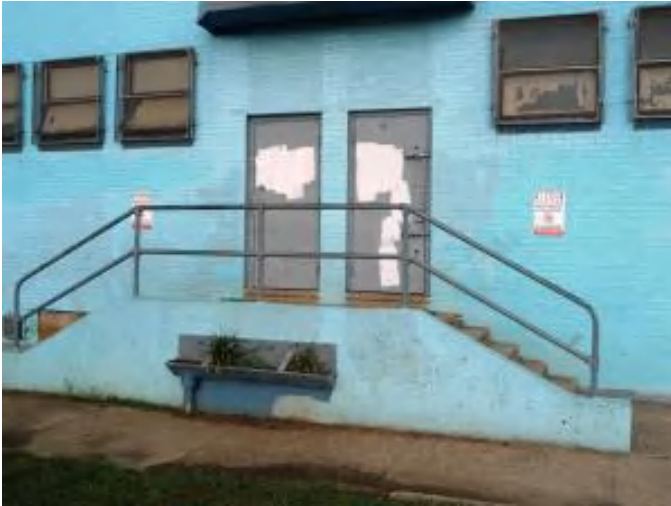
Location: Exterior Elevation

System: B2030 - Exterior Doors

Distress: Damaged

Notes: There are three exterior doors one facing the East and entrance gate and two facing west towards the fields. The doors are metal applications with wooden or metal frames. The exterior door system for this field house is a very high traffic system. The doors are in poor condition. These doors are out of service and need immediate attention. Other doors are aging at a faster rate than expected based on traffic and condition. The exterior door system is recommended for upgrade. Special consideration to enhance the first step concrete pads to prevent pinch points and prevent injury to doors opening into walkways is also expected to be included in this effort.

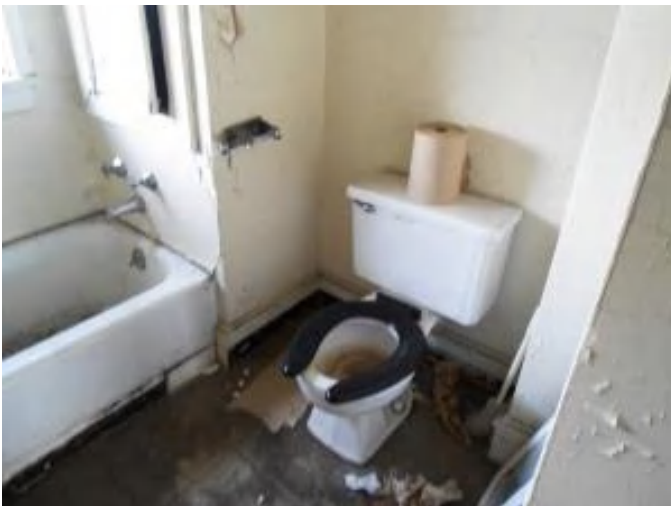
Location: Second Floor Restroom

System: C1010 - Partitions

Distress: Failing

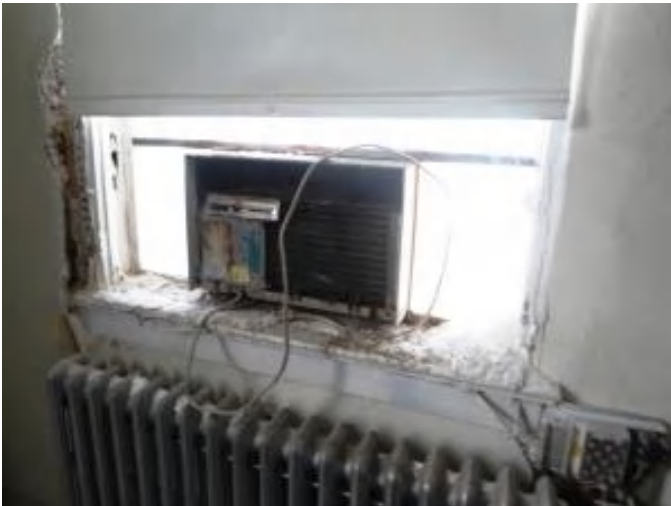
Location: Building Wide

System: C3010230 - Paint & Covering

Distress: Failing

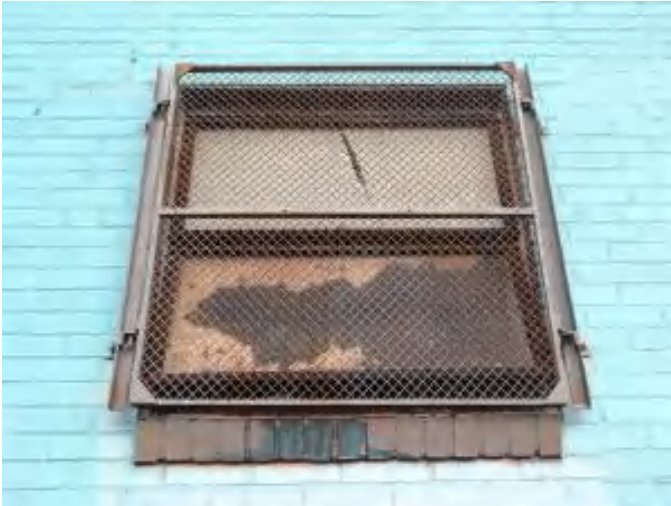
Location: Exterior Elevation

System: B2020 - Exterior Windows

Distress: Damaged

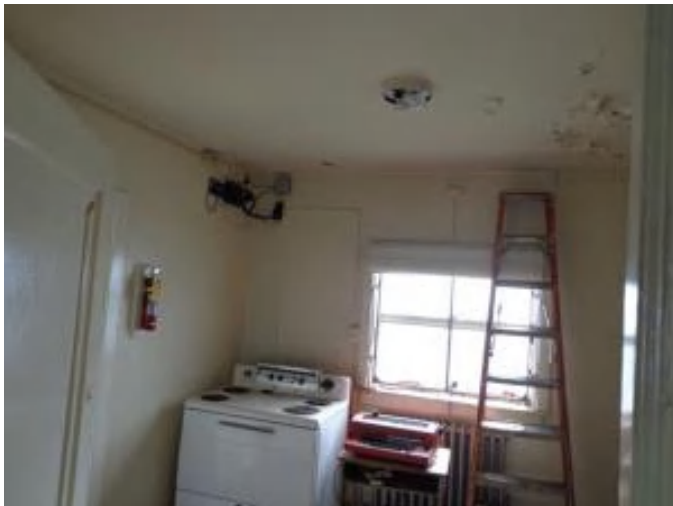
Location: Building wide

System: D5020 - Lighting and Branch Wiring

Distress: Beyond Service Life

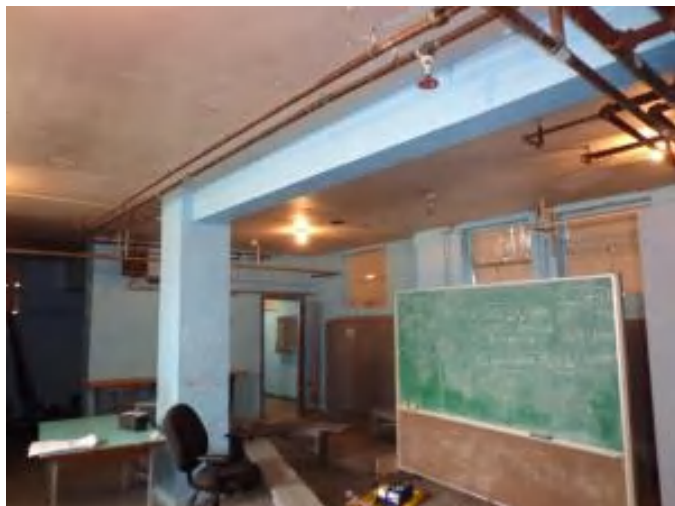
Location: Building wide

System: D5090 - Other Electrical Systems

Distress: Life Safety / NFPA / PFD

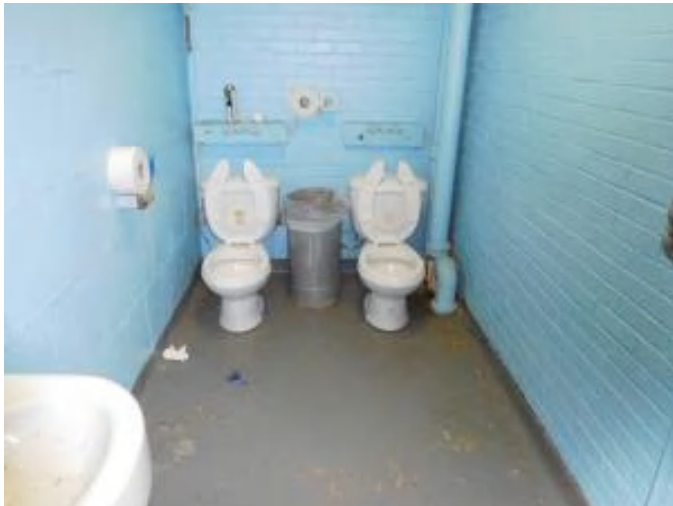
Location: toilet rooms

System: D2010 - Plumbing Fixtures

Distress: Beyond Service Life

Notes: Replace old plumbing fixtures, including water closets, lavatories, service sinks, tubs, showers and water coolers. Include fittings and trim.

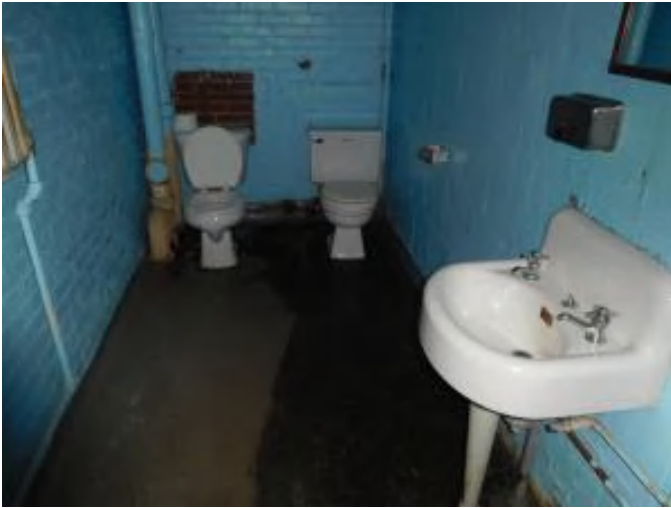
Location: toilet rooms

System: D2010 - Plumbing Fixtures

Distress: Beyond Service Life

Notes: Replace old plumbing fixtures, including water closets, lavatories, service sinks, tubs, showers and water coolers. Include fittings and trim.

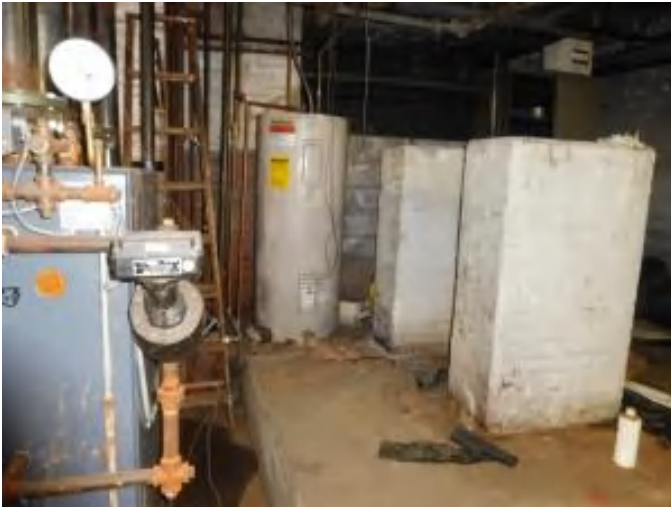
Location: mechanical room

System: D2020 - Domestic Water Distribution

Distress: Building / MEP Codes

Notes: Provide new three inch domestic water service with backflow preventer.

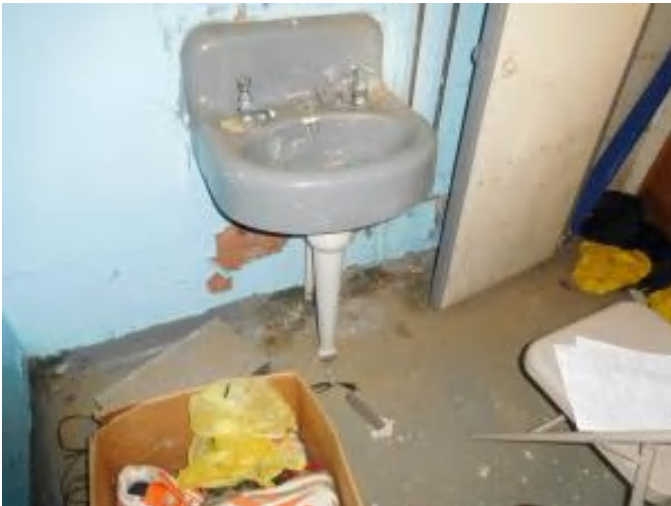
Location: entire building

System: D2030 - Sanitary Waste

Distress: Beyond Service Life

Notes: Inspect old cast iron sanitary piping including camera observation and replace damaged sections.

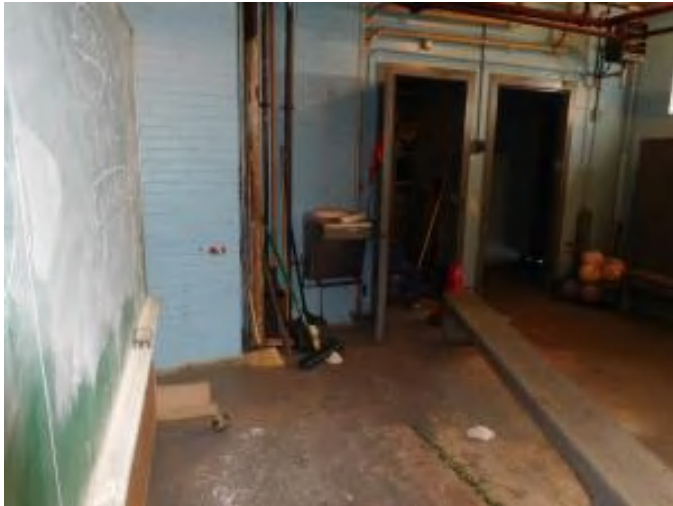
Location: locker rooms, toilet rooms

System: D3040 - Distribution Systems

Distress: Building / MEP Codes

Notes: Provide new mechanical exhaust system for toilet rooms and locker rooms. Include fans, grills, ductwork and exterior wall louvers.

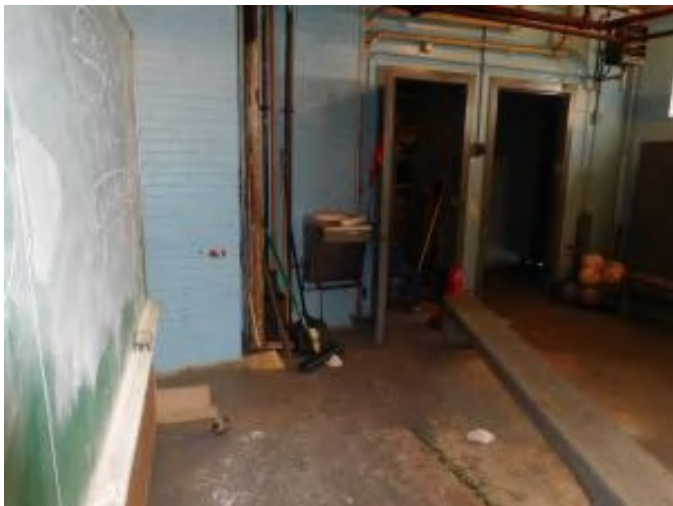
Location: locker rooms, toilet rooms

System: D3040 - Distribution Systems

Distress: Building / MEP Codes

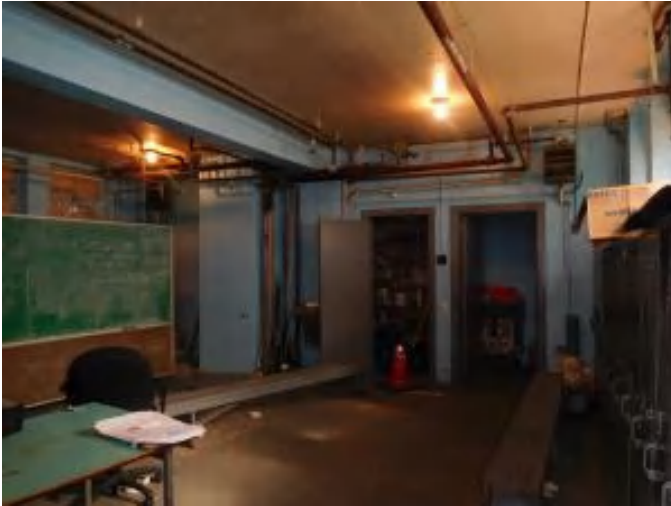
Location: entire building

System: D2020 - Domestic Water Distribution

Distress: Beyond Service Life

Notes: Replace domestic hot and cold water pipe, fittings, valves, hangers and insulation

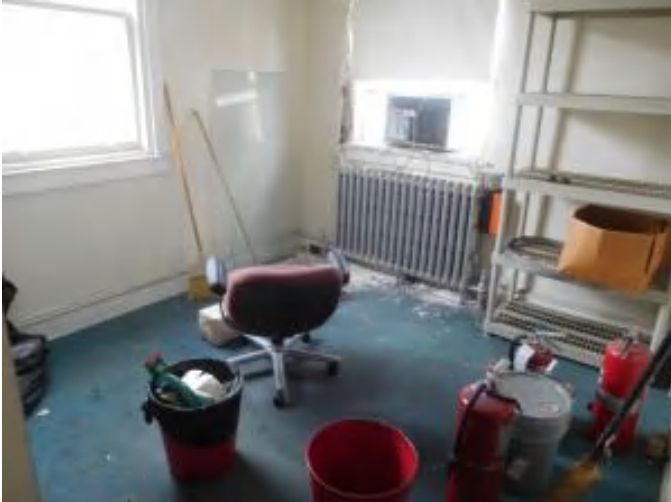
Location: entire building

System: D3050 - Terminal & Package Units

Distress: Building / MEP Codes

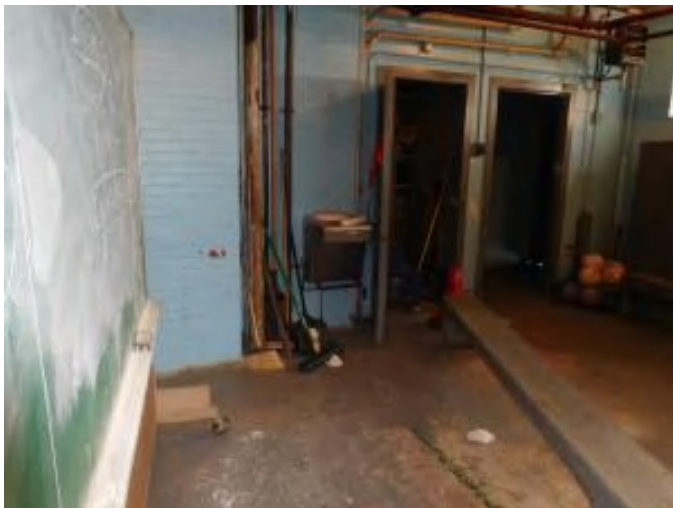
Location: entire building

System: D4010 - Sprinklers

Distress: Life Safety / NFPA / PFD

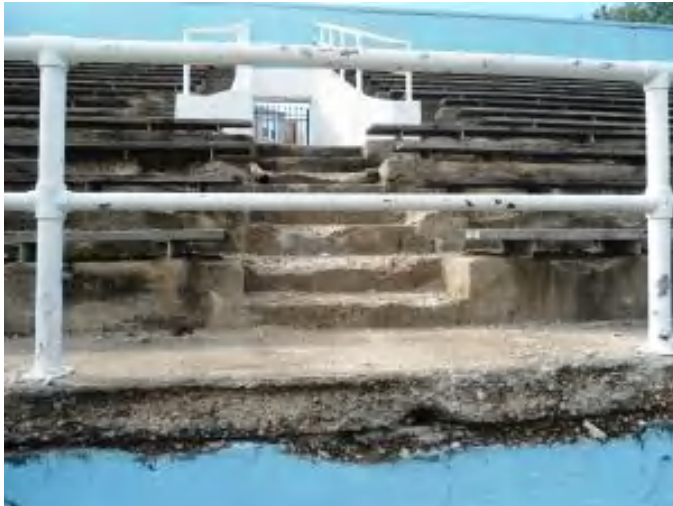
Location: Stands

System: B1010 - Floor Construction

Distress: Failing

Notes: This seating stands facility is unique in its usage to the school system. This section of the school is abandoned and has had no preventative maintenance or measures to mitigate damage that results from these conditions. Considering the overall effort to recover such an area this deficiency is a combination of the coordinated requirements for a renovation to include all aspects of HVAC, Electrical, Fire Life Safety, Health and ADA. Note: This effort also includes budgetary consideration for Asbestos, Lead Paint and a major Abatement program.

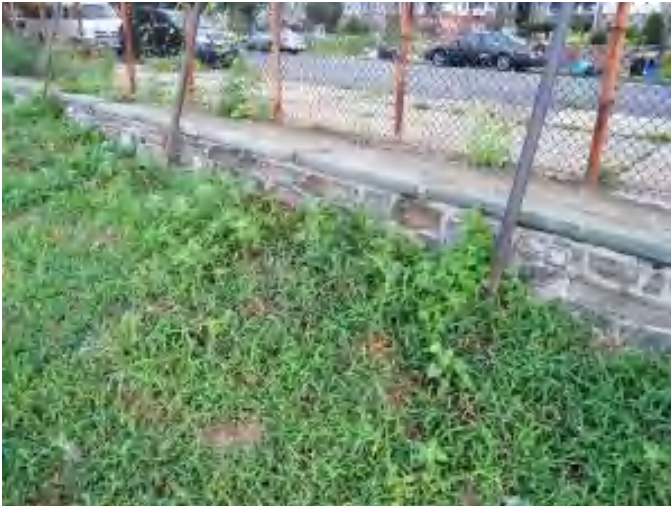
Location: Site

System: G2040 - Site Development

Distress: Security Issue

Notes: This Olney sports complex school grounds has a perimeter fence surrounding the baseball / playground / football areas. The fence has several areas of repairs and the mounting post are damaged in several areas, overall the fence is in fair condition. This fence system is recommended to be removed and replaced with a new system within the next five to ten years.

Correction: Replace chain link fence - 8' high

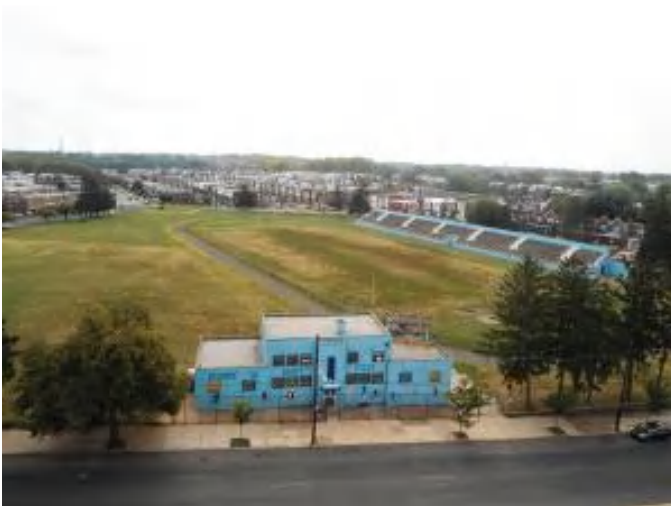
Location: Site

System: G2040 - Site Development

Distress: Damaged

Notes: The football field have been abandoned prior to the new school opening. These fields have overgrown and several areas that present hazards such as holes and debris issues exist. This entire field is recommended for universal renovation efforts. This deficiency provides a budgetary consideration to upgrade the football field to current standards.

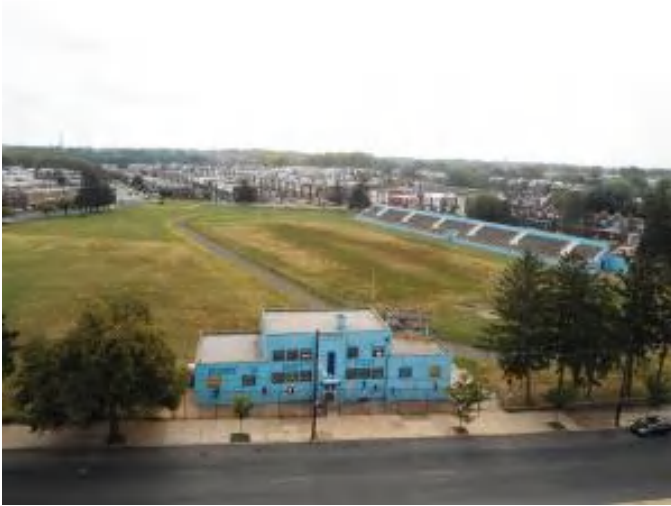
Location: Site

System: G2040 - Site Development

Distress: Damaged

Notes: The track that surround the football field has overgrown and sections are missing. This area requires immediate attention prior to any usage due to the debris and holes that are hazards for Track and Field activities. This deficiency provides a budgetary consideration to upgrade the Track and Field areas for the Olney sports complex.

Correction: Refurbish running track - replace AC paving with asphalt latex rubber system

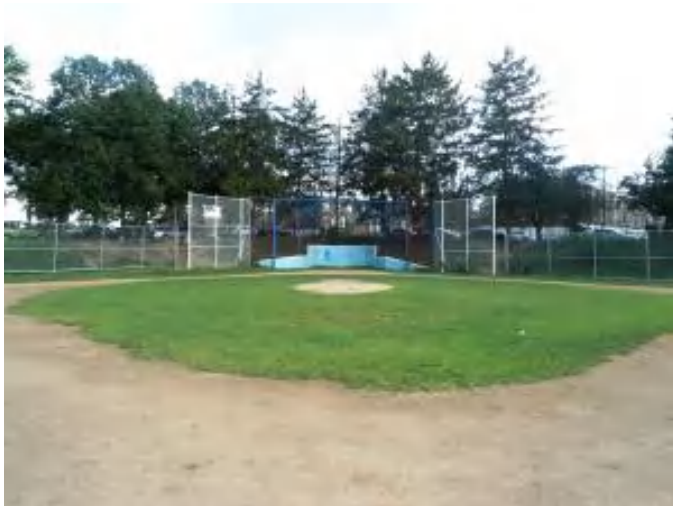
Location: Site

System: G2040 - Site Development

Distress: Damaged
