Facility Condition Assessment Summary Report

Pennell School

School District of Philadelphia
S634001;Pennell
Final
Site Assessment Report

January 31, 2017

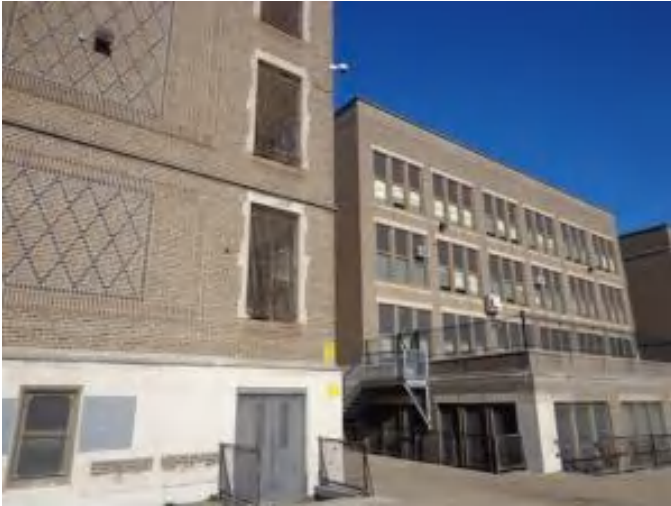
Location: Site

System: G4030 - Site Communications & Security

Distress: Beyond Service Life

- Replace all four (4) building mounted exterior video surveillance cameras.

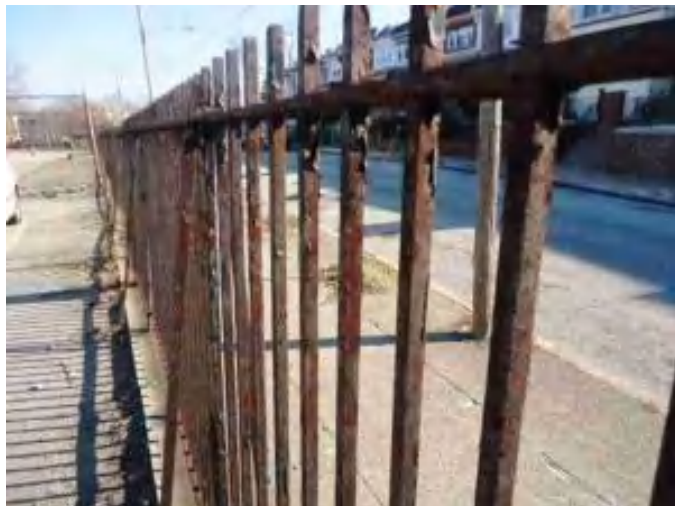
Location: Site

System: G2040 - Site Development

Distress: Damaged
