Facility Condition Assessment Summary Report

Penrose School

January 30, 2017

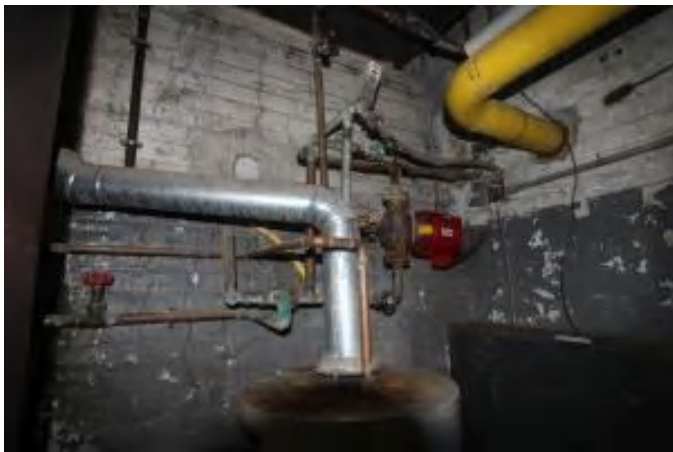
System: D2020 - Domestic Water Distribution

Location: Boiler room.

Distress: Building / MEP Codes

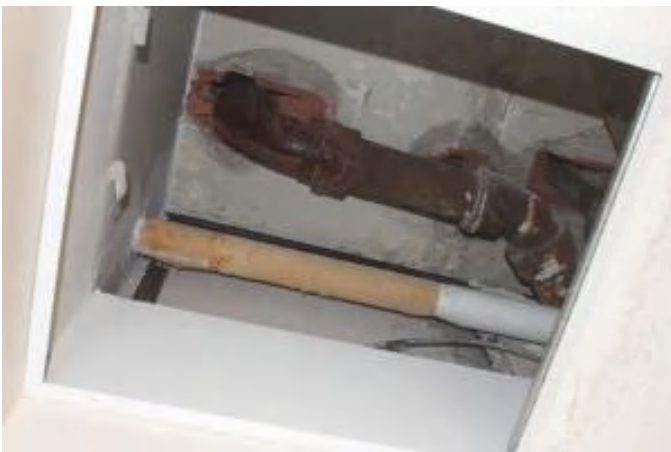
System: D2030 - Sanitary Waste

Location: Entire building

Distress: Failing

Notes: Inspect and repair sanitary drain piping due to age and noticeable clogged pipes and install floor drains in toilet rooms.

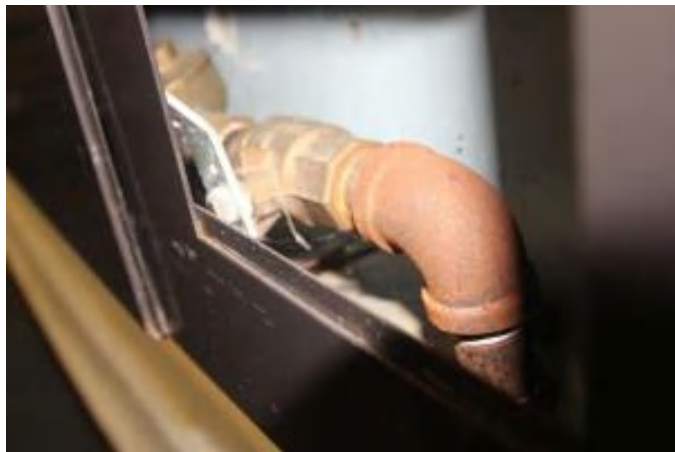
System: D3040 - Distribution Systems

Location: Entire building

Distress: Beyond Service Life

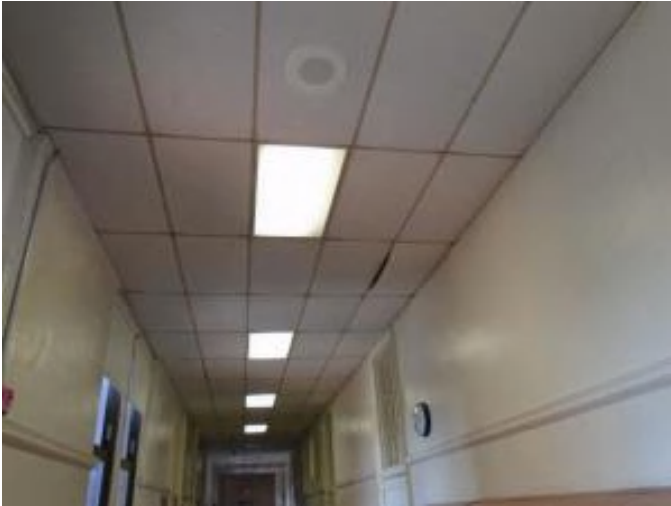
System: C3030 - Ceiling Finishes

Location: Throughout

Distress: Beyond Service Life

Notes: Replace suspended acoustic tile ceiling system – beyond service life (75% of suspended ceiling)

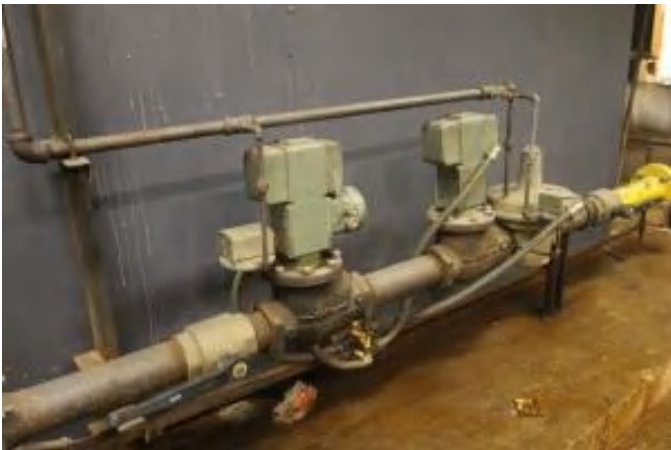
System: D3020 - Heat Generating Systems

Location: Boiler room

Distress: Beyond Service Life

Notes: Replace boilers including gas supply equipment due to age.

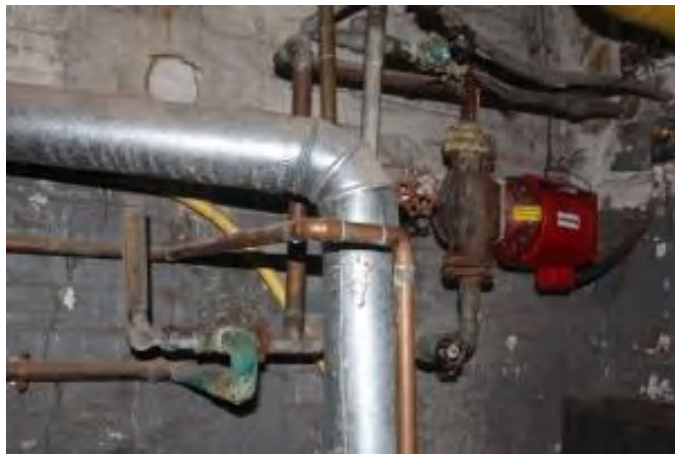
System: D3060 - Controls & Instrumentation

Location: Basement

Distress: Damaged

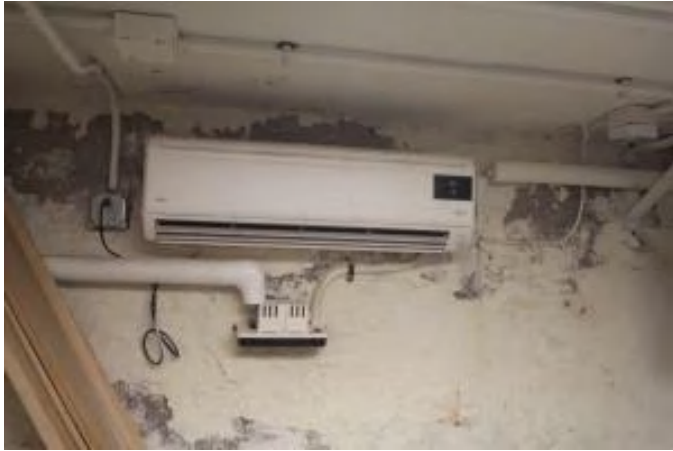
System: D3030 - Cooling Generating Systems

Location: Entire building

Distress: Inadequate

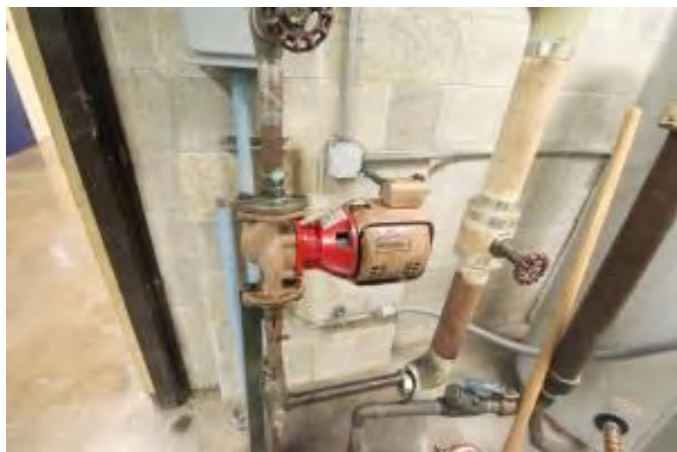
System: D2020 - Domestic Water Distribution

Location: Basement

Distress: Inadequate

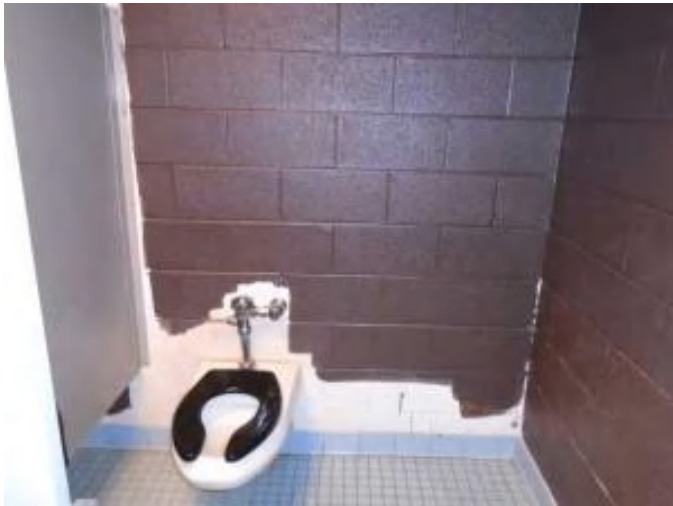
System: C1030 - Fittings

Location: Toilets

Distress: Accessibility

Notes: Replace toilet partitions for accessibility

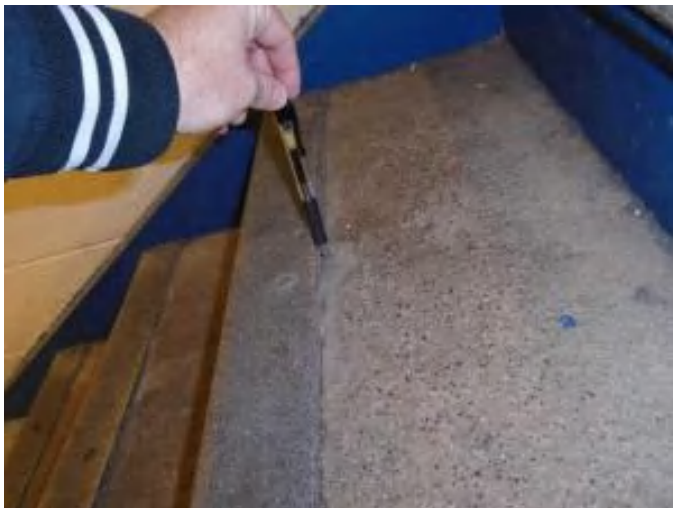
System: C2010 - Stair Construction

Location: Stairs

Distress: Health Hazard / Risk

Notes: Add elevator for accessibility

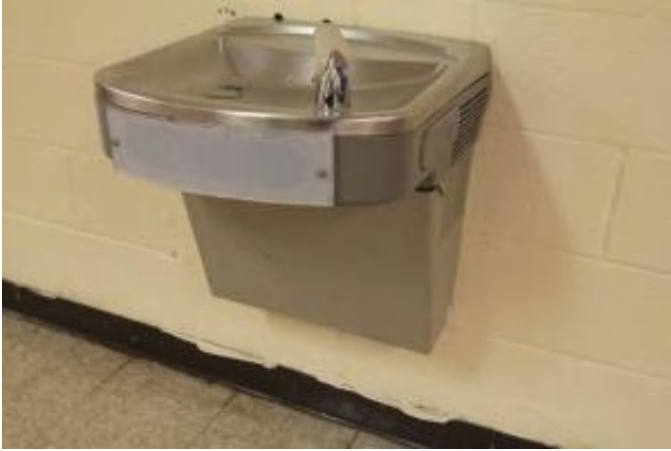
System: D2010 - Plumbing Fixtures

Location: Corridor

Distress: Damaged

Notes: Replace damaged water fountain

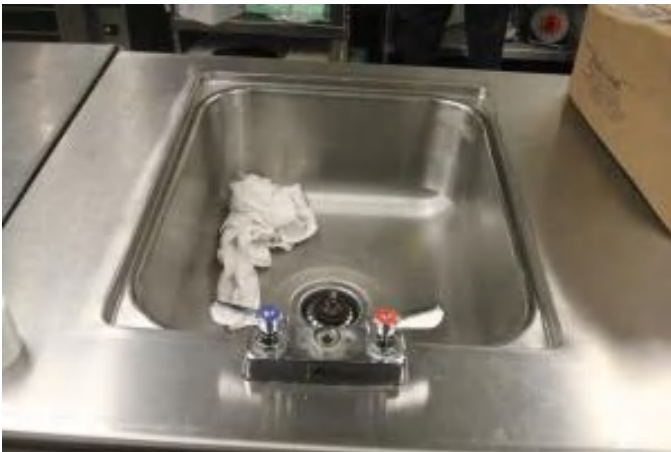
System: D2010 - Plumbing Fixtures

Location: Kitchen

Distress: Damaged

Notes: Replace broken faucet in kitchen

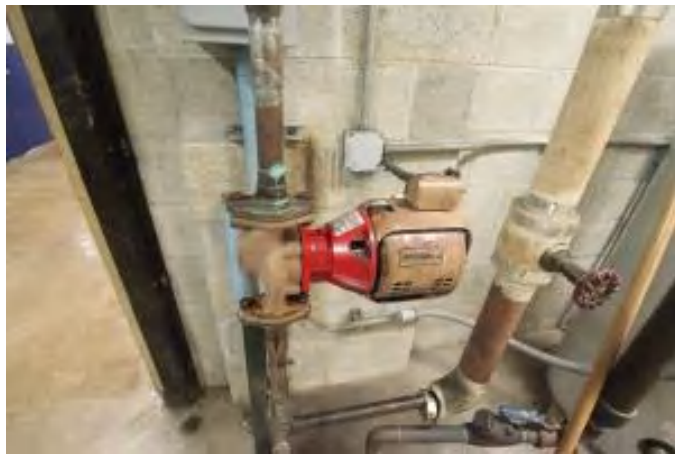
System: D2020 - Domestic Water Distribution

Location: Basement

Distress: Failing

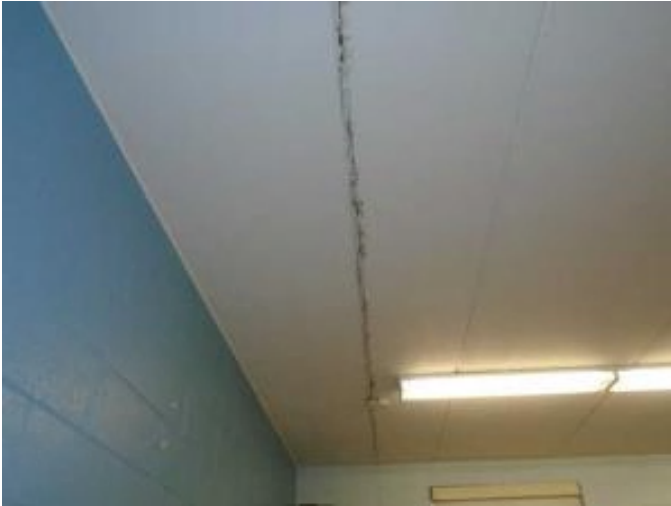
System: B2010 - Exterior Walls

Location: East and south ends

Distress: Damaged

Notes: Repair CMU exterior and partition walls – structural cracks developing

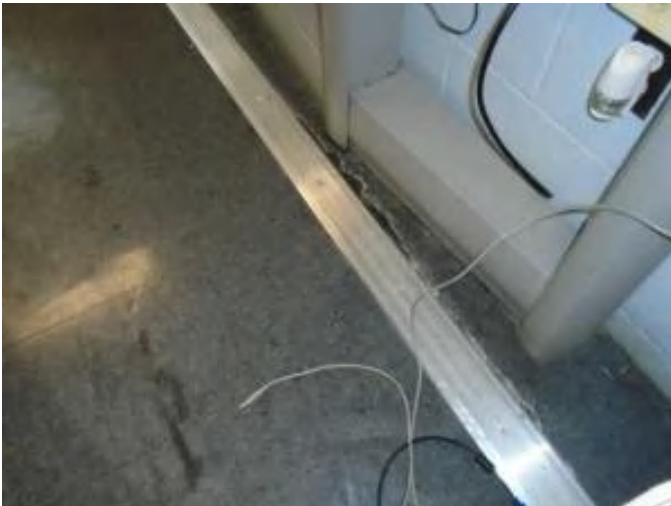
System: C3020411 - Carpet

Location: Stairs

Distress: Beyond Service Life

Notes: Replace carpet – beyond service life

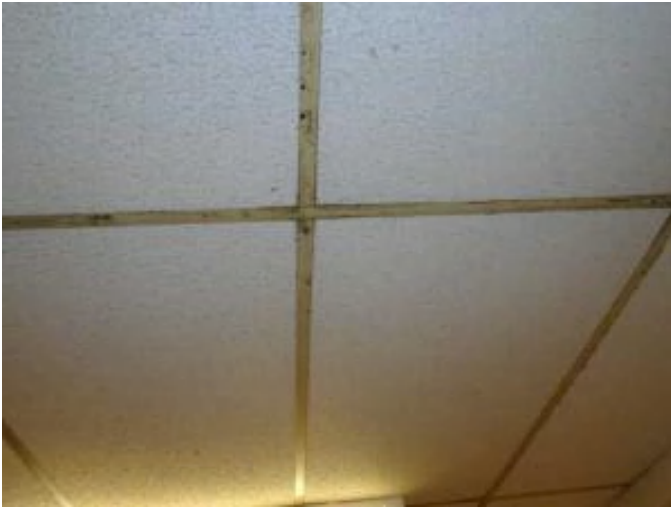
System: C3030 - Ceiling Finishes

Location: Corridors

Distress: Beyond Service Life

Notes: Replace suspended acoustic tile ceiling system – beyond service life (corridors)

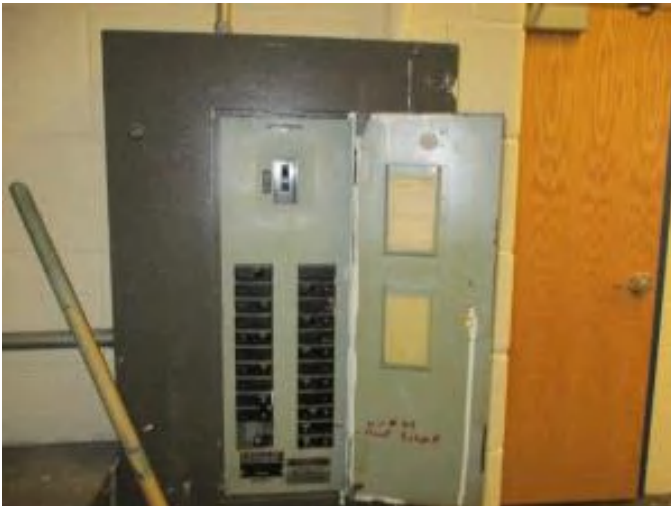
System: D5010 - Electrical Service/Distribution

Location: Entire Building

Distress: Beyond Service Life

Notes: Provide an outdoor diesel powered generator. Approximate 100KW

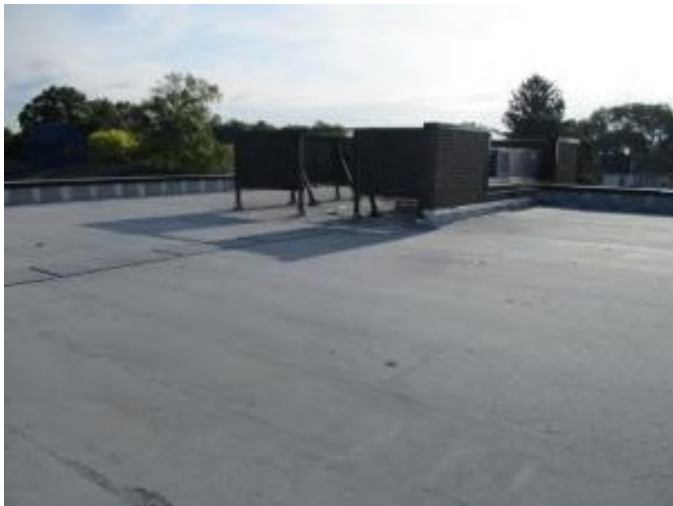
System: D5090 - Other Electrical Systems

Location: Roof

Distress: Building / MEP Codes

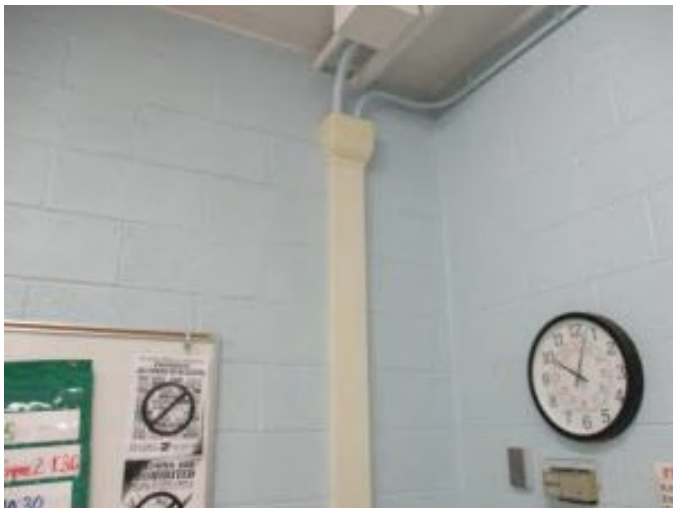
System: D5030 - Communications and Security

Location: Entire Building

Distress: Inadequate

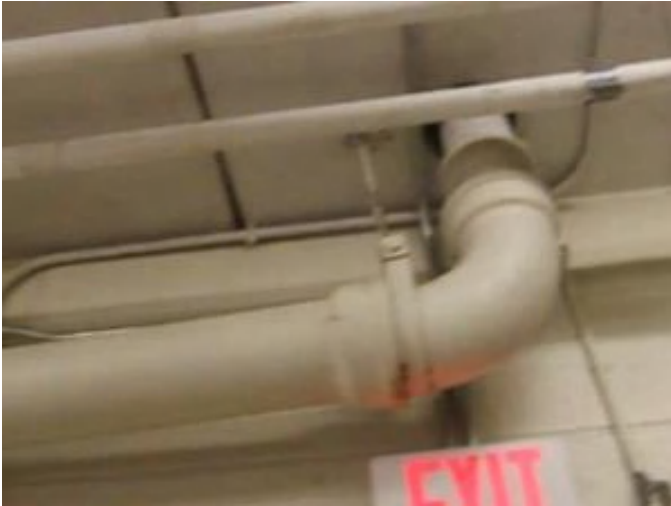
System: D2030 - Sanitary Waste

Location: Original building

Distress: Beyond Service Life

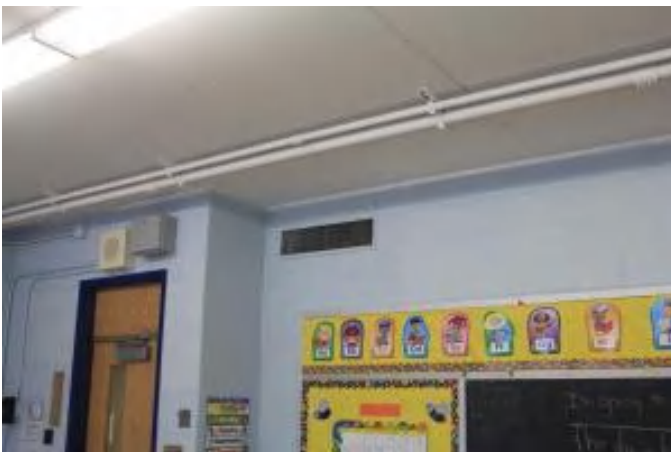
System: D4010 - Sprinklers

Location: Original building

Distress: Life Safety / NFPA / PFD

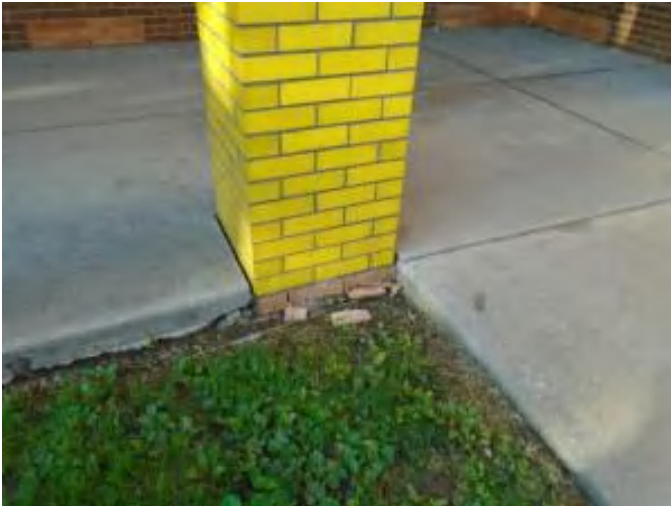
System: B2010 - Exterior Walls

Location: Front columns

Distress: Damaged

Correction: Repair cracks in masonry - replace missing mortar and repoint - SF of wall area

Notes: Repair and replace exterior face brick on front columns

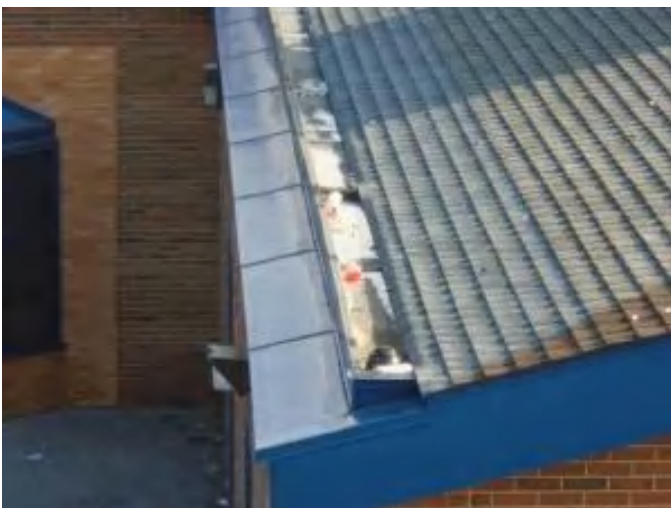
System: B3010140 - Shingle & Tile

Location: Roof gutters

Distress: Failing

Correction: Remove and replace step flashing for shingle roofs

Notes: Repair gutter drains and seal joint

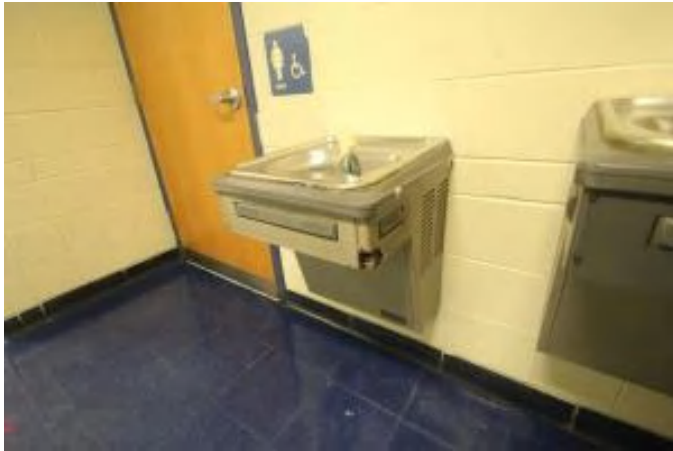
System: D2010 - Plumbing Fixtures

Location: Corridor

Distress: Damaged

Correction: Remove and Replace Water Fountains - without ADA new recessed alcove

Notes: Repair or replace damaged fountain

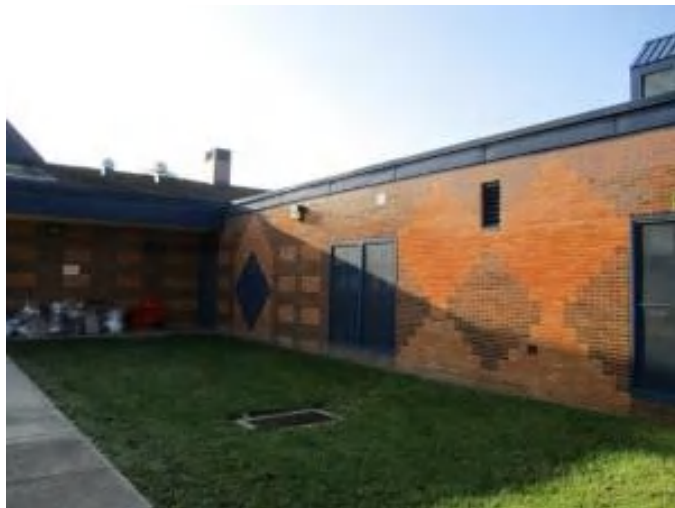
System: D5090 - Other Electrical Systems

Location: Roof

Distress: Building / MEP Codes

Correction: Repair Lightning Protection System

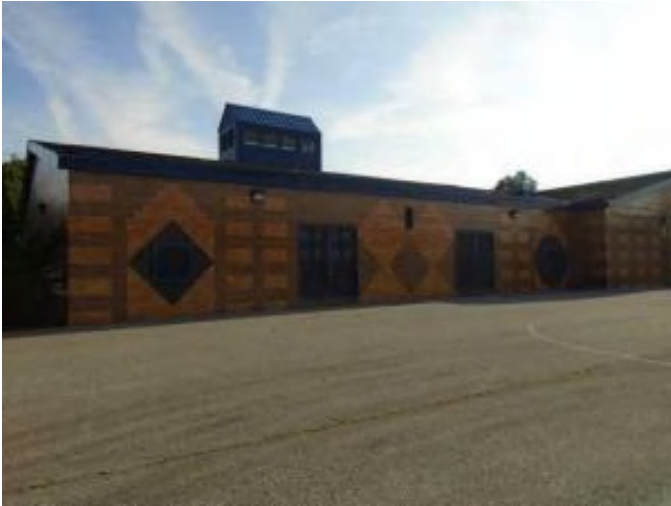
System: B2020 - Exterior Windows

Location: Windows

Distress: Energy Efficiency

Notes: Replace Plexiglas window – hazed and not energy efficient

Correction: Remove and replace double slider windows

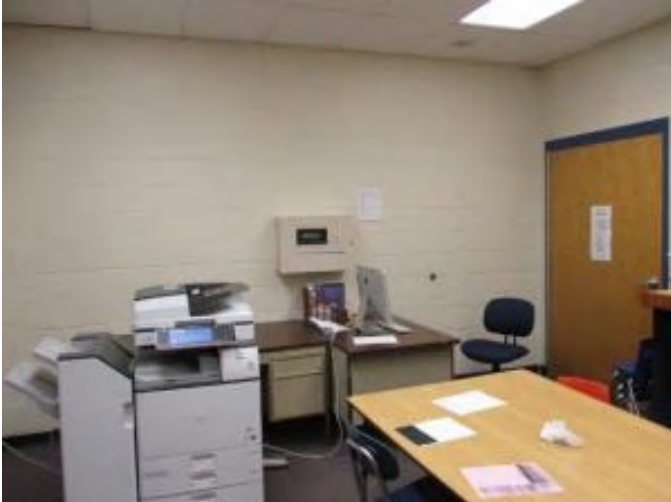
System: D5030 - Communications and Security

Location: Entire Building

Distress: Inadequate

Correction: Add/Replace Clock System or Components

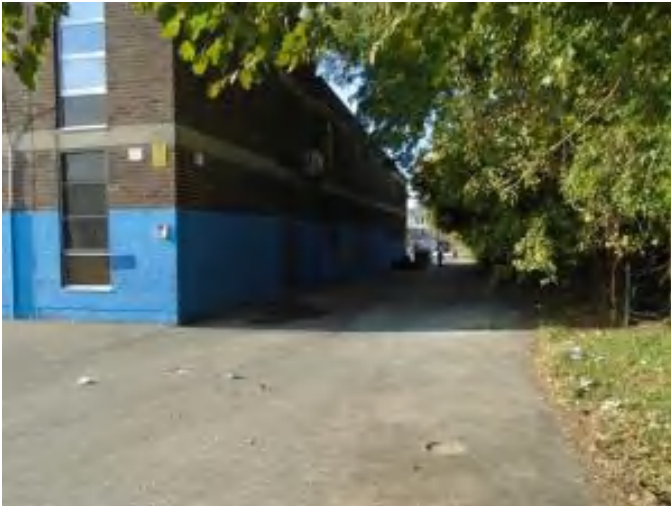
System: G2040 - Site Development

Location: West side

Distress: Failing

Notes: Replace fence on west side of site

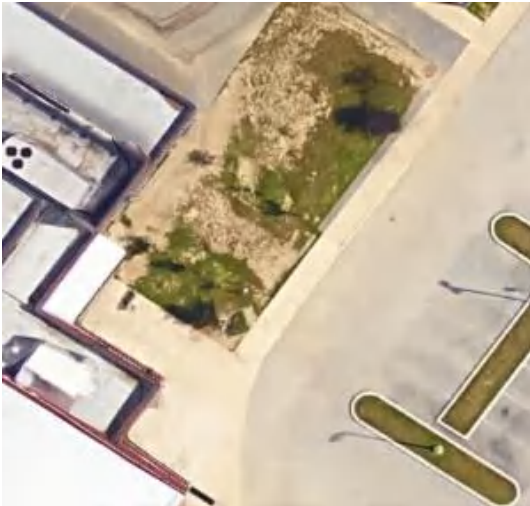
System: G2040 - Site Development

Location: Center of site

Distress: Inadequate

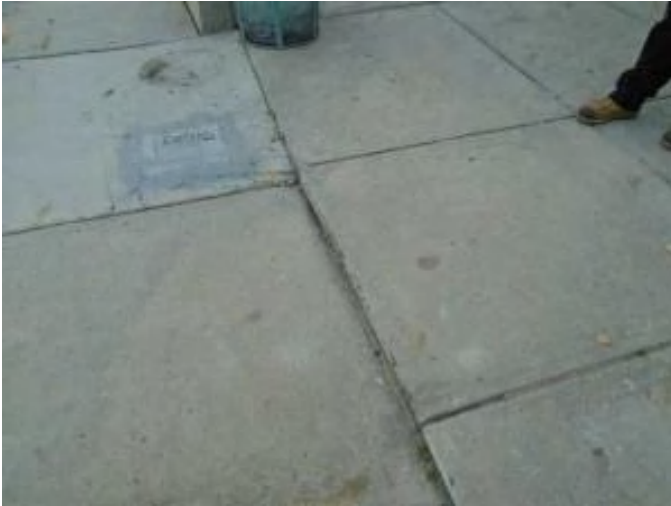
System: G2030 - Pedestrian Paving

Location: Entry yard

Distress: Damaged
