## Facility Condition Assessment Summary Report

### Powel School

School District of Philadelphia  
**S139001;Powel**  
Final  
**Site Assessment Report**

January 30, 2017

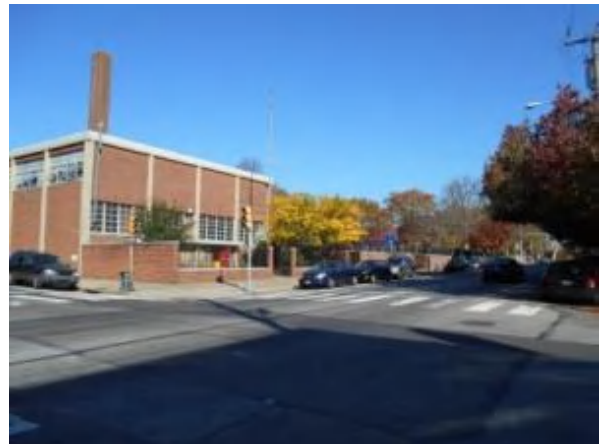
Gross Area (SF):	18,000
Year Built:	1961
Last Renovation:	
Replacement Value:	\$11,346,006
Repair Cost:	\$5,335,102.36
Total FCI:	47.02 %
Total RSLI:	66.18 %

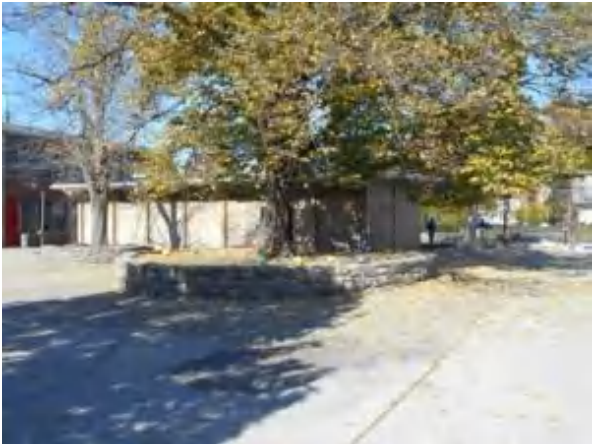
Function:	Elementary School
Gross Area (SF):	18,000
Year Built:	1961
Last Renovation:	
Replacement Value:	\$10,297,412
Repair Cost:	\$4,979,148.80
Total FCI:	48.35 %
Total RSLI:	68.60 %

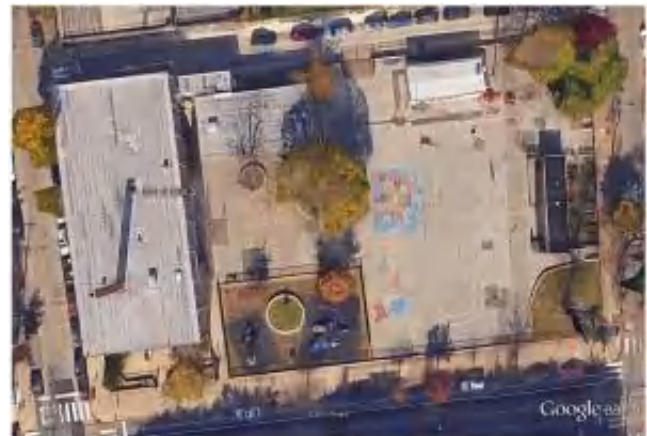
Function:	
Gross Area (SF):	50,200
Year Built:	1961
Last Renovation:	
Replacement Value:	\$1,048,594
Repair Cost:	\$355,953.56
Total FCI:	33.95 %
Total RSLI:	42.46 %
