## Facility Condition Assessment Summary Report

### Rhawnhurst School

## **Site Assessment Report**

January 31, 2017

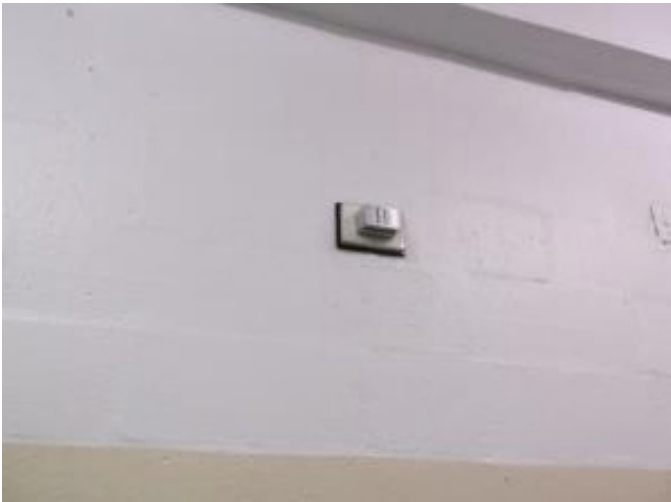
**System: D3060 - Controls & Instrumentation**

**Location:** Throughout the building

**Distress:** Beyond Service Life

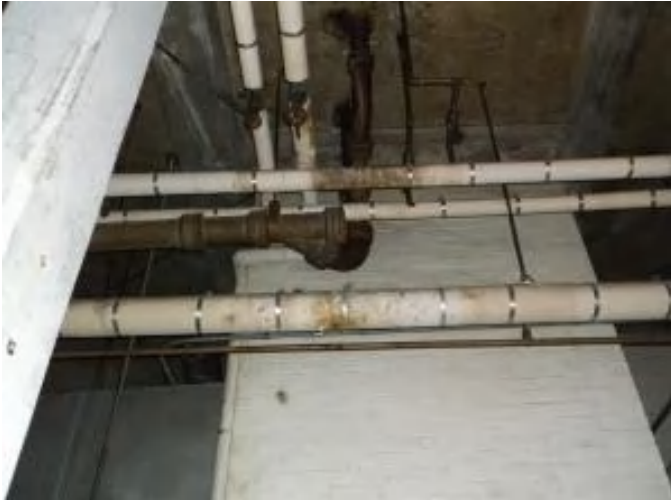
**System: D2030 - Sanitary Waste**

**Location:** Throughout the building

**Distress:** Beyond Service Life

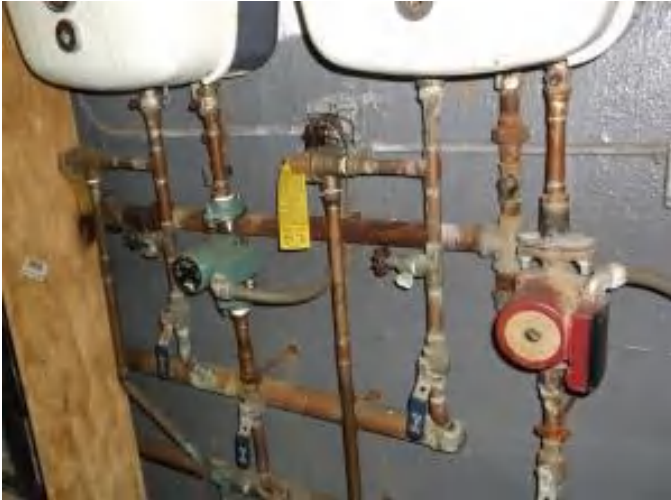
**System: D2020 - Domestic Water Distribution**

**Location:** Throughout the building

**Distress:** Beyond Service Life

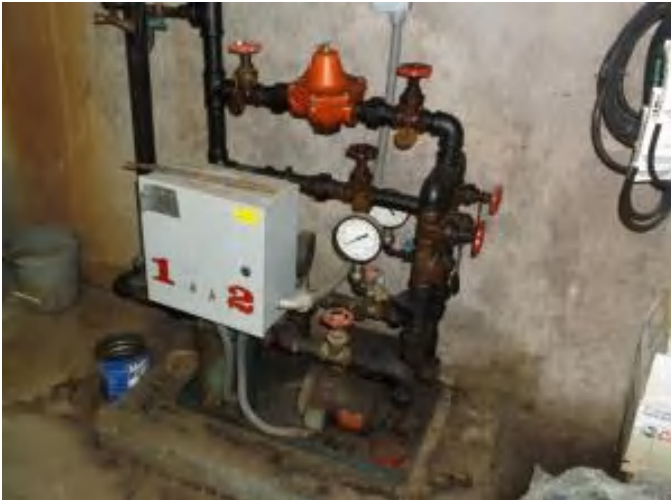
**System: D3020 - Heat Generating Systems**

**Location:** Main boiler mechanical equipment room

**Distress:** Beyond Service Life
