## Facility Condition Assessment Summary Report

### Robeson School

School District of Philadelphia  
**S105001;Robeson**  
Final  
**Site Assessment Report**  
January 30, 2017

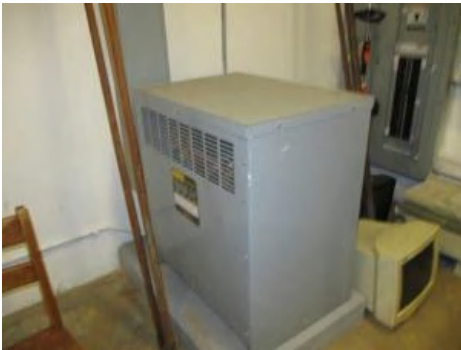
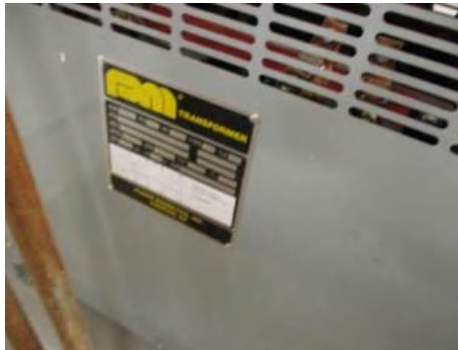
**System:** D5010 - Electrical Service/Distribution

A pole mounted transformer on S. 42<sup>nd</sup> Street and an underground secondary conductors serve this building. The electrical service entrance is located in the basement which houses the utility main disconnect switch and utility metering PECO 222MUC 38354. The electrical distribution is obtained via a 100KVA phase converter 240V to 120/208V and 400A 120/208V distribution section. The electrical service entrance was upgraded in 2011. It has no extra capacity for new Heating, Ventilation, and Air Conditioning (HVAC) system. The electrical service entrance should be upgraded, using the present utility pole, and adding a pad mounted transformer on S. 42<sup>nd</sup> Street. The new service will be 208V/120V, 3 phase power, approximate 1200 Amperes and will be located in the vicinity of the existing electrical service. The electrical service will feed Motor Control Center (MCC), HVAC equipment, receptacles, lighting and other smaller loads.

There are 120/240V panel-boards in each floor for lighting and receptacles. These panelboards and associated wiring have exceeded the end of their useful life and are undersized to absorb new loads. The entire distribution system needs to be replaced with new 208/120 volt, 3 phase panelboards and new wiring. The raceway is mainly conduits run above the ceiling.

- Install accessible ramp on at least one entrance
- Provide new service 208V/120V, 3 phase power, approximate 1200 Amperes.
- Replace the entire distribution system with new panels and new wiring/conduits. Approximate (9) 208/120V.
