## Facility Condition Assessment Summary Report

### Rush School

Facility Condition Assessment

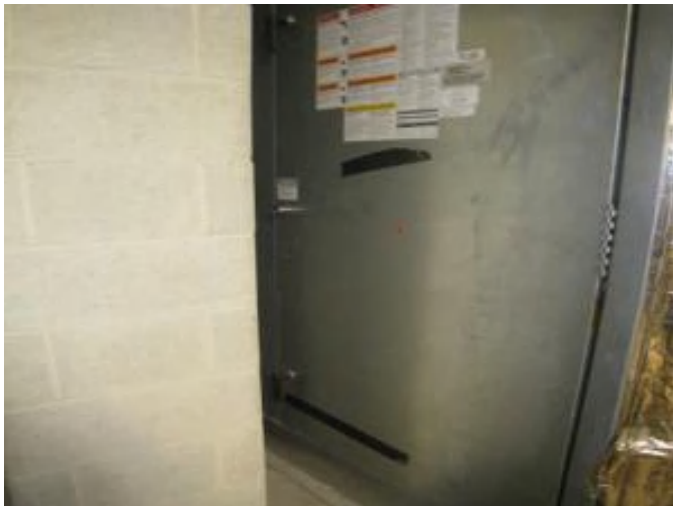
**Location:** Rush - interior doors

**System: C1020 - Interior Doors**

**Distress:** Appearance

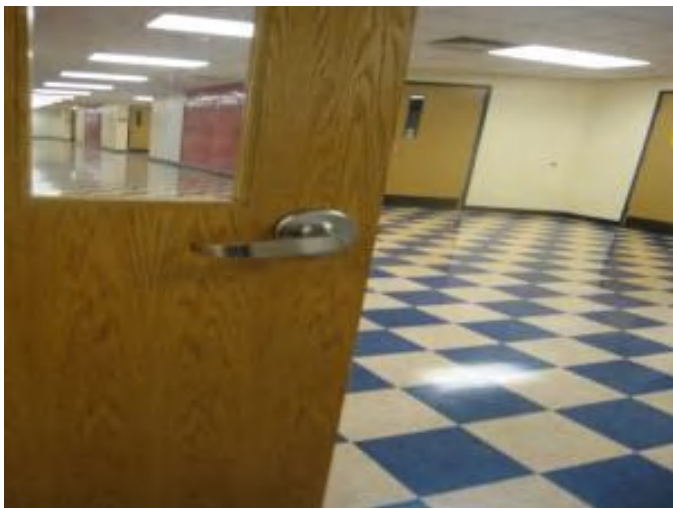
**Location:** Rush - classroom doors

**System: C1020 - Interior Doors**

**Distress:** Security Issue

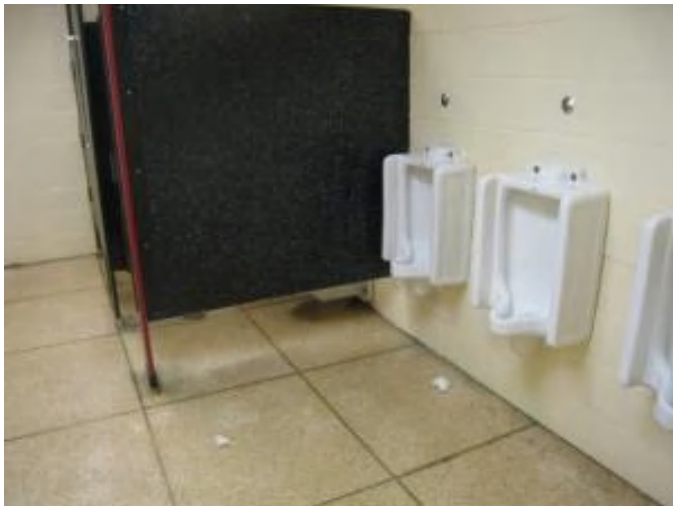
**Location:** Rush - toilet room floors

**System: C3020412 - Terrazzo & Tile**

**Distress:** Appearance

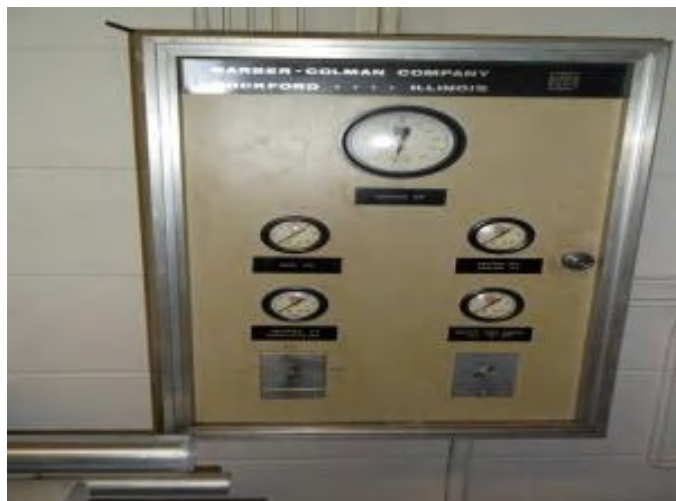
**Location:** Throughout Building

**System: D3060 - Controls & Instrumentation**

**Distress:** Beyond Service Life

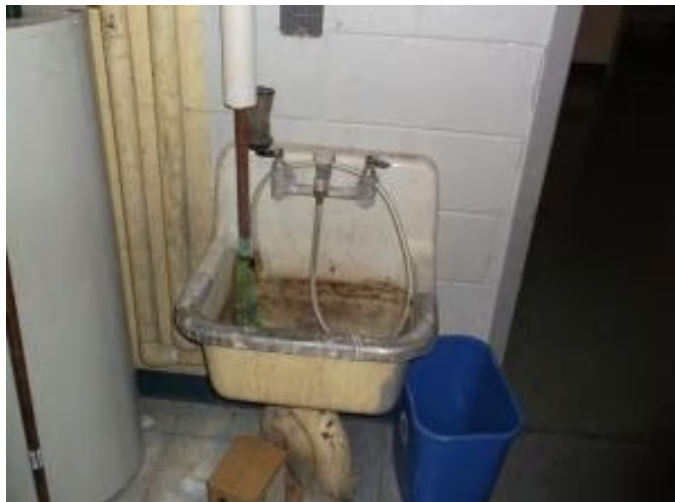
**Location:** Janitor Closet

**System: D2010 - Plumbing Fixtures**

**Distress:** Beyond Service Life

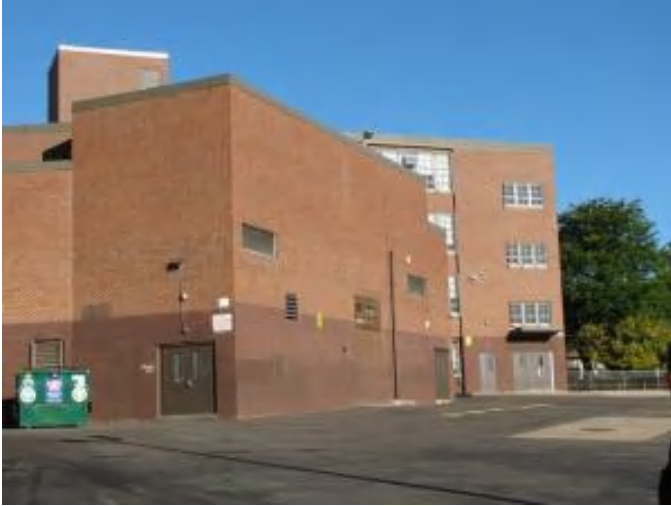
**Location:** Fitzpatrick- Entire Building

**Distress:** Security Issue

**Correction:** Add/Replace Video Surveillance System

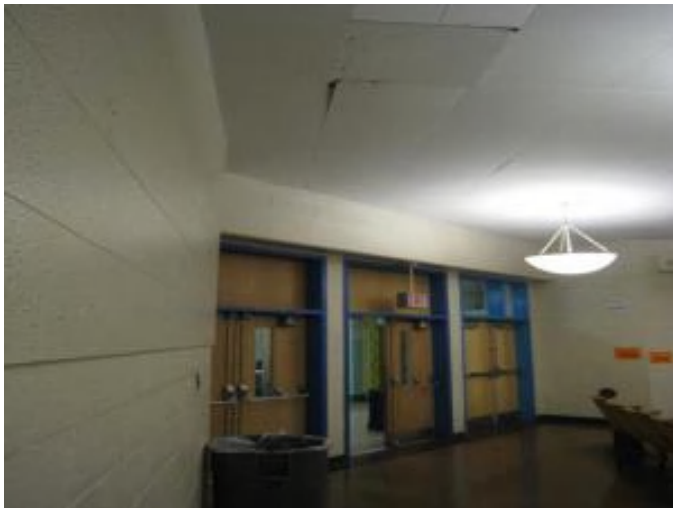
**Location:** Fitzpatrick - interior doors

**Distress:** Appearance

**Correction:** Remove and replace interior doors - wood doors with hollow metal frames - per leaf

**Notes:** Replace all original wood doors into classroom, toilet rooms, office, and auditorium in corridors where damaged; first floor doors already replaced (50) 3x7

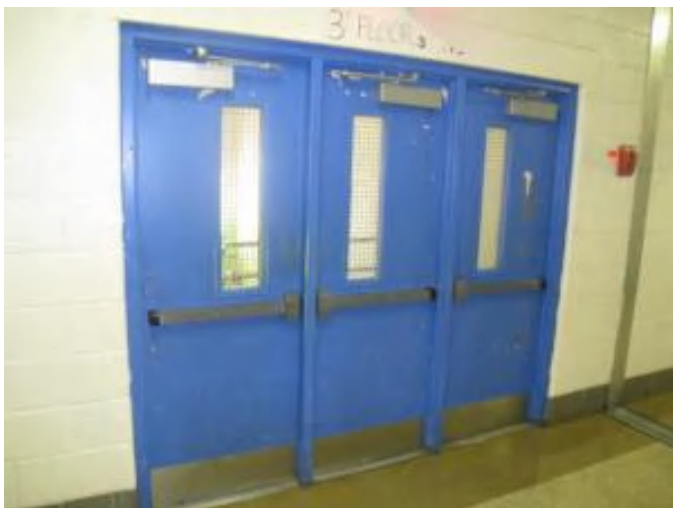
**Location:** Fitzpatrick - interior doors

**Distress:** Appearance

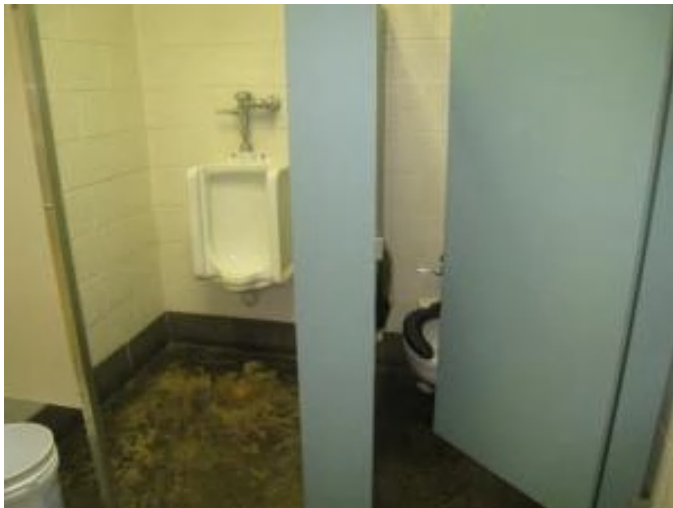
**Location:** Fitzpatrick - toilet rooms

**Distress:** Beyond Service Life

**Correction:** Replace toilet accessories - select accessories and quantity

**Notes:** Provide toilet room accessories where partitions are replaced (4 toilet rooms)

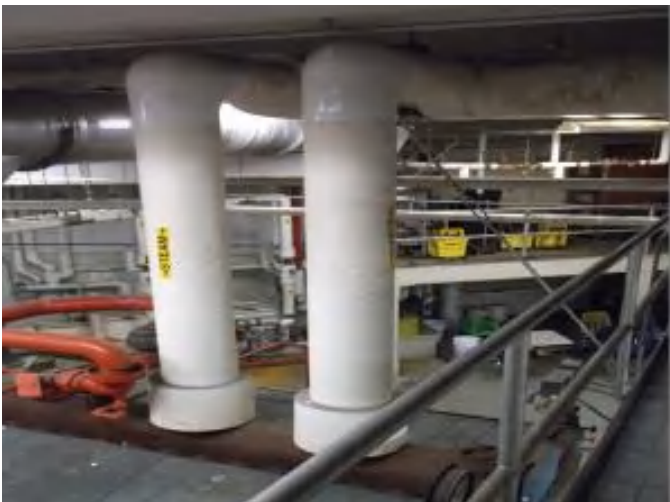
**Location:** Fitzpatrick - throughout the building

**Distress:** Beyond Service Life

**Correction:** Perform testing to identify and replace damaged steam and condensate piping.

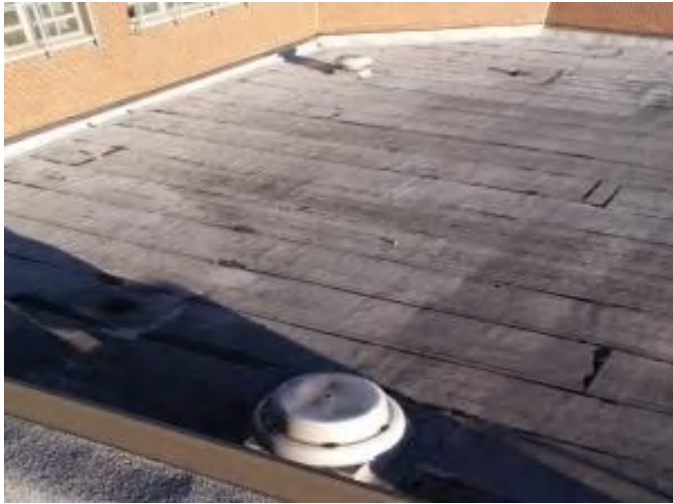
**Location:** Fitzpatrick - roof

**Distress:** Beyond Service Life

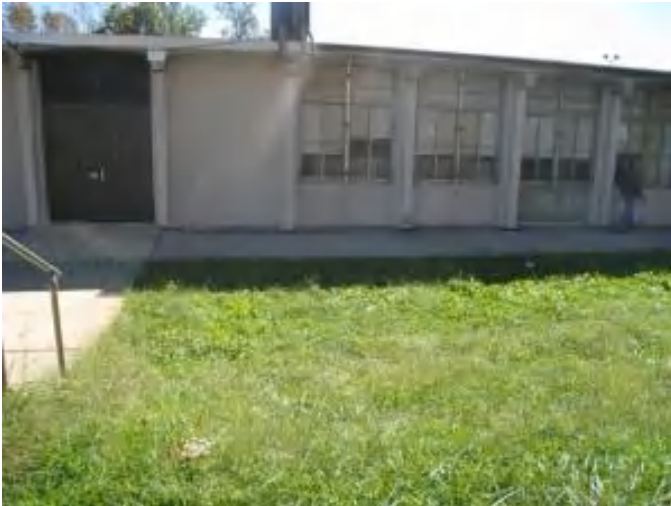
**Location:** Fitzpatrick Annex - exterior doors

**System: B2030 - Exterior Doors**

**Distress:** Appearance

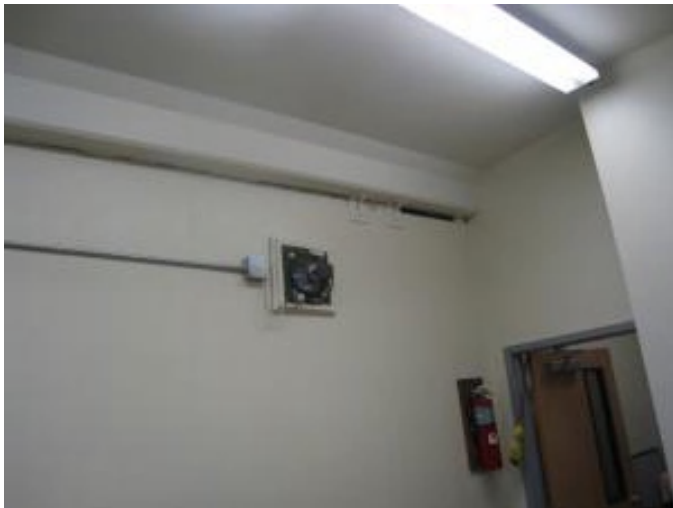
**Location:** Fitzpatrick Annex - doors

**System: C1020 - Interior Doors**

**Distress:** Building / MEP Codes

**Correction:** Replace door knobs with compliant lever type

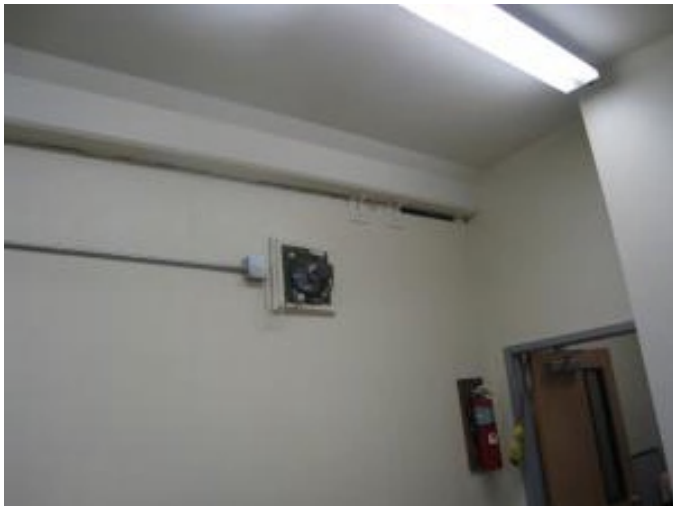
**Location:** Fitzpatrick Annex - doors

**System: C1020 - Interior Doors**

**Distress:** Security Issue

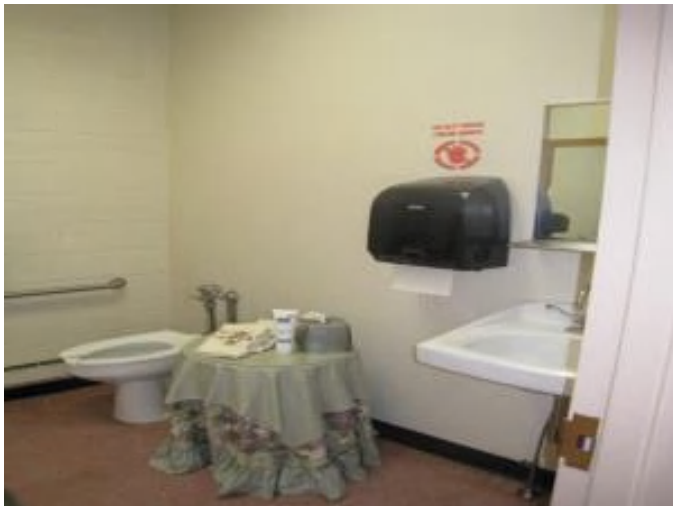
**Location:** Fitzpatrick Annex - toilet room

**System: C1030 - Fittings**

**Distress:** Building / MEP Codes

**Correction:** Replace toilet accessories - select accessories and quantity
