Facility Condition Assessment Summary Report

Saul School

S604001;Saul

February 2, 2017

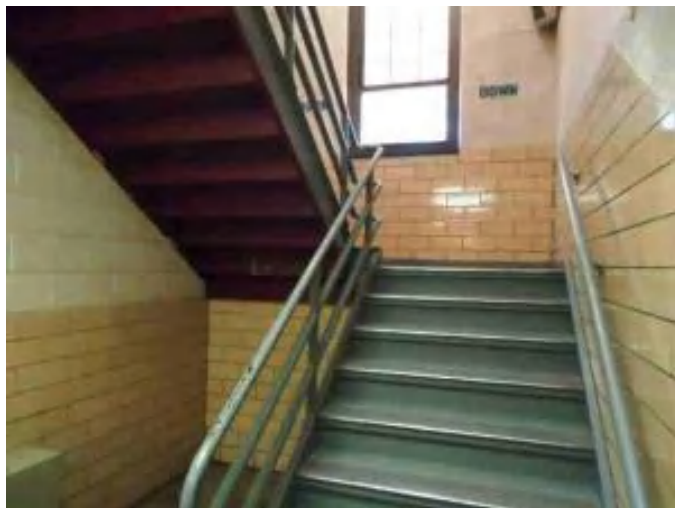
Location: Main Stairs

Distress: Life Safety / NFPA / PFD

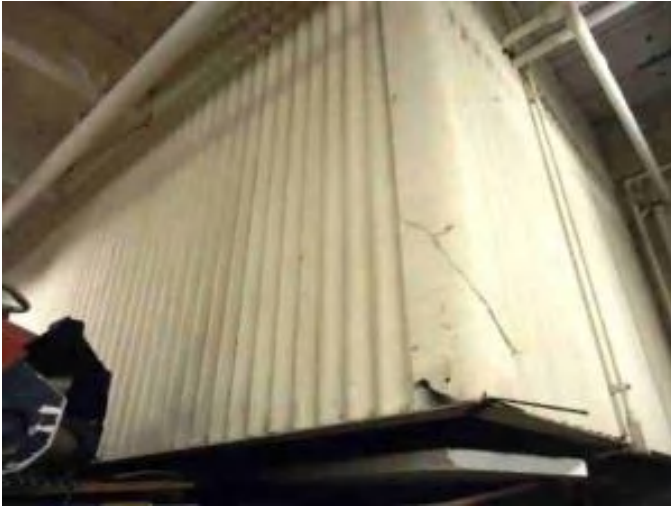
Location: Main Shop

Distress: Health Hazard / Risk

Notes: The shop in the main building has a transite wall finish. The transite wall finish is wall mounted application and is suspect to contain asbestos. This finish is recommended for upgrade to a new dry wall finish application. Suspected asbestos containing materials (ACM) are believed to be limited to the original transite wall finish. While currently sound and manageable in place, future renovation efforts should include provision to test and abate any and all ACM.

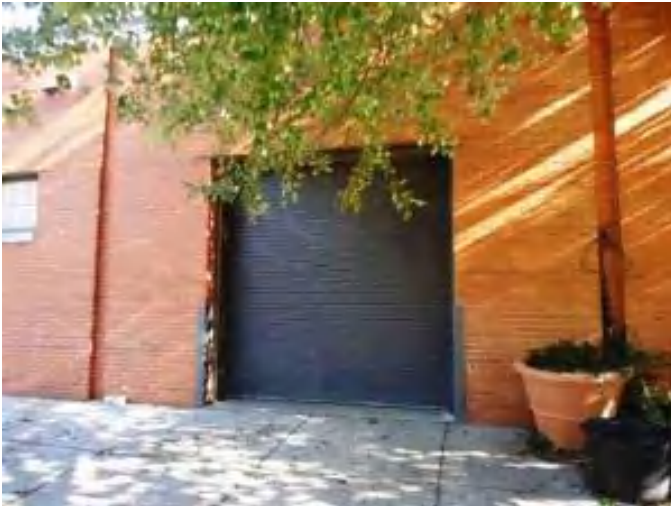
Location: Main Exterior Elevation

Distress: Damaged

Notes: The Grounds Shop roll up door is an original metal roll up door. The safety equipment for this door is no longer functional and the door was reported to be limited in operation. This door system is recommended to be removed and replaced with a modern overhead door system with safety and security considerations

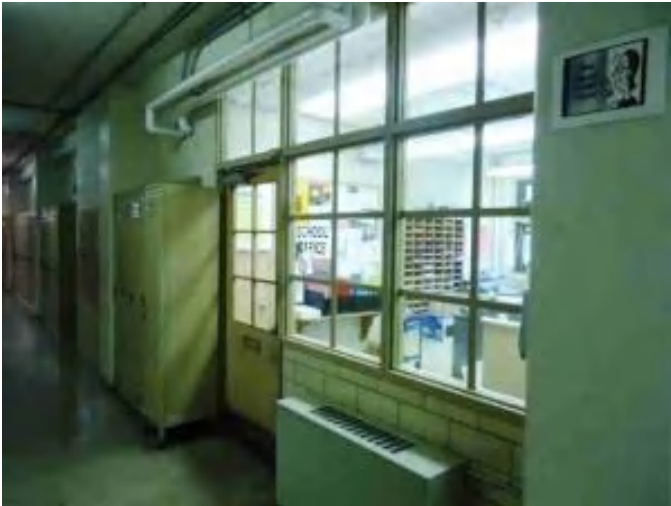
Location: Main Office

Distress: Life Safety / NFPA / PFD

Notes: The main office located in the central hallway on the first floor has the original metal framed single glass pane windows designed into the interior wall system. This system however compliant during the time of construction no longer meets code. This deficiency provides a budgetary consideration for the removal and replacement of the office interior window system.

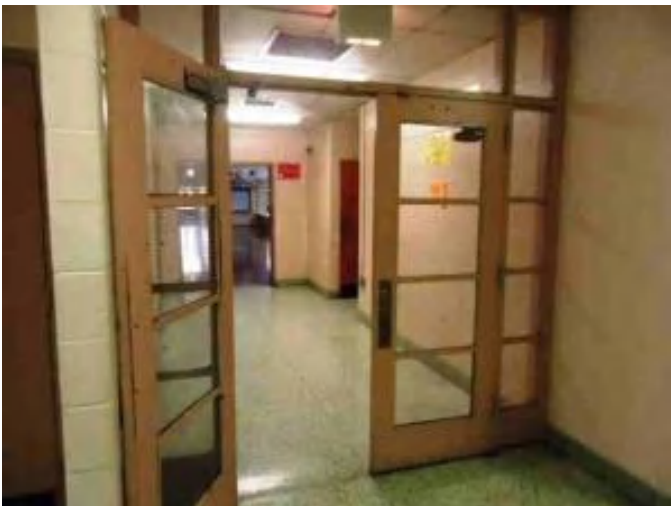
Location: Main Stairs

Distress: Life Safety / NFPA / PFD

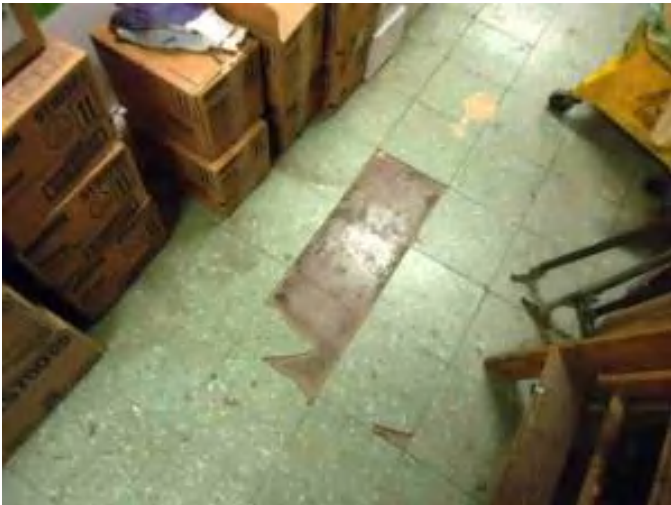
Location: Main Building Wide

Distress: Health Hazard / Risk

Notes: The Saul main building's interior floor finish is a combination of tile in the restrooms, kitchen and service line areas, wooden Gym / Auditorium with vinyl, concrete or painted concrete hallways and stairs. The classroom finishes are a mix of concrete in the shops and vinyl tile in the lecture / classrooms. The vinyl tile finish is a 9 x 9 application and is suspect to contain asbestos. Suspected asbestos containing materials (ACM) are believed to be limited to the original vinyl floor tile and mastic. While currently sound and manageable in place, future renovation efforts should include provision to test and abate any and all ACM.

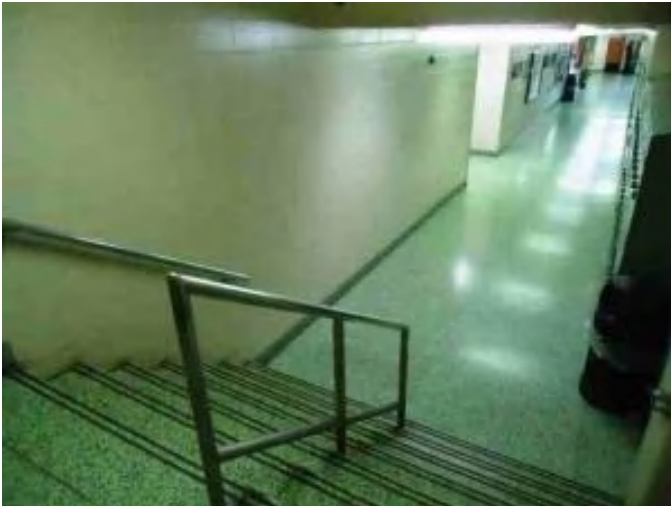
Location: Building Wide

Distress: Inadequate

Notes: There is no elevator that services this school. Goods, services, and amenities offered in public buildings are generally required to be available to all persons. To assist those that may be physically challenged and to meet current accessibility legislation to provide wheelchair access to the upper floors of this facility, the installation of a new hydraulic elevator has been recommended on the exterior elevation of the building or at another suitable location. The new installation should blend as much as possible with the overall appearance of this historic structure and include all required ADA features, such as audible jewels and gongs, an accessible control panel, etc

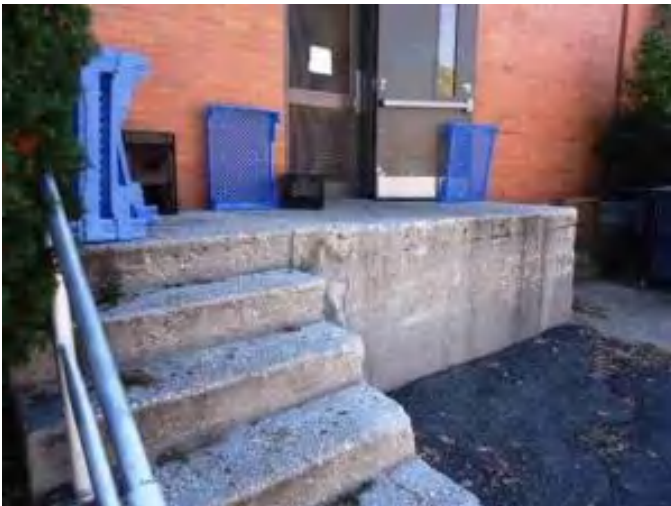
Location: Main Loading Dock

Distress: Damaged

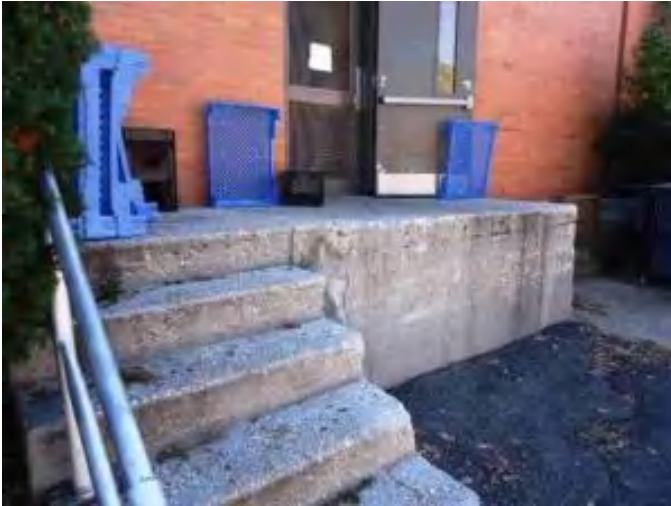
Location: Main Exterior Elevation

Distress: Damaged

Notes: The exterior doors are metal applications with metal frames. The exterior doors are in very high traffic areas. Although the exterior doors are in good condition several warrant replacement. The doors are in fair condition but are aging at a faster rate than expected based on traffic and condition. Replace worn or damaged exterior door systems and service doors as needed. The new doors are expected to retain their dimensions and profiles, but that incorporate updated energy-efficient features.

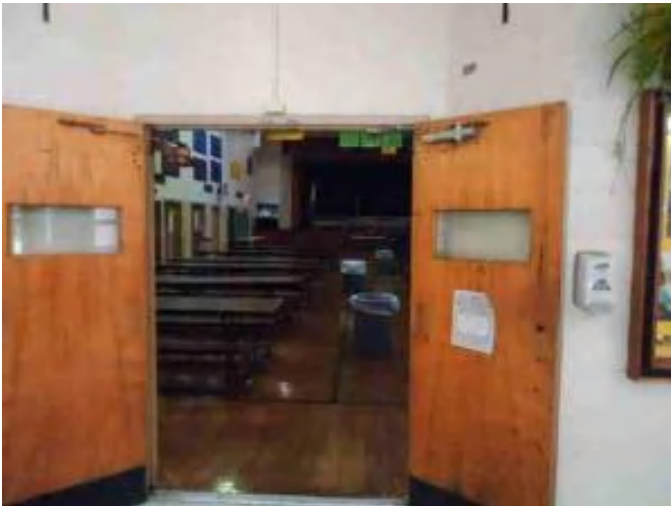
Location: Main Building Wide

Distress: Damaged

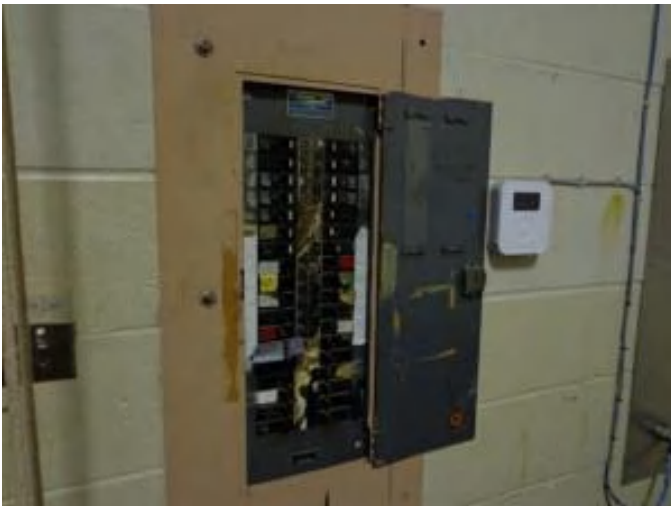
Location: Building wide

Distress: Beyond Service Life

Notes: Replace 800A, 208/120V, 3 phase, 4 wire Main Distribution Panelboard.

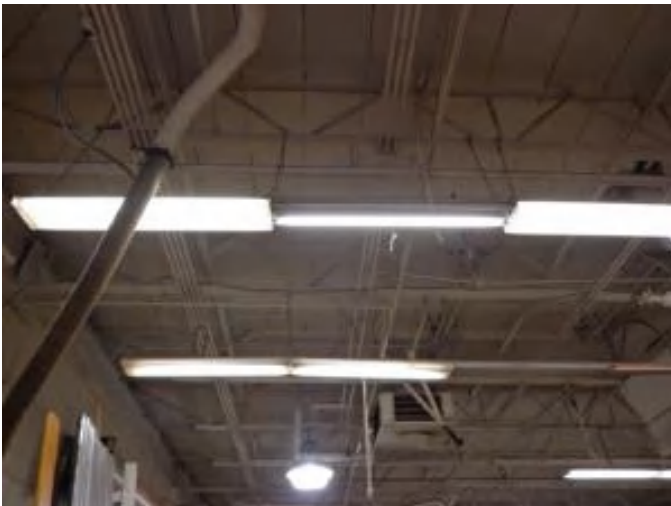
Location: Building wide

Distress: Beyond Service Life

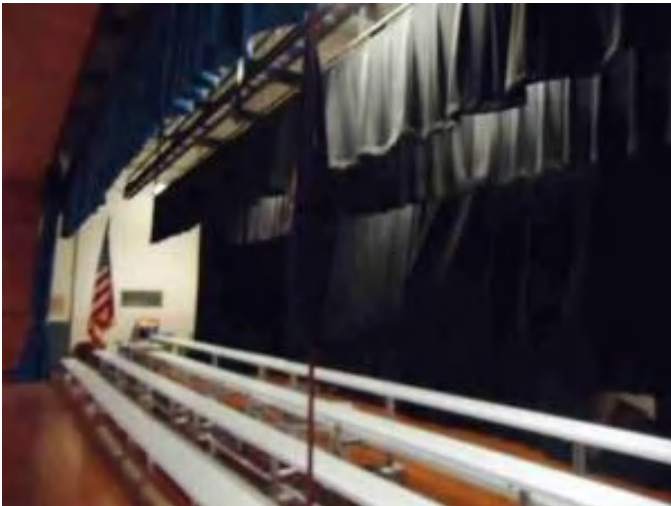
Location: Main Stage

Distress: Life Safety / NFPA / PFD

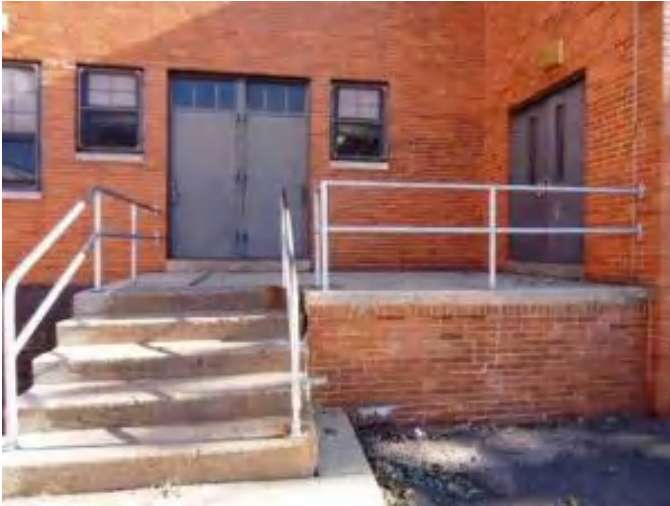
Location: Main Exterior Elevation

Distress: Damaged

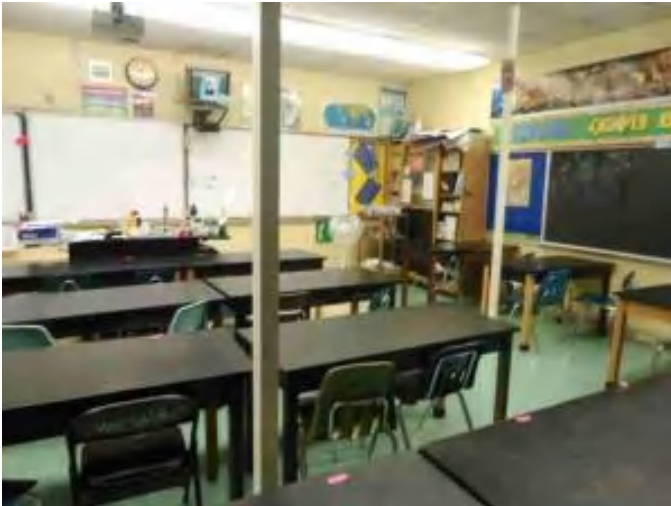
Location: Main Building Wide

Distress: Damaged

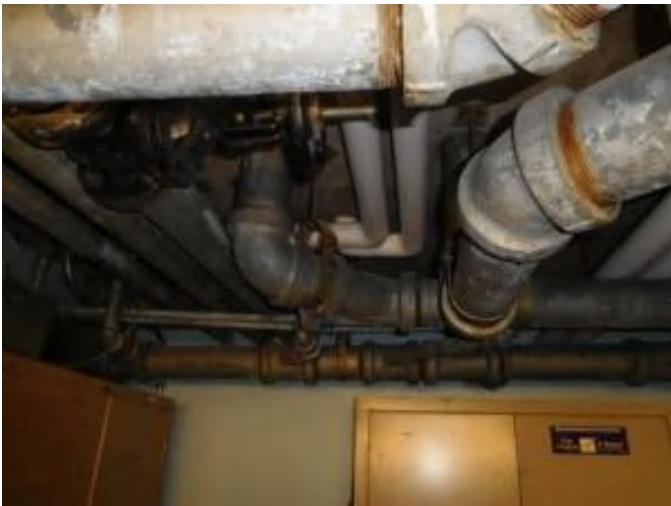
Location: entire building

Distress: Beyond Service Life

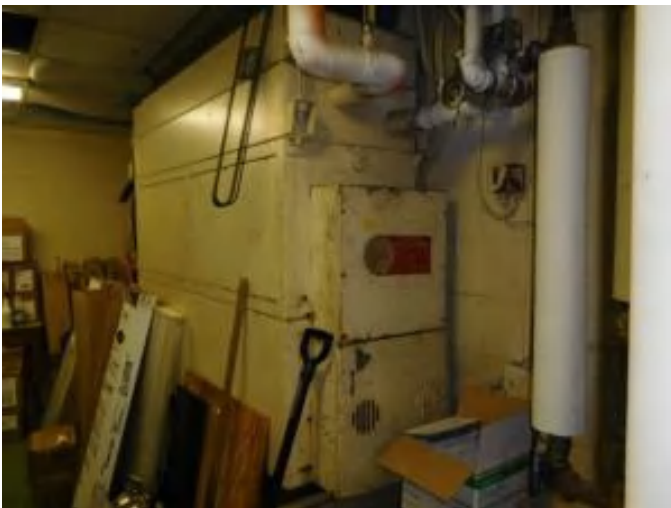
Location: cafeteria

Distress: Building / MEP Codes

Notes: Install new central station air handling unit for cafeteria with hot and chilled water coils, blower and motor, filters, return and outside air dampers, control valves and controls. Connect to hot and chilled water piping and control system. Include new air distribution and electrical connection.

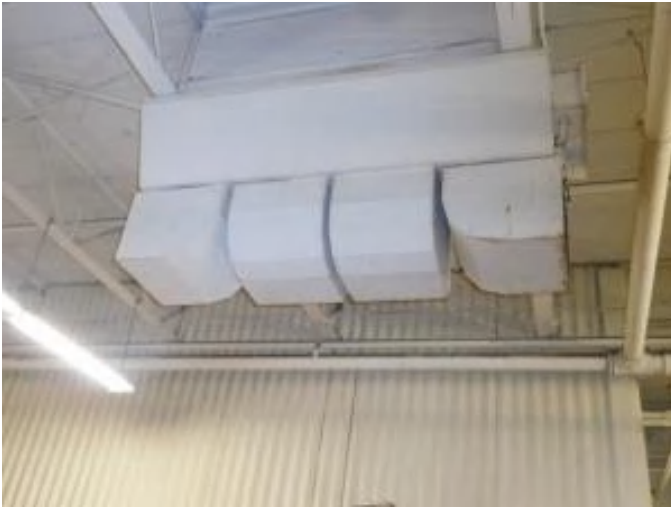
Location: shop

Distress: Building / MEP Codes

Notes: Install new roof mounted heating and ventilating system for shop. Connect to hot water piping, control system and existing duct system. Include electrical connection.

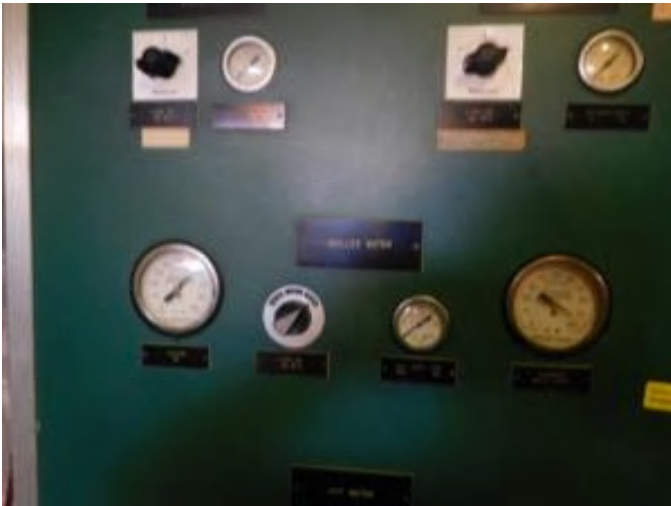
Location: entire building

Distress: Inadequate

Notes: Install new DDC control system with building automation for HVAC equipment. Include computer monitor, software and graphics package.

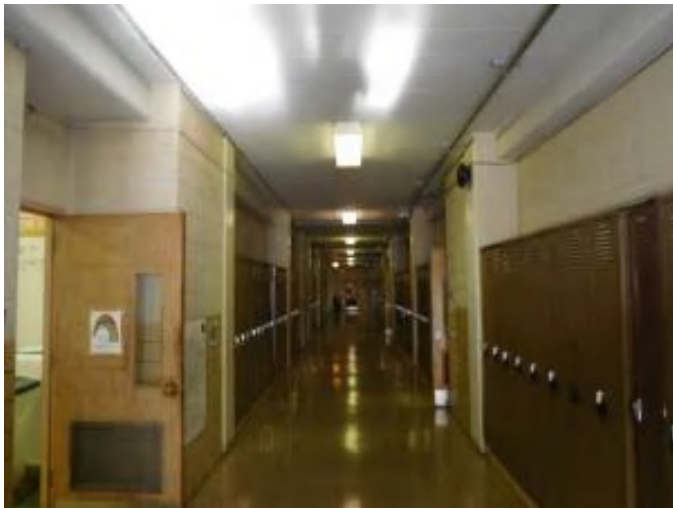
Location: entire building

Distress: Life Safety / NFPA / PFD

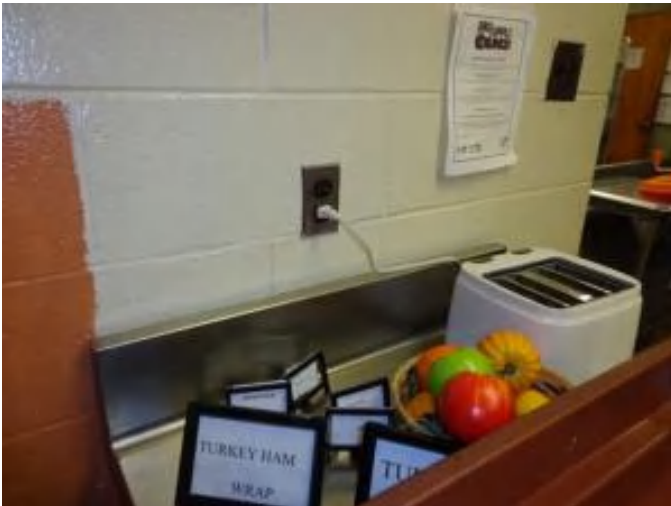
Location: Kitchen

Distress: Life Safety / NFPA / PFD

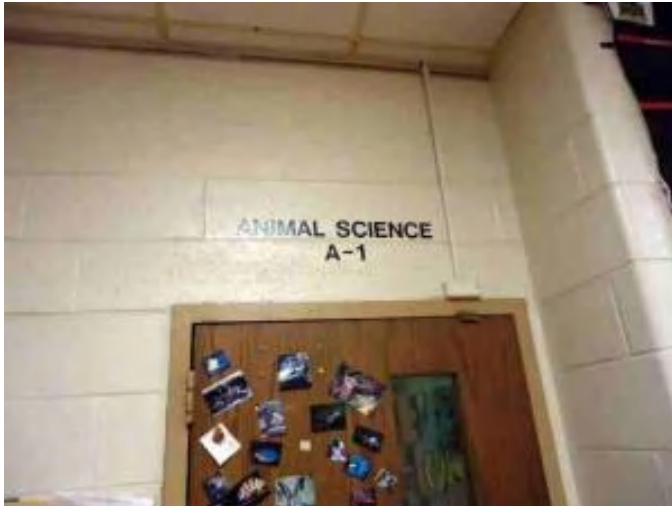
Location: AG Building Wide

Distress: Damaged

Notes: There is no directional signage and room signage is a custom design in places and scarce or painted with no consistency in others. Accessibility signage criteria have been established for the physically challenged. These include mounting heights, contrast and finish, raised and Braille characters and pictograms, and character proportions and heights. It is recommended that compliant signage be installed throughout the building.

Correction: Replace missing or damaged signage - insert the number of rooms

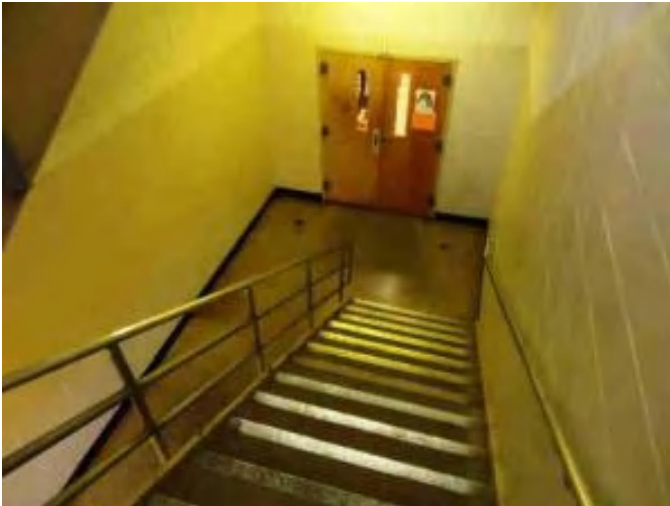
Location: AG Stairs

Distress: Life Safety / NFPA / PFD

Notes: Current requirements for stairs indicate that they have graspable handrails on both sides, that the rails have a specific end geometry, and that the handrails continue horizontally at the landings. In addition, guardrails must prevent the passage of a 4 inch diameter sphere (6 inches in the triangle formed by the lower rail and tread/riser angle). Although the stairs are compliant with the code enforced at the time of construction until a major renovation occurs, they are deficient in handrail and guardrail design relative to current standards. Future efforts should include comprehensive stair railing removal and replacement upgrades.

Correction: Replace inadequate or install proper stair railing
- select appropriate material

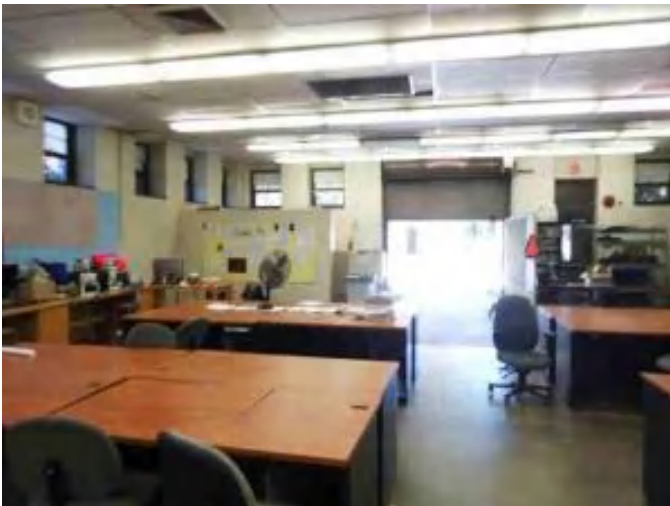
Location: AG Building Wide

Distress: Damaged

Notes: The ceiling finish is a 2 x 4 Acoustical tile finish. Ceilings have been repaired in several areas and is in good condition considering the age of the application and the current condition of the school. The ceiling finish is expected to require upgrades to support the recommended efforts in this report prior to re-opening. This deficiency provides a budgetary consideration for removal and replacement of the current ceiling finish to a new acoustical tile finish. Considering the recommended mechanical and electrical upgrades this effort should be completed as part of an overall renewal program for the school.

Correction: Remove and replace suspended acoustic
ceilings - lighting not included

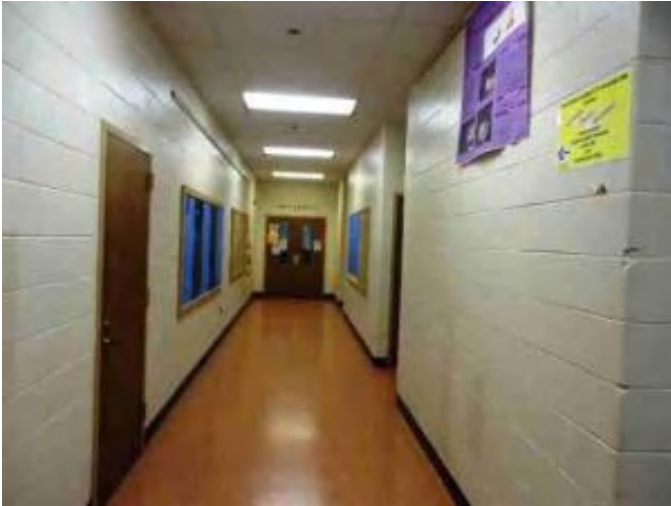
Location: AG Building Wide

Distress: Damaged

Notes: Interior doors are typically wood in wood or metal frames. Doors are generally in fair condition and is a mix of ADA compliant and non-complaint doors with both non-rated and fire rated. Several of the classroom doors are aging at a faster than normal rate for this application. Numerous repairs to locksets and door hardware have advanced the deterioration of the doors. This deficiency provides a budgetary consideration to replace a portion of the interior doors and frames with consideration for the physically challenged.

Correction: Remove and replace interior doors - wood doors with hollow metal frames - per leaf

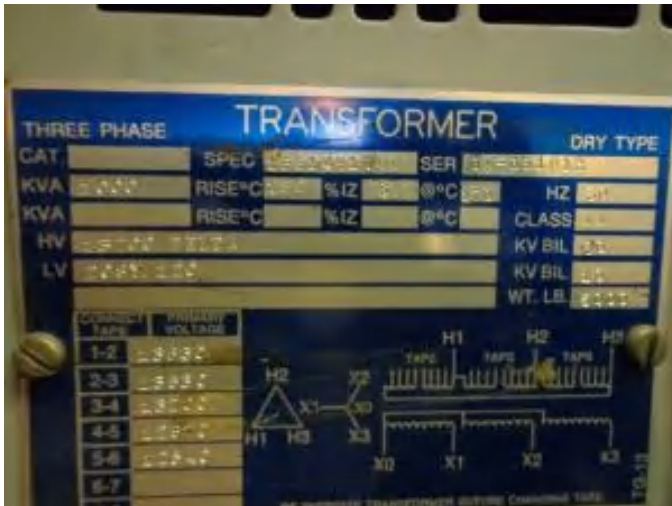
Location: Basement Main Electrical Room

Distress: Beyond Service Life

Notes: Replace the substation that serves the campus, which consists of a 600A load interrupter switch, 1000 kVA, 208/120V, 3 phase, 4 wire dry-type transformer, and 4000A Main Switchboard with three distribution sections with 21 feeder circuit breakers.

Correction: Replace Substation

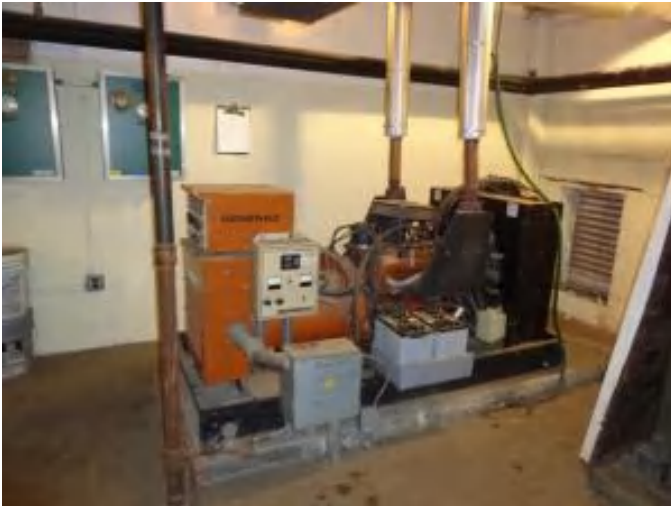
Location: Ag Bldg. Basement

Distress: Beyond Service Life

Notes: Replace standby generator and emergency lighting Panelboards A and B.

Correction: Replace standby generator system

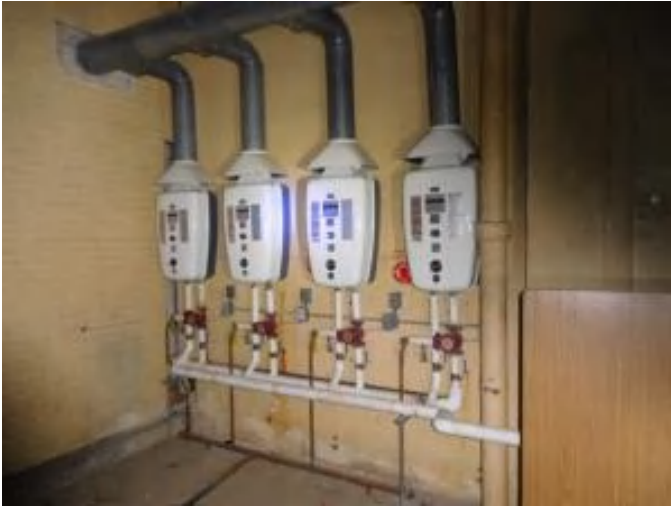
Location: entire building

Distress: Beyond Service Life

Notes: Replace domestic water supply piping including fittings, valves, hangers and insulation.

Correction: Replace domestic water piping (75 KSF)

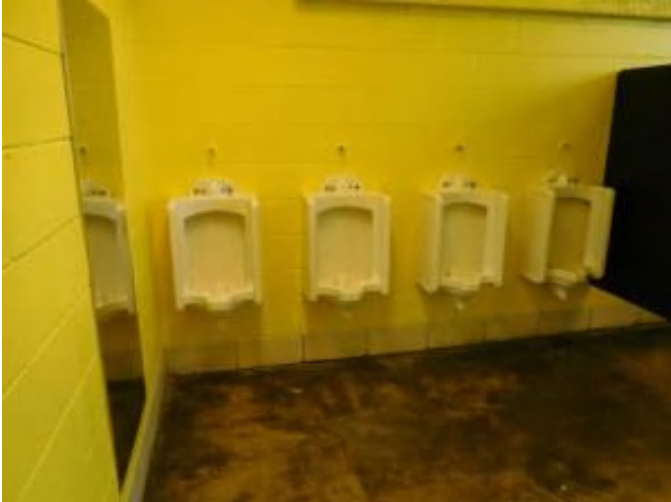
Location: entire building

Distress: Beyond Service Life

Notes: Inspect sanitary and waste plumbing piping including camera survey. Repair or replace as required.

Correction: Inspect sanitary waste piping and replace damaged sections. (+50KSF)

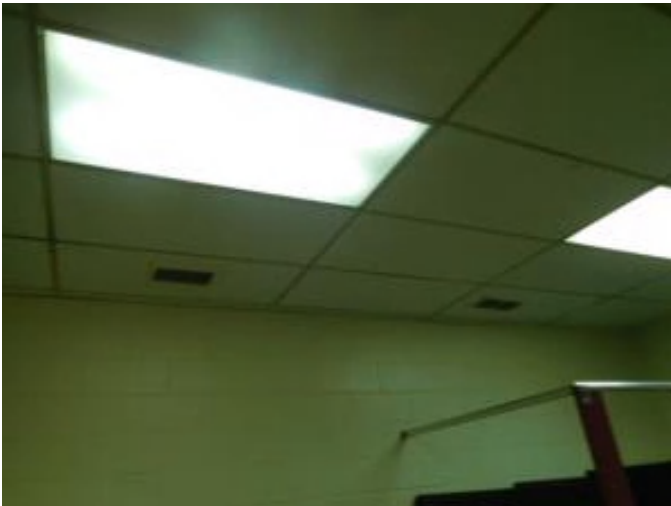
Location: entire building

Distress: Life Safety / NFPA / PFD

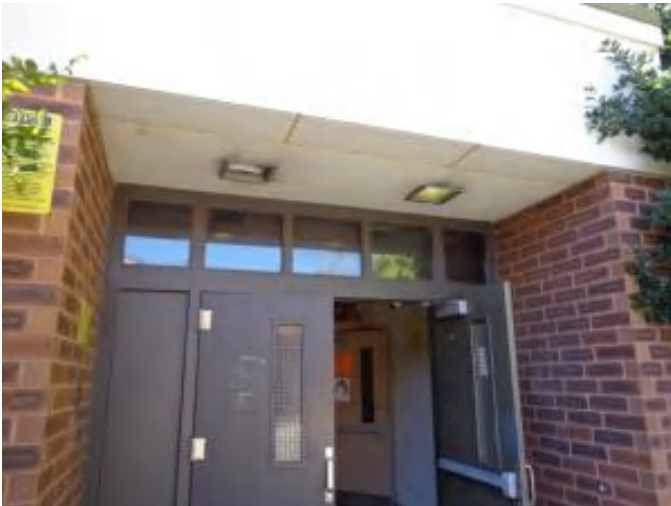
Location: Main Entrance canopy

Distress: Beyond Service Life

Notes: Replace the recessed HID lighting fixtures in the canopy at the main entrance with wet location, LED recessed fixtures.

Correction: Replace lighting fixtures

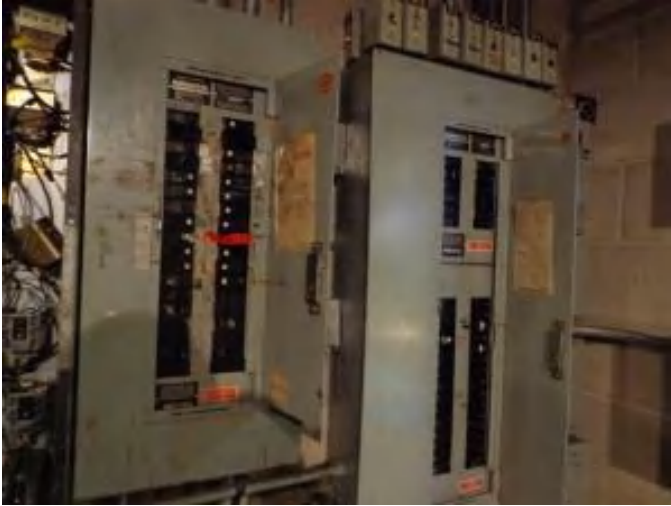
Location: Gym Mechanical Room

Distress: Beyond Service Life

Notes: Remove the 225A Panelboard, 100A Panelboard, and their existing main disconnecting means located in the Gymnasium Mechanical Room and replace with main circuit breaker panelboards.

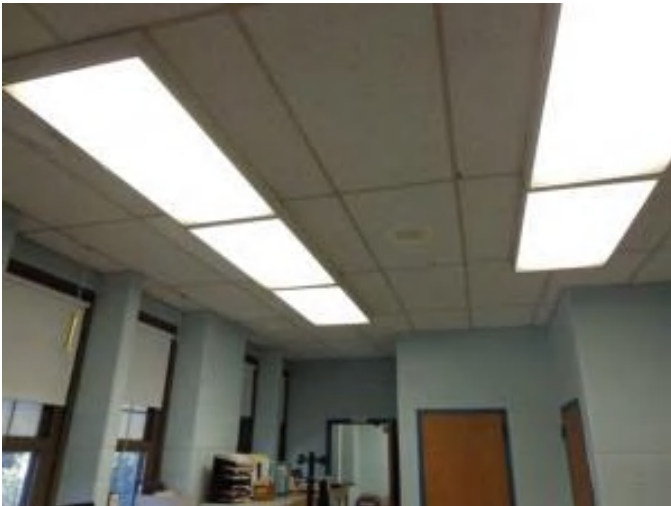
Location: Building wide

Distress: Beyond Service Life

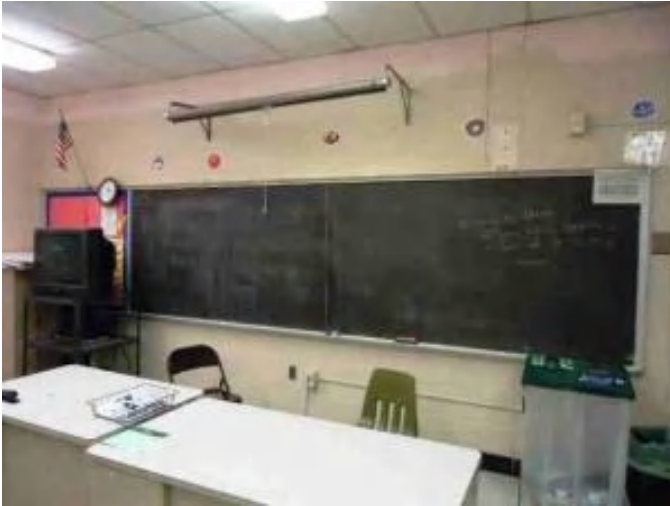
Location: GYM Building Wide

Distress: Damaged

Notes: Some of the classroom chalk boards are original to the buildings construction. This system is damaged and beyond its expected life, universal upgrades are warranted. Remove and upgrade damaged chalk boards to new marker board systems.

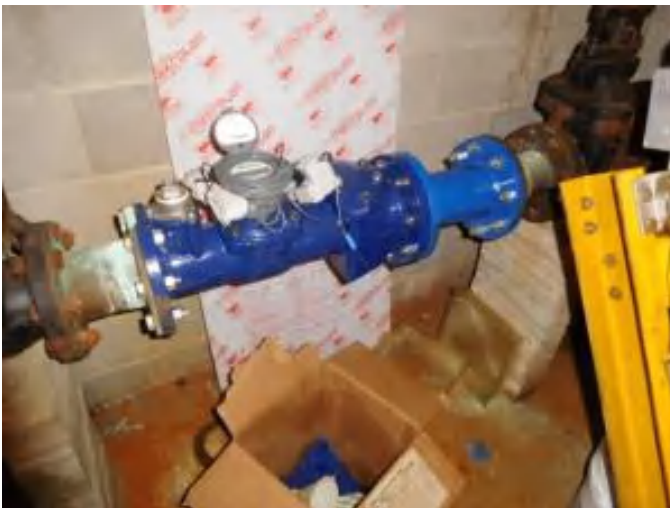
Location: entire building

Distress: Beyond Service Life

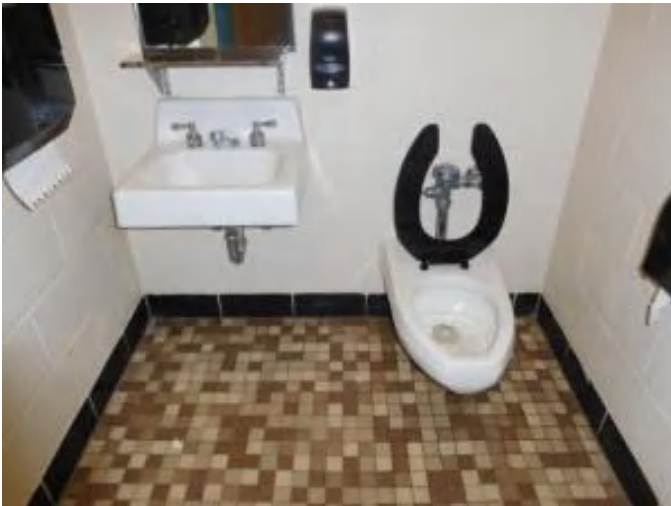
Location: entire building

Distress: Beyond Service Life

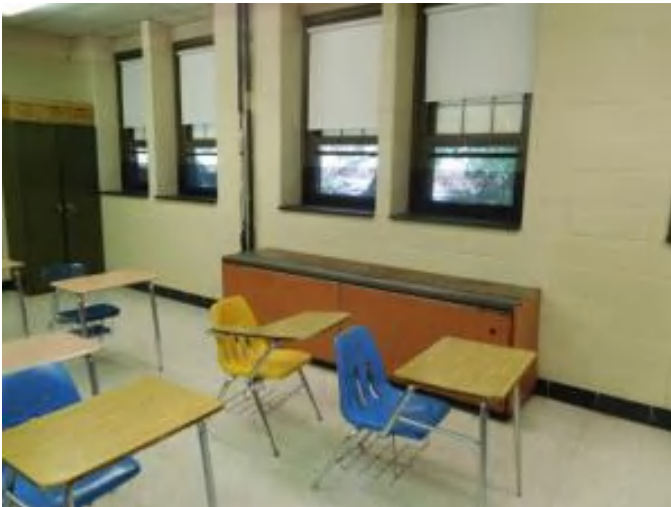
Location: office area

Distress: Building / MEP Codes

Notes: Replace small air handling unit for office area. Unit to have hot and chilled water coils, blowers and motors, outside and return air dampers, valves and controls. Connect to hot and chilled water piping systems and control system. Include electrical connection.

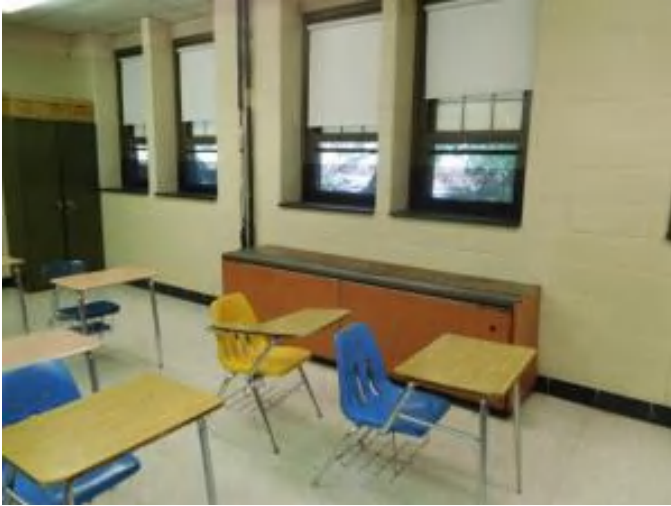
Location: classroom, offices

Distress: Beyond Service Life

Notes: Replace three older unit ventilators in classroom and office area with new units with hot and chilled water coils, blowers and motors, outside air dampers, valves and controls. Connect to hot and chilled water systems and control systems. Include electrical connections.

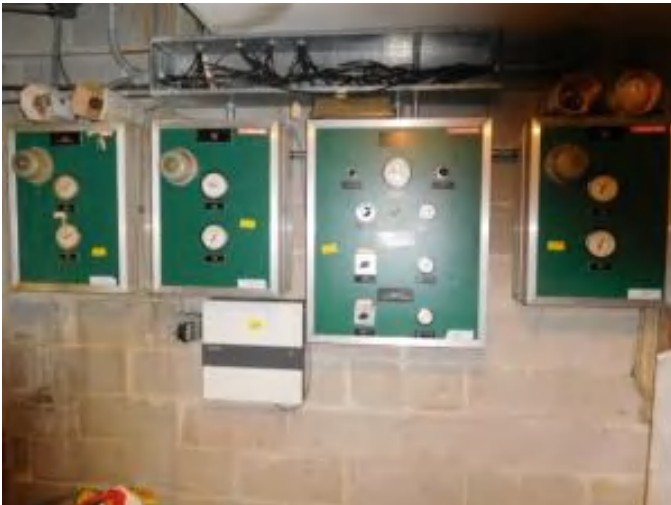
Location: entire building

Distress: Inadequate

Notes: Install new DDC control system with building automation for HVAC equipment. Include computer monitor, software and graphics package.

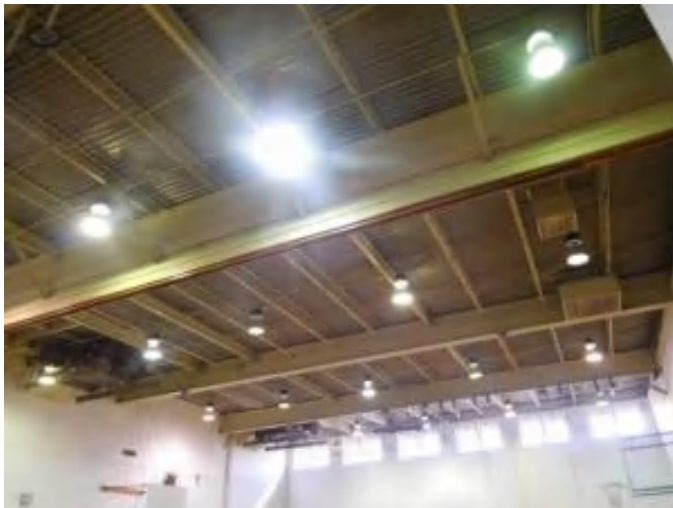
Location: entire building

Distress: Life Safety / NFPA / PFD

Notes: Install complete NFPA automatic sprinkler system including fire pump if required.

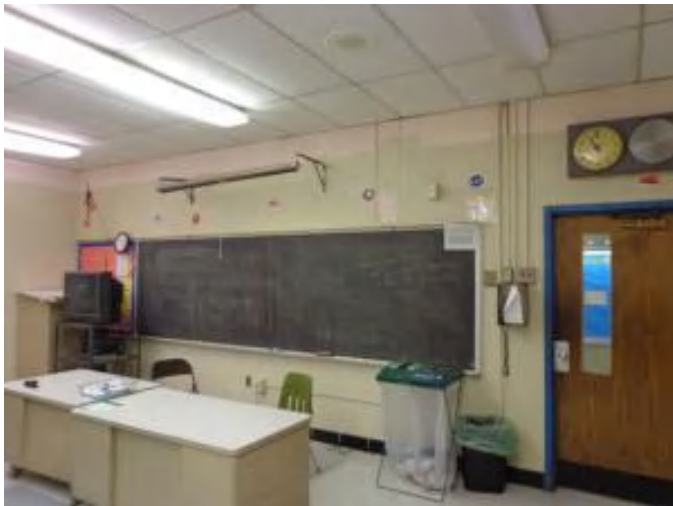
Location: Health Education Classroom

Distress: Inadequate

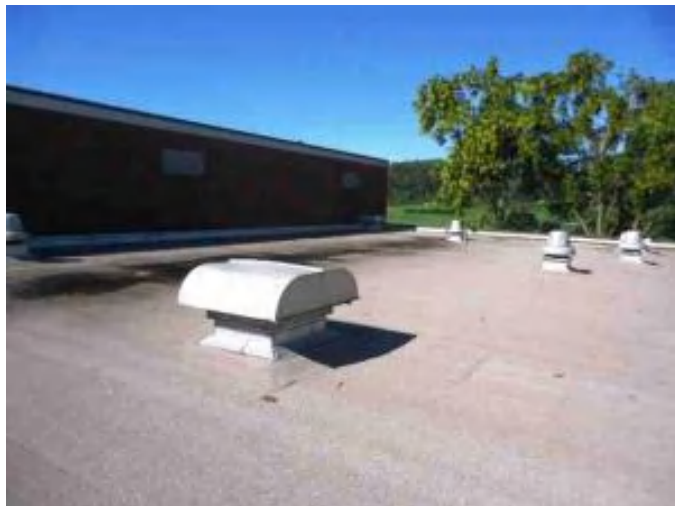
Location: GYM Roof

Distress: Beyond Service Life

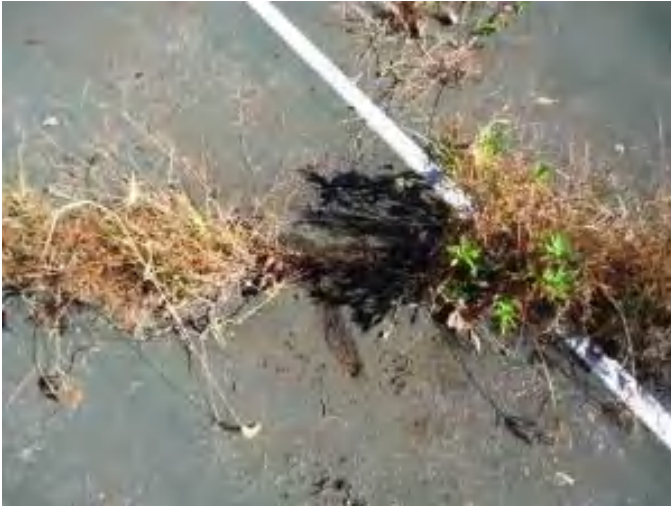
Location: Site Tennis Courts

Distress: Damaged

Notes: The Tennis courts are located on the main site just west of the exterior student commons. The student commons and the hardscape, landscape and sidewalks are in good condition however, the tennis courts will require some maintenance. Only one of the two courts are being used by the students because of the growth between the cracks of the asphalt finish on the second court. This deficiency provides a budgetary consideration for the restoration of the court surface.

Correction: Fill cracks in AC paving - by the LF - select appropriate width and depth

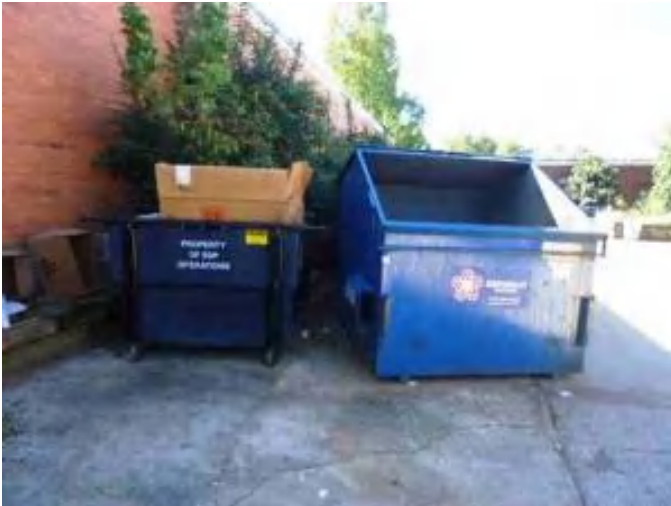
Location: Loading Dock

Distress: Health Hazard / Risk

Notes: The trash dumpster is located in the parking lot open to the students and to the public. The exterior services are not protected. Upgrades to protect the exterior services and trash area is necessary for the safety of the students and the general public. Construction of a secure lockable dumpster area is recommended.
