Facility Condition Assessment Summary Report

Spruance School

School District of Philadelphia
S835001; Spruance
Final
Site Assessment Report
January 31, 2017

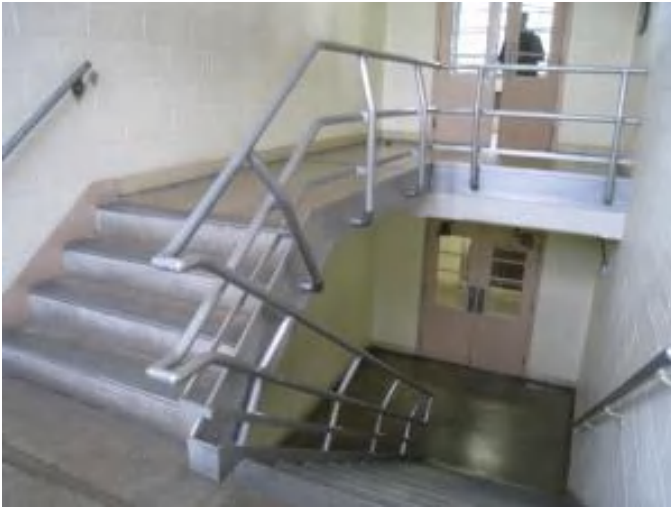
Location: stairways

System: C2010 - Stair Construction

Distress: Building / MEP Codes

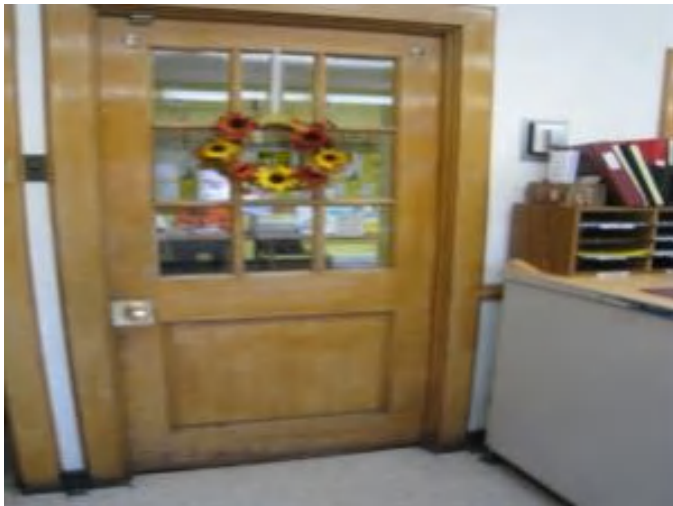
Location: interior doors

System: C1020 - Interior Doors

Distress: Inadequate

Notes: Replace old, broken wood interior doors with new solid core oak doors with safety glass vision panels (for classrooms at corridors) and wood frames with lever handle hardware sets (90) 3'x7'

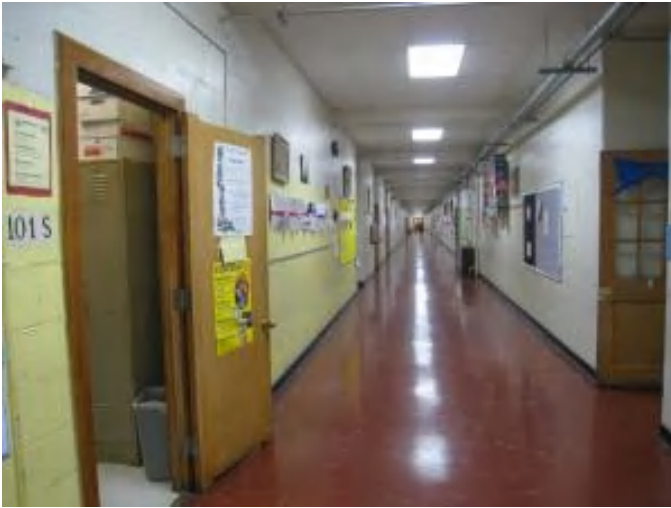
Location: interior corridor doors

System: C1020 - Interior Doors

Distress: Security Issue

Notes: Provide security hardware for classrooms and offices locking from inside of room (90 each)

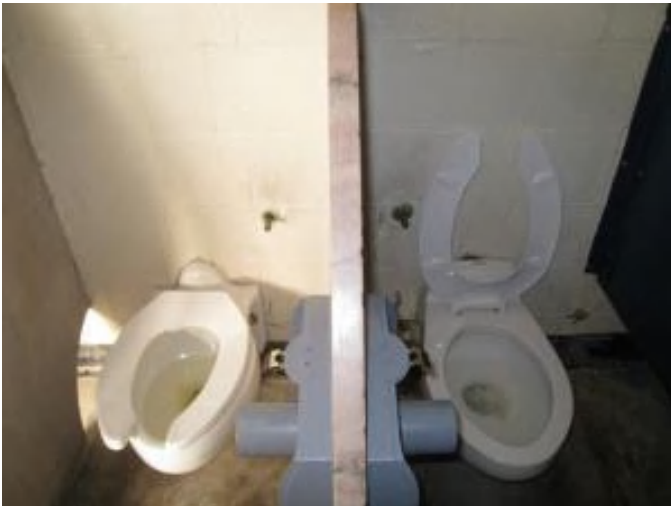
Location: toilet rooms

System: C1030 - Fittings

Distress: Beyond Service Life

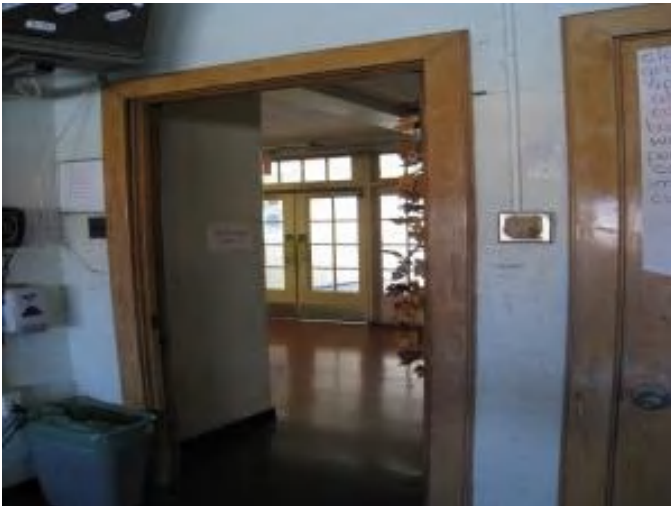
Location: corridor walls

System: C3010230 - Paint & Covering

Distress: Damaged

Notes: Repair and repaint damaged corridor and classroom walls (10,000sf)

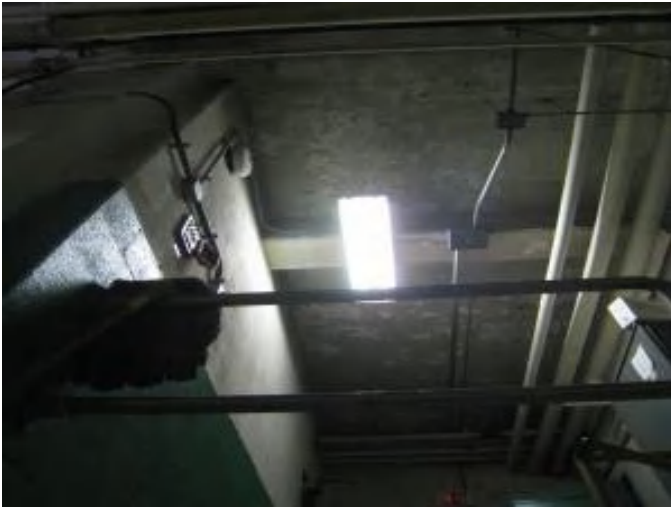
Location: mechanical rooms

System: C3010230 - Paint & Covering

Distress: Appearance

Notes: Repaint basement walls and ceilings in area of mechanical equipment (3,000sf)

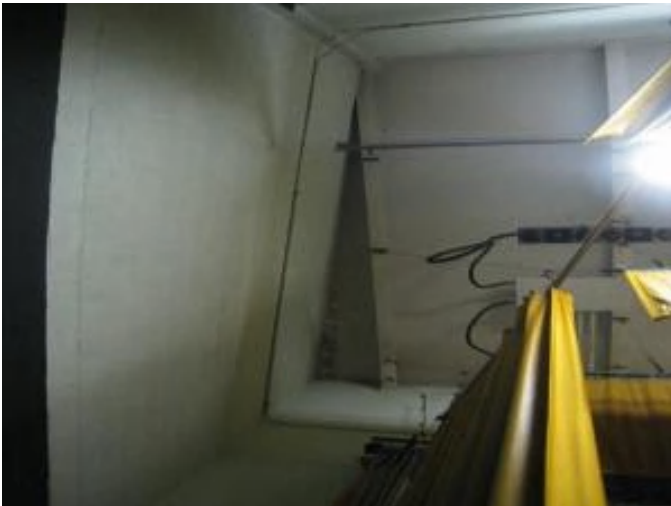
Location: ceilings

System: C3010230 - Paint & Covering

Distress: Damaged

Notes: Patch, repair, repaint plaster ceilings in auditorium and classrooms where damaged by water (1,000sf)

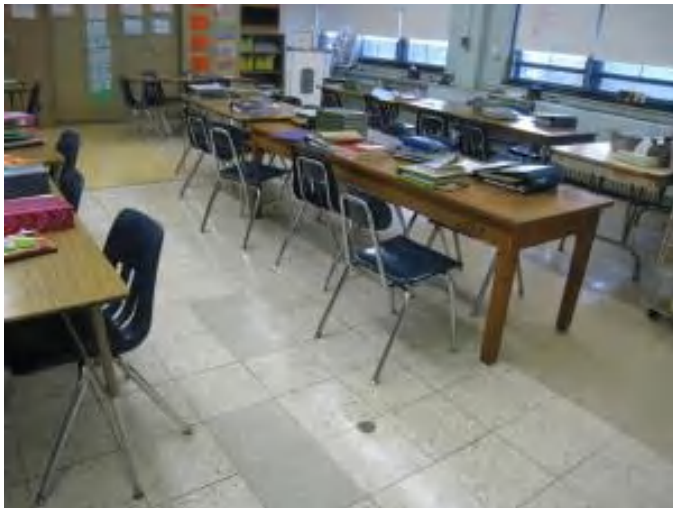
Location: floors

System: C3020413 - Vinyl Flooring

Distress: Damaged

Notes: Replace VAT with VCT; properly remove and dispose after testing to confirm presence of asbestos in VAT (76,043sf)

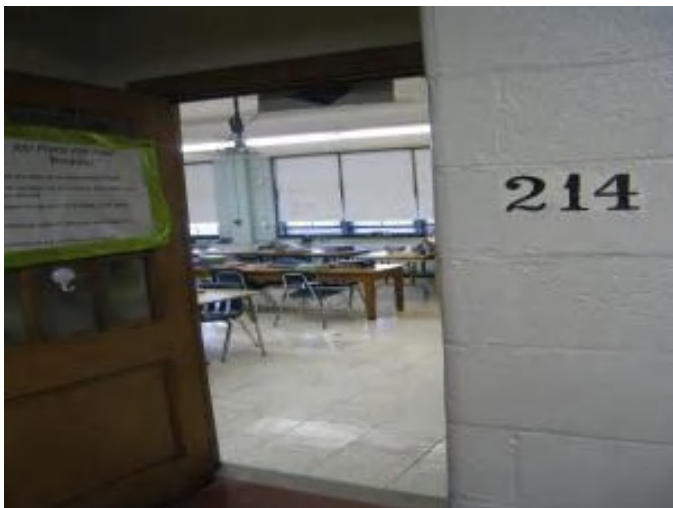
Location: floors

System: C3020413 - Vinyl Flooring

Distress: Damaged

Notes: Replace damaged VCT (1000sf)

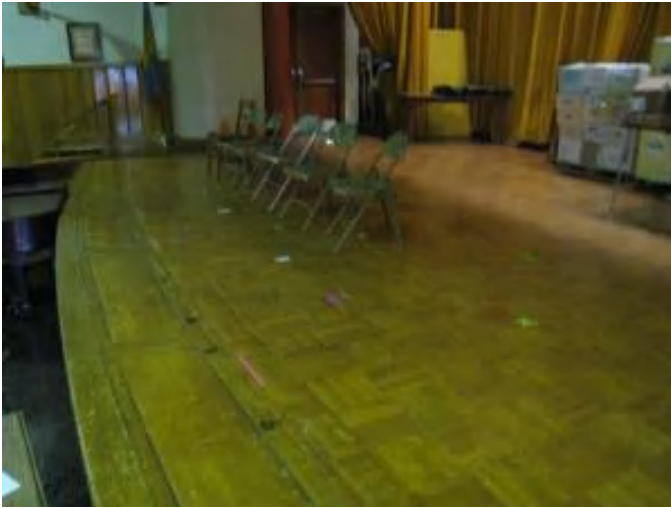
Location: gymnasium and stage floors

System: C3020414 - Wood Flooring

Distress: Appearance

Notes: Refinish wood floors in gymnasium and stage (3,700sf)

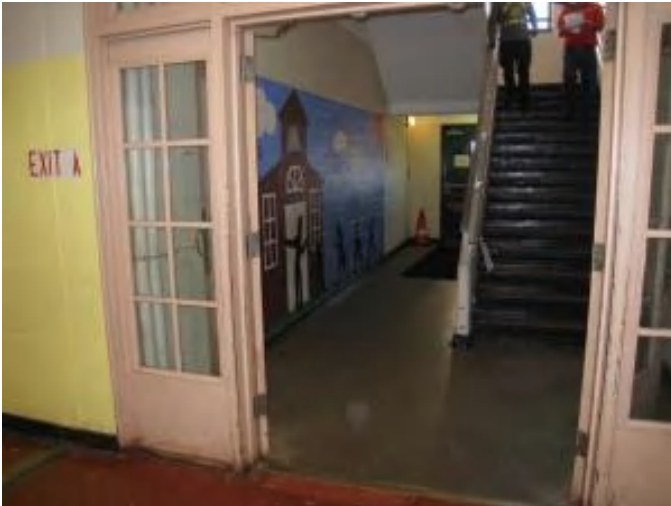
Location: mechanical rooms, stairways, toilet rooms

System: C3020415 - Concrete Floor Finishes

Distress: Appearance

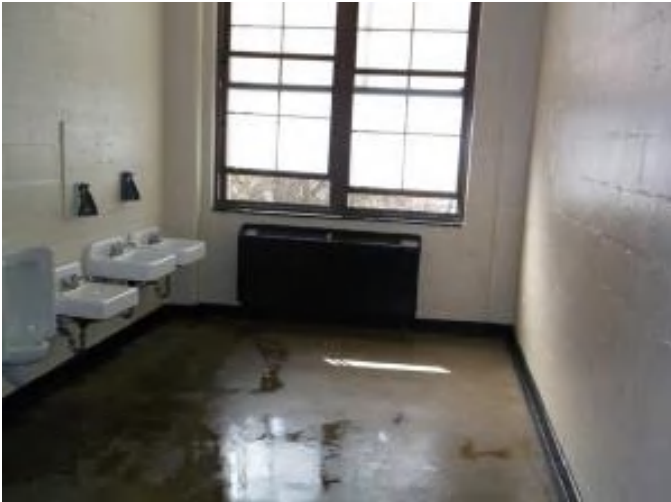
Location: Throughout the building

System: D2010 - Plumbing Fixtures

Distress: Beyond Service Life

Notes: In the Main Building replace all lavatories in the building with lower flow fixtures, as the fixtures are original.

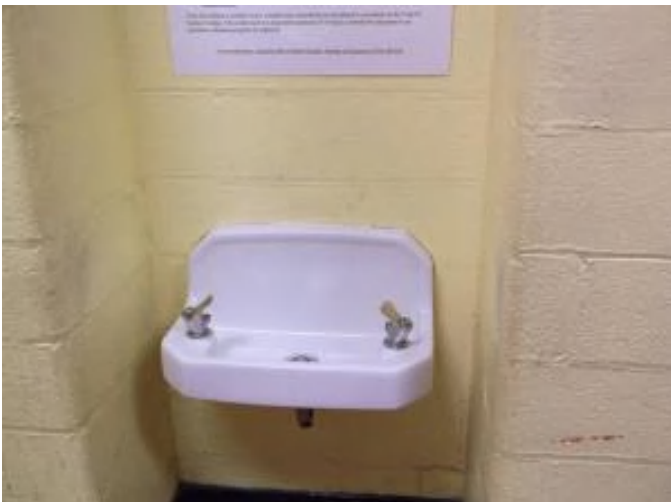
Location: Throughout the building

System: D2010 - Plumbing Fixtures

Distress: Beyond Service Life

Notes: In the Main Building replace the wall hung drinking fountains and integral refrigerated coolers in the corridors and at the restrooms. These units are well beyond their service life and most are NOT accessible type.

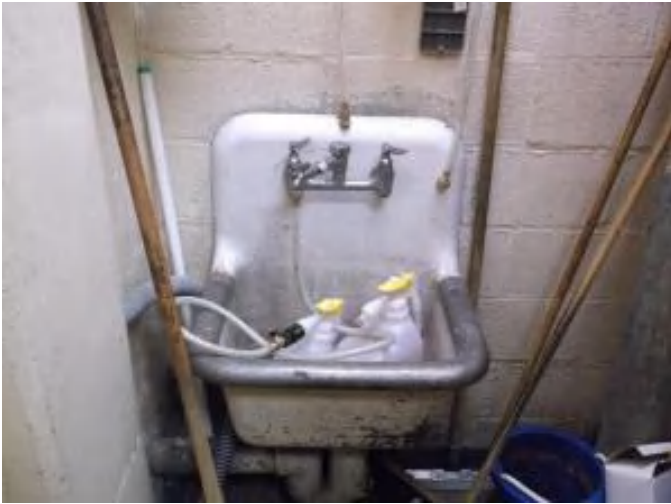
Location: Throughout the building

System: D2010 - Plumbing Fixtures

Distress: Beyond Service Life

Notes: In the Main Building replace service sinks (janitor sinks) in the building.

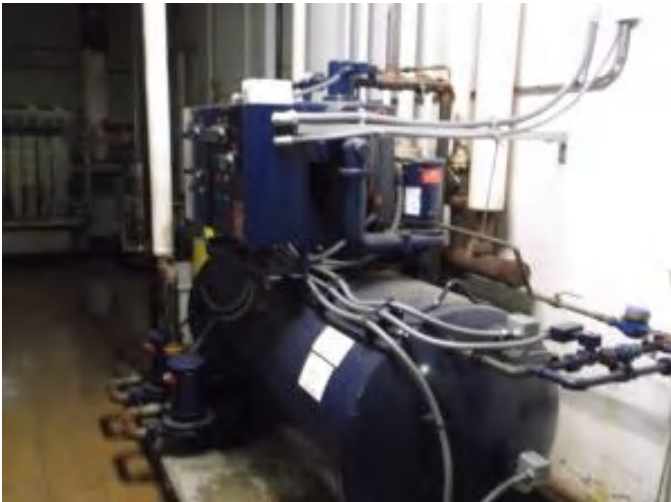
Location: Main boiler mechanical equipment room

System: D3020 - Heat Generating Systems

Distress: Beyond Service Life

Notes: In the Main Building replace the boiler feedwater system

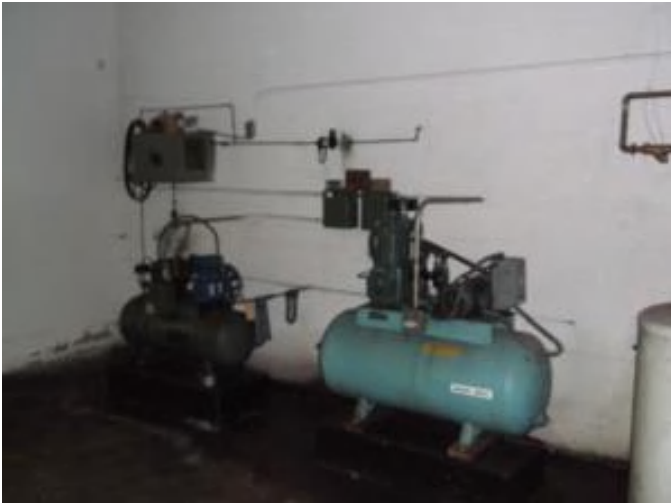
Location: Throughout the building

System: D3060 - Controls & Instrumentation

Distress: Beyond Service Life

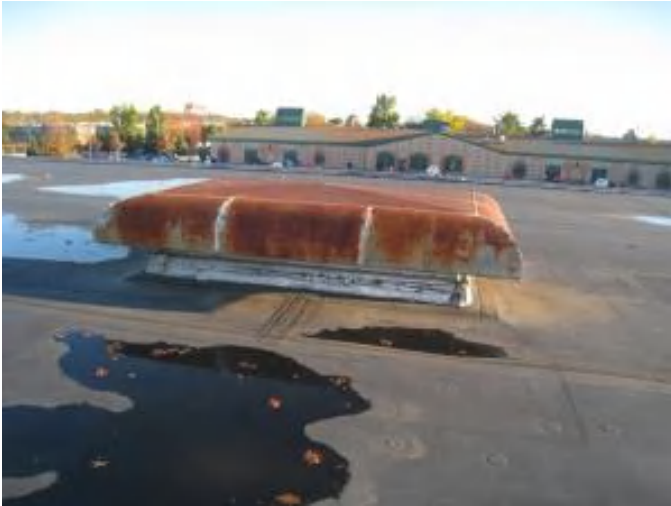
Location: roof

System: B3020 - Roof Openings

Distress: Building Envelope Integrity

Notes: Replace rusted gravity vent housings on roof; patch and repair roof as needed (10)

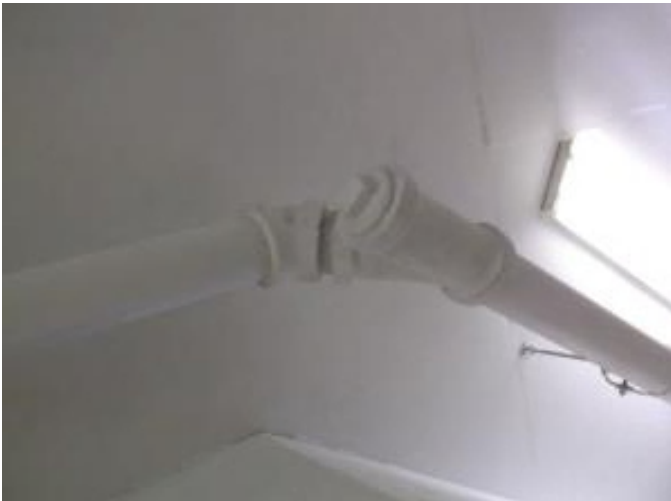
Location: Throughout the building

System: D2030 - Sanitary Waste

Distress: Beyond Service Life

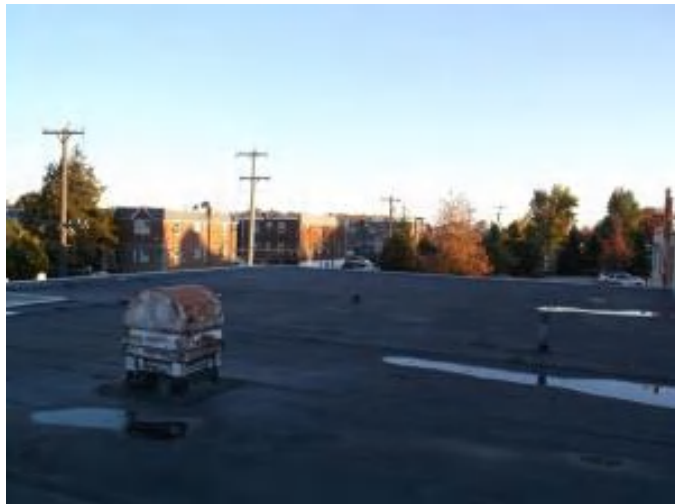
Location: Roof

System: D3040 - Distribution Systems

Distress: Beyond Service Life

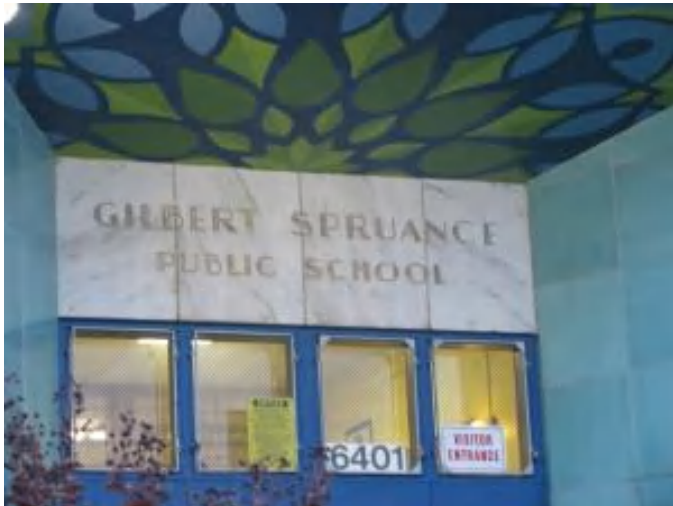
Location: Entire Building

System: D5030 - Communications and Security

Distress: Security Issue

Notes: Provide additional surveillance cameras where required. Estimated 10 cameras

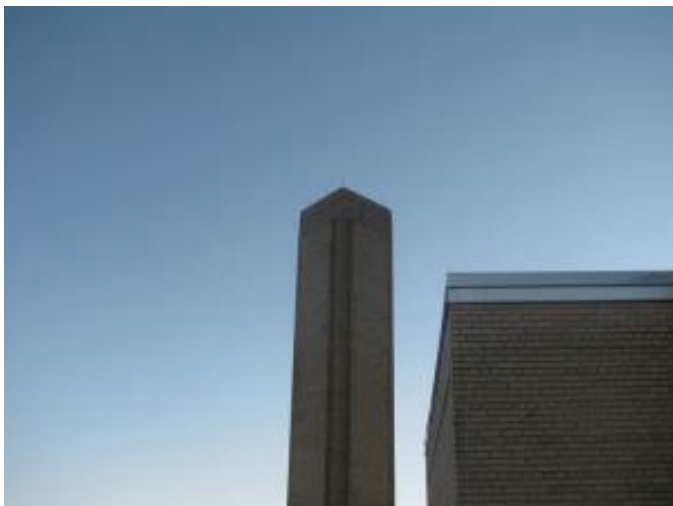
Location: Roof

System: D5090 - Other Electrical Systems

Distress: Life Safety / NFPA / PFD

Notes: Provide lightning protection studies to ascertain adequacy of existing systems.

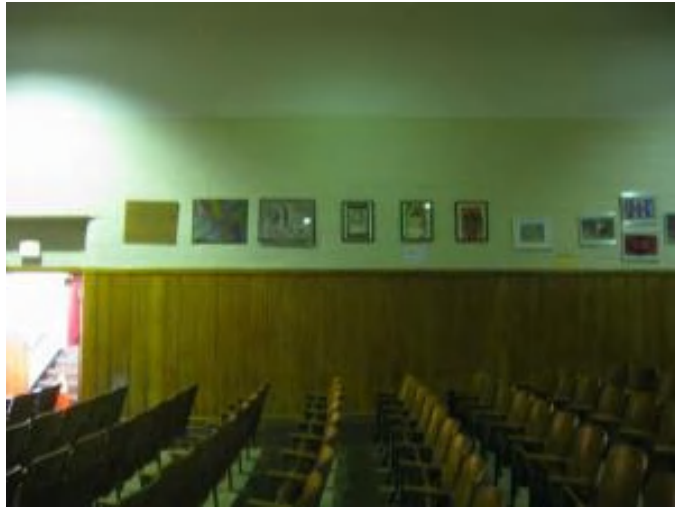
Location: auditorium

System: E2010 - Fixed Furnishings

Distress: Appearance

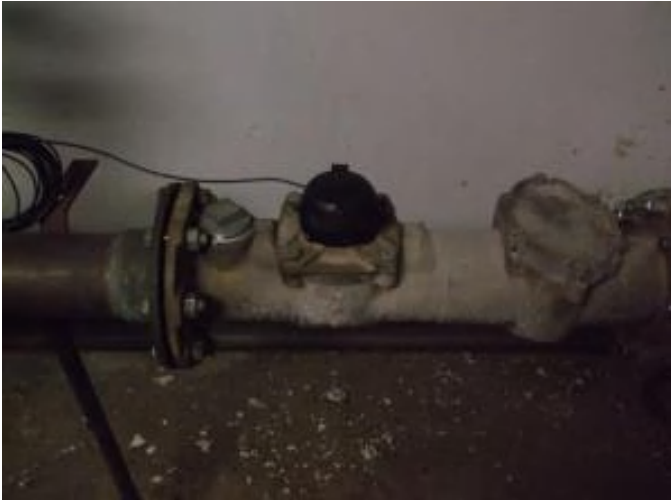
Location: Throughout the school

System: D2020 - Domestic Water Distribution

Distress: Beyond Service Life

Notes: In the Main Building inspect and replace the original as needed the domestic water piping in the

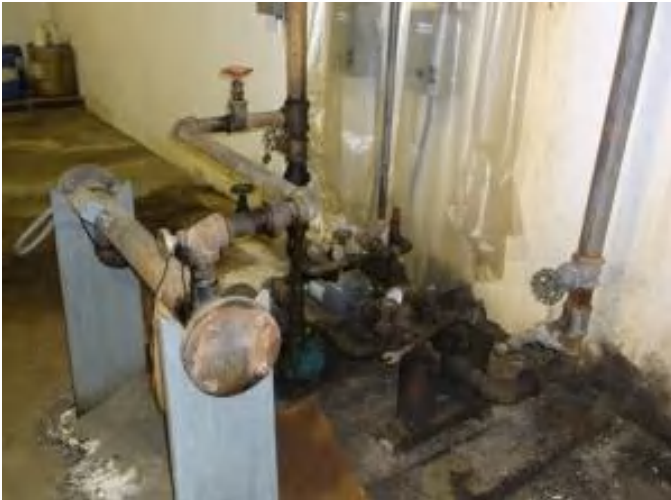
Location: Main boiler mechanical equipment room

System: D3020 - Heat Generating Systems

Distress: Beyond Service Life

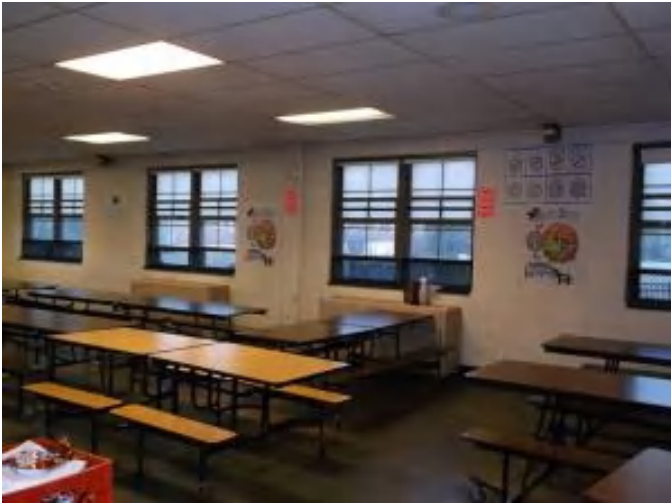
Location: Roof

System: D3040 - Distribution Systems

Distress: Beyond Service Life

Notes: In the Main Building provide ventilation, heating and cooling for the Cafeteria by removing the existing unit ventilators and installing a package rooftop constant volume air handling unit with distribution ductwork and registers.

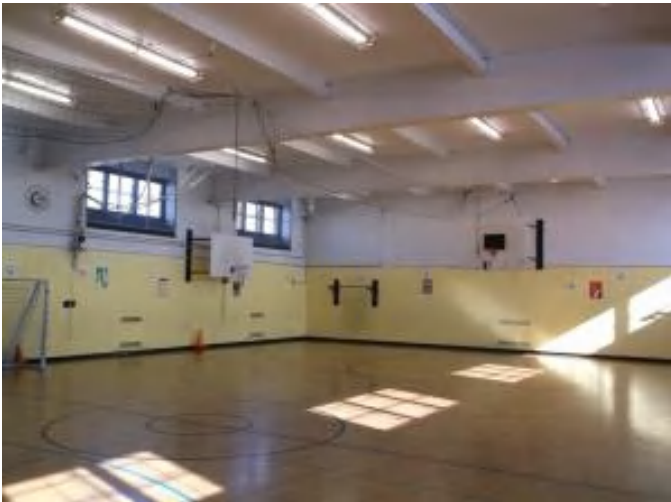
Location: Roof

System: D3040 - Distribution Systems

Distress: Beyond Service Life

Notes: In the Main Building provide ventilation, heating and cooling for the gymnasium by installing a packaged roof top unit.

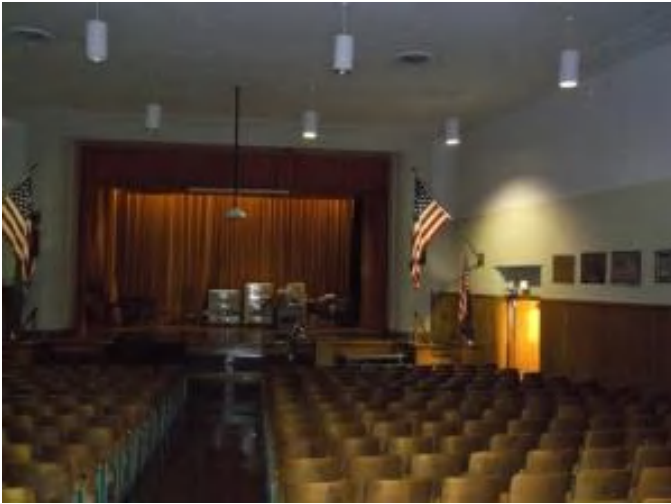
Location: Roof

System: D3040 - Distribution Systems

Distress: Beyond Service Life

Notes: In the Main Building provide ventilation, heating and cooling for the Auditorium by removing the existing unit ventilators and installing a package rooftop constant volume air handling unit with distribution ductwork and registers.

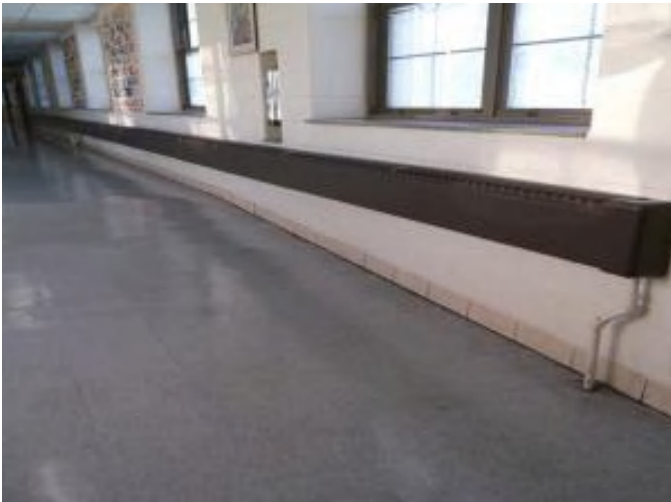
Location: Throughout the building

System: D3040 - Distribution Systems

Distress: Beyond Service Life

Notes: In the Main Building replace the steam convectors.

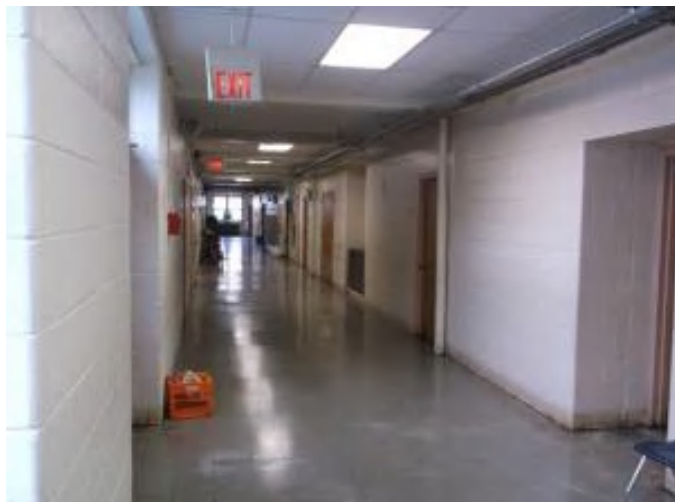
Location: Throughout the building

System: D4010 - Sprinklers

Distress: Life Safety / NFPA / PFD

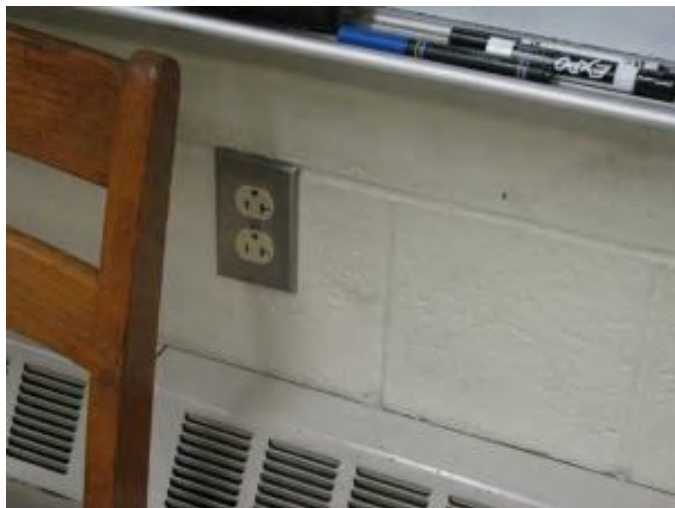
Location: Classrooms

System: D5020 - Lighting and Branch Wiring

Distress: Life Safety / NFPA / PFD

Notes: Replace all existing receptacles with GFCI type receptacle in areas subject to kid access. Estimated 30each.

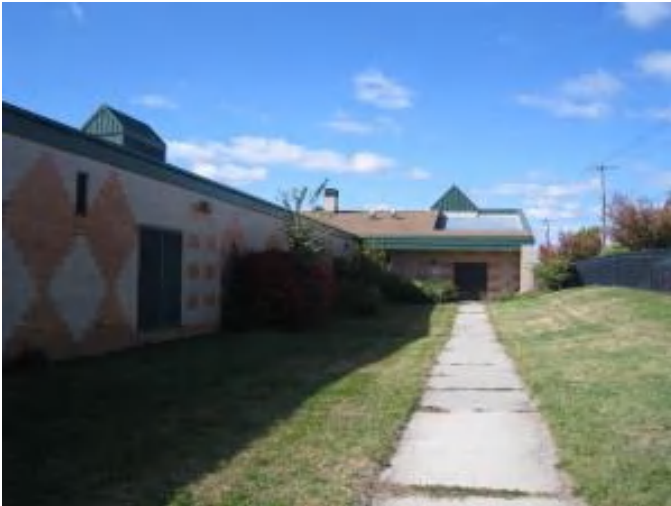
Location: exterior doors

System: B2030 - Exterior Doors

Distress: Appearance

Notes: Repaint exterior hollow metal doors (6 3x7)

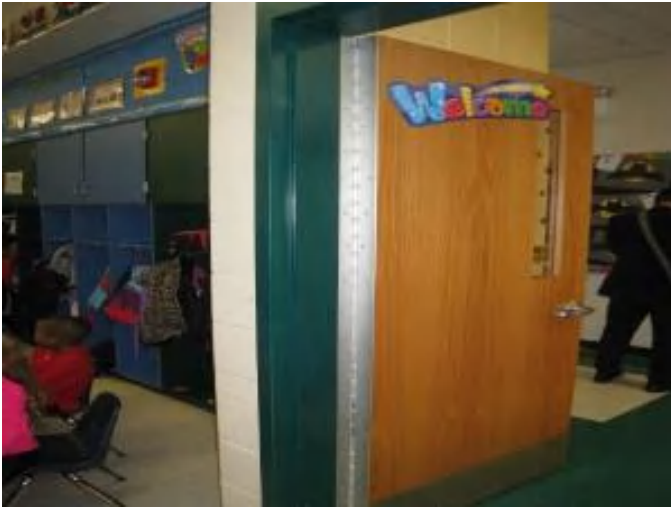
Location: interior door frames

System: C1020 - Interior Doors

Distress: Appearance

Correction: Repair and repaint HM door frames - per frame

Notes: Repaint all interior door frames (approx. 20 frames = 400sf)

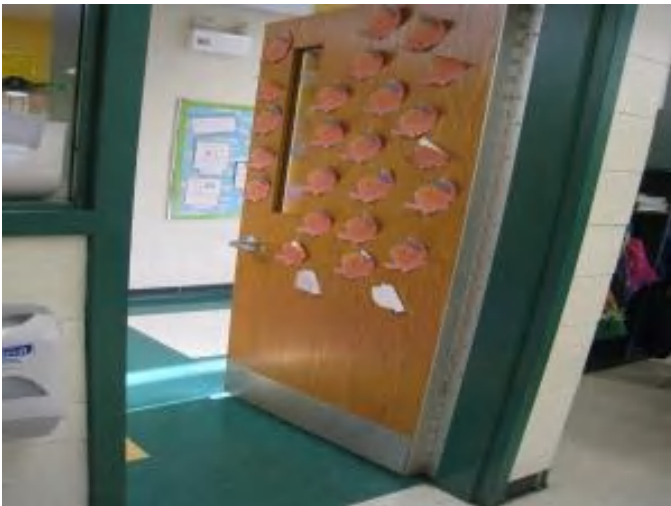
Location: corridor doors

System: C1020 - Interior Doors

Distress: Security Issue

Notes: Provide security hardware for classrooms and offices, locking from the inside of the room (17)

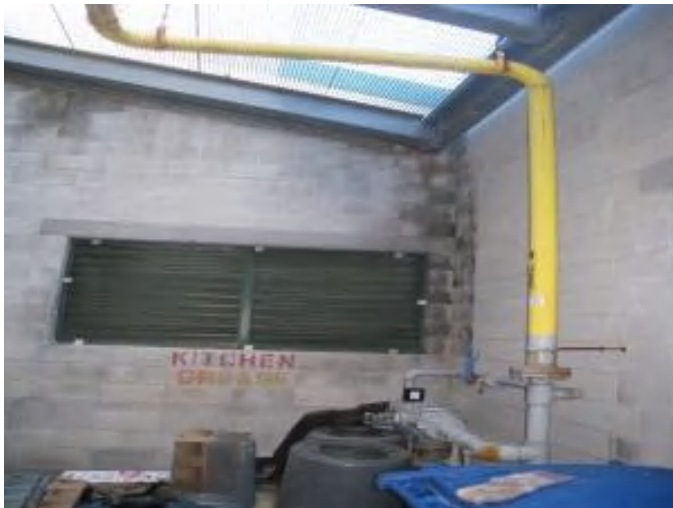
Location: beams in mechanical area

System: C3010230 - Paint & Covering

Distress: Damaged

Correction: Repair substrate and repaint interior walls - SF of wall surface

Notes: Repaint rusted steel roof beams in mechanical area (800sf)

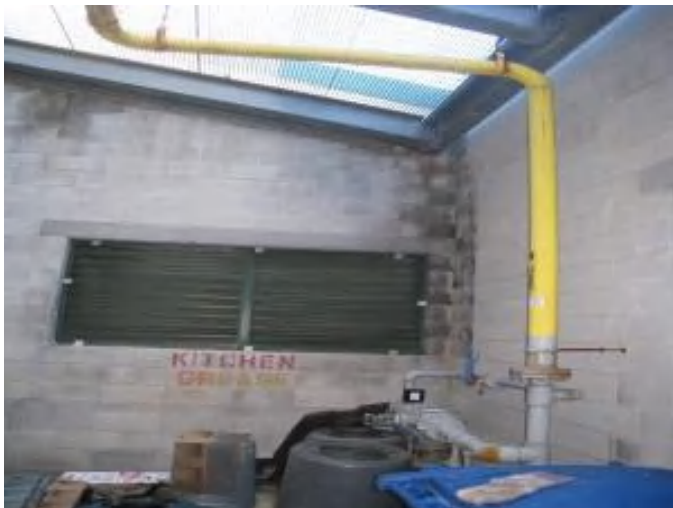
Location: block wall in mechanical area

System: C3010230 - Paint & Covering

Distress: Damaged

Correction: Repair substrate and repaint interior concrete or CMU walls - SF of wall surface

Notes: Repair masonry cracks in classroom wall and outside mechanical area (100sf)

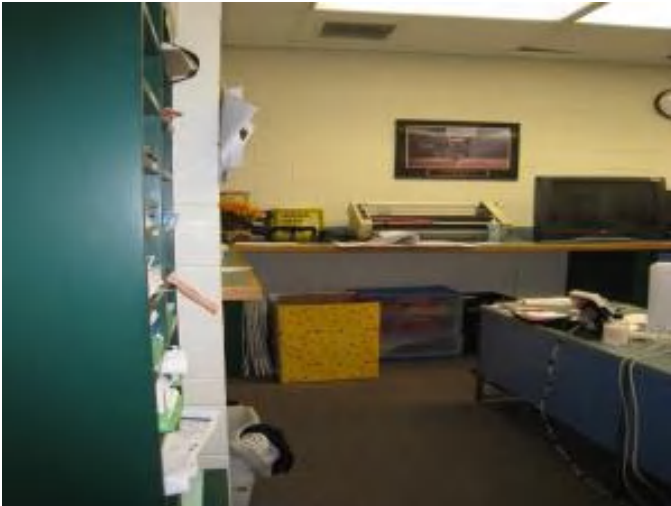
Location: offices

System: C3020411 - Carpet

Distress: Failing

Correction: Remove and replace carpet

Notes: Replace carpet in offices (1,400sf)

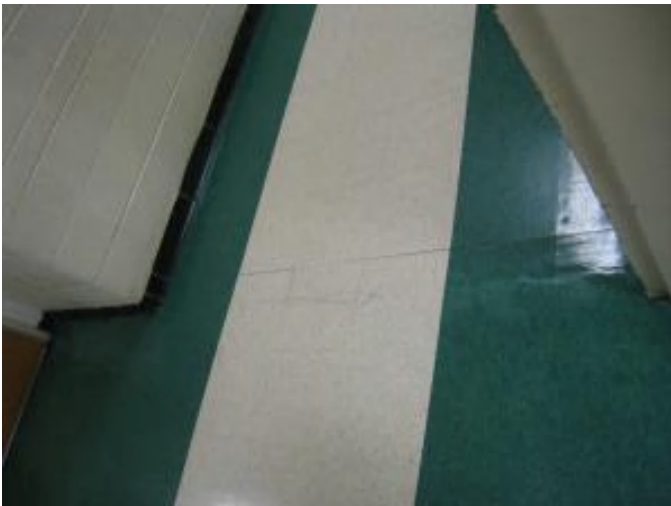
Location: floors

System: C3020413 - Vinyl Flooring

Distress: Damaged

Correction: Remove and replace VCT

Notes: Replace cracked and damaged VCT with new VCT; patch concrete slab before replacement (1,200sf)

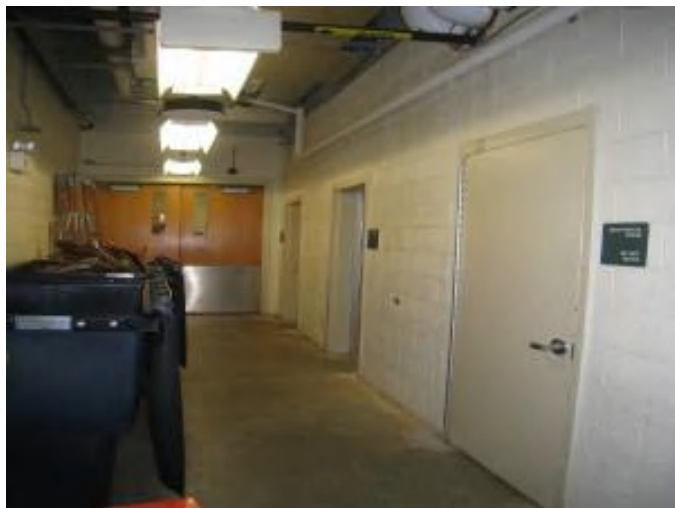
Location: mechanical area floors

System: C3020415 - Concrete Floor Finishes

Distress: Appearance

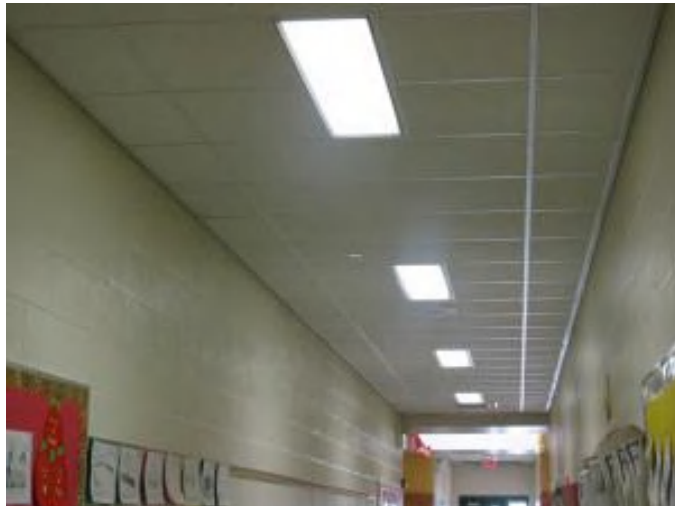
Location: Entire Building

System: D5020 - Lighting and Branch Wiring

Distress: Life Safety / NFPA / PFD

Correction: Replace lighting fixtures

Notes: Replace existing exit sign with battery pack exit signs. Total 7 exit sign.
