Facility Condition Assessment Summary Report

Taylor School

Taylor Annex (Our Lady of Pompei) School

S744001;Taylor

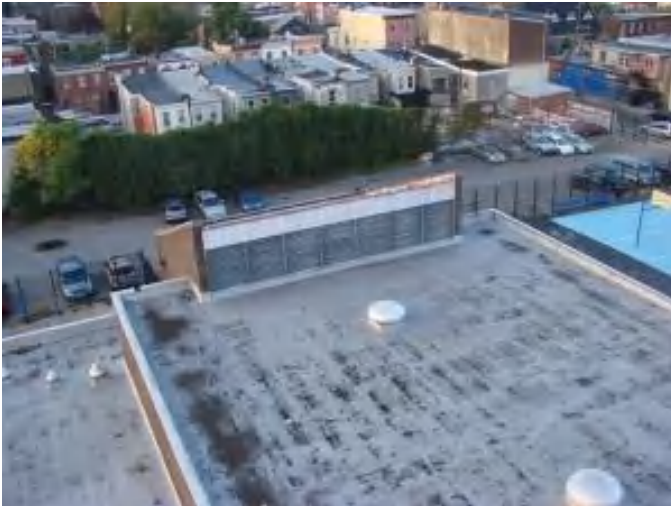
System: B3010105 - Built-Up

Location: Exterior

Distress: Building Envelope Integrity

Notes: Install all new roofing system including insulation; tear-down existing roofing; install flashing, counter flashing and reglets

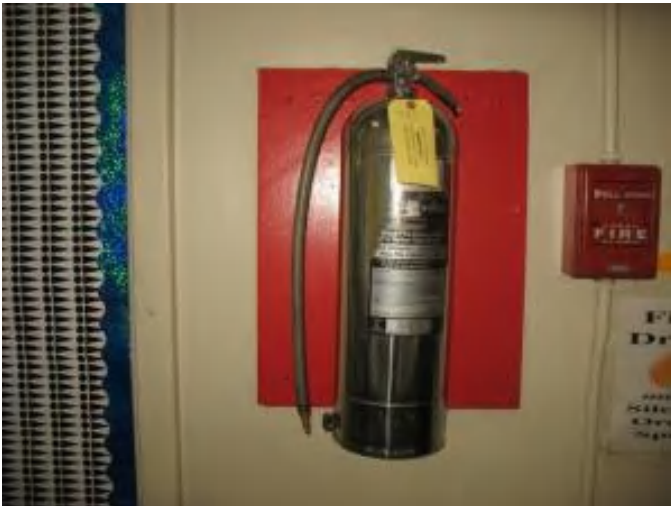
System: D4010 - Sprinklers

Location: Throughout building

Distress: Life Safety / NFPA / PFD

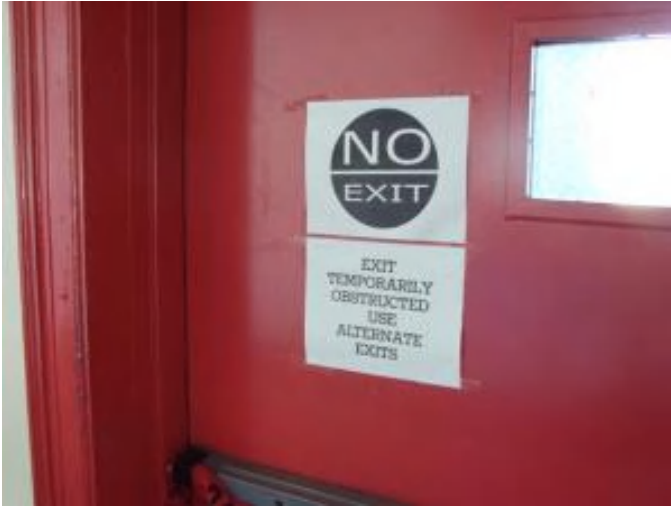
System: C2010 - Stair Construction

Location: Interior/Exterior

Distress: Life Safety / NFPA / PFD

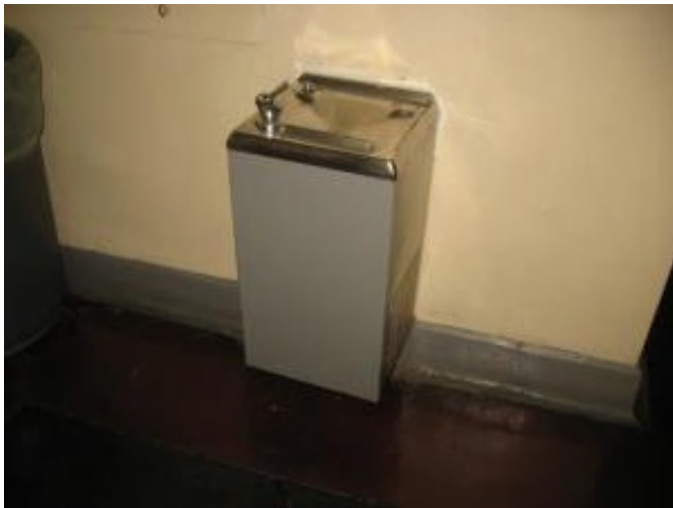
System: D2010 - Plumbing Fixtures

Location: Corridors

Distress: Beyond Service Life

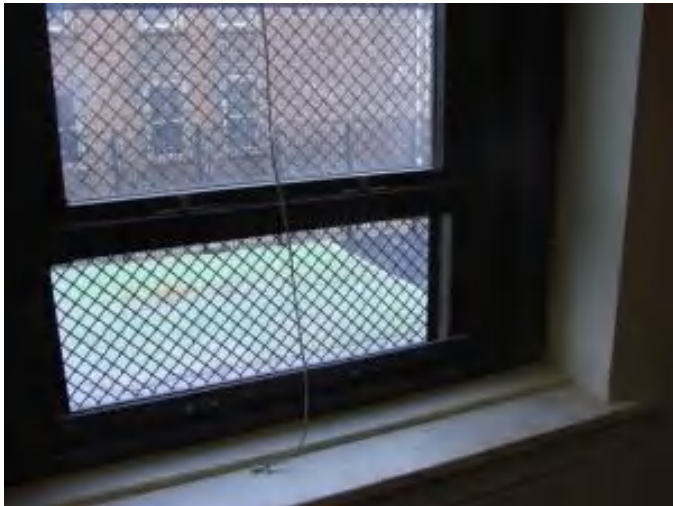
System: B2020 - Exterior Windows

Location: Exterior

Distress: Beyond Service Life

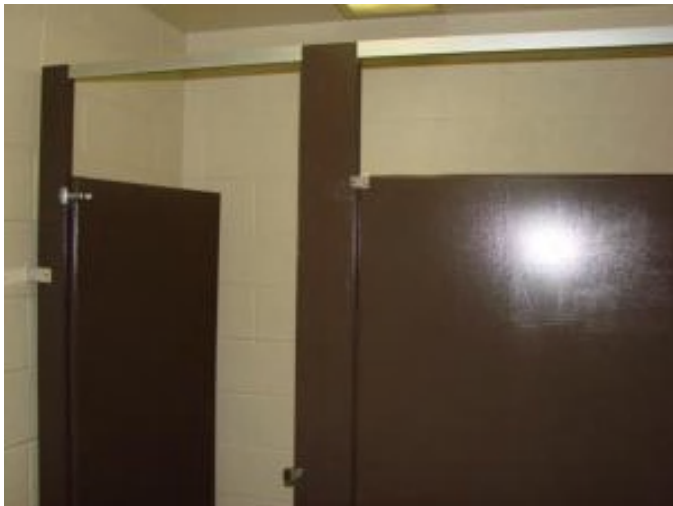
System: C1030 - Fittings

Location: Interior

Distress: Accessibility

Notes: Reconfigure toilets on each floor for accessibility, provide new toilet partitions

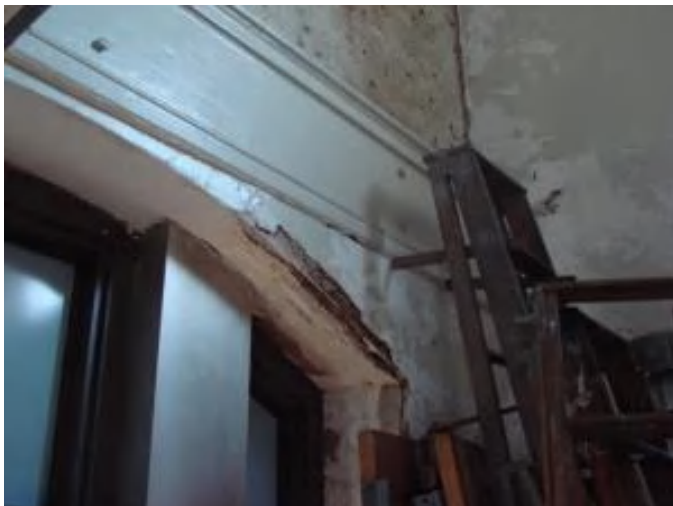
System: C3010230 - Paint & Covering

Location: Interior

Distress: Beyond Service Life

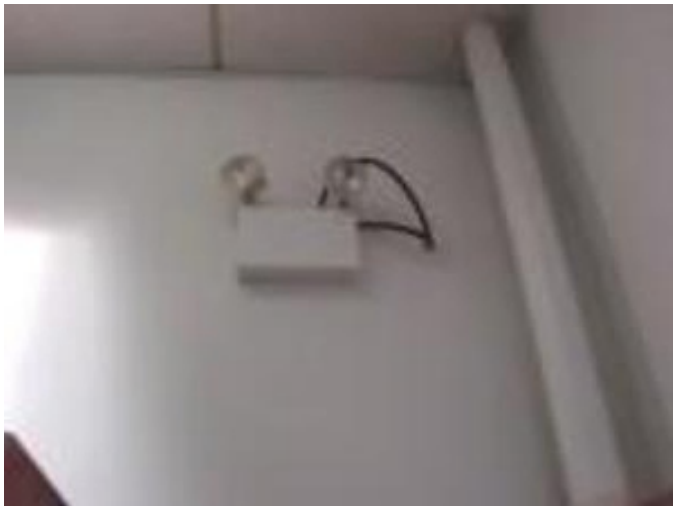
System: D5090 - Other Electrical Systems

Location: throughout the building

Distress: Beyond Service Life

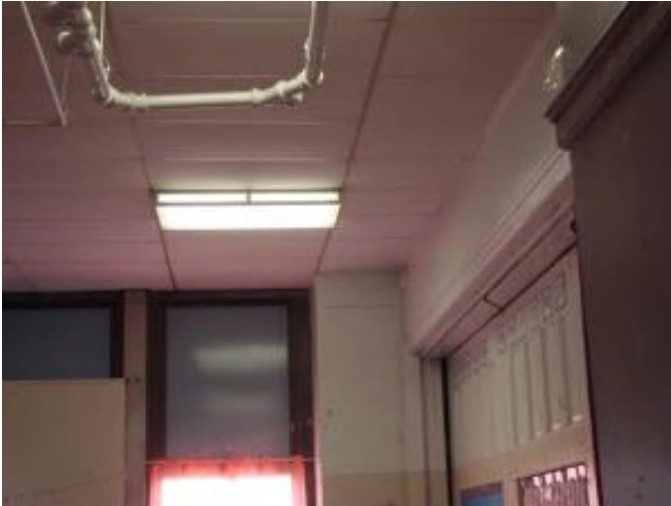
System: C1010 - Partitions

Location: Interior

Distress: Beyond Service Life

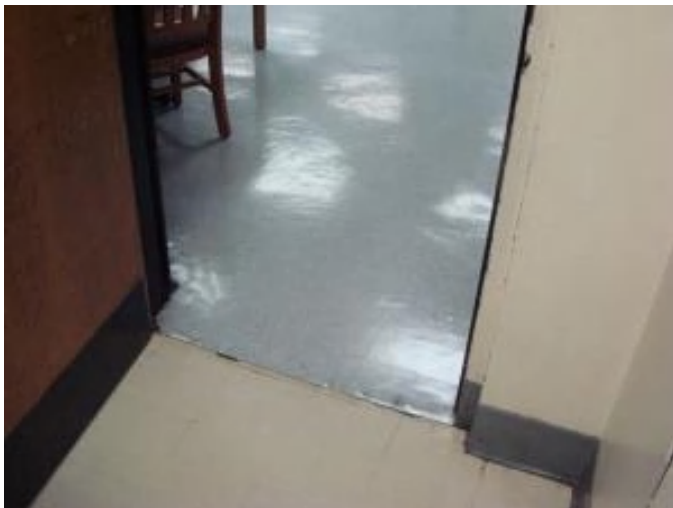
System: C3020413 - Vinyl Flooring

Location: Interior

Distress: Beyond Service Life

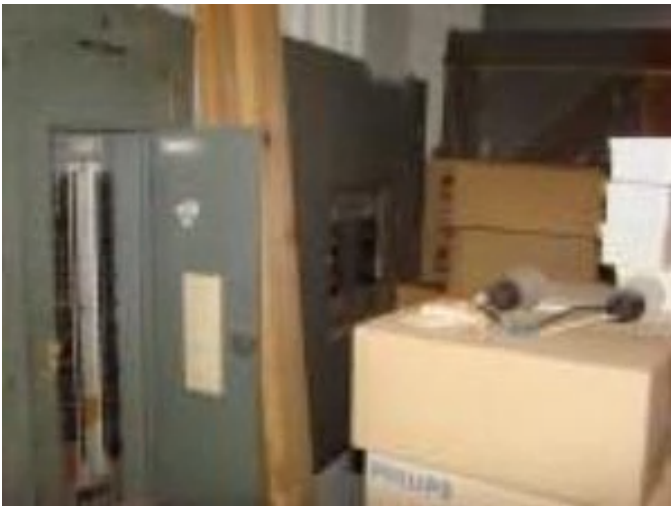
System: D5010 - Electrical Service/Distribution

Location: electrical room

Distress: Beyond Service Life

Notes: Install new Site electrical service 750KVA, 480V, 3 Phase to feed the HVAC, lighting and receptacle loads.
Install a new 480V, 3 phase switchgear.
Install a new 120V/208V, 3 phase switchgear.

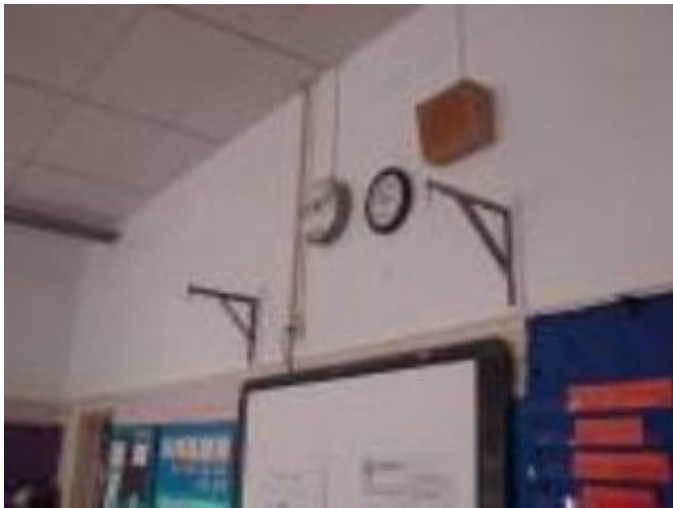
System: D5030 - Communications and Security

Location: throughout the building

Distress: Beyond Service Life

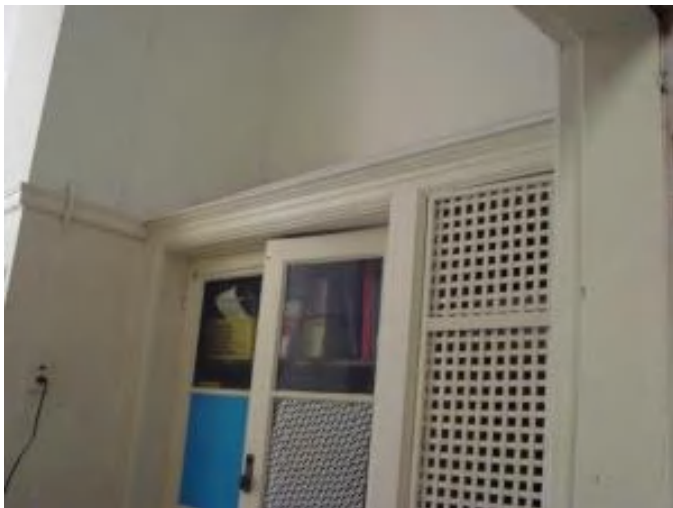
System: E2010 - Fixed Furnishings

Location: Interior

Distress: Beyond Service Life

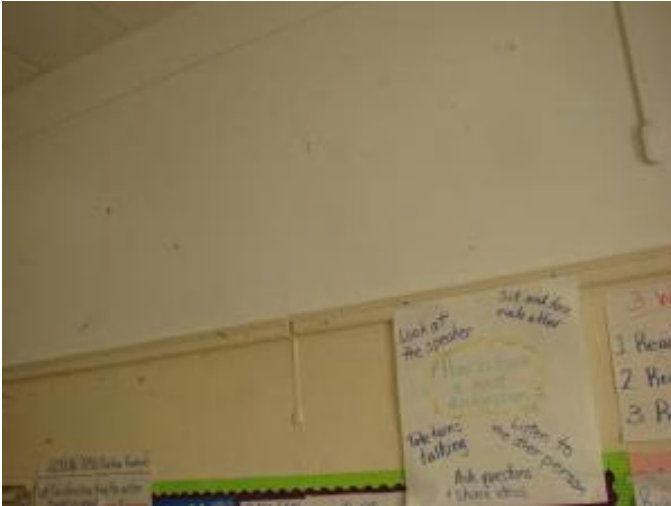
System: C1030 - Fittings

Location: Interior

Distress: Beyond Service Life

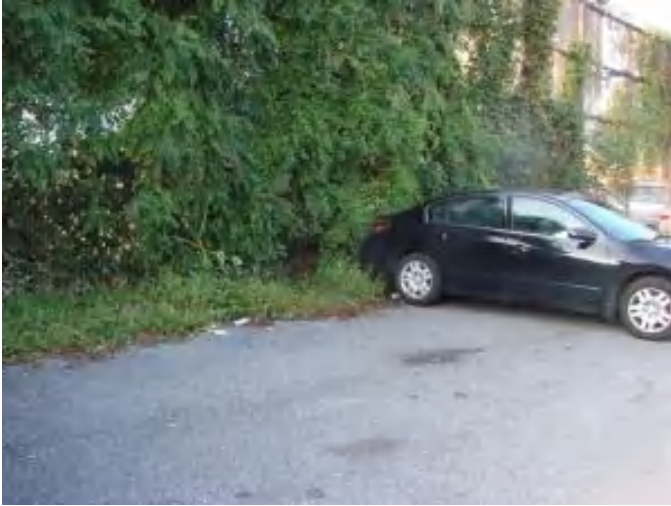
System: G2020 - Parking Lots

Location: Grounds

Distress: Beyond Service Life

Notes: Provide parking striping with (2) accessible spaces and aisles

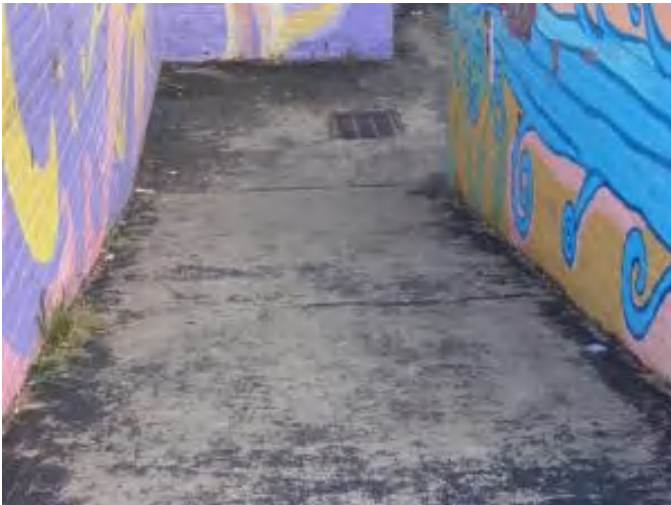
System: G2030 - Pedestrian Paving

Location: Grounds

Distress: Beyond Service Life

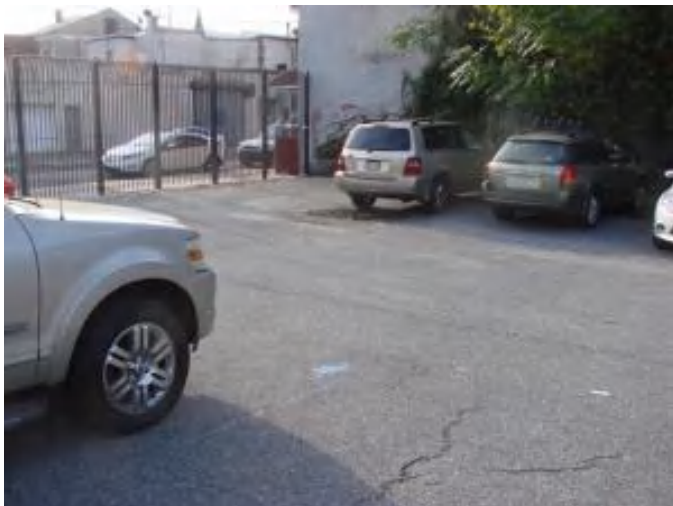
System: G2020 - Parking Lots

Location: Grounds

Distress: Beyond Service Life

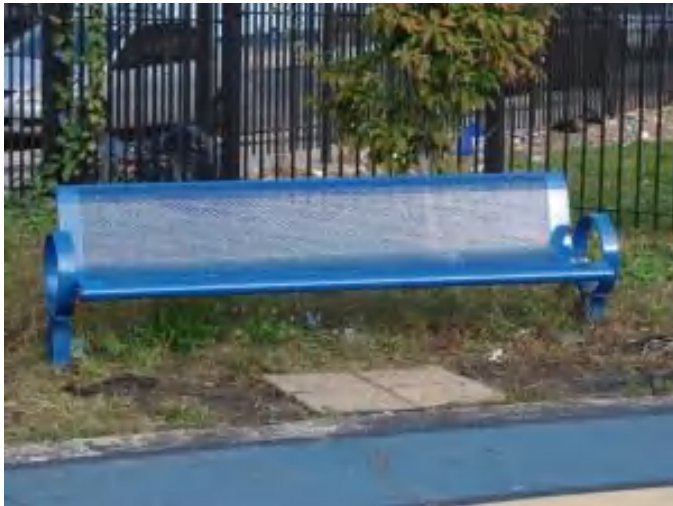
System: G2050 - Landscaping & Irrigation

Location: Grounds

Distress: Beyond Service Life

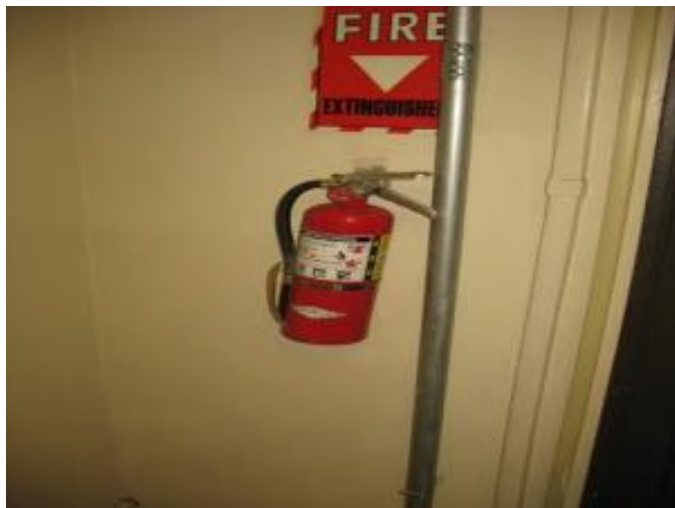
System: D4010 - Sprinklers

Location: Throughout building

Distress: Life Safety / NFPA / PFD

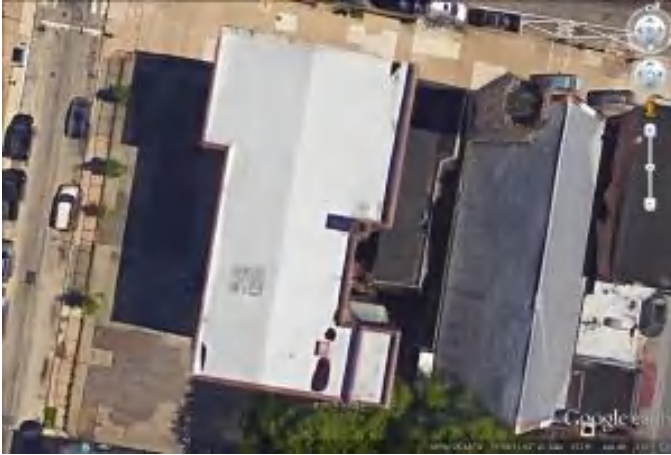
System: B3010105 - Built-Up

Location: Exterior

Distress: Building Envelope Integrity

Correction: Remove and Replace Built Up Roof

Notes: Install all new roofing system including insulation; tear-down existing roofing; install flashing, counter flashing and reglets

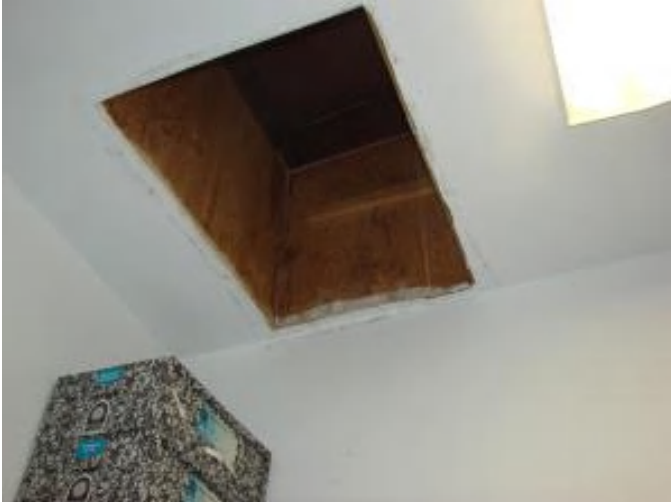
System: B3020 - Roof Openings

Location: Exterior

Distress: Beyond Service Life

Correction: Replace roof hatch - pick the closest size

Notes: Replace roof hatch

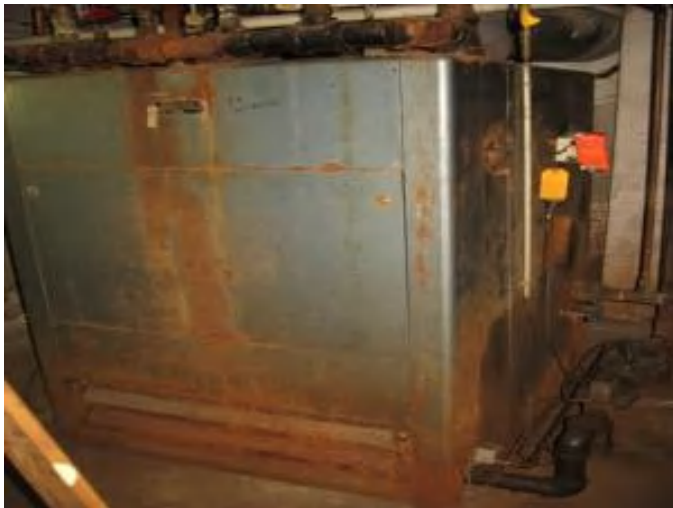
System: D3020 - Heat Generating Systems

Location: Boiler room

Distress: Beyond Service Life

Correction: Replace boiler, cast iron sectional (50 HP)

Notes: Replace the one existing 891MBH cast iron boiler, which is beyond its service life, burners, and exhaust ductwork.

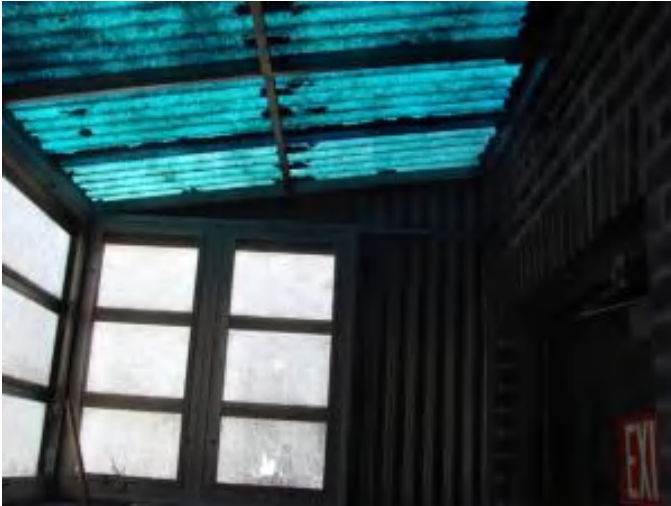
System: B1020 - Roof Construction

Location: Exterior

Distress: Beyond Service Life

Correction: Rehabilitate chain link fabric roof structure - paint the frame and replace the chain link - insert the SF of roof area in the qty.

Notes: Replace roof structure above 3rd floor external landing with new insulated structure

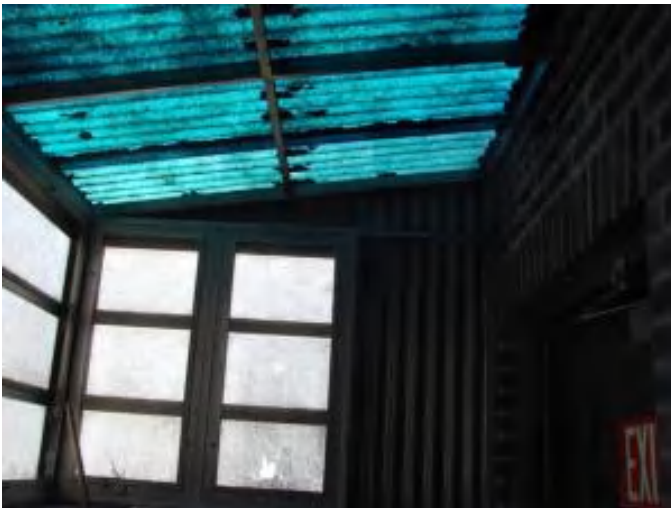
System: B2010 - Exterior Walls

Location: Exterior

Distress: Beyond Service Life

Correction: Remove transite wall panels and replace with steel siding panels

Notes: Replace exterior walls on 2nd and 3rd floor external landings with insulated metal panel walls

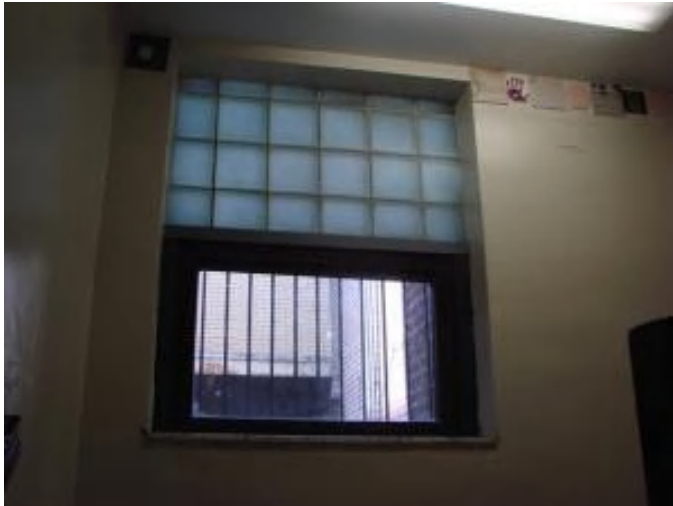
System: B2020 - Exterior Windows

Location: Exterior

Distress: Beyond Service Life

Correction: Remove and replace aluminum windows - pick the appropriate size and style and insert the number of units

Notes: Replace all windows (with integral security screens)

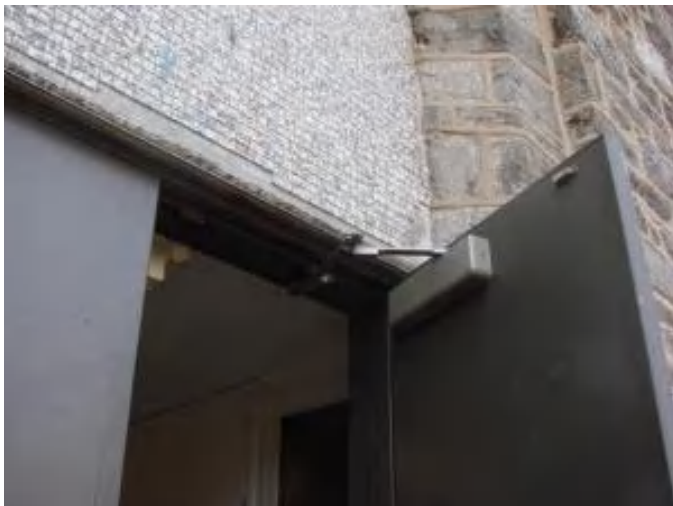
System: B2030 - Exterior Doors

Location: Exterior

Distress: Beyond Service Life

Correction: Remove and replace exterior doors - per leaf

Notes: Replace all exterior doors

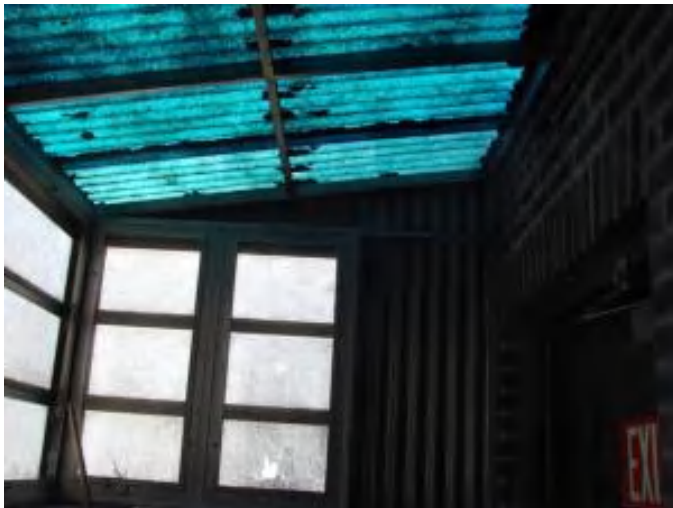
System: B3010130 - Preformed Metal Roofing

Location: Exterior

Distress: Building Envelope Integrity

Correction: Remove and replace standing seam metal roofing

Notes: Install new standing seam roofing system over 3rd floor external landing

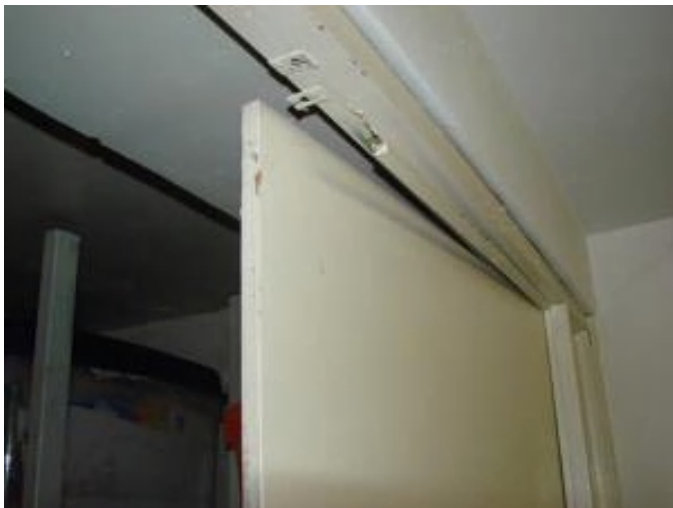
System: C1020 - Interior Doors

Location: Interior

Distress: Beyond Service Life

Correction: Remove and replace interior doors - wood doors with wood frame - per leaf

Notes: Replace all interior doors

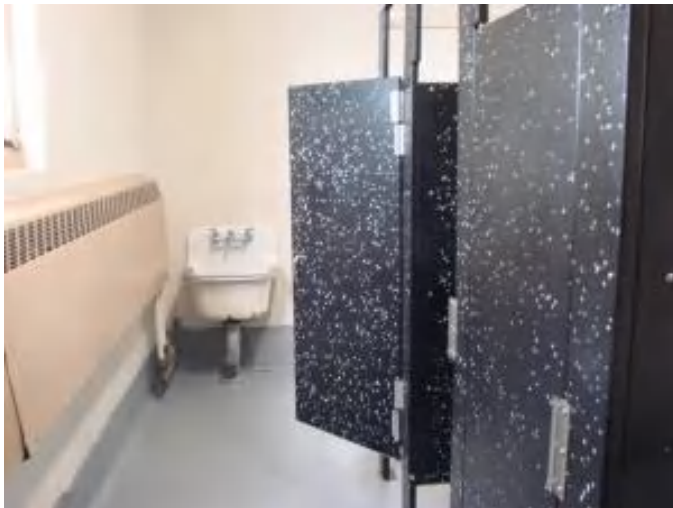
System: C1030 - Fittings

Location: Interior

Distress: Accessibility

Correction: Remove and replace damaged toilet partitions - handicap units

Notes: Reconfigure toilets on each floor for accessibility, provide new toilet partitions

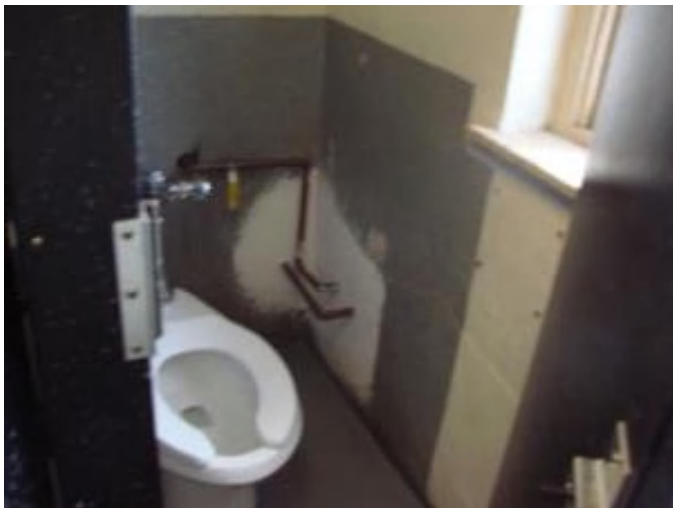
System: C1030 - Fittings

Location: Interior

Distress: Beyond Service Life

Correction: Replace toilet accessories - select accessories and quantity

Notes: Provide new toilet accessories including grab bars

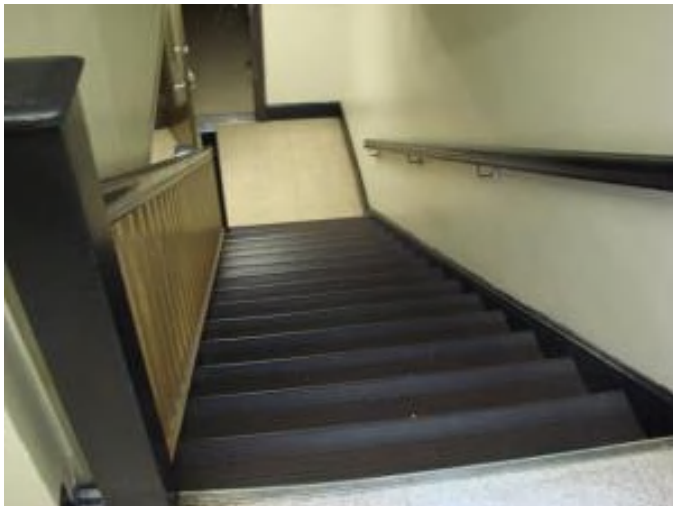
System: C2010 - Stair Construction

Location: Interior/Exterior

Distress: Accessibility

Correction: Replace enclosed egress masonry stair tower including new stairs - per flight approximately 600 SF footprint and 15' floor to floor

Notes: Provide additional external stairway to satisfy access/egress requirements

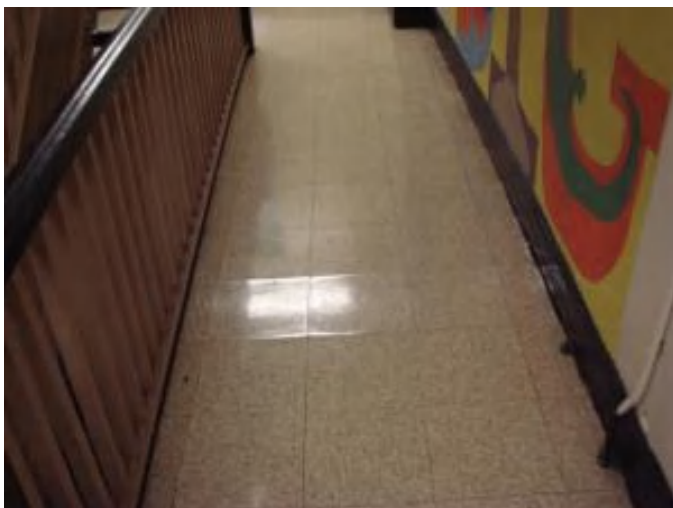
System: C3020413 - Vinyl Flooring

Location: Interior

Distress: Beyond Service Life

Correction: Remove and replace VCT

Notes: Replace all VCT flooring

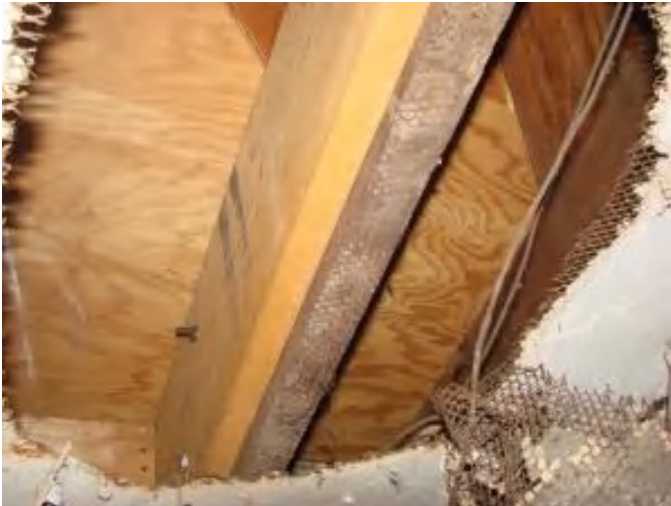
System: C3030 - Ceiling Finishes

Location: Interior

Distress: Beyond Service Life

Correction: Repair and resurface plaster ceilings - 2 coats plaster

Notes: Repair plaster ceilings (25% area), repaint all ceilings

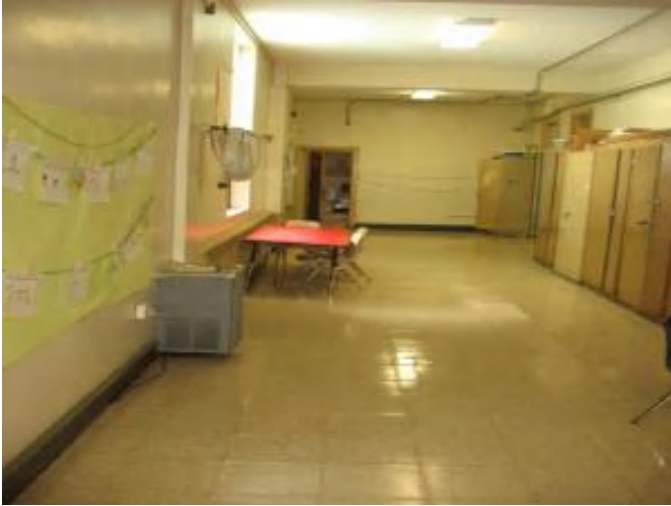
System: D2010 - Plumbing Fixtures

Location: Corridors

Distress: Beyond Service Life

Notes: Replace two (2) wall hung drinking fountains and integral refrigerated coolers in the corridors. These units are beyond their service life and are NOT accessible type.

Correction: Remove and Replace Water Fountains - without ADA new recessed alcove

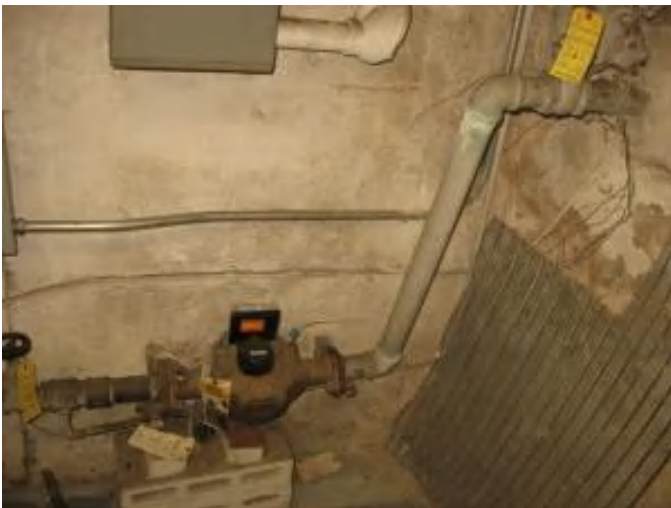
System: D2020 - Domestic Water Distribution

Location: Throughout building

Distress: Beyond Service Life

Correction: Replace domestic water piping (75 KSF)

Notes: Hire a qualified contractor to perform a detailed inspection of the domestic water piping, in use for decades, and replace any damaged piping.

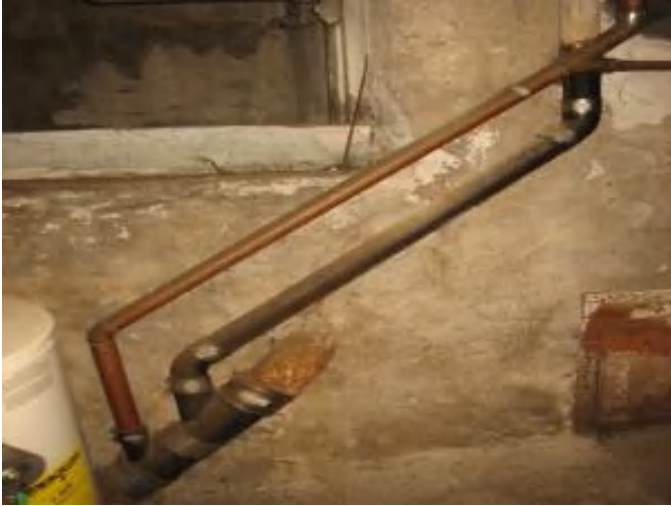
System: D2030 - Sanitary Waste

Location: Throughout building

Distress: Beyond Service Life

Correction: Inspect sanitary waste piping and replace damaged sections. (+50KSF)

Notes: Hire a qualified contractor to perform a detailed examination of the sanitary waste piping using visual inspection and video cameras to locate and replace any damaged piping and to further quantify the extent of potential failures.

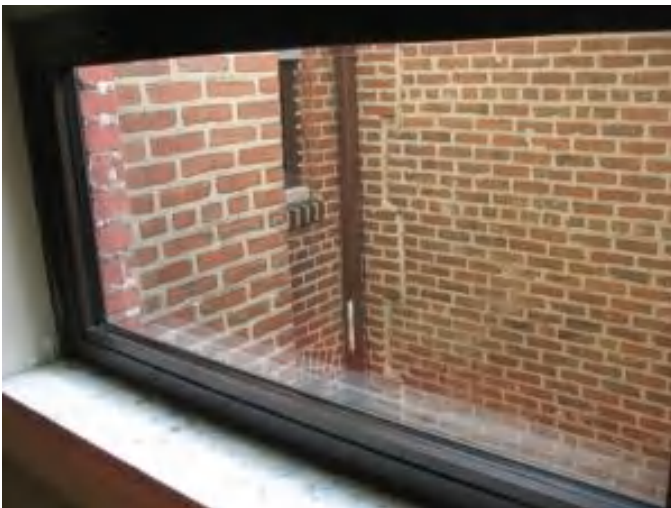
System: D2040 - Rain Water Drainage

Location: Throughout building

Distress: Beyond Service Life

Correction: Inspect internal rain water drainage piping and replace pipe - based on SF of multi-story building - insert SF of building

Notes: Hire a qualified contractor to perform a detailed examination of the rain water drainage piping using visual inspection and video cameras to locate and replace any damaged piping and to further quantify the extent of potential failures.

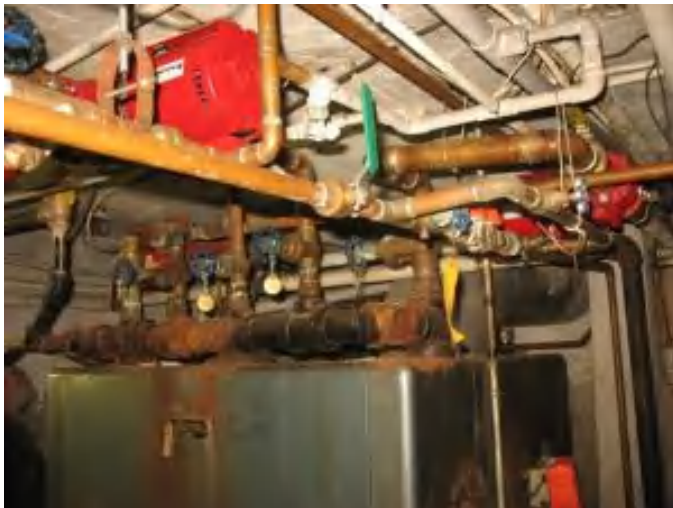
System: D3040 - Distribution Systems

Location: Throughout building

Distress: Beyond Service Life

Correction: Perform testing to identify and replace damaged steam and condensate piping.

Notes: Hire a qualified contractor to examine the hot water distribution piping, in service for over 85 years, and perform additional testing to locate and replace any damaged piping and to further quantify the extent of potential failures.

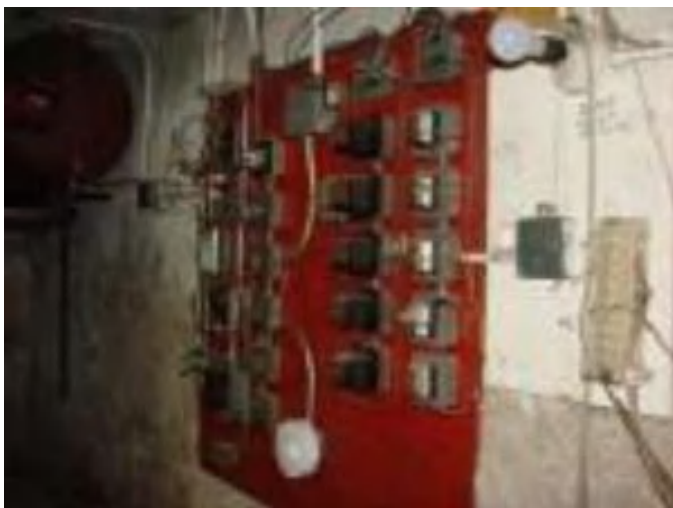
System: D5030 - Communications and Security

Location: throughout the building

Distress: Health Hazard / Risk

Correction: Replace fire alarm system

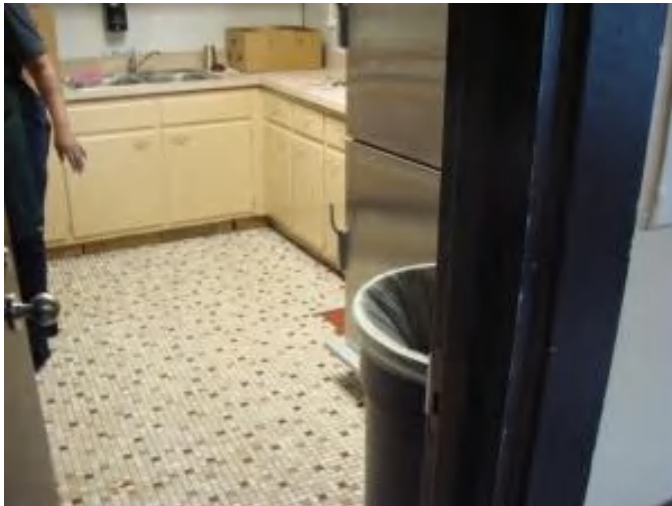
System: E2010 - Fixed Furnishings

Location: Interior

Distress: Beyond Service Life

Correction: Remove and replace casework - per LF - insert quantities for cabinets in the estimate

Notes: Replace built-in cabinets in staff lounge

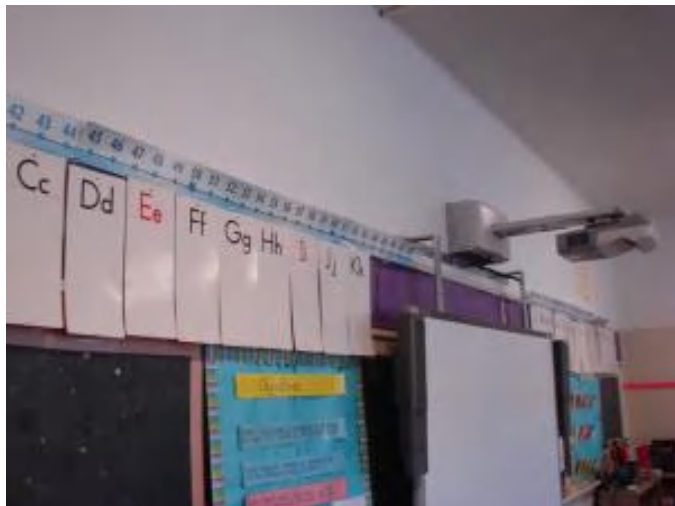
System: C1030 - Fittings

Location: Interior

Distress: Beyond Service Life

Correction: Replace blackboards with marker boards - pick the appropriate size and insert the quantities

Notes: Replace chalkboards with marker boards

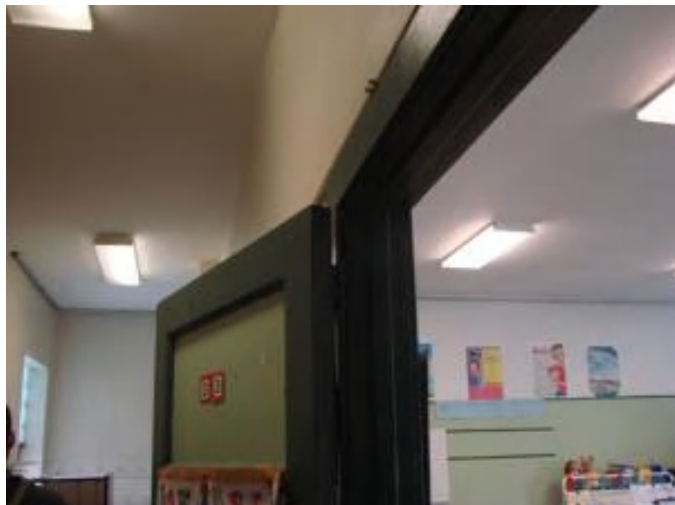
System: C1030 - Fittings

Location: Interior

Distress: Beyond Service Life

Correction: Replace missing or damaged signage - insert the number of rooms

Notes: Provide new signage throughout the building

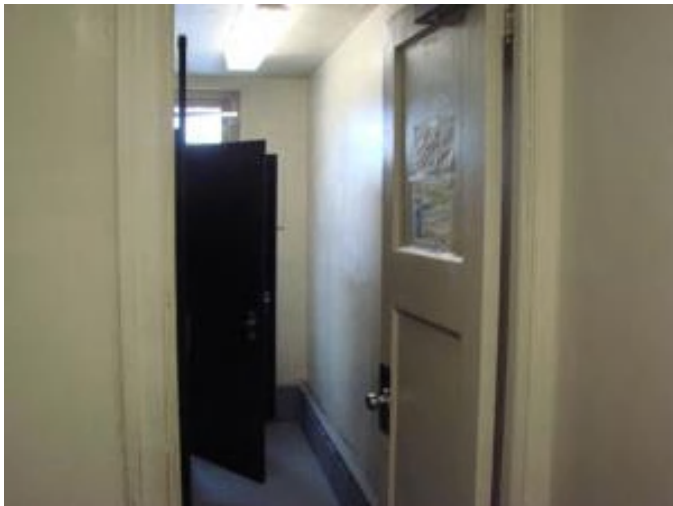
System: C3010230 - Paint & Covering

Location: Interior

Distress: Beyond Service Life

Correction: Repair and repaint all interior walls - SF of wall surface

Notes: Repair and repaint interior walls

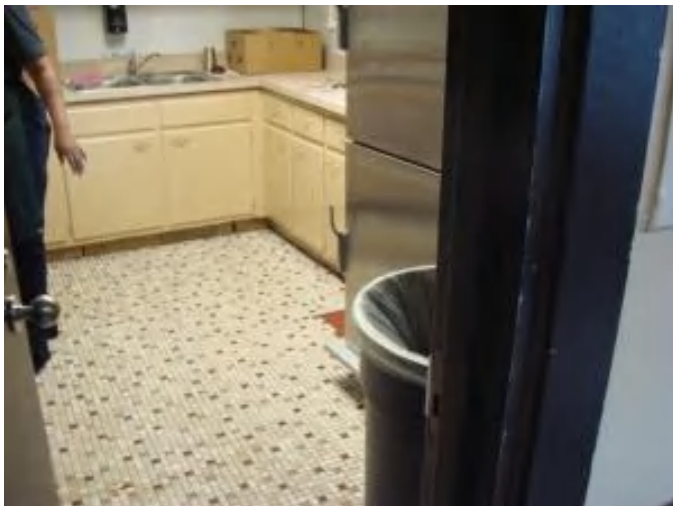
System: C3020412 - Terrazzo & Tile

Location: Interior

Distress: Beyond Service Life

Correction: Remove and replace terrazzo or tile flooring - pick the appropriate material

Notes: Replace ceramic tile in staff lounge

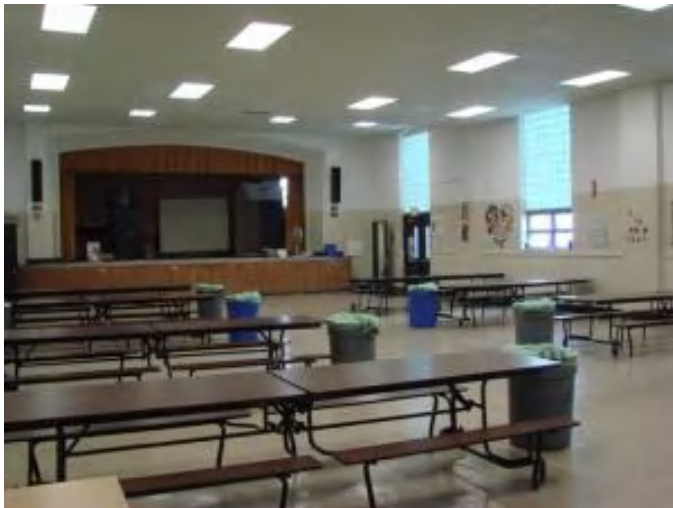
System: C3030 - Ceiling Finishes

Location: Interior

Distress: Beyond Service Life

Correction: Remove and replace suspended acoustic ceilings - lighting not included

Notes: Replace all suspended acoustical ceilings

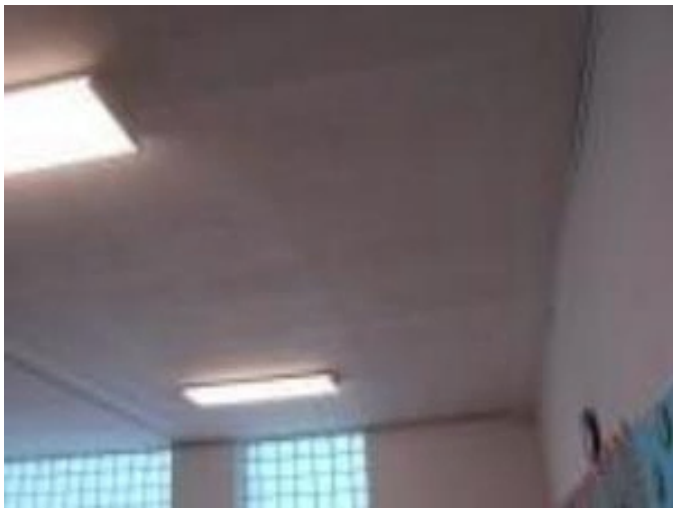
System: D5030 - Communications and Security

Location: throughout the building

Distress: Inadequate

Correction: Add/Replace Clock System or Components

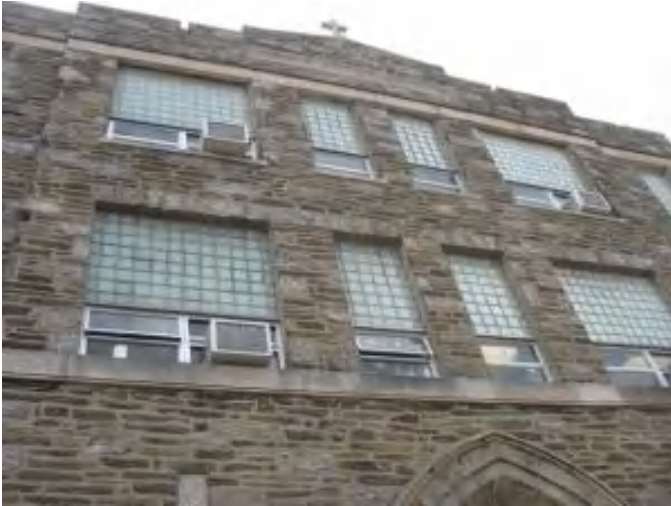
System: D3030 - Cooling Generating Systems

Location: Throughout building

Distress: Inadequate

Notes: Remove the window air conditioning units and install a 30 ton air-cooled chiller with chilled water distribution piping and pumps to supply more reliable air conditioning for the building with a much longer service life.

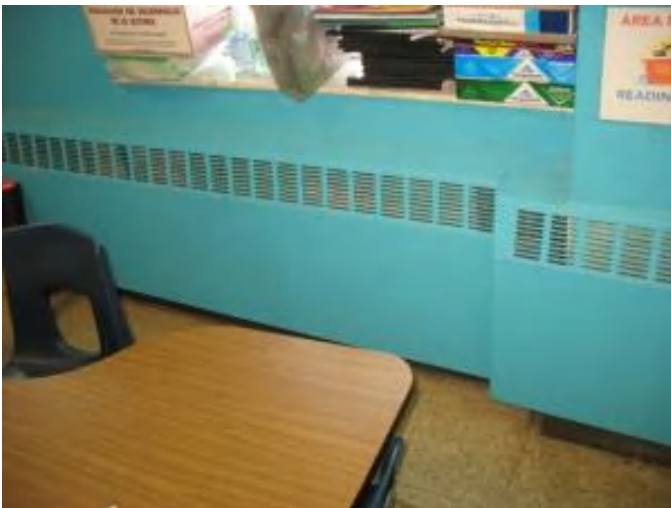
System: D3040 - Distribution Systems

Location: Classrooms

Distress: Building / MEP Codes

Notes: Remove the existing fin tube radiators and install fan coil units with hot and chilled water coils and a dedicated outdoor air system.

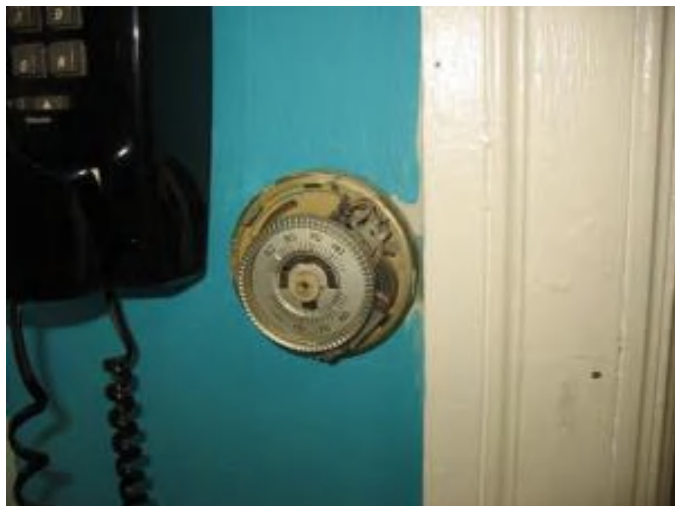
System: D3060 - Controls & Instrumentation

Location: Throughout building

Distress: Inadequate

Correction: Replace pneumatic controls with DDC (75KSF)

Notes: Replace the electric controls for the HVAC systems with modern DDC modules, valves and actuators to improve reliability and energy efficiency. Provide a new building automation system (BAS) with communication interface to the preferred system in use throughout the District.

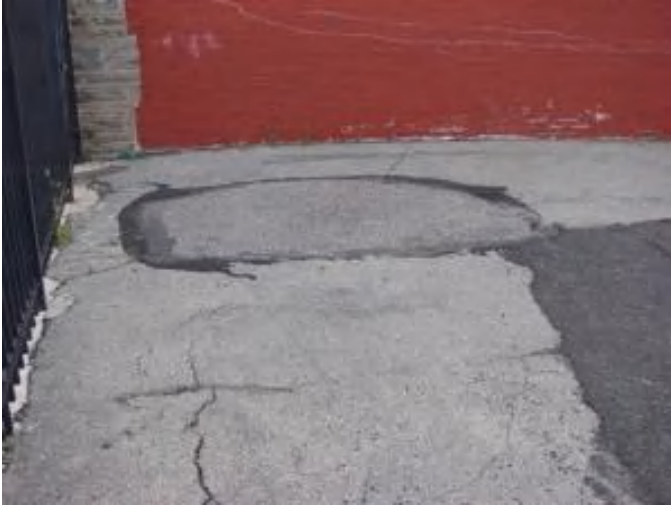
System: G2030 - Pedestrian Paving

Location: Grounds

Distress: Beyond Service Life

Correction: Remove and replace concrete sidewalk or concrete paving - 4" concrete thickness
