Facility Condition Assessment Summary Report

Tilden School

School District of Philadelphia
S101001; Bartram and Tilden
Final
Site Assessment Report
January 30, 2017

Site Assessment Report

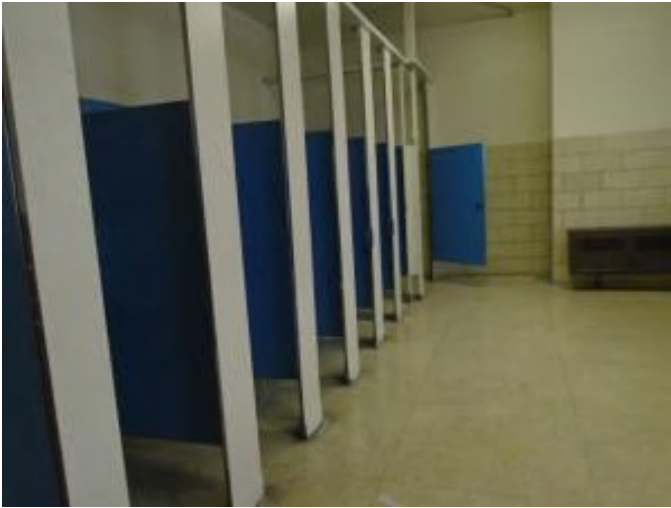
Location: Toilets

System: C1030 - Fittings

Distress: Beyond Service Life

Notes: Provide new toilet partitions and toilet accessories including grab bars for accessibility

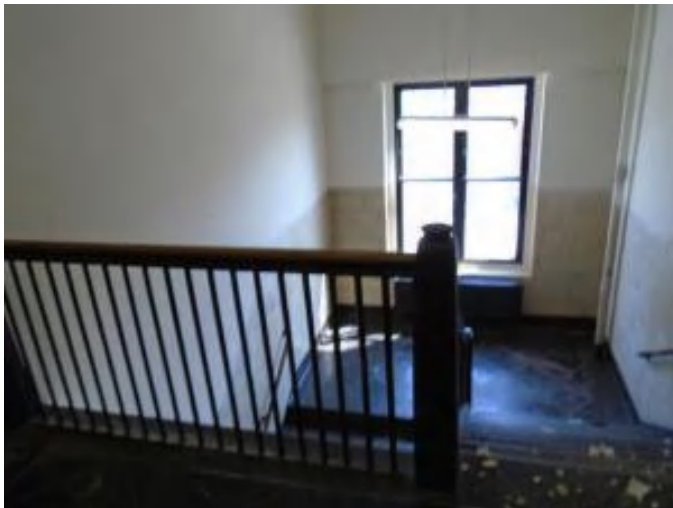
Location: Stairs

System: C2010 - Stair Construction

Distress: Building / MEP Codes

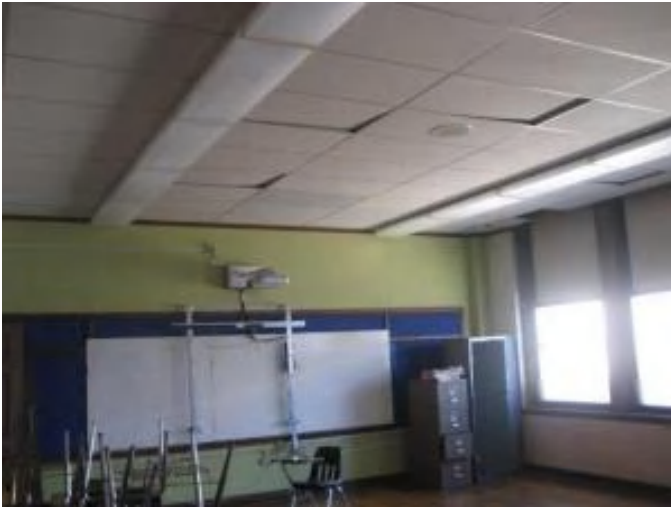
Location: Entire Building

System: D5030 - Communications and Security

Distress: Life Safety / NFPA / PFD

Notes: Provide fire alarm system audio/visual devices in each classroom. Approximate 360

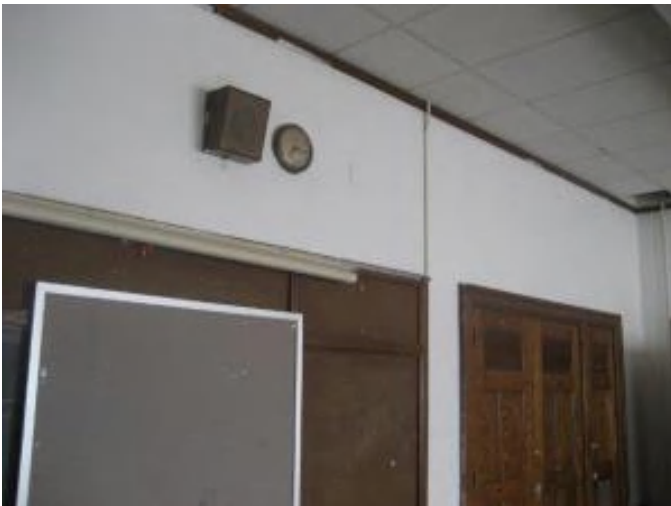
Location: Entire Building

System: D5030 - Communications and Security

Distress: Obsolete

Notes: Provide a new clock system. Approximate 150 clocks.

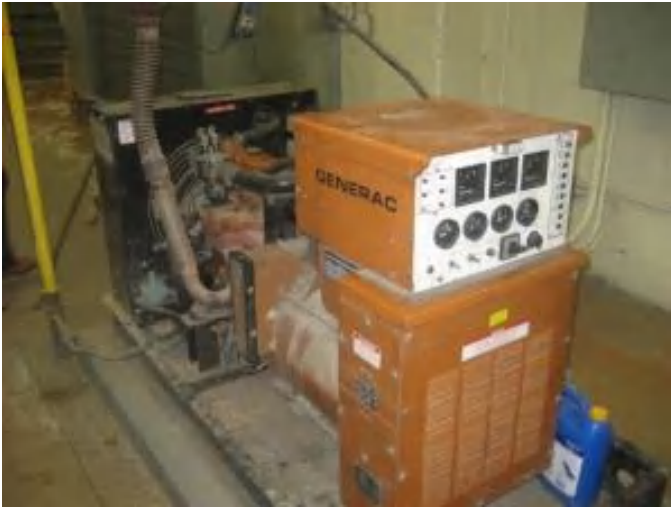
Location: Basement

System: D5090 - Other Electrical Systems

Distress: Beyond Service Life

Notes: Provide a new emergency power system, outdoor, diesel powered, rated 300KW.

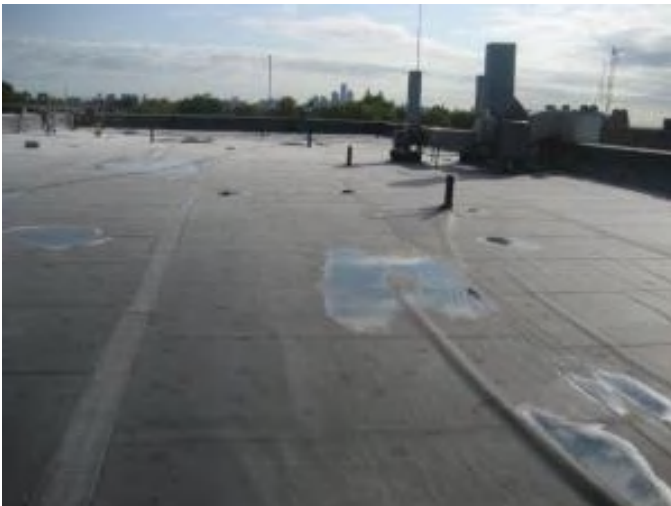
Location: Roof

System: D5090 - Other Electrical Systems

Distress: Building / MEP Codes

Notes: A study needs to be conducted to determine if the school requires lightning protection system.

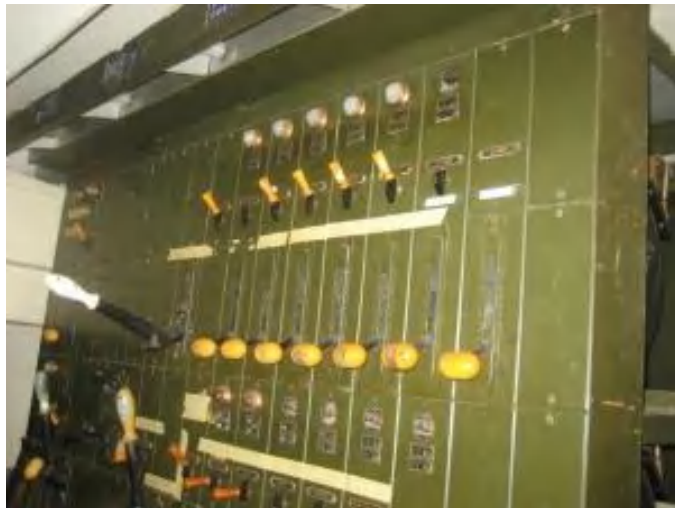
Location: Auditorium

System: E1020 - Institutional Equipment

Distress: Beyond Service Life

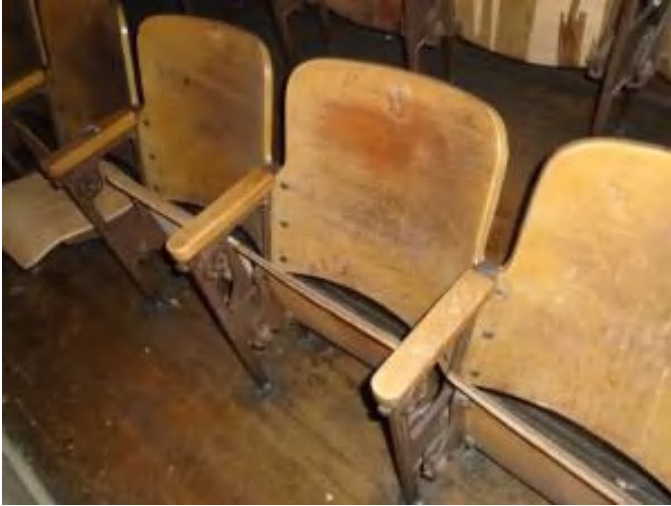
Location: Auditorium, balcony

System: E2010 - Fixed Furnishings

Distress: Beyond Service Life

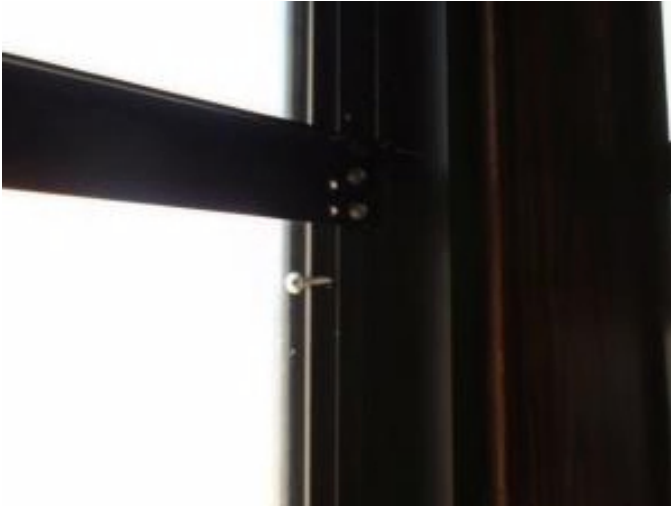
Location: Throughout

System: B2020 - Exterior Windows

Distress: Energy Efficiency

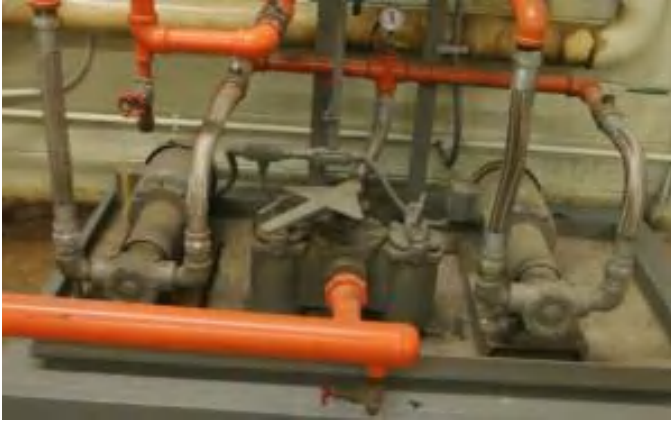
Location: Boiler room

System: D3020 - Heat Generating Systems

Distress: Failing

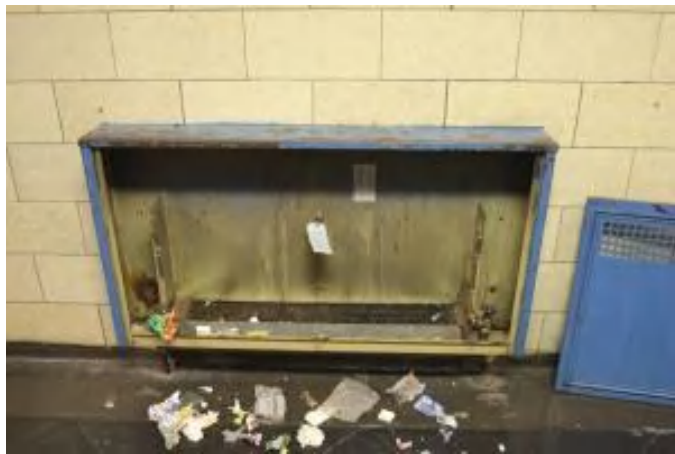
Location: Fan rooms

System: D3040 - Distribution Systems

Distress: Beyond Service Life

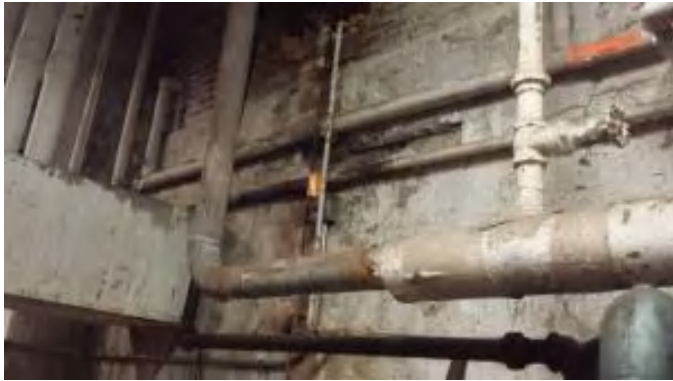
Location: Basement

System: A2020 - Basement Walls

Distress: Damaged

Notes: Repair basement walls – water damaged

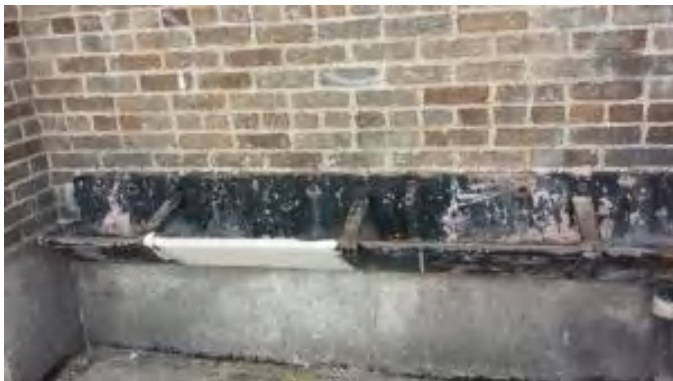
Location: Ground level

System: B2010 - Exterior Walls

Distress: Failing

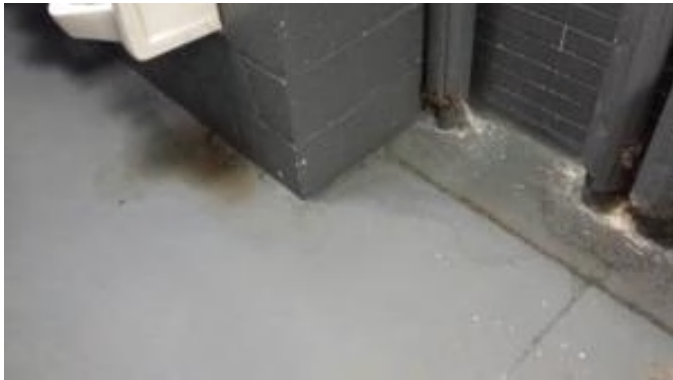
System: C3020415 - Concrete Floor Finishes

Location: Toilets
Distress: Health Hazard / Risk
Category: 1 - Health & Safety
Priority: 3 - Response Time (3-4 yrs)
Correction: Repair spalled concrete floor surface
Qty: 800.00
Unit of Measure: S.F.
Estimate: \$57,262.46
Assessor Name: System
Date Created: 09/23/2015

Notes: Level and repair concrete floors in toilets – not sloped to drain

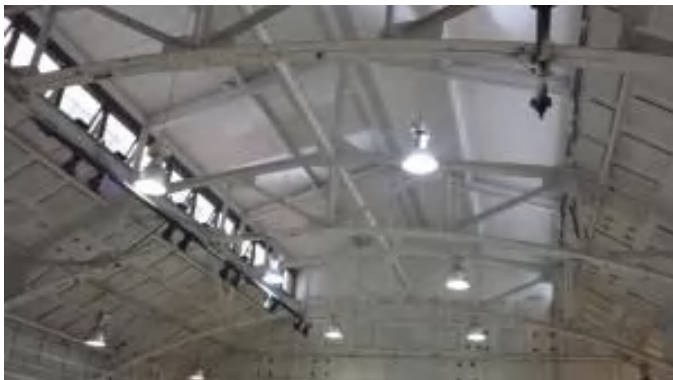
System: C3030 - Ceiling Finishes

Location: Gyms
Distress: Maintenance Required
Category: 3 - Operations / Maint.
Priority: 3 - Response Time (3-4 yrs)
Correction: Re-paint ceilings - SF of ceilings
Qty: 8,320.00
Unit of Measure: S.F.
Estimate: \$75,140.15
Assessor Name: System
Date Created: 09/23/2015

Notes: Paint structural steel ceiling and replace acoustic panels in gyms

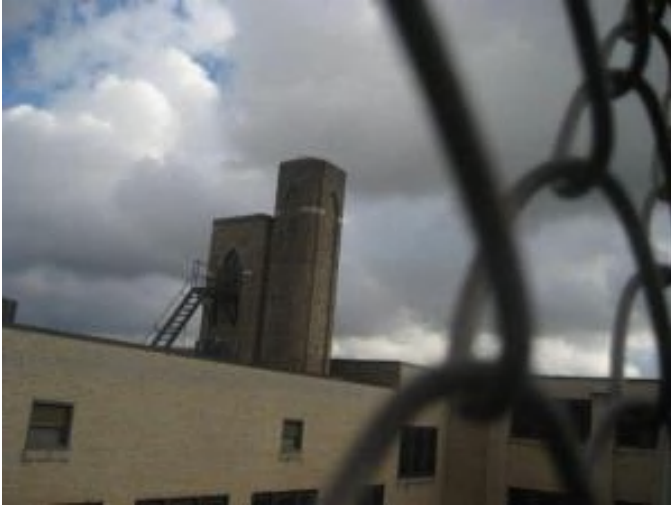
Location: Roof

System: D5090 - Other Electrical Systems

Distress: Building / MEP Codes

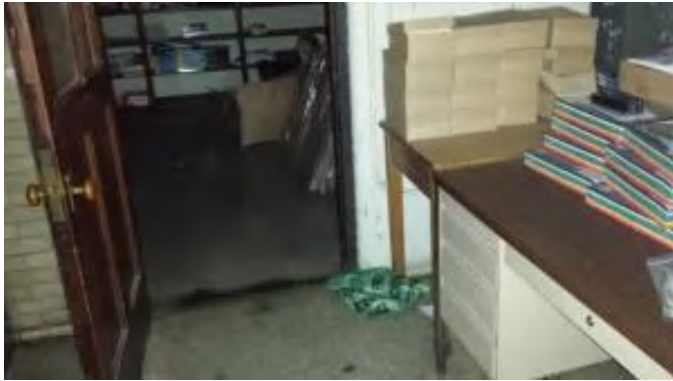
Location: Storage doors

System: C1020 - Interior Doors

Distress: Not Reliable

Notes: Replace latch sets on classroom storage rooms – no keys or master keys

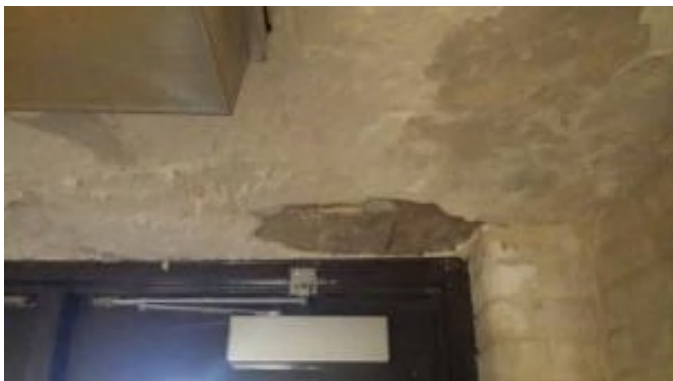
Location: Various

System: C3010230 - Paint & Covering

Distress: Damaged

Notes: Repair and paint interior plaster walls – damaged (10% of plaster area and entire 5th floor)

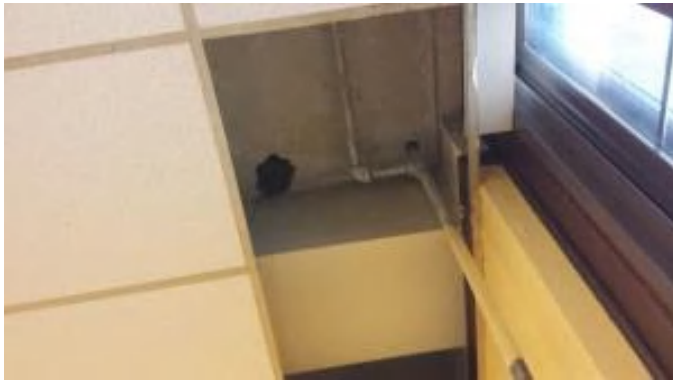
Location: Various

System: C3030 - Ceiling Finishes

Distress: Beyond Service Life

Notes: Replace suspended acoustic tile ceiling system – beyond service life (50% of suspended ceiling)

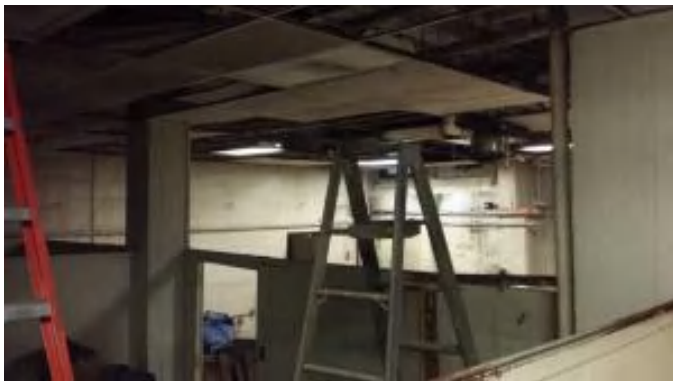
Location: Basement

System: C3030 - Ceiling Finishes

Distress: Failing

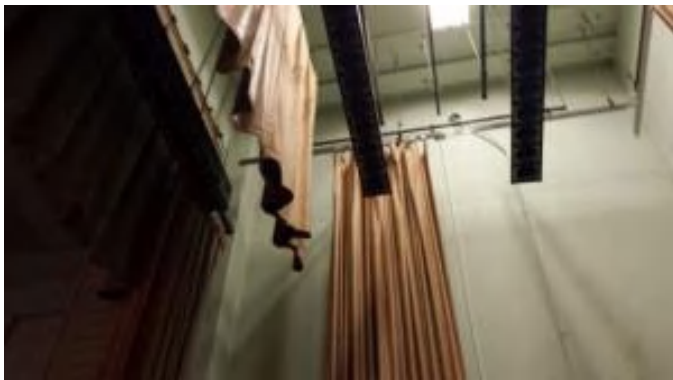
System: E1020 - Institutional Equipment

Location: Stage
Distress: Damaged
Category: 3 - Operations / Maint.
Priority: 4 - Response Time (4-5 yrs)
Correction: Add/Replace Stage Theatrical Lighting System
Qty: 3.00
Unit of Measure: Ea.
Estimate: \$4,267.72
Assessor Name: System
Date Created: 09/23/2015

Notes: Replace stage equipment – damaged curtains

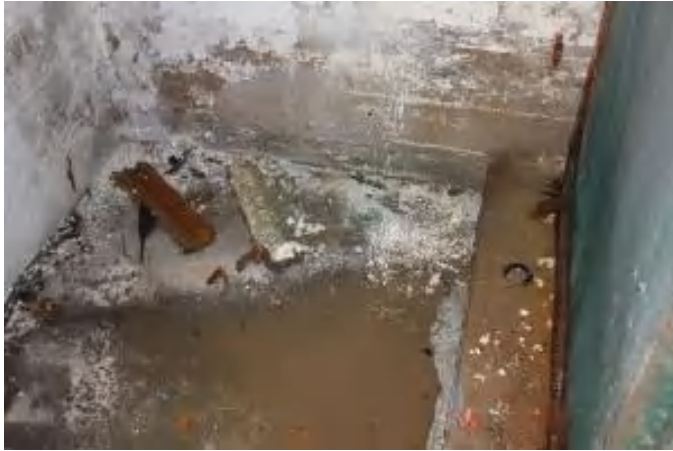
Location: Entire building

System: D2020 - Domestic Water Distribution

Distress: Beyond Service Life

Correction: Replace domestic water piping (150 KSF)

Notes: Replace domestic water supply piping.

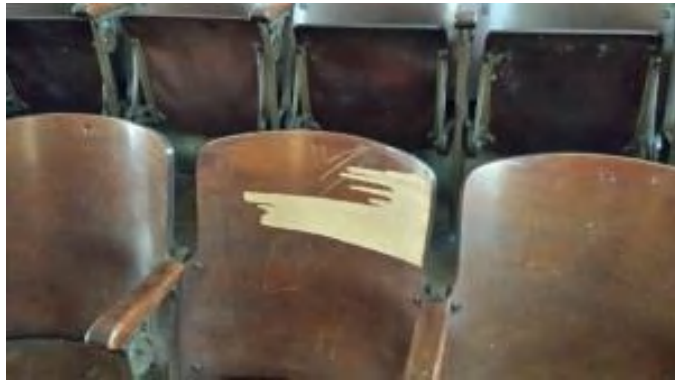
Location: Auditorium / balcony

System: E2010 - Fixed Furnishings

Distress: Failing

Notes: Replace auditorium seats – failing and beyond service life

Correction: Replace auditorium seating - add tablet arms if required. Veneer seating is an option.

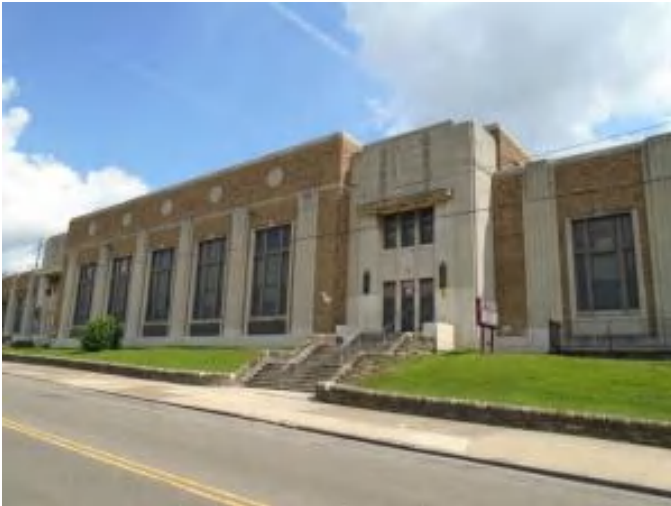
Location: Entrance

System: G2030 - Pedestrian Paving

Distress: Accessibility

Notes: Provide ADA compliant ramp at one entrance (location TBD)

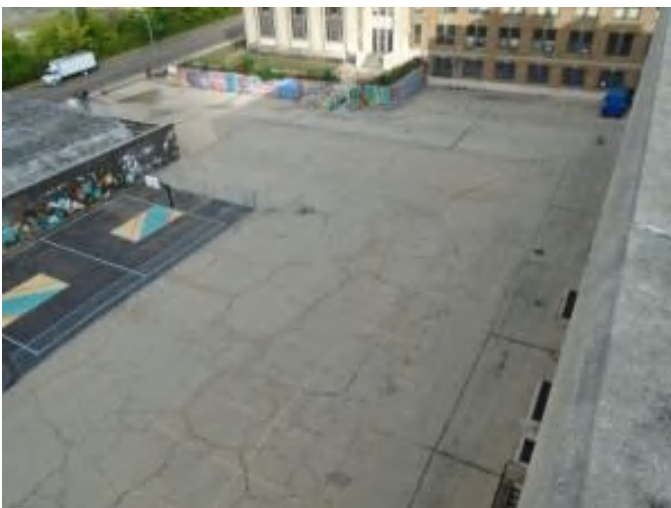
Location: Yard

System: G2040 - Site Development

Distress: Security Issue

Notes: Provide 12 pole mounted lighting fixtures for security

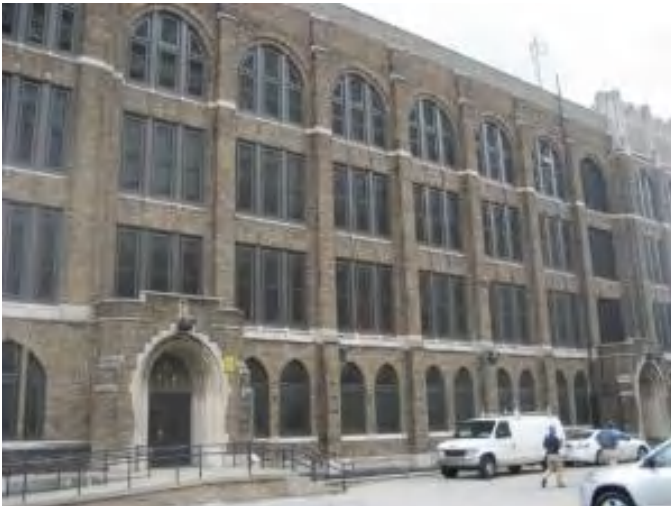
Location: Tilden- Building Perimeter

System: G4030 - Site Communications & Security

Distress: Security Issue

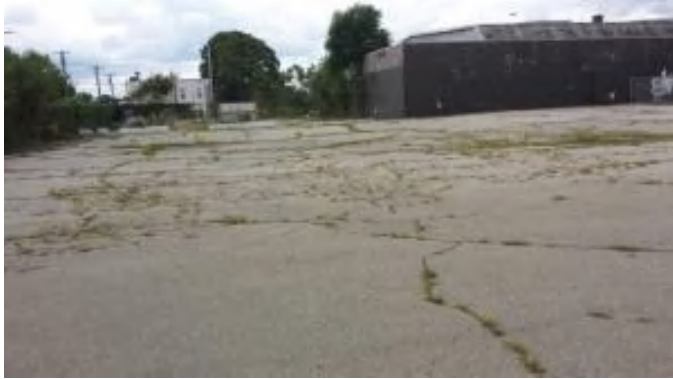
System: G2030 - Pedestrian Paving

Location: Yard
Distress: Maintenance Required
Category: 3 - Operations / Maint.
Priority: 3 - Response Time (3-4 yrs)
Correction: Resurface AC pedestrian paving - grind and resurface
Qty: 1,425.00
Unit of Measure: S.F.
Estimate: \$5,086.62
Assessor Name: Craig Anding
Date Created: 09/23/2015

Notes: Repair cracks in asphalt paving
