Facility Condition Assessment Summary Report

Washington High School

School District of Philadelphia
S803001; Washington HS and Field
Final
Site Assessment Report
January 31, 2017

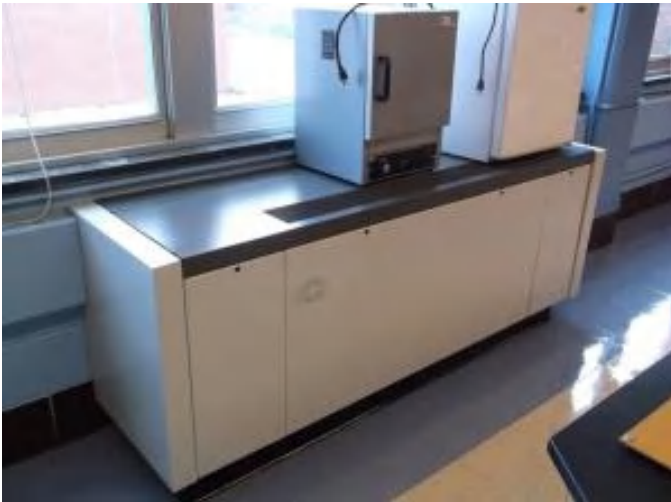
System: D3040 - Distribution Systems

Location: Throughout the building

Distress: Beyond Service Life

Notes: Replace the existing unit ventilators throughout the building with new units designed to provide adequate ventilation per ASHRAE Std 62. The new units shall be equipped with hot water / chilled water coils and integral heat exchanger.

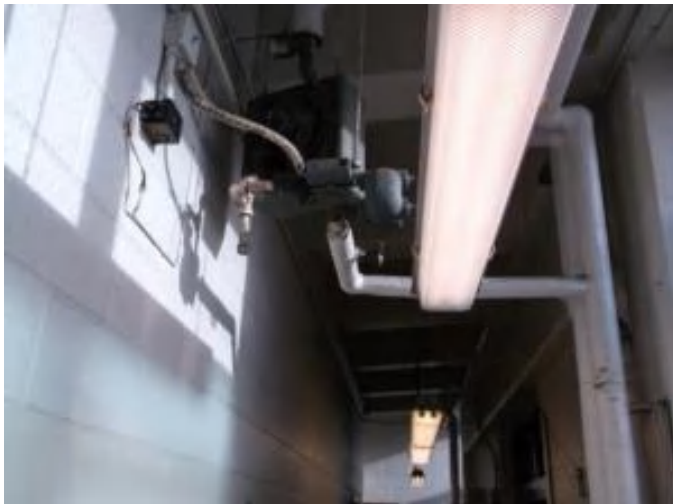
System: D3040 - Distribution Systems

Location: Throughout the building

Distress: Beyond Service Life

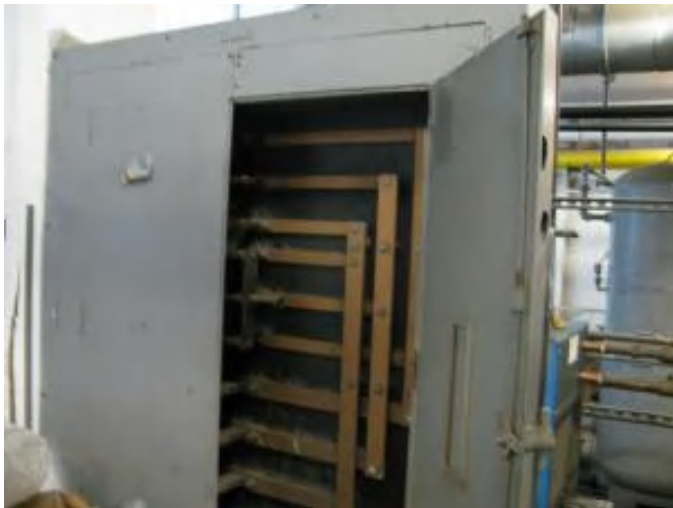
System: D5010 - Electrical Service/Distribution

Location: Entire Building

Distress: Beyond Service Life

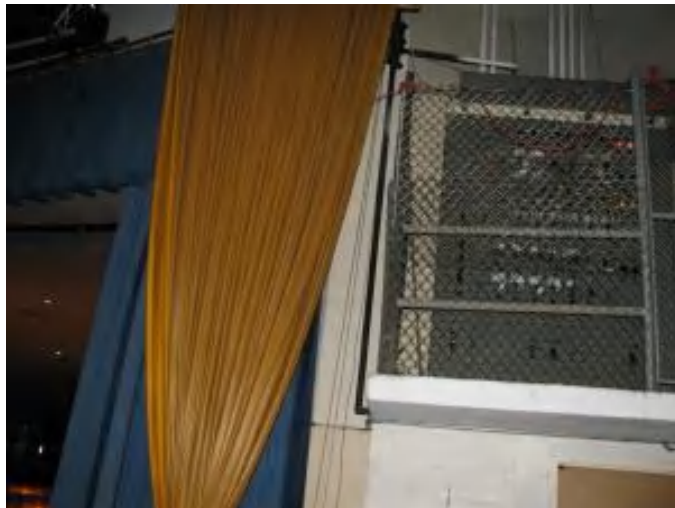
System: E1020 - Institutional Equipment

Location: Auditorium

Distress: Beyond Service Life

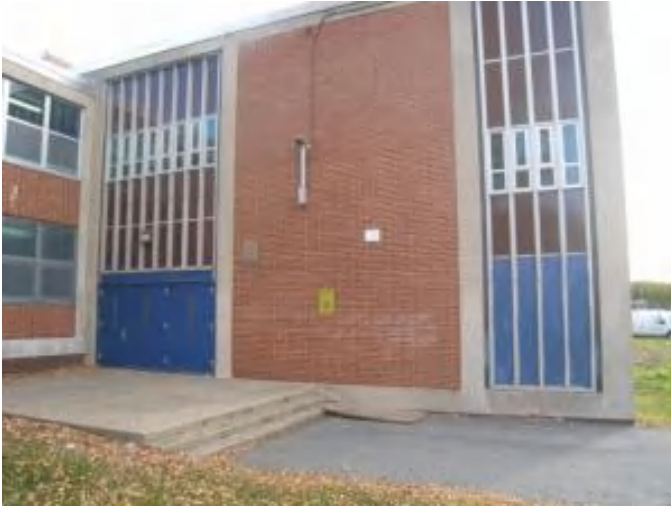
System: B2010 - Exterior Walls

Location: exterior brick and limestone

Distress: Appearance

Notes: Powerwash brick and limestone building walls (100,000sf)

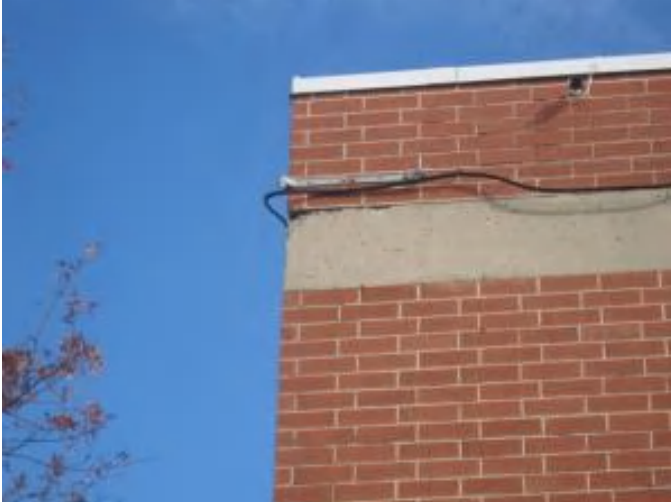
cracking; that section of concrete visible to the exterior appears to be structural and should be repaired structurally to ensure a solid, weatherproof connection and support of the corridor above. Some brick pointing is required on Annex north and south walls as grout is cracked and possibly letting moisture into the stairways. The horizontal joint above and below the first floor and roof concrete bands (beam lines) need to be repointed to prevent moisture intrusion.

System: B2010 - Exterior Walls

Location: exterior walls

Distress: Damaged

Notes: Patch structural connection between Annex and Wing D – repair steel beam bearing in concrete in Annex wall.

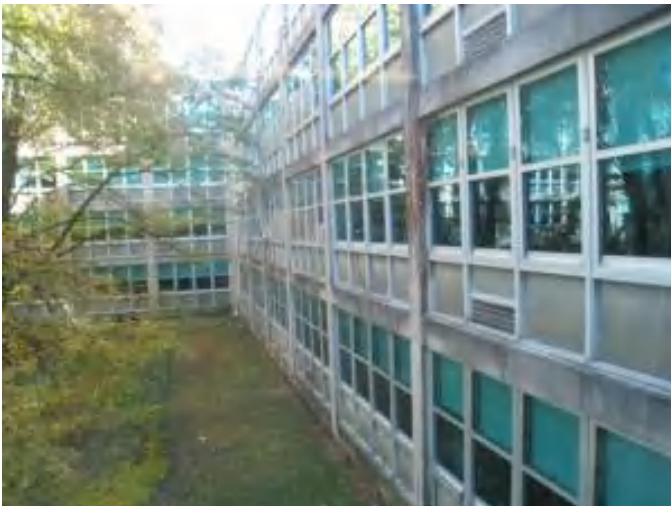
System: B2020 - Exterior Windows

Location: windows

Distress: Building Envelope Integrity

Notes: Recaulk perimeter of window frames set in limestone (10,000lf)

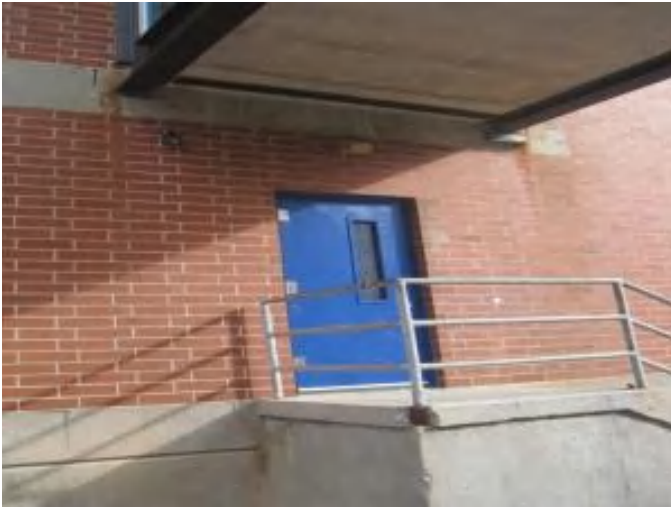
System: B2030 - Exterior Doors

Location: exterior doors

Distress: Appearance

Notes: Repaint exterior doors and frames; also provide new exit hardware. (50 3x7)

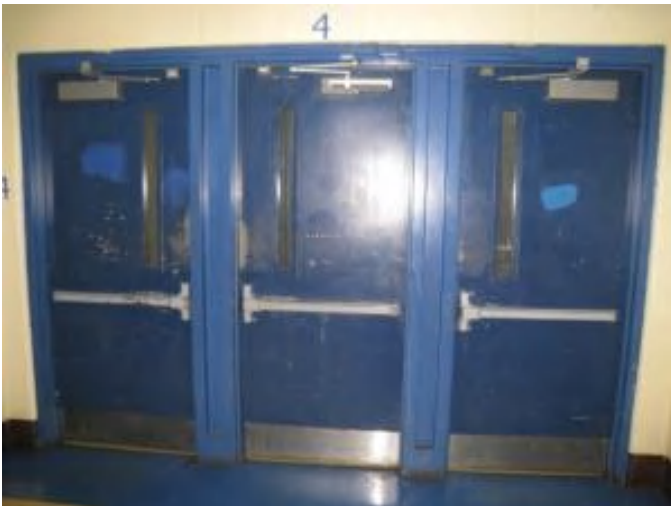
System: C1020 - Interior Doors

Location: stairway doors

Distress: Building / MEP Codes

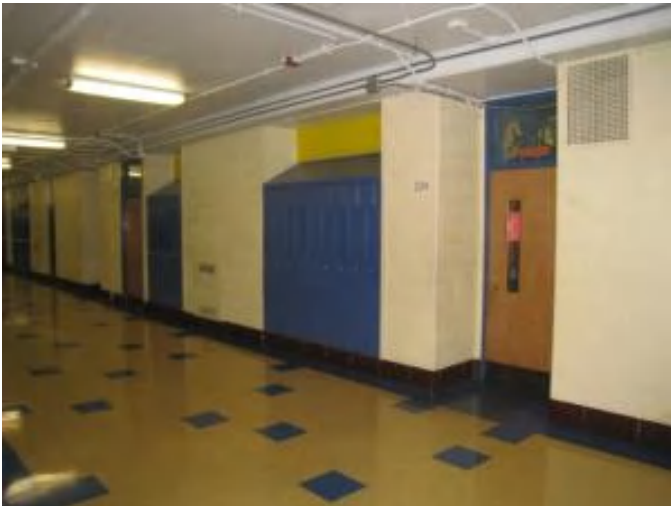
System: C3010230 - Paint & Covering

Location: corridors - lockers

Distress: Damaged

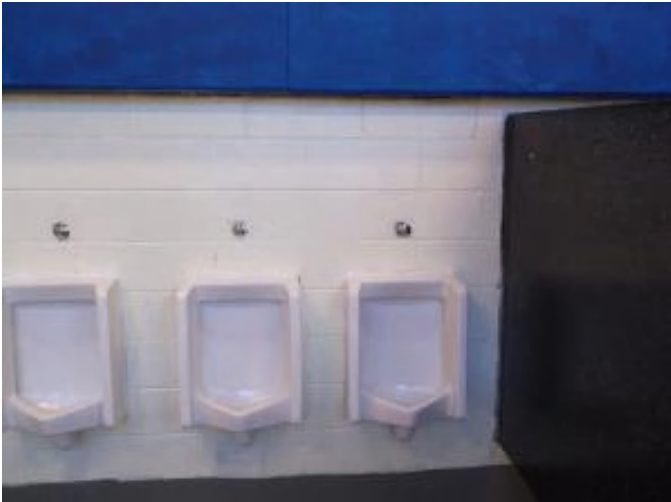
System: D2010 - Plumbing Fixtures

Location: Throughout the building

Distress: Beyond Service Life

Notes: Replace all urinals in the building with lower flow fixtures, as the fixtures are original.

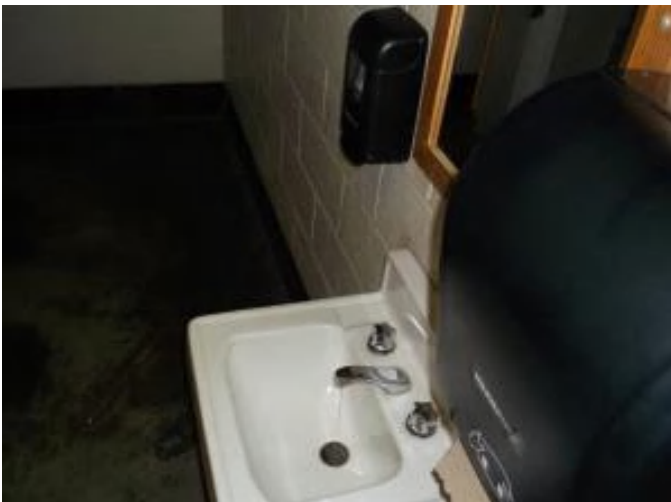
System: D2010 - Plumbing Fixtures

Location: Throughout the building

Distress: Beyond Service Life

Notes: Replace all lavatories in the building with lower flow fixtures, as the fixtures are original.

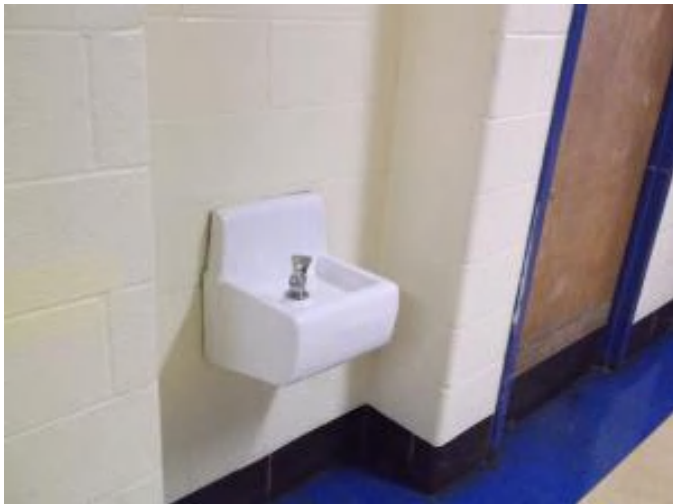
System: D2010 - Plumbing Fixtures

Location: Throughout the building

Distress: Beyond Service Life

Notes: Replace the wall hung drinking fountains and integral refrigerated coolers in the corridors and at the restrooms. These units are well beyond their service life and most are NOT accessible type.

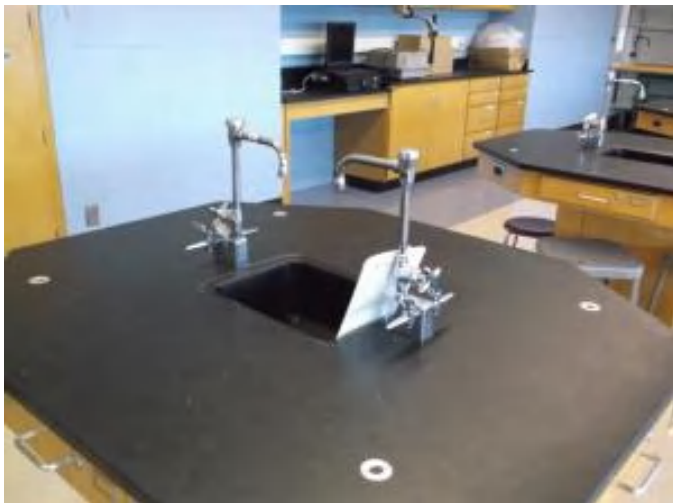
System: D2010 - Plumbing Fixtures

Location: Throughout the building

Distress: Beyond Service Life

Notes: Replace science lab sinks in the building.

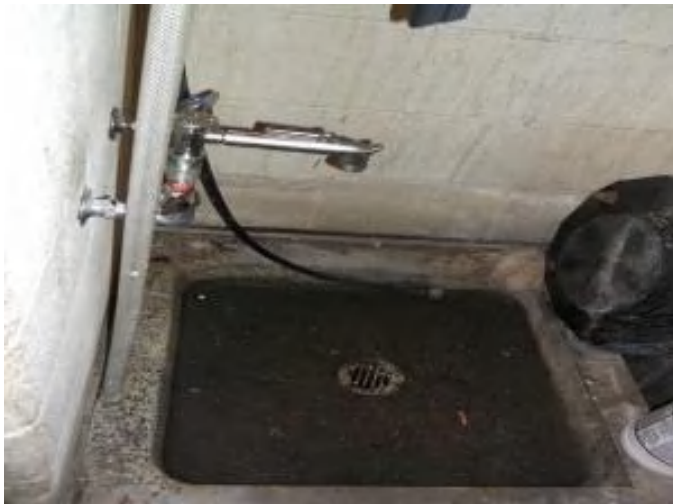
System: D2010 - Plumbing Fixtures

Location: Throughout the building
Distress: Beyond Service Life
Category: 3 - Operations / Maint.
Priority: 2 - Response Time (2-3 yrs)
Correction: Remove and replace floor janitor or mop sink - insert the quantity
Qty: 12.00
Unit of Measure: Ea.
Estimate: \$81,793.11
Assessor Name: Craig Anding
Date Created: 02/17/2016

Notes: Replace service sinks (janitor sinks) in the building.

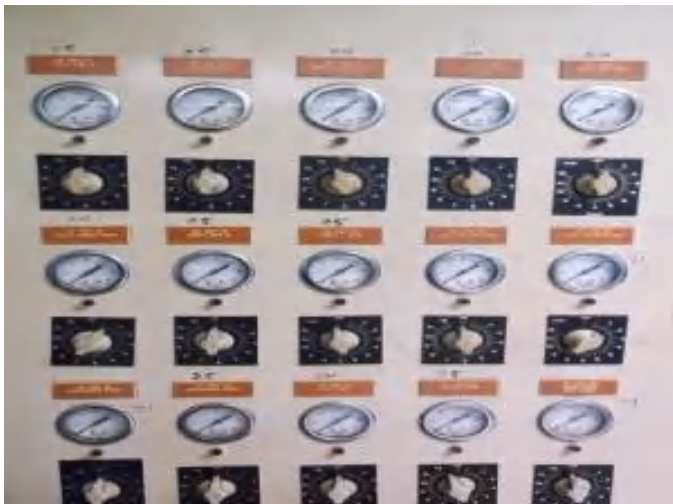
System: D3060 - Controls & Instrumentation

Location: Throughout the building
Distress: Beyond Service Life
Category: 3 - Operations / Maint.
Priority: 2 - Response Time (2-3 yrs)
Correction: Replace pneumatic controls with DDC (350KSF)
Qty: 310,296.00
Unit of Measure: S.F.
Estimate: \$5,716,724.90
Assessor Name: Craig Anding
Date Created: 02/17/2016

Notes: Replace the pneumatic controls for the HVAC systems with modern DDC modules, valves and actuators to improve reliability and energy efficiency. Provide a new building automation system (BAS) with communication interface to the preferred system in use throughout the District.

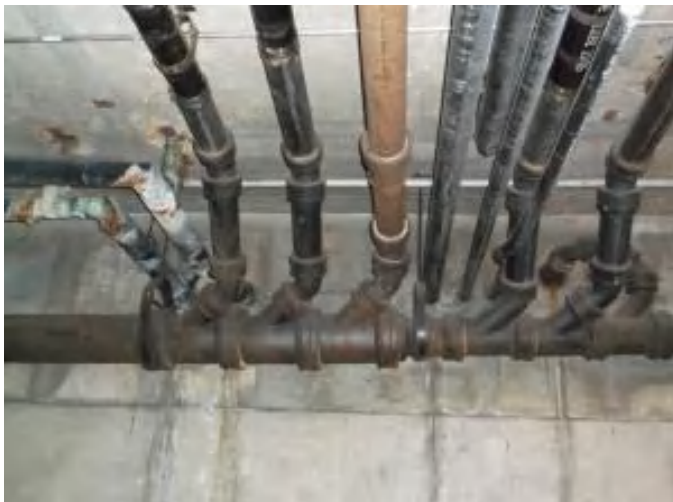
System: D2030 - Sanitary Waste

Location: Throughout the building

Distress: Beyond Service Life

Notes: Hire a qualified contractor to perform a detailed examination of the sanitary waste piping using visual inspection and video cameras to locate and replace any damaged piping and to further quantify the extent of potential failures.

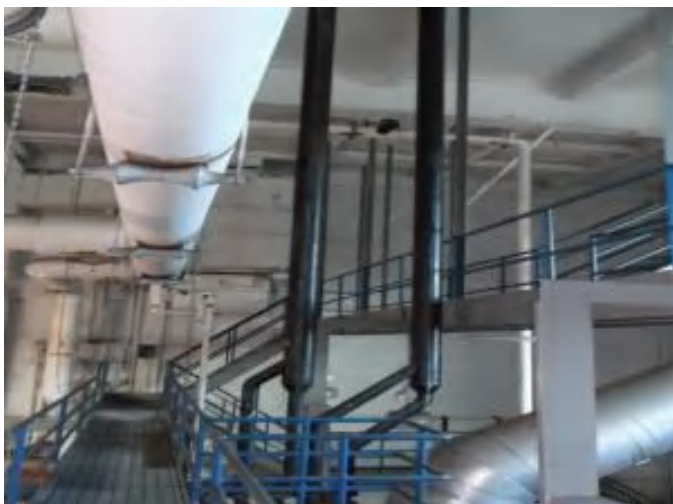
System: D3040 - Distribution Systems

Location: Throughout the building

Distress: Beyond Service Life

Notes: Hire a qualified contractor to examine the steam and condensate piping in service for 53 years and perform additional testing to locate and replace any damaged piping and to further quantify the extent of potential failures. The District should budget for replacing this piping over the next 10 years.

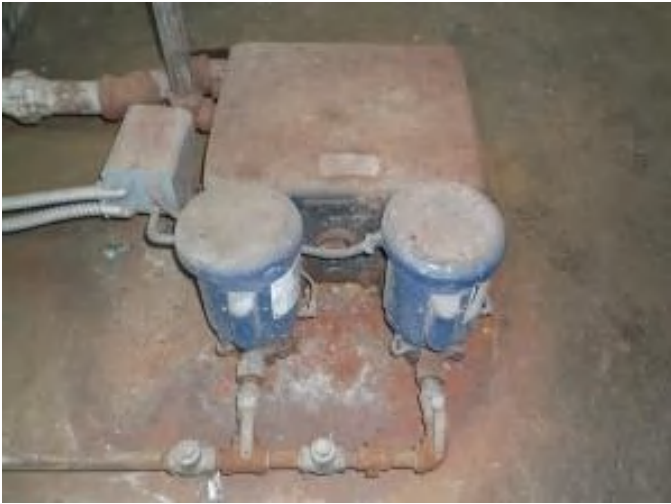
System: D3040 - Distribution Systems

Location: Throughout the building

Distress: Beyond Service Life

Notes: Hire a qualified contractor to examine the steam and condensate piping in service for 53 years and perform additional testing to locate and replace any damaged piping and to further quantify the extent of potential failures. The District should budget for replacing this piping over the next 10 years.

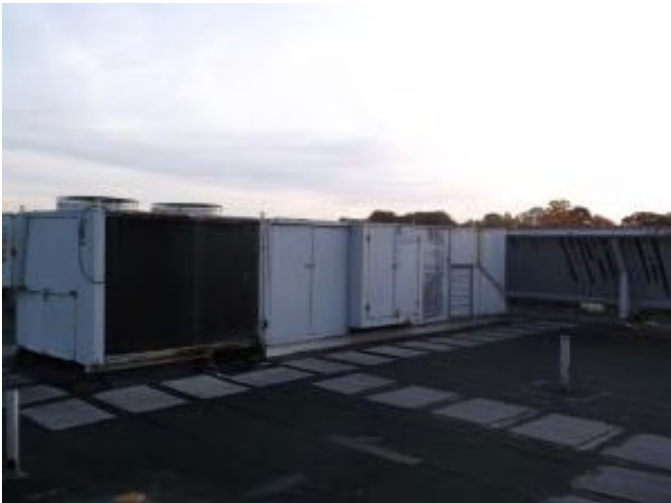
System: D3040 - Distribution Systems

Location: Annex roof

Distress: Damaged

Notes: Replace rooftop units for Annex.

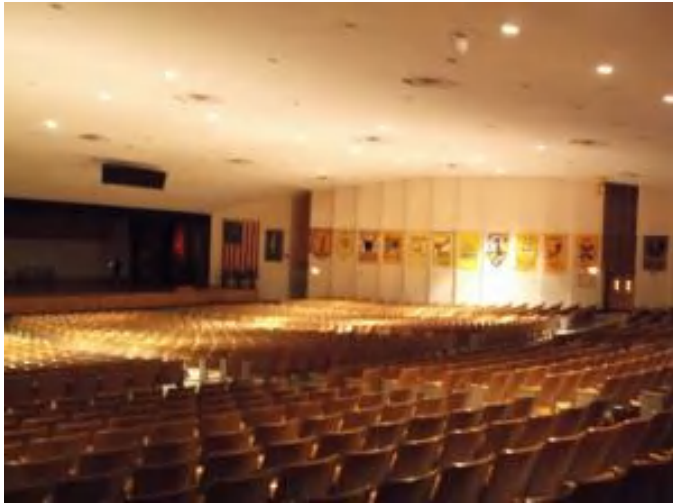
System: D3040 - Distribution Systems

Location: Roof

Distress: Beyond Service Life

Notes: Provide ventilation, heating and cooling for the Auditorium by removing the existing heating and ventilating and installing a new modular constant volume air handling unit with heating and cooling.

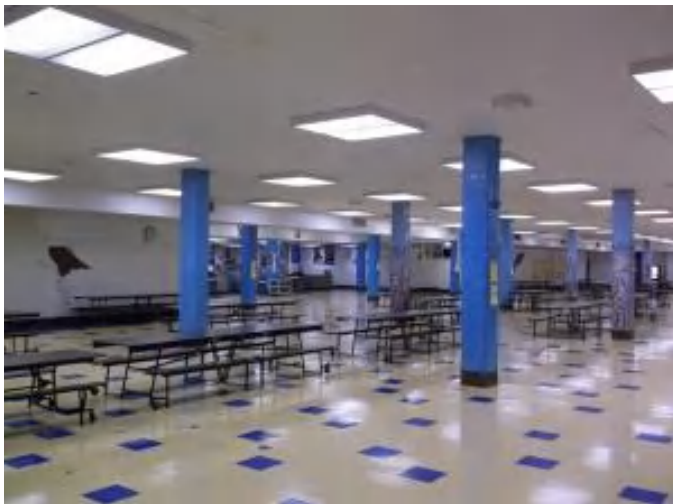
System: D3040 - Distribution Systems

Location: Roof

Distress: Beyond Service Life

Notes: Provide ventilation, heating and cooling for the Cafeteria by removing the existing heating and ventilating unit and installing a new modular constant volume air handling unit with heating, cooling, distribution ductwork and registers.

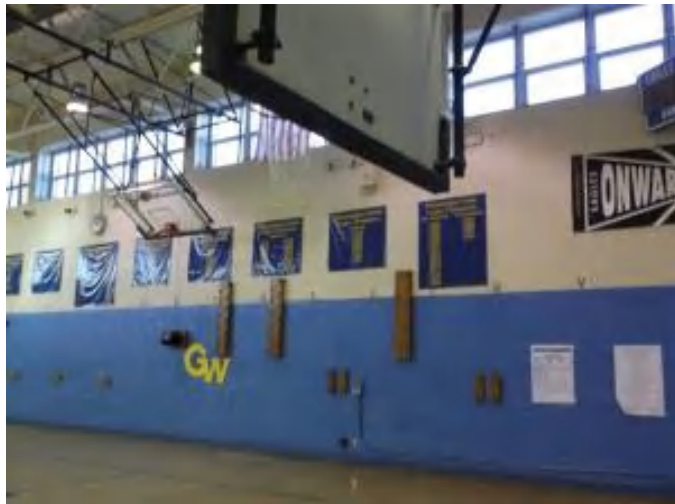
System: D3040 - Distribution Systems

Location: Roof

Distress: Beyond Service Life

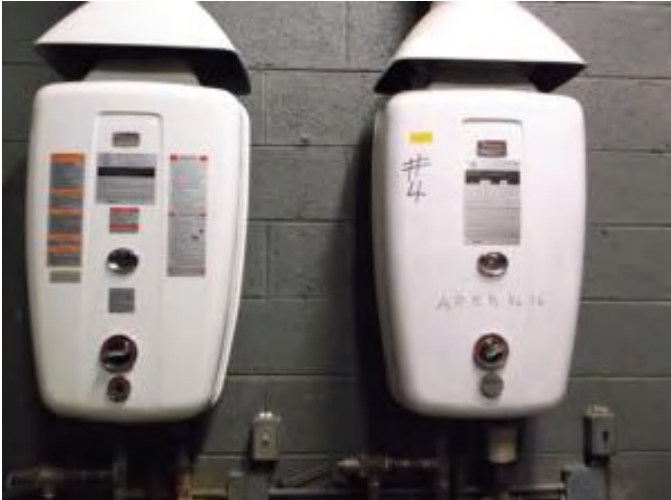
System: D2020 - Domestic Water Distribution

Location: Main boiler mechanical equipment room

Distress: Beyond Service Life

Notes: Replace four instantaneous natural gas fired water heaters.

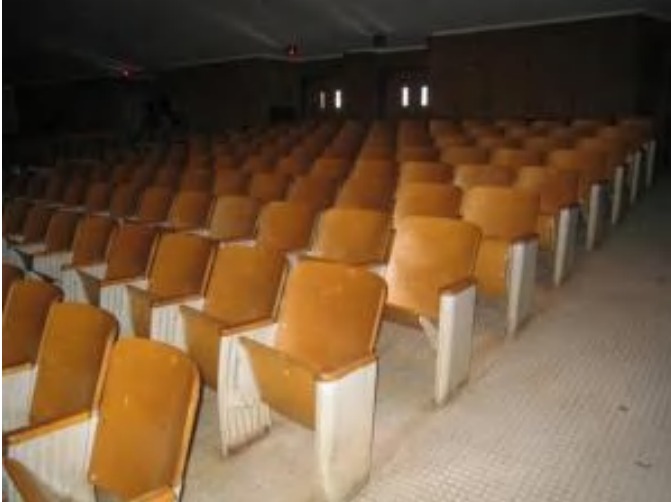
System: E2010 - Fixed Furnishings

Location: auditorium

Distress: Appearance

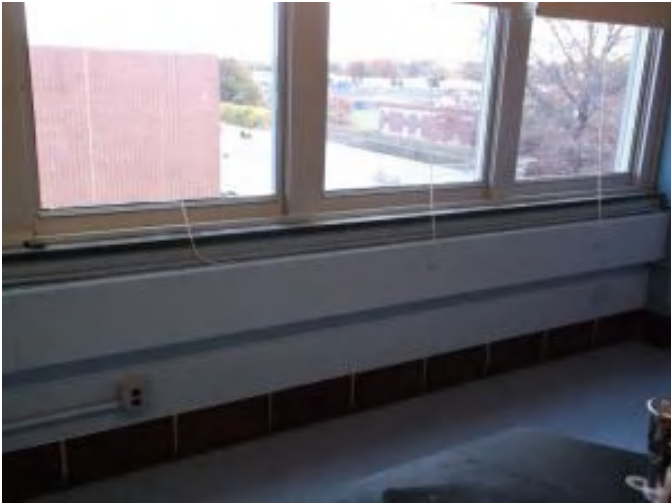
System: D3040 - Distribution Systems

Location: Throughout the building
Distress: Beyond Service Life
Category: 3 - Operations / Maint.
Priority: 5 - Response Time (> 5 yrs)
Correction: Replace finned tube radiation terminals (per 100 LF)
Qty: 1,000.00
Unit of Measure: L.F.
Estimate: \$403,541.43
Assessor Name: Craig Anding
Date Created: 02/17/2016

Notes: Replace the steam convection

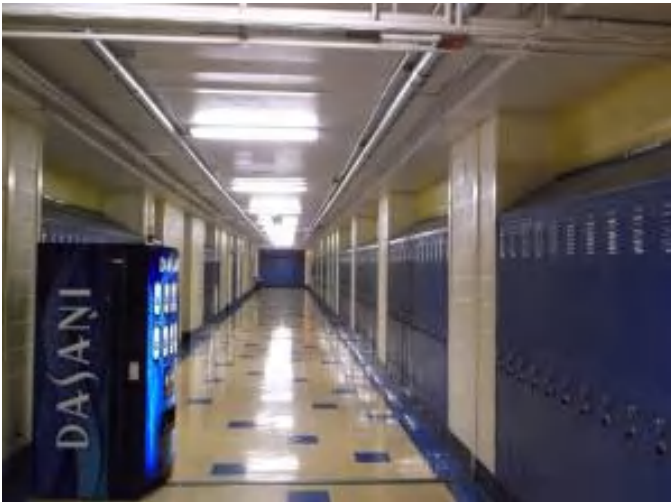
System: D4010 - Sprinklers

Location: Throughout the building
Distress: Beyond Service Life
Category: 3 - Operations / Maint.
Priority: 5 - Response Time (> 5 yrs)
Correction: Install a fire protection sprinkler system
Qty: 310,296.00
Unit of Measure: S.F.
Estimate: \$4,438,922.82
Assessor Name: Craig Anding
Date Created: 02/17/2016

Notes: Install a fire protection sprinkler system with quick response type heads to reduce insurance costs by providing protection for the property. A fire pump may be required depending on the available city water pressure. Install a new sprinkler system throughout the building

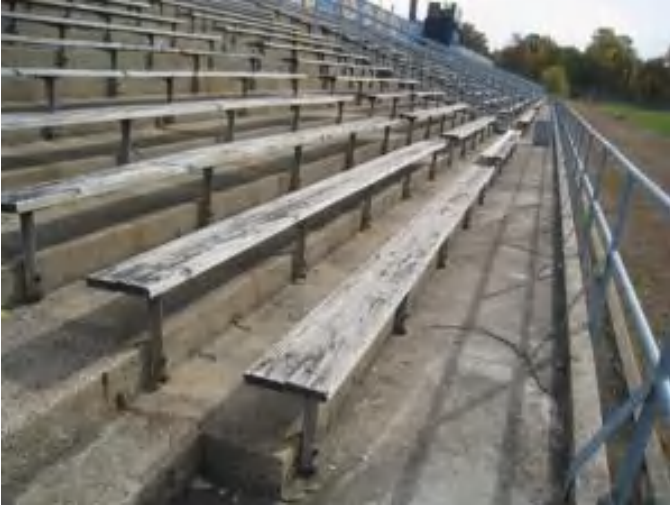
System: C2010 - Stair Construction

Location: Fieldhouse stands

Distress: Building / MEP Codes

Notes: Replace all handrails/guards with code compliant systems along edge of seating, open passageways and bottom of grandstands (300ft handrails/guards; 800ft guards only at bottom and openings)

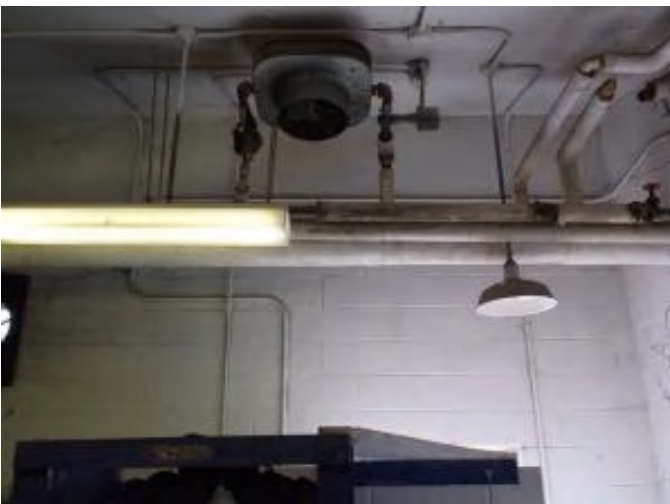
System: D3040 - Distribution Systems

Location: Throughout the building

Distress: Beyond Service Life

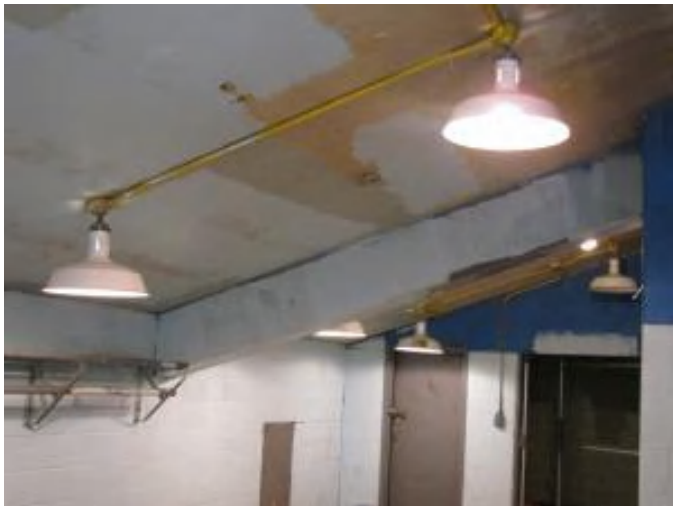
System: D5020 - Lighting and Branch Wiring

Location: Fieldhouse Entire Building
Distress: Life Safety / NFPA / PFD
Category: 1 - Health & Safety
Priority: 1 - Response Time (< 2 yr)
Correction: Add Lighting Fixtures
Qty: 1.00
Unit of Measure: Ea.
Estimate: \$14,673.79
Assessor Name: Craig Anding
Date Created: 01/13/2016

Notes: Provide emergency battery pack lights in locker rooms and at the egress ways. Estimated 6 total.

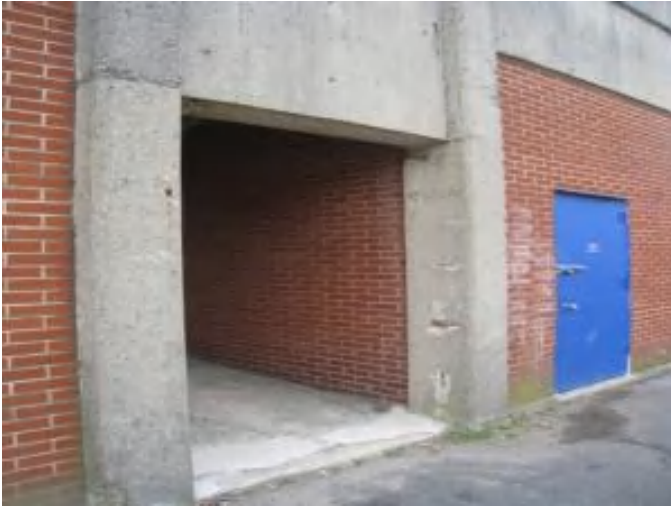
System: A2020 - Basement Walls

Location: Fieldhouse concrete beams and columns

Distress: Failing

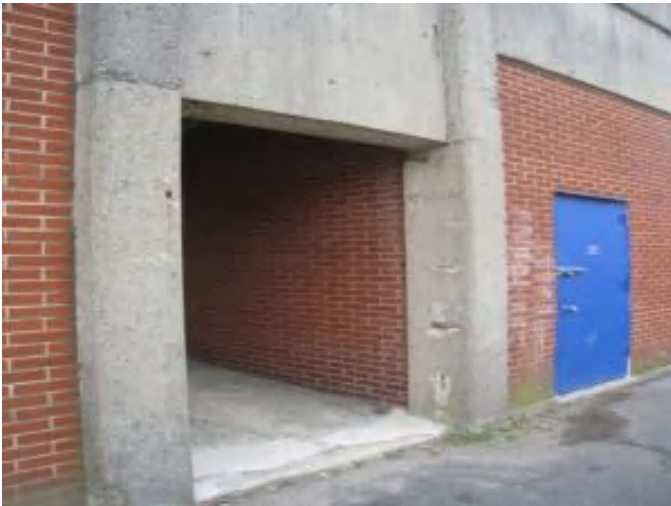
System: B2030 - Exterior Doors

Location: Fieldhouse exterior

Distress: Damaged

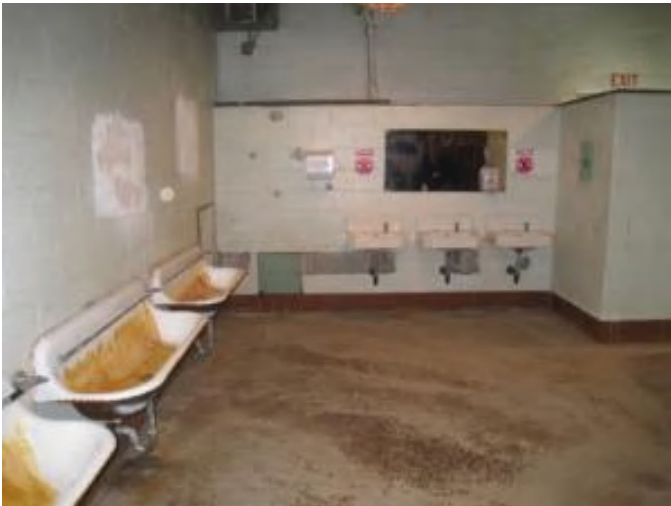
System: C3010230 - Paint & Covering

Location: Fieldhouse interior walls

Distress: Damaged

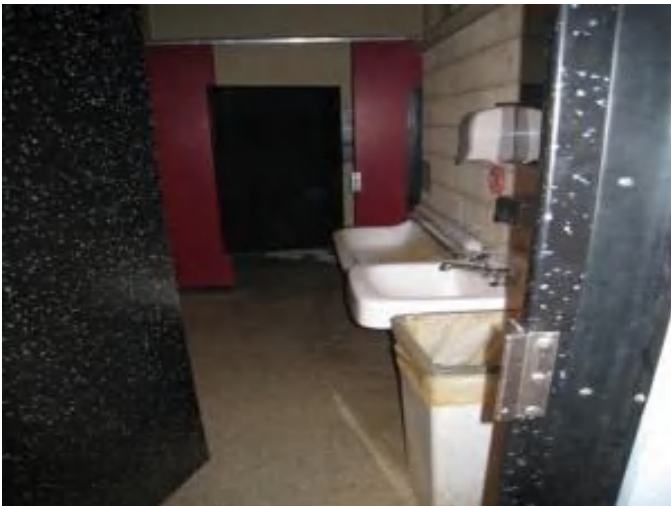
System: C3020415 - Concrete Floor Finishes

Location: Fieldhouse floors
Distress: Appearance
Category: 3 - Operations / Maint.
Priority: 2 - Response Time (2-3 yrs)
Correction: Clean and reseal concrete floors
Qty: 18,000.00
Unit of Measure: S.F.
Estimate: \$69,201.60
Assessor Name: Craig Anding
Date Created: 02/03/2016

Notes: Refinish all interior concrete floor slabs (18,000sf)

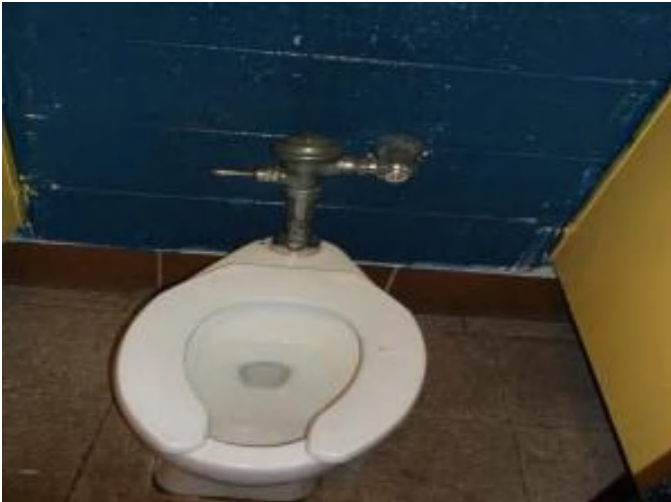
System: D2010 - Plumbing Fixtures

Location: Throughout the building
Distress: Beyond Service Life
Category: 3 - Operations / Maint.
Priority: 2 - Response Time (2-3 yrs)
Correction: Remove and replace or replace water closet - quantify additional units
Qty: 18.00
Unit of Measure: Ea.
Estimate: \$134,318.66
Assessor Name: Craig Anding
Date Created: 02/17/2016

Notes: Replace all water closets in the building with lower flow fixtures, as the fixtures are original.

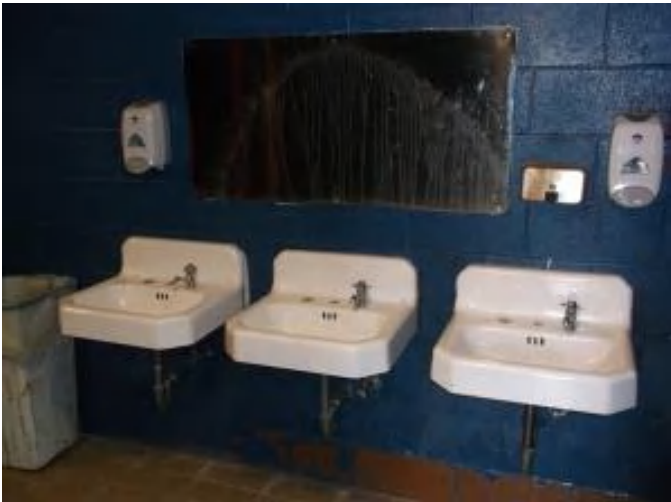
System: D2010 - Plumbing Fixtures

Location: Throughout the building
Distress: Beyond Service Life
Category: 3 - Operations / Maint.
Priority: 2 - Response Time (2-3 yrs)
Correction: Remove and replace or replace lavatory - quantify accessible if required
Qty: 16.00
Unit of Measure: Ea.
Estimate: \$60,976.20
Assessor Name: Craig Anding
Date Created: 02/17/2016

Notes: Replace all lavatories in the building with lower flow fixtures, as the fixtures are original.

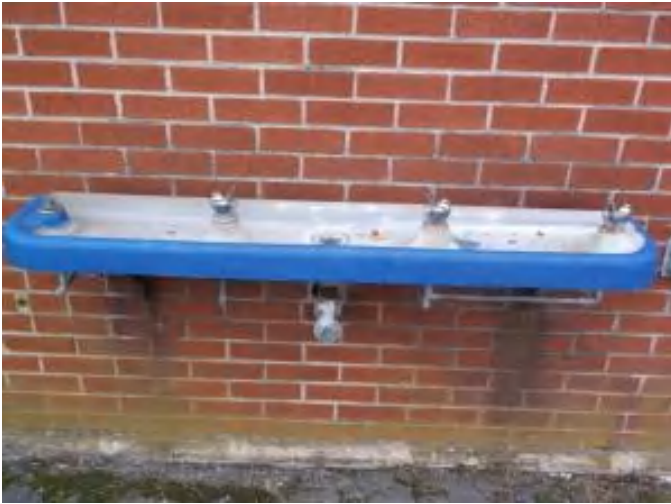
System: D2010 - Plumbing Fixtures

Location: Throughout the building

Distress: Beyond Service Life

Notes: 4. Replace the drinking fountains. These units are well beyond their service life and most are NOT accessible type.

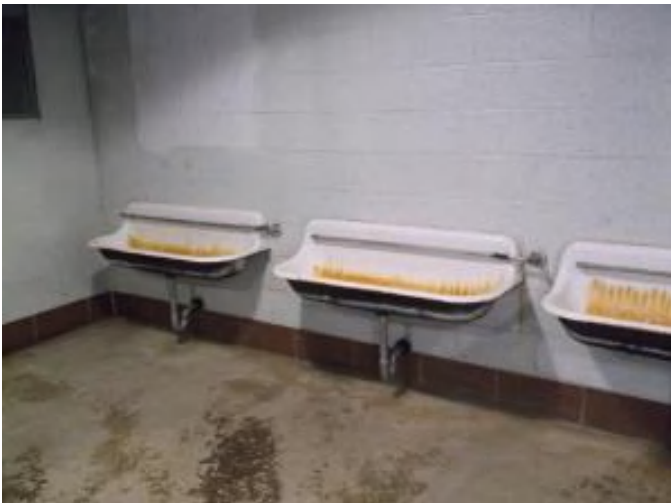
System: D2010 - Plumbing Fixtures

Location: Throughout the building

Distress: Beyond Service Life

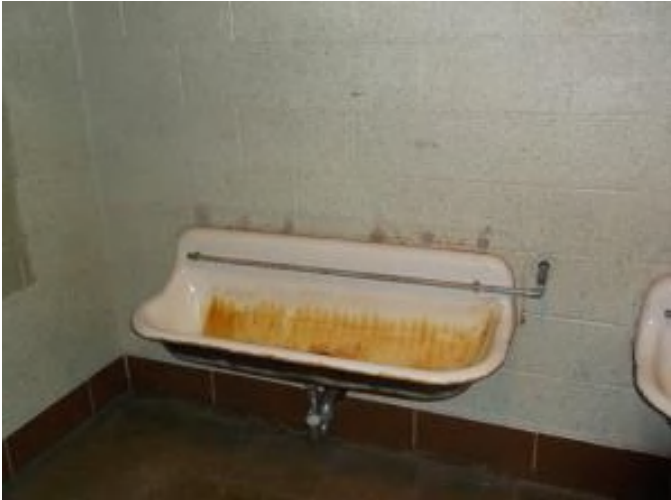
System: D2030 - Sanitary Waste

Location: Throughout the building

Distress: Beyond Service Life

Notes: Hire a qualified contractor to perform a detailed examination of the sanitary waste piping using visual inspection and video cameras to locate and replace any damaged piping and to further quantify the extent of potential failures.

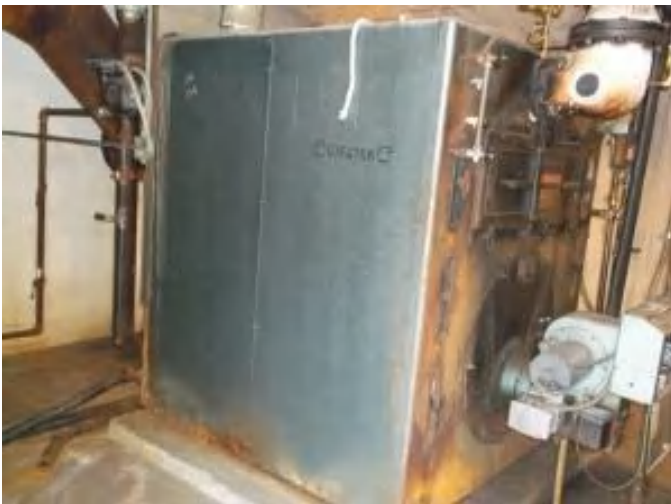
System: D3020 - Heat Generating Systems

Location: Main boiler mechanical equipment room

Distress: Beyond Service Life

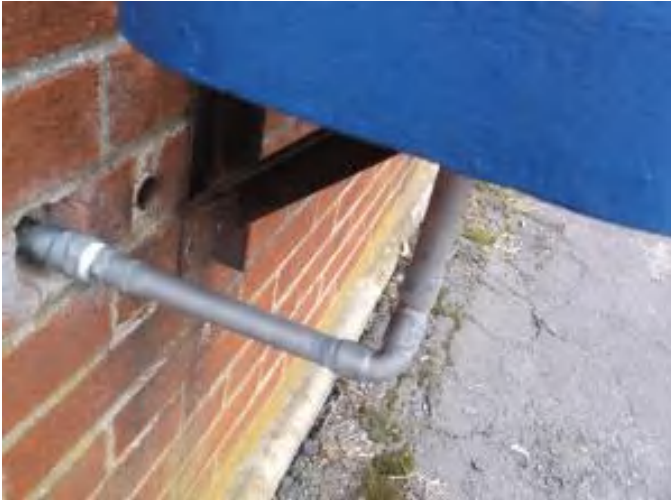
System: D2020 - Domestic Water Distribution

Location: Throughout the building

Distress: Beyond Service Life

Notes: Inspect and replace the original as needed the domestic water piping in the building.

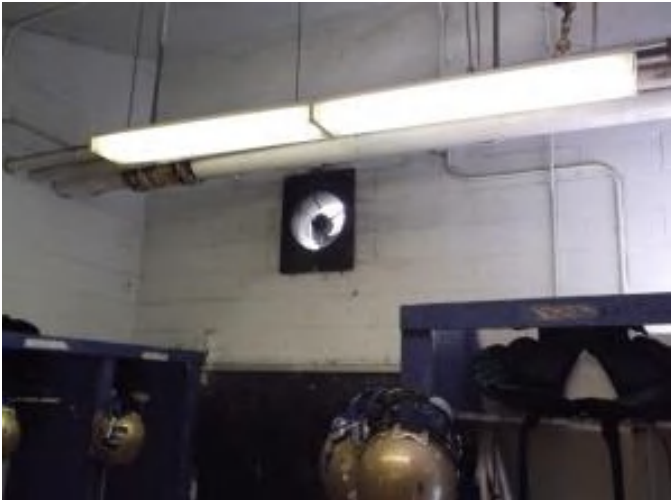
System: D4010 - Sprinklers

Location: Throughout the building

Distress: Beyond Service Life

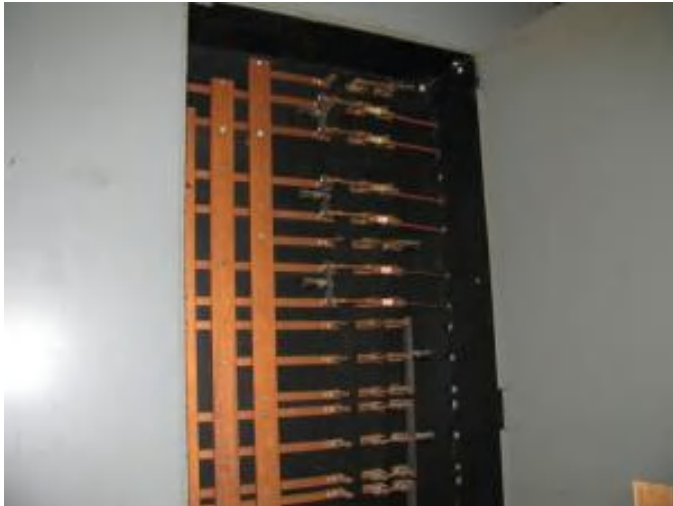
System: D5010 - Electrical Service/Distribution

Location: Interior Building

Distress: Beyond Service Life

Notes: Upgrade existing distribution system by replacing new panel boards and new feeders. Provide arc flash label on all panel boards. Estimated 4 panels.

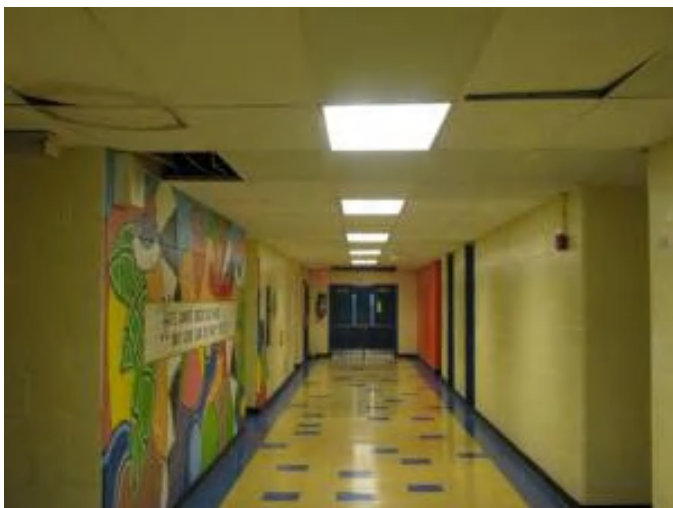
System: D5020 - Lighting and Branch Wiring

Location: Entire Building

Distress: Beyond Service Life

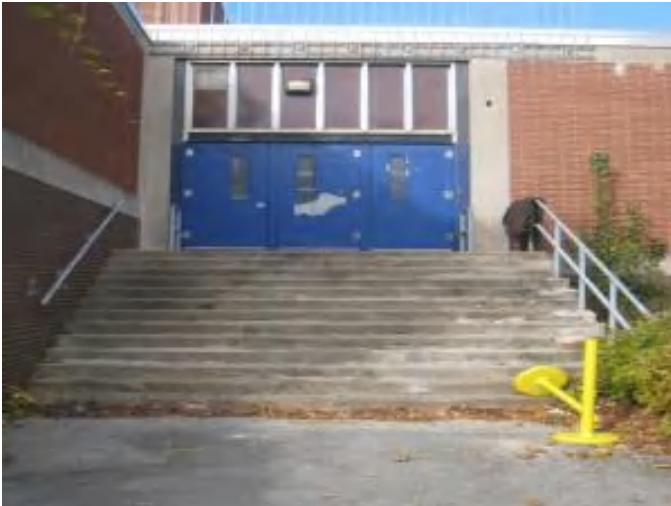
System: G2030 - Pedestrian Paving

Location: exterior stairs

Distress: Damaged

Notes: Repair concrete treads/risers at misc. exterior stairs (23 treads, 8ft long; 13 treads 30ft long)

Correction: Remove and replace exterior egress stairway - per flight

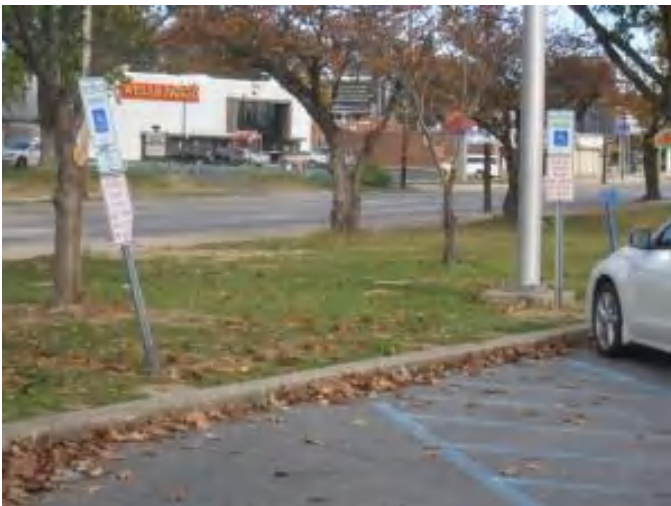
System: G2030 - Pedestrian Paving

Location: sidewalks

Distress: Damaged

Notes: Repave damaged sections of concrete walkway in courtyard and along Bustleton Ave (700sf)

Correction: Remove and replace concrete sidewalk or concrete paving - 4" concrete thickness

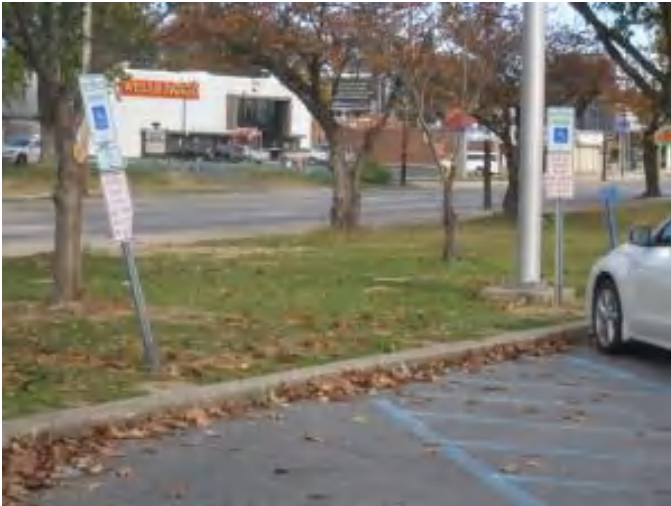
System: G2030 - Pedestrian Paving

Location: sidewalks

Distress: Damaged

Notes: Repave damaged sections of concrete walkway in courtyard and along Bustleton Ave (700sf)

Correction: Remove and replace concrete sidewalk or concrete paving - 4" concrete thickness

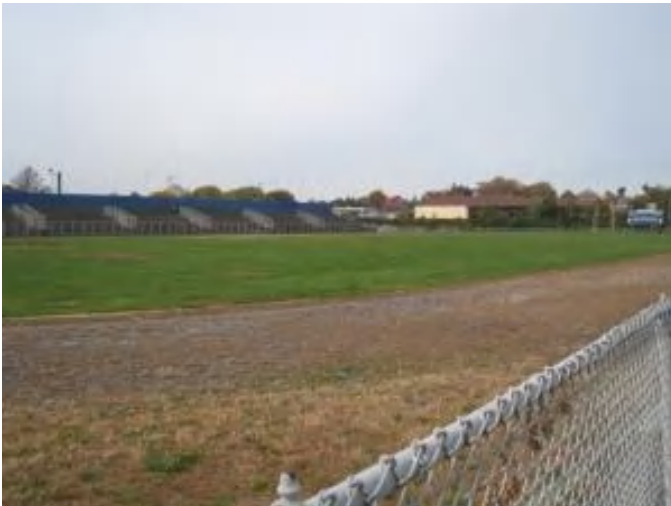
System: G2040 - Site Development

Location: Football field track

Distress: Damaged

Correction: Refurbish running track - replace AC paving with asphalt latex rubber system

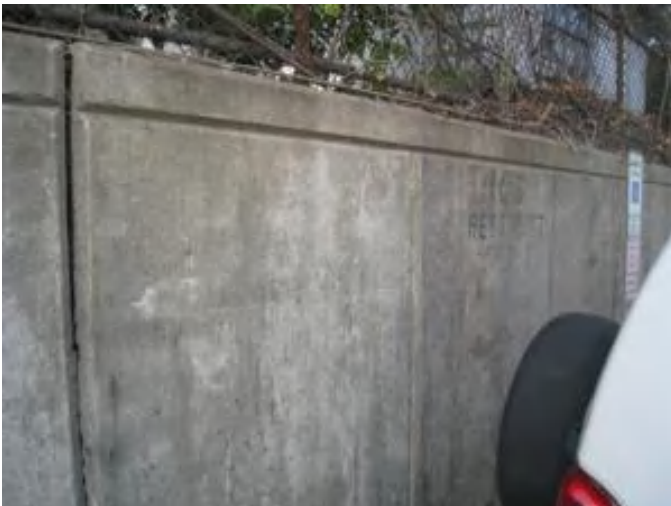
System: G2040 - Site Development

Location: faculty parking

Distress: Failing

Notes: Repair/Reconstruct retaining walls leaning and broken in Faculty Parking on south side of building (20ft long x 5 ft. h.)

Correction: Repair concrete retaining wall in poor condition including rebar doweling - insert the SF of wall area

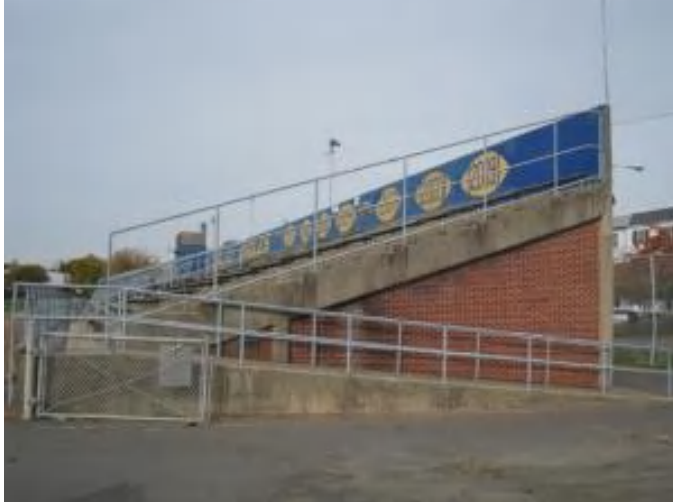
System: G2030 - Pedestrian Paving

Location: Fieldhouse asphalt paving

Distress: Damaged
