Facility Condition Assessment Summary Report

Wister School

S643001;Wister

Site Assessment Report

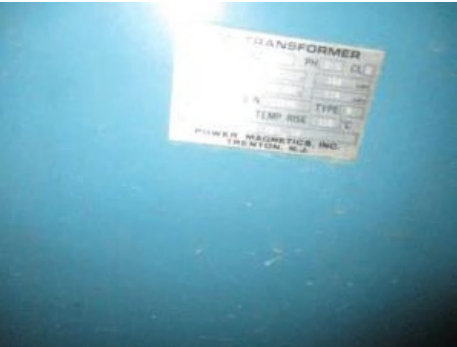
System: D5010 - Electrical Service/Distribution

Note: There is a phase converter rated 75KVA (estimated)

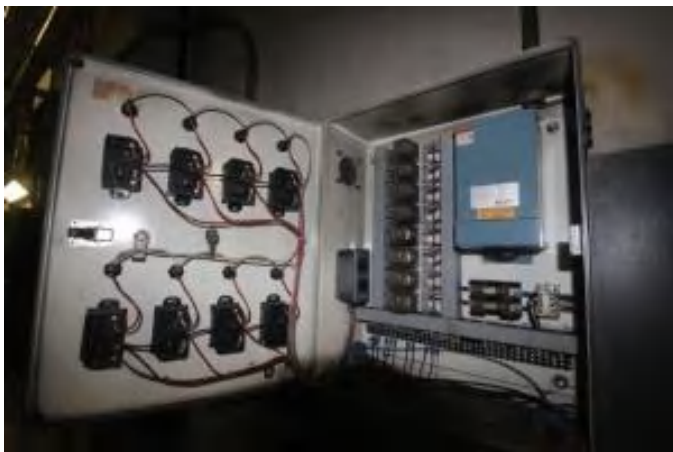
System: D3060 - Controls & Instrumentation

Controls for heating are pneumatic. There is an air compressor with one pump and tank, but the filter dryer is inoperative because the power cable is removed. The pneumatic control panel is located in the basement and all of the gauges read zero. Classrooms have pneumatic thermostats which are falling apart and unit vents have pneumatic actuators. The whole system is obsolete and should be replaced with a digital control system when the HVAC equipment is overhauled.

Location: Entire building

Distress: Obsolete

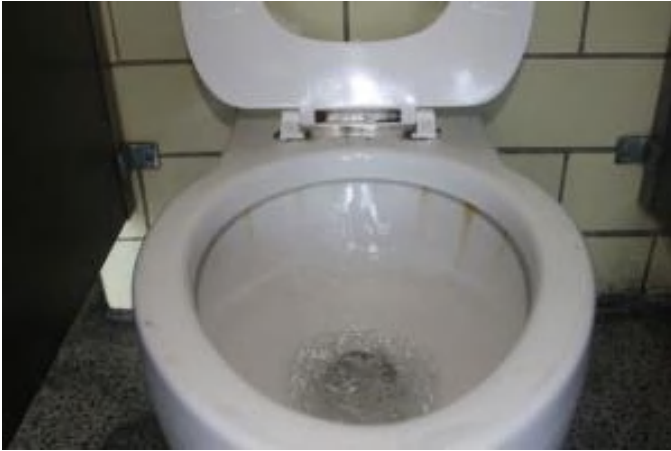
System: D2020 - Domestic Water Distribution

Water enters the building in the boiler room through a 4 inch line. There is a compound water meter and Y-strainer but the back flow preventer has been removed and replaced with a spool piece. The water meter bypass line has a 2 inch back flow preventer. A new backflow preventer should be installed. Domestic hot water is heated by 2 Paloma model 24M-DN tankless natural gas water heaters manufactured in 1986. Each heater has a circulation pump. Heaters have exceeded their expected life span by 20 years and should be replaced due to age. Domestic water distribution pipe is soldered copper. Somehow there are rust streaks in porcelain fixtures, so perhaps some of the domestic piping is steel. Stained fixtures indicate corroding pipes, so domestic water distribution pipes should be replaced. The building does not have a domestic water pressure booster.

Location: Entire building

Distress: Beyond Service Life

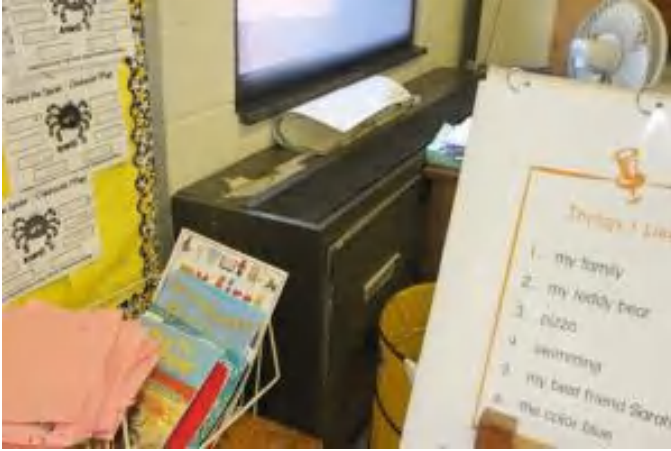
System: D3040 - Distribution Systems

Classroom unit vents are flanked by finned tube convection units installed in bookcases. Toilet rooms, entryways, small offices, and store rooms have convectors as their only source of heat. Unit vents are mostly original, many have badly bent fins, and some are very rust. They should all be replaced.

Location: Classrooms

Distress: Beyond Service Life

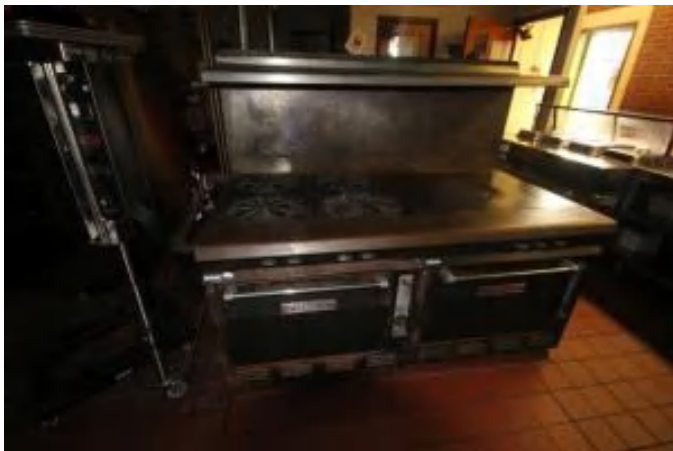
System: D4010 - Sprinklers

exceeded their service life and lack cooling capacity so should be replaced. There is a gas burning range (8 burners, 2 ovens) and a convection oven. They are installed under an exhaust hood, but it does not have a fire suppression system. A fire suppression system should be installed for the range and oven. Toilet rooms have dedicated exhaust fans, but some locations are missing the fans or they are inoperable. Some toilet rooms still had unpleasant odors present on Saturday. Toilet exhaust fans should be replaced. The original building has steam heat and the classroom addition has hot water. The steam and condensate pipes are heavily rusted throughout the building and should be replaced. Steam hammer was occurring and easily audible in the health suite. Hydronic circulation is provided by two 7.5 HP circulation pumps. One was running well at the time of inspection. They are both in good condition and appear to have been replaced recently, so they should last 15-20 year more.

Location: Kitchen

Distress: Life Safety / NFPA / PFD

Notes: Install fire protection sprinkler system
