School District of Philadelphia

# **S820001;Allen, Ethan**

## **Site Assessment Report**

January 31, 2017

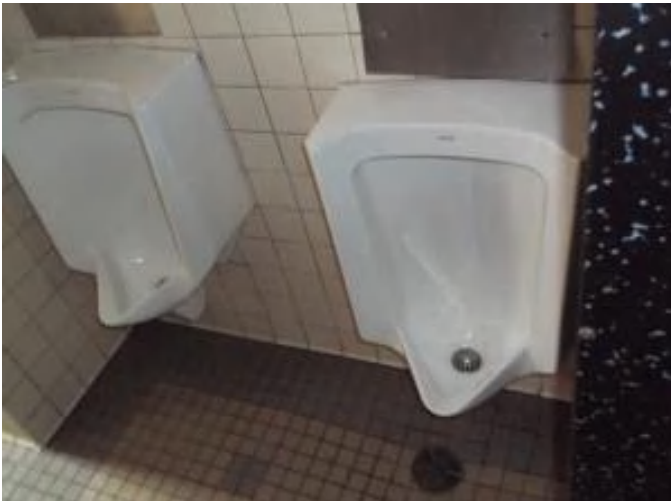
**Location:** Throughout the building

Many of the original plumbing fixtures remain in service. Fixtures in the restrooms on each floor consist of both floor and wall mounted flush valve water closets, wall hung urinals and lavatories with wheel handle faucets. Some lavatories have blade handles. The units appear to be in good condition and should provide reliable service for the next 5-10 years. The bathrooms are also equipped with floor drains. Drinking fountains are located in the corridors consisting of wall hung fixtures with integral refrigerated coolers and drinking fountains. They are beyond their service life and should be replaced; most are NOT accessible type.

**System: D2010 - Plumbing Fixtures**

**Distress:** Beyond Service Life
