## **Andrew Hamilton School**

5640 Spruce Street, Philadelphia, PA 19139

### **Scope Determination Report: Major Renovation**

May 11, 2018

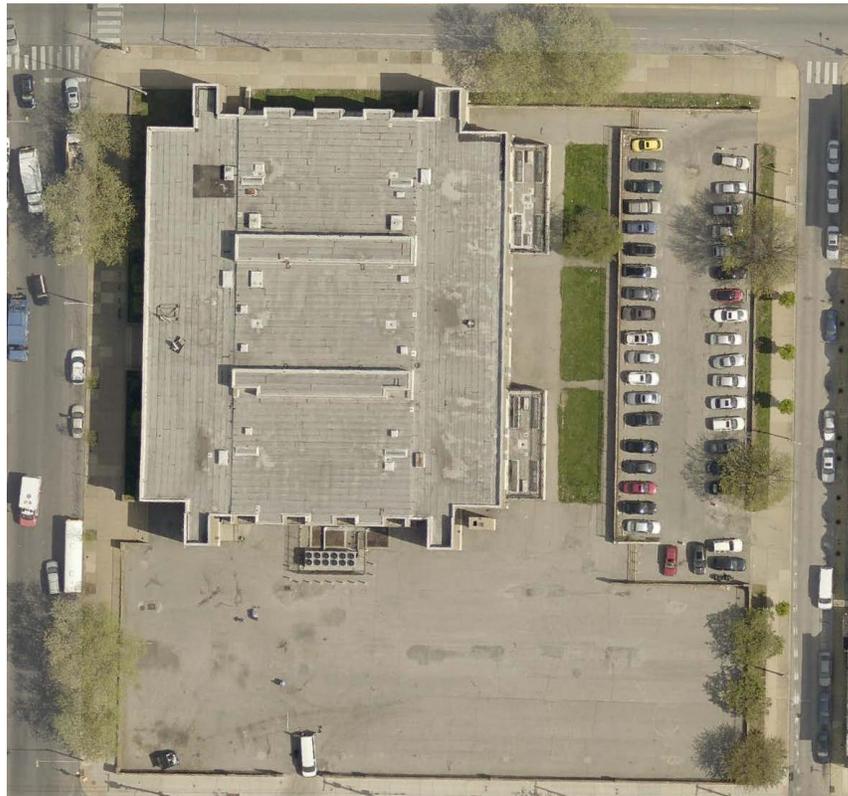
The site consists primarily of paved surfaces surrounding the main school building footprint. Yellow brick perimeter walls border the site at varying heights. Adjacent and south to the front entrance of the building, the low retaining walls are covered with a mosaic mural that appears to be in good condition. The rear walls are freestanding with a yellow brick façade and iron picket fencing mounted on top. All brick site walls appear to be in good condition. The asphalt pavement is in moderate condition throughout with areas that have more significant degradation in the southwestern corner of the site. A parking area is located at the northeastern portion of the site. The parking area pavement has two pronounced patches of degraded asphalt within the drive lane. The school does not have an ADA accessible entrance currently. The mechanical equipment to the south of the building within the asphalt play yard produces a constant, high-pitched squeaking sound during warmer months.

1. Basketball / Track. Provide two basketball hoops (gooseneck 5/16 OD diameter steel, breakaway rims and backboards). Provide Plexipave acrylic surfacing or approved equal (assume 6000 sf). Provide asphalt paint for track / basketball.
2. Site seating. Provide six benches (use Victor Stanley CR-296, 6' length as basis for design).
3. Trash and Recycling Stations. Provide two stations (use Victor Stanley Ironsites Model SD-242 as basis for design).
4. Play equipment. Allowance for equipment: \$40,000 TBD. Provide rubber safety surfacing beneath play equipment (4" thick layer of poured in place installed on top of asphalt - assume 1600 sf).
5. Planting. Provide new topsoil (2' depth, +/- 8 cy). Provide two new trees (3" – 3 ½" caliper, balled and burlapped). Provide perennial groundcovers (50 #1 containers).
