ADDENDUM No. 02

Subject: Northeast High School – AC Upgrade Project
SDP Contract No. B-006c & 007c 2020/21

Location: Northeast High School
1601 Cottman Avenue
Philadelphia PA 19111

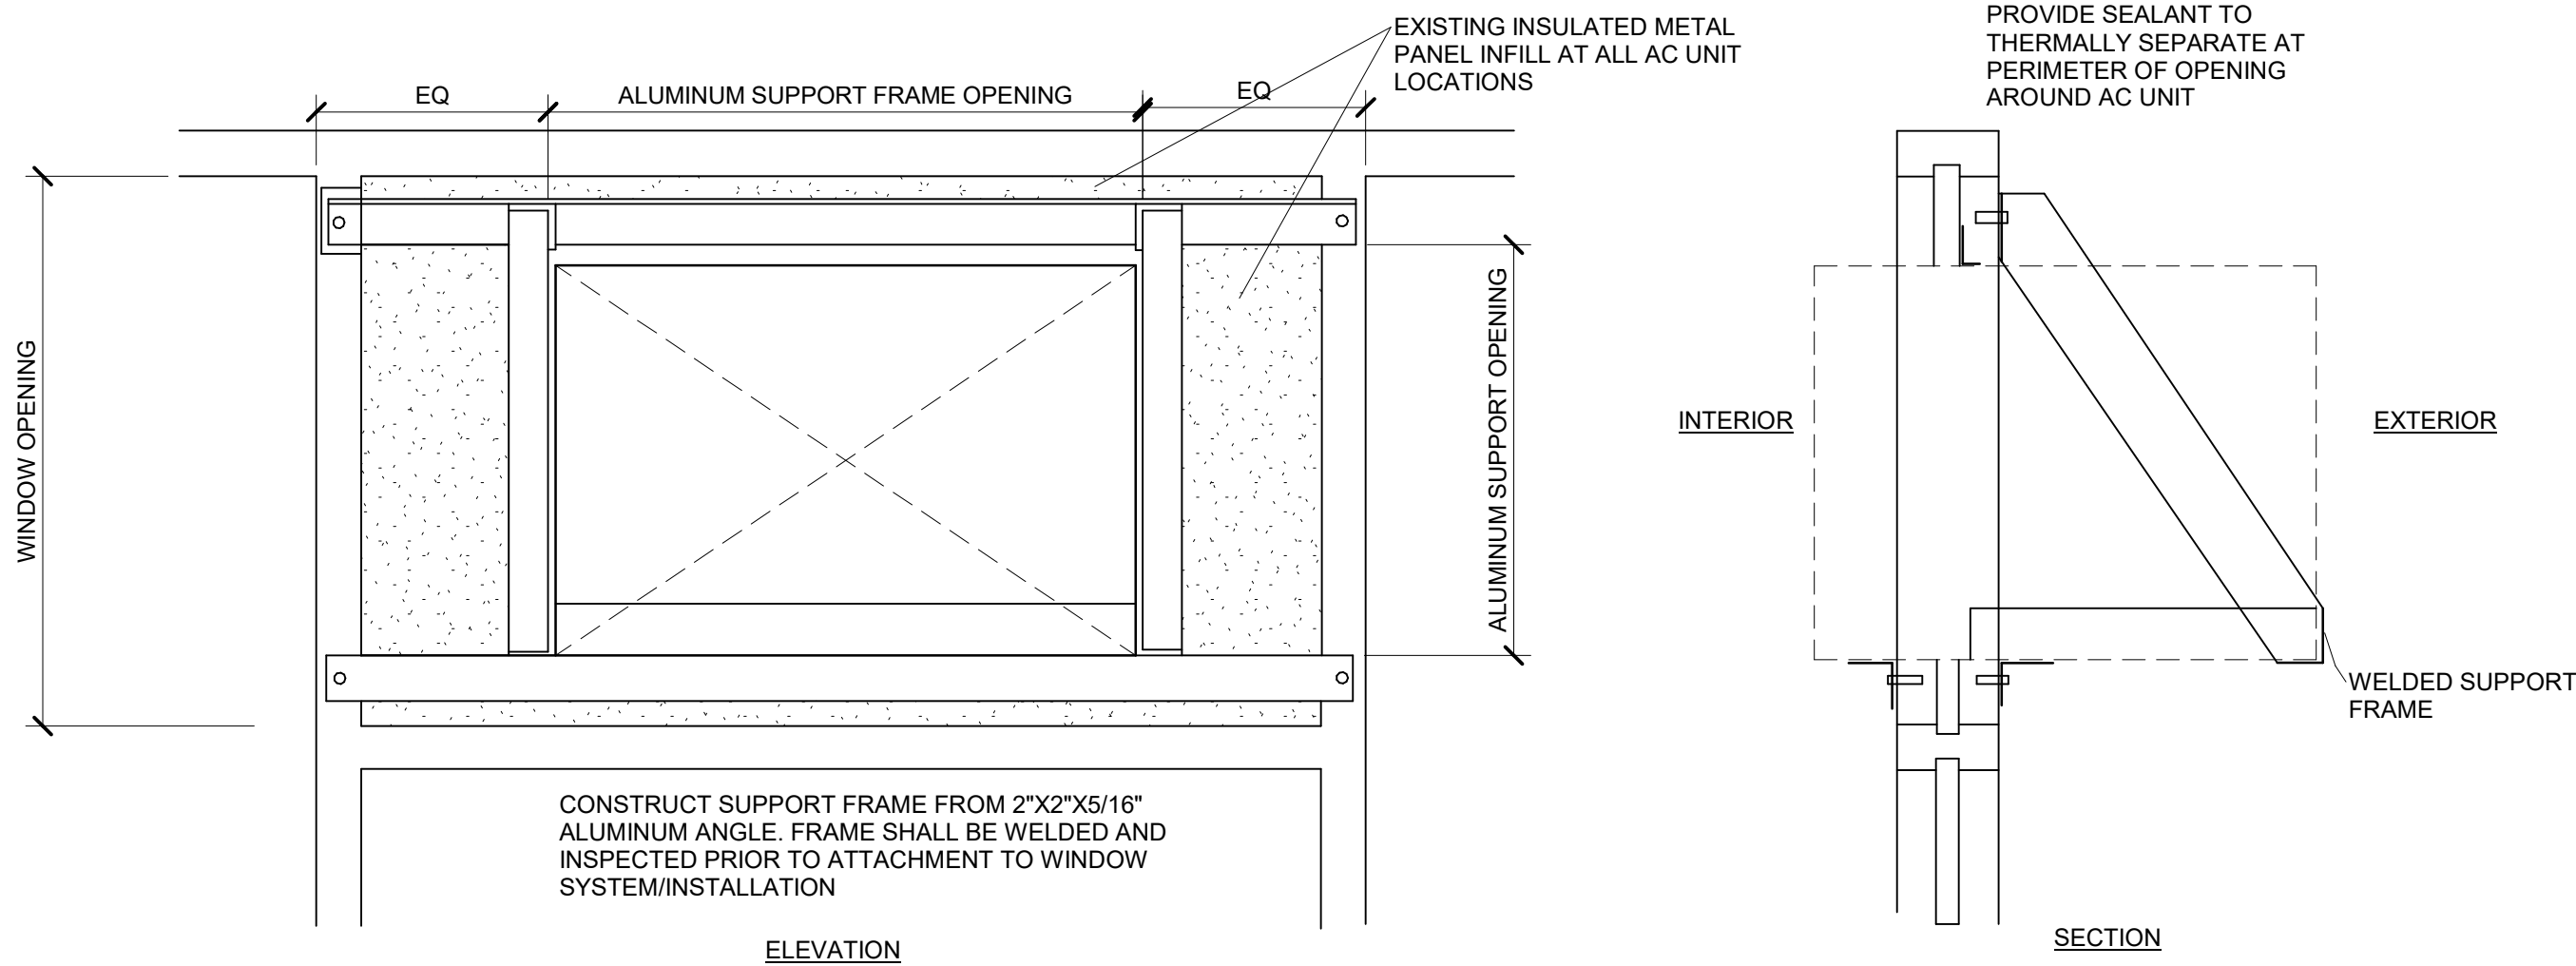
- GENERAL NOTES
- INTERIOR SUPPORT ANGLES TO BE 2"x2"x5/16" ALUMINUM ANGLE FASTENED TO WINDOW FRAMING.
 - WINDOW UNIT TO BE SUPPORTED BY ALUMINUM FRAMING AND INTERIOR ANGLE AND NOT RESTING ON METAL PANEL INFILL MATERIAL.
 - FLASHING SHALL BE 18 GAUGE AND SCREWED THROUGH METAL PANEL INFILL. SEALANT SHALL BE SILICON.
 - ALL FASTENERS SHALL BE STAINLESS STEEL.
 - PAINT ALUMINUM FRAMING AND INTERIOR ANGLE TO MATCH EXISTING FINISHES

1 EXTERIOR AIR CONDITIONING WALL UNIT - INSTALLATION DETAIL

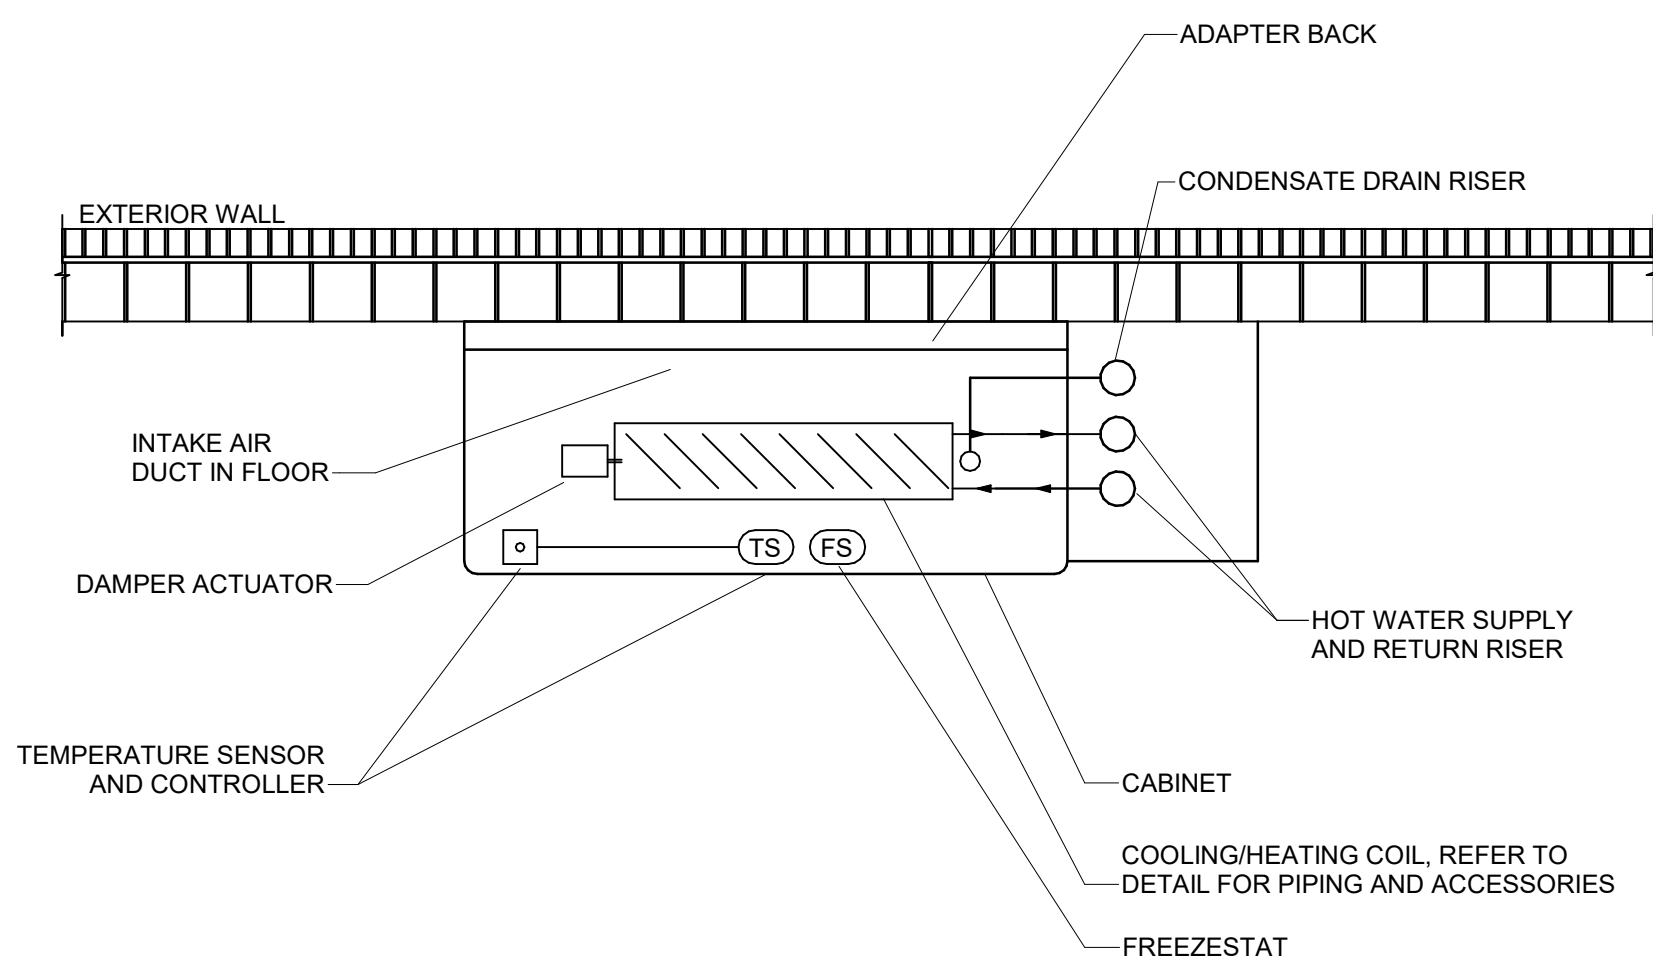
2 UNIT VENTILATOR

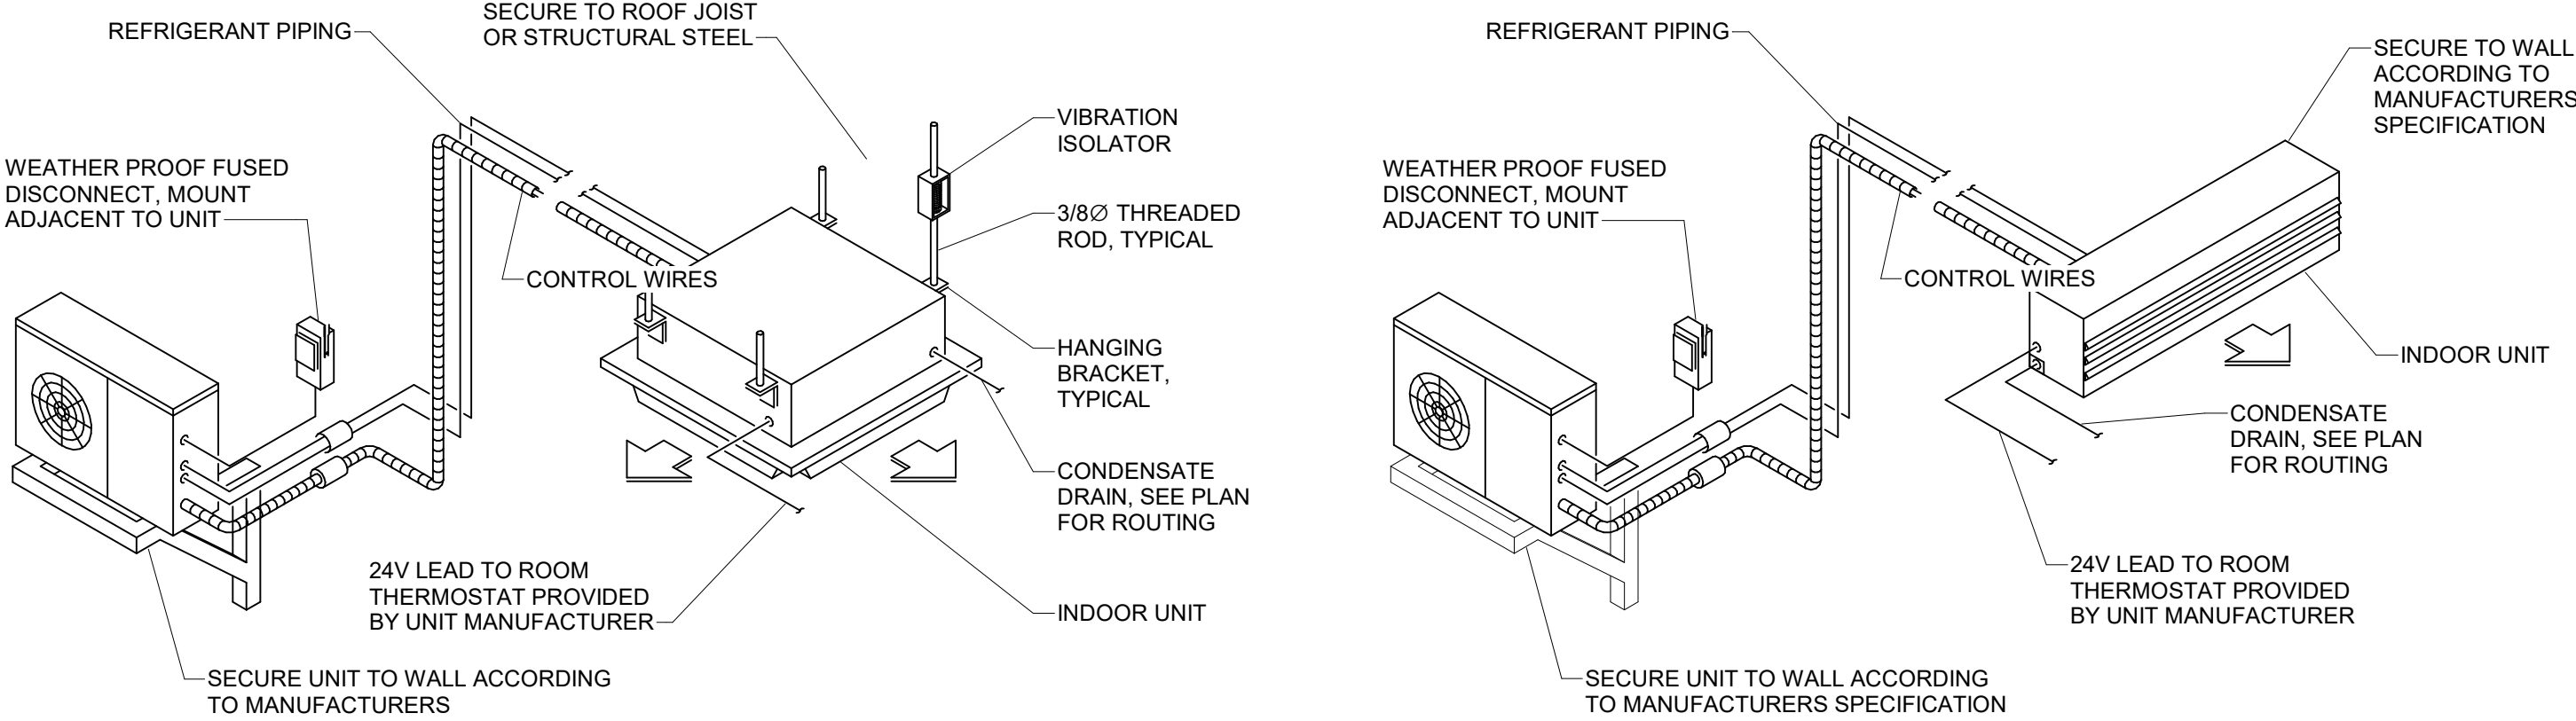
3 DUCTLESS SPLIT SYSTEM WALL MOUNTED INSTALL DETAIL

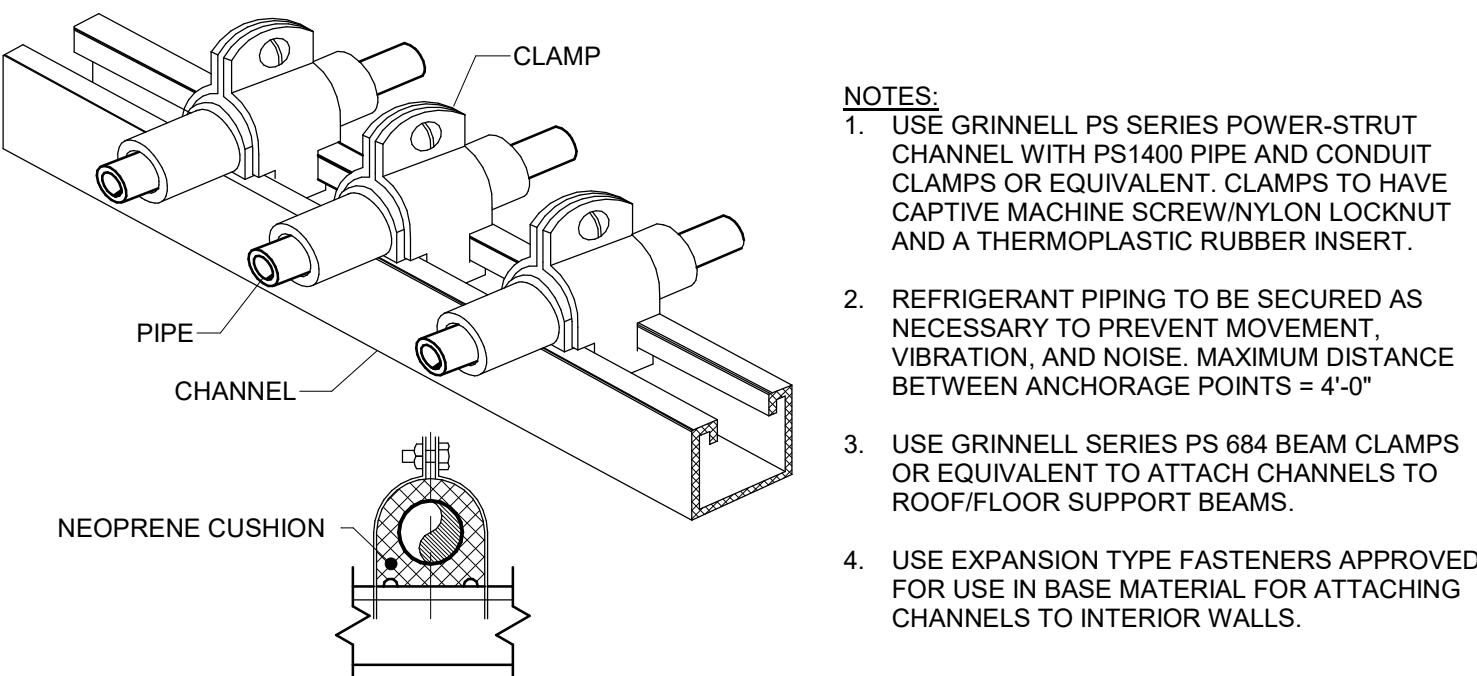
4 REFRIGERANT AND CONDENSATE PIPING SUPPORT DETAIL

INSULATION THICKNESS SCHEDULE							
FLUID OPERATING TEMPERATURE RANGE AND USAGE (°F)		INSULATION CONDUCTIVITY		NOMINAL PIPE OR TUBE SIZE (INCHES)			
		CONDUCTIVITY (BTU-IN/(H-FT²-F))	MEAN RATING TEMP. (°F)	< 1	1 TO < 1.5	1.5 TO < 4	4 TO < 8
COOLING SYSTEMS (CHILLED WATER, REFRIGERANT, AIR CONDITIONING CONDENSATE)							
40 - 60		0.21 - 0.27	75	0.5	0.5	1	1
< 40		0.20 - 0.26	50	0.5	1	1	1.5

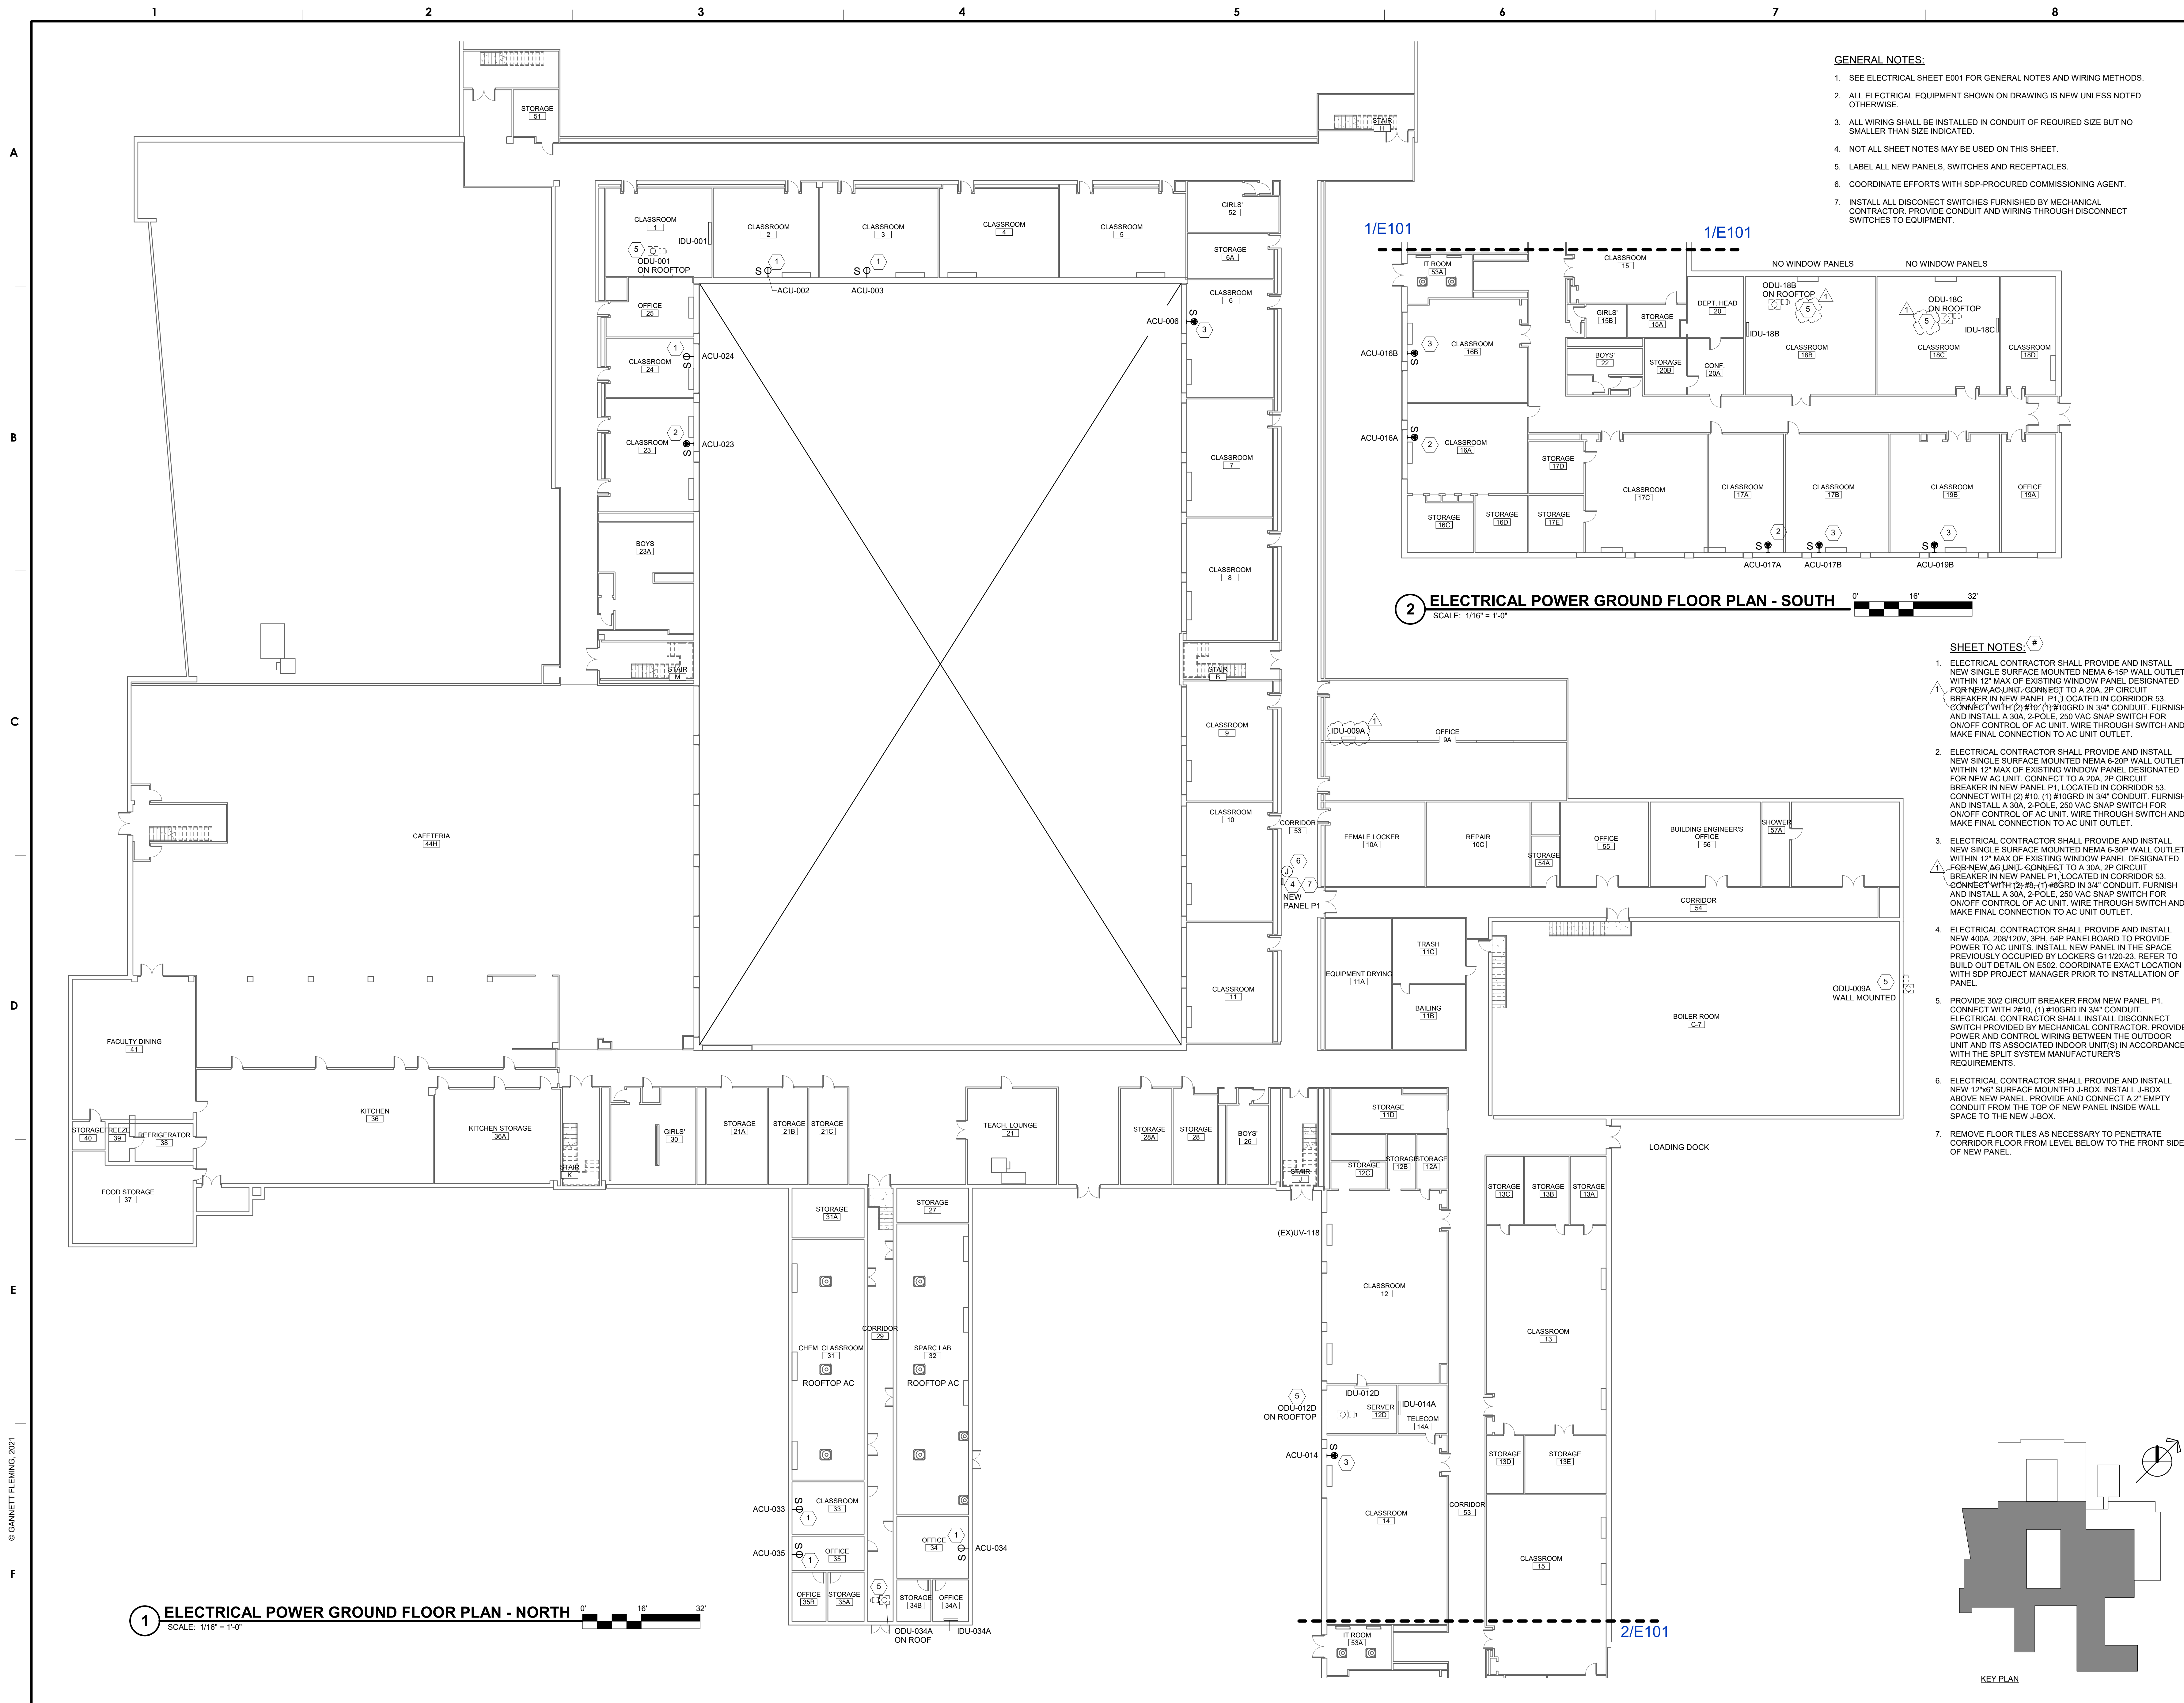
DRAWING NO.
E101
SHEET 12 OF 18

1. SEE ELECTRICAL SHEET E001 FOR GENERAL NOTES AND WIRING METHODS
2. ALL ELECTRICAL EQUIPMENT SHOWN ON DRAWING IS NEW UNLESS NOTED OTHERWISE.
3. ALL WIRING SHALL BE INSTALLED IN CONDUIT OF REQUIRED SIZE BUT NO SMALLER THAN SIZE INDICATED.
4. NOT ALL SHEET NOTES MAY BE USED ON THIS SHEET.
5. LABEL ALL NEW PANELS, SWITCHES AND RECEPTACLES.
6. COORDINATE EFFORTS WITH SDP-PROCURED COMMISSIONING AGENT.
7. INSTALL ALL DISCONNECT SWITCHES FURNISHED BY MECHANICAL CONTRACTOR. PROVIDE CONDUIT AND WIRING THROUGH DISCONNECT SWITCHES TO EQUIPMENT.

Drawing E101, sheet note #1 indicates to connect to a 20/2 CB in new panel P2. Is this the correct panelboard since the ground floor units are shown to connect to panel P1 on drawing E502? If P1 is the correct panelboard, ACU units 033 & 034 are shown with 30/2 CB's Which is correct?

Response: Note #1 on Drawing E101 will be revised to indicate “Panel P1” instead of Panel 2. For Units 033 & 034, the correct CB is 30/2. Panel schedule is correct.

Drawing E101, ACU 035 is shown but not indicated on M501. Is this unit being replaced? PTAC units 035 & 035B are shown on M502 but not on drawing E101 or E502. Are these units being installed?

Response: Drawings E101 & E502 will be updated to show units PTAC-035 & 035B as shown on M101.

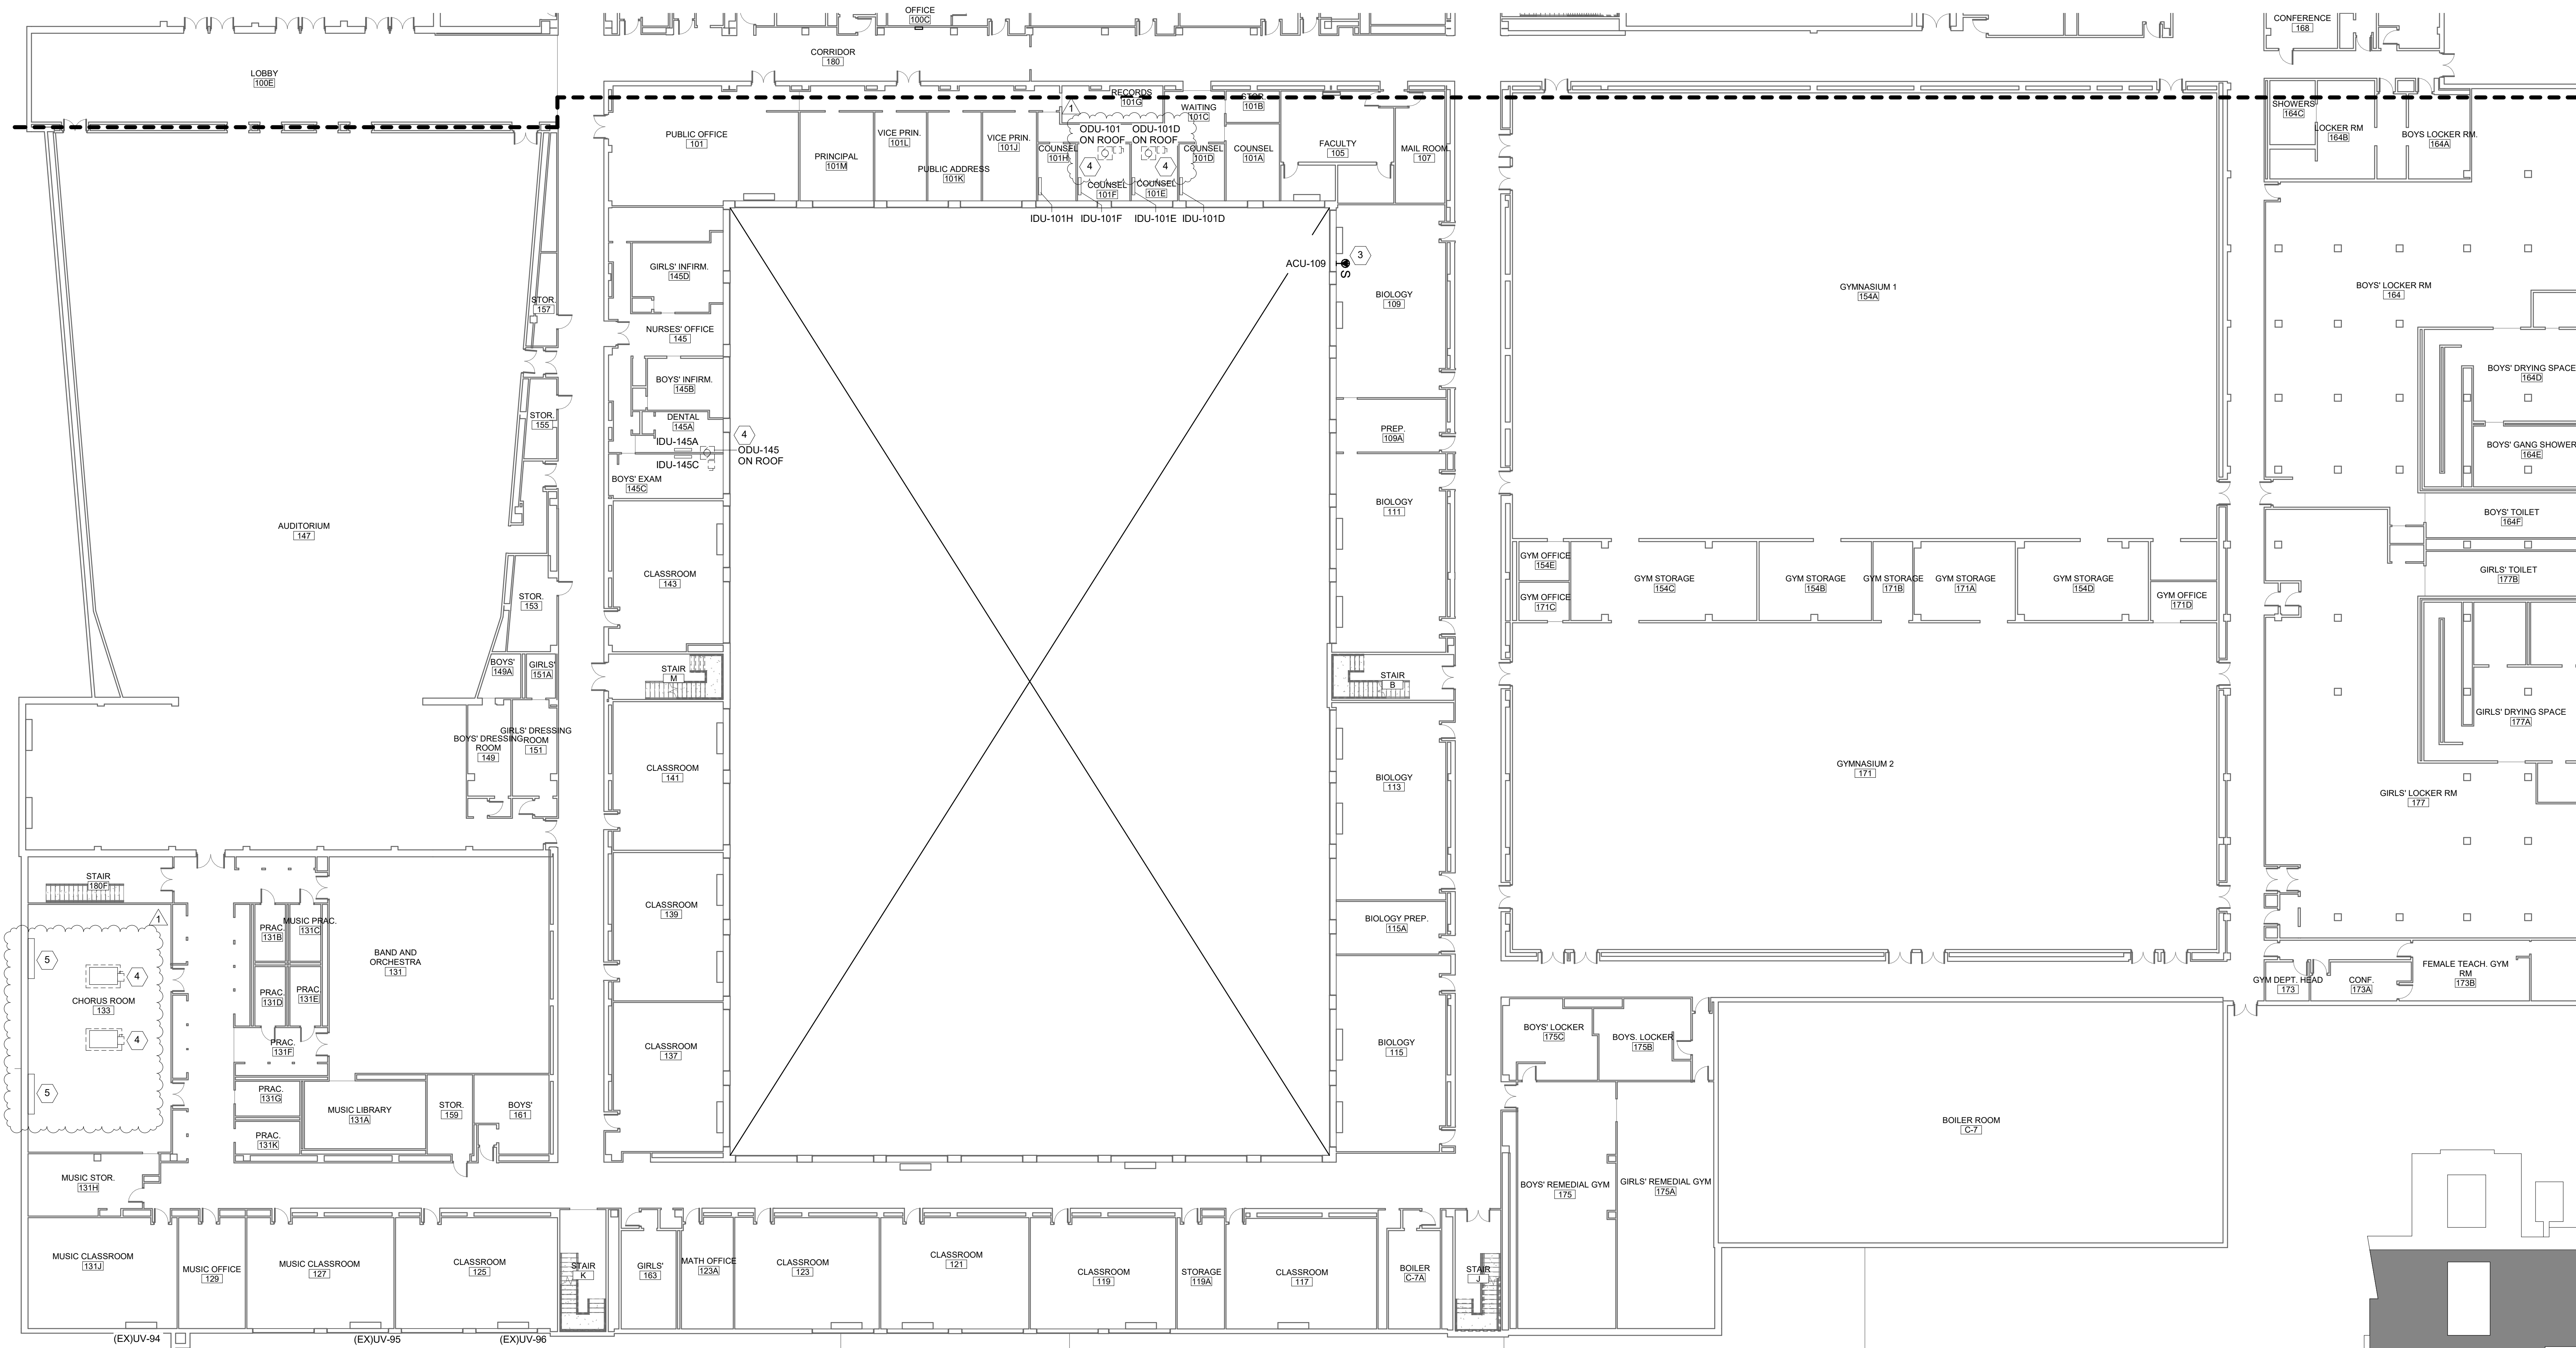
5. ELECTRICAL CONTRACTOR SHALL INSTALL DISCONNECT SWITCH, PROTECT BY MECHANICAL CONTROLLER. PROVIDE POWER AND CONTROL WIRING BETWEEN THE OUTDOOR UNIT AND ASSOCIATED INDUOR UNIT IN ACCORDANCE WITH THE SPLIT SYSTEM MANUFACTURERS REQUIREMENTS.

6. UV UNITS 133-1 AND 133-2. RECONNECT TO EXISTING

1 ELECTRICAL POWER FIRST FLOOR PLAN - SOUTH
SCALE: 1/16" = 1'-0"

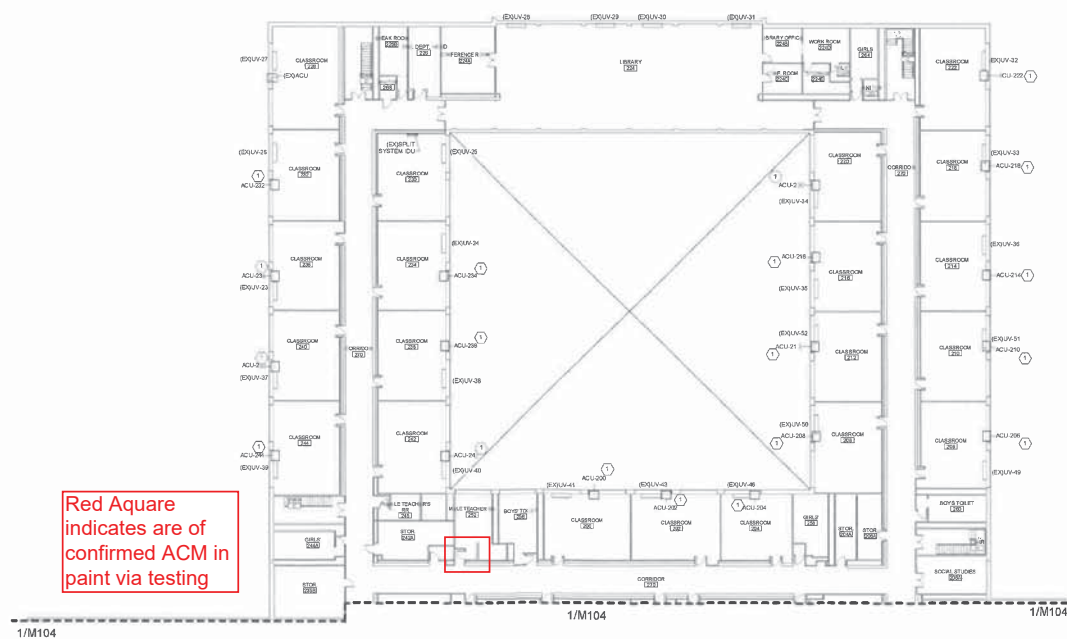
1/M104

Red Square indicates are of confirmed ACM in paint via testing

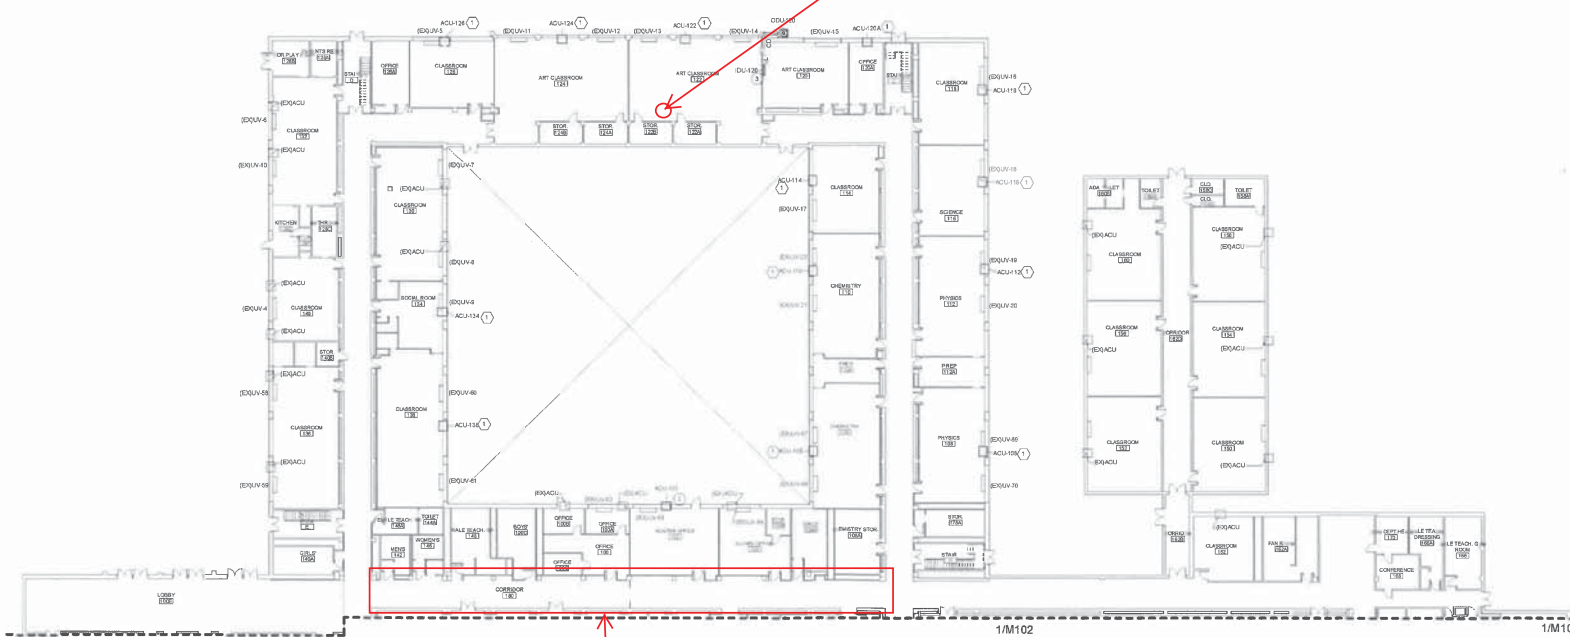
1 MECHANICAL HVAC FIRST FLOOR PLAN - NORTH
