Facility Condition Assessment Summary Report

Emlen School

School District of Philadelphia
S622001;Emlen
Final
Site Assessment Report
January 31, 2017

Site Assessment Report

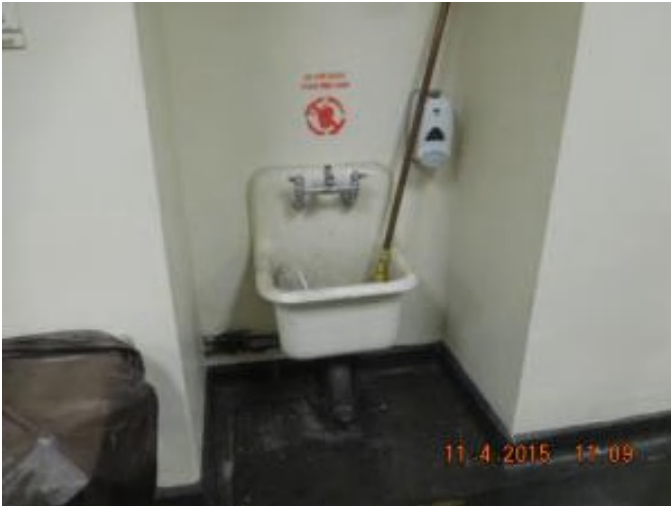
System: D2030 - Sanitary Waste

Location: entire building

Distress: Beyond Service Life

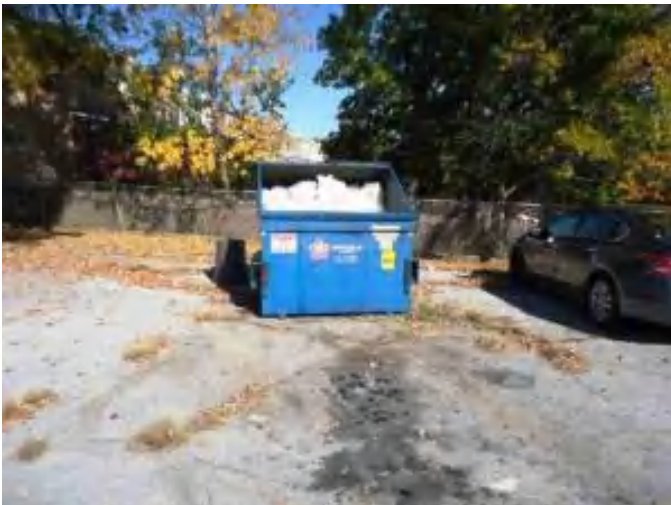
System: G2040 - Site Development

Location: Site

Distress: Health Hazard / Risk

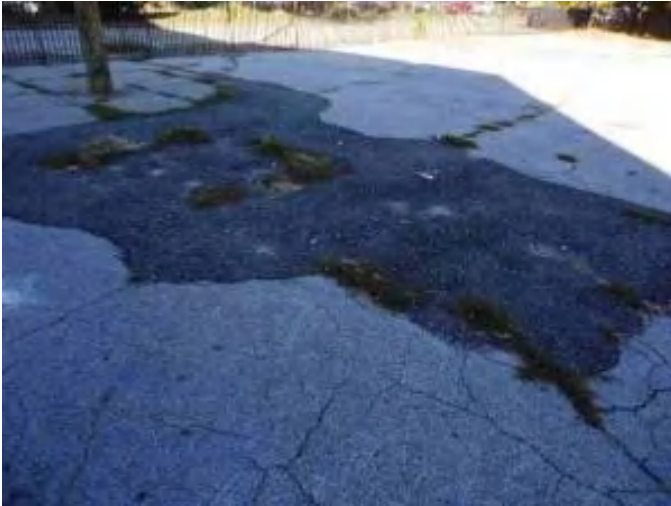
System: G2020 - Parking Lots

Location: Site Parking / Play Area

Distress: Damaged

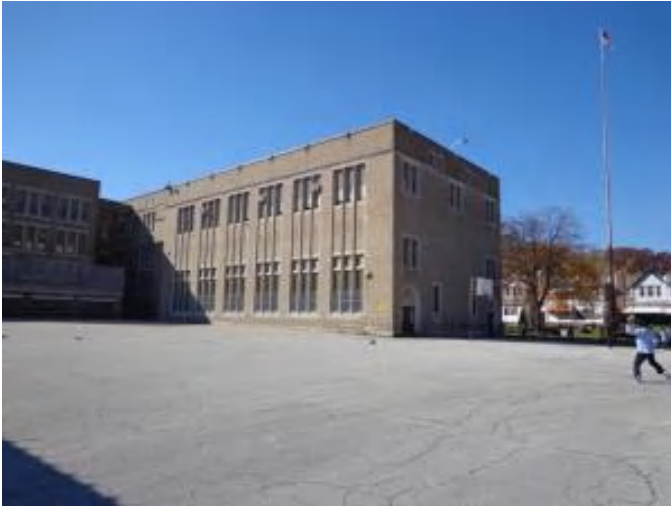
System: G4020 - Site Lighting

Location: Site

Distress: Inadequate

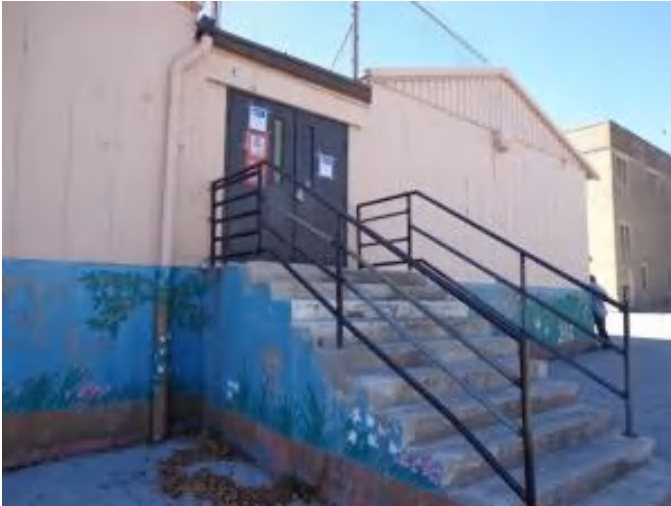
System: G4030 - Site Communications & Security

Location: Site

Distress: Inadequate
