Facility Condition Assessment Summary Report

Allen, Ethan School

S820001;Allen, Ethan

Site Assessment Report

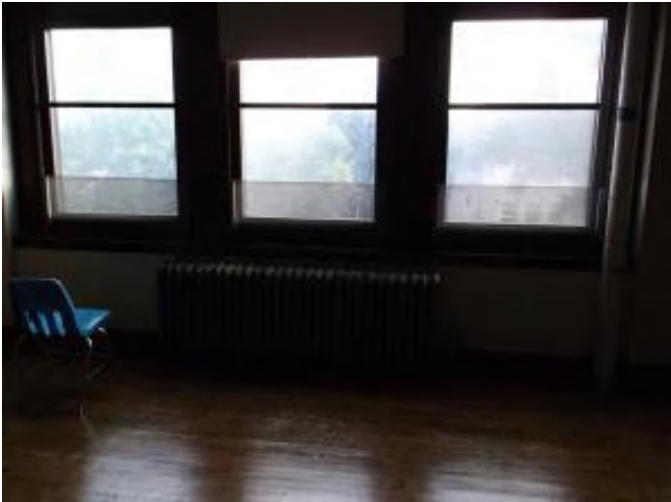
System: D3040 - Distribution Systems

Location: Throughout the building

Distress: Beyond Service Life

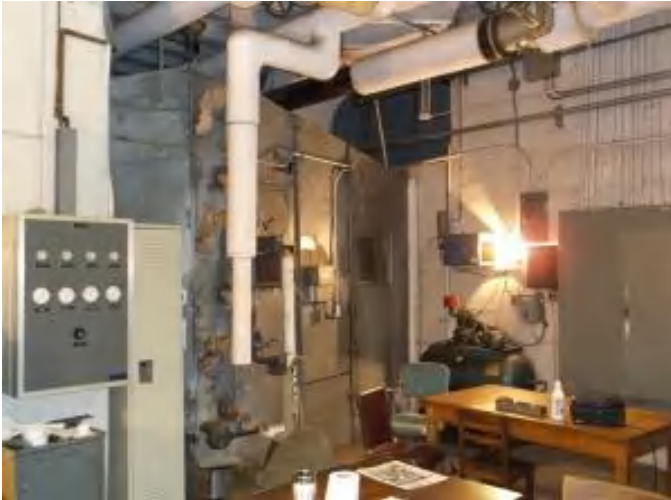
System: D2030 - Sanitary Waste

Location: Throughout the building

Distress: Beyond Service Life

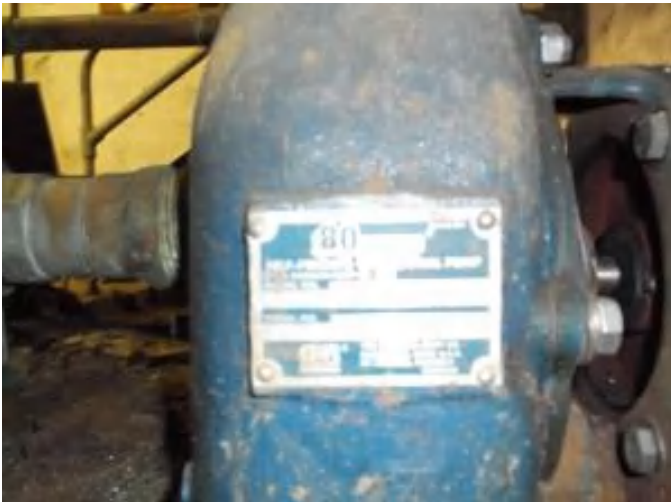
System: D3040 - Distribution Systems

Location: Throughout the building

Distress: Beyond Service Life

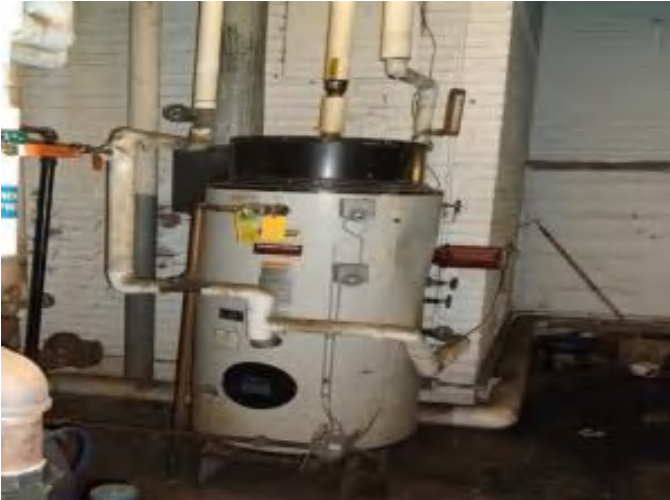
System: D2020 - Domestic Water Distribution

Location: Boiler Mechanical Equipment Room

Distress: Beyond Service Life

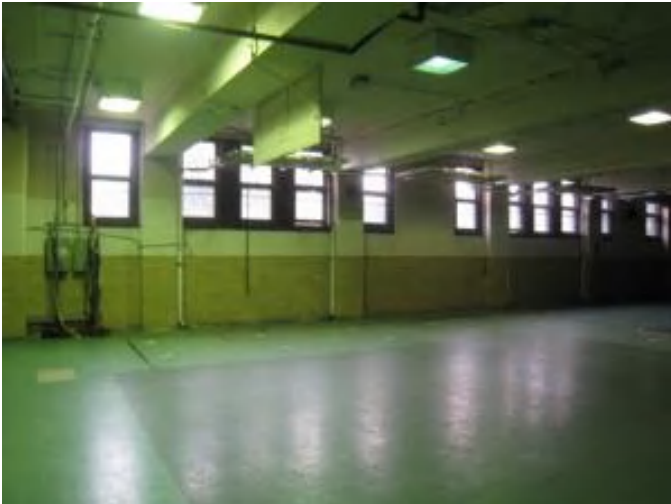
System: D3040 - Distribution Systems

Location: Gym

Distress: Beyond Service Life

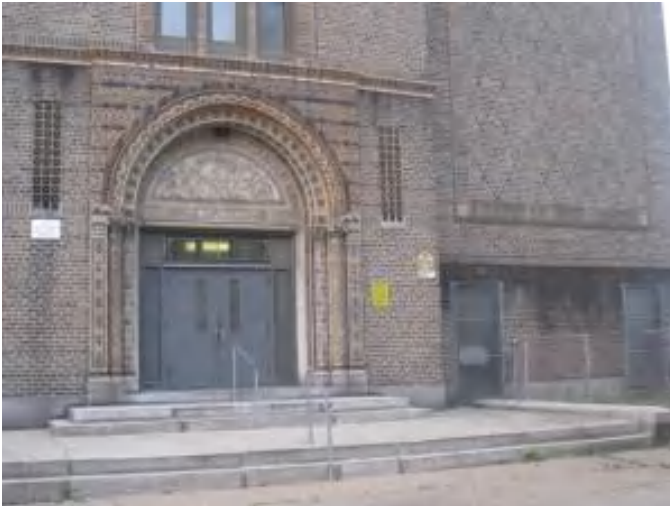
System: G2030 - Pedestrian Paving

Location: front door

Distress: Accessibility
