School District of Philadelphia

# **S101001; Bartram and Tilden**

## **Site Assessment Report**

January 30, 2017

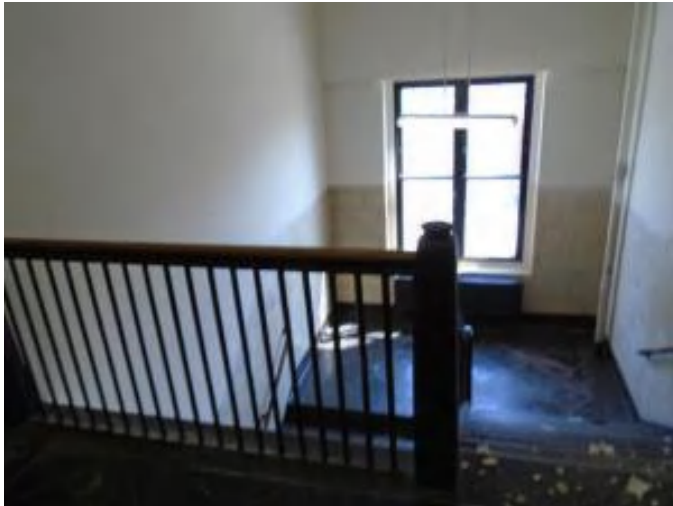
**System: C2010 - Stair Construction**

**Location:** Stairs

**Distress:** Building / MEP Codes

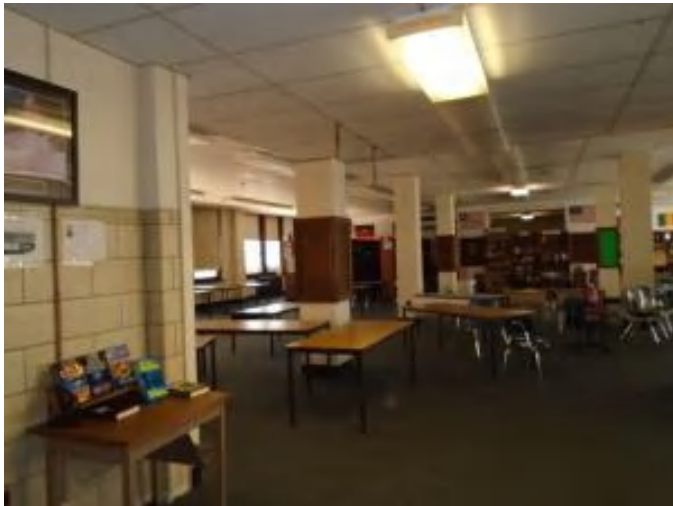
**System: C3020411 - Carpet**

**Location:** IMC, music, offices

**Distress:** Beyond Service Life

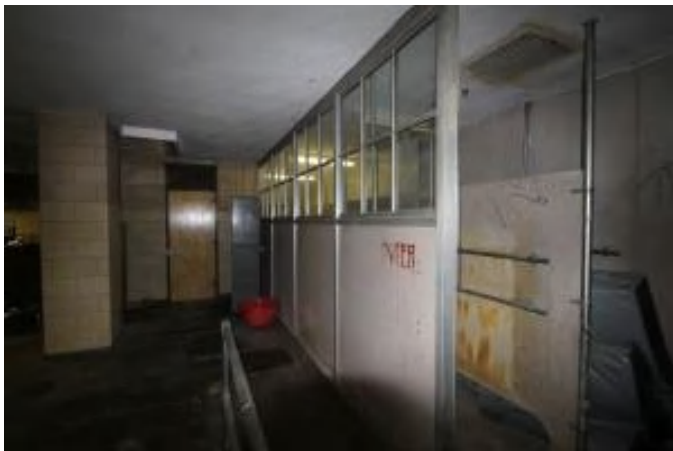
**System: D2010 - Plumbing Fixtures**

**Location:** Basement

**Distress:** Beyond Service Life

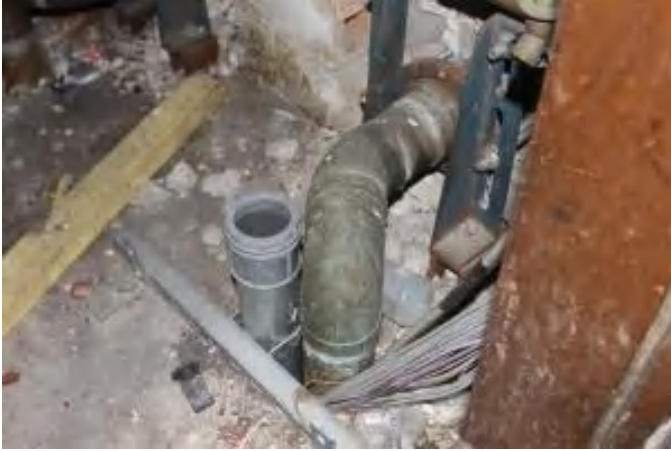
**System: D2030 - Sanitary Waste**

**Location:** Entire building

**Distress:** Beyond Service Life

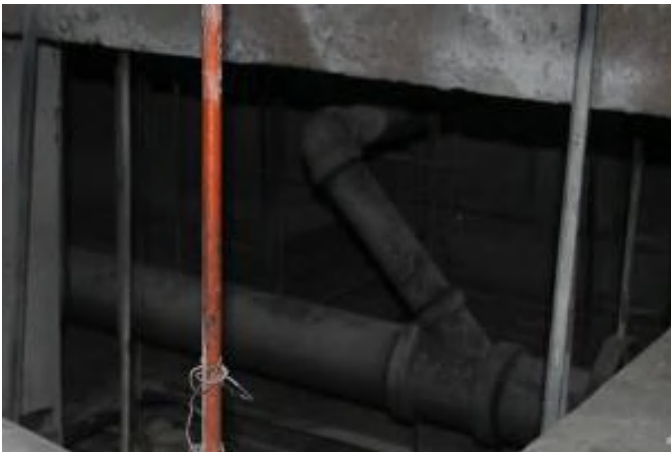
**System: D2040 - Rain Water Drainage**

**Location:** Entire building

**Distress:** Beyond Service Life

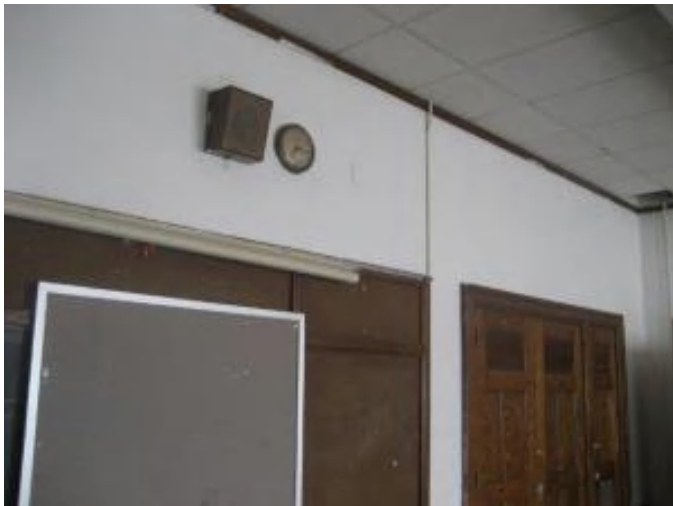
**System: D5030 - Communications and Security**

**Location:** Entire Building

**Distress:** Obsolete

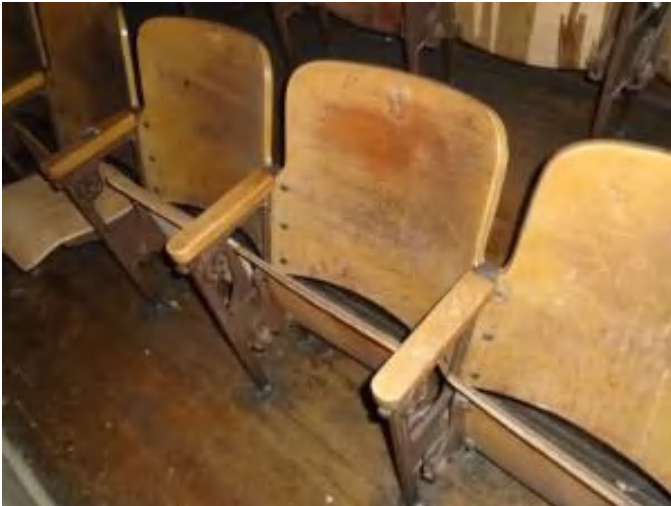
**System: E2010 - Fixed Furnishings**

**Location:** Auditorium, balcony

**Distress:** Beyond Service Life

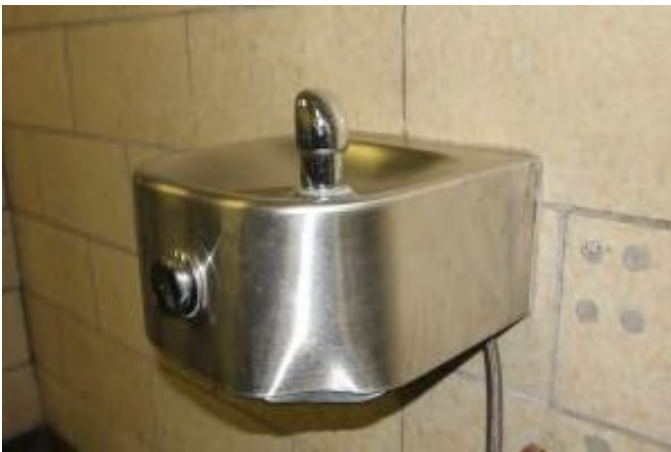
**System: D2010 - Plumbing Fixtures**

**Location:** Corridors

**Distress:** Accessibility

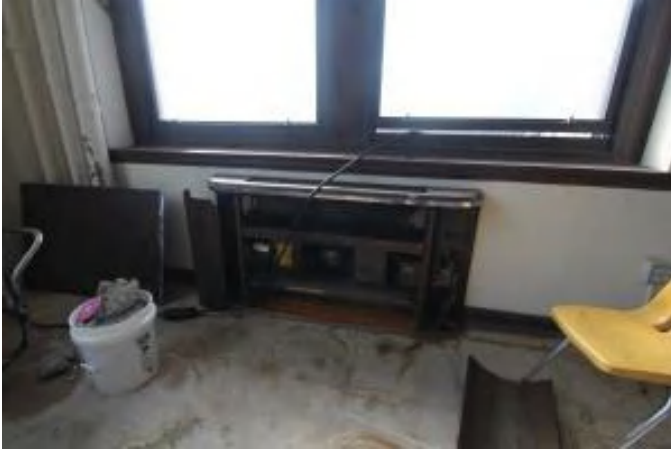
**System: D3040 - Distribution Systems**

**Location:** Entire building

**Distress:** Beyond Service Life

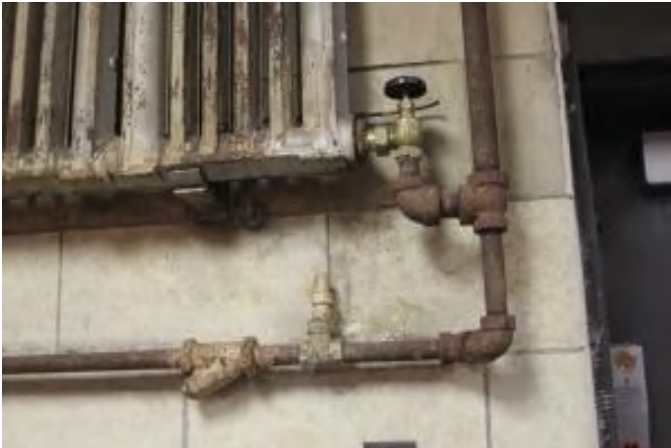
**System: D3040 - Distribution Systems**

**Location:** Entire building

**Distress:** Beyond Service Life

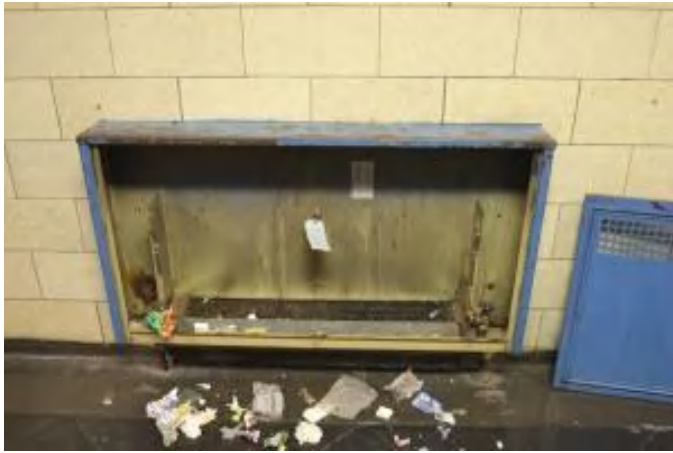
**System: D3040 - Distribution Systems**

**Location:** Fan rooms

**Distress:** Beyond Service Life

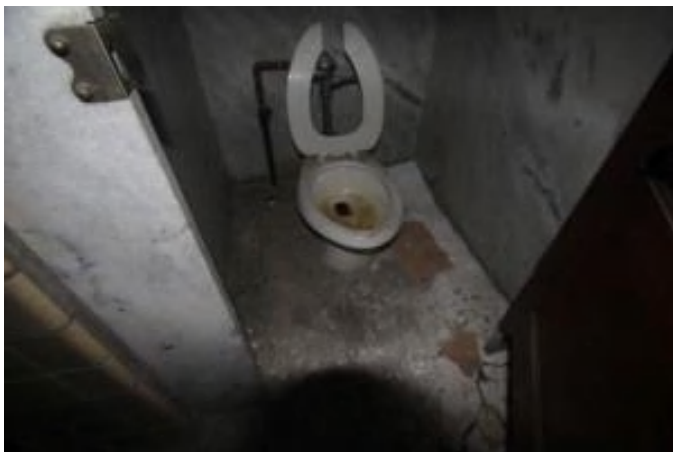
**System: D2010 - Plumbing Fixtures**

**Location:** Toilet rooms

**Distress:** Beyond Service Life

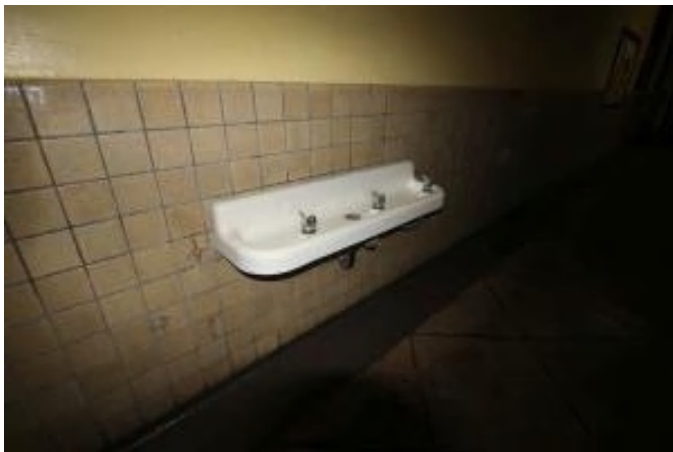
**System: D2010 - Plumbing Fixtures**

**Location:** Hallways

**Distress:** Accessibility

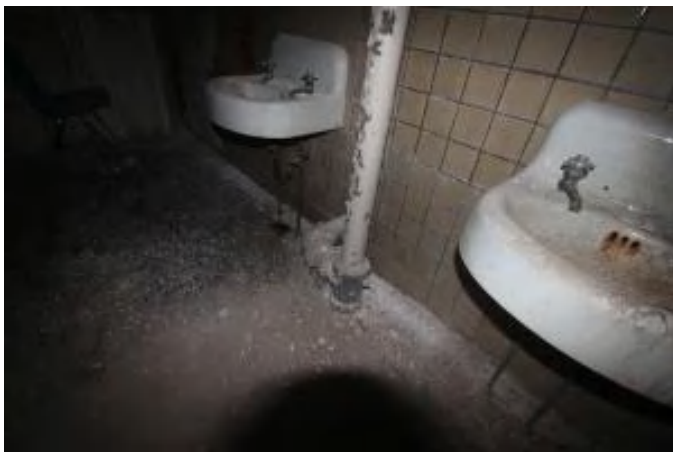
**System: D2010 - Plumbing Fixtures**

**Location:** Toilet rooms and classrooms

**Distress:** Beyond Service Life

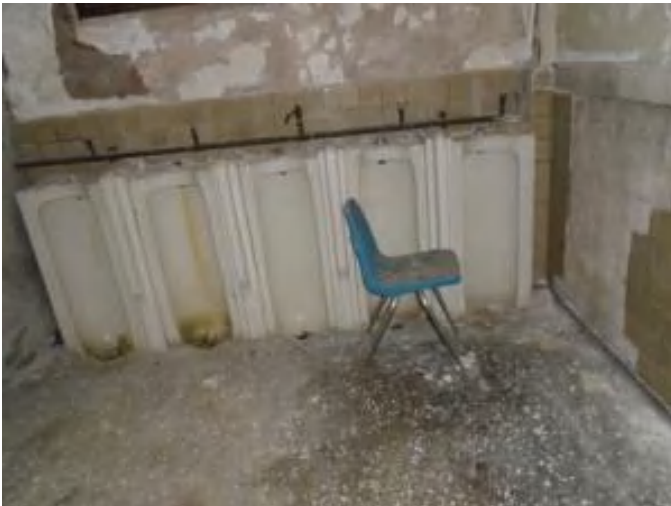
**System: D2010 - Plumbing Fixtures**

**Location:** Toilet rooms

**Distress:** Building / MEP Codes

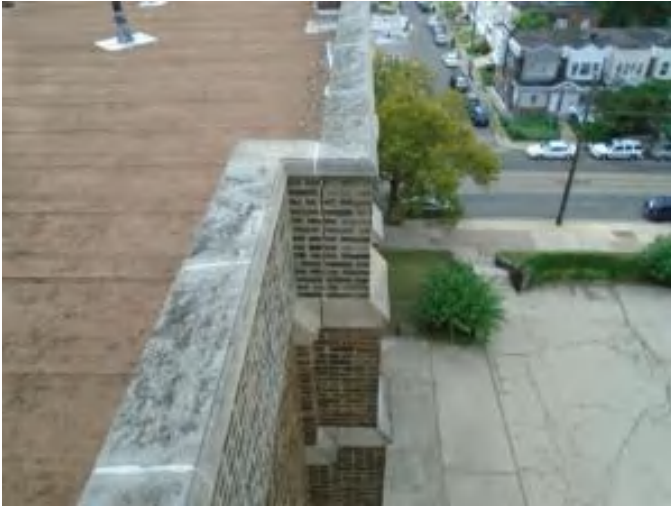
**System: B2010 - Exterior Walls**

**Location:** Roof

**Distress:** Maintenance Required

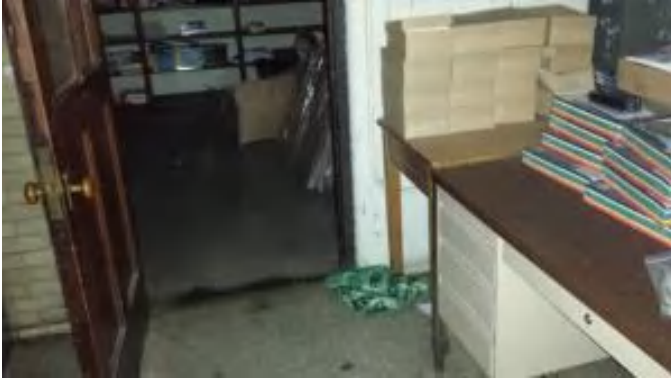
**System: C1020 - Interior Doors**

**Location:** Storage doors

**Distress:** Not Reliable

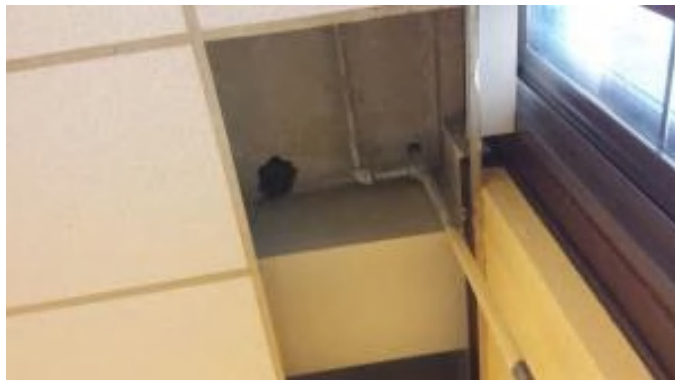
**System: C3030 - Ceiling Finishes**

**Location:** Various

**Distress:** Beyond Service Life

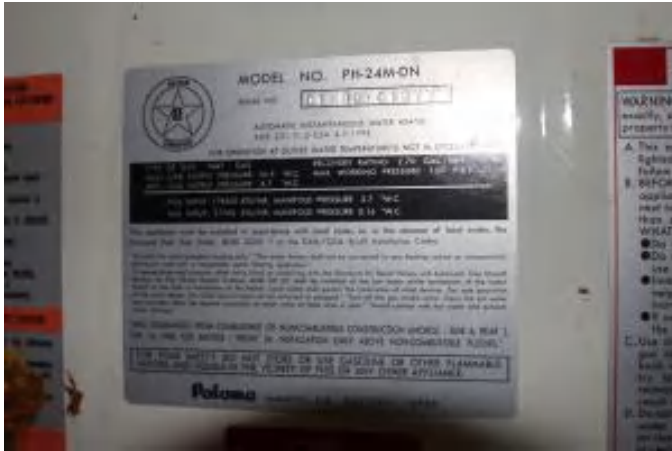
**System: D2020 - Domestic Water Distribution**

**Location:** Basement

**Distress:** Building / MEP Codes

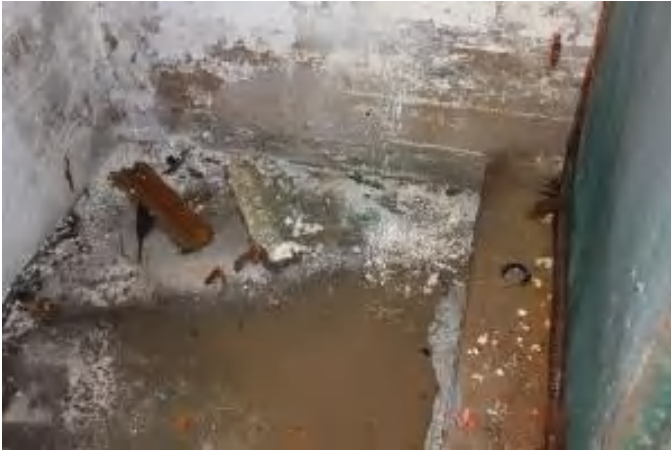
**System: D2020 - Domestic Water Distribution**

**Location:** Entire building

**Distress:** Beyond Service Life

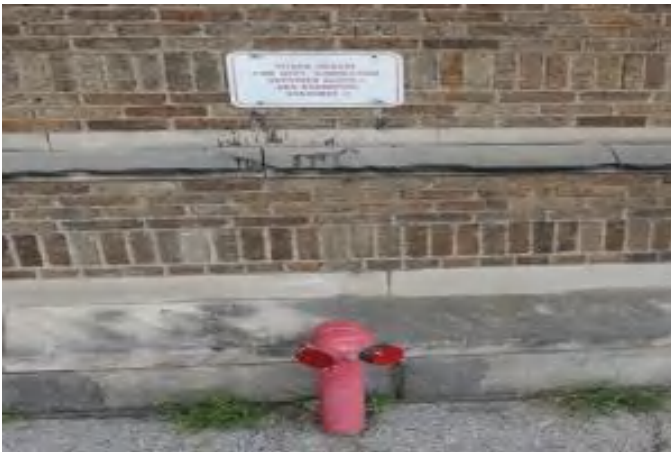
**System: D4010 - Sprinklers**

**Location:** Entire building.

**Distress:** Life Safety / NFPA / PFD

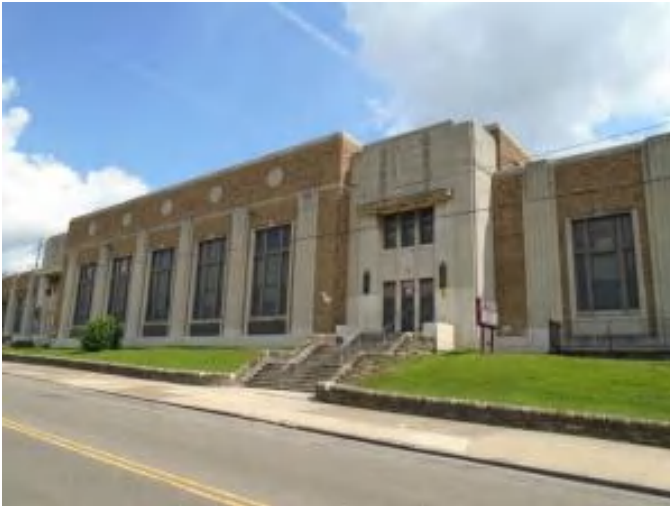
#### System: G2030 - Pedestrian Paving

**Location:** Entrance

**Distress:** Accessibility

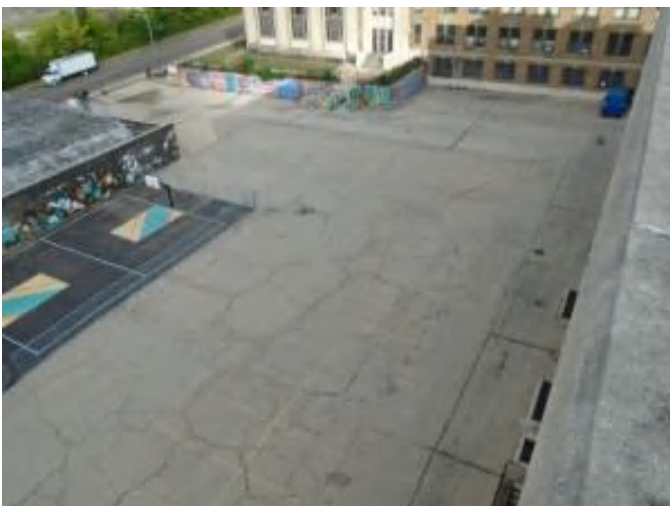
#### System: G2040 - Site Development

**Location:** Yard

**Distress:** Security Issue

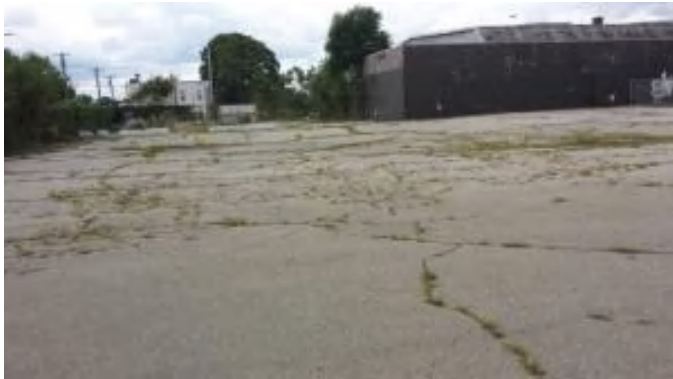
**System: G2030 - Pedestrian Paving**

**Location:** Yard

**Distress:** Maintenance Required
