## Facility Condition Assessment Summary Report

### Cassidy School

School District of Philadelphia  
**S424001;Cassidy**  
Final  
**Site Assessment Report**  
January 30, 2017

Facility Assessment  
October 26<sup>th</sup>, 2015

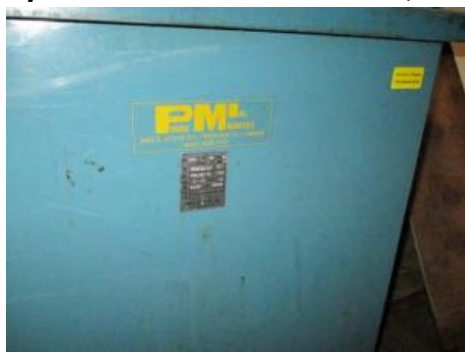
**System:** D5010 - Electrical Service/Distribution

**Note:** Phase converter manufactured by PMI, rated 37.5KVA 240/120-208V

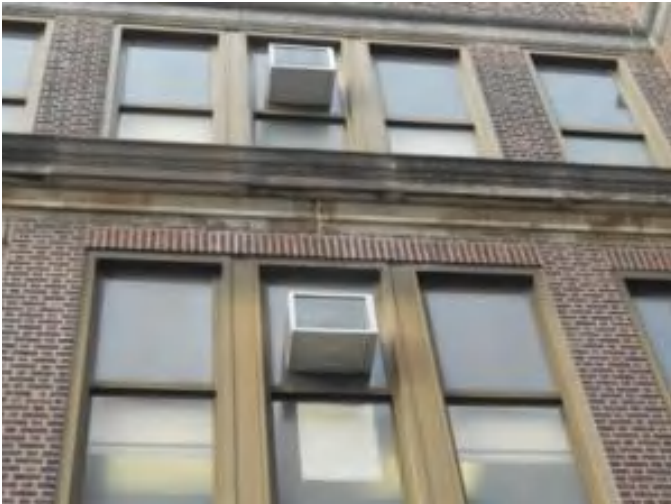
**System: B2020 - Exterior Windows**

**Location:** Exterior windows

**Distress:** Beyond Service Life

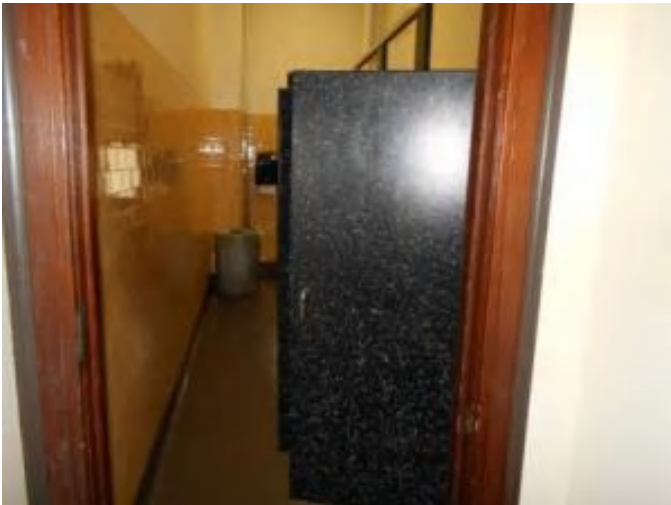
**System: C1010 - Partitions**

**Location:** Student Toilet Rooms

**Distress:** Accessibility

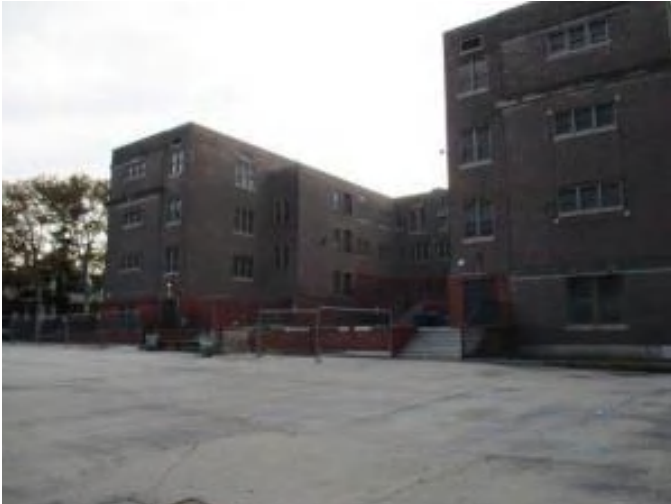
**System: G4030 - Site Communications & Security**

**Location:** Building Perimeter

**Distress:** Security Issue
