Facility Condition Assessment Summary Report

Catharine School

Catharine Annex (St Vincents) School

January 30, 2017

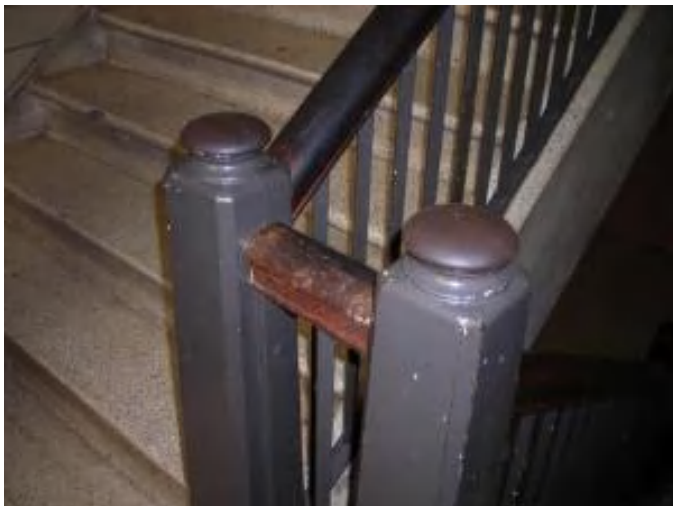
Location: Stairways

System: C2010 - Stair Construction

Distress: Building / MEP Codes

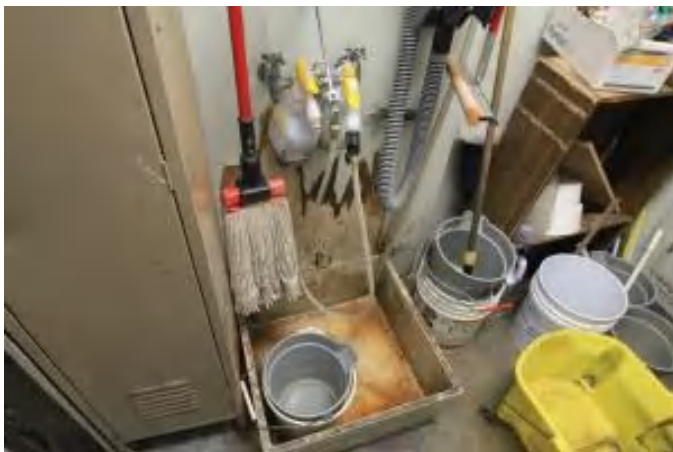
Location: Janitor closets

System: D2010 - Plumbing Fixtures

Distress: Beyond Service Life

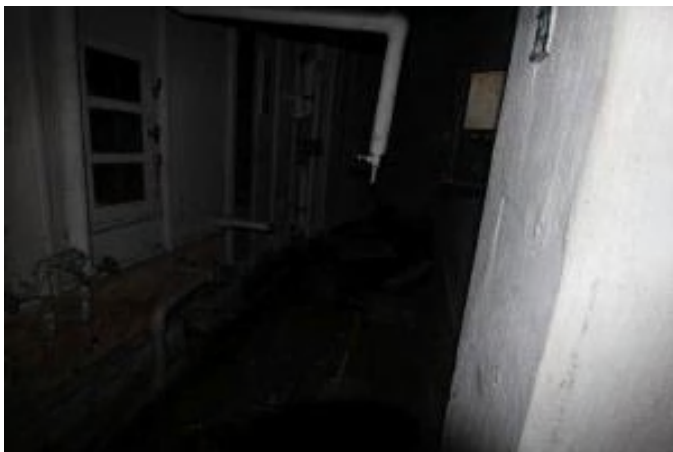
Location: Mechanical room

System: D3040 - Distribution Systems

Distress: Obsolete

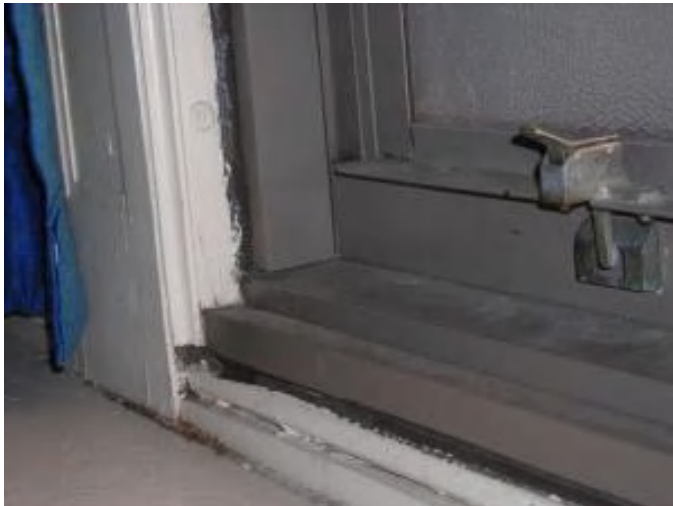
Location: Entire Building

System: B2020 - Exterior Windows

Distress: Energy Efficiency

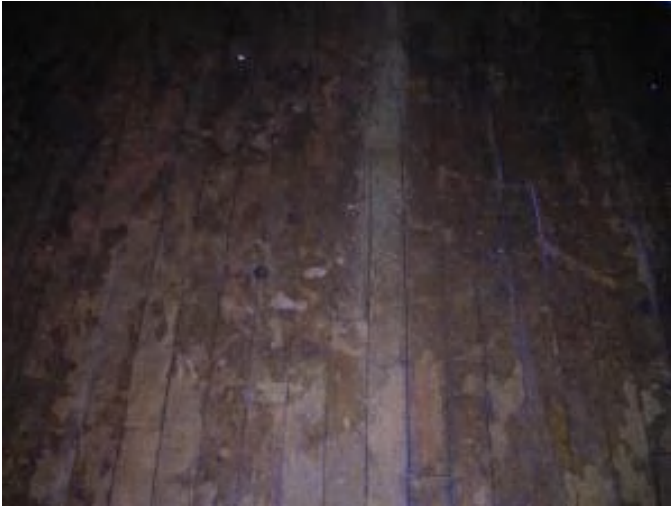
Location: Auditorium, classrooms

System: C3020414 - Wood Flooring

Distress: Appearance

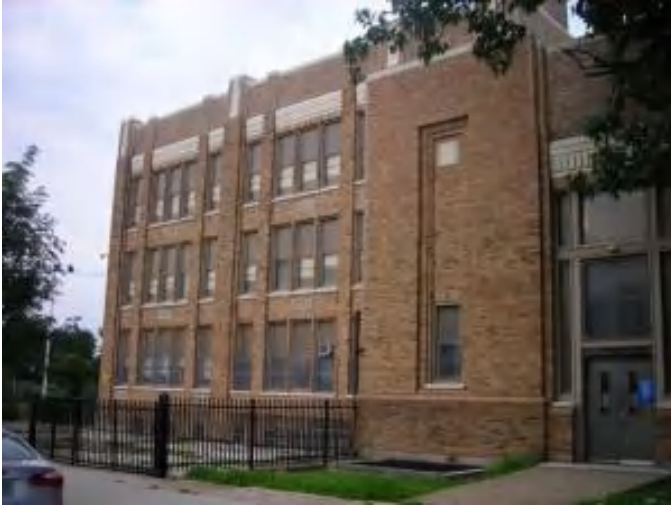
Location: Ext. Entrance

System: G2030 - Pedestrian Paving

Distress: Accessibility
