Facility Condition Assessment Summary Report

Conwell School

Conwell Annex School

School District of Philadelphia
S523001;Conwell
Final
Site Assessment Report
February 2, 2017

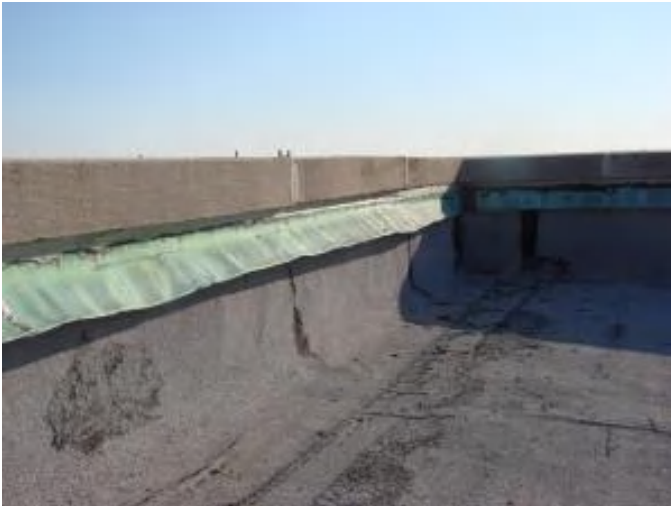
System: B3010105 - Built-Up

Location: Exterior

Distress: Building Envelope Integrity

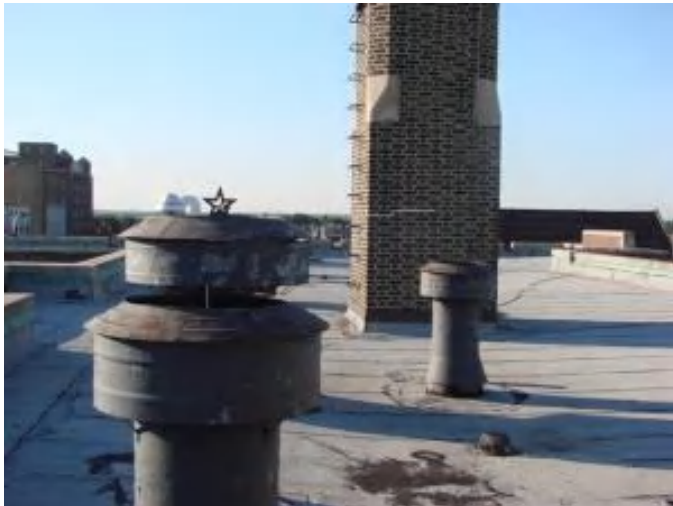
System: B2010 - Exterior Walls

Location: Exterior

Distress: Building Envelope Integrity

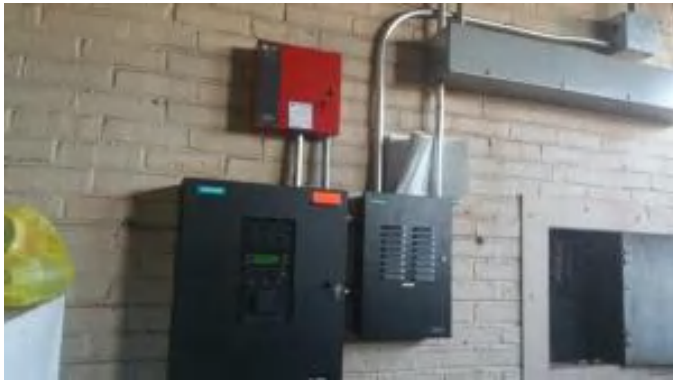
System: D5030 - Communications and Security

Location: Throughout the building

Distress: Building / MEP Codes

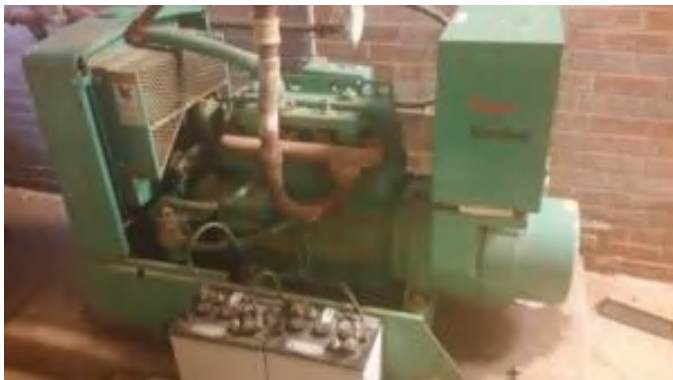
System: D5090 - Other Electrical Systems

Location: Electrical Room (in the basement)

Distress: Building / MEP Codes

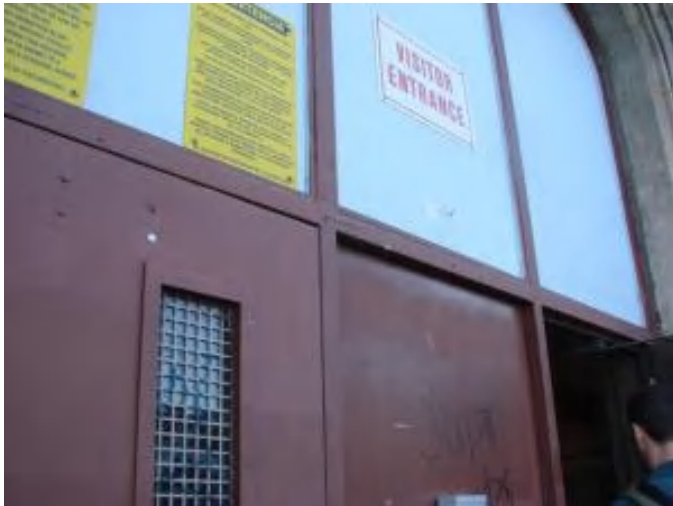
System: B2030 - Exterior Doors

Location: Exterior

Distress: Beyond Service Life

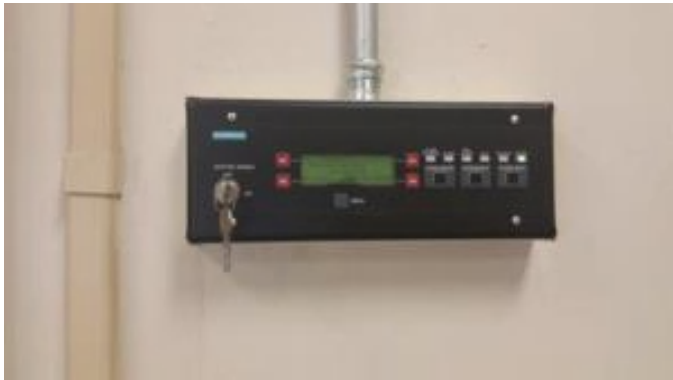
System: D5030 - Communications and Security

Location: Indors/ Outdoors

Distress: Security Issue

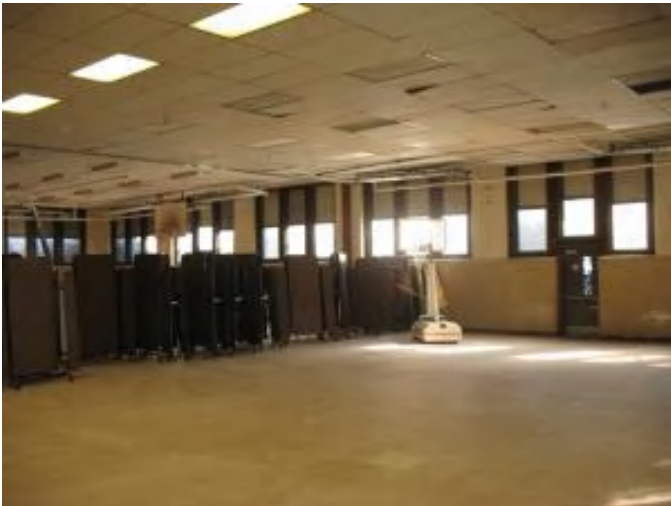
System: D3040 - Distribution Systems

Location: Cafeteria/Gymnasium

Distress: Building / MEP Codes

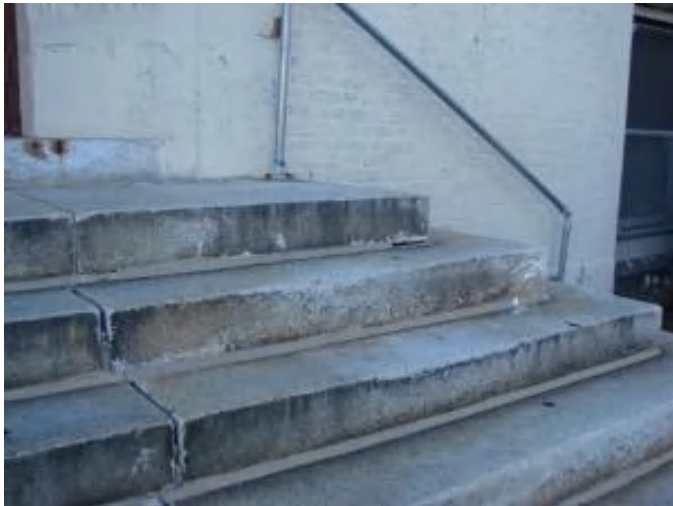
System: G2030 - Pedestrian Paving

Location: Grounds/ site

Distress: Maintenance Required

Notes: Reset stone stoops and stairs at all entrances

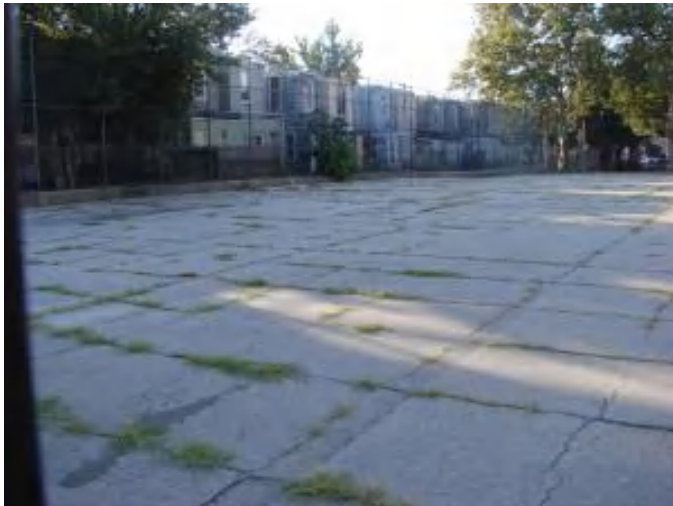
System: G2030 - Pedestrian Paving

Location: Grounds/ site

Distress: Beyond Service Life

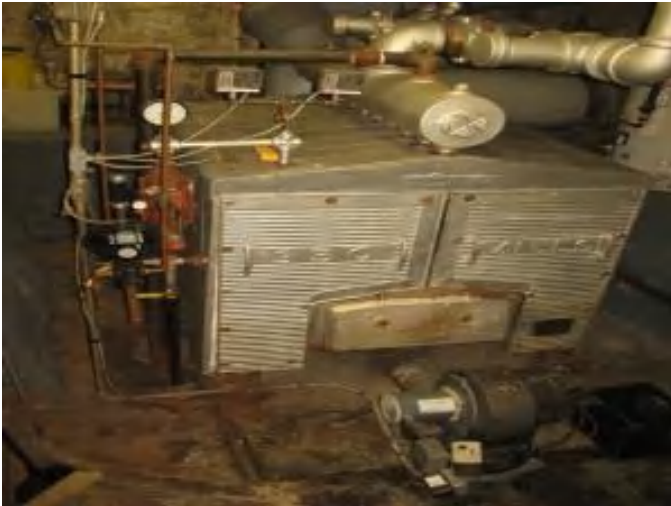
Location: Boiler room

System: D3020 - Heat Generating Systems

Distress: Beyond Service Life

Correction: Replace boiler, cast iron sectional (50 HP)

Notes: Replace the one existing 1,005MBH cast iron boiler, which is beyond its service life, burners, and exhaust ductwork.

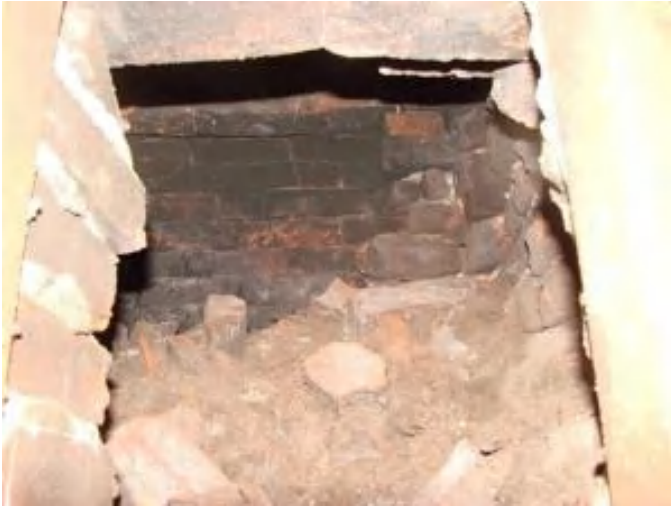
Location: Exterior

System: B2010 - Exterior Walls

Distress: Building Envelope Integrity

Correction: Repair cracks in masonry - replace missing mortar and repoint - SF of wall area

Notes: Repair cracks in masonry, replace missing mortar, tuck-point original building – all walls, window pilasters in basement and chimney

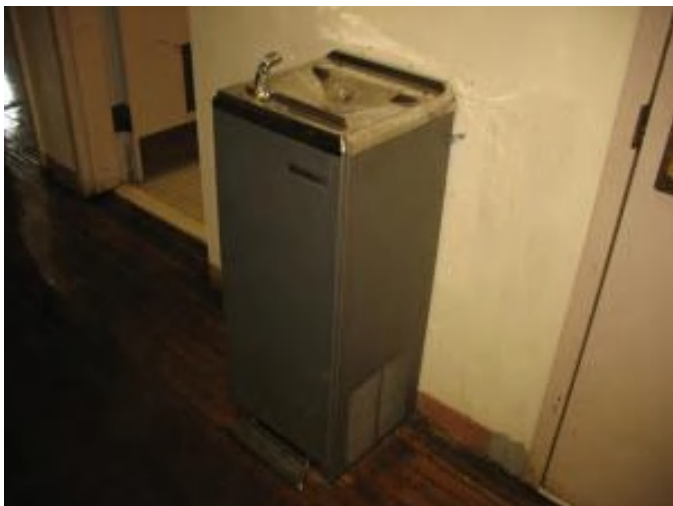
Location: Corridors

System: D2010 - Plumbing Fixtures

Distress: Beyond Service Life

Correction: Remove and Replace Water Fountains - without ADA new recessed alcove

Notes: Replace two (2) wall hung drinking fountains and integral refrigerated coolers in the corridors. These units are beyond their service life and are NOT accessible type.

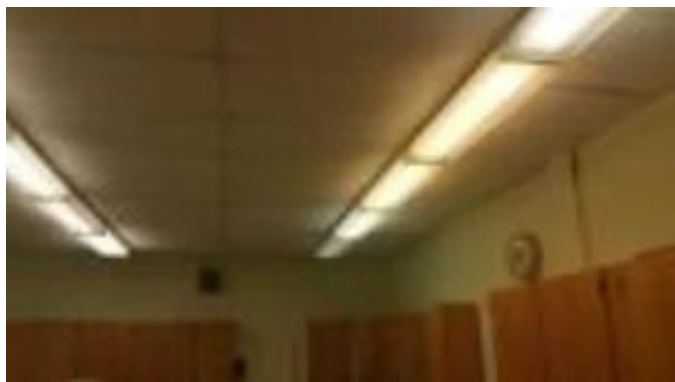
Location: throughout the building

System: D5020 - Lighting and Branch Wiring

Distress: Beyond Service Life

Correction: Replace Lighting Fixtures (SF)

Notes: Install new lighting system for the entire building

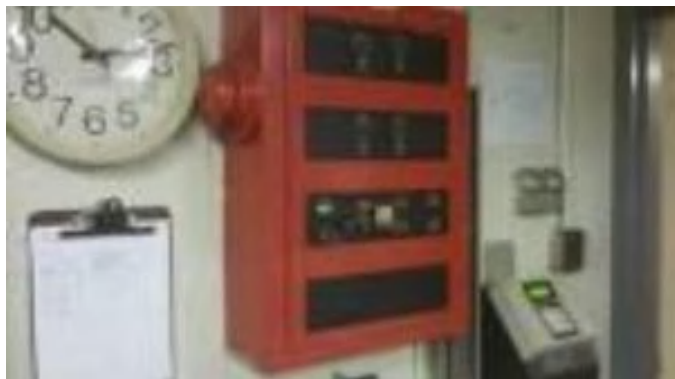
Location: throughout the building

System: D5030 - Communications and Security

Distress: Beyond Service Life

Correction: Replace fire alarm system

Notes: Install new automated FA system

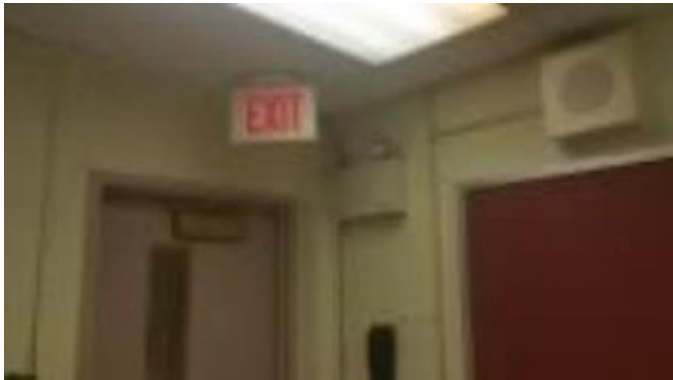
Location: throughout the building

System: D5090 - Other Electrical Systems

Distress: Life Safety / NFPA / PFD

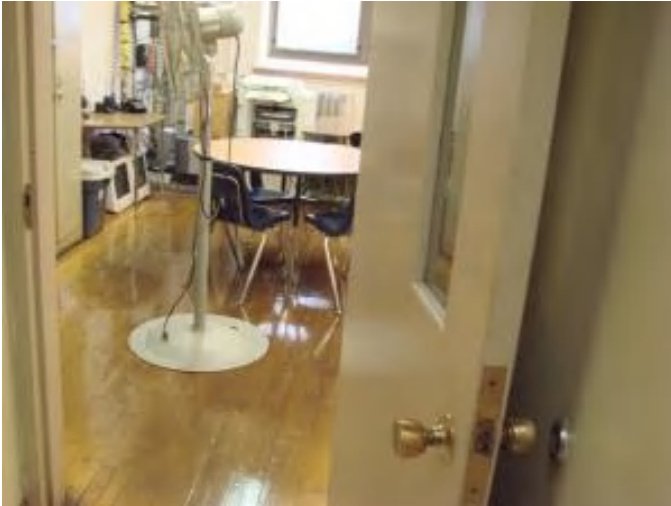
Location: Interior

System: C1020 - Interior Doors

Distress: Accessibility

Correction: Replace door knobs with compliant lever type

Notes: Replace all door hardware for accessibility

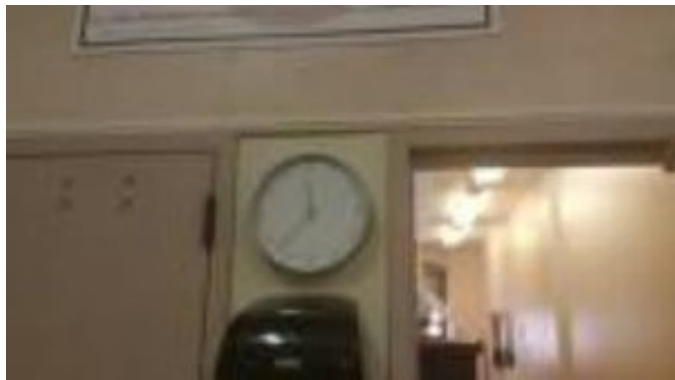
Location: throughout the building

System: D5030 - Communications and Security

Distress: Beyond Service Life

Correction: Add/Replace Clock System or Components

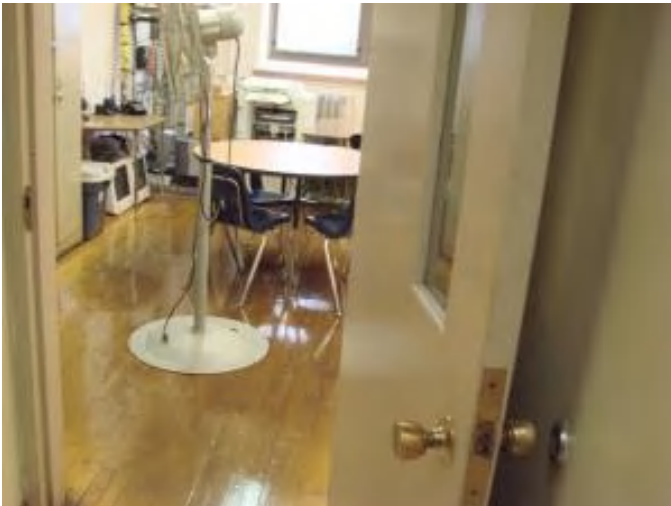
Location: Interior

System: C3020414 - Wood Flooring

Distress: Appearance

Correction: Remove and replace partial area of wood flooring and refinish entire floor - set replacement area

Notes: Refinish hardwood flooring

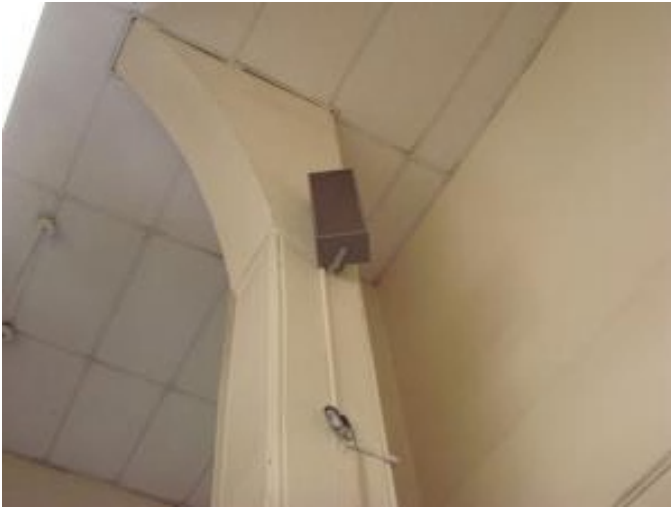
Location: Interior

System: C3030 - Ceiling Finishes

Distress: Beyond Service Life

Correction: Remove and replace suspended acoustic ceilings - lighting not included

Notes: Replace all suspended acoustical ceilings
