Facility Condition Assessment Summary Report

Dobbins High School

School District of Philadelphia
S406001;Dobbins
Final
Site Assessment Report
January 30, 2017

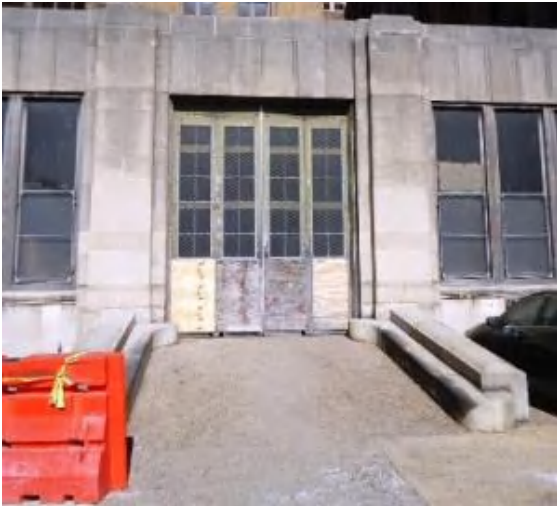
Location: Loading Dock

The loading dock door is an original wooden folding door that is damaged in several areas and no longer functional. This system is a very high traffic system and represents the only access for deliveries to the school. This door system is recommended to be removed and replaced with a modern overhead door system with safety and security considerations. This door is expected to be completed as part of other recommended corrections with the loading dock.

System: B2030 - Exterior Doors

Distress: Damaged

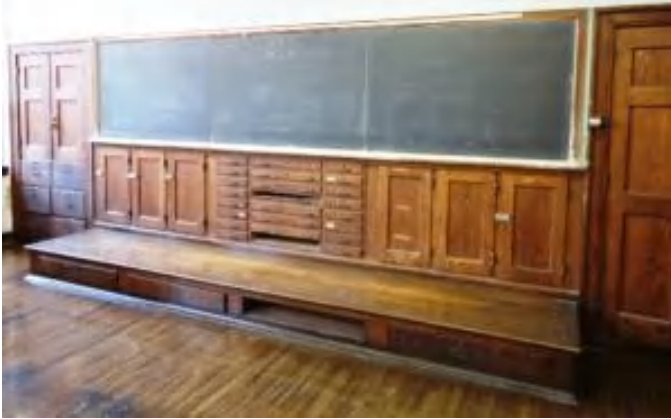
Location: Building Wide

System: C1030 - Fittings

Distress: Damaged

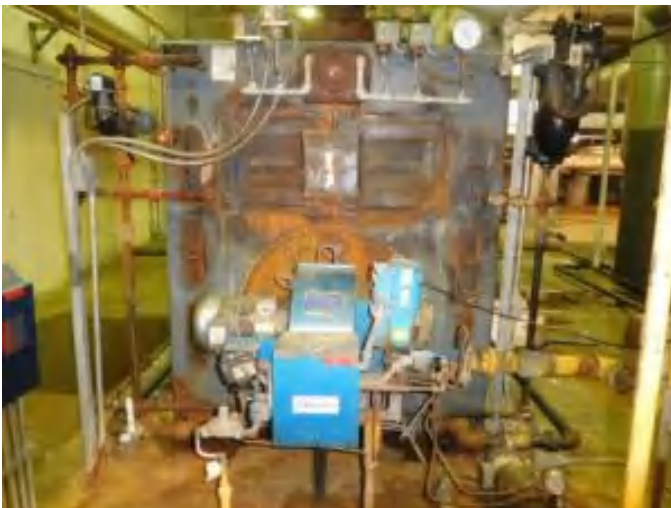
Location: mechanical room

System: D3020 - Heat Generating Systems

Distress: Beyond Service Life

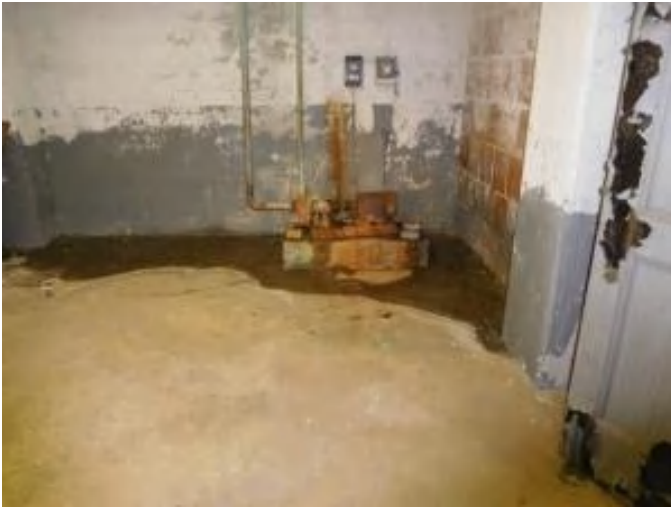
Location: mechanical room

System: D2020 - Domestic Water Distribution

Distress: Beyond Service Life

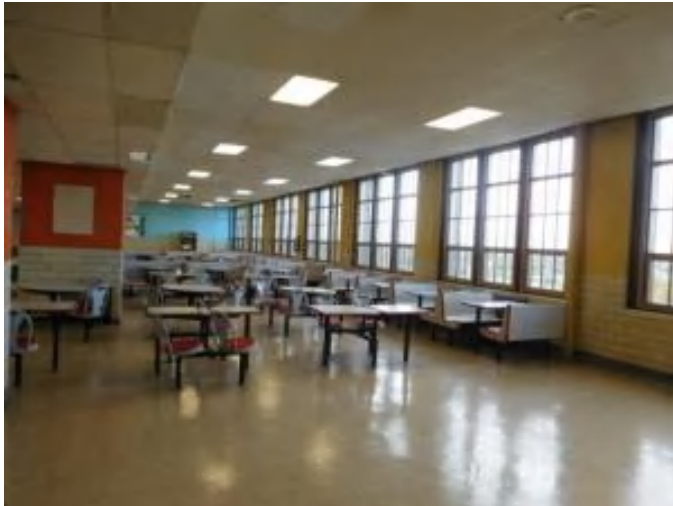
Location: cafeteria

System: D3040 - Distribution Systems

Distress: Building / MEP Codes

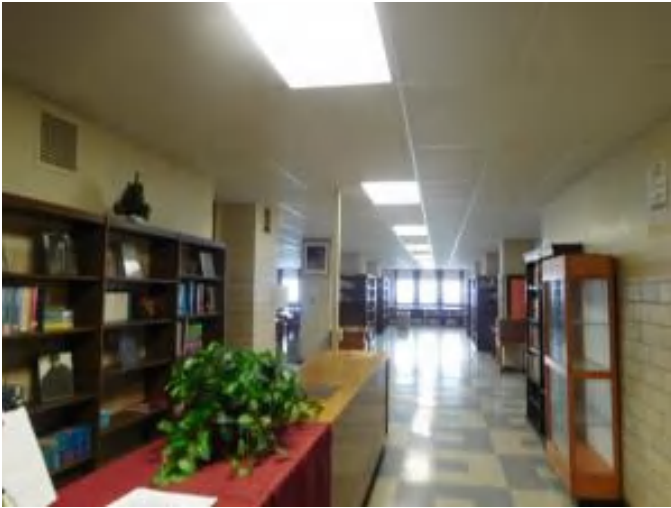
Location: entire building

System: D4010 - Sprinklers

Distress: Life Safety / NFPA / PFD

Notes: Install complete NFPA wet pipe automatic sprinkler system and standpipes. If required provide fire pump and jockey pump with controller.

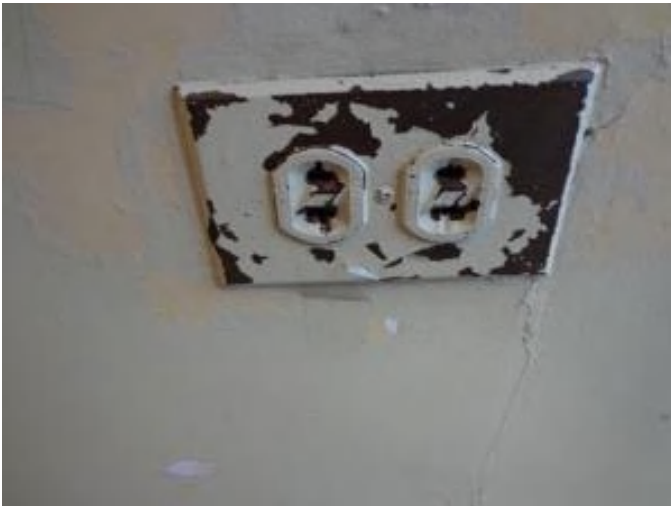
Location: Building wide

System: D5020 - Lighting and Branch Wiring

Distress: Beyond Service Life

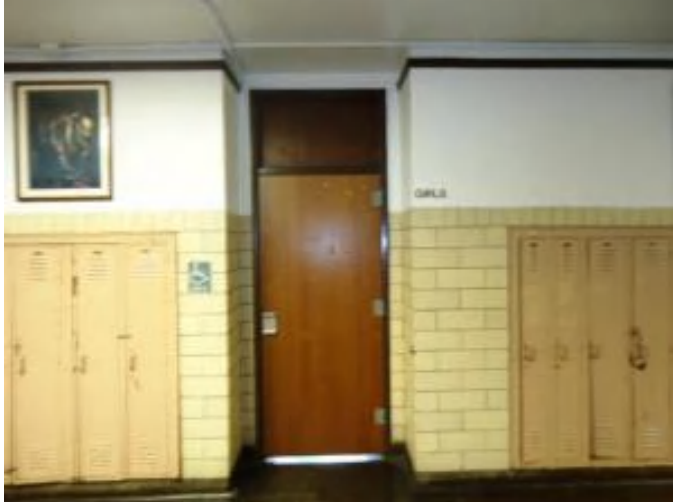
Location: Building Wide

System: C1030 - Fittings

Distress: Damaged

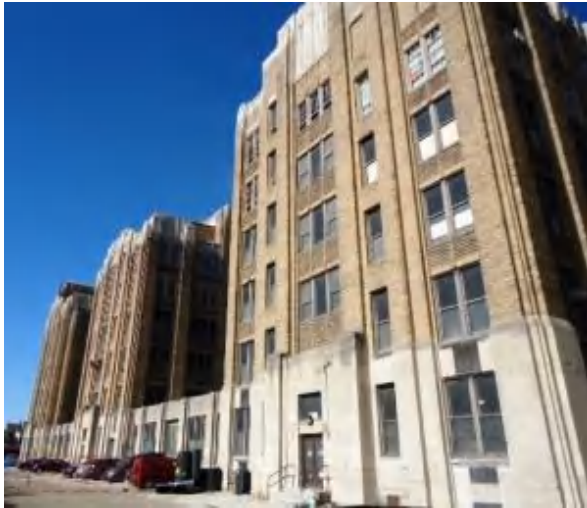
Location: Parking Lot

System: G2020 - Parking Lots

Distress: Damaged

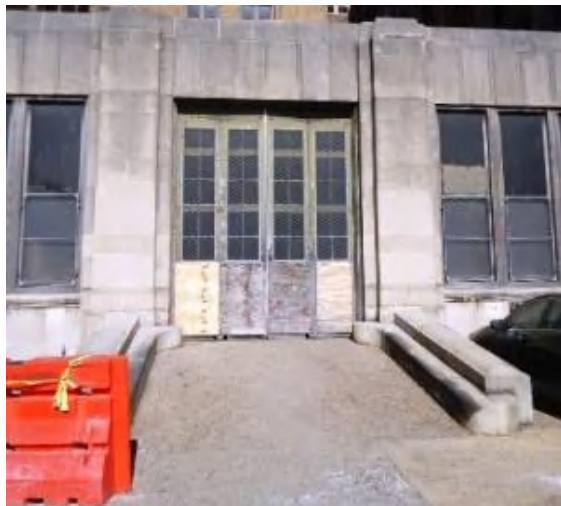
Location: Loading Dock

System: G2040 - Site Development

Distress: Health Hazard / Risk
