Facility Condition Assessment Summary Report

Duckrey School

School District of Philadelphia
S446001; Duckrey
Final
Site Assessment Report

January 30, 2017

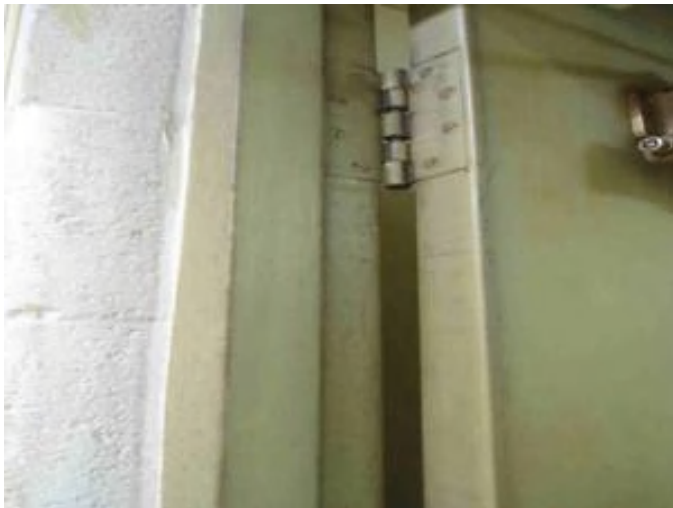
Location: Mechanical Space

System: C1010 - Partitions

Distress: Life Safety / NFPA / PFD

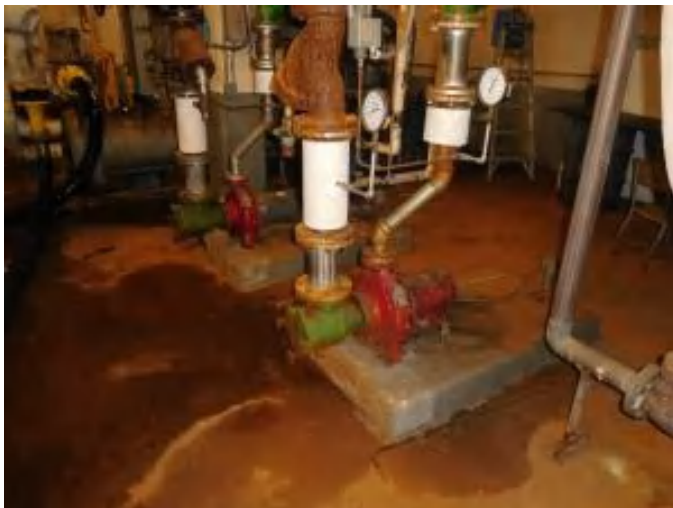
Location: mechanical room

System: D3020 - Heat Generating Systems

Distress: Beyond Service Life

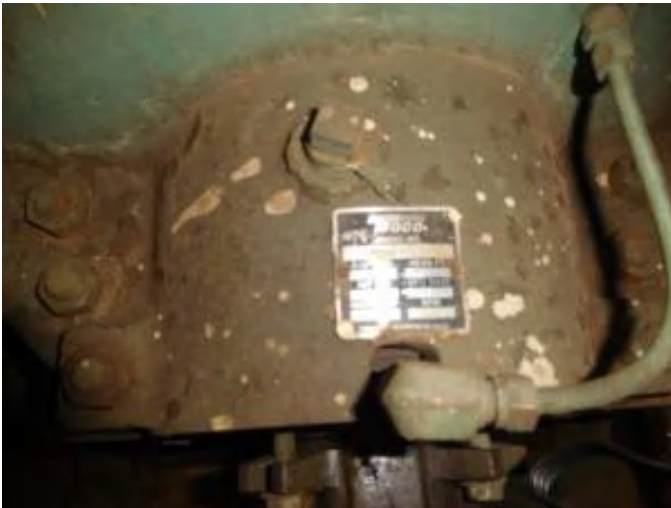
Location: mechanical room

System: D3030 - Cooling Generating Systems

Distress: Beyond Service Life

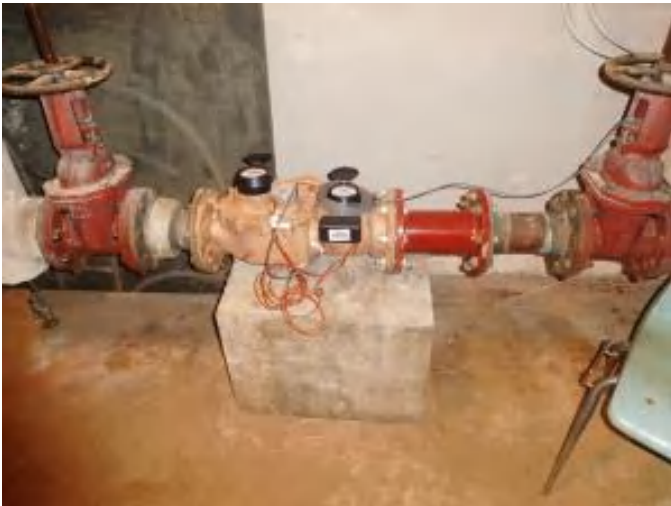
System: D2020 - Domestic Water Distribution

Location: mechanical room
Distress: Building / MEP Codes
Category: 2 - Code Compliance
Priority: 4 - Response Time (4-5 yrs)
Correction: Provide 3" reduced pressure back flow preventer
Qty: 1.00
Unit of Measure: Ea.
Estimate: \$34,306.86
Assessor Name: Craig Anding
Date Created: 11/10/2015

Notes: Install new reduced pressure backflow preventer in three inch water service.

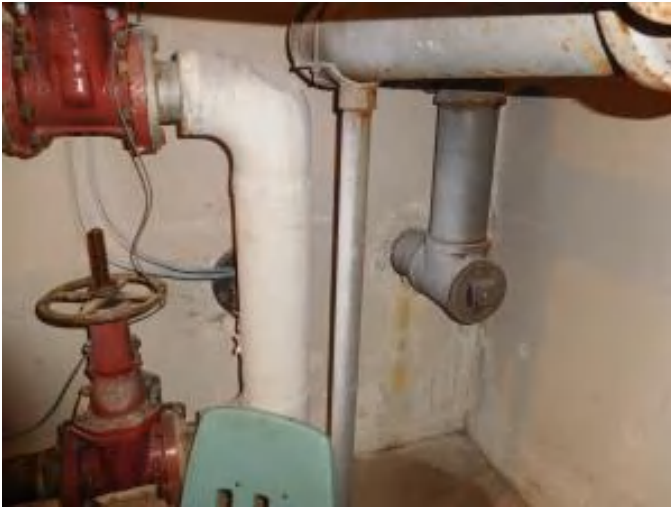
Location: entire building

System: D2030 - Sanitary Waste

Distress: Beyond Service Life

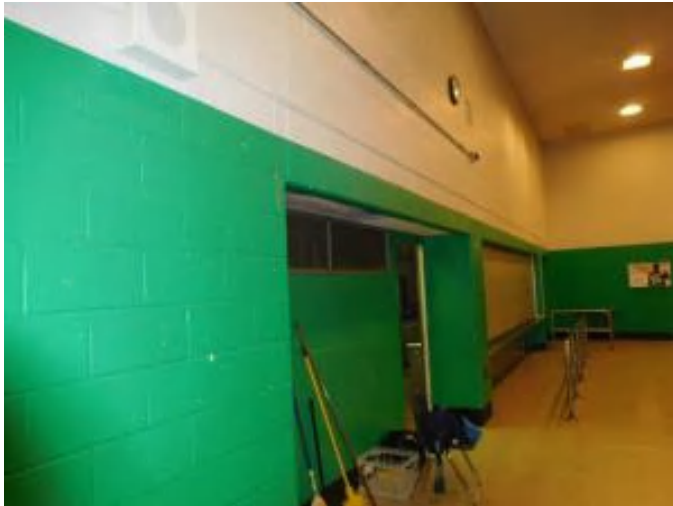
Location: cafeteria

System: D3040 - Distribution Systems

Distress: Building / MEP Codes

Notes: Provide a new central station air handling unit for the cafeteria with hot and chilled water coils, filters, outside and return air dampers, hydronic valves and controls, blower and motor. Connect to hot and chilled water systems.

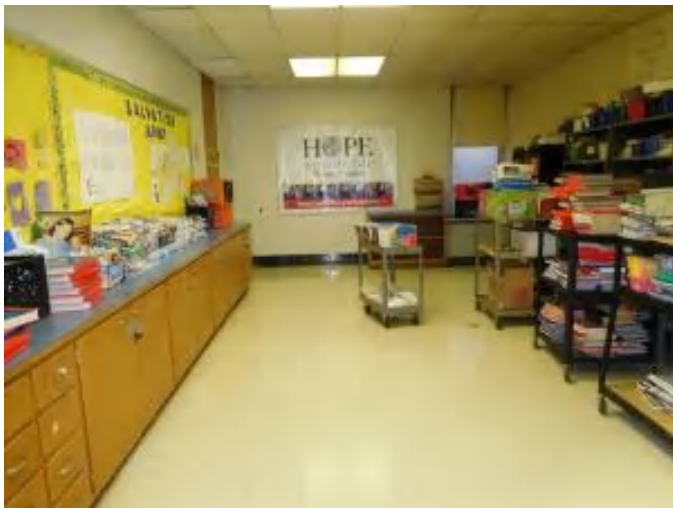
System: D4010 - Sprinklers

Location: entire building
Distress: Life Safety / NFPA / PFD
Category: 1 - Health & Safety
Priority: 4 - Response Time (4-5 yrs)
Correction: Install a fire protection sprinkler system
Qty: 101,115.00
Unit of Measure: S.F.
Estimate: \$1,446,497.35
Assessor Name: Craig Anding
Date Created: 11/10/2015

Notes: Install complete NFPA wet pipe automatic sprinkler system and standpipes. If required provide fire pump and jockey pump with controller.
