Facility Condition Assessment Summary Report

Fell School

School District of Philadelphia
S219001;Fell and Thomas
Final
Site Assessment Report
January 30, 2017

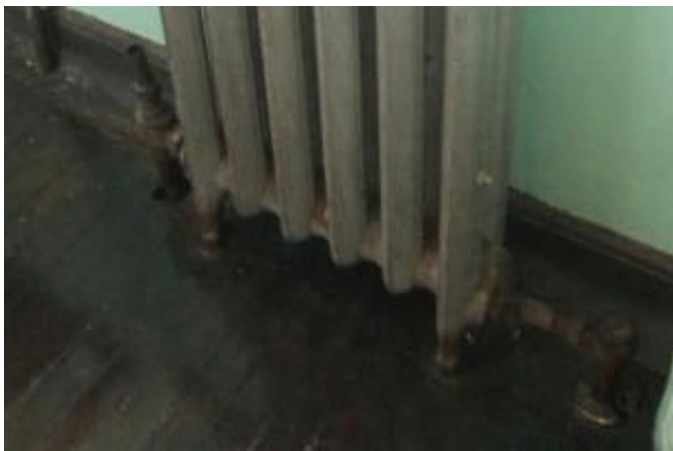
System: D3040 - Distribution Systems

Location: Entire building

Distress: Maintenance Required

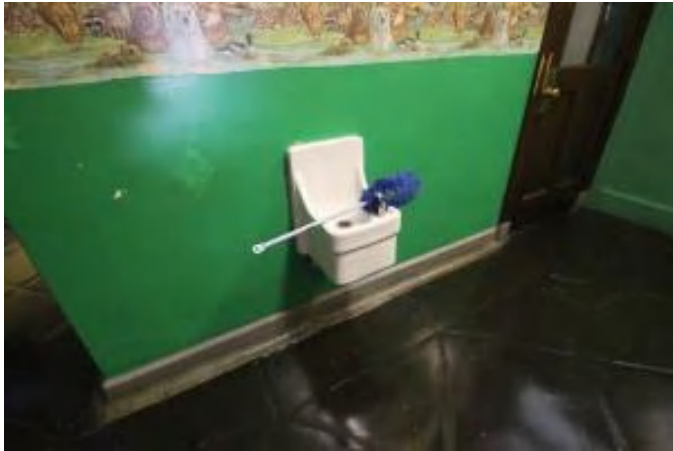
System: D2010 - Plumbing Fixtures

Location: Hallways

Distress: Accessibility

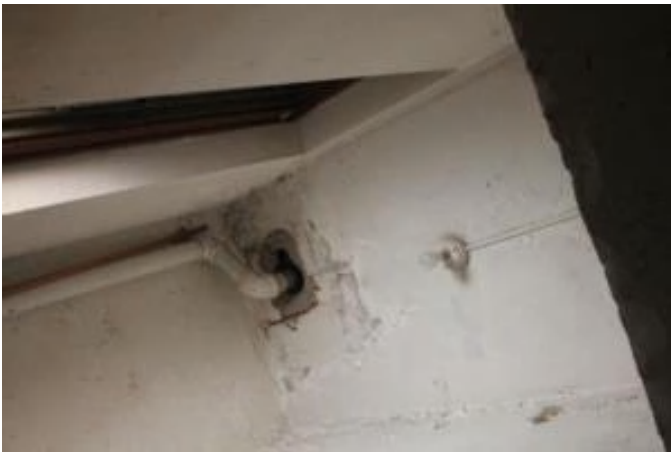
System: D2040 - Rain Water Drainage

Location: Entire building

Distress: Beyond Service Life

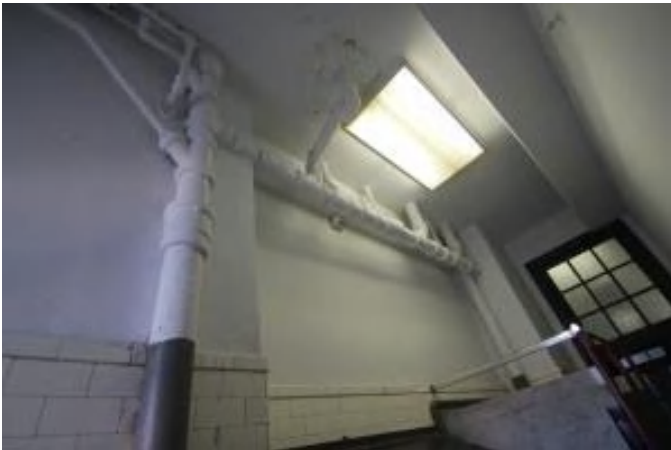
System: D2030 - Sanitary Waste

Location: Entire building

Distress: Beyond Service Life

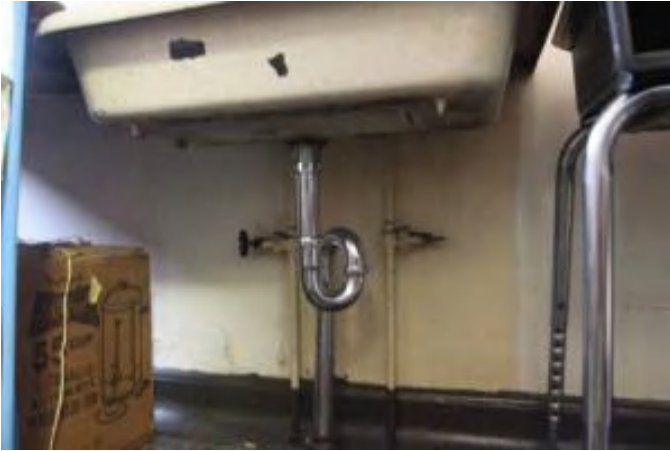
System: D2020 - Domestic Water Distribution

Location: Entire building

Distress: Beyond Service Life

Notes: Replace domestic water distribution piping due to age.

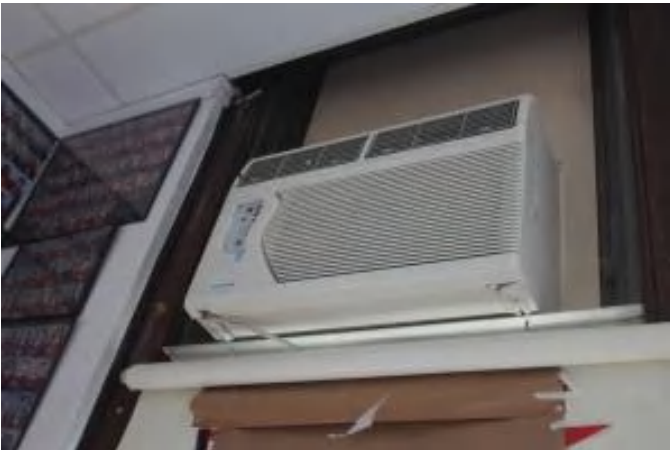
System: D3030 - Cooling Generating Systems

Location: Entire building

Distress: Inadequate

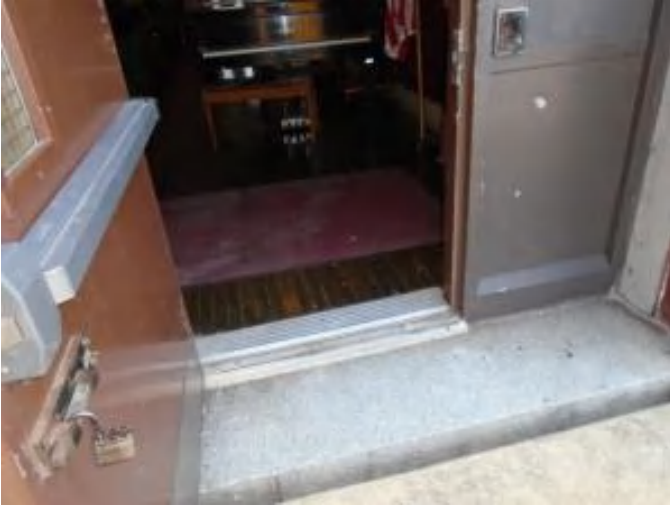
System: G2030 - Pedestrian Paving

Location: Auditorium Entrance

Distress: Accessibility

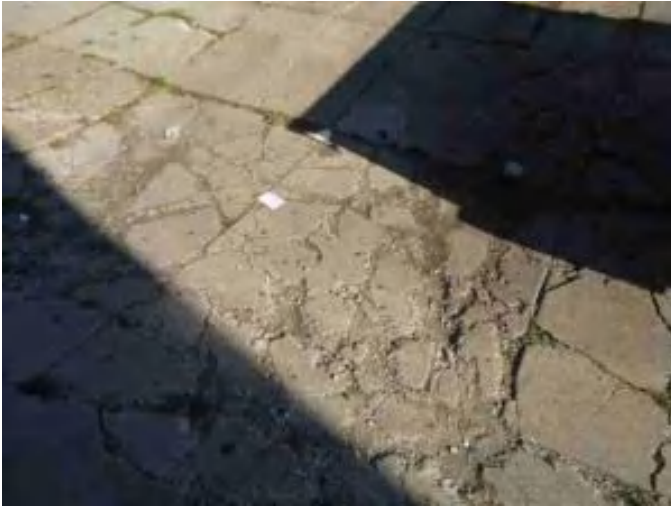
System: G2030 - Pedestrian Paving

Location: Thomas Site

Distress: Damaged

Notes: The sidewalk system is original to the buildings construction. There are a several areas of cracking concrete but no tripping hazards. The sidewalk system is expected to expire in the near future. Removal of the entire system is recommended. Universal upgrades are required and should include all aspects of current ADA legislation.

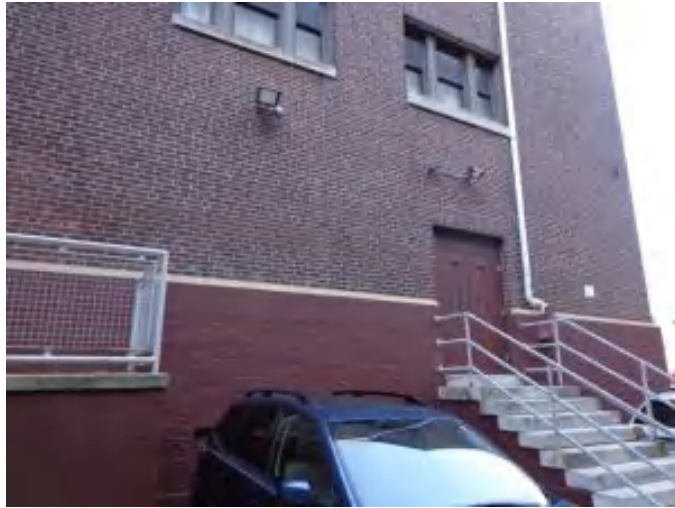
Location: Site exterior at Thomas

Distress: Beyond Service Life

Notes: Provide an allowance for the replacement of 6 exterior video surveillance cameras.

Correction: Replace video surveillance camera
